Evaluating Liftoff Debris for NASA's Space Launch System (SLS) Prior to the Artemis I Launch

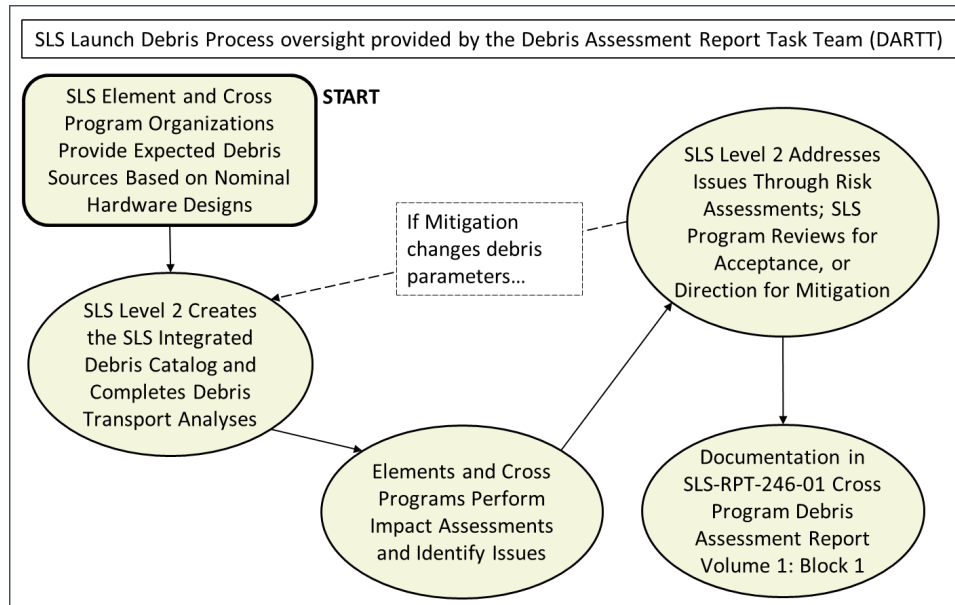
Fig. 2 Simplified Launch Debris Assessment Process

Assessment of the launch debris hazards to the SLS mission are performed as a nominal process using a widely reviewed and historically developed process that begins with the definition of debris sources that are expected to release during the liftoff and ascent phases of the mission. The defined debris parameters are typically maximum expected sizes based on historical data and test data or conservative sizes based on analyses and test data. Once defined, debris transport analyses are performed for each of the debris sources to predict impact energies on the components on the vehicle. The vehicle components are assessed for impact damage tolerance from the predicted impact energies by either deterministically clearing the predicted impacts or identifying impacts as concerns for further evaluation. Figure 2 shows a general process flow for assessment of expected launch debris.

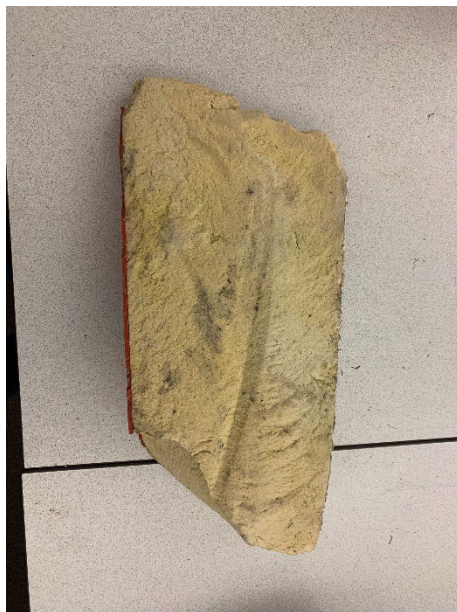
Fig. 3 Booster Throat Plug Fragment Recovered after Artemis I

SLS Program accepted the throat plug risk for Artemis I with direction to study the results of Artemis I to inform the risk for future, crewed missions. The SLS and Exploration Ground Systems (EGS) teams conducted extensive post-launch walkdowns to retrieve the throat plug fragments after the Artemis I mission. The results from the walkdowns and accompanying catalogs and analysis are being used to inform the risk moving toward the Artemis II launch [2].

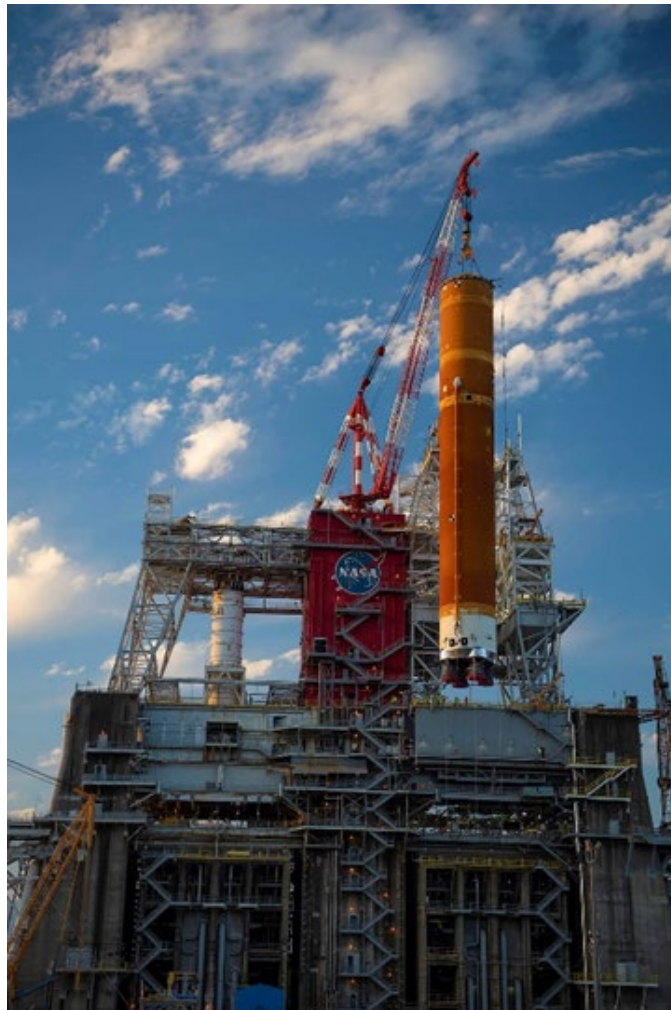
Fig. 5 Artemis I Core Stage and Stennis B-Stand

The Green Run test campaign was performed on the B-Stand at NASA's Stennis Space Center (SSC). The SLS Artemis I Core Stage (CS1) was vertically integrated into the stand on January 22, 2020 after being delivered to SSC from Michoud Assembly Facility (MAF) via NASA's Pegasus barge. The Artemis I Core Stage remained in the B-Stand at Stennis for an extended period of time while the Green Run test campaign was performed. There were a number of test points along this campaign to demonstrate the capability of the integrated stage with the four RS-25 engines that would propel the Artemis I mission into an orbit around the moon. The Green Run campaign run at Stennis was the first opportunity to test a configuration of four RS-25 engines and the new liquid hydrogen tank and liquid oxygen tank components of the Artemis I Core Stage along with extensive Developmental Flight Instrumentation (DFI) and new designs for sub-systems such as the Thrust Vector Control (TVC) system. Near the completion of the Green Run test campaign, the final two milestones were the Wet Dress Rehearsal (WDR) and Hot Fire tests. The Wet Dress Rehearsal test was the first opportunity to fuel the liquid hydrogen and liquid oxygen tanks on CS1 with cryogenic fluid. The initial WDR for Green Run was unable to fully complete all objectives and thus a second WDR was required. The second Green Run WDR was successful, and the program pressed toward towards the Green Run Hot Fire Test—which involved a full-duration burn of all four RS-25 engines and TVC gimbaling. The initial Green Run Hot Fire Test was prematurely aborted due to triggering of a system redline. The Artemis I Core Stage was able to safely perform engine shutdown and then drain the remaining cryogenic propellant. The second Green Run Hot Fire Test was fully successful and achieved full duration burn along with nominal TVC performance.
