Advancements in Low Leakage Valves for Long Duration Missions.

NASA Marshall Space Flight Center, Alabama, USA

This paper reports on the advancements in the development of low-leakage valve technology for cryogenic environments, currently under development at NASA's Marshall Space Flight Center. These valves consist of a 3-inch isolation valve, a 3-inch relief valve, and an 8-inch pre-valve. Each of these valves contain a self-aligning seat and poppet design to significantly reduce the quantity of propellant flowing past the seat when the valve is in its closed state (internal leakage). This self-aligning design utilizes a metallic poppet head with five degrees of freedom and is intended to allow a valve to be more tolerant of the imperfect contacts and misalignments that are commonly found between sealing surfaces. This paper covers the test articles, facilities, objectives, and test results.

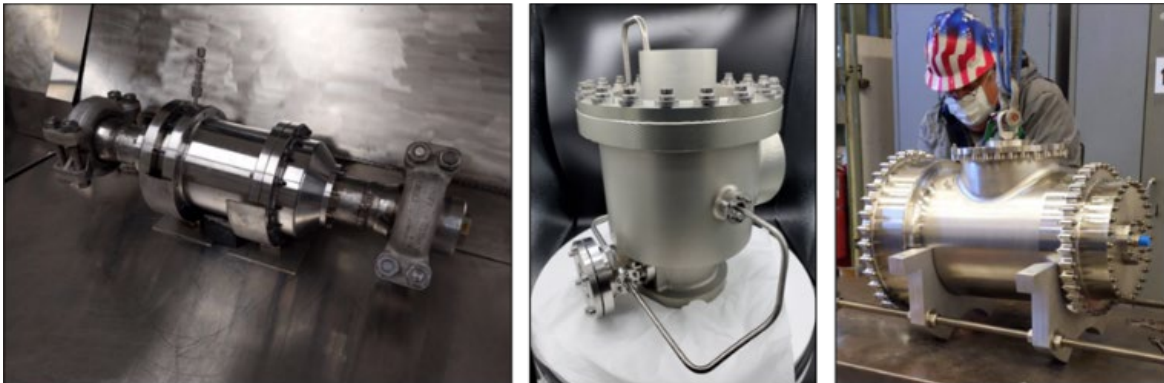
- 1) A 3" isolation valve for liquid flow (LN_2 and LH_2).
- 2) A 3" relief valve for gas flow (GHe chilled with LN_2 and LH_2).
- 3) An 8" pre-valve for gas and / or liquid flow (LN_2 -chilled GHe and LH_2).

Fig. 5 Low-Leakage Test Valves: LLIV (Left), LLRV (Center), LPV (Right)

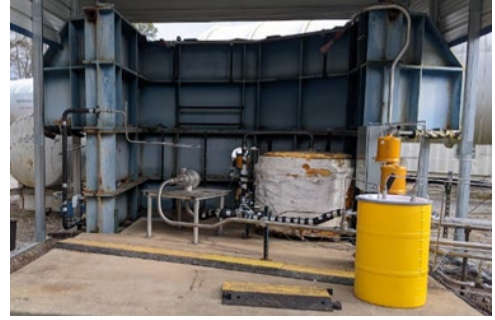
Fig. 7 Test Stand 300 Bunker

Upon the completion of LN₂ testing, the test articles were moved to Test Stand 300 (situated in the East Test Area at MSFC), to undertake LH₂ testing (test bunker shown in Fig. 7).

After completing “LN₂ testing”, the LLRV was moved to Test Stand 300 to conduct “LH₂ testing”. Since the test article functions as a relief valve, cryogenic hydrogen gas (GH₂) was used as the fluid medium instead of LH₂. The primary objective of the “LH₂ test” for the LLRV was to measure the internal leakage rate through the valve after subjecting the test article flow of GH₂. As with the testing conducted at the CDA, an LN₂ spraybar was placed above the test article in order to chill-in the valve body. The LLRV is shown in its test setup in Fig. 14 and Fig. 15.

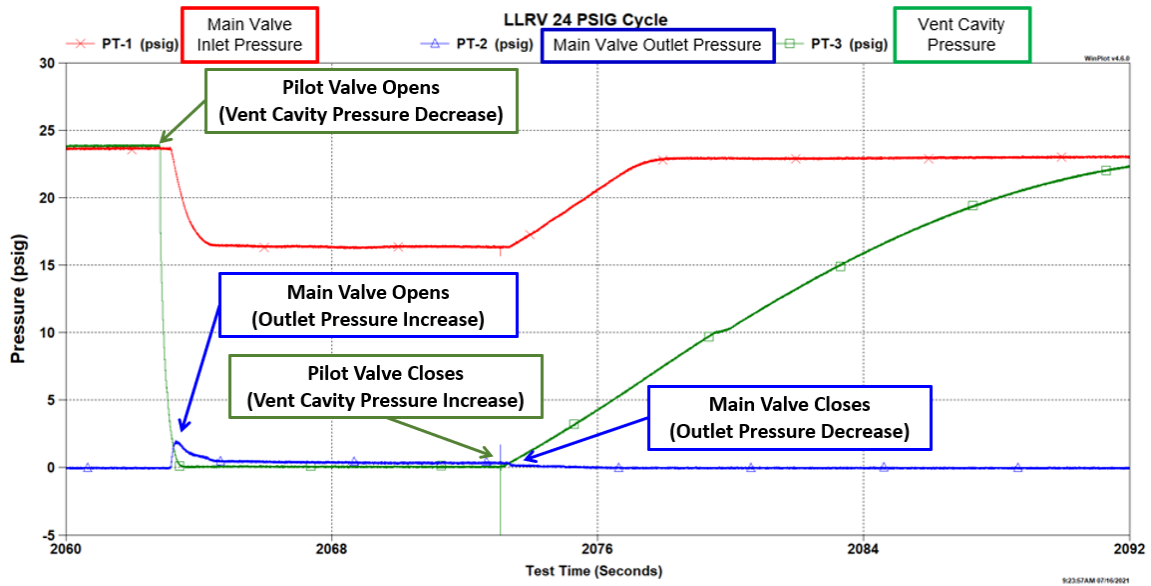
Once the pressure differential between the inlet bore and the vent cavity reaches the appropriate level, the main spring preload is overcome, and the main valve begins to open. This allows direct connection between inlet and outlet, thus relieving inlet pressure. As inlet pressure drops below the pilot valve reseal pressure, the pilot valve closes and allows pressure to build in the vent cavity via the bleed hole. As pressure in the vent cavity and inlet bore begins to equalize, the force of the pressure differential is overcome by the main spring preload, which returns the test article to its normally-closed state. Fig. 11 illustrates the different pressure levels over time for the test article.

Fig. 11: Pressure Levels During an LLRV Cycle

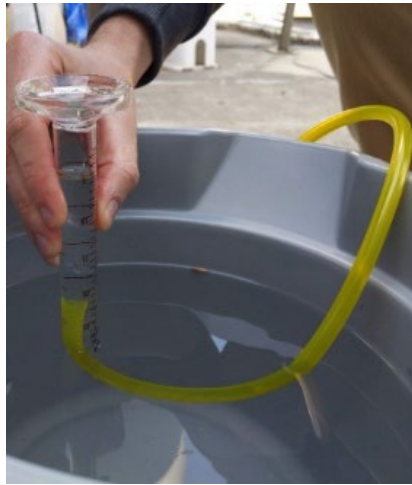
The end of the Tygon tubing was submerged in water and observed for a minimum of 2 minutes, capturing any bubbles within an inverted graduated cylinder (as shown in Fig. 12). If no bubbles were observed, the Tygon tubing would be exchanged out for a flowmeter, which would be observed until the reading stabilized. Unlike the LLIV and the LPV, submerging the LLRV in LN₂ to achieve cryogenic temperatures was not feasible due to the nature of the valve (relief valve). A spraybar for LN₂ was instead placed above the test article (as shown in Fig. 13) in order to chill in the valve body.

Fig. 12: Bubble Check

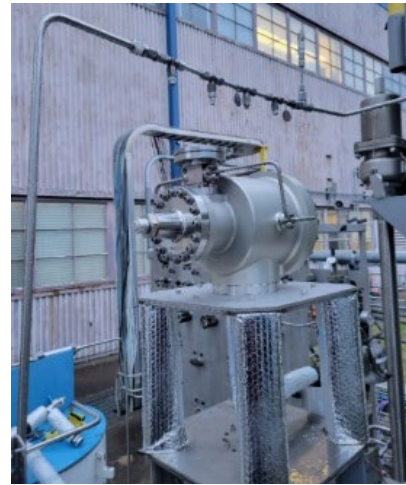
Fig. 13: CDA Spraybar Setup

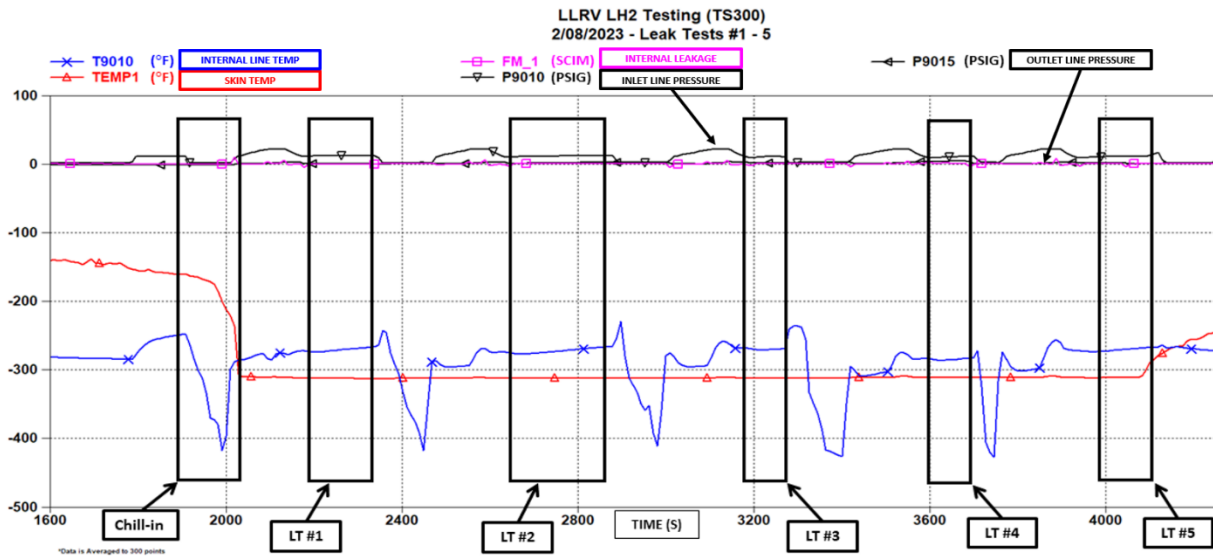
A general plot of the LLRV LH₂ Test timeline and parameters measured is shown in Fig. 17. Internal leakage rates measured for the LLRV were again excellent, consistently falling under 1.0 SCIM. A more detailed look at individual LH₂ Leak Tests for the LLRV is included on subsequent pages.

Fig. 17: Overview of LLRV “LH₂” Test Data

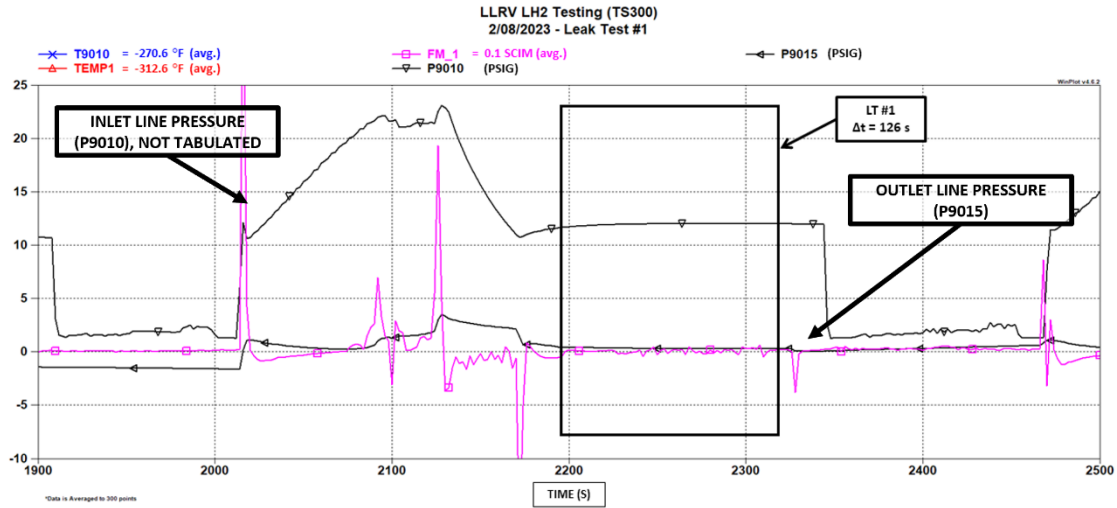
Fig. 18: LLRV Flow and Leak Test #1

For LLRV Leak Test and Measurement #1, values were recorded over a duration of approximately 126 seconds, as shown in Fig. 18. Internal line temperature (T9010) rises at a slow rate due to the LN₂ spray bar, and the test article skin temperature (TEMP1) is held constant. Outlet line pressure (P9015) stays relatively stable throughout the measurement staying at or below 0.4 psig. Internal leakage was recorded at rates of 0.5 SCIM or less. It should be noted that although inlet line pressure is shown in the figure, it is not tabulated below.

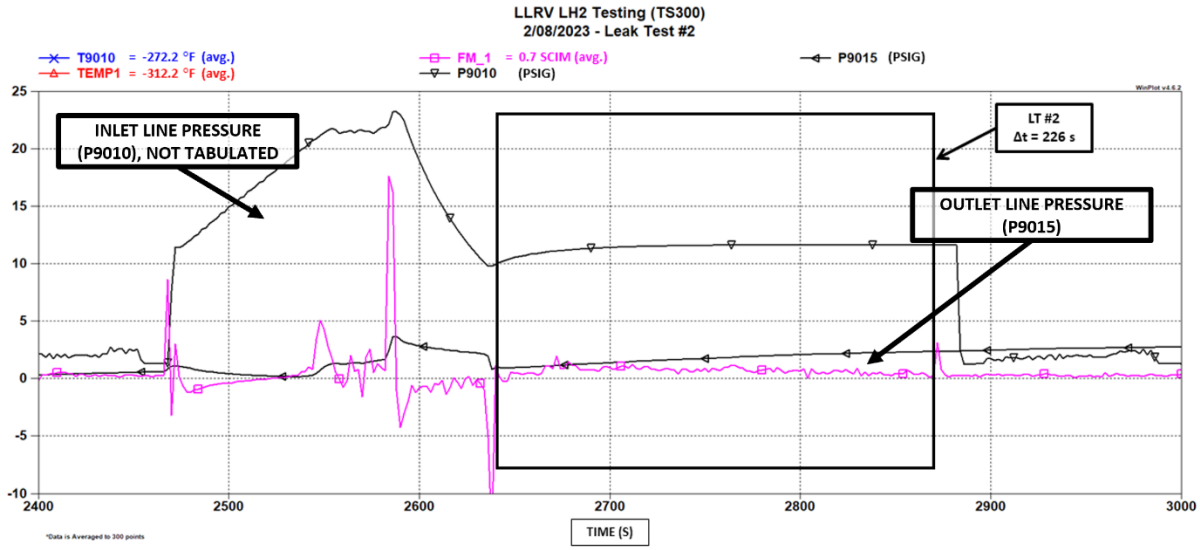
Fig. 19: LLRV Flow and Leak Test #2

For LLRV Leak Test and Measurement #2, values were recorded over a duration of approximately 226 seconds, as shown in Fig. 19. Internal line temperature (T9010) rises at a slow rate due to the LN₂ spray bar, and the test article skin temperature (TEMP1) is held constant. Over the course of the measurement, outlet line pressure (P9015) increases from a value of 0.94 psig to 2.30 psig, but still stays well below the 5 psig cracking pressure of the check valve. Internal leakage was recorded at rates ranging from 0.4 SCIM to 1.1 SCIM. Although the effects from outlet line pressure on the check valve are believed to be minimal or non-existent, a larger backpressure can also result in higher internal leakage rates due to a smaller net sealing force acting across the poppet and the seat. As such, it is believed that the most accurate value for internal leakage is found at the local minimum for outlet pressure and the active flowmeter. In the case of LLRV Leak Measurement #2, this value was 0.5 SCIM, occurring at a time value of approximately 2640s. It should be noted that although inlet line pressure is shown in the figure, it is not tabulated below.

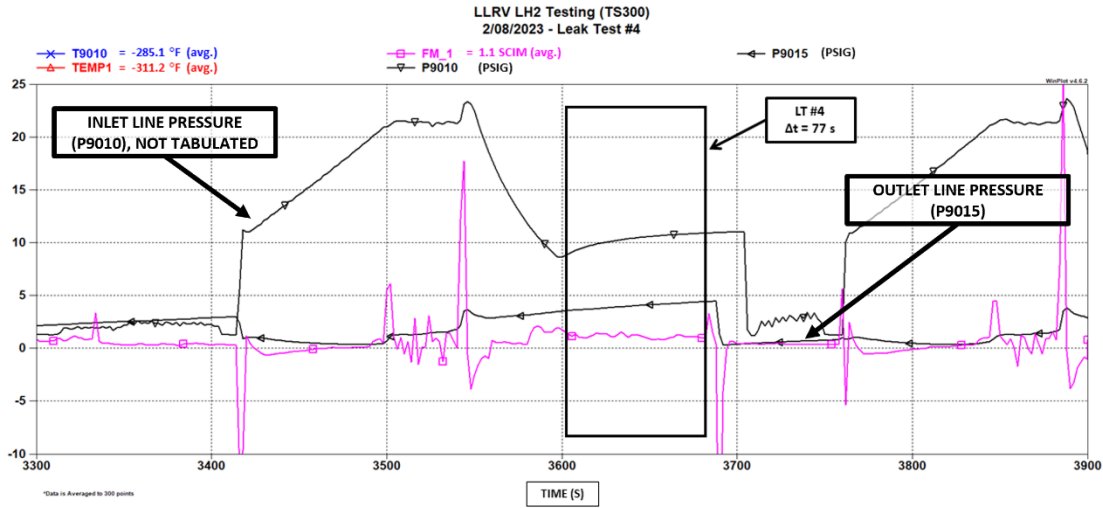
Fig. 21: LLRV Flow and Leak Test #4

For LLRV Leak Test and Measurement #4, values were recorded over a duration of approximately 77 seconds, as shown in Fig. 21. Internal line temperature (T9010) and test article skin temperature (TEMP1) are held constant due to the LN₂ spray bar. Over the course of the measurement, outlet line pressure (P9015) increases from a value of 3.64 psig to 4.4 psig, starting to approach the 5 psig cracking pressure of the check valve. Internal leakage was recorded at rates ranging from 0.7 SCIM to 1.4 SCIM. Although the effects from outlet line pressure on the check valve are still believed to be minimal, a larger backpressure can also result in higher internal leakage rates due to a smaller net sealing force acting across the poppet and the seat. As such, it is believed that the most accurate value for internal leakage is found at the local minimum for outlet pressure and the active flowmeter. In the case of LLRV Leak Measurement #4, this value was 0.8 SCIM, occurring at a time value of approximately 3610s. It should be noted that although inlet line pressure is shown in the figure, it is not tabulated below.

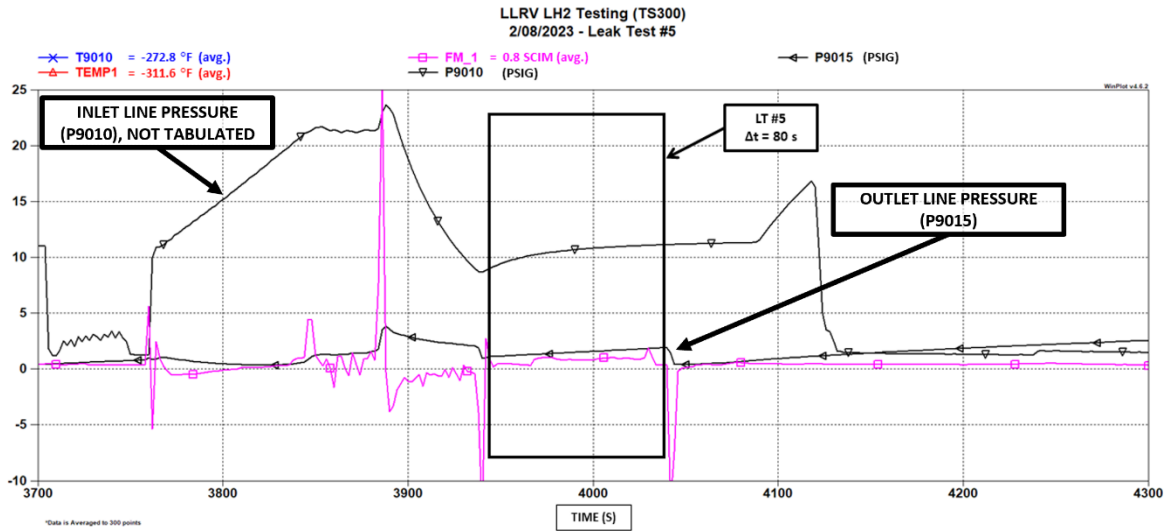
Fig. 22: LLRV Flow and Leak Test #5

For LLRV Leak Test and Measurement #5, values were recorded over a duration of approximately 80 seconds, as shown in Fig. 22. Internal line temperature (T9010) and test article skin temperature (TEMP1) are held constant due to the LN₂ spray bar. Over the course of the measurement, outlet line pressure (P9015) increases from a value of 1.14 psig to 1.75 psig, but still stays well below the 5 psig cracking pressure of the check valve. Internal leakage was recorded at rates ranging from 0.4 SCIM to 0.9 SCIM (the 2.5 SCIM value is a momentary result from opening the flowmeter). Although the effects from outlet line pressure on the check valve are believed to be minimal or non-existent, a larger backpressure can also result in higher internal leakage rates due to a smaller net sealing force acting across the poppet and the seat. As such, it is believed that the most accurate value for internal leakage is found at the local minimum for outlet pressure and the active flowmeter. In the case of LLRV Leak Measurement #5, this value was 0.5 SCIM, occurring at a time value of approximately 3950s. It should be noted that although inlet line pressure is shown in the figure, it is not tabulated below.

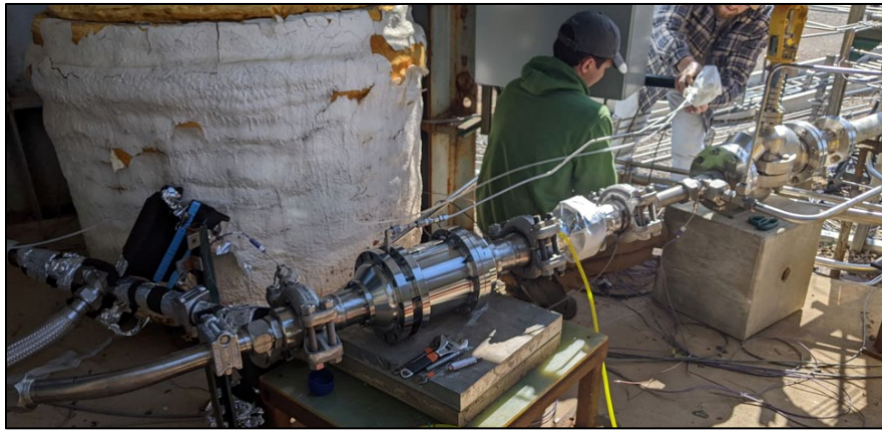
Fig. 26: LLIV LH₂ Test Setup

The primary objective of the LH₂ test for the LLIV was to measure the internal leakage rate through the test article after subjecting the test article to flow of liquid hydrogen (LH₂). The LLIV is shown being integrated into its test setup in Fig. 26.

To prevent air and moisture from entering the system (also known as “cryopumping”) and impacting the operation of the LLIV, a check valve and extended vent line were installed from the vent for the actuator control valve into the burn stack duct. A check valve to prevent cryopumping was also installed downstream of the flow meters. Although these check valves were not included on the original schematic, their approximate location has been noted in Fig. 27. Both check valves were rated for 5 psig cracking pressure. Color-coded boxes have also been included, which correspond to the parameters plotted in subsequent figures.

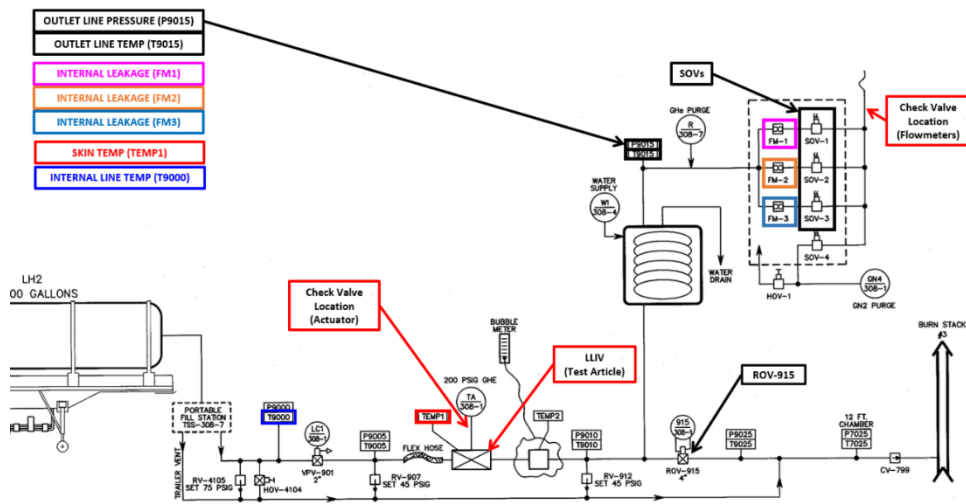
Fig. 27: LLIV LH₂ Test Schematic Details

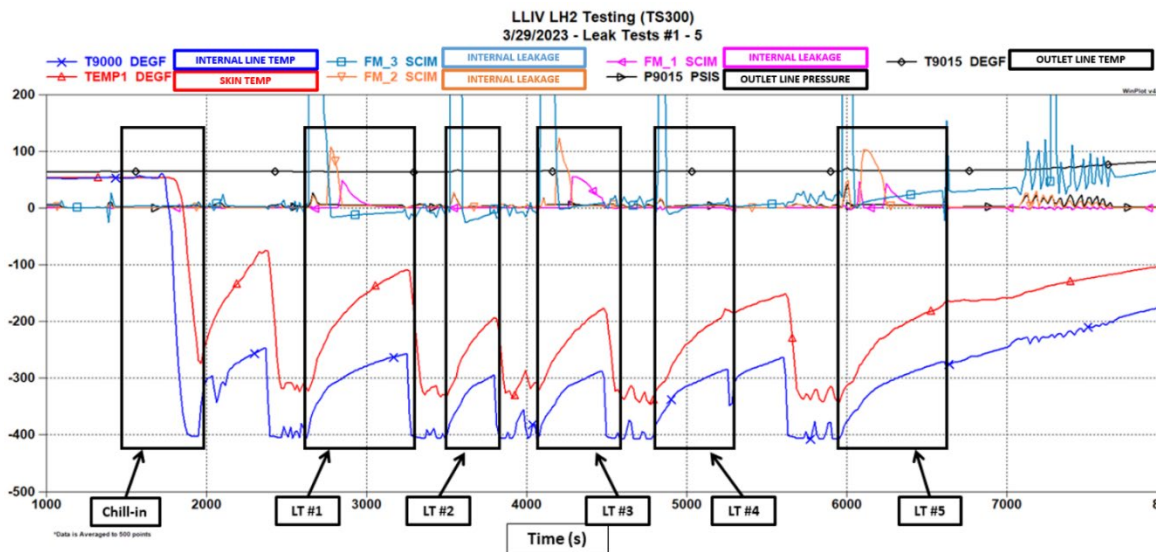
Due to the check valve placed to prevent cryopumping, a build-up of outlet line pressure between the test article and the flowmeters would occur if ROV-915 was closed before the test article outlet line had been fully drained. This “short drain” would lead to a large initial reading of internal leakage (as seen in Leak Tests #1, #3, and #5 from Fig. 28), but was done in order to retain cryogenic temperatures for as long as possible. This internal leakage would decrease as outlet line pressure dropped, but while also seeing temperatures rise.

Fig. 28: Overview of LLIV LH₂ Test Data

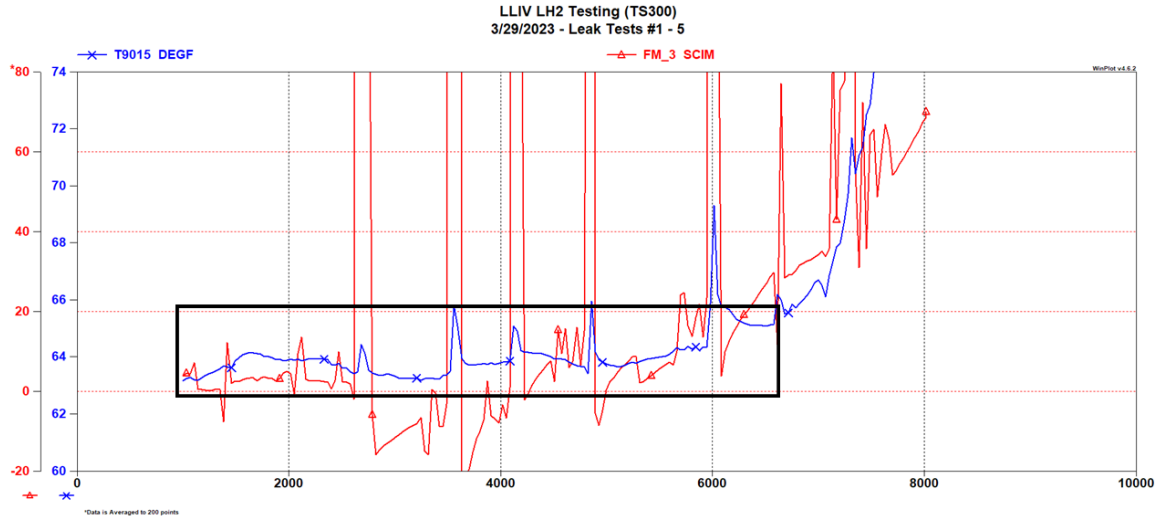
Throughout the test the zero-offset of FM3 was seen to increase by approximately 20 SCIM. This change is likely due to the large capacity of the flow meter combined with the increase in ambient temperature throughout the day (as recorded between time values of 1000s and 6500s by T9015 and seen in Fig. 29). No significant shift in zero-offset was observed in FM2 and FM1 (not shown).

Fig. 29: LLIV FM3 Zero-Offset Shift

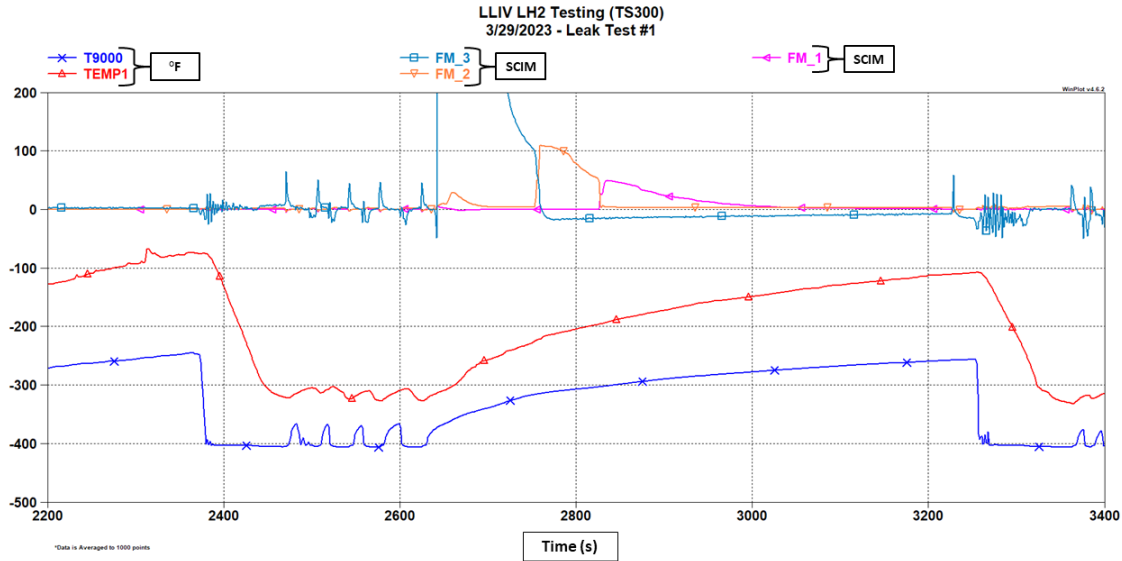
Fig. 31: LLIV Flow and Leak Test #1

For LLIV Leak Test and Measurement #1, a “short drain” process was performed, quickly closing ROV-915 in an attempt to retain cryogenic temperatures for as long as possible. Although internal leakage can be seen to decrease as temperature rises, post-test analysis revealed a much stronger correlation with outlet line pressure (as previously shown in Fig. 30). Internal leakage (bold values in “FM” columns) was seen to drop below 50 SCIM as outlet line pressure (P9015) dropped to 4.71 psig. As shown in Table 14, this event occurred at an approximate time value of 2830 seconds, with internal line temperature (T9000) at -302.5°F and test article surface temperature (TEMP1) at -194.4°F. It should be noted that this table has been separated by a horizontal line that indicates a change in time step.

Internal leakage continues to decrease as outlet line pressure drops below the 5 psig cracking pressure of the check valve. Although this reduction in internal leakage measured is largely driven by flow reduction after the check valve reseats, a lower (or decreasing) backpressure can also result in lower internal leakage rates due to a larger net sealing force acting across the poppet and the seat. As such, it is believed that the most accurate value for internal leakage is found at the local minimum for outlet pressure and the active flowmeter. In the case of LLIV Leak Measurement #1, this value was 1.0 SCIM, occurring at a time value of approximately 3130s.

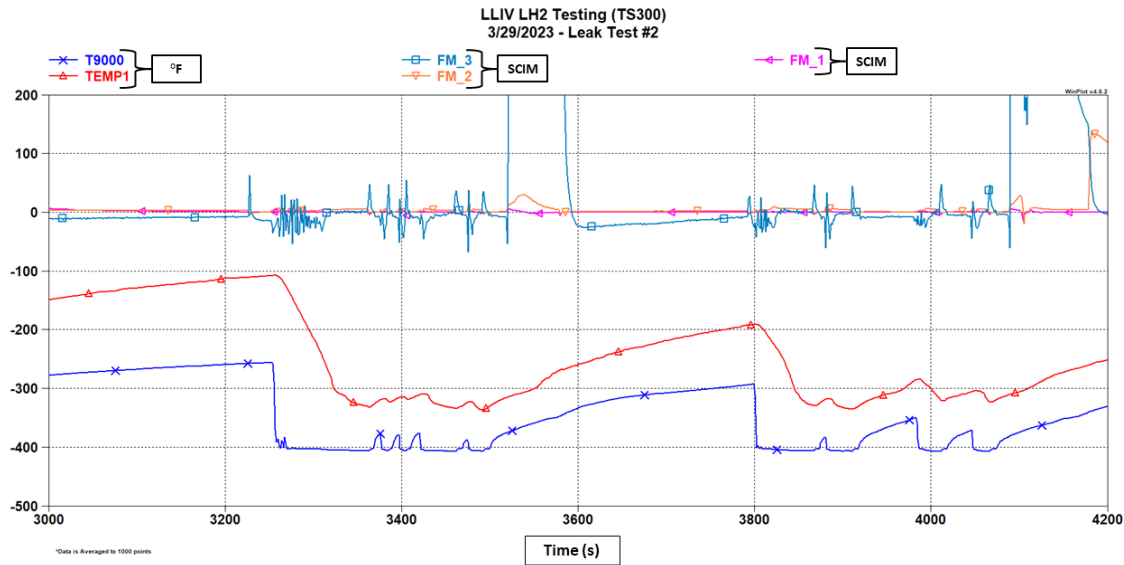
Fig. 32: LLIV Flow and Leak Test #2

For LLIV Leak Test and Measurement #2, ROV-915 was allowed to remain open for a longer period (a “full drain”) in order to remove more hydrogen from the line (and reduce pressure) for leak measurements. This quickly resulted in a local minimum for outlet pressure and the active flow meter. As shown in Table 15, this event occurred at an approximate time value of 3610 seconds, with outlet line pressure (P9015) at 1.18 psig, internal line temperature (T9000) at -328.5°F and test article surface temperature (TEMP1) at -255.2°F.

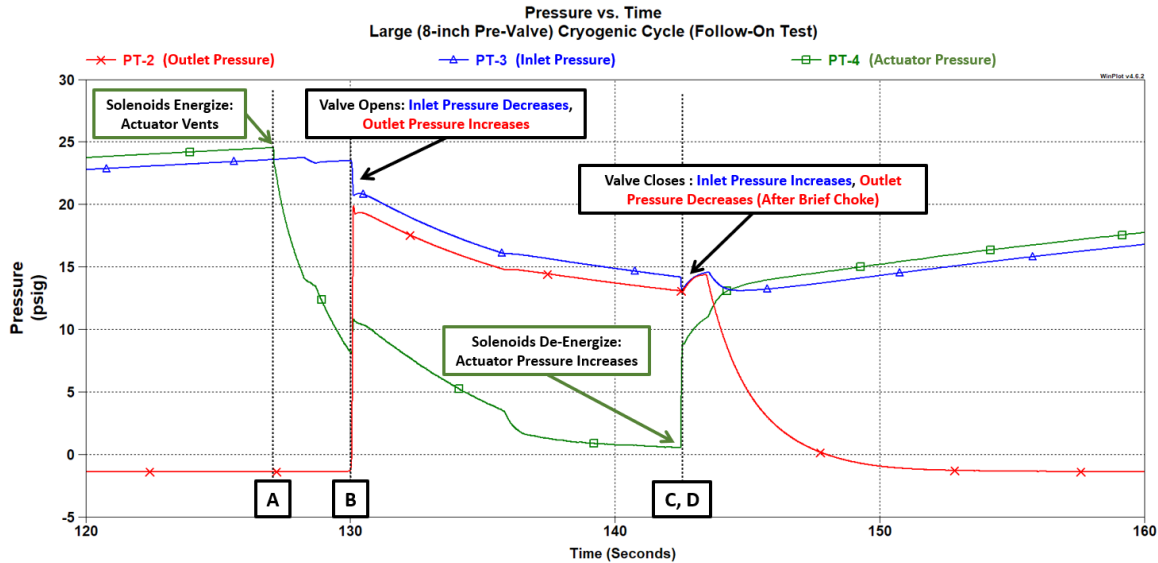
To close the LPV, the solenoid valves are de-energized, repressurizing the actuator chamber (**Event C**). This reduction in the pressure differential allows the compression spring preload to return the test article to its normally closed position (**Event D**).

Fig. 38: Pressure Levels During an LPV Cycle

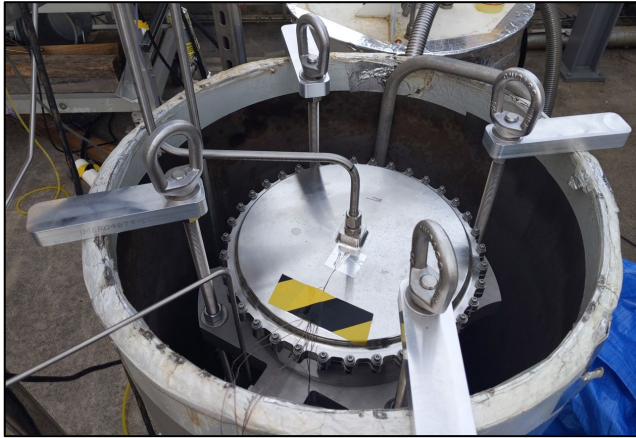
Fig. 39: LPV Test Setup (LN₂)

Internal leakage rate testing was conducted by connecting Tygon tubing to the outlet of the test article, submerging the end of the tubing in water, and capturing any bubbles within an inverted graduated cylinder over the course of 2 minutes (minimum). For measurements where a lower internal leakage rate was observed, this time period was

extended to 5 minutes. The Tygon tubing would then be exchanged with a flowmeter and another measurement would be performed (Fig. 40).

The LPV successfully completed the proof test at 45 psig, after which point an external leakage check was conducted. The LPV was pressurized to 25 psig and a leak check (soap) solution was utilized to monitor for any signs of external leakage (bubbles) at exposed fittings and other connection points. Not all fittings were accessible due to the size of the test article and its location within a tank (Fig. 39), so a pressure decay check was performed as well, monitoring for any pressure drop over the course of 10 minutes.

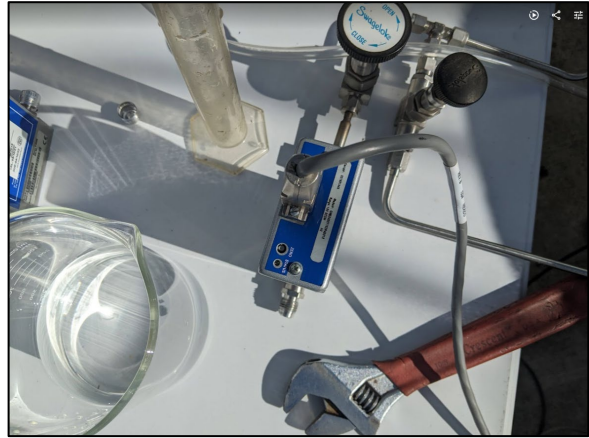
Fig. 40: Dual Instrument Manifold

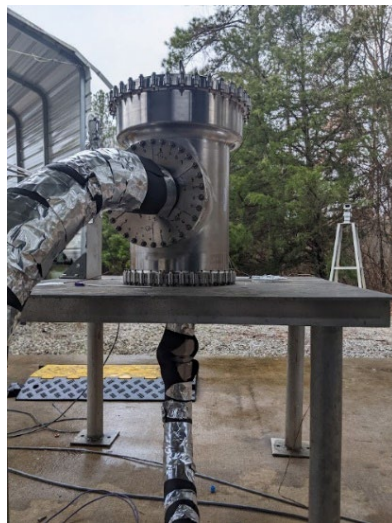
Fig. 41: LPV Prior to LH₂ Test

The primary objective of the LH₂ test for the LPV was to measure the internal leakage rate through the test article after subjecting the test article to flow of liquid hydrogen (LH₂). The LPV is shown in its test setup in Fig. 41 and Fig. 42.

To prevent air and moisture from entering the system (also known as “cryopumping”) and impacting the operation of the LPV, a check valve (rated for 5 psig cracking pressure) was installed downstream of the flow meters. Although this check valve was not included on the original schematic, its approximate location has been noted in Fig. 43. Color-coded boxes have also been included, which correspond to the parameters plotted in subsequent figures.

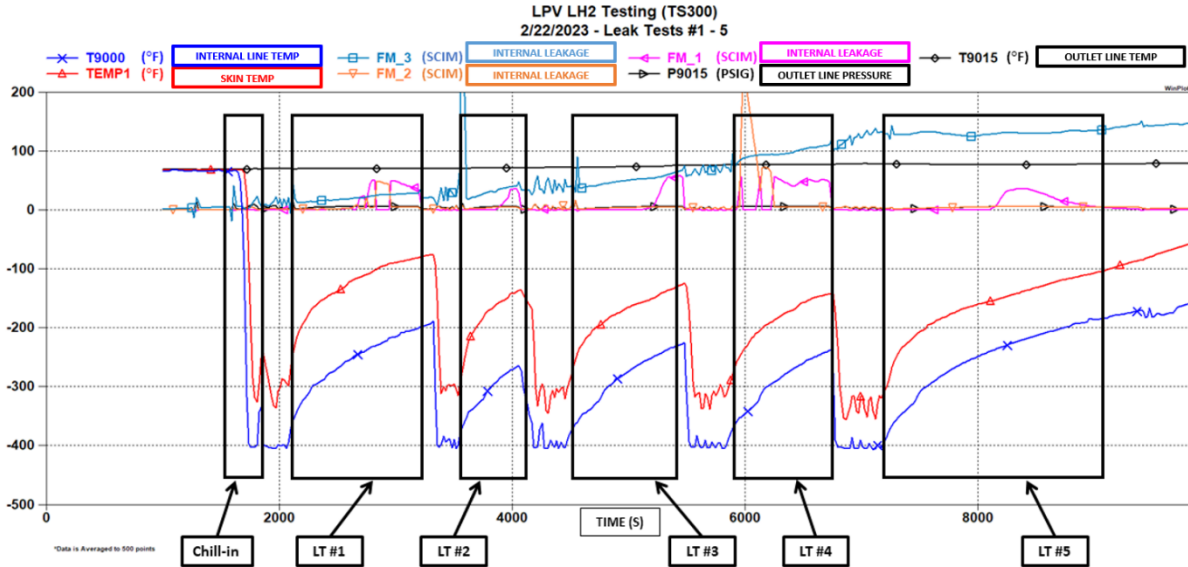
Due to the check valve placed to prevent cryopumping, a build-up of outlet line pressure between the test article and the flowmeters would occur if ROV-915 was closed before the test article outlet line had been fully drained. This “short drain” would lead to a large initial reading of internal leakage (as seen in Leak Test #4 in Fig. 44), but was done in order to retain cryogenic temperatures for as long as possible. This internal leakage would decrease as outlet line pressure dropped, but while also seeing temperatures rise.

Fig. 44: Overview of LPV LH₂ Test Data

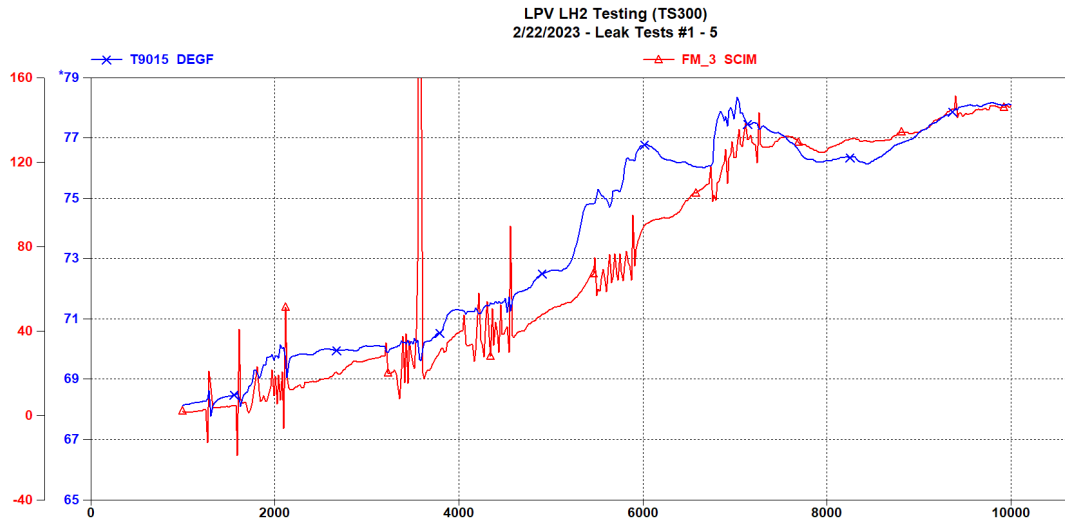
Throughout the test, the zero-offset of FM3 was seen to increase by approximately 150 SCIM. This change is likely due to the large capacity of the flow meter combined with the increase in ambient temperature throughout the day (as recorded by T9015, and seen in Fig. 45). FM2 (not shown) demonstrated a similar but reduced effect, increasing by approximately 5 SCIM over the same period. No significant shift in zero-offset was observed in FM1.

Fig. 45: LPV FM3 Zero-Offset Shift

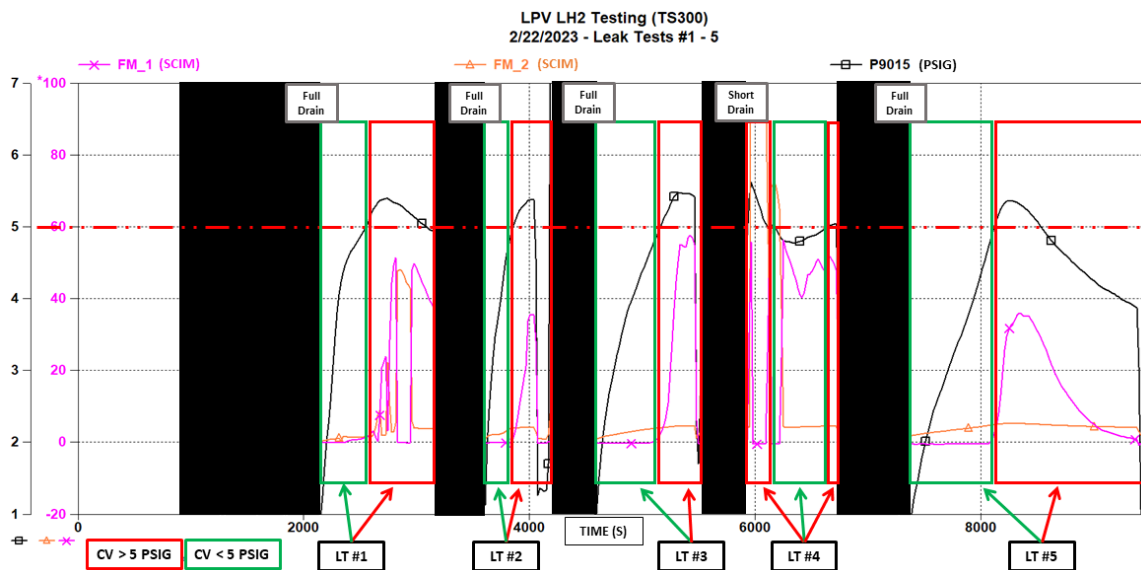
A correlation between the outlet line pressure and the measured internal leakage rates can be observed in the “multi-Y” plot shown in Fig. 46. The red boxes enclose time intervals where outlet line pressure (P9015) exceeds 5 psig. Leak rates recorded within the red segments often measure 30 SCIM or more, most likely indicating that additional flow is occurring from the cracking of the check valve (“CV”). The green boxes enclose time intervals where outlet line pressure falls below 5 psig. Leak rates recorded within the green segments tend to stay under 10 SCIM (or trend towards single digits). To optimize the clarity of data from leak tests in Fig. 46, any data from chill-in or valve cycling events have been visually obscured. This correlation with outlet line pressure appears to have a stronger effect upon observed leakage rates for this particular setup than temperature. A detailed look at individual tests for the LPV is included on subsequent pages.

Fig. 46: LPV Outlet Pressure and Leak Rate Correlation
