# Tracking and Recovery of the LOFTID RV

**The LOFTID mission launched from Vandenberg on Nov 10, 2022, and successfully demonstrated the reentry of a 6m diameter inflatable aeroshell from low Earth orbit. This paper will cover the design features implemented to enable recovery of the flight vehicle, and will discuss the splashdown calculations, in-flight tracking, recovery from the ocean, and post-flight inspection of the flight vehicle.**

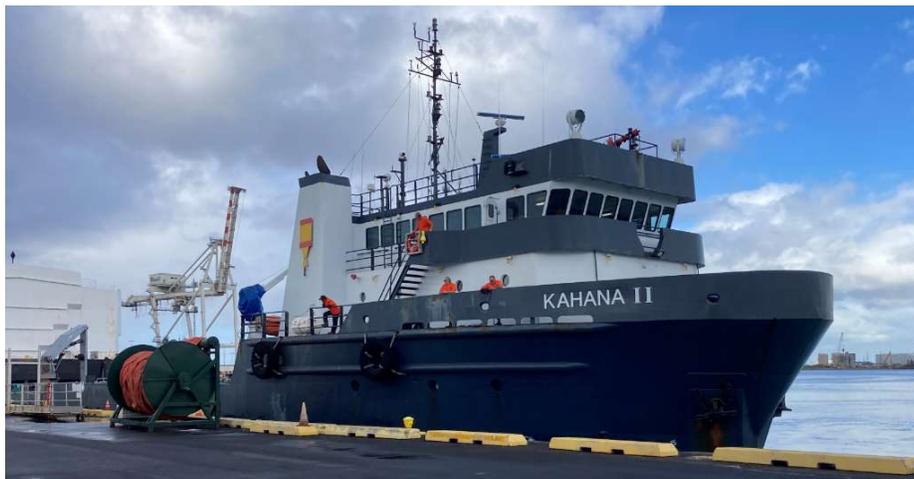
**Fig. 1 Kahana II**

Recovery of the LOFTID hardware after splashdown was made possible by our partner United Launch Alliance (ULA), who rented the offshore supply vessel Kahana II from Honolulu's P&R Water Taxi for the mission. The 220' Kahana II had a flat cargo deck 138' long by 37' wide, giving us plenty of space for the 20x20' recovery stand that would support the RV once it was hoisted onto the ship. The onboard knuckle boom crane was rated for 6000 lbs, at a full extension of just over 40', giving us more than enough capacity to lift the RV unless it was totally waterlogged; the ship also had bow and stern station-keeping thrusters enabling it to maintain position near objects in the water during operations. The ship's 10-knot cruising speed meant that we would need over 2 days to travel between the port and the predicted splashdown site, so departure was planned for 2½ days before launch to provide sufficient time to get the ship on station.

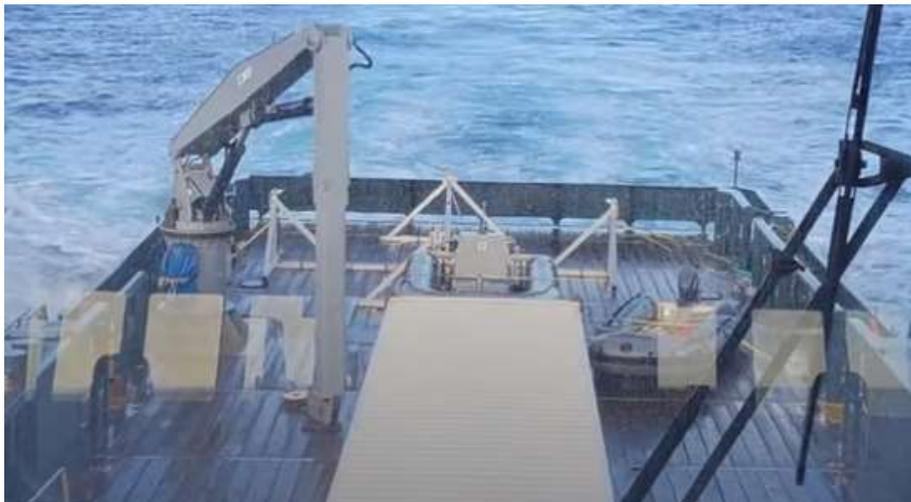
**Fig. 2 Recovery equipment on deck of the Kahana II.**

Two and a half days before the initial launch date of Nov 1, 2022, the recovery ship left Honolulu for the splashdown site, with the recovery stand that would support the RV secured on the aft end of the deck near the crane, and our shipping container of recovery equipment secured amidship. However, on the morning of our second day out of port, the launch was scrubbed due to a battery issue on the Atlas, and we returned to port. We took the opportunity during the return trip to again practice recovery of the EDR, releasing an EDR engineering unit into the ocean, motoring away, then tracking it down by GPS and scooping it from the water. Upon return to port, half the recovery team flew home to await the new launch date, while the other half stayed with the recovery hardware, as it was unclear whether we'd need to transfer to a new ship to support the new launch date. Several days later it was confirmed we'd be able to stay on the Kahana II for the new launch date, and the recovery team gathered again in Honolulu.

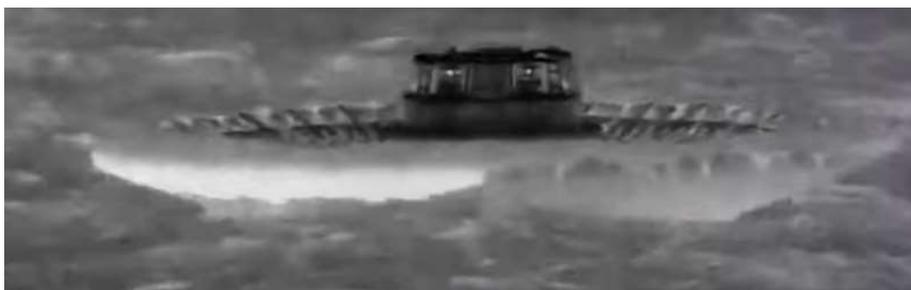
**Fig. 3 IR view of LOFTID RV floating before recovery.**

With the GPS data from the RTB providing a direction vector, the recovery team was able to spot the lights on the RV, descending slowly under parachute. The IR camera team was soon tracking the RV as well. As sufficient time had passed for any Centaur debris to have splashed down, the recovery ship headed back into the ellipse to recover the RV. "Steer for the light in the sky" worked well until the RV dropped below the horizon, after which the ship maintained the same vector until the RV became visible again. As the ship approached the RV it became clear that the vehicle was in great shape, floating high in the water, nose-down. While later inspection showed some localized melting of exposed Kapton tape and Tygon tubing, to initial appearances the RV looked as if it had been moved from the assembly facility directly into the ocean, with no apparent change from flight, reentry, and splashdown.

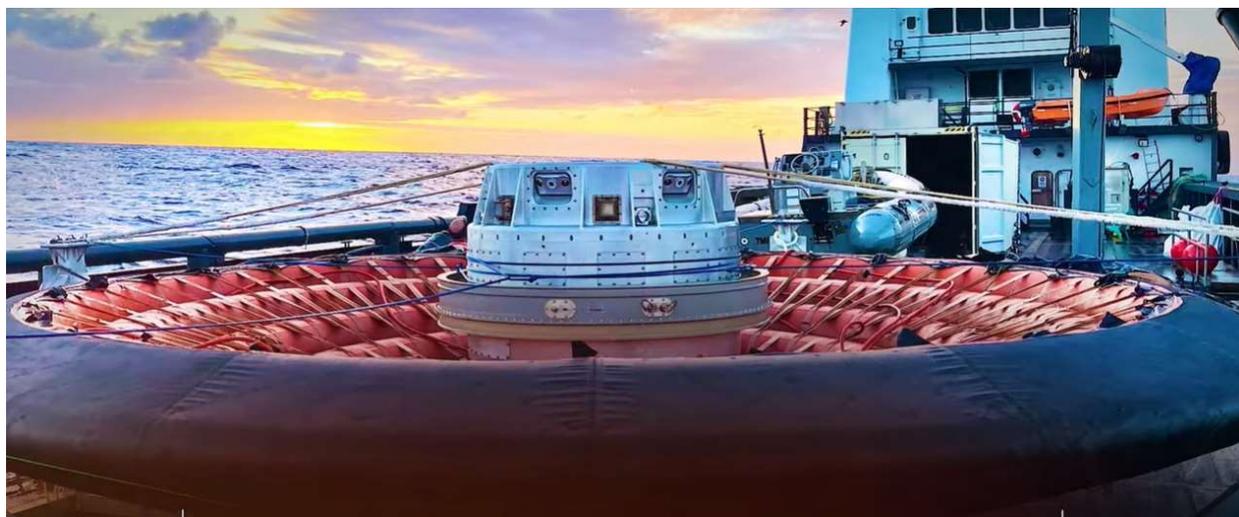
**Fig. 4 LOFTID RV on the Kahana II.**

from the ship, we connected the crane hook to the slack parachute riser lines, after which the RHIB backed off and the RV was hoisted onto the ship. With the ship rocking on the ocean waves, the tag lines were very much needed to stabilize the RV during the lift. After the RV was lowered into the recovery stand on the ship's deck, the parachute riser legs were detached from the crane, and connected to the legs of the stand to secure the RV in position. The tag lines were then removed from the perimeter of the aeroshell, wrapped around the RV centerbody, and likewise secured to the stand as backups. The RHIB pulled alongside the ship and was connected to the crane; the RHIB personnel climbed aboard the ship, and the RHIB was craned back to its cradle on the ship's deck. Shop air was connected to the aeroshell through a pressure regulator to maintain inflation for the trip back to port.

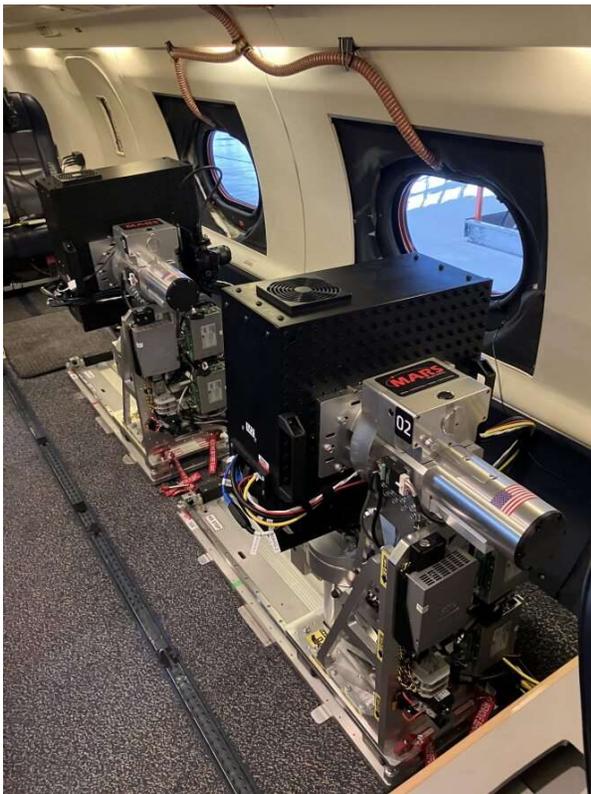
**Fig. 7 SLIM imaging payload configuration. Two SkyShow-A gimbals are depicted here, with the custom UV-Acrylic windows in view.**

The mission to provide airborne imagery of the LOFTID test article, SCIFLI LOFTID Imaging Mission (SLIM), was developed and executed in approximately one month. The effort was executed in conjunction with partners Opto-Knowledge Systems, Inc. (OKSI) and MARS Scientific. NASA Langley's Gulfstream IV airplane, NASA 522, was outfitted with two 4-axis gimbals featuring seven different science instruments provided by MARS Scientific.

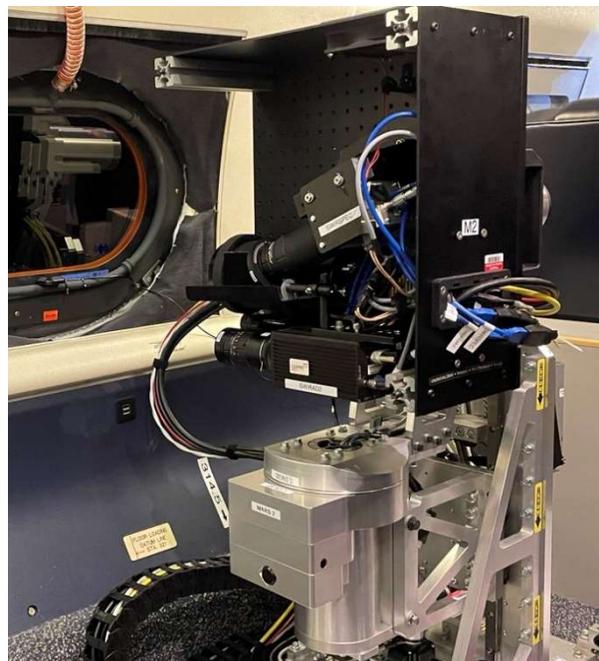
**Fig. 8 Payload configuration for the SWIRSPEC spectrometer.**

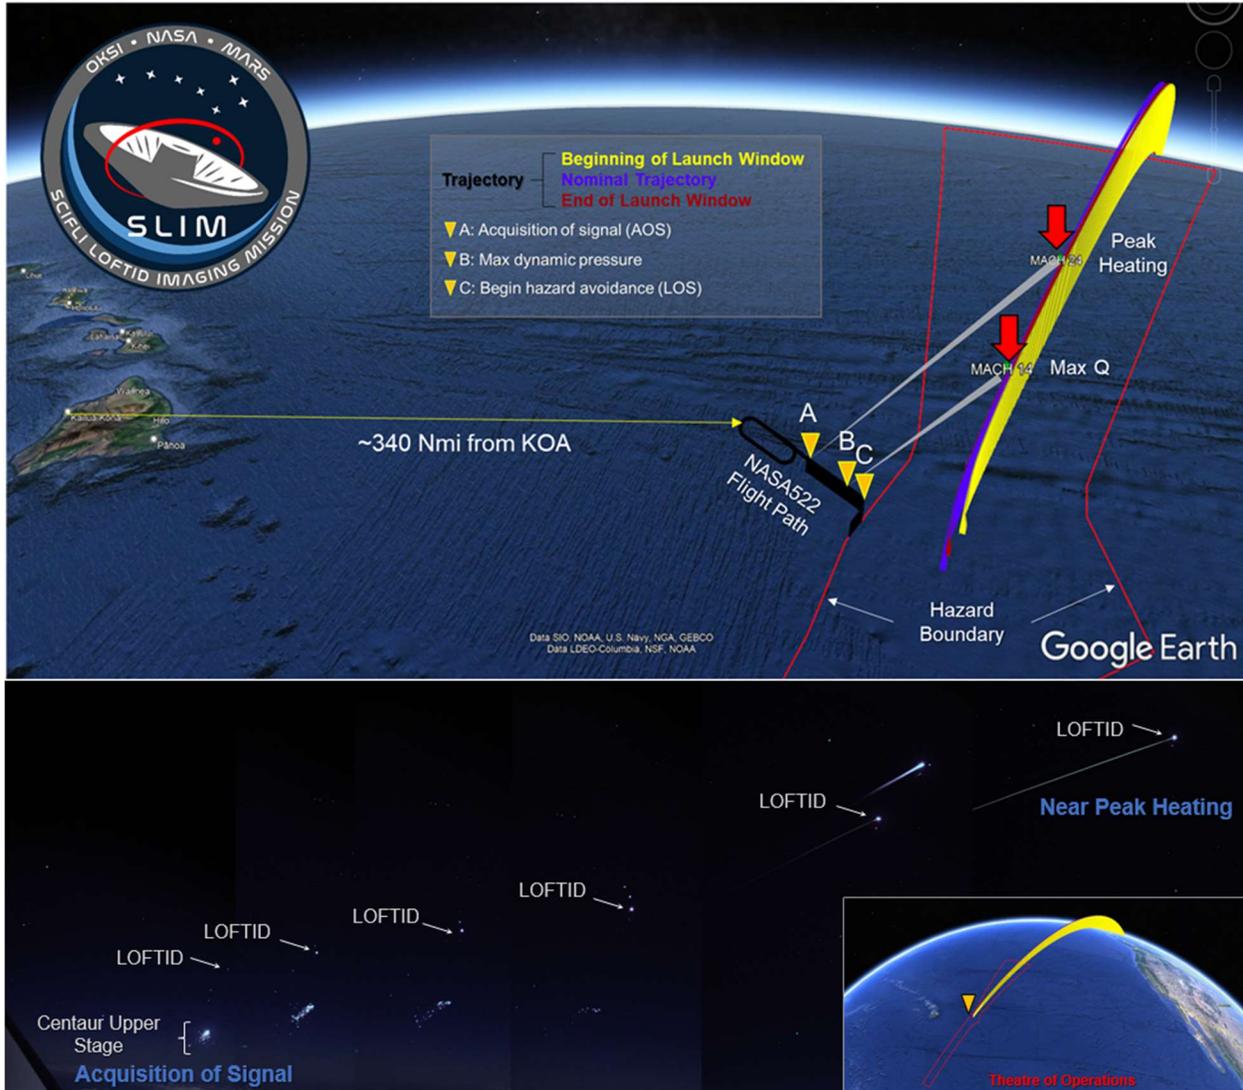
**Fig. 9 (Top) SLIM Concept of Operations. (Bottom) Image Sequence of LOFTID flight.**

To accomplish these complex goals, SCIFLI optimized the imagery flight path for early target acquisition, high signal-to-noise ratio (SNR), low aspect angle to TPS near the maximum dynamic pressure (Max Q) event, and collection of TPS temperature data from Entry Interface through Mach 12. The aircraft was equipped with single-pane, large-aperture optical windows to increase the quality and quantity of the data collected from the Gulfstream aircraft. The optical windows, made of Poly-II UV-transmissive acrylic, met the strict operational waveband requirements for the imaging goals as well as the material strength to withstand the mechanical loads from the aircraft in flight.

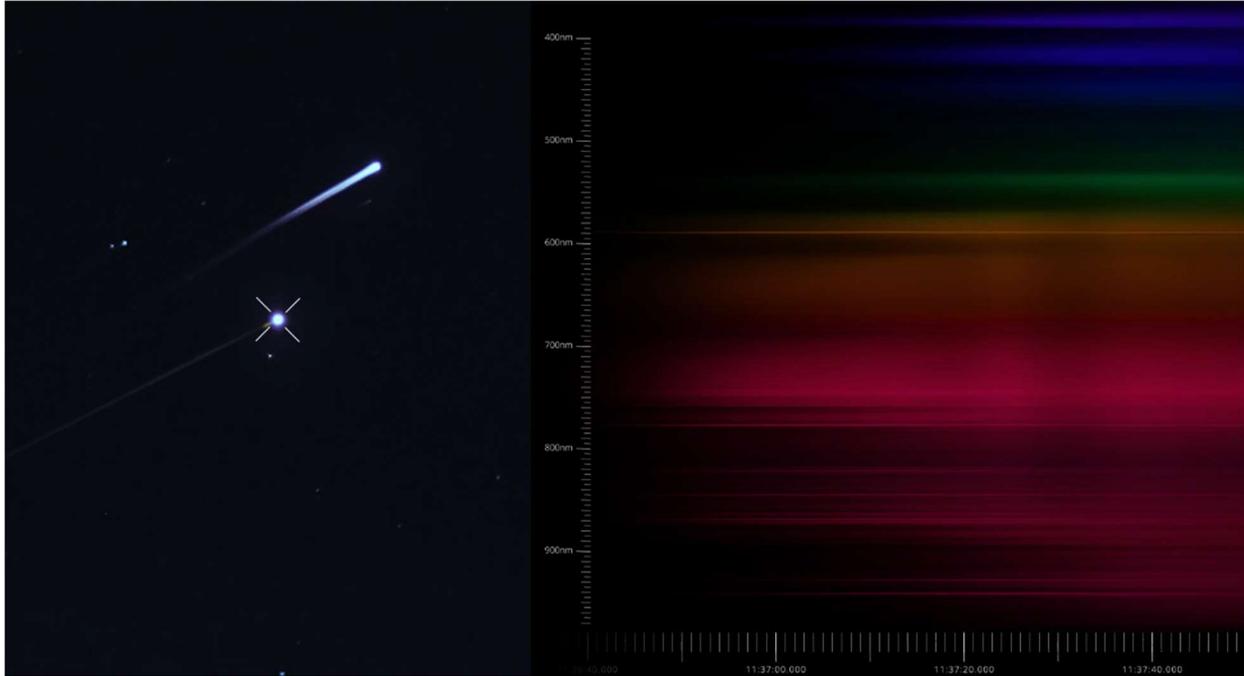
**Fig. 10 Spectral data visualization of the LOFTID vehicle in flight.**

The Atlas V rocket with both the Joint Polar Satellite System (JPSS-2) and LOFTID payload launched from Vandenberg Space Force Base on November 10 at 9:49 UTC. Following the deployment of JPSS-2, the LOFTID heat shield re-entered Earth's atmosphere. The SLIM team successfully tracked the LOFTID test article from entry interface to Mach 12. Imaging data were successfully captured from all seven science instruments, including spectral emissions from the inflatable heatshield surface, shock layer, and wake in the visible, near-infrared, and short-wave infrared spectrum over approximately 200 seconds.
