NASA/TP–20240000154

NOAA-17 Break-up Engineering Investigation Board Final Report

August 2021

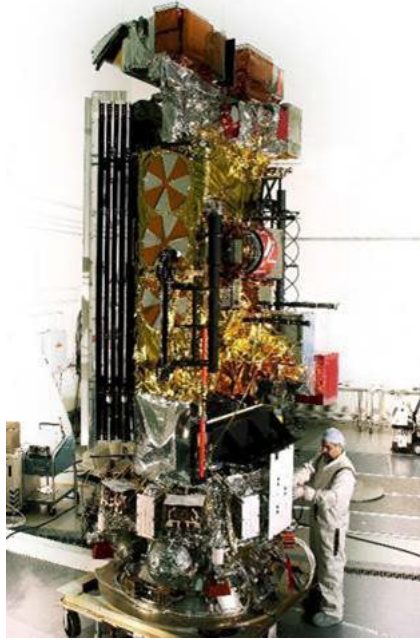
Figure 1: NOAA-17 before launch.

NOAA-17 (called NOAA-M before launch) was built by Lockheed Martin and is part of the NOAA KLM series; see pre-launch photo in Figure 1. The KLM series is very similar to DMSP 5D3 and was a continuation of the Television Infrared Observation Satellite (TIROS) Program known as the NOAA Polar Operational Environmental Satellites (POES) System. It was launched from Vandenberg Airforce Base on 24 Jun 2002. On-orbit verification was completed by NASA and then handover over to NOAA operations on Oct 15, 2002. After products were verified by NOAA, NOAA-17 was designated the Prime Reference mission for the morning (AM) orbit – 98.7 deg inclination and 810 km altitude.

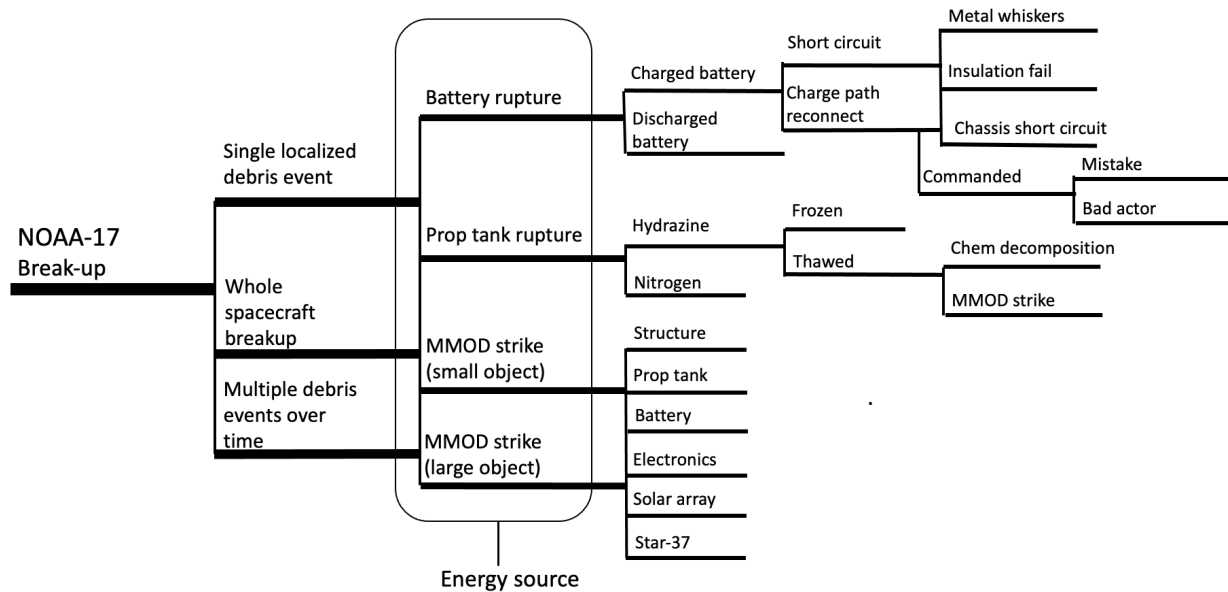
Figure 5: The likely cause fault tree was developed and explored through the investigation.

A fault tree, or fishbone diagram, was created and then expanded over the course of the investigation to map out likely causes. At the left of the diagram is the break-up itself followed by the type of break-up and then the source of energy of the break-up. The right half of the diagram are the specific subsystems and components that would have led to the energetic event. As the elements of the fault tree are explored, certain “bones” on the fishbone can be exonerated as the likely cause if there is evidence for exoneration.

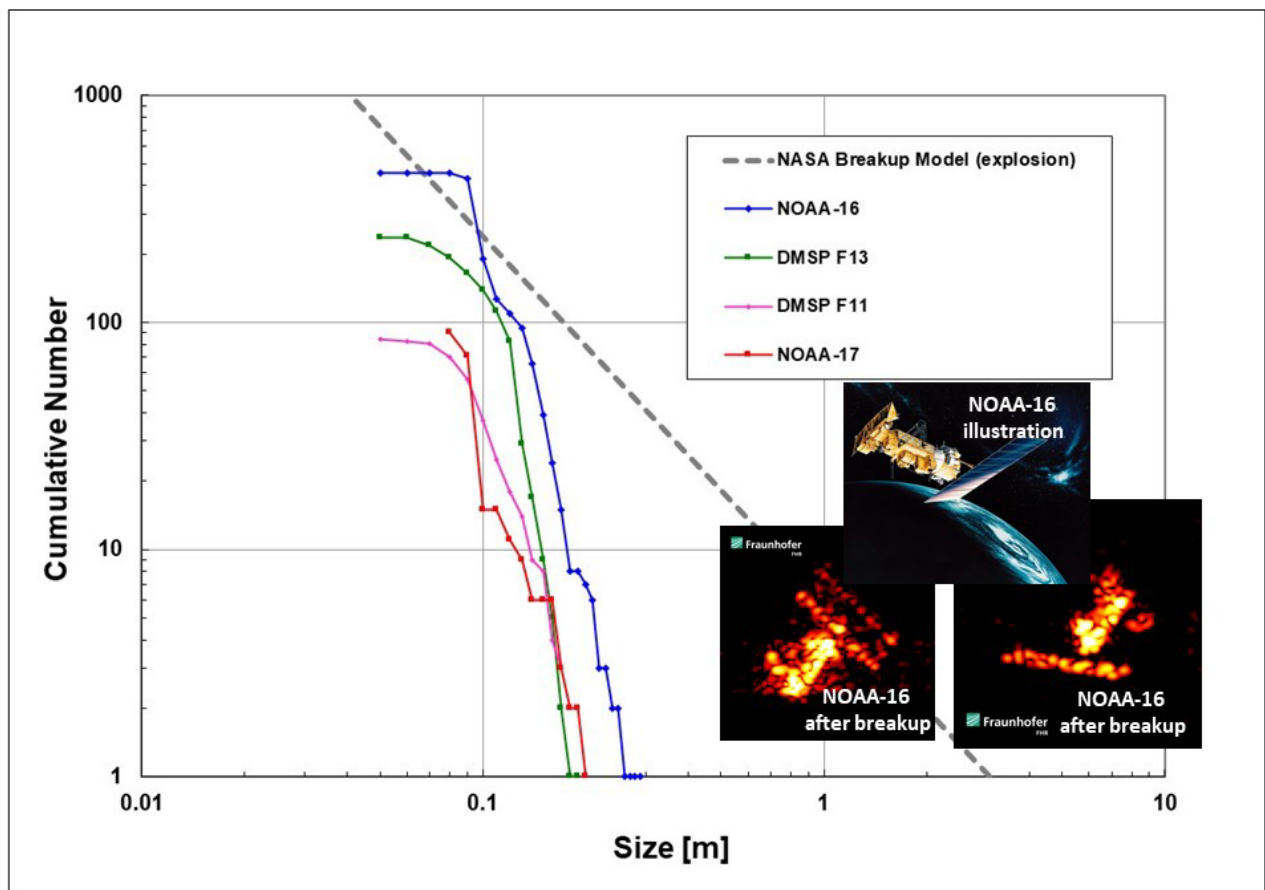
Figure 6: Cumulative size distributions of the NOAA-16, NOAA-17, DMSP F11, and DMSP F13 fragments. The gray dashed line is the power-law fragment size distribution as predicted by the

NASA Standard Satellite Breakup Model for the full explosion of a spacecraft. Credit the German Fraunhofer Society for the inset radar images of NOAA-16.

The physical size of a tracked fragmentation debris can be estimated from its RCS, based on the NASA radar Size Estimation Model (SEM). Figure 6 shows the cumulative size distributions of fragments from the four breakups. Most of the fragments are between approximately 8 and 20 cm in size. The four fragment clouds have similar distributions. The gray dashed line is the power-law fragment size distribution predicted by the NASA Standard Satellite Breakup Model for the full explosion of a spacecraft, which is very different from the size distributions of the four fragment clouds.

The cumulative size distributions seem to suggest that those fragments were generated from similar “localized, component-level” breakups. The spacecraft remained intact after the localized breakups. This is consistent with radar images provided by the German Fraunhofer Society to NOAA after the breakup of NOAA-16. Although 458 fragments were detected and tracked by the SSN after the breakup of NOAA-16, the radar images show the spacecraft remained mostly intact afterward.

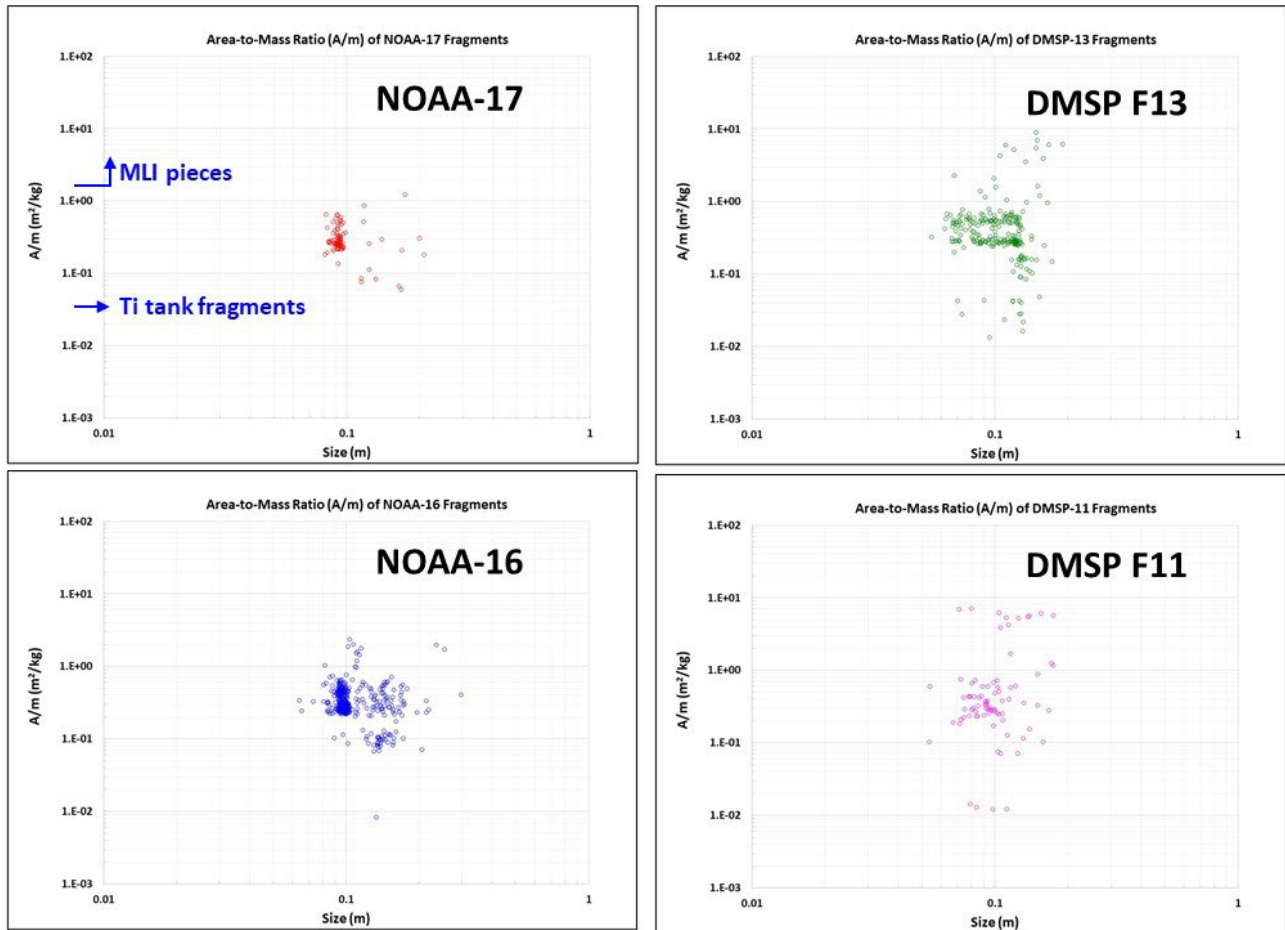
Figure 8: Area-to-mass ratio distributions of the four fragment clouds. Most of the fragments have values between 0.1 and 1 m²/kg, with a strong concentration at 0.2-to-0.3 m²/kg and a secondary concentration at 0.4-to-0.6 m²/kg.

Although the numbers of the tracked fragments from NOAA-16 and NOAA-17 differ by close to a factor of five, the concentrations of the fragments line up very well in size, between 9 and 10 cm, as shown by the two left-hand plots in Figure 8. This is another indication that fragments from the two breakups are similar in size and material type. It is likely that they were generated in a similar manner from the same component(s).

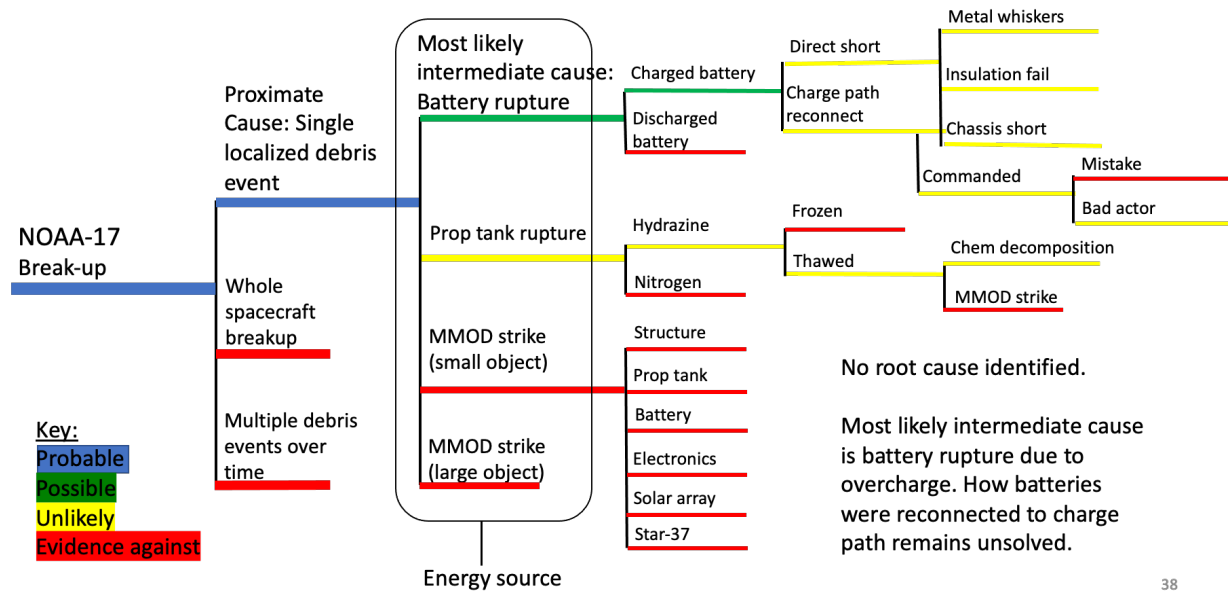
Figure 25: The likely cause fault tree has been colored in based on the results of the investigation.

Throughout the investigation, the tree of possible causes for the break-up was colored in as more was learned. The proximate cause for the break-up is a single, localized debris event; there is evidence against a whole spacecraft break-up and no additional debris events. The most likely intermediate cause is the rupture of a battery pack; Figure 25. There was no root cause found as the decommissioning telemetry clearly showed the batteries were disconnected from the charge path as intended. Several short circuit or sneak path modes of reconnecting solar array current to at least one battery were investigated and none found to have any evidence to support. So it remains a mystery how a battery could become overcharged after

being disconnected. Tank rupture remains on the unlikely list since it could not be exonerated with evidence but the debris generated is not consistent with other known tank ruptures.

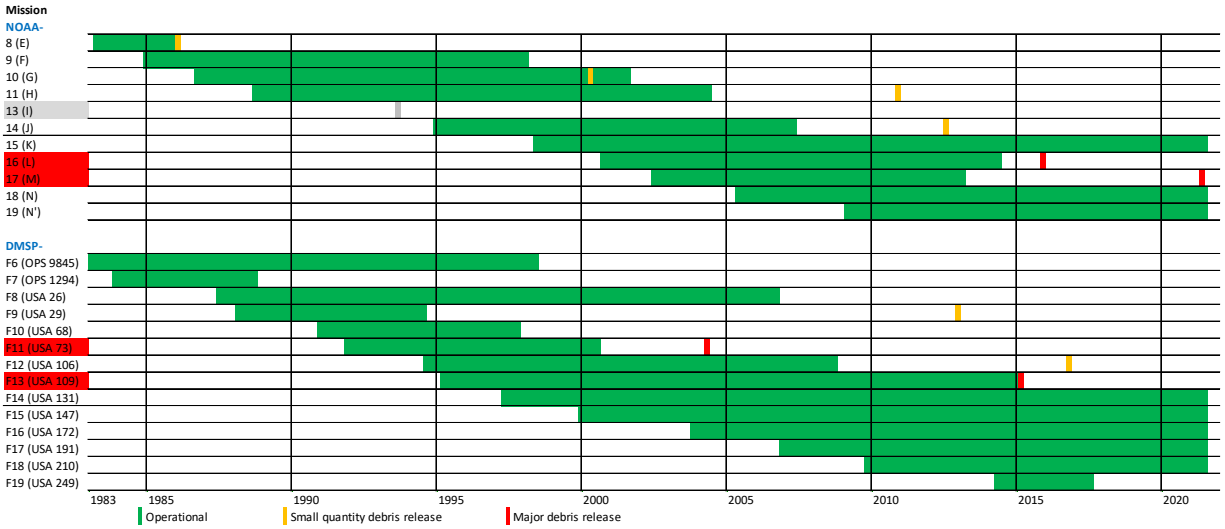
Figure 26: Fleet timeline organized with respect to calendar years.

The spacecraft histories above were arranged by both calendar date and spacecraft age (Figures 26 and 27), to observe any trends in the breakup occurrences. The timelines shown below include both the Big Four events and the smaller quantity debris shedding events. No clear trends were observed for the events. Both major and minor breakups occurred at times when the spacecraft were operational and previously decommissioned; one spacecraft even remained operational after a minor debris shedding event. The events ranged from as little as three years into the mission to as much as 25 years after launch. The Big Four events all occurred between 12 and 20 years after launch, but there is no reason to expect that breakups could not occur outside that range.
