# X-57 Cruise Motor and Inverter Failure Modes

Sean Clarke, X-57 Subproject Principal Investigator  
Jacob Terry, X-57 Subproject Power and Command IPT

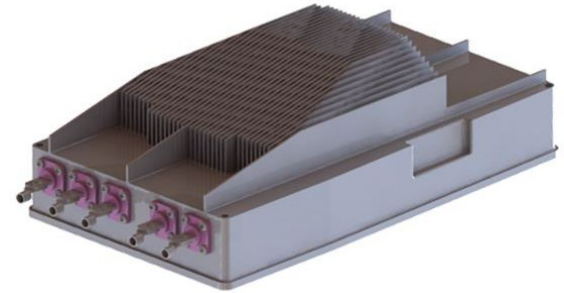
**BM2 CMC**

- Original CMC developed by Joby and QDESYS

**Microsemi CMC**

- Same as BM2 but with a different MOSFET Module

**XM3 CMC**

- Flight Qualified CMC

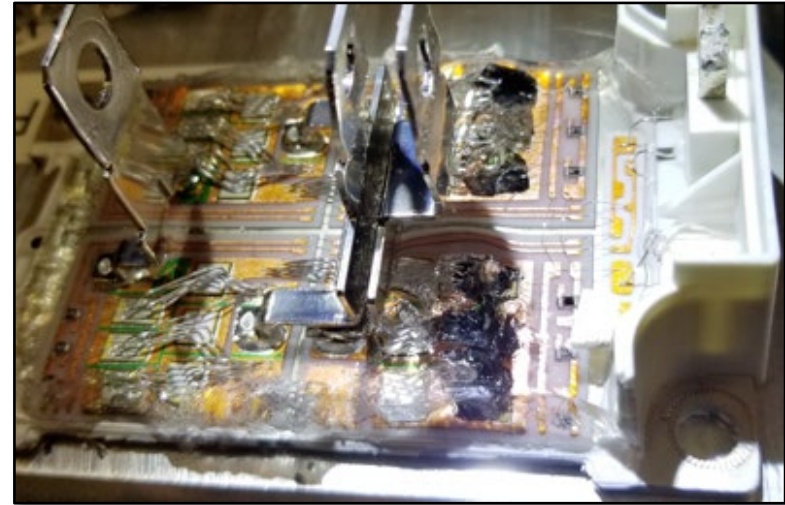
- Initial CMC MOSFET module could not survive vibration tests
- Typical failure mode: short circuit across DC bus resulting in module failure
- Tests conducted at  $\leq 10$  kW
- Module case stayed intact, but material ejection probable at higher power levels
- Initial Vibe Level: Random Vibe, 7.7 Grms, 20 min/axis

*BM2 MOSFET Catastrophic Failure from Vibe*

- MOSFETs utilized in inverters have high power density and can short circuit the DC Bus, rapidly heat, and explode/eject material
  - Enclosure/mechanical design should take this failure mode into consideration
- Incorporate overcurrent and shoot-through protection in software and hardware
- Ensure that the thermal management system is robust enough to reject required heat from power MOSFETs
- Measure MOSFET temperature as close to the junction as possible
- Test critical components individually, if possible, and powered
- Perform MOSFET health/degradation checks if possible (blocking voltage, reverse diode voltage/current,  $R_{ds}$  measurements)
  - A curve tracer is extremely helpful for this type of testing
- Gather temperature data over time to detect signs of degradation

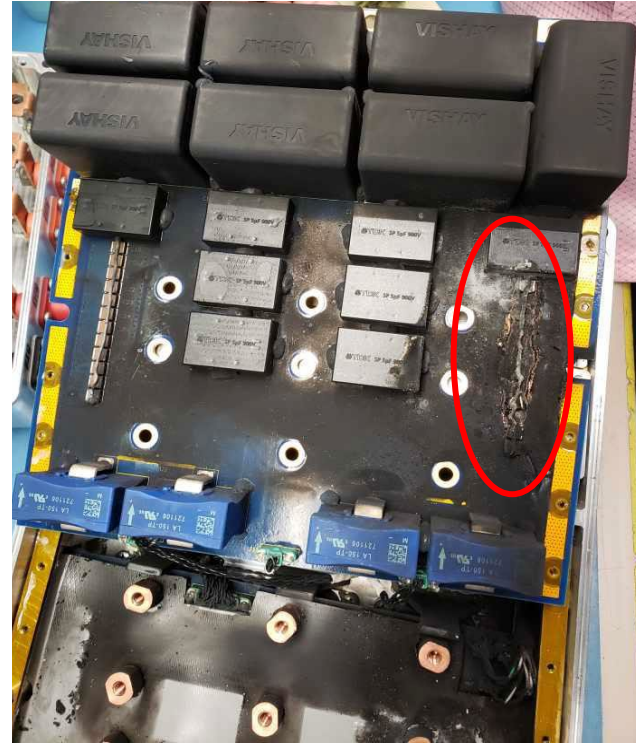
- Failure in isolation between the DC bus and enclosure led to an explosive failure of multiple ceramic DC Link capacitors within the CMC
- Failure of one capacitor may further degrade others and cause cascade failures

*Flight XM3 CMC Row of Capacitors Failed due to Error in Assembly Process to Properly Isolate DC Bus and Gnd*

- DC Link capacitor failure has multiple sources including vibration, electrical stress, temperature, PCB placement, reflow temperature, component quality, etc
- Mechanical stress should be mitigated as much as possible, especially when using ceramic capacitors
- Inverter enclosure design should take explosive failures into account
- Internal (PCB) and external (connector) Hi-pot tests should be conducted regularly to confirm isolation between the DC bus positive and negative planes, as well as to the enclosure

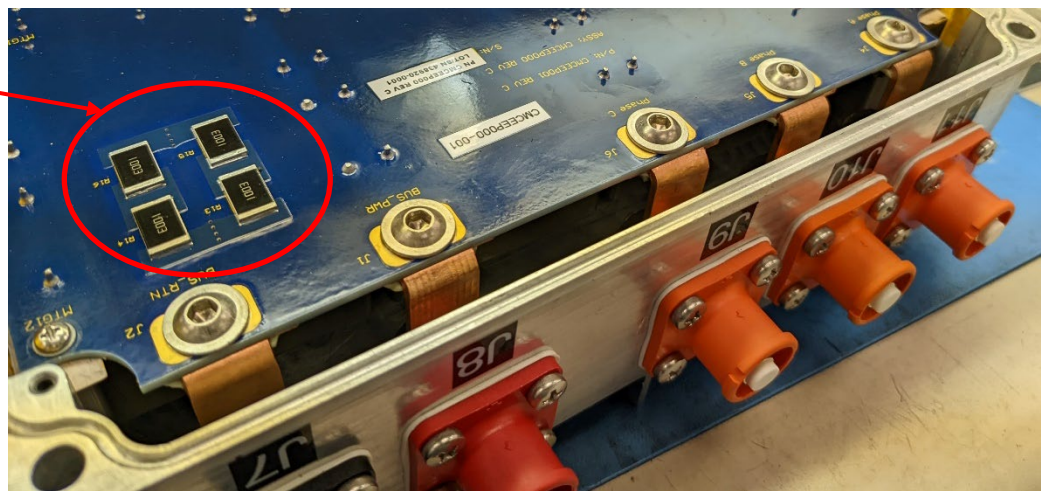
DC Link Bleed Resistors

- Discharges DC Link Capacitors to safe voltage
- Time to discharge can be tuned

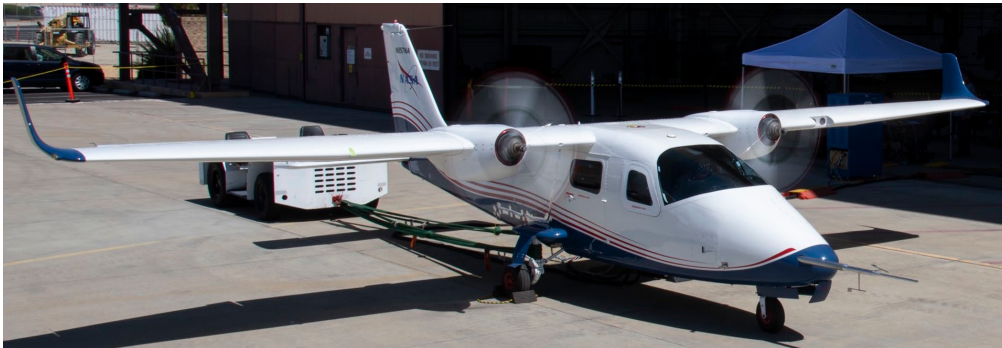
- **Manufacturer:** Designed and built by Joby Aviation under contract to ESAero to meet NASA specification
- **Model:** JM-X57 Rev K, build 2
- **Function:** Provides up to 72 kW of propellor shaft power at 255 Nm of torque at a speed of 2700 RPM
  - Air-cooled out-runner design
- **Subsystem Testing:** Proto-qual and Acceptance performed by ESAero

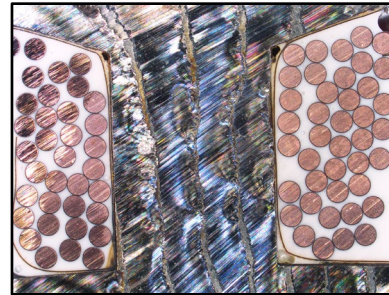
Improved fabrication process (typical for 80% of samples)

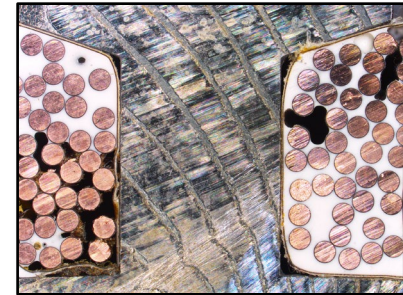
Improved fabrication process still exhibits some voids

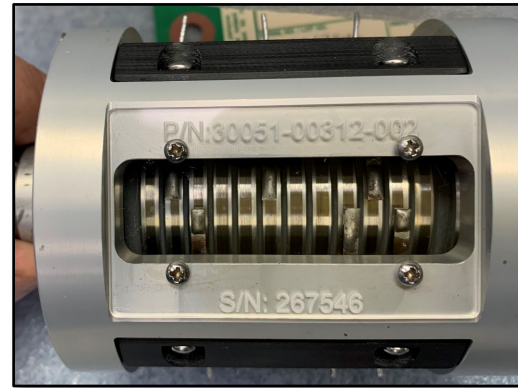
Slip Ring brush arms and rotor rings via inspection window  
Also visible: pins not in use after channel reassignment  
("guard channels" providing extra clearance)

- Electrical Discharge Machining: rapid switching in modern AC drive systems may generate high frequency (HF) current pulses through the bearings
- If the energy of these pulses is sufficiently high, metal transfers from the ball and the races to the lubricant and is manifested as pitting
- Recommend creating a rotor to chassis drain path (grounding pin) through slip ring
