Portable Cleanroom for NASA OSIRIS-REx Mission Deintegration

Jacobs at NASA Johnson Space Center Houston, TX

Cleanroom Construction

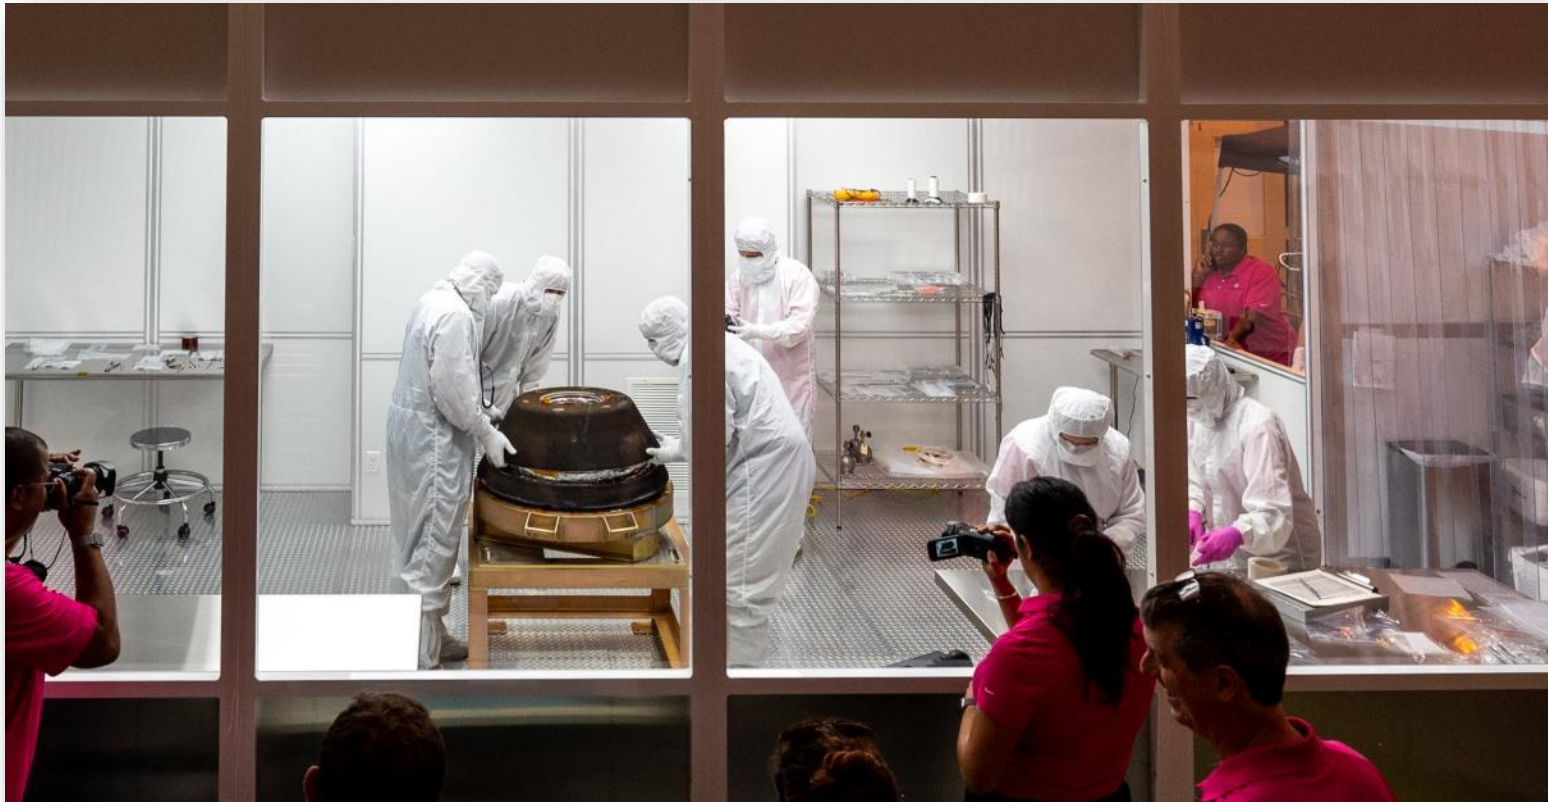
- Getting the sample under an Ultra-high Purity (UHP) nitrogen purge was one of the OSIRIS-REx team's most critical tasks. Nitrogen is a gas that doesn't interact with most other chemicals, and a continuous flow of it into the sample container inside the capsule will keep out terrestrial contaminants to leave the sample pure for scientific analyses.

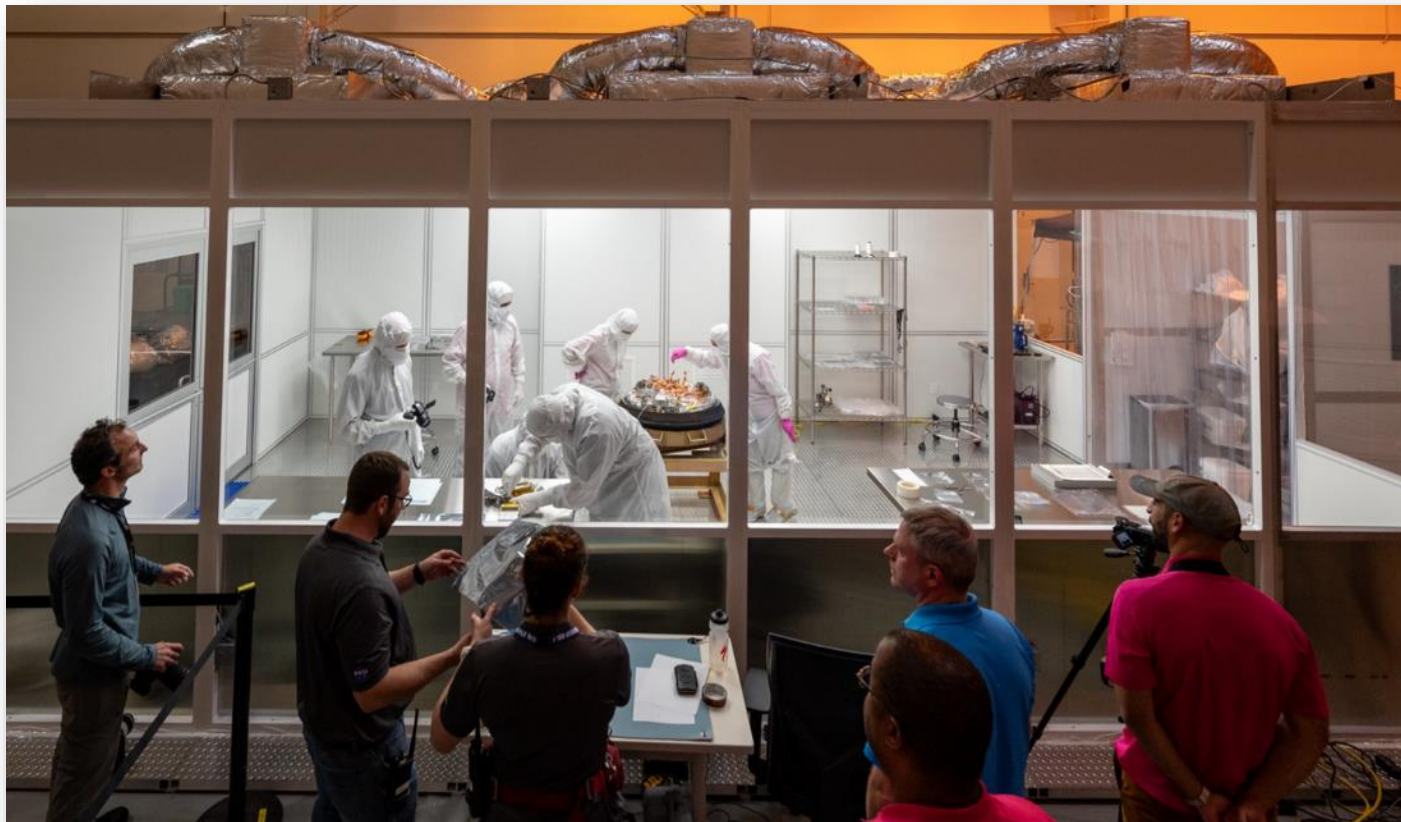
- Rehearsal and disassembly of OREX sample return canister.
- Heat shield and backshell were removed inside the cleanroom.
- Sample return canister was prepped (hardware removed) to allow a nitrogen purge to be installed (via a cart).

- Here the sample return capsule is opened.

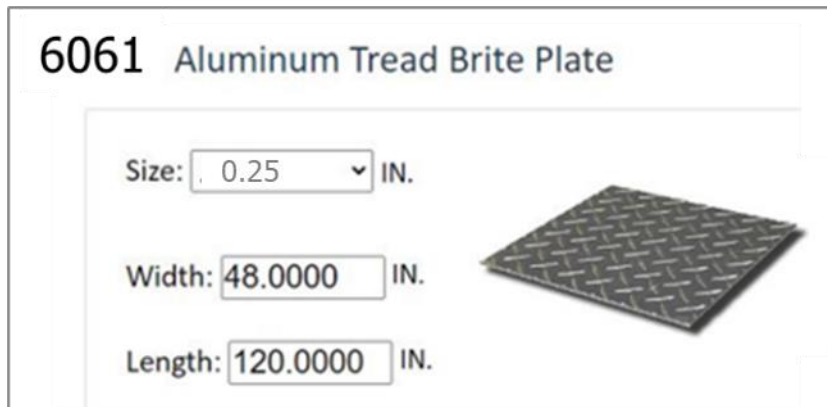
- Curation technical staff in-person examination of current condition of the UTTR Building 1012 space (happened September 2022). Delay in deciding the floor system. Science team didn't want vinyl flooring due to organic outgassing.
- Defining requirements with input from mission contamination control
- Iterating with vendors and contamination control to identify acceptable options
- Ultimately settled on diamond aluminum 6061 flooring rather than vinyl flooring used for Stardust and Genesis. This took about 2-3 months
 - Lesson learned for next mission - Recommend budgeting more time

- Pro: no organic off-gassing
- Cons: particle generation onto cleaning cloths, uneven mating with cleanroom walls, no anodization, and no time to properly clean potential oil/grease.

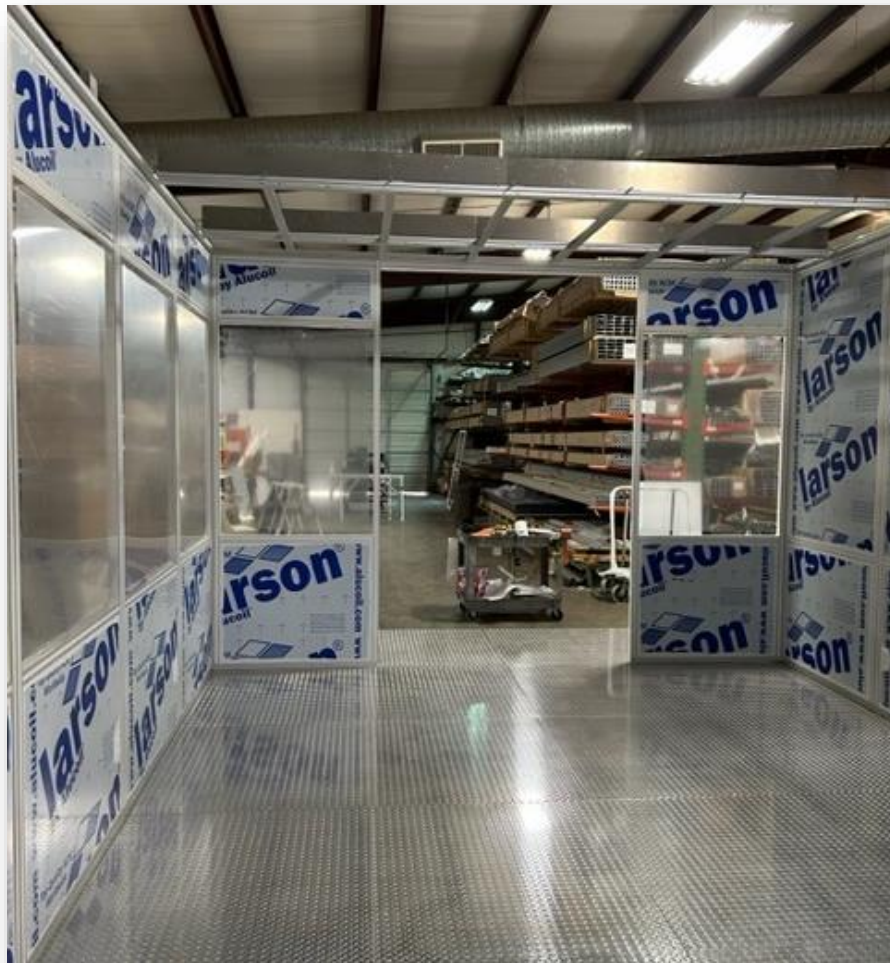
- After Purchase Order awarded to Lasco Services, they began full construction at their facility to flush out any issues before installation in the field at UTTR.
- Created Master drawing – fabricated and labeled according to drawing.
- Onsite floor was sloped so accounted for it in the shop to accommodate field install

Room #	Clean Classification	Wall Height	Length	Width	Ceiling Height
Cleanroom	ISO 7	10'	24'	14'	10'

Lasco 1751 Modular Cleanroom Wall System

- Trims are clear anodized
- White PVC Snap Cover
- Solid Panels are ¼" aluminum composite panels
- Clear Panels are ¼" clear acrylic
- Framing Tubes are Powder Coat White
- Includes return air grills

Lasco 2" Smooth Face Cleanroom Ceiling Grid

- Santoprene gasket
- Finish is Clear Anodized
- Self-supported
- Ceiling Tiles are Vinyl faced

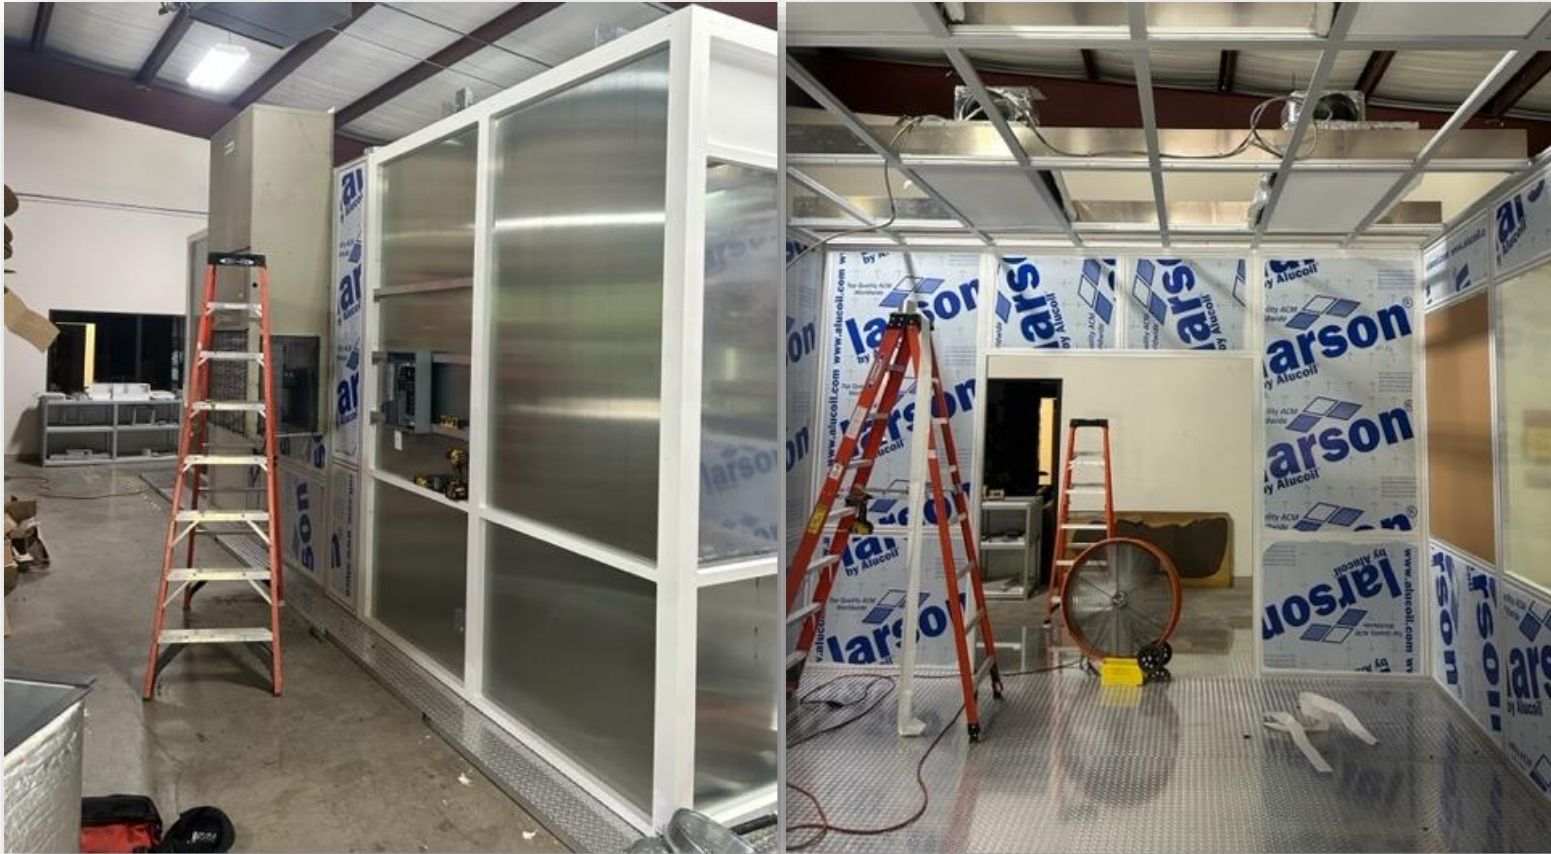
- In shop – one module was backward (quality issue) so it was swapped out in shop versus in the field
- They hooked up the air conditioner, lights, FFUs and electrical power to test everything in the shop before being deployed to the field. Commissioned FFUs and took particle counts.

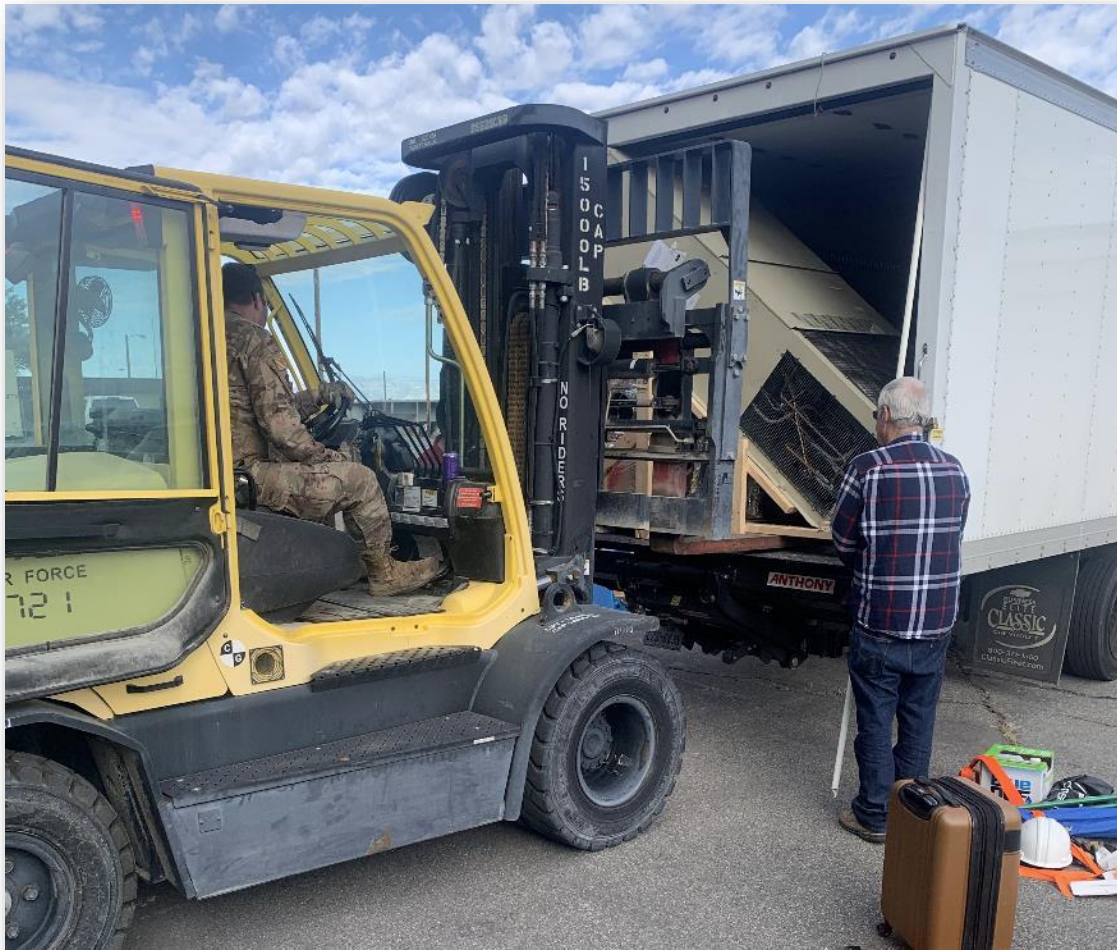
- Once it was built and tested in the shop meeting all requirements. It was taken down, all pieces were labeled and packaged together for easy reinstallation reducing install time, then shipped to UTTR.
- Lasco used same people to build in shop and then in the field – made it very smooth operation

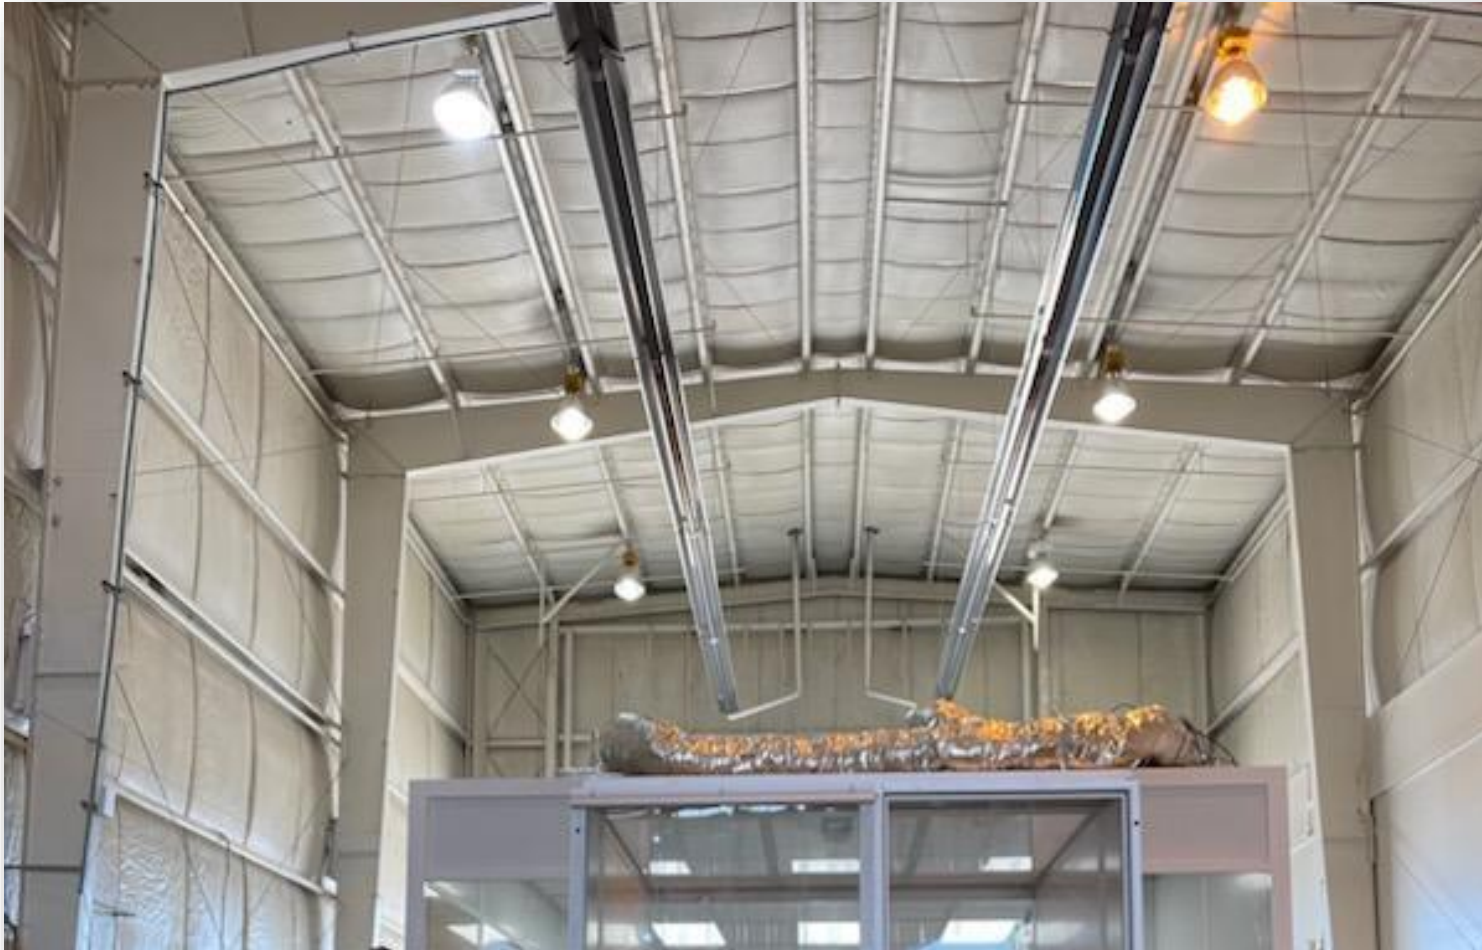
- Location in the field was inside another building (warehouse style).
- Conducted site visit to verify that location would work and noted some issues with garage roll-up doors being very contaminated and there was also contamination from the lights. Mitigations implemented later.

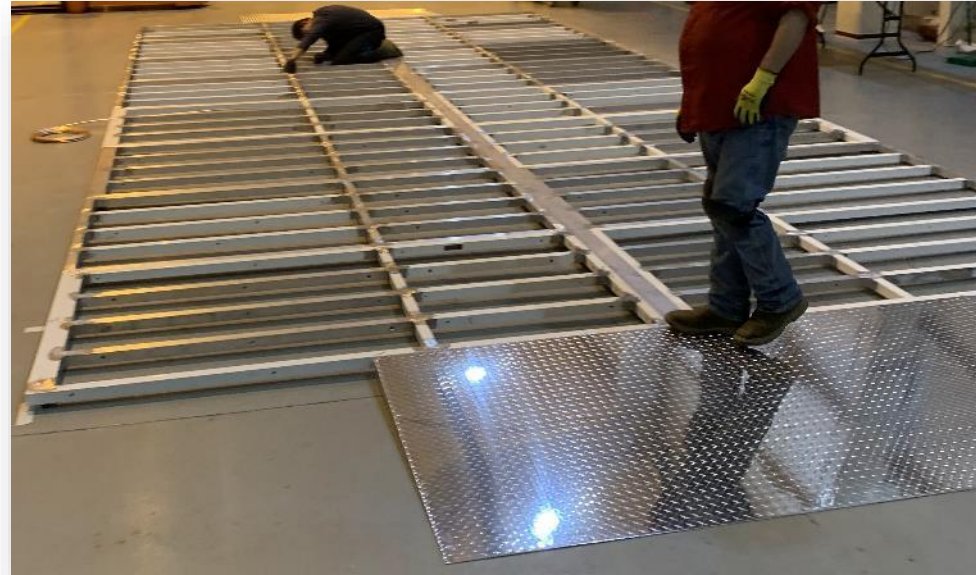
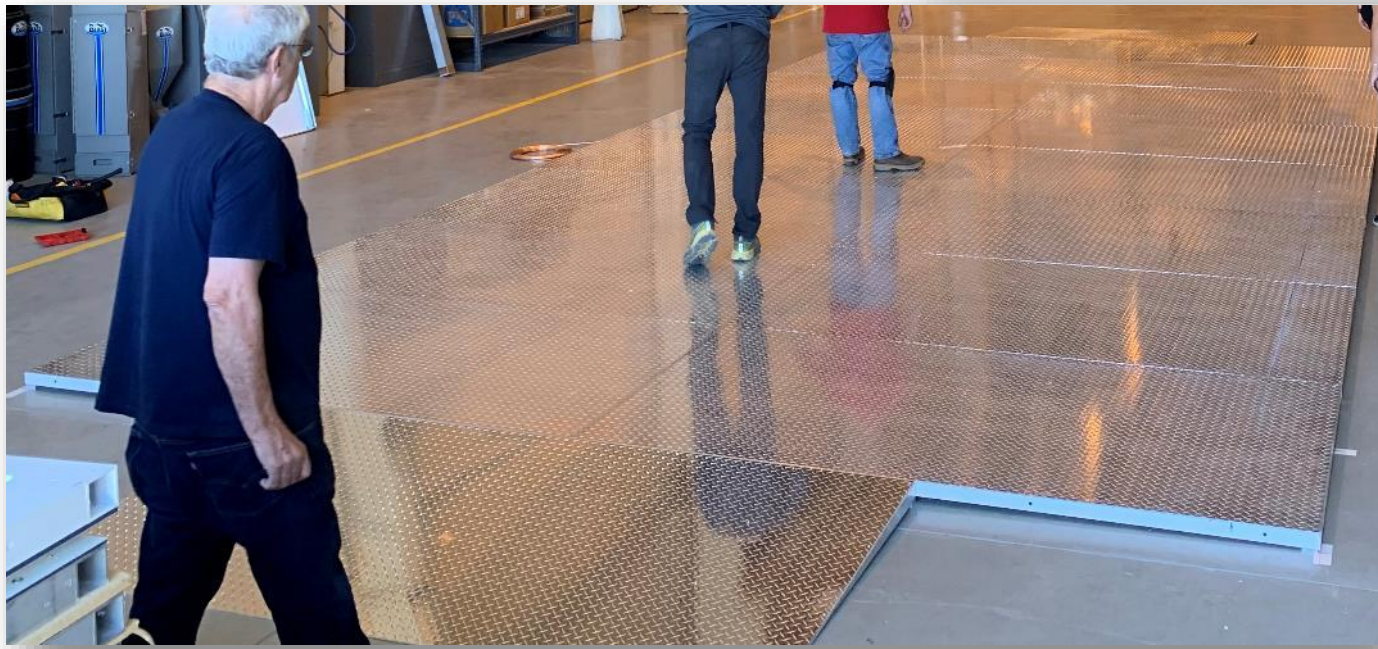
Flooring:

- Layout to be 32'x16'
- .250 6061 Aluminum Tread Brite Plate fastened to Aluminum Tube Framing
- Tube platform to be 1.75"x1.75" welded tube frames, mill finish. Platform to be prefabricated into bolt together modules and leveled onsite.
- Includes (2) 2"Hx72"Wx14"D Ramps

- Usually just sit cleanroom frame directly on floor. Took some engineering to make metal floor work with 1/8" diamond plate so not too heavy but didn't want it to deflect. Thousands of screws to attach floor to frame.
- Added cleanroom tape to any open seam to better seal up cleanroom on the outside of the wall floor system. The 6061-diamond aluminum flooring did not mate seamlessly with the temporary cleanroom because that flooring type is inherently not flat, so we ended up taping the exterior of the cleanroom to the floor with cleanroom tape to mitigate dust, etc., getting in through the gap.

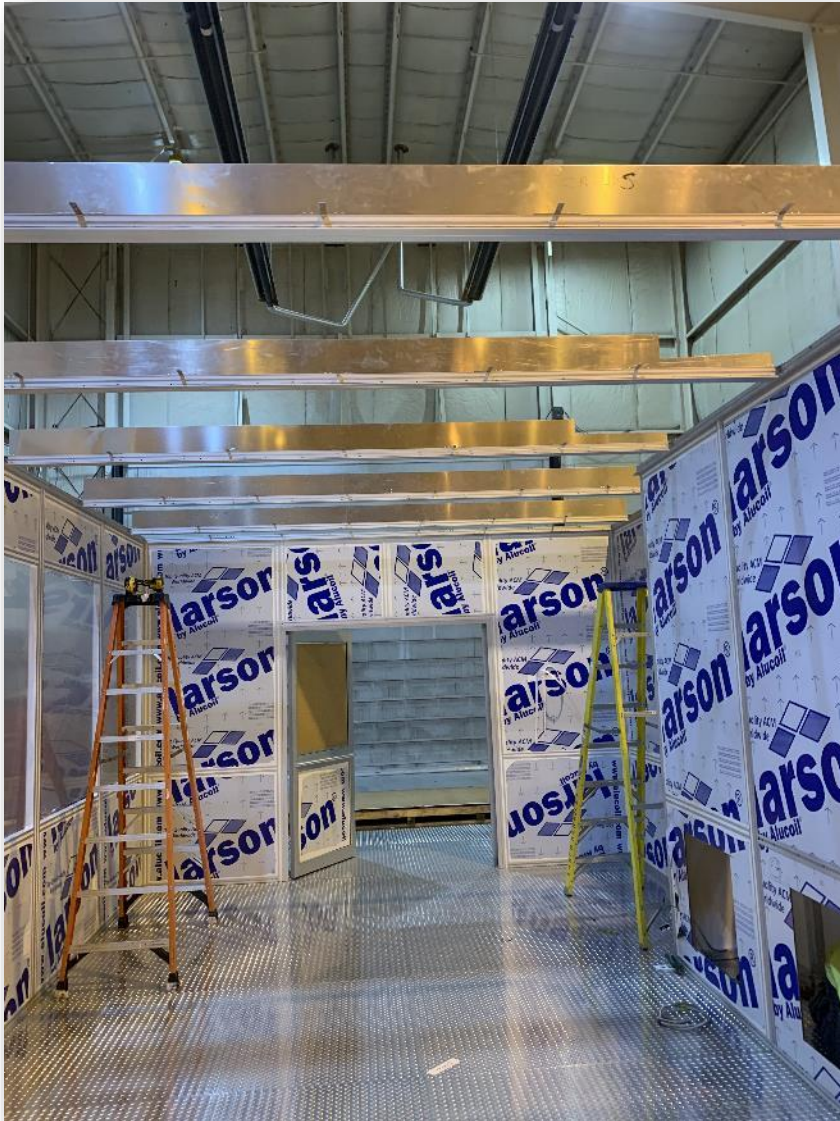
- Onsite location was remote and no local hardware stores available – spare materials were brought just in case (4-hour trip to get parts).

- 5 installers in the field (landing to ready in 3 days and then powered up when temp power was available. 1 guy left to commission in the field to verify all working)

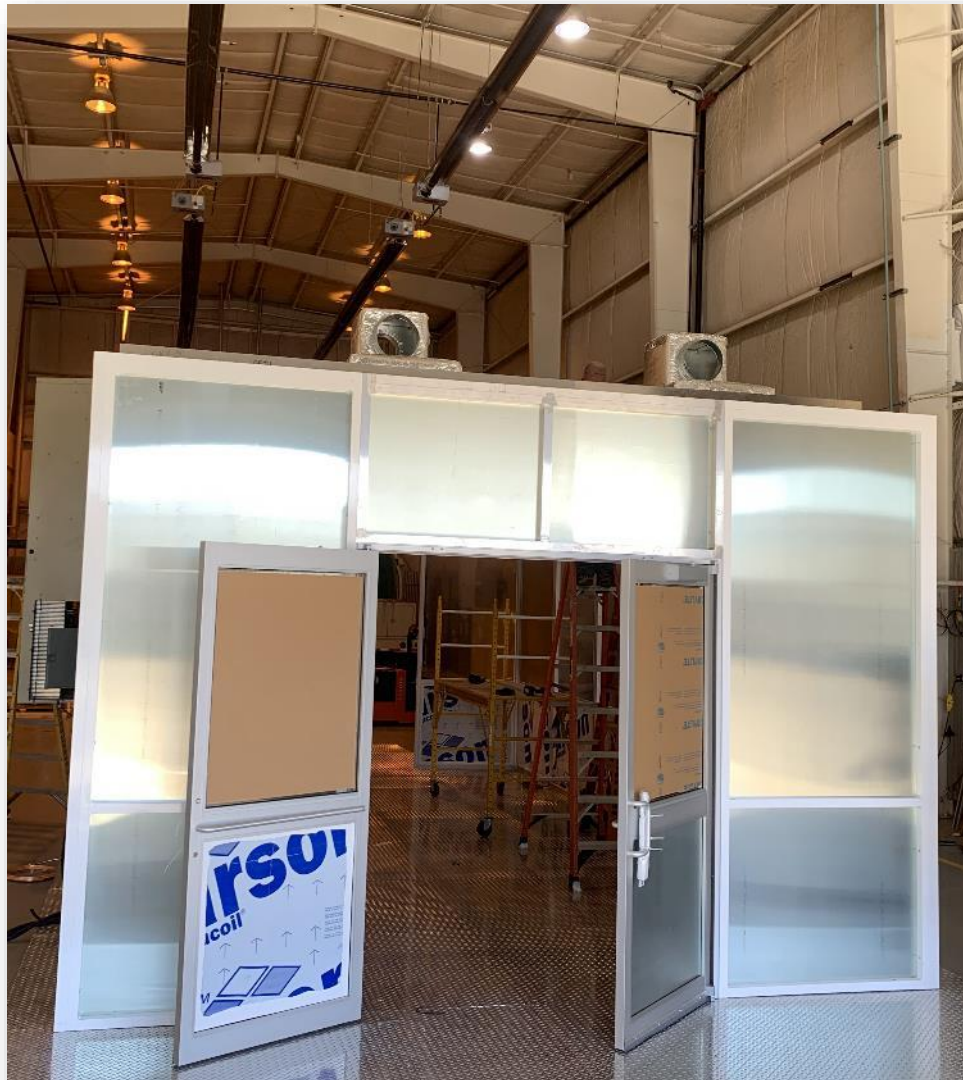
- Only had access to one side of building so changed orientation of cleanroom so original curtain door did not face the outside roll up door.

- (1) 6'0 x 7'0 Double Cleanroom Doors:
 - Aluminum Framing
 - ¼" Clear Acrylic in top and bottom panels
 - Push/Pull hardware
 - Closer included
- (1) 6'0 x 10'0 Clear Strip Curtain Door:
 - .040 Clear PVC Strips
 - 8" Strips with 2" overlap
 - Aluminum Mounting Bar

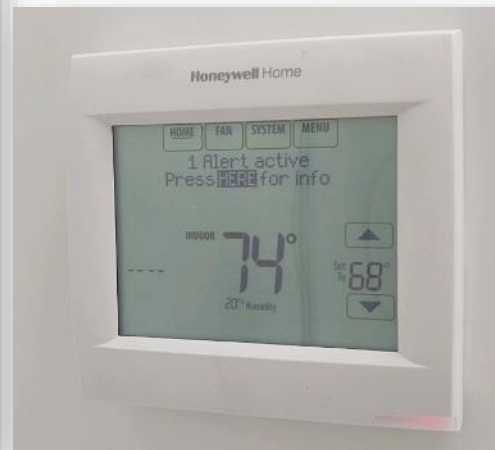
- Building didn't have a/c just heat so had to provide a/c as part of cleanroom

- Furnish and Install wall mount HVAC Unit
 - Add one 24" x 96" RA Chase within Cleanroom
 - Supply and recirculating ducting to Plenum boxes on each FFU
 - Return air ducting
 - Thermostat and wiring
 - Condensate piping to within 10'
- Air conditioning that does not require exterior doors are needed next time (Swamp coolers offered by UTTR required a large door being partially open).
 - LM provide localized AC units with exhaust diverted out thru an intermediate side room.

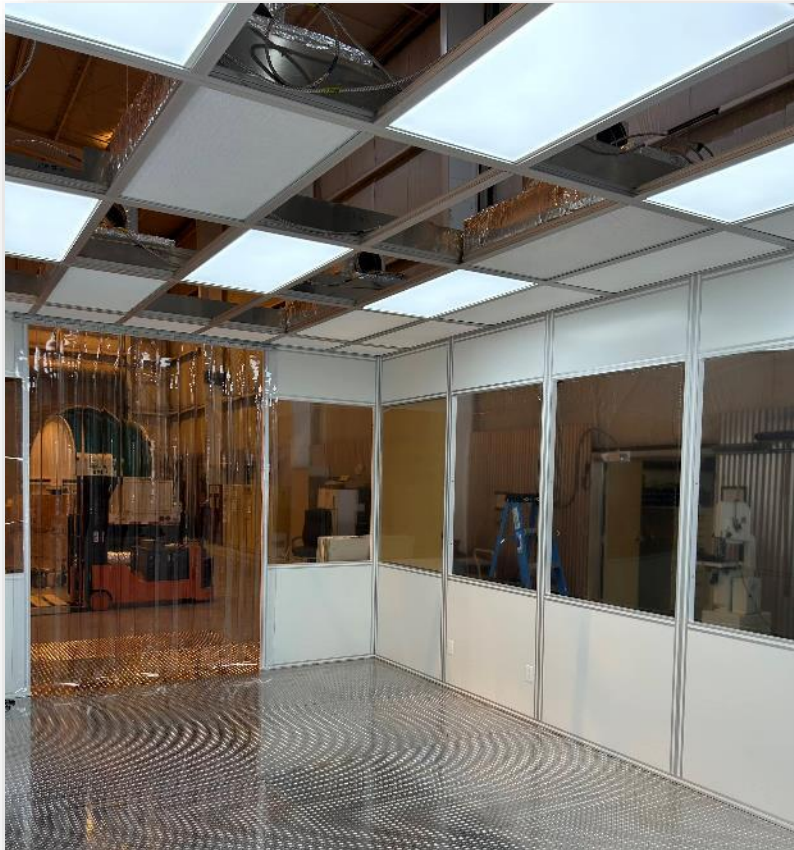
- Provide 1 120/240 100AMP single phase panel
- Panel to mount to surface mount to outside side of cleanroom wall
- Breaker and circuits J boxes for four outlets in Cleanroom
- Breaker and circuit for six Fan filter units
- Breaker and circuit for lights
- Breakers and circuits to HVAC equipment
- Provide and install new raceway and wiring for (4) duplex/data receptacles.
Receptacle are flush mounted in wall, wired to J-box on top of wall module

- Provide 2' x 4' LED Cleanroom lights

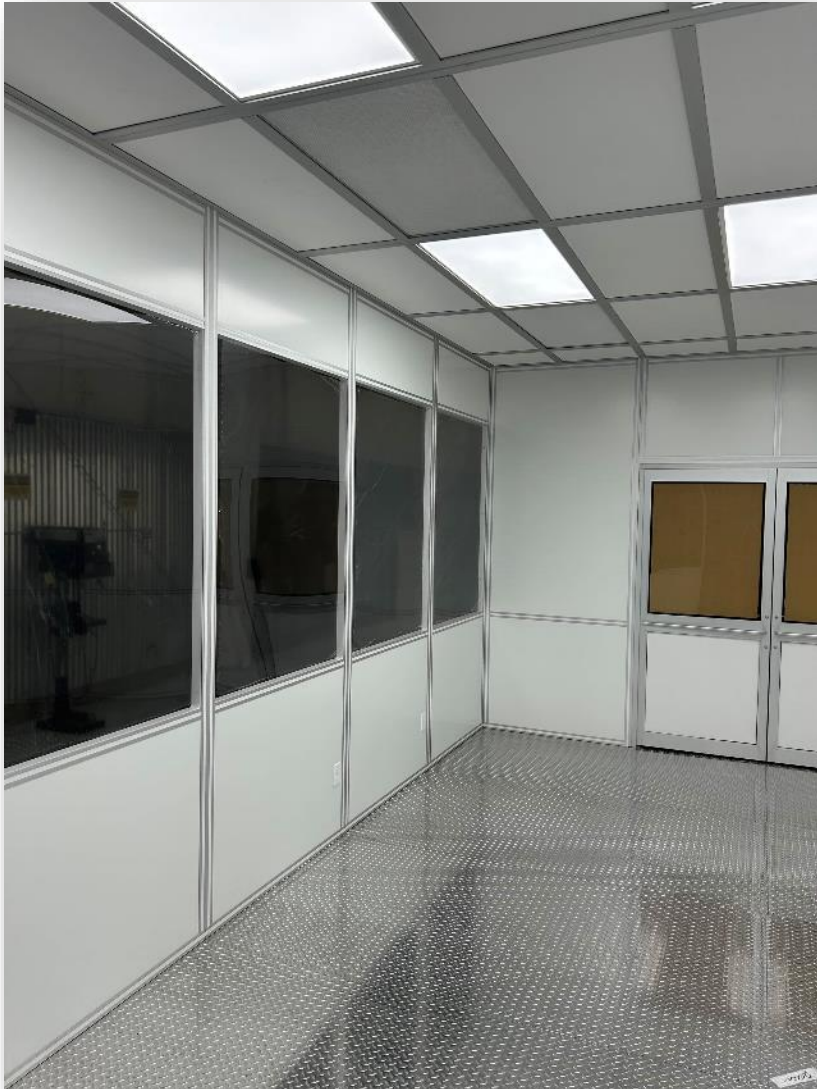
- HEPA FFUs directly ducted and wrapped.
- Lasco commissioned particle counts and FFU setpoints and ARES verified particle counts and FFU settings for ISO-7.

- Variable Speed or 3-speed control
- 23 5/8" x 47 5/8" x 12" Nominal dimensions
- Voltage is 120V or 277V
- Filter efficiency is 99.9% at 0.3 micron
- Aluminum housing
- White face-screen

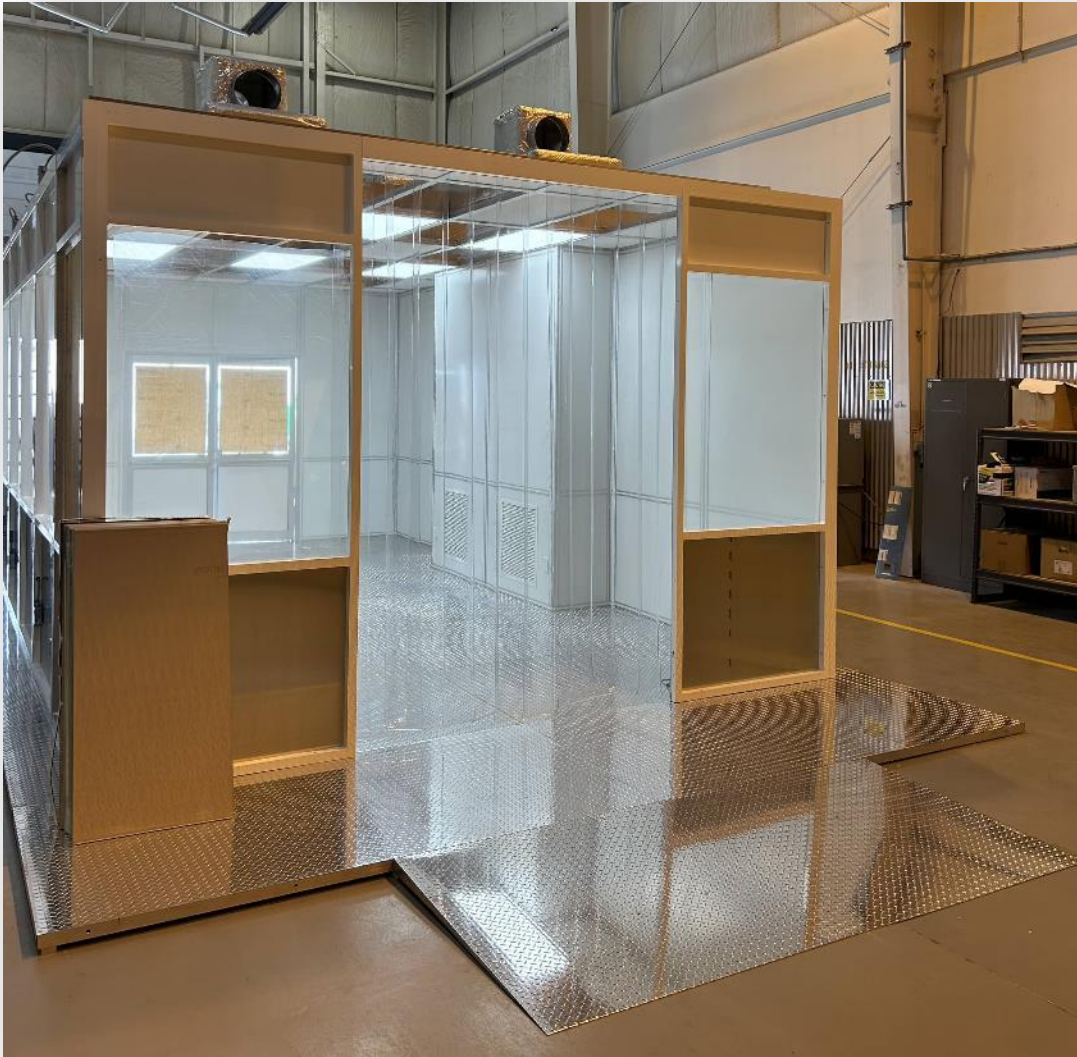
- Lots of integration for power from facility to generator for a/c, FFUs and lights.
- Vendor left some ceiling panels and one FFU along with some elec breakers plus a ladder at site in case it was needed later.

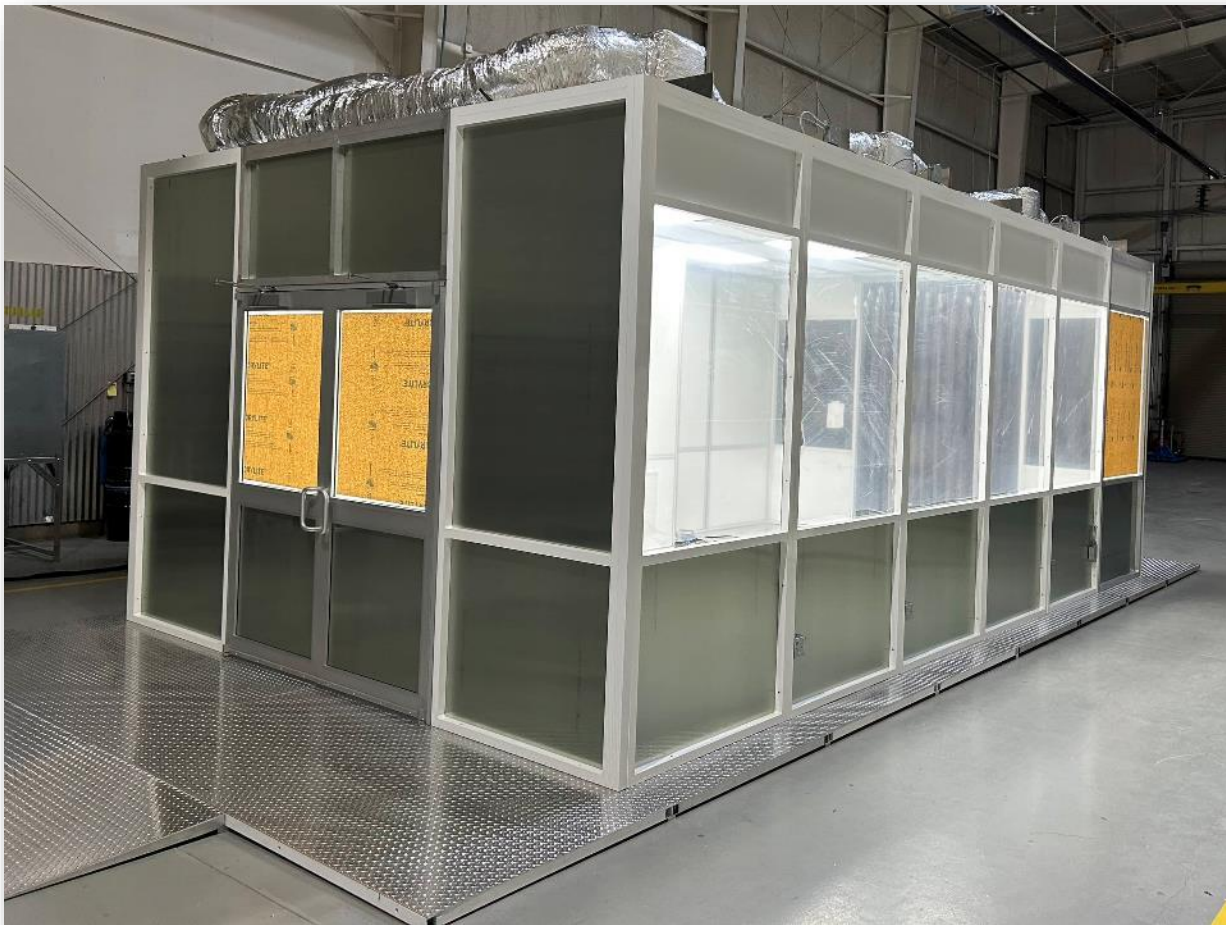
- No issues with actual Lasco construction/tear down (3 people 1 day)
- Lasco deconstructed the cleanroom and transported it back to their facility where they were able to utilize it for another customer – who built it themselves from the master drawings. They will also use the flooring for the permanent installatio, but right now it is at a temporary location.

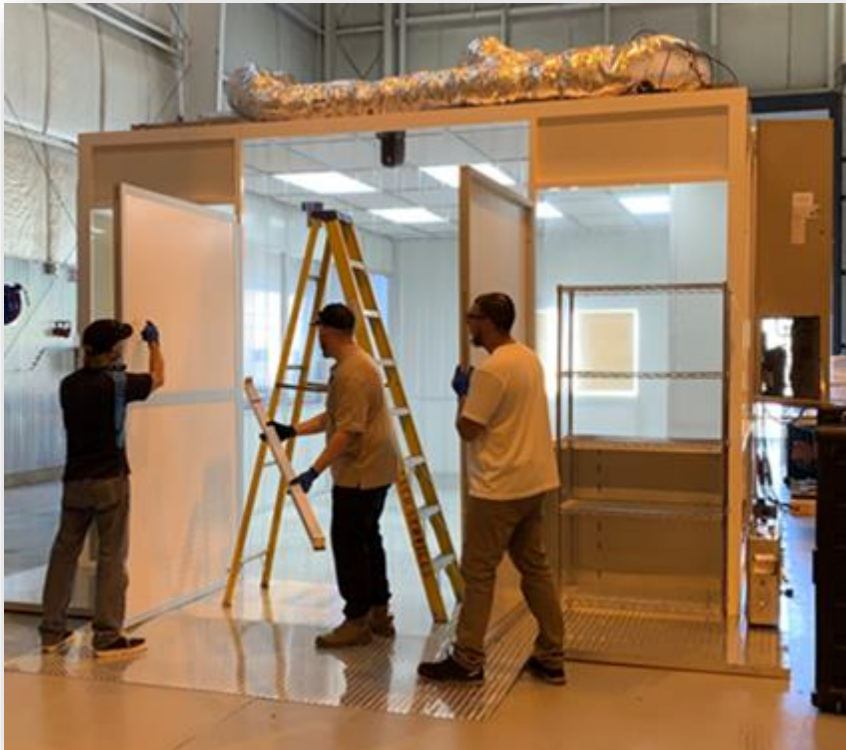
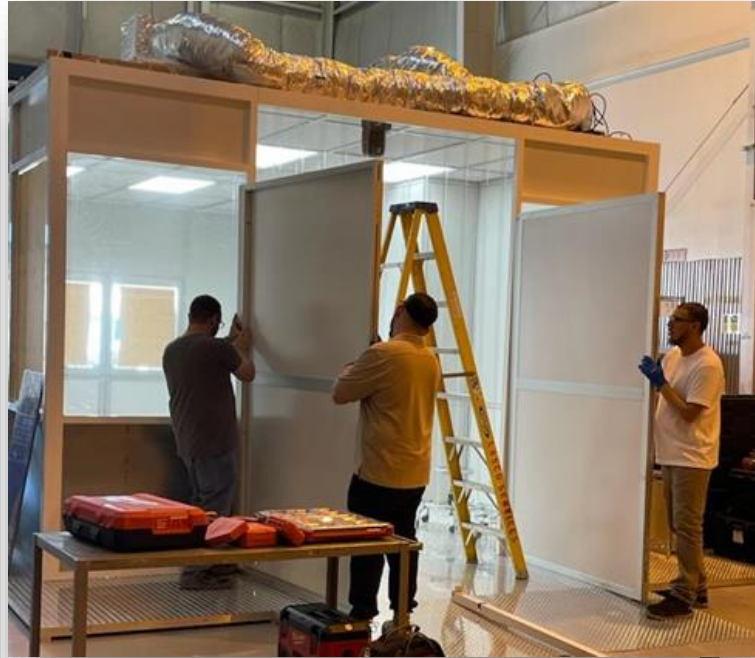
- Cleanliness Challenges
 - Debris of black flaky material “raining” down from ceiling heating elements
 - Particles in cleanroom increased when any of the exterior doors to the hangar were open
 - Flies were disconcertingly abundant inside hangar part of the building in June and July
- Mitigation for Cleanliness Challenges
 - The readiness review findings that we add an anteroom came much too late to include in the procurement so we were lucky that we could borrow an anteroom that curation already had in storage at JSC.

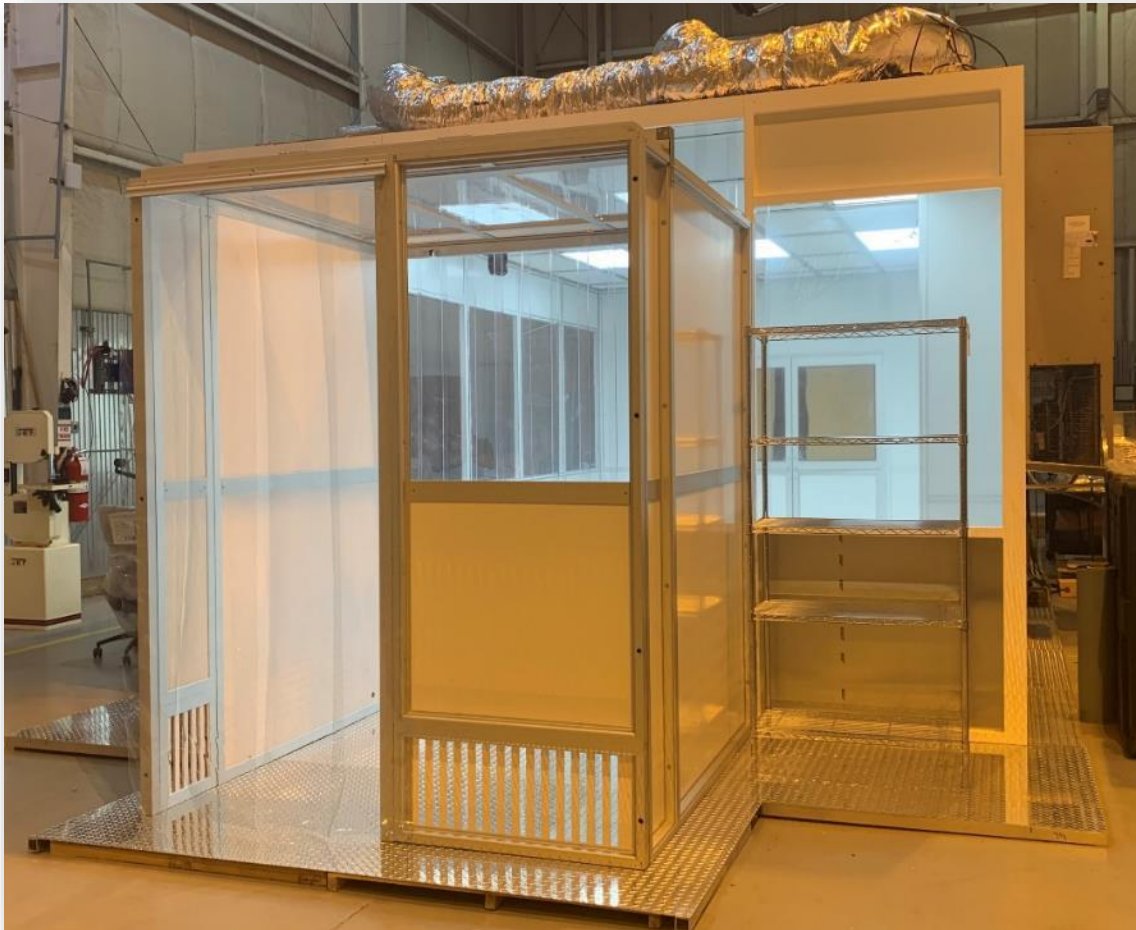
- Cleanroom installed by Lasco in June 2023 – Anteroom added by ARES Curation in July 2023
- Lesson learned – recommend that the mission review that includes the UTTR temporary cleanroom happen with enough lead time for feedback to be incorporated into purchase order

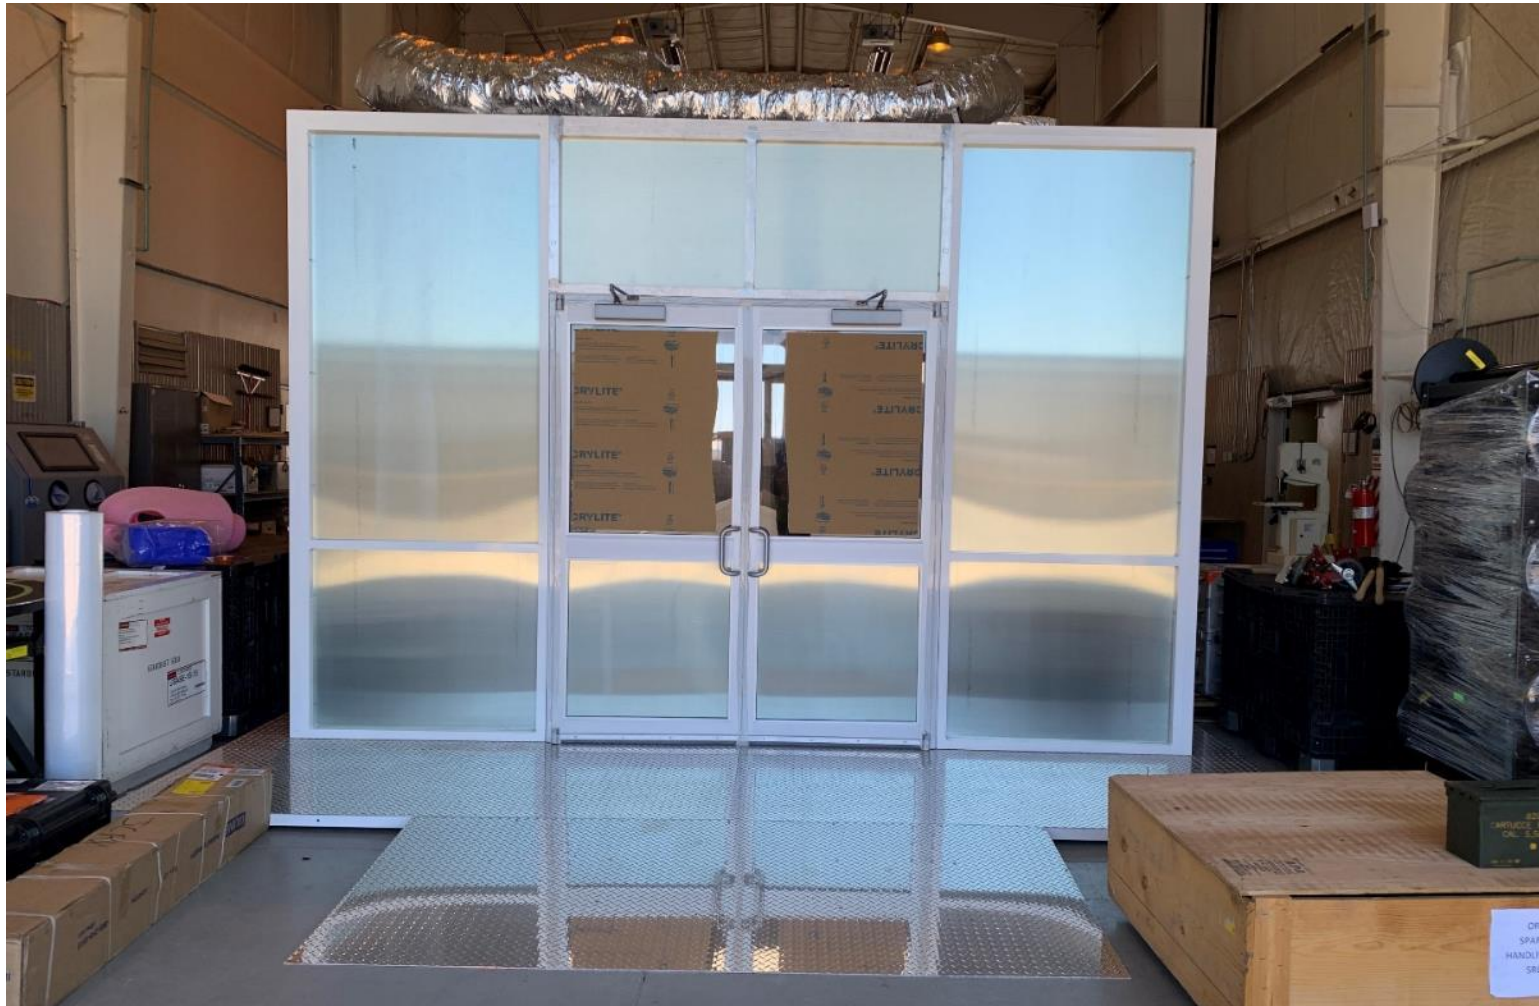
- Wrapped cleanroom doors with additional layer of plastic sheeting and taped the sheeting down with cleanroom tape when not in use
- Archived and analyzed debris from ceiling heating elements

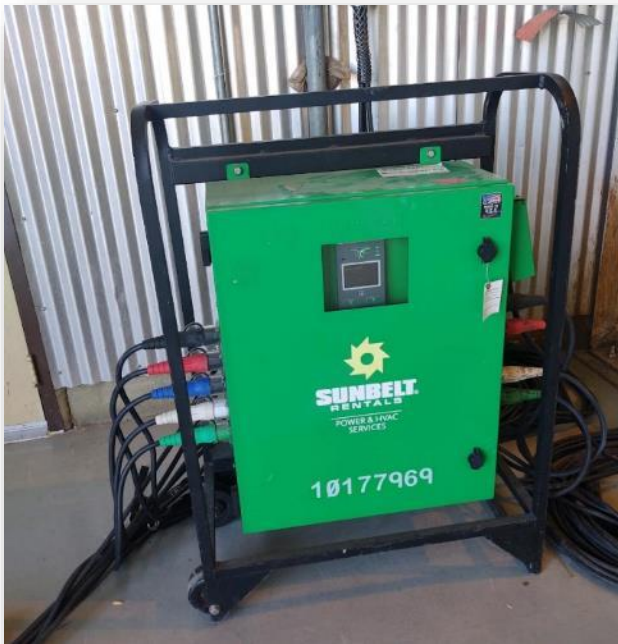
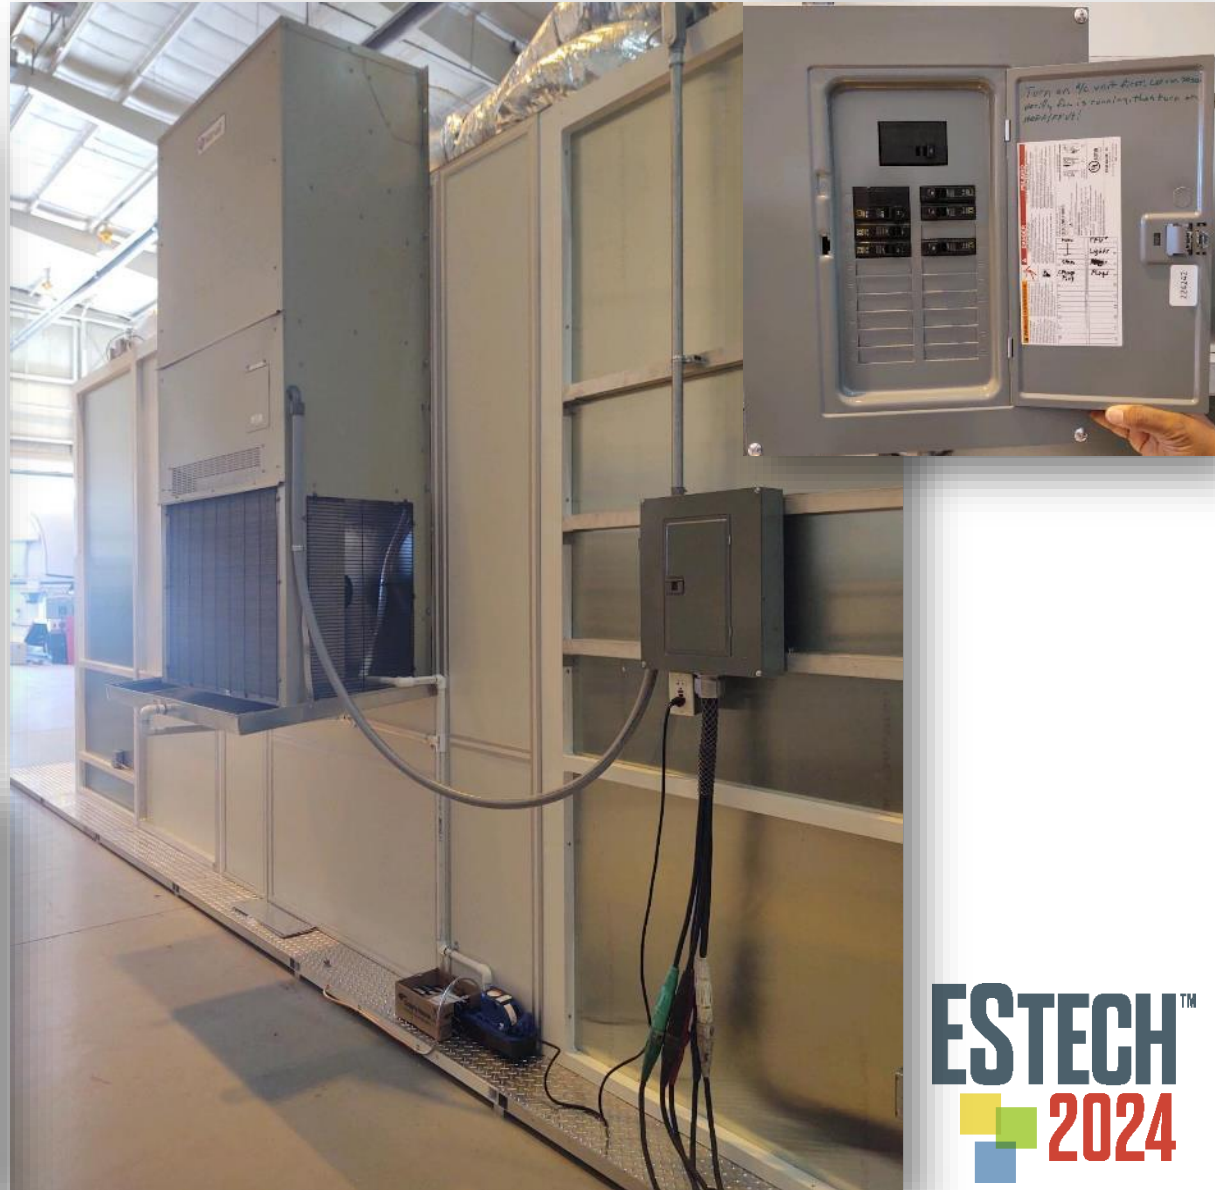
- Power panel connection to backup generator (20KW, 208V, 3 phase) outside installed by vendor.
