Portable Cleanroom for NASA OSIRIS-REx Mission Deintegration

Jacobs at NASA Johnson Space Center Houston, TX

Cleanroom Construction

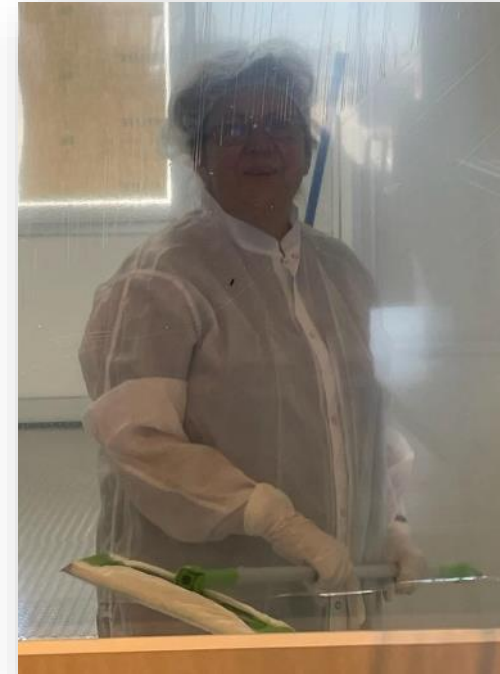
- Conducted a full wipe down with 70% isopropyl alcohol wet wipes and Ammonia free Windex with our ARES Cleaning Techs. Mopped floor a lot to keep clean. Cleaned to ISO 5 levels.

OSIRIS-Rex CLEAN CHECKLIST ISO CLASS 5											
POC: RACHEL FUNK											
GOWNING: BOOTIES HAIR NET FACE MASK HOOD BUNNY SUIT BOOTS SINGLE GLOVES (NO JEWELRY ALLOWED)											
SUPPLIES: VALUTEK-IPA NON-AMMONIA WINDEX											
MOP ALL FLOORS WITH CONTEC WIPES AND WATER											
(ONLY USE VALUTEK-IPA OR NON-AMMONIA WINDEX ON STAINED FLOORS. WIPE AGAIN WITH WATER.)											
DAILY		Monday		Tuesday		Wednesday		Thursday		Friday	
RM 216		Date	Initials	Date	Initials	Date	Initials	Date	Initials	Date	Initials
	Remove trash										
	Clean SS surfaces										
	Wipe down all surfaces										
	Mop floor with contec floor & water										
	Clean all glass and pass thru										
MONTHLY		Monday		Tuesday		Wednesday		Thursday		Friday	
RM 216		Date	Initials	Date	Initials	Date	Initials	Date	Initials	Date	Initials
	Ceiling to floor cleaning										
	Remove trash										
	Clean SS surfaces										
	Wipe down all surfaces/walls

Mop floor with contec floor & water										
	Clean all glass and pass thru

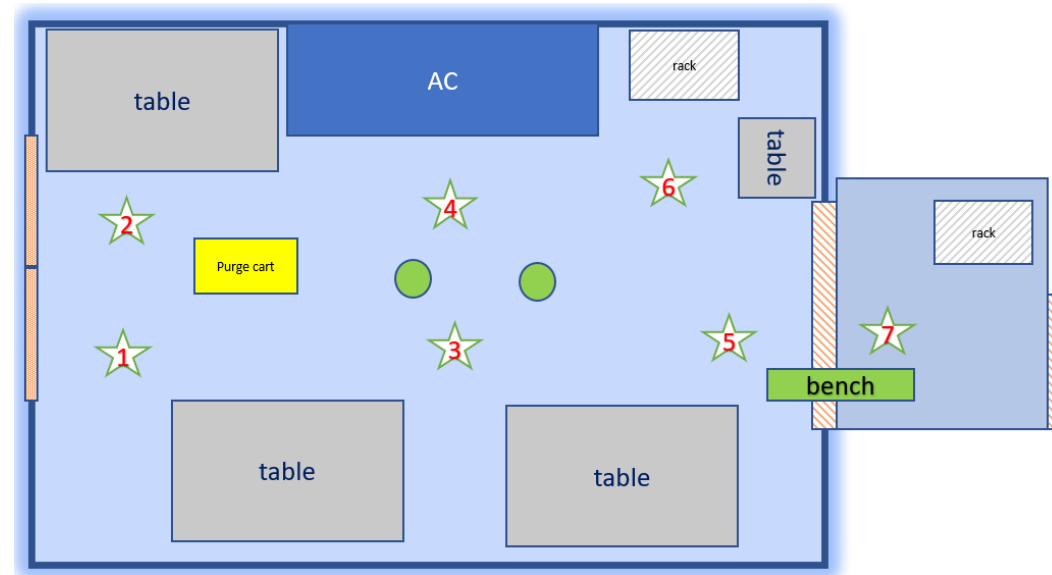
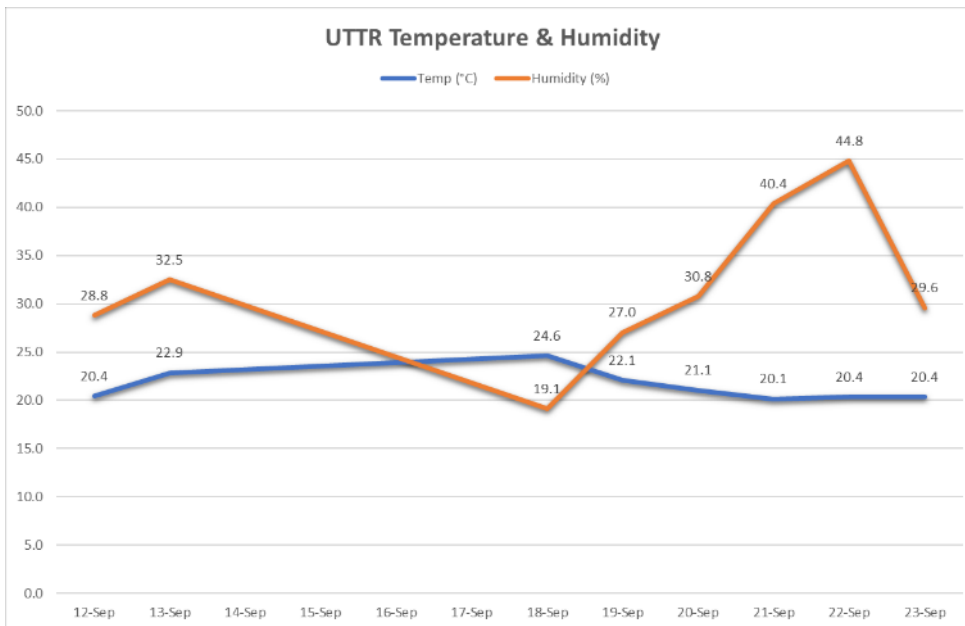
- Particle Counts were taken with ARES Technicians using TSI Handheld particle counter with Sample rate: 2.83 L/min at the following marked locations.
- Nominal Environmental Conditions (*except spike when roll-up doors to the outside were opened*)

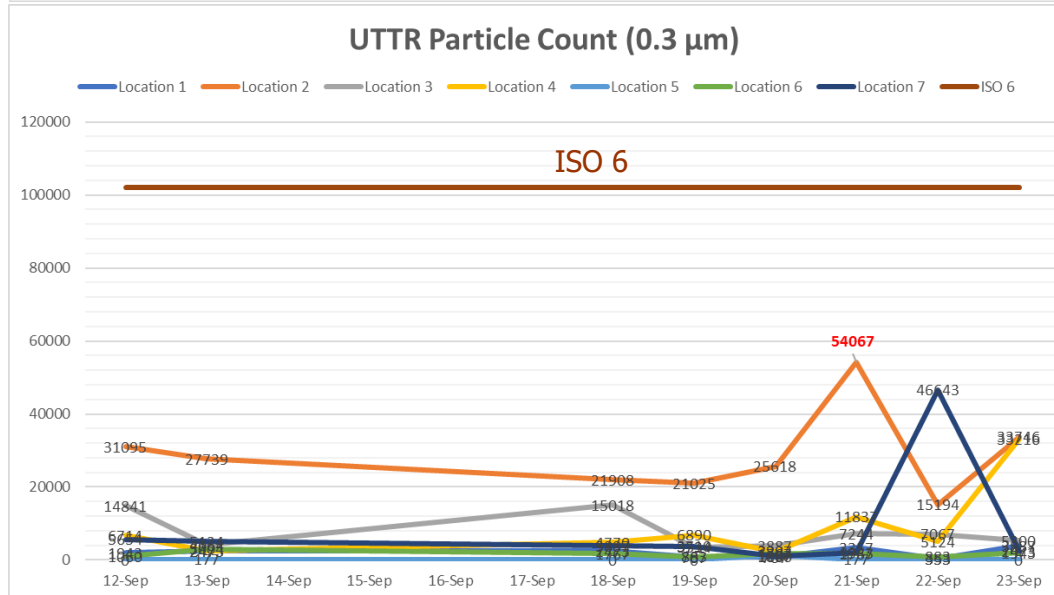
Particle Counts:

- The data covers from 12 days before landing to 1 day before landing. The cleanroom was built to ISO7 and the particle data indicates better than ISO6.
- The a/c was left off when not in use (until Sep 21st). It was turned on for return and then left on all the time.

Particle Spike:

- Heavier traffic inside of the cleanroom
- Rollup door was opened
- All the tools were being transported into the cleanroom
- Camaras were being set up in the cleanroom
- Particle count back to normal on the 23rd

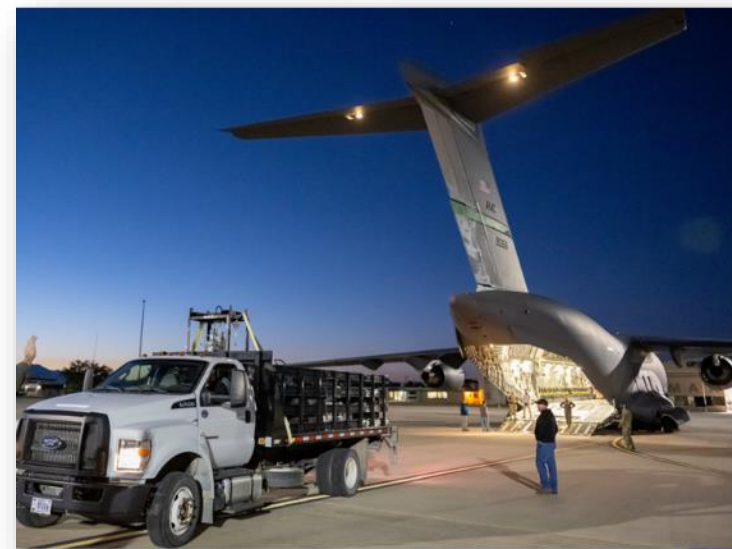
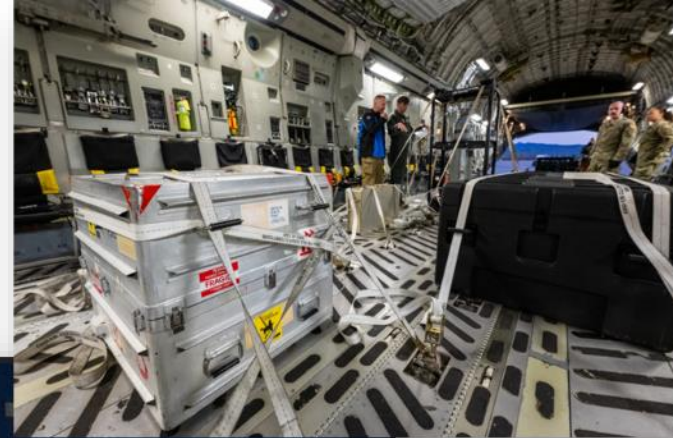
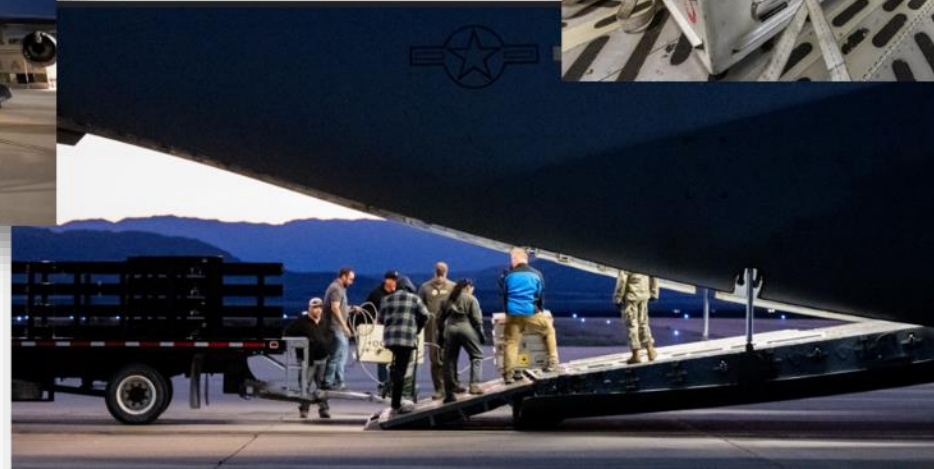
- The Bennu sample – an estimated 8.8 ounces, or 250 grams, was transported under nitrogen purge onto the aircraft for a flight to Houston, Tx.

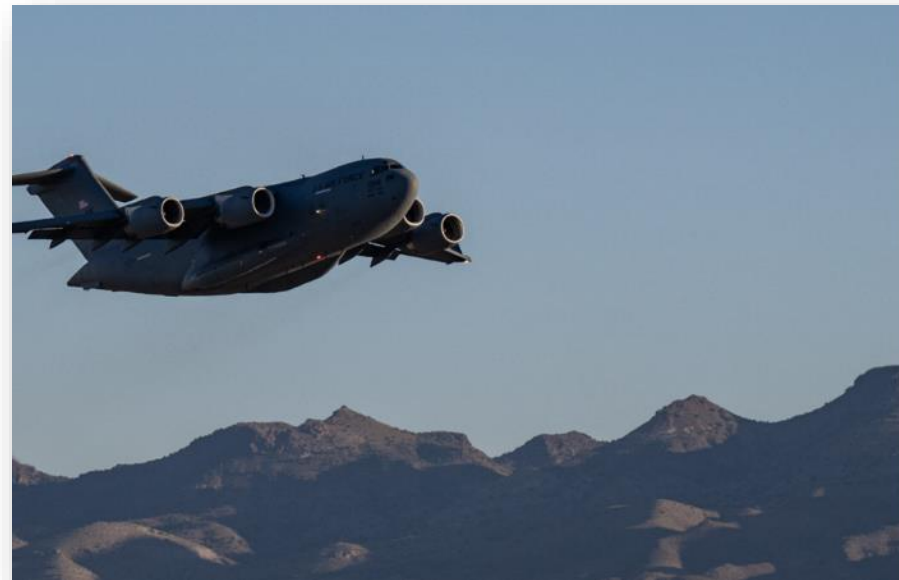
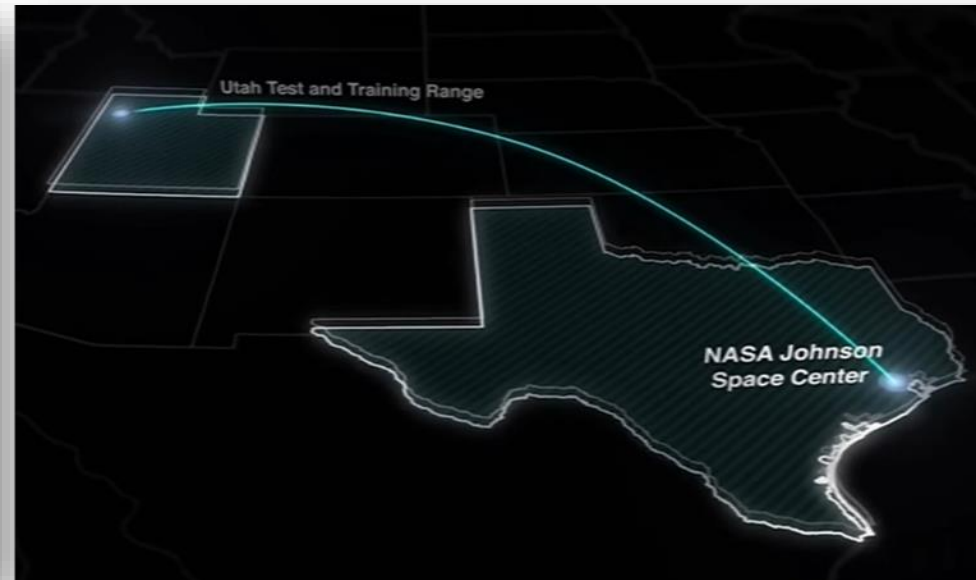
- The Bennu sample was transported in its unopened canister by aircraft to NASA's Johnson Space Center in Houston on Monday, Sept. 25, 2023.
- Curation scientists there disassembled the canister, extracted and weighed the sample.
- They are in the process of creating an inventory of the rocks and dust and will, over time, distribute pieces of Bennu to scientists worldwide.
