Contamination Results of MISSE 8 Wake and Nadir Samples After 2 Years of Space Exposure on the International Space Station

*Kim K. de Groh
Glenn Research Center, Cleveland, Ohio*

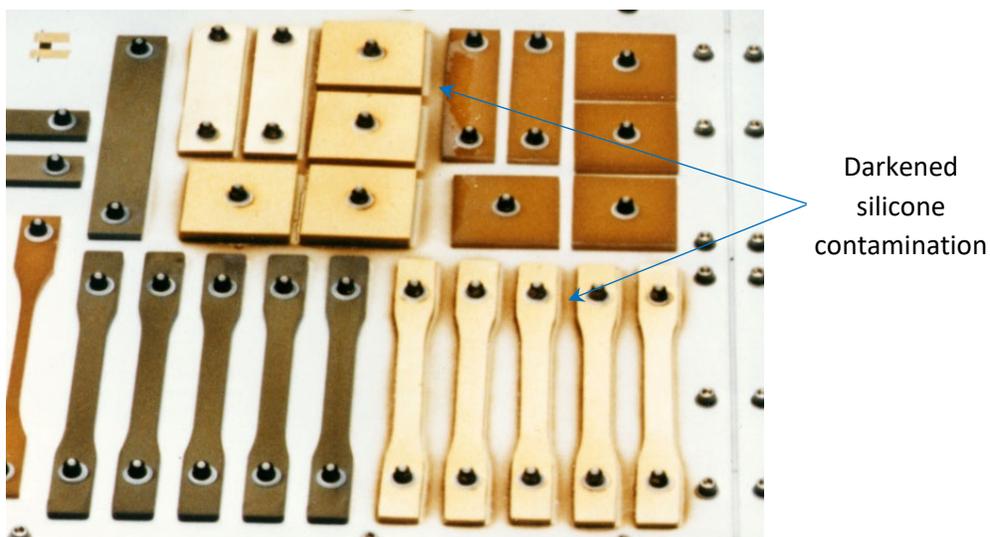
Figure 1. Atomic oxygen and UV darkened silicone contamination on LDEF (arrows point to areas with the dark contamination layer).^{4,5}

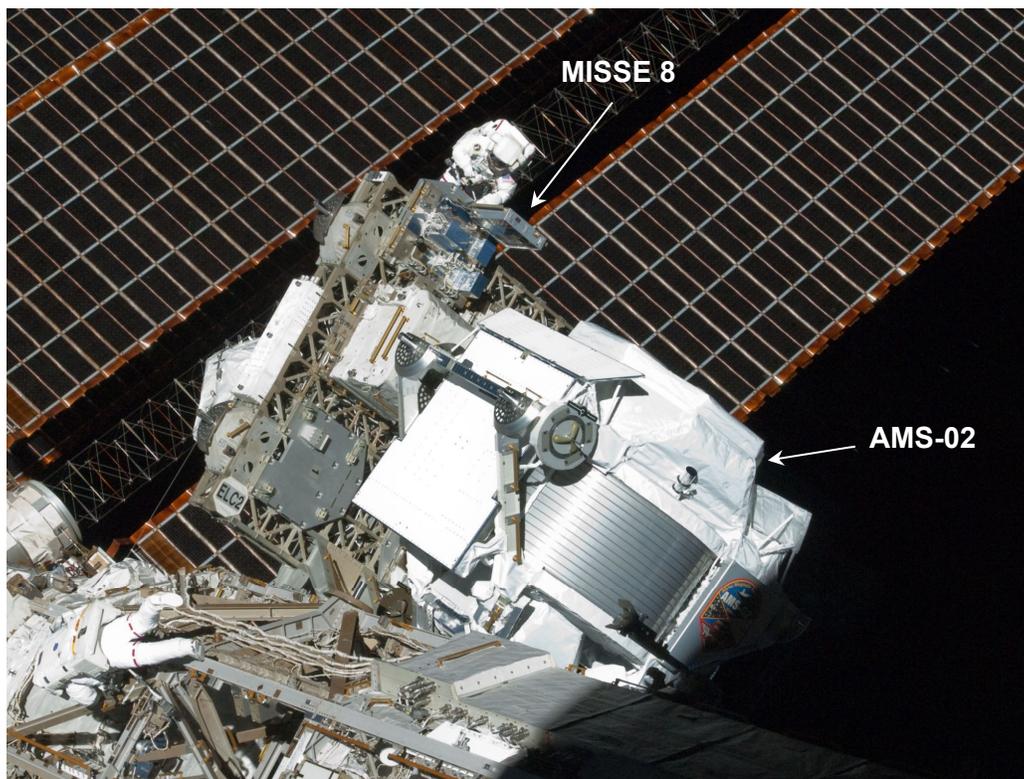
Figure 2. On-orbit photograph of the MISSE 8 zenith/nadir PEC and the AMS-02 taken during the MISSE 8 PEC installation EVA on May 20, 2011.

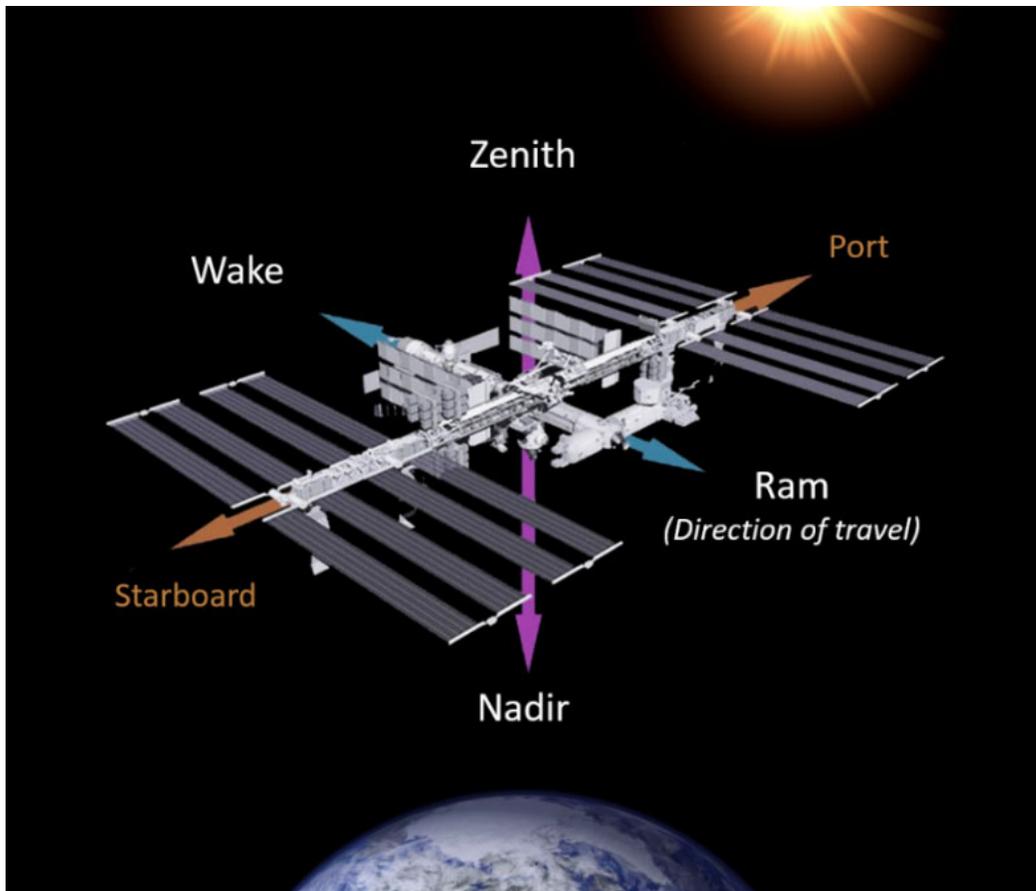
Figure 3. Diagram showing ram, wake, zenith, and nadir flight directions on the International Space Station.

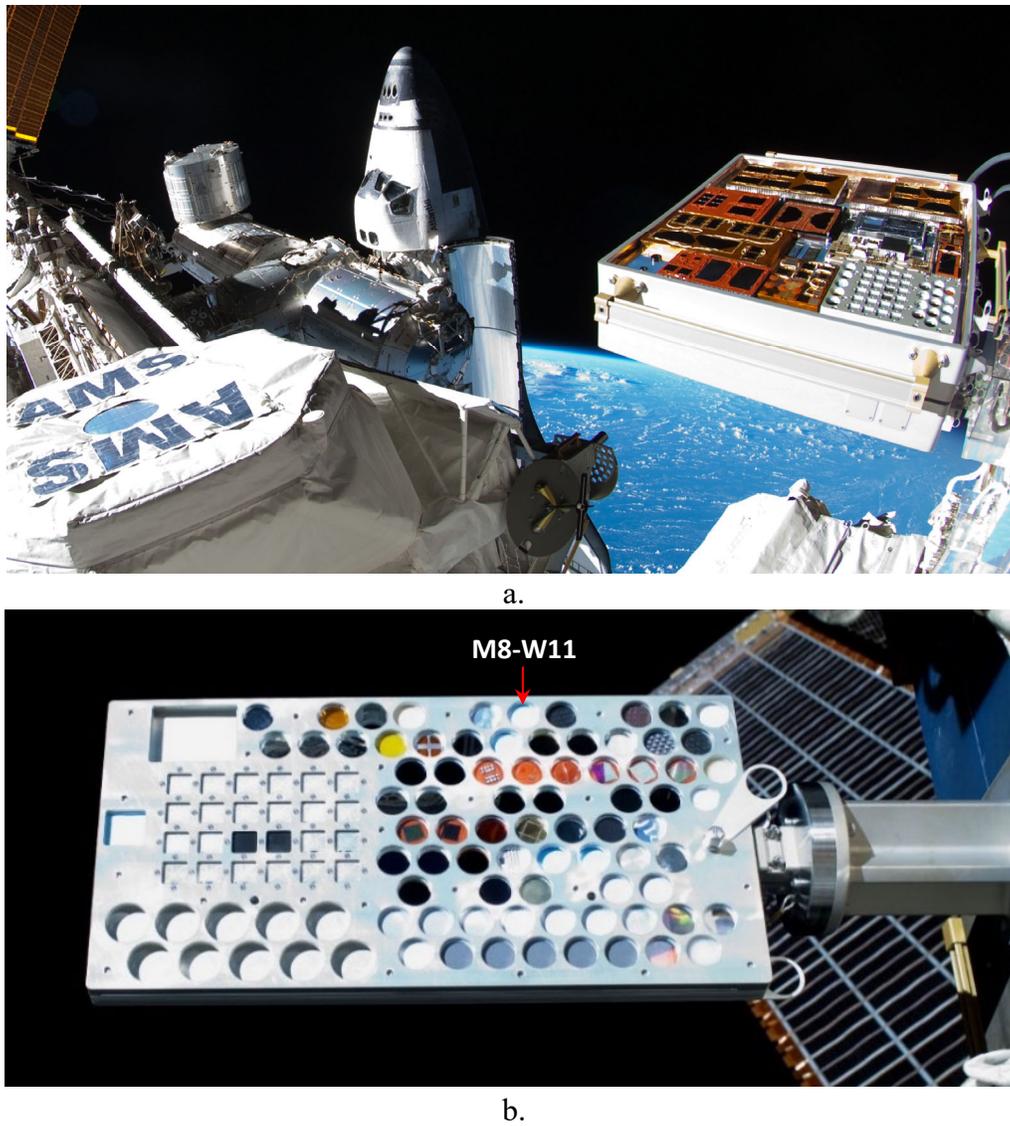
Figure 5. On-orbit images of the MISSE 8 PEC and ORMatE-III R/W as imaged during the STS-135 mission in July 2011: a). The zenith surface of the PEC is visible on the right side of the image and the AMS-02 is visible on the left, and b). The wake surface of ORMatE-III R/W.

R/W tray. The position of M8-W11 is shown in Figure 5b. Additional details on the MISSE 8 Polymers Experiment along with the AO E_y results are provided by de Groh in Reference 9.

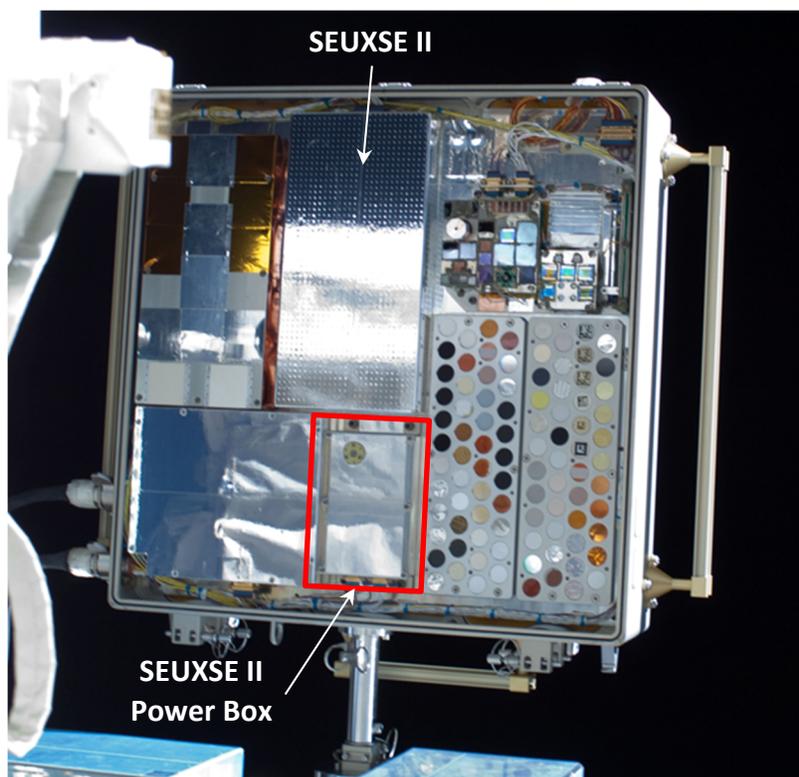
Figure 6. The SEUXSE II Power Box (red box) on the nadir side of the MISSE 8 PEC.

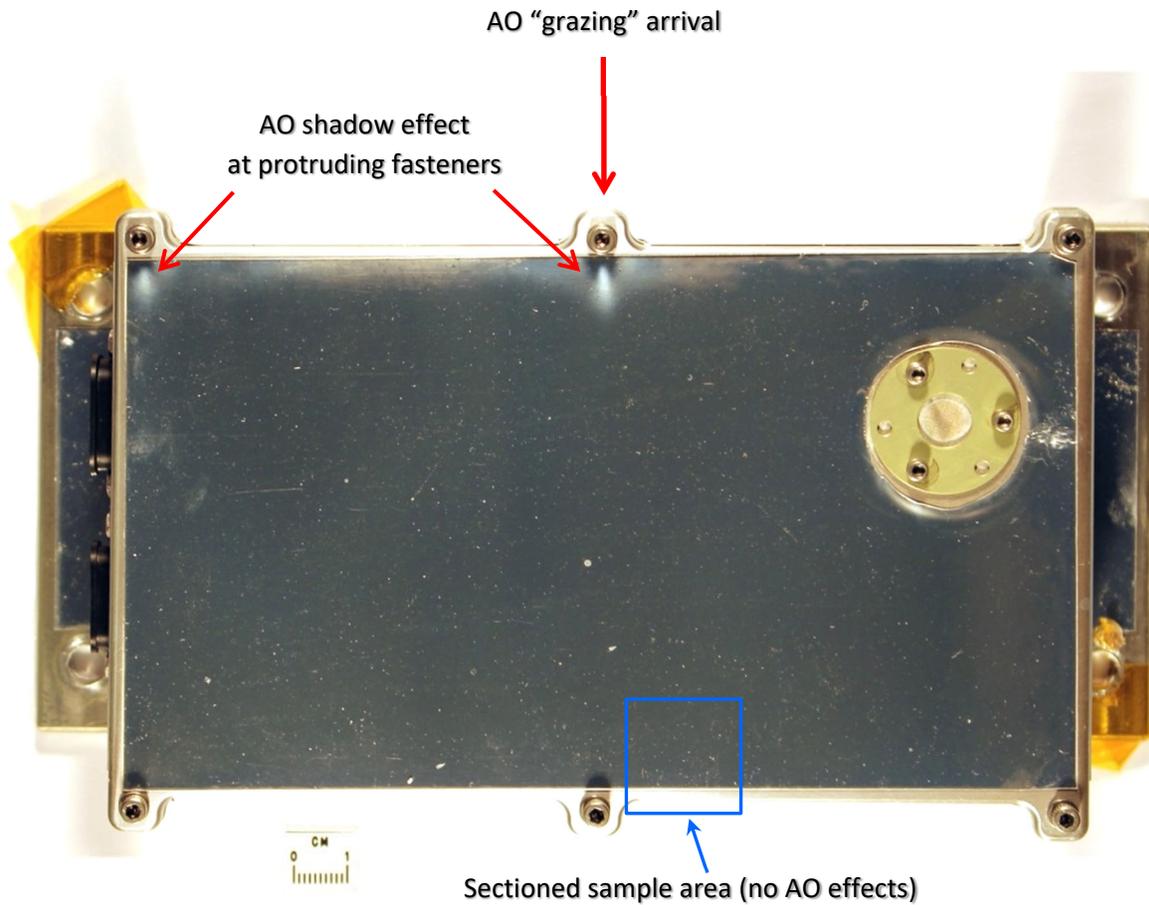
Figure 7. Post-flight photograph of the SEUXSE II Power Box showing AO effects at fasteners and the location of the MISSE 8 nadir contamination samples before sample removal.

The MISSE-8 nadir contamination test materials were silver-Teflon radiator material from the nadir surface of the SEUXSE II Power Box. The MISSE-8 SEUXSE-II experiment was designed to measure Single Event Upset (SEU) radiation effects on field programmable gate arrays (FPGAs).¹¹ Figure 6 provides an on-orbit photograph of the nadir side of the MISSE 8 PEC with the SEUXSE II Power Box highlighted. The silver-Teflon was 10 mil (254 μm) thick Teflon FEP that is back-surface coated with thin coatings of silver and Inconel (FEP/Ag/Inconel). The silver-Teflon film was adhered to the SEUXSE II Power Box with Y966 acrylic adhesive. The SEUXSE II Power Box was provided to Glenn from the Naval Research Laboratory (NRL) MISSE-8 principal investigator. Two test samples, one for X-ray Photoelectron Spectroscopy (XPS) analyses and one for Scanning Electron Microscopy (SEM) and Energy Dispersive Spectroscopy (EDS) analyses, were carefully sectioned from the nadir surface (top) of the SEUXSE II Power Box in an area where there was no observable AO effects, as shown in Figures 7 and 8.

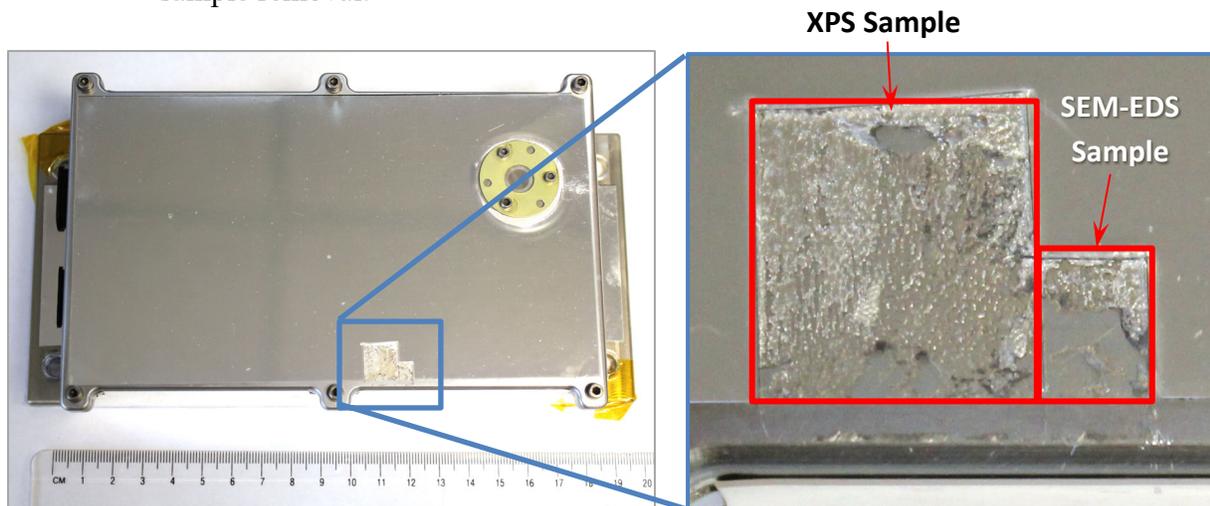
Figure 8. Location of the two sectioned SEUXSE II Power Box samples after sample removal (XPS and SEM-EDS samples).

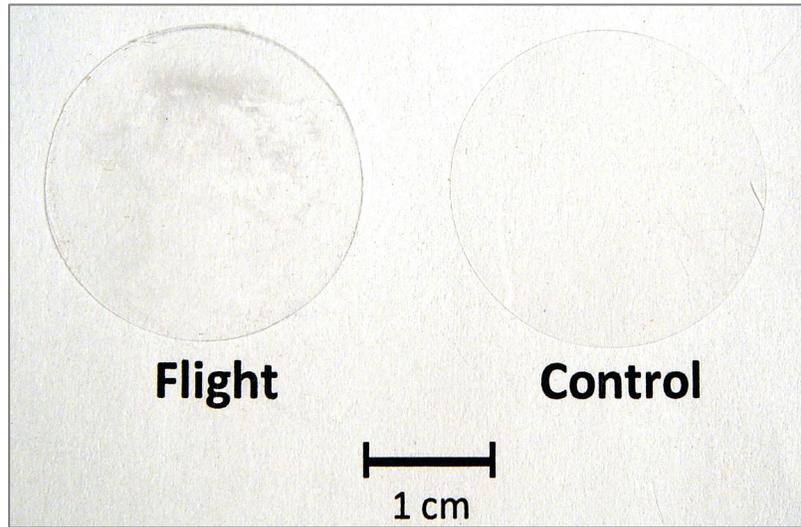
Figure 10. Post-flight photograph of the MISSE 8 wake FEP flight (M8-W11) and corresponding control (M8-R9-B) samples.

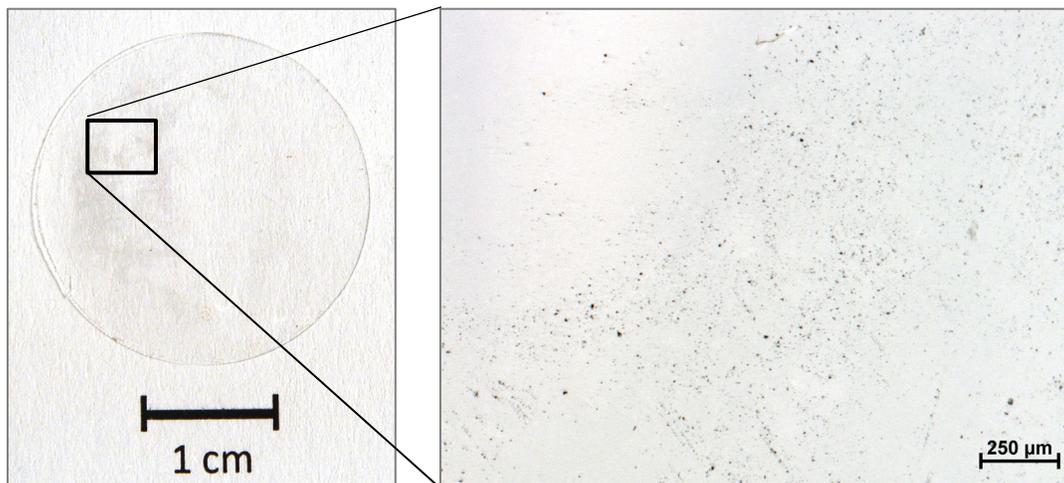
Figure 11. Post-flight photo of the wake FEP flight sample (M8-W11) with a close-up optical microscope image of the particulate-rich hazy area.

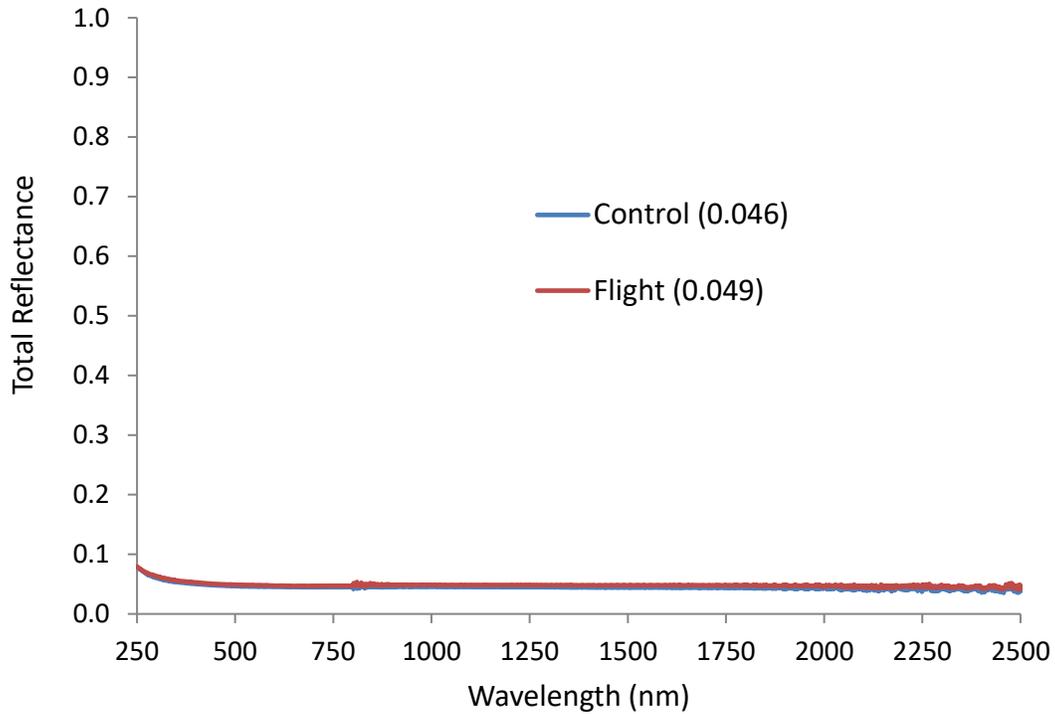
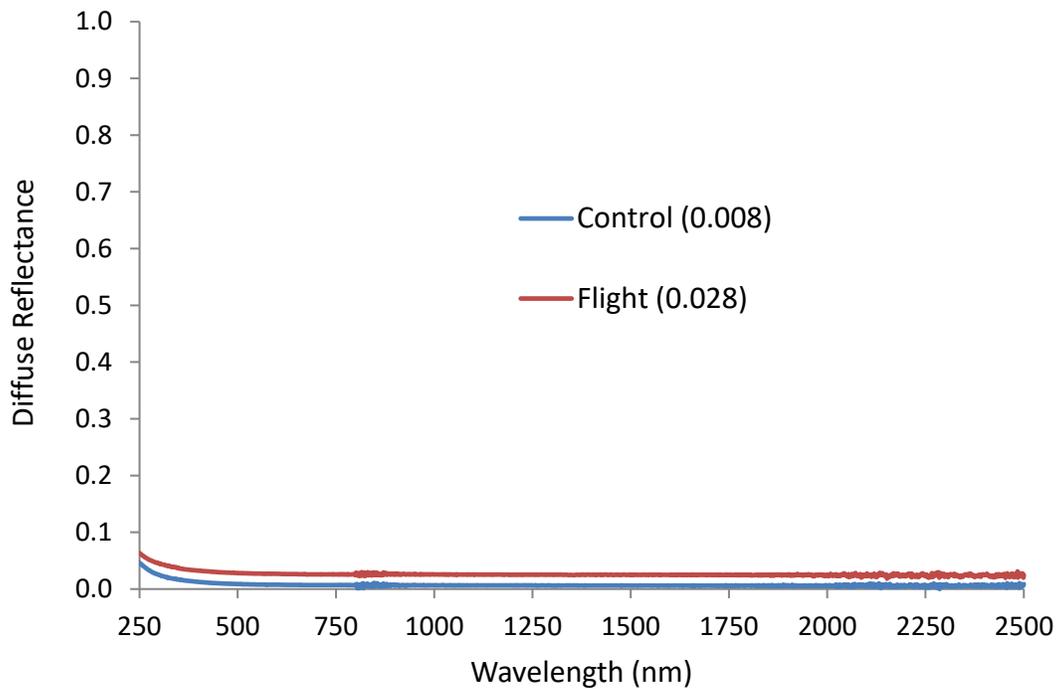
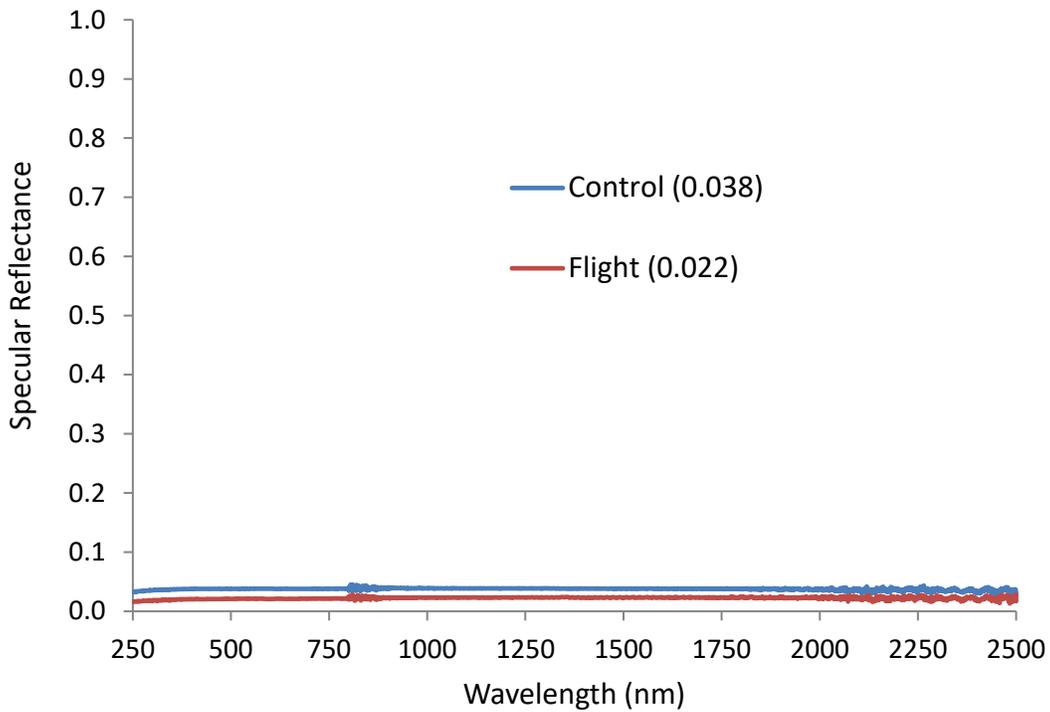
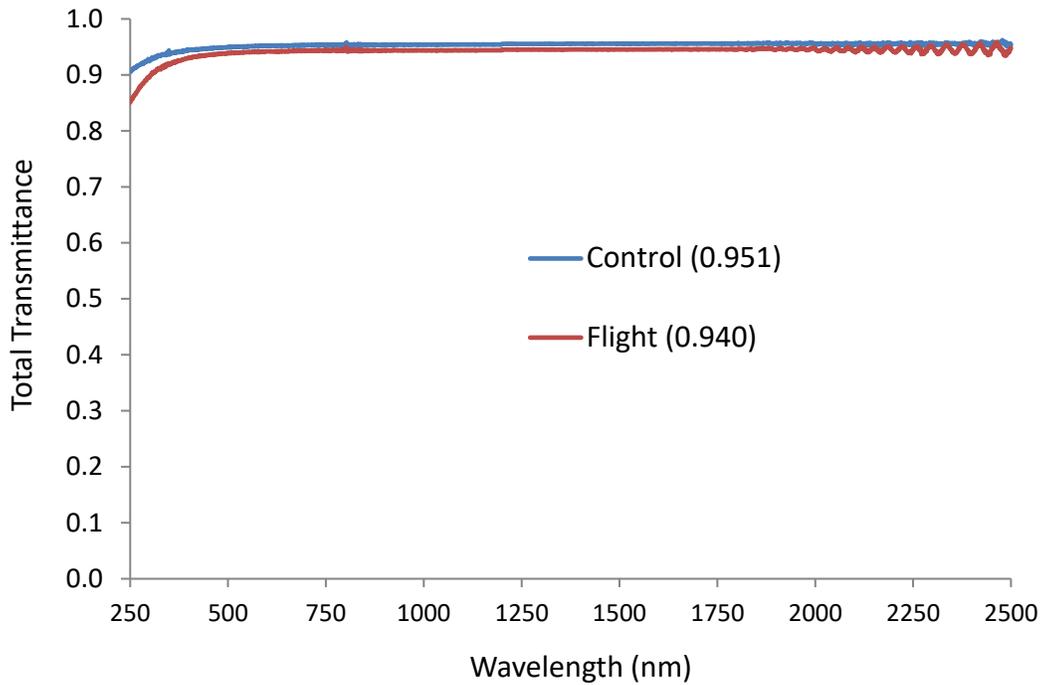
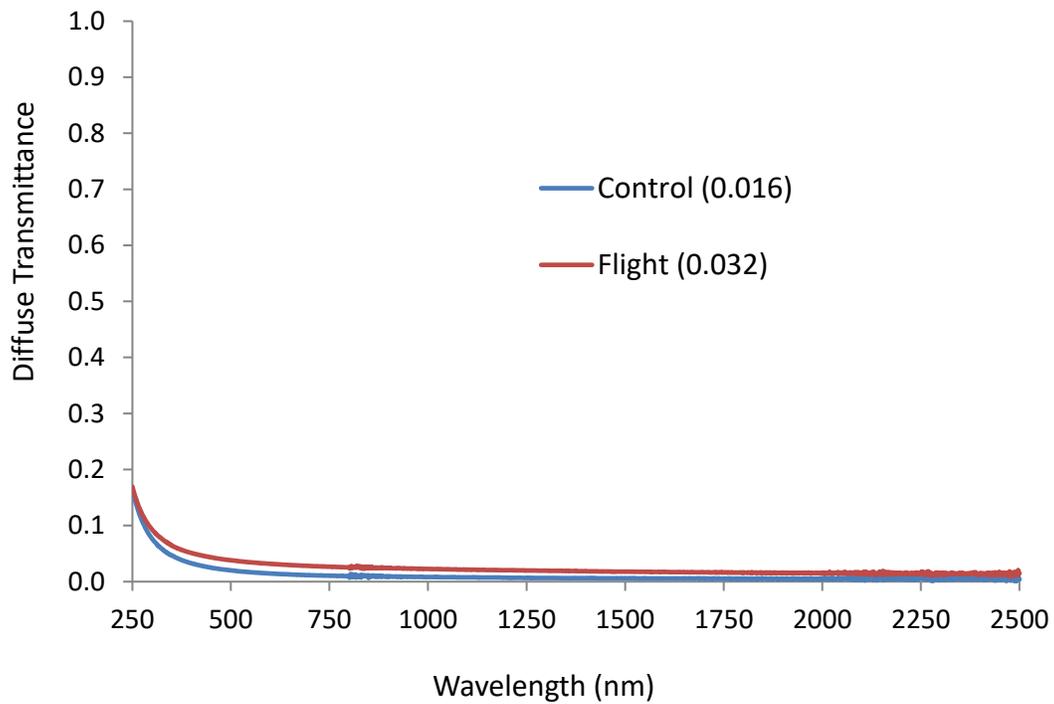
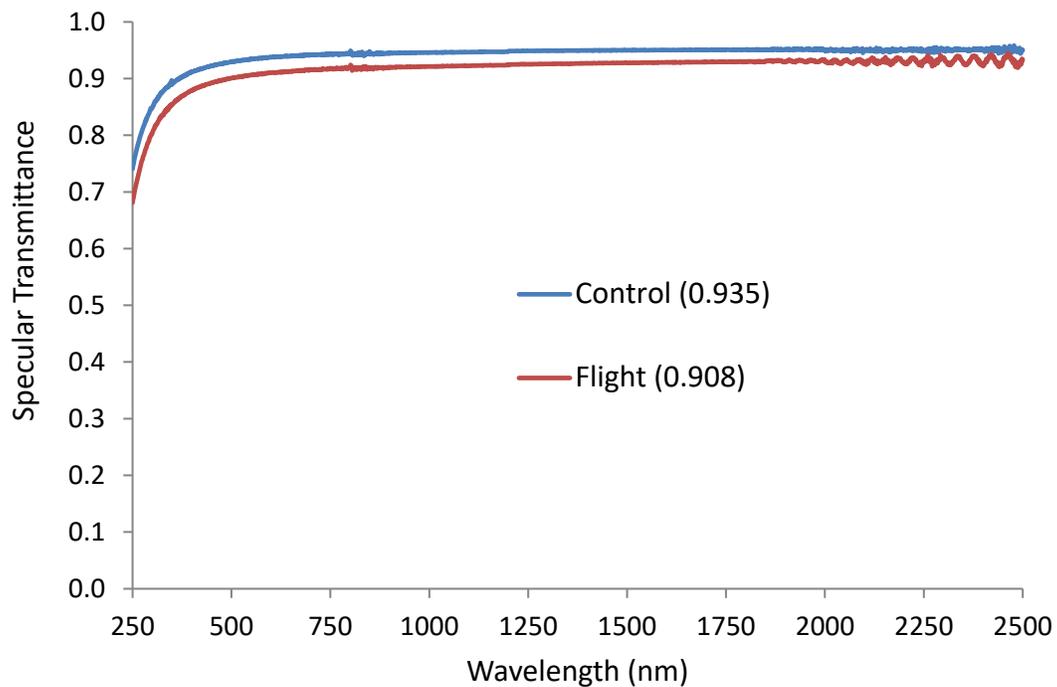
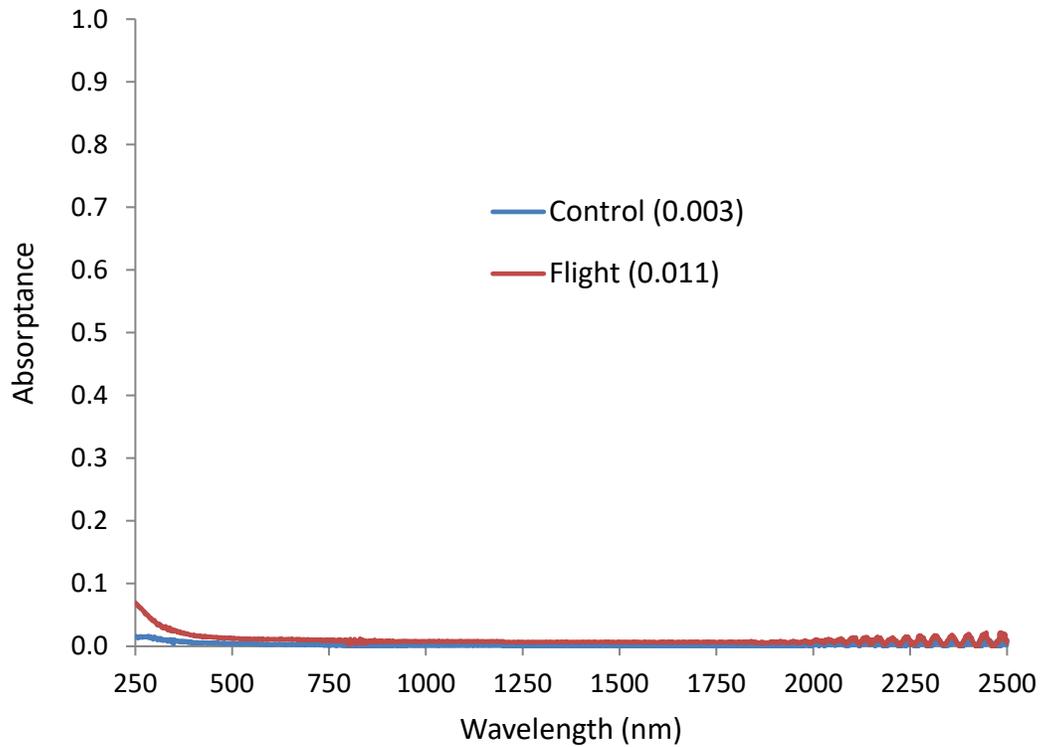
Figure 12. Total reflectance spectra for the MISSE-8 wake Teflon FEP flight (M8-W11) and control (M8-R9-B) samples.

Figure 13. Diffuse reflectance spectra for the MISSE-8 wake Teflon FEP flight (M8-W11) and control (M8-R9-B) samples.

Figure 14. Specular reflectance spectra for the MISSE-8 wake Teflon FEP flight (M8-W11) and control (M8-R9-B) samples.

Figure 15. Total transmittance spectra for the MISSE-8 wake Teflon FEP flight (M8-W11) and control (M8-R9-B) samples.

Figure 16. Diffuse transmittance spectra for the MISSE-8 wake Teflon FEP flight (M8-W11) and control (M8-R9-B) samples.

Figure 17. Specular transmittance spectra for the MISSE-8 wake Teflon FEP flight (M8-W11) and control (M8-R9-B) samples.

Figure 18. Absorbance spectra for the MISSE-8 wake Teflon FEP flight (M8-W11) and control (M8-R9-B) samples.

Figures 12 to 18 provide the TR, DR, SR, TT, DT, ST and α_s spectral curves for the flight (M8-W11) and control (M8-R9-B) samples, respectively. As can be seen in Figures 12 to 14, there was insignificant change in the TR spectra but there was an observable increase in the DR, and decrease in the SR, across all wavelengths of the flight samples as compared to the control sample. The TT of the flight sample decreased most notably in the UV region of the spectra, as shown in Figure 15. Whereas the DT increased, and the ST decreased, across most wavelengths, as shown in Figures 16 and 17 respectively. The diffuse reflectance and transmittance increase is likely contributed to by the hazy regions. Table 3 provides a summary of the AM0 integrated optical properties for the MISSE 8 wake flight and control samples. Overall, the α_s of the flight sample increased 0.008 as compared to the control sample, mostly in the UV region (see Figure 18).

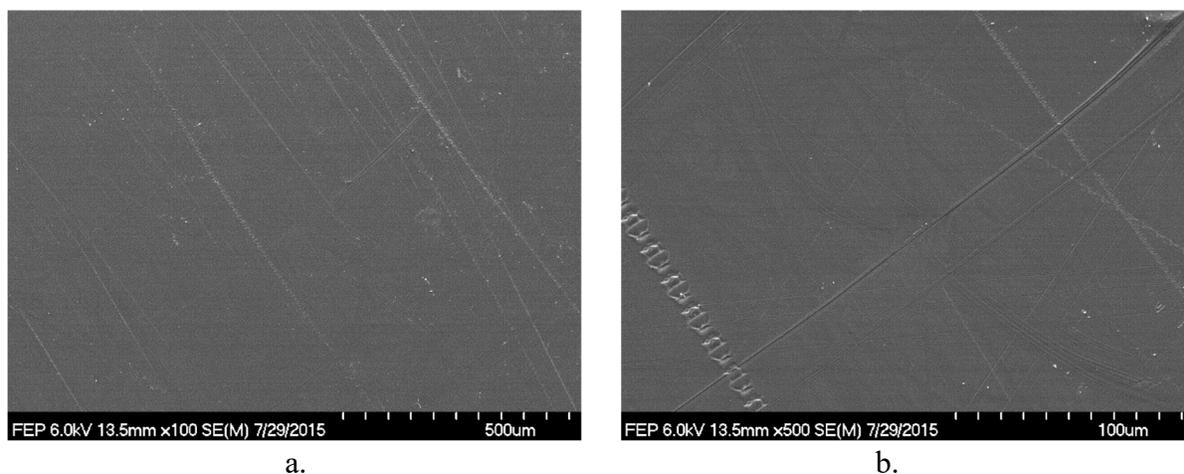
Figure 19. FESEM images of the MISSE 8 wake FEP control sample (M8-R9-B): a). Image FEP-01 taken at 100X and 0° tilt, b). Image FEP-02 taken at 500X and 0° tilt.

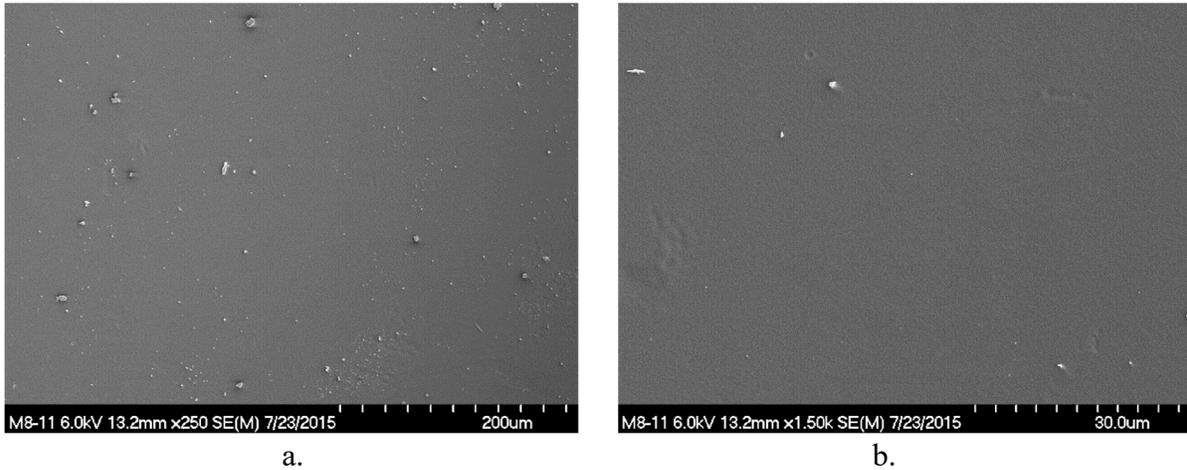
Figure 22. FESEM images of the MISSE 8 wake flight sample (M8-W11) in space exposed “cleaner” regions: a). Image S1-06 taken at 250X and 0° tilt, b). Image S1-07 taken at 1.5kX and 0° tilt.

Figures 22 and 23 provide FESEM images and corresponding EDS area analysis spectra, respectively, for the MISSE 8 wake flight sample (M8-W11) in “cleaner” space exposed regions. The FESEM images show a smooth surface with a few bright particles. The EDS spectra show the F and C peaks for FEP and the Pt peak for the conductive coating that was applied. The EDS spectra also show very small aluminum (Al) and O peaks, which are believed to be associated with the particles. Figure 24 provides XPS spectra of the space exposed area of the wake flight sample in a cleaner region. The XPS spectra corresponds with the EDS data. The surface atomic concentration for F was 64.65 at.% and for C was 33.55 at.%. These are slightly less than the F and C atomic concentrations for the FEP control sample (67.04 and 32.88 at.%, respectively). The cleaner region of the flight sample also had small peaks for O (1.30 at.%) and Al (0.49 at.%). An insignificant amount of silica (Si) was also detected (0.02 at.%). The at.% of O increased from 0.09 to 1.30 at.%, so oxidation of the flight sample has occurred. And, the flight sample has Al, likely from the particles. The EDS and XPS spectra do not provide evidence of Si (i.e. silicone) molecular contamination on the flight sample.

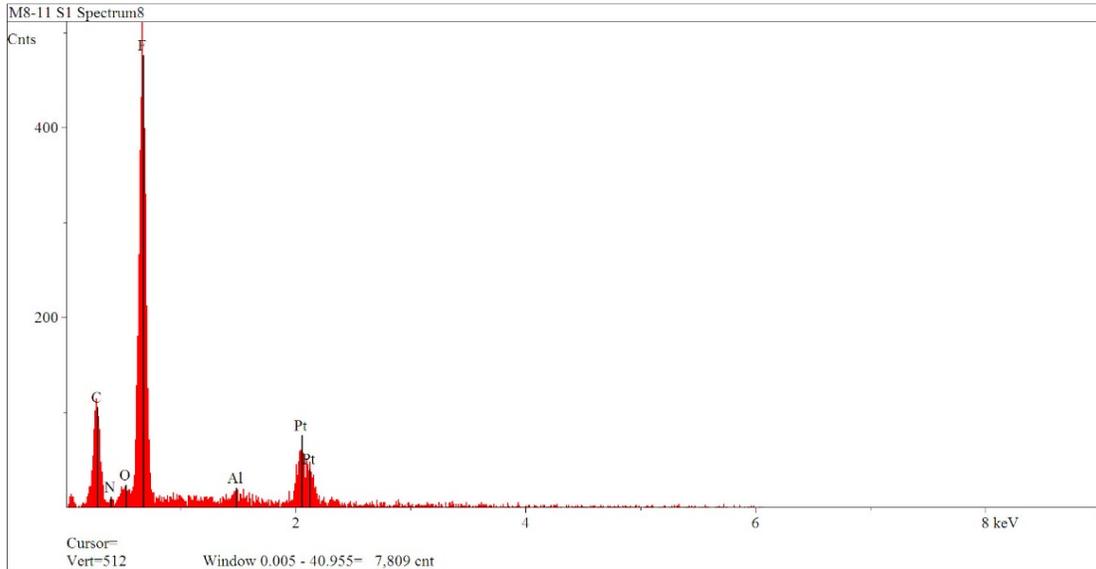
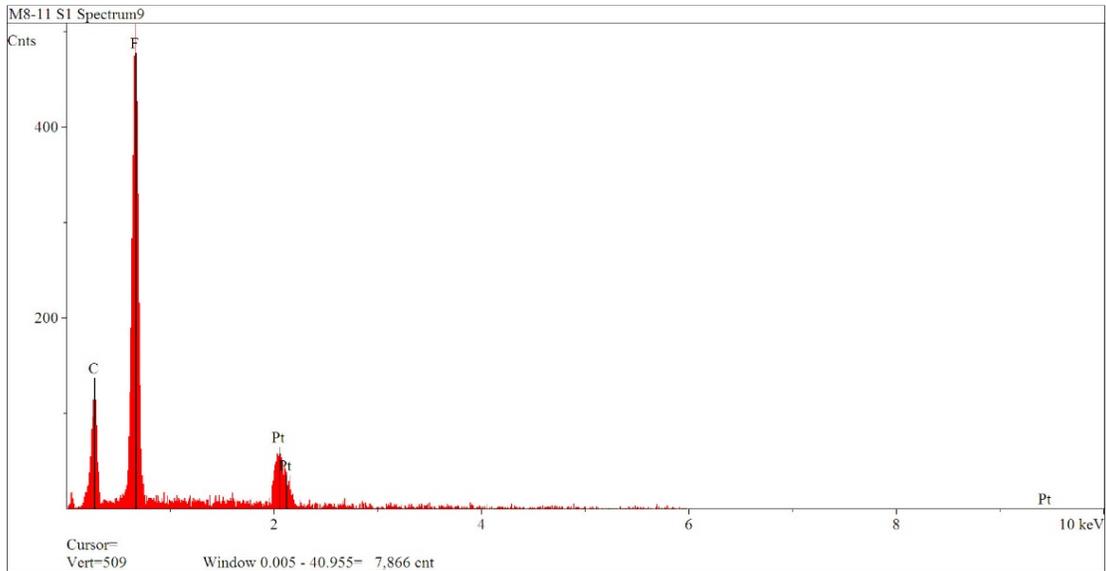
Figure 23. EDS area analysis spectra of M8-W11 in cleaner regions from: a). FESEM image area in Figure 22a (6 kV), and b). FESEM image area in Figure 22b (6 kV).

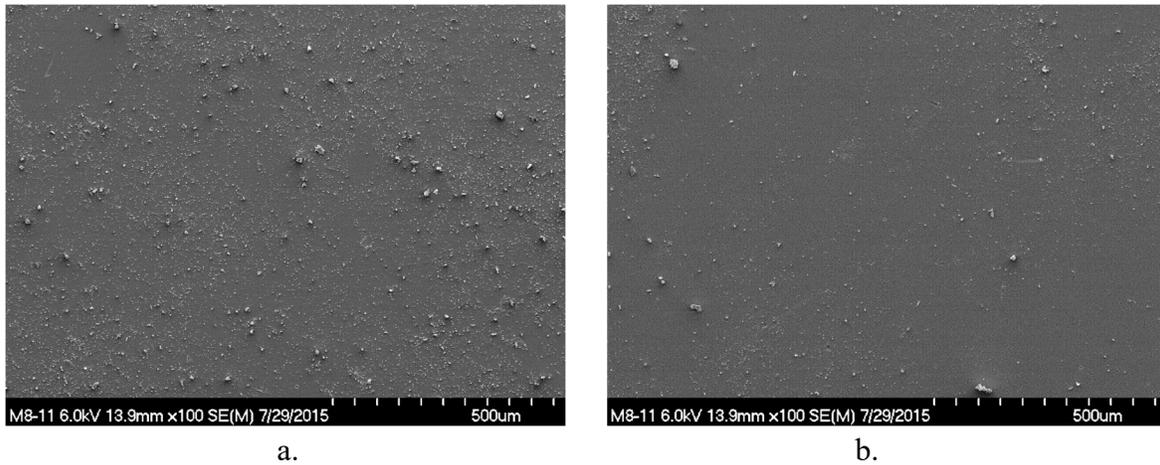
Figure 25. FESEM images of the MISSE 8 wake flight sample (M8-W11) in space exposed “hazy” regions: a). Image (S1-14) taken at 100X and 0° tilt, b). Image (S1-15) taken at 100X and 0° tilt.

Figures 25 and 26 provide FESEM images and corresponding EDS area analysis spectra, respectively, for the MISSE 8 wake flight sample (M8-W11) in “hazy” space exposed regions. The FESEM images show more small particles than seen in the cleaner regions shown in Figure 22. The EDS spectra show the F and C peaks for FEP and the Pt peak for the conductive coating that was applied. The EDS spectra also show very small Al, O and sulfur (S) peaks. No additional elements were identified using the higher accelerating voltage of 15 kV, as shown in Figure 26b, and the very small S peak was not present at 15 kV. Figure 27 provides XPS spectra of the space exposed area of the wake flight sample in a hazy region. The XPS spectra corresponds with the EDS data. The surface atomic concentration for F was 60.88 at.% (down from 64.65 at.% in the clean region) and for C was 38.36 at.% (up from 33.55 at.% in the clean region). There were also small peaks for O (0.61 vs. 1.30 at.%) and Al (0.11 vs. 0.49 at.%). And, insignificant amount of Si (0.02 at.%) and lead (Pb) (0.02 at.%) were also detected. Thus, the hazy region had fairly significant increase in C (38.36 vs. 32.88 at.% for the control sample) and decrease in F (60.88 vs. 67.04 at. % for the control sample). The EDS and XPS spectra do not provide evidence of Si (i.e., silicone) molecular contamination on the flight sample.

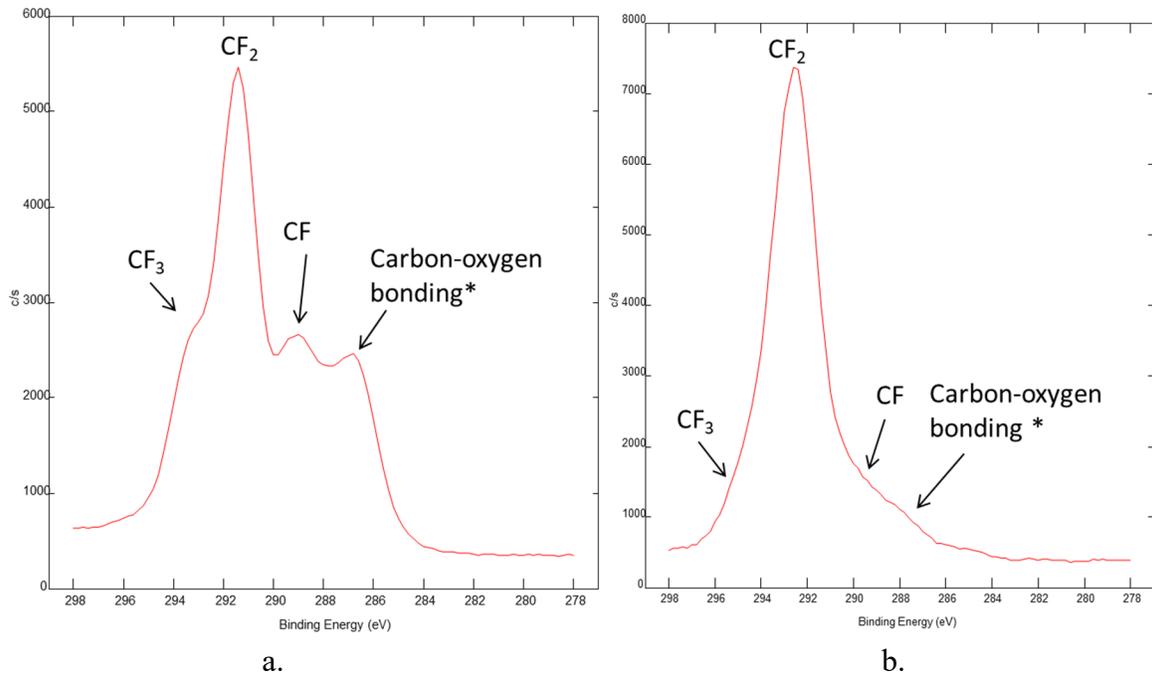
Figure 28. Expanded C regions of the XPS binding energy data for: a). MISSE 8 wake FEP flight sample (M8-W11), and b). Control FEP sample (M8-R9-B) surface.

The XPS analyses of the MISSE 8 wake FEP flight sample (M8-W11) also indicated visible (optical camera) evidence of erosion. Figure 28 provides expanded XPS C binding energy spectra for the MISSE 8 wake flight sample space exposure surface (Figure 28a) and the control sample (Figure 28b). There could be some degradation of the polymer C-O bonding caused by x-ray irradiation during analysis. This is highlighted with an asterisk (*) in the two graphs shown in Figure 28. The comparisons also show that the flight sample has more degradation, which is most likely caused by AO oxidation.

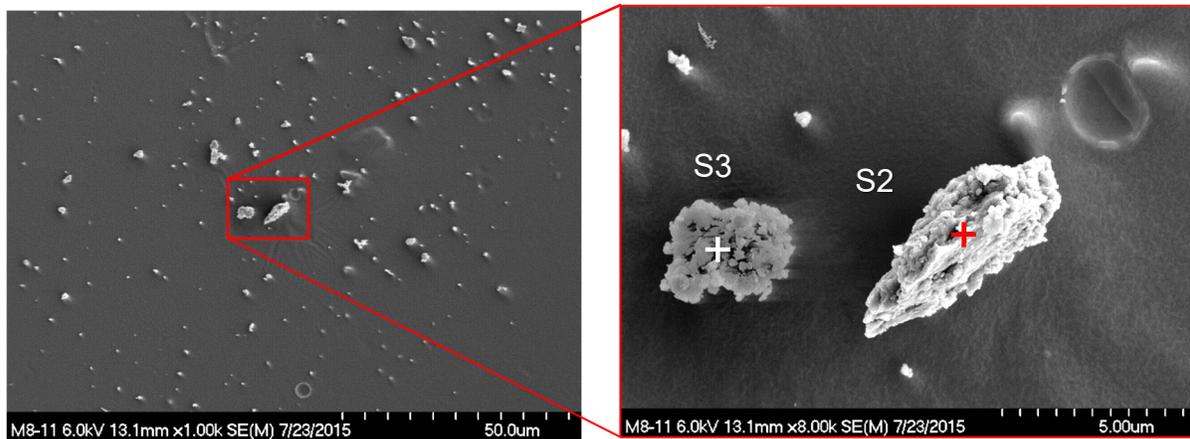
Figure 29. FESEM image of the space exposed area of the MISSE 8 wake flight sample (M8-W11) with a higher magnification image (right) showing the spot analysis locations (S2 and S3) of the central two particles.

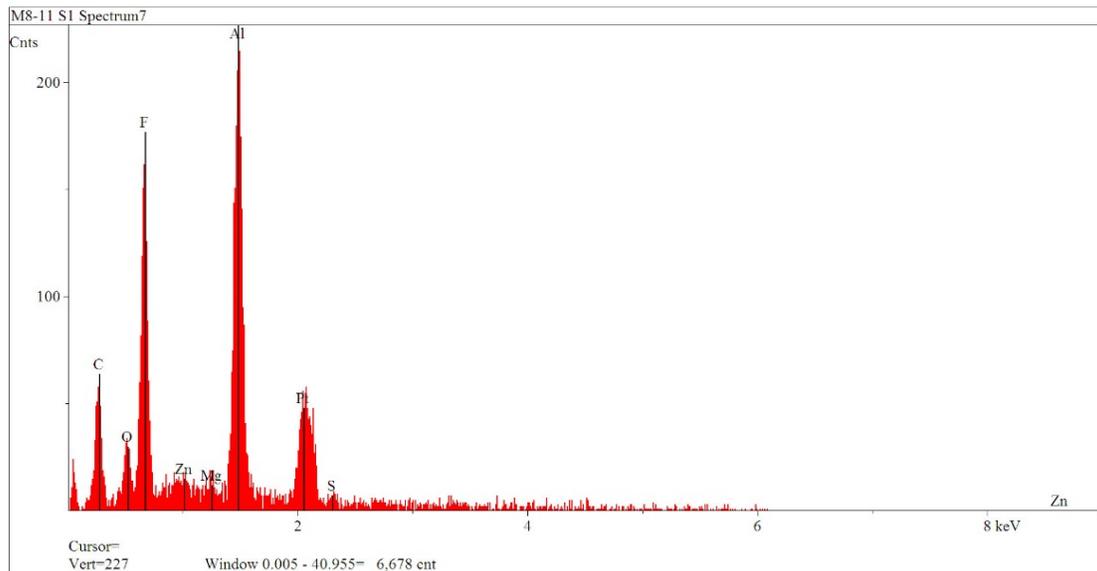
Figure 33. EDS spot analysis spectra (S7) of the particle shown in Figure 32 with Al, O, Zn and Mg peaks in addition to F, C and Pt (conductive coating).

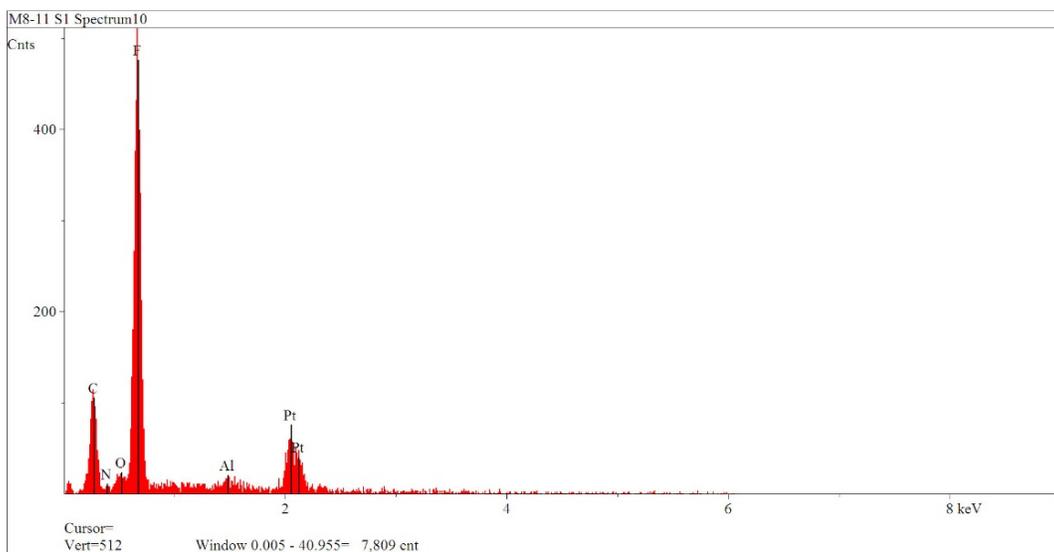
Figure 35. EDS area analysis spectra (S10) of the wake flight sample (M8-W11) for the area shown in Figure 34 with Al and O in addition to F, C and Pt (conductive coating).

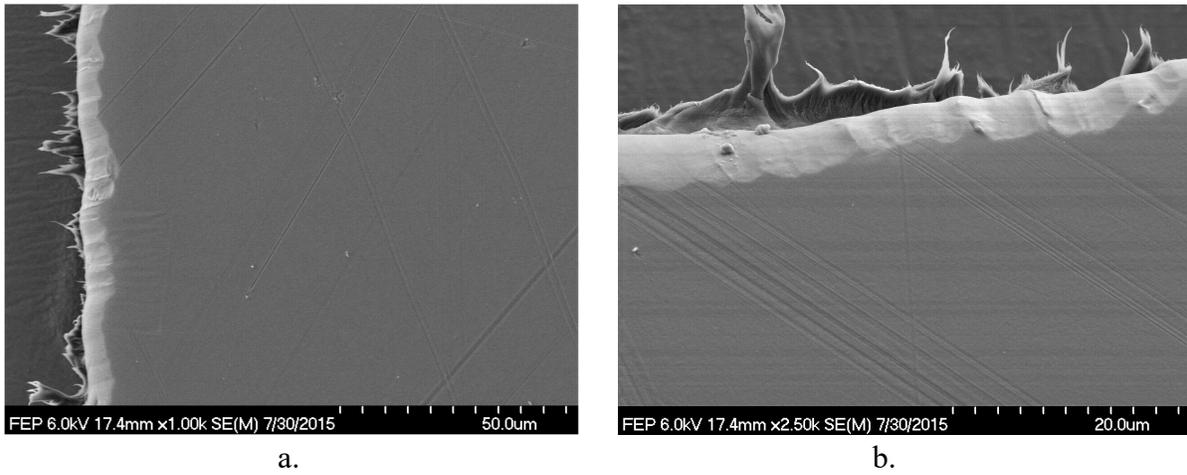
Figure 47. FESEM images of the cut edge of the MISSE 8 wake control sample (M8-R9-B): a). Image taken at 1kX (40° tilt), and b). Image taken at 2.5kX (40° tilt).

Figure 46 provides FESEM images of the cut edge of the MISSE 8 wake flight sample sectioned for FESEM imaging. The top surface of the space exposed surface is embrittled, as can be seen in these images. Teflon is known to be come embrittled with radiation and thermal exposure in the space environment.¹⁴⁻¹⁶ Figure 47 provides FESEM images of the cut edge of the MISSE 8 control sample sectioned for FESEM imaging. These images show that the FEP control sample does not display the same cracking as the embrittled space exposed flight sample.

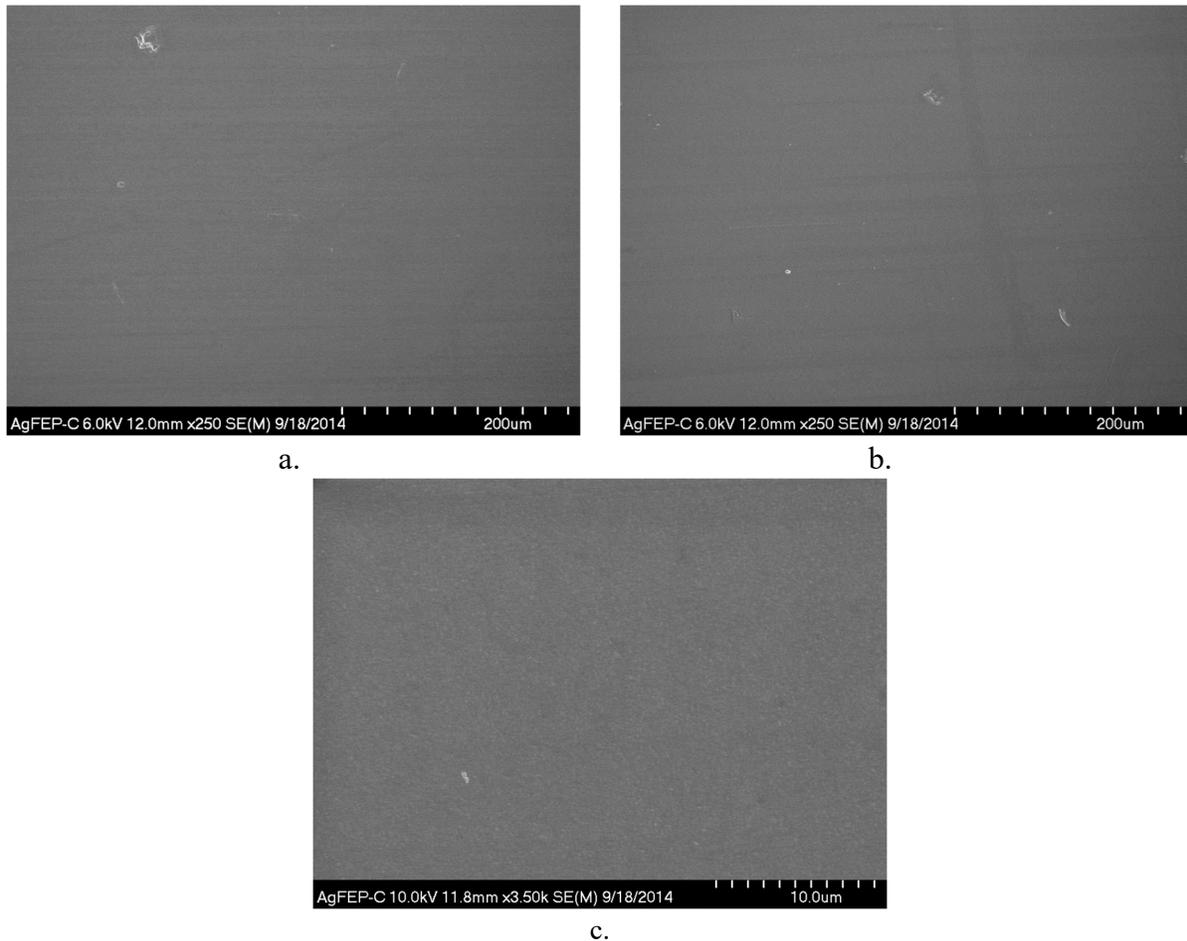
Figure 48. FESEM images of the silver-Teflon control sample (0° tilt): a). Image taken at 250X and 6 kV (C01), b). Image taken at 250X and 6 kV (C11), and c). Image taken at 3.5kX and 10 kV (C13).

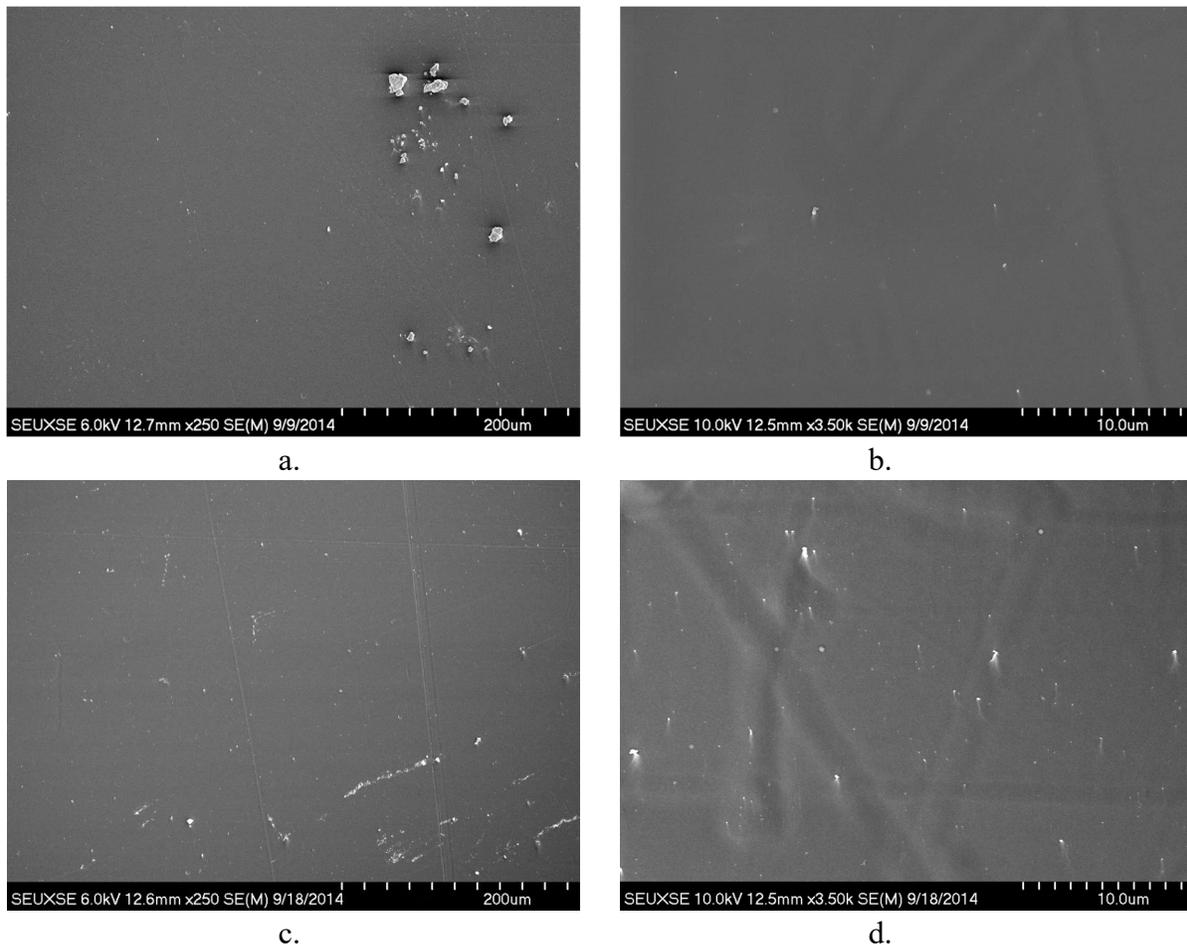
Figure 53. FESEM images of the SEUXSE flight sample (0° tilt): a). Image taken at 250X and 6 kV (02), b). Image taken at 3.5kX and 10 kV (19), c). Image taken at 250X and 6 kV (25), and d). Image taken at 3.5kX and 10 kV (27).
