Contamination Results of MISSE 8 Wake and Nadir Samples After 2 Years of Space Exposure on the International Space Station

*Kim K. de Groh
Glenn Research Center, Cleveland, Ohio*

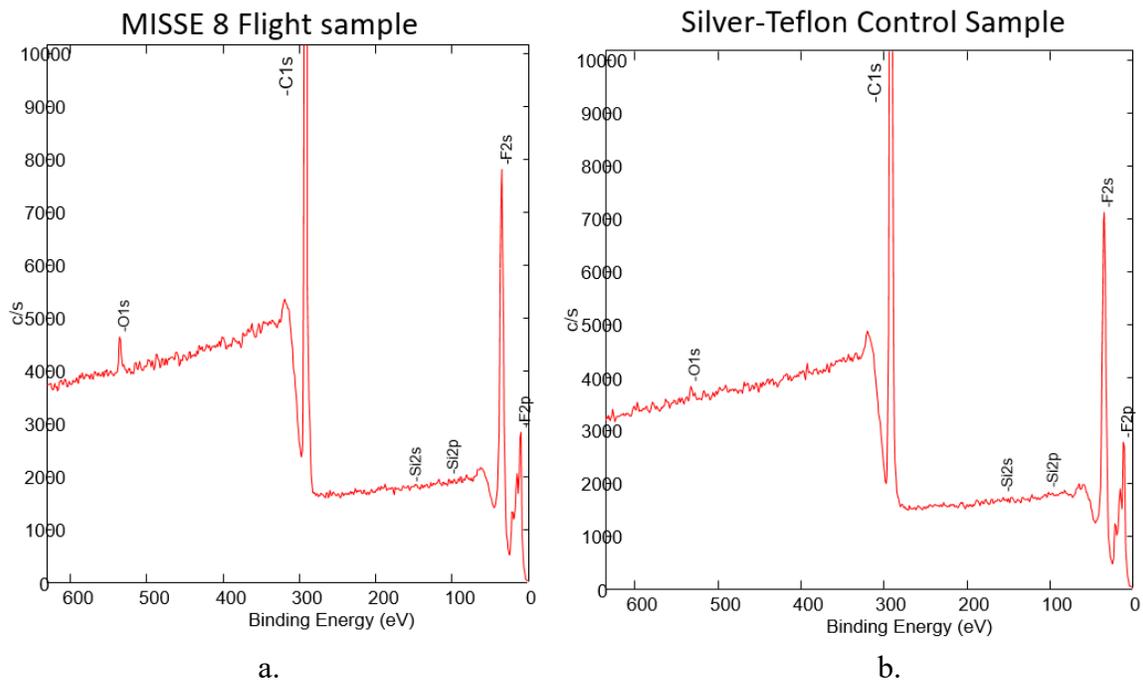
Figure 59. Expanded regions of the XPS binding energy data for: a). MISSE 8 nadir SEUXSE silver-Teflon flight sample, and b). Silver-Teflon control sample.

Figure 59 provides expanded regions of the XPS binding energy data for the MISSE 8 nadir SEUXSE silver-Teflon flight sample (Figure 59a) and the silver-Teflon control sample surface (Figure 59b). The expanded region indicates that there is no Si molecular contamination, but some oxidation is observed.

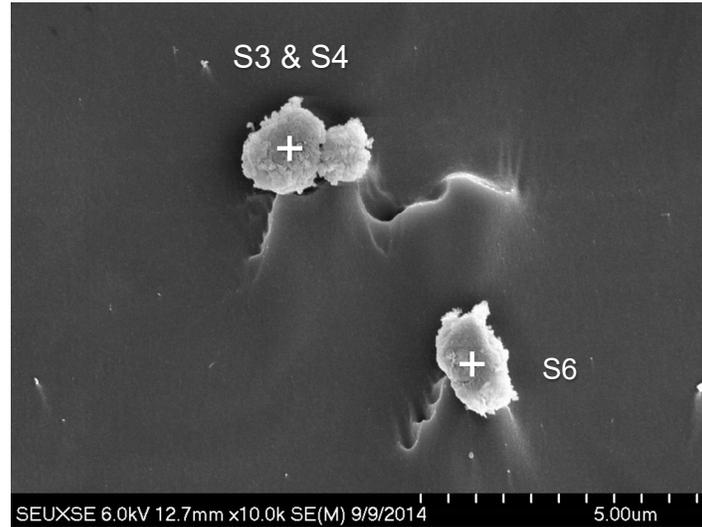
Figure 60. FESEM image of particles on the space exposed surface of the MISSE 8 nadir SEUXSE silver-Teflon flight sample with the locations identified for EDS spot analyses (S3, S4, and S6).

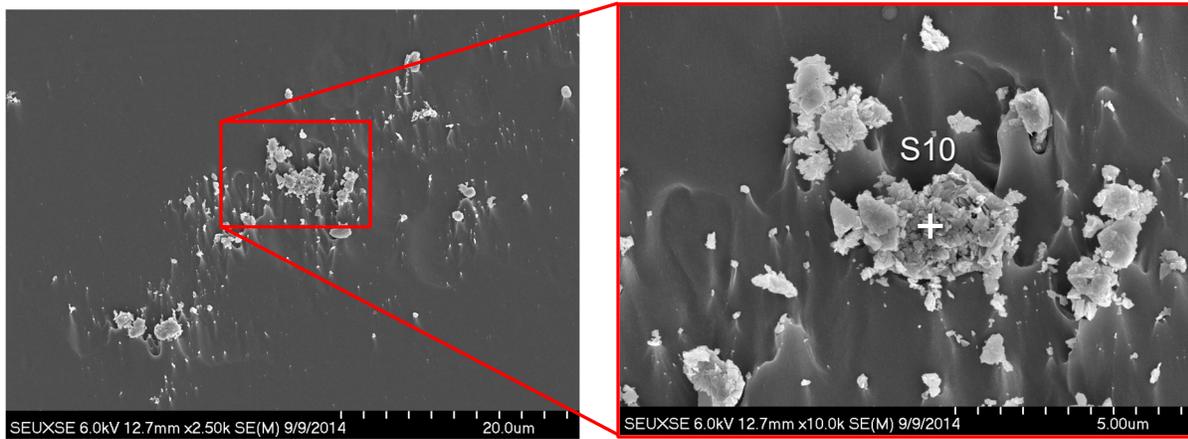
Figure 65. FESEM image of the MISSE 8 nadir SEUXSE silver-Teflon flight sample with a higher magnification image (right) showing the spot analysis location (S10) of a particle cluster.

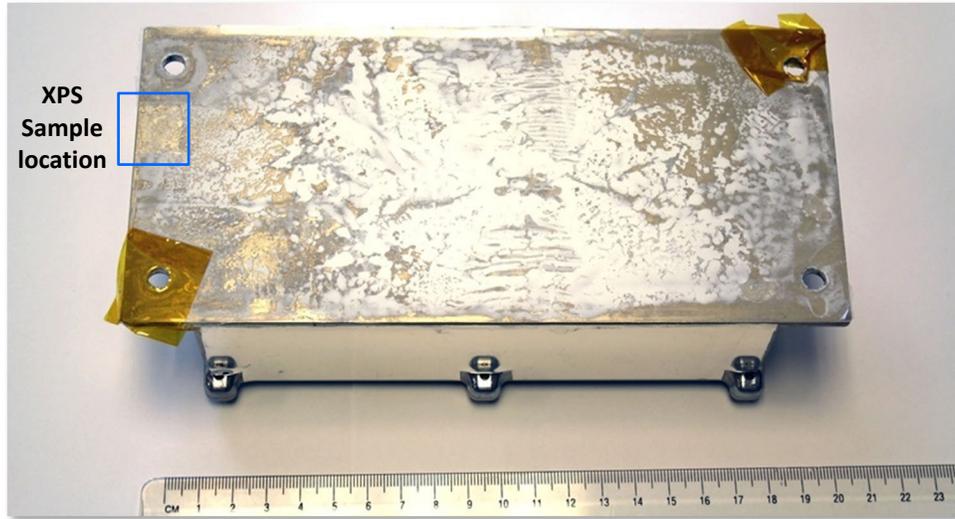
Figure 67. The bottom side of the MISSE 8 SEUXSE Power Box showing the white Nusil CV-9341 thermally conductive silicone grease that was applied pre-flight.

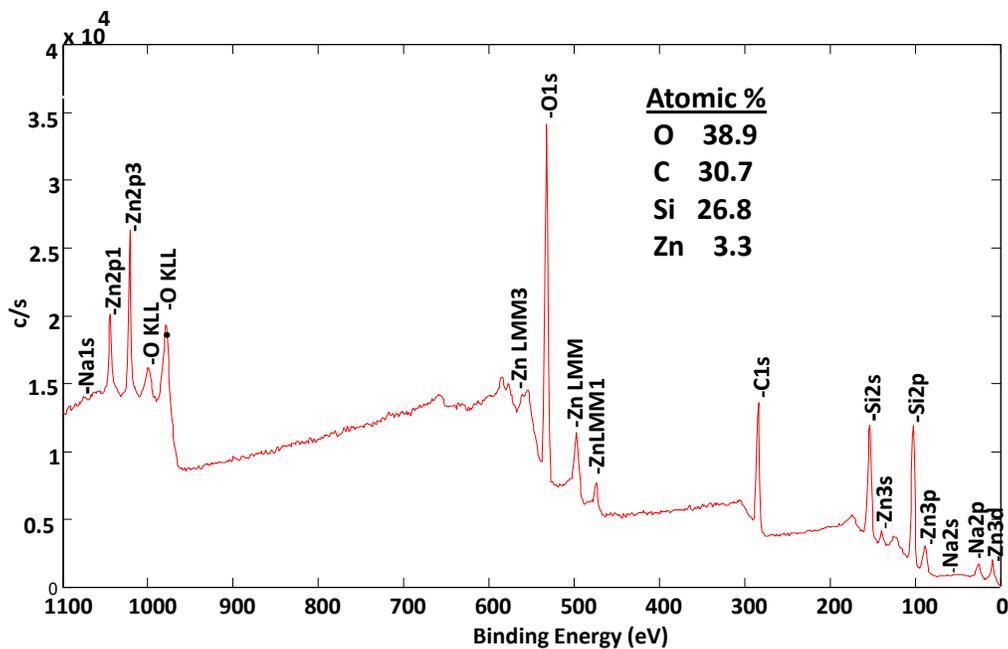
Figure 68. The XPS binding energy data of the sample sectioned from the bottom side of the MISSE 8 SEUXSE Power Box showing the white Nusil CV-9341 thermally conductive silicone grease that was applied pre-flight.

hydrocarbon contamination). High resolution XPS scans were obtained on C, F, O and Si regions. The C region showed a slight increase in the amount of O incorporation over time (as expected due to AO interaction). However, there was not any evidence of C-Si bonds or hydrocarbons. The Si regions for both the flight and control samples showed only noise. Particles on the surface were found to be composed mainly of Zn, and also contained Na, Al, Cl and Si. One particulate area analyzed by EDS was found to be Fe-rich. Heat-sink grease on the bottom of the SEUXSE Power Box was also analyzed and found to contain Zn and Si.

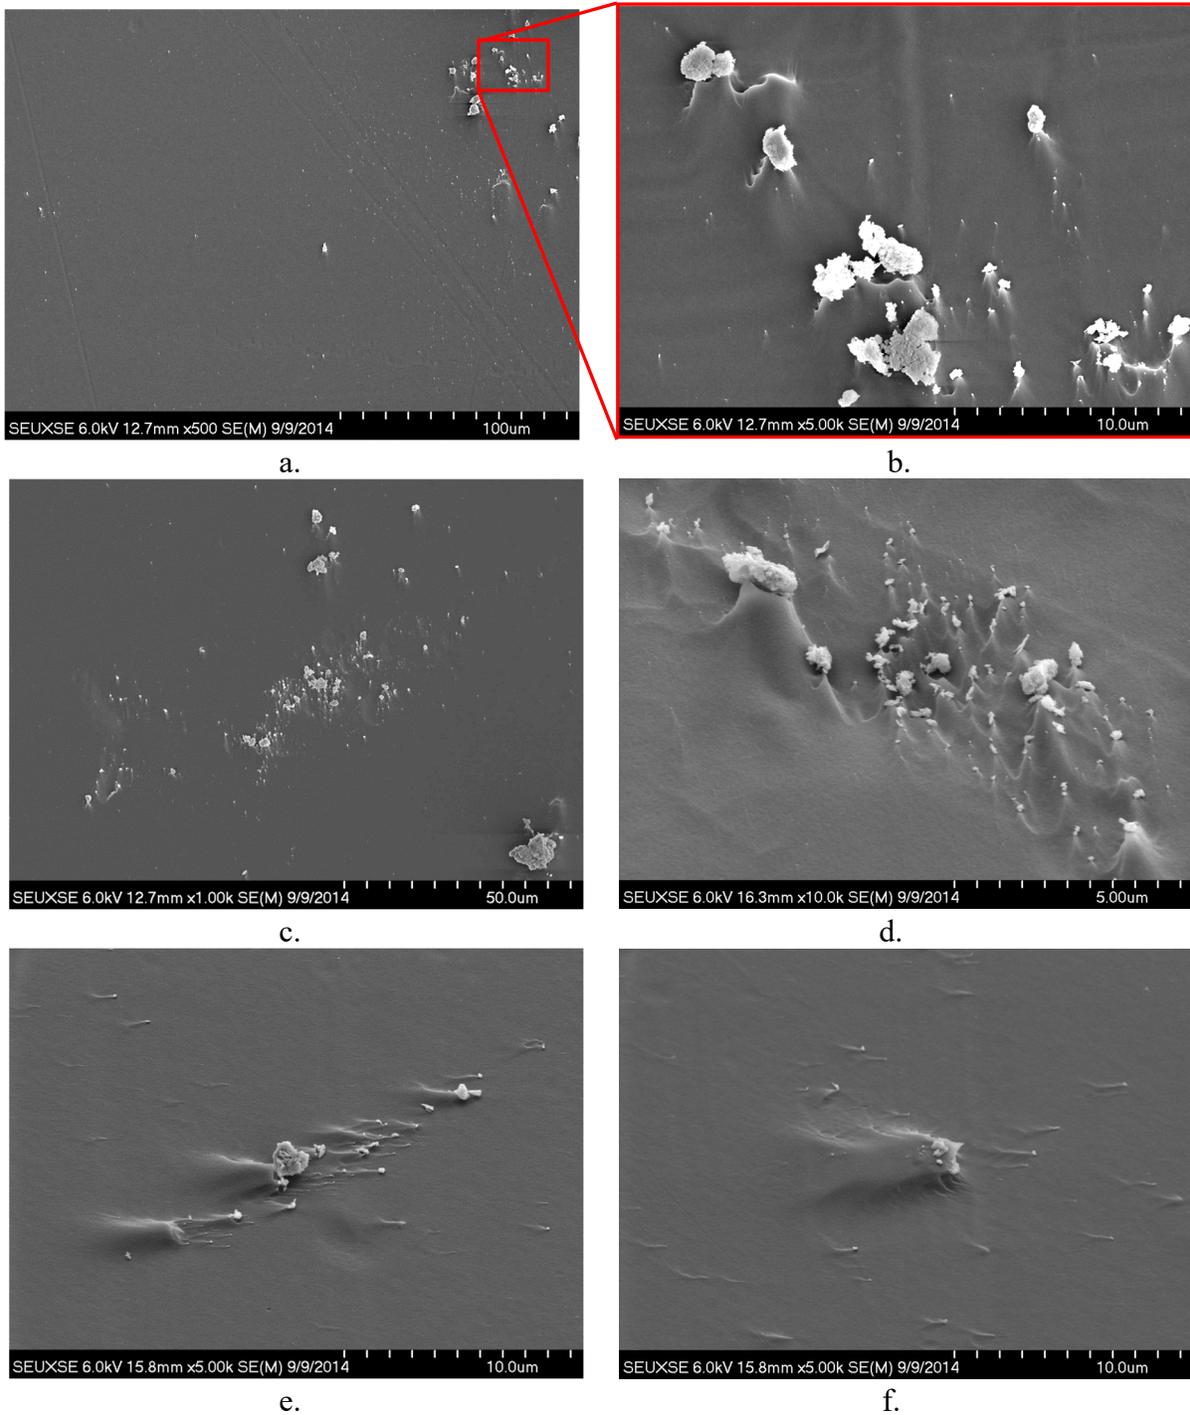
Figure 69 provides FESEM images showing the topography of the MISSE 8 nadir SEUXSE silver-Teflon flight sample surface. These images show a smooth surface with a small amount of particles. High magnification images show that a very small amount of erosion occurred around the particles ($< 0.5 \mu\text{m}$) and that the erosion was very directional, consistent with grazing AO arrival. The amount of erosion for the MISSE 8 nadir Teflon surface was less than that observed for the MISSE 8 wake Teflon surface, as shown in Figure 42. This is consistent with the AO

Figure 69. FESEM images of MISSE-8 nadir SEUXSE Power Box silver-Teflon sample: a). Image taken at 500X (0° tilt), b). Image taken at 5kX (0° tilt), c). Image taken at 1kX (0° tilt), d). Image taken at 10kX (45° tilt), e). Image taken at 5kX (45° tilt), and e). Image taken at 500X (45° tilt).
