## International Space Station (ISS) Environmental Control and Life Support (ECLS) System Overview of Events 2023

**Nov 20th, 2023 marks the 25th anniversary of the beginning of construction of the International Space Station (ISS). The ECLS system is constantly changing to meet the needs of current missions and future exploration. The ISS has become the laboratory that was always envisioned, allowing for an ever-growing class of exploration level technologies that will propel the stage forward as humanity advances beyond Low Earth Orbit (LEO). This paper will review the past year, and look towards the future for each U.S. ECLS subsystem. The impacts, challenges, and successes related to the intermingling of incumbent and cutting edge technologies are summarily discussed in this paper.**

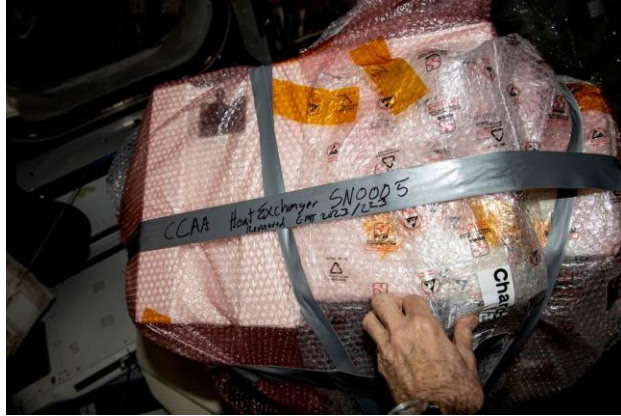
The Node 3 HX Liquid Sensor (LS) started experiencing wet indications at an increased rate, which means that water is being detected downstream of the HX. If not fixed, water can end up on the cabin diffusers or will stick to the ducting and evaporate back into the air. Typically, a wet indication is a sign of a degraded HX. From the Snorkel DTO in December 2019, which was conducted in the US Lab, it is known that HX wet indications do not pick up all HX carryover events and it is likely that many other carryover events are taking place within a degrading HX. However, the ducting in Lab and Node 3 do have different configurations. The Node 3 CCAA has high priority since the unit affects the management of Node 3 Carbon Dioxide Removal Assembly (CDRA) via flight rules. Therefore, a HX Remove & Replace (R&R) was performed in Node 3. However, the wet indications did not clear after the R&R of the HX ORU. The next step was to R&R the CCAA WS ORU. The condensate pressure in the WS was slowly increasing over time, which was initially interpreted as a pressure sensor shift. Once the WS pressure passes a certain limit, though, it will affect WS operations. Once the Node 3 WS was also R&R'd, the HX LS wet indications continued for about six days, but then stopped after that. It is still unclear if the indications stopped because of a temperature set point increase in Node 3 or the HX ORU started operating nominally. The CCAA unit will be tested in 2024 after some run time at different LTL configurations to help determine why the system continued to produce HX LS wet indications.

**Figure 1. CCAA HX Packed for Return**

Because the team was concerned that the WS may have been contributing to the Node 3 HX carryovers prior to the HX R&R, a wettability test was performed on-orbit on the removed Node 3 HX. The test included placing water droplets onto the HX to test its properties for water absorption. From this test, it was determined that the removed HX still had the capacity to support effective humidity removal. Therefore, it was decided to R&R this HX ORU unit with the one in A/L, which is degraded, and it is the first and only HX installed in A/L since the beginning of A/L operations in 2001. The A/L HX started having a high rate of wet indications in 2007 and has not been used for frequent condensate collection since approximately 2011. The unit is now only regularly used for sensible heat removal due to its limited ability to remove humidity. Installing the Node 3 HX into A/L will

require swapping coolant hoses with the A/L HX's QDs on-orbit. After successfully breaking the high torque on the Node 3 HX coolant hose fittings on-orbit, the A/L HX R&R will be completed in 2024 and the A/L HX will return on SpX-30.

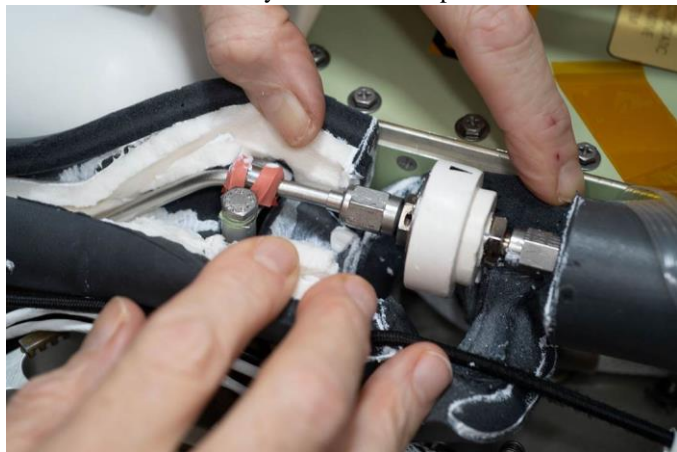
One such occurrence, when the LCV became stuck open, happened at the end of 2022 on the LAB1P6 WS. The pressure sensor that monitors the water pressure inside the WS started to closely follow the bus pressure while the WS was powered down, which is a clear indication that the LCV is stuck open. Therefore, the LAB1P6 WS LCV was R&R'd in August 2023 and the LAB1P6 CCAA reassumed control over temperature and humidity in Lab. The first analysis of water pressure in the LAB1P6 WS confirmed that the LCV R&R was successful, and the LCV also passed a visual check for the signs of leak or moisture. However, the new valve failed the BIT test because the new valve was not able to hold the high pressure provided by WS Impeller, nor was it able to hold the Water Bus pressure from downstream of the poppet valve. Therefore, there could be an internal leak in the LCV between the valve diaphragm/plunger interface. Further analysis and discussion of the data is needed to understand if this is a nominal internal leak, and data analysis of a dry cycle on the WS is also needed to understand the condition of the LAB1P6 WS LCV. In order to verify whether this internal leak is

**Figure 2. CCAA LCV**

nominal, another BIT test will be required as well, likely on LAB1S6 WS, as that unit is functioning nominally. In the end, though, while the newly-installed LCV did fail the pressure check, the internal pressure readings do appear nominal during operation, proving that the LCV can be R&R'd on-orbit.

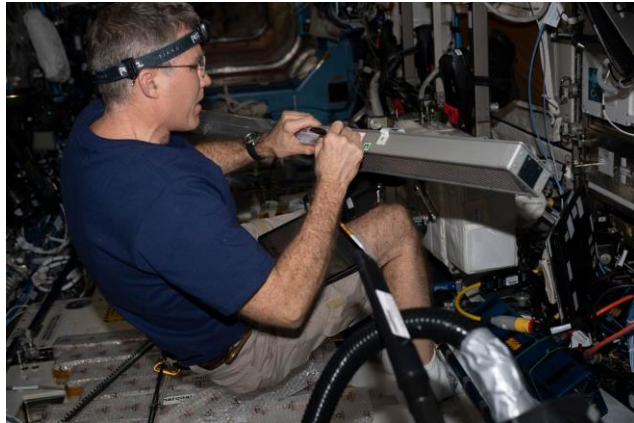
In 2019, 21 CHIPS Filters were installed throughout the USOS, replacing the preexisting Bacteria Filters in each location. Each CHIPS Filter contains a Charcoal Filter affixed on top of a HEPA Filter, and sits upstream of the CCAAs or Cabin Fans to filter particulates and volatiles out of the air that are harmful to Temperature and Humidity Control (THC) and Water systems, including trimethylsilanol (TMS) and dimethylsilanediol (DMSD). The initial life expectancy for the Charcoal Filters was 3 – 5 years, however, could actually be as short as 1.6 years, and the initial life expectancy for the HEPA Filters was 2 – 5 years, depending on location, based on data from the prior Bacteria

Figure 3. CHIPS Filter R&R

Filters. Since the Charcoal Filters do not have a set life, the health of these filters has been monitored by DMSD levels measured in the potable water and total organic carbon (TOC) breakthroughs in the Multifiltration (MF) Bed. The HEPA Filters are monitored through CCAA/Cabin Fan pressure differentials. The HEPA Filter life was extended to the current 3.5 – 5 years, depending on location, in 2021 after successful inspections and good pressure differential trending across the modules at the time.

In early 2023, the R&R of the Charcoal Filters across Station was requested due to the DMSD levels in the potable water returning to pre-CHIPS installation concentrations. Based on continued ORU Inlet Fan

pressure differential trending analysis, the Node 3 HEPA Filters were also requested to be R&R'd with the Charcoal Filters while the rest of the HEPA Filters across the USOS were requested to be inspected and cleaned. These R&Rs and cleanings were conducted in August 2023, and, based on this set of inspections and continued ORU Inlet Fan pressure differential trending, the lives of the HEPA Filters will be extended to be 5 years in every module. Following this on-orbit work, a Charcoal Filter from each module was returned on SpX-29 to be analyzed for loading patterns and to determine the official life of these filters. An additional Charcoal Filter and one HEPA Filter, both from Node 3, were also returned on SpX-29 to be analyzed for changes in performance following long-term continuous use, DMSD formation, and to complement efforts to determine the per-person particulate emission rates with data from the Airborne Particulate Monitor (APM) payload.

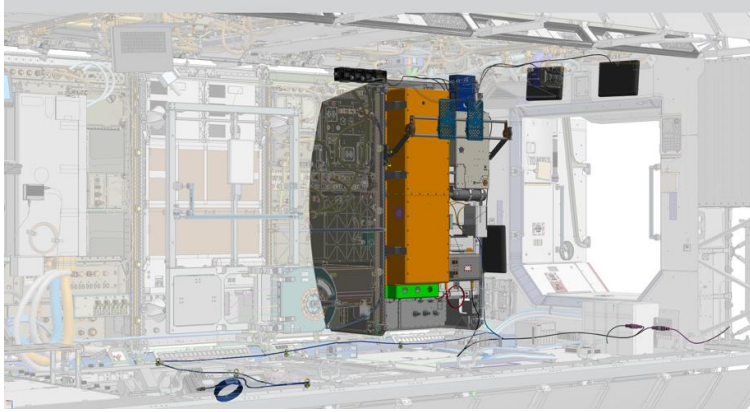
AOGA is an upgrade to the OGA since system incorporates a new design cell stack (same maximum oxygen 20.4 lbm/day production rate as OGA), increases cell stack life by minimizing membrane thinning, allows for additional system maintenance, and incorporates manual dormancy nitrogen purge and deionized water flush of the recirculation loop to allow the system to be shut down for up to one year without biofouling and as a preventative maintenance feature to periodically reduce build-up of concentrating contaminants.

For ISS demonstration, the AOGA is controlled by the existing OGA Process Controller with its original software and firmware. Commanded software overrides will be utilized for unique AOGA system operation parameters and fault limits. The AOGA will be reusing most of the hardware that is in the OGA system but will be replacing the OGA Hydrogen Dome ORU (includes a fracture containment dome that is not removeable on-orbit rendering the cell stack, Rotary Separator/Accumulator (RSA), valves, pressure and temperature sensors non-maintainable) with the AOGA maintainable Oxygen Hydrogen Domes Assembly (OHDA) to enable significant reductions in spares mass and volume.

Figure 8. AOGA as would be installed in Node 3

The OHDA contains two smaller domes (cell stack and RSA) that are removable on-orbit for replacement of failed components with spares. The new AOGA pressure sensors are now located external to the domes. The OGA RSA Differential Pressure (DP) sensors will be reused and remain located within the OHDA's RSA Dome Assembly.
