Assessment of Performance Degradation of the Spacesuit Water Membrane Evaporator (SWME) Materials Due to Environmental Conditions

Morgan B. Abney¹ and Sara Wilson²
NASA Engineering & Safety Center, Hampton, VA 23681

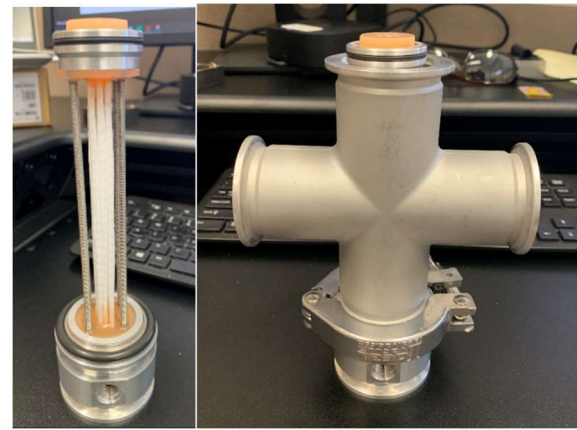
Figure 3. Critical characteristic sub-scale module (left) and test assembly (right).

Sub-scale modules were fabricated in-house at NASA with each of the hollow fiber membranes, as shown in Figure 3. Each module was fabricated with ~600 tubes of 11.9 cm (4.7 in) length (shown in white in Figure 3). The tubes were bonded to a standard KF40 vacuum flange ring with custom seats (silver in the image) using epoxy (orange in the image). Stiffeners (vertical silver bars in the image) were added to the assembly to prevent bending of the fibers during handling. The sub-scale modules were installed into a KF40 cross for testing in the Thermal Performance Test Stand.

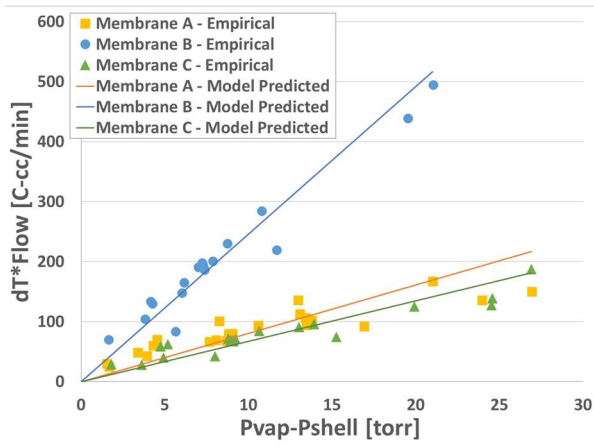
Figure 4. Empirical data compared to model predictions for lumen temperature differences vs driving force.

Three membranes with unique critical characteristics were chosen to evaluate the effect of those characteristics on heat rejection performance. Figure 4 shows both the raw empirical data (data points) and the model predicted values (lines) for lumen temperature difference ($dT = T_{in} - T_{out}$), normalized by multiplying by the flow rate versus the

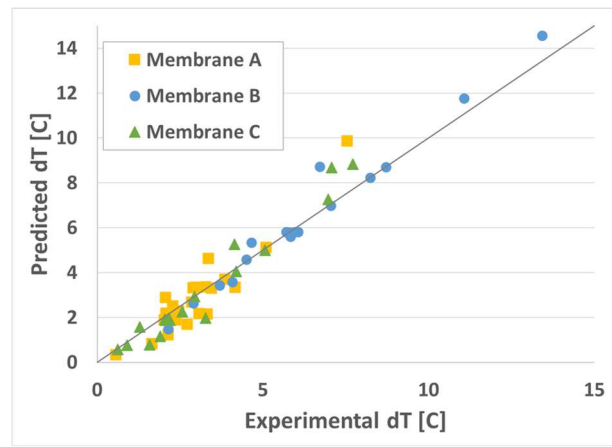
Figure 5. Parity plot for experimental vs predicted lumen temperature difference.

evaporation driving force (ΔP). To estimate the value of S_p , a least squares regression was performed to minimize the difference between predicted and experimental temperature change for the data obtained with each module. A parity plot (Figure 5) shows the relative agreement of the experimental vs the calculated (model-predicted) values for lumen temperature difference. This data provides validation of the defined models and verifies the quality of data collected in the test stand over the ranges shown.

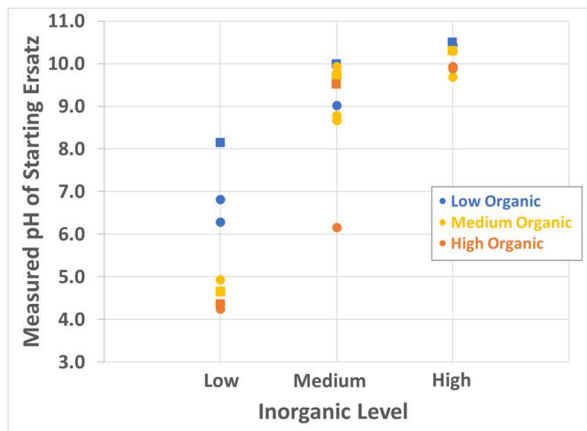
Figure 6. Starting pH of ersatz mixtures for Contamination Testing runs. Square data points denote biocide present in the ersatz.

Ersatz mixtures for contamination testing were prepared within 24 hours of beginning each test in the Recirculation Test Stand. Conductivity and pH measurements were taken of the fresh ersatz. Notably, the pH and conductivity were strongly a function of the inorganic contamination concentration (pH data shown in Figure 6), with the High level of inorganics resulting in the highest values of pH, iron precipitation, and conductivity. Organic contamination contributed slightly to the measured pH with lower organics resulting in slightly higher pH, though did not seem to affect conductivity. Finally, the presence of iodine biocide generally increased the overall pH of the ersatz relative to mixtures without biocide.

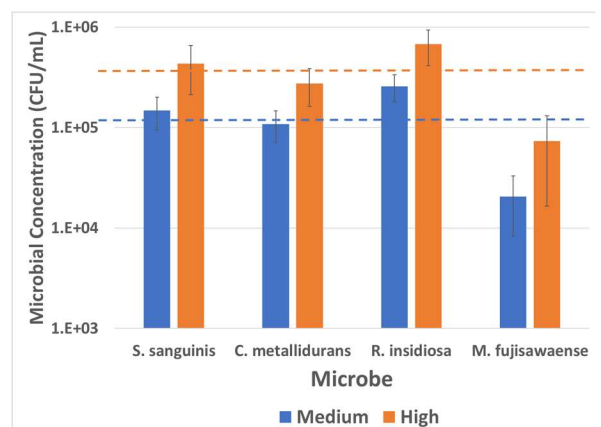
Figure 7. Average microbial concentration in ersatz for Contamination Testing at Medium and High organic levels. Error bars indicate one standard deviation. Dashed lines indicate targeted concentration for Medium (blue) and High (orange) microbe counts.

Two levels of microbial concentrations were targeted as described above. The actual microbial concentrations of the ersatz varied as shown in Figure 7.

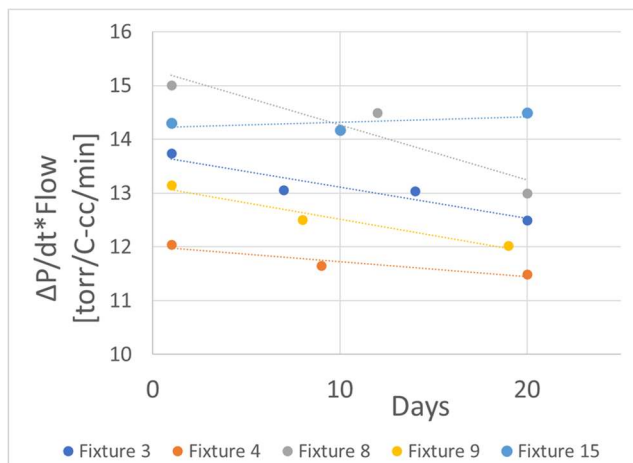
Figure 10. Reduction in performance as a function of time and Fixture under identical contamination exposure conditions.

at the end of each contamination challenge test. Fixtures 3, 4, 8, 9, and 15 were exposed to identical conditions (Medium Organics, Medium Inorganics, and Low Biocide). The ratio of the driving force to the measured temperature drop at a given flow rate ($\Delta P/dT \cdot \text{Flow}$) can be used as an initial gauge of membrane degradation. Figure 10 shows the change $\Delta P/dT \cdot \text{Flow}$ as a function of days exposed to contamination ersatz and Fixture number. As can be seen, there was a reduction in performance observed for all fixtures except Fixture 15, which was approximately flat (though not clear why). A similar observation was made in a previous study³ where the SWME membrane was challenged for three days with 33 EVA, 66 EVA, and 100 EVA equivalent concentration of contaminants. Over 3 days, the test observed a 0.54% decrease in heat rejection performance. This study shows ~6.5% reduction in performance over 7-10 days at ~25 EVA equivalent concentration of contaminants.

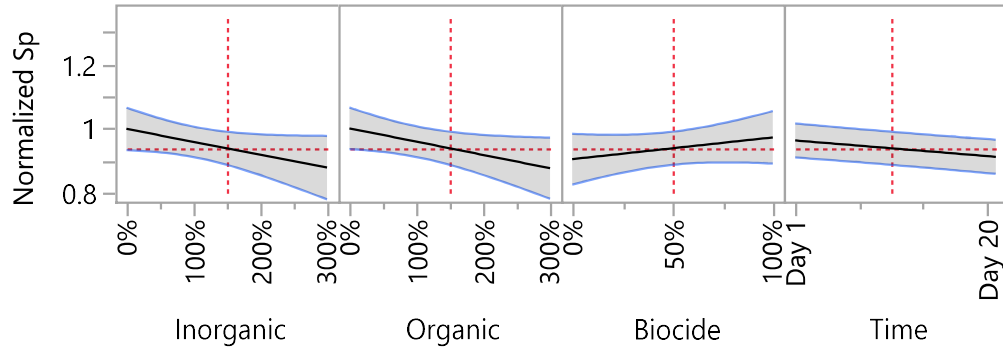
Figure 11. Plot showing the effects of Time, Inorganic levels, Organic levels, and Biocide on S_p .

The statistical analysis showed (90% confidence) that Inorganics, Organics, and time all reduced S_p , as shown by the plot in Figure 11. While the specific critical membrane characteristics that are changing have not been confirmed, observations from the test may provide some clue. First, as mentioned above, precipitation of iron oxide was observed in cartridges with high Inorganic. It is plausible that small quantities of the precipitate deposited along the inner lumen walls, thereby reducing the effective porosity and pore diameters within membrane. For Organics, no biofilm formation was observed on any of the modules. However, it is possible that individual microbes could have adhered to the internal lumen surfaces, again reducing the effective porosity and pore diameters within the membrane. Finally, time is shown to result in a decrease in S_p . Polypropylene membranes are noted for their robustness to chemical degradation. Further, the test exposure time did not exceed 20 days, much shorter than the duration these types of materials are used in industry. As such, this observed decrease in S_p with time is likely to be a function of duration of exposure of the chemicals rather than a result of natural change in the membrane over time.

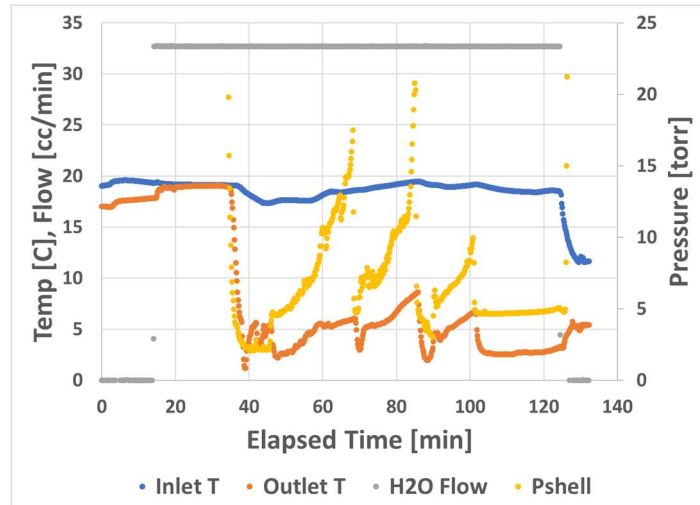
Figure 13. Cut test data showing cyclic loss of vacuum followed by steady-state sublimation.

Two fixtures were tested to observe the effect of fibers being cut. The original test plan had 0, 1, 2, 5, and 10 fibers cut with performance checks between. However, in both cases, the data showed that with a single fiber cut, sufficient liquid water entered the shell side prior to initiating vacuum, that the vacuum pump had to cyclically pump out the liquid, thereby temporarily losing vacuum. During the loss of vacuum, the temperature of the membrane would increase, partially thawing the membrane, and additional liquid would enter the shell side. This cycle occurred a total of three times for both membranes before the system achieved a steady-state. A graph showing this phenomenon for one of the fixtures is shown in Figure 13. Notably the vacuum, when achieved, was sufficiently low for sublimation to occur (~5 torr). Depending on the intravehicular cooling loop design and startup operation for a future spacesuit, there is potential for liquid water to enter the shell side prior to full vacuum. If this then partially or fully blocks the vacuum control valve, the cyclic freeze/thaw may be observed. Testing here shows that this is a recoverable failure, though intermediate thermal control may be compromised. Additional cuts (beyond 1 cut) were not tested in this study in order to protect the vacuum pump. Future testing would benefit from an evaluation to determine the “break point” of numbers of cut fibers from which there is no recovery.

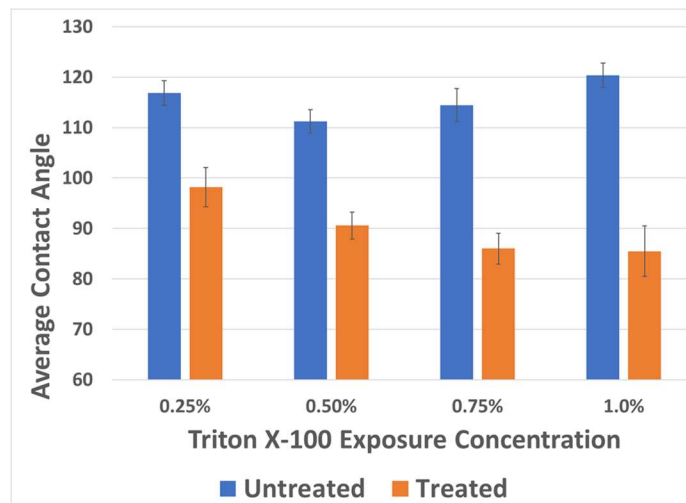
Figure 14. Effect of Triton X-100 concentration on contact angle of hollow fiber membranes.

Phase 1 test data provided two pieces of information used in the remaining testing. First, it demonstrated the variability of the raw membrane contact angle. It is not clear if this variability is due to the goniometer method itself or real differences in local surface energy of the membrane. Regardless, the untreated membrane had an overall average contact angle measurement of 116° with a standard deviation of 4° . This is slightly higher than the reported 110° contact angle of this type of membrane. Second, testing showed that small increases in the concentration of Triton-X-100 resulted in measurable differences in contact angle of the membrane, as seen in Figure 14. Accordingly, 0.25% Triton X-100 was chosen as a starting point for cartridge exposure in Phase 2, with small increases to prevent instantaneous wetout of the membranes.

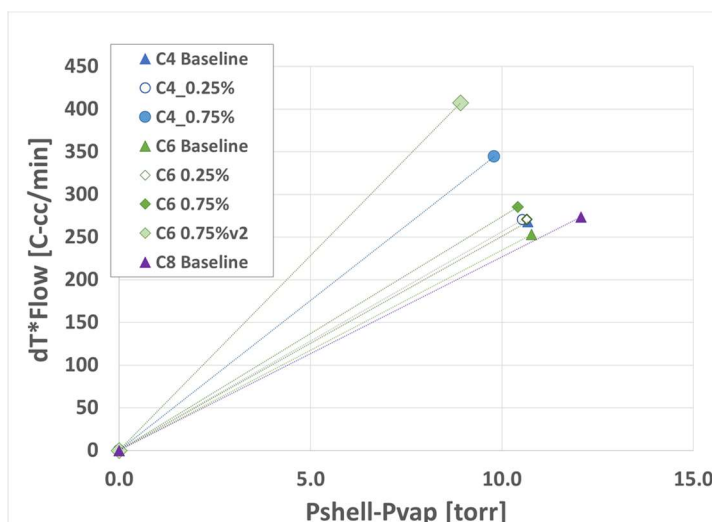
Figure 15. Performance vs driving force results for Phase 2 hydrophobicity testing.

Surfactant is known to decrease the surface energy of the membrane. This results in increased water entry into the pores and a corresponding decrease in effective membrane thickness. As effective membrane thickness decreases, S_p will increase and the slope of the performance vs driving force correlation will increase. Figure 15 shows the performance vs driving force results for Phase 2 hydrophobicity testing. The triangles show baseline performance for Cartridge 4 (C4), Cartridge 6 (C6), and Cartridge 8 (C8). As expected, the curves are very similar and differences can be attributed to slight differences in the cartridges themselves (i.e. actual number of fibers, variability between lots of fibers, variability of porosity and pore size across membranes, etc.). The circles and diamonds show performance following exposure to Triton X-100 for C4 and C6, respectively. The data showed that exposure to the 0.25% Triton X-100 had negligible effect on either cartridge. All of the cartridges were exposed to 0.75% Triton X-100 and each showed a different effect. When C4 was subsequently exposed to 0.75% Triton X-100 (filled blue circle), a significant change in performance was observed as indicated by the increase in the slope of the line. However, when C6 was exposed to 0.75% Triton X-100 (dark green diamond), very little change was observed. There were no differences in procedure for this test and the same Triton X-100 solution was used for both Cartridges. However, when evaluating the contact angle on the unassembled membrane for the two tests, a significant difference was observed. The water contact angle on the unassembled membrane for C4 after exposure to 0.75% was 80.2° while the contact angle for C6 after exposure to the same 0.75% solution (albeit 24 hours later) was 93.2° . While it is not clear why this difference was observed, the unassembled membrane data and the performance vs driving force data make sense if we assume the internal contact angles of the cartridges were similar to the unassembled membrane. One theory is that the Triton X-100 solution was not fully mixed before application to C6. Regardless, a new 0.75% Triton X-100 solution was mixed and applied to the unassembled membrane and C6. The light green diamond shows the performance after this exposure and an increase in slope is observed. As expected, the slope of the line increases as the effective wall thickness decreases and S_p increases. Finally, C8 was exposed to 0.75% Triton X-100 several weeks after the other two cartridges. A new solution was used for the treatment. The cartridge wetted out immediately and thermal performance data could not be collected. Notably, the measured contact angle on the unassembled membrane for the C8 test was only 76.7° . Other membranes (data from Phase 3 discussed below) with similar contact angle did not exhibit wetout.

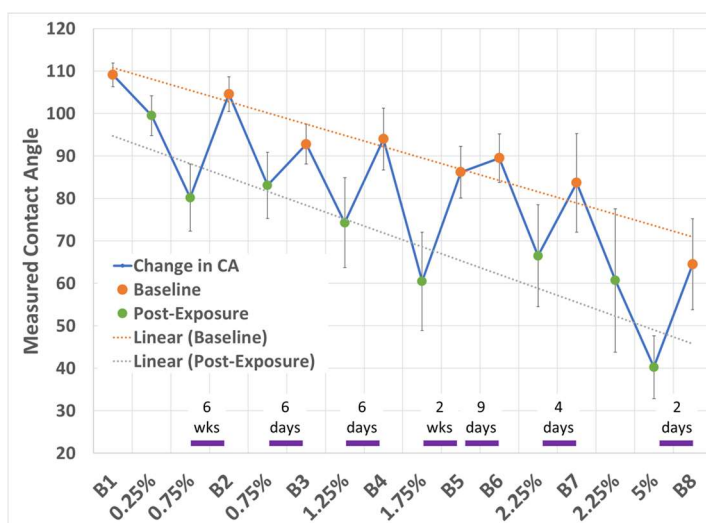
Figure 16. Phase 3 baseline and post-exposure contact angle measurements.

Cartridge 4 was used for Phase 3 testing. Several observations were made. First, as expected, repeated exposure to increasing concentrations of Triton X-100 resulted in continuous decrease in contact angle of the membrane. Unexpected, however, was that between treatments, the membranes seemed to partially recover their hydrophobicity. Figure 16 shows all contact angle measurements on the unassembled membranes. The “Baseline” (B#) contact

angle was measured at the start of a test day on the dry membrane before Triton X-100 was administered. The measurements labeled with concentrations were taken following Triton X-100 exposure. Measurements are shown in the order they were taken (left to right). Purple lines show the durations the unassembled membranes and cartridge sat dry between samples. It is not clear why the partial recovery of contact angle was observed. If flow of water during performance checks was able to flush out residual Triton X-100 at the pores, then performance of the cartridge would be expected to look similar to baseline performance. However, as can be seen in Figure 17, performance checks showed that the slope of performance vs driving force was greater than baseline performance for every test sequence. This suggests that for the entirety of the performance check after Triton X-100

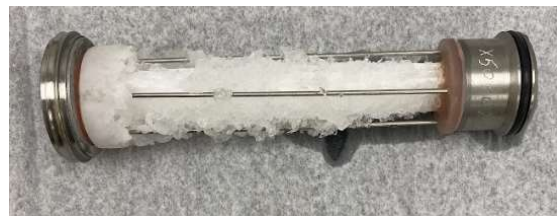
Figure 18. Water frozen along external length of Cartridge 4 following full wet-out.

For all contact angles <75°, full wet out of the membrane was observed. In these cases water froze along the external length of the fibers as seen in Figure 18. This data shows that for low concentrations of surfactant, performance of the cartridge will appear to improve. However, at a critical surface energy, the membrane will fully wet out. No additional effort was made here to recover performance of the fully wetted cartridge. Future testing will look at a variety of recovery methods for this scenario. Additionally, the membrane tested here had a wall thickness of 48 nm. Membranes with thinner walls would be more susceptible to wet out because the time to reach the critical point (wherein the Kundsen diffusion layer exceeds the vapor thickness layer) would occur more rapidly. Additionally, repeated exposure to surfactant will gradually decrease hydrophobicity, but periods of dry out may partially recover performance.
