X-57 Flight Systems Integration Path

NASA Armstrong Flight Research Center, Edwards, California, 93523, USA

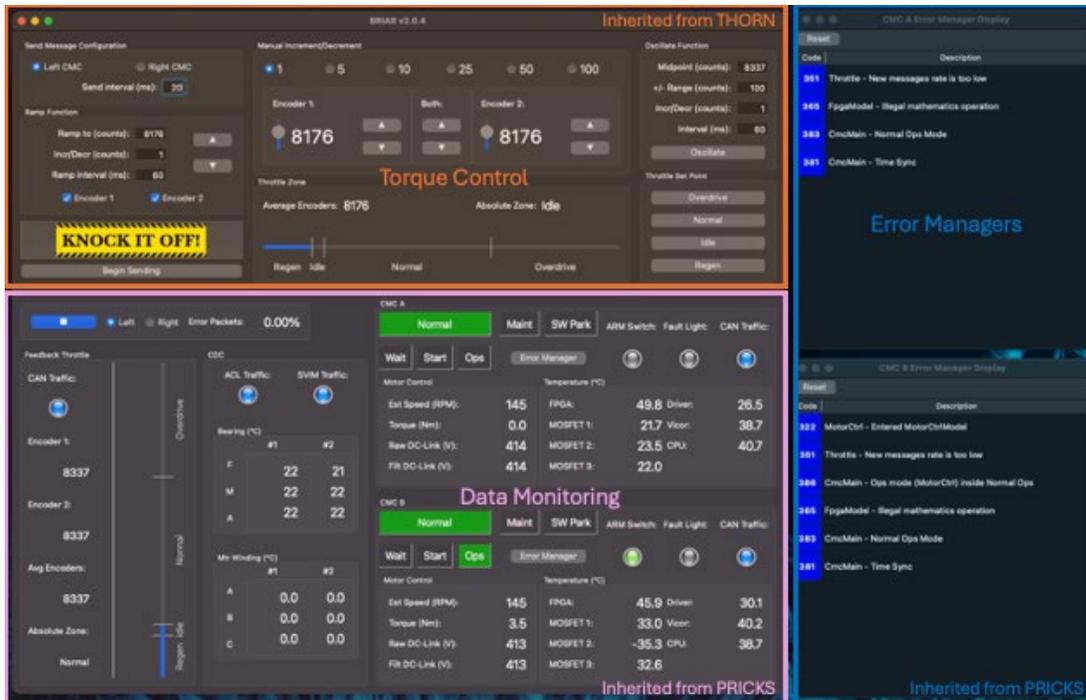
Fig. 9 The BRIAR GUI.

The PRICKS, the first of the Spiky GUIs, was used for monitoring only and displayed data from all four CMCs, the left and right torque levers, and the left and right CMs. The THORN, the second of the Spiky GUIs, was developed for the sole purpose of sending torque commands. This tool provided the ability to precisely control the encoder count values, which was a necessity for testing of the torque control logic in the CMC software. The THORN could also be used when the torque levers were unavailable, such as in the lab or on the airplane if the torque levers were removed. The THORN, however, could only be used for either the left or right torque lever at one time but not for both. The BRIAR was also developed to monitor data and control torque for two CMCs controlling a single motor, which was particularly useful in the lab environment with a single unloaded motor. This program inherited code from both PRICKS and THORN, as shown in Fig. 9, but narrowed down the data monitoring and torque control to only one wing instead of both wings.

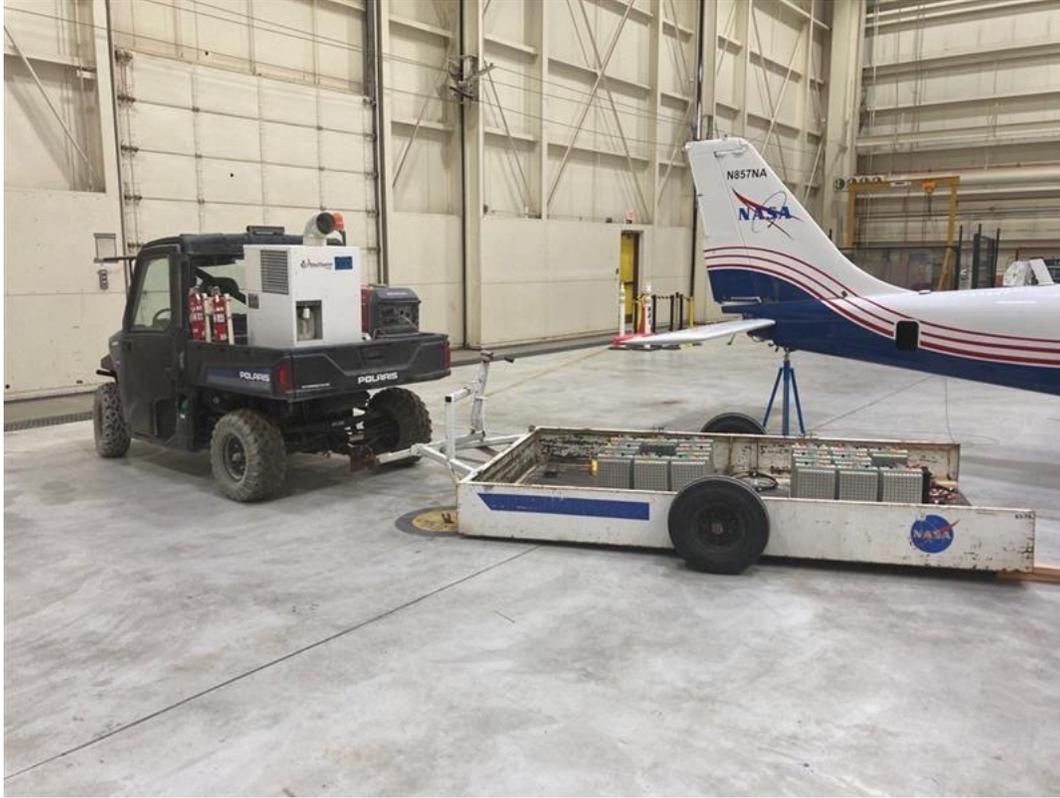
Fig. 17 Aircraft testing setup with batteries on tow cart.

Significant challenges were uncovered during operational ground testing of the X-57 Maxwell when dry runs of the V&V test procedures with the battery system were first attempted. These tests were the first time the flight batteries were integrated with the airplane. The team decided that the batteries would not be physically installed on the airplane for these tests because the parallel installation of the batteries in the airplane would make it hard to troubleshoot any battery anomalies should any wiring or single modules come into question. This configuration would also reduce risk to the entire airframe since it was the first time the battery system would be operated outside of the manufacturing facility. Rather than being installed in the airplane, the two battery packs (2 BCMs, 2 LOTOs, and 16 modules) were placed on a tow cart by the side of the airplane to limit the length of wiring as much as possible, as shown in Fig. 17. Placing the battery system on the tow cart would also allow the system to be moved outdoors quickly in case of emergency.

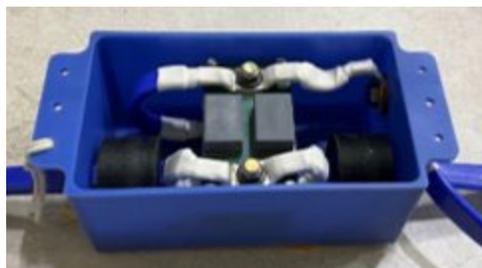
Fig. 19 Final Pi filter design.

From the HIL testing, the team determined that Pi filters (Fig. 19), consisting of capacitors and soft-core magnetic material inductors, needed to be added to the traction line to reduce the effects of EMI caused by the switching transients between the inverter and battery. Using the HIL setup to create the Pi filters was beneficial for many reasons, but the team had to keep the differences between this type of setup and the airplane in mind throughout the progression of testing. Since the unloaded motor was being used for testing in the HIL, the team knew that the size of the Pi filters, which were used to mitigate noise in this setup, would not be adequate for the airplane. The Pi filters were sized up to accomplish a similar noise mitigation on the airplane to accommodate the higher power environment. In addition to the Pi filters on each traction input to the CMCs, stand-alone soft-core magnetic inductors were used on all other copper interfaces with the motors. Advance knowledge that this difference existed was important to limiting the amount of redesign the Pi filters had to go through and allowed the team to implement the solution as quickly as possible on the airplane.
