# Video Analysis for Surveillance of Spacecraft Parachute Systems

The Commercial Crew Program (CCP) has established a surveillance methodology to ensure the reliability of spacecraft parachute systems. The implemented methodology relies on an interconnected framework consisting of imagery analysis, hardware inspections, and vehicle data analysis. Imagery analysis serves as a foundation for these core activities which provide a robust approach to the surveillance of spacecraft parachute systems. As the surveillance framework has been developed, the role of imagery has become more prominent, and therefore imagery requirements have changed. To complete photogrammetric analysis, careful consideration must be made to the role of imagery, required data, imagery requirements, the analysis process, and mission planning. The role of imagery will drive the required data, which will in turn drive imagery requirements. Imagery requirements are likely to drive mission planning through consideration to camera selection and placement. If onboard imagery is required, the camera and data system must be implemented prior to launch. If external imagery is required, the photography package must be im

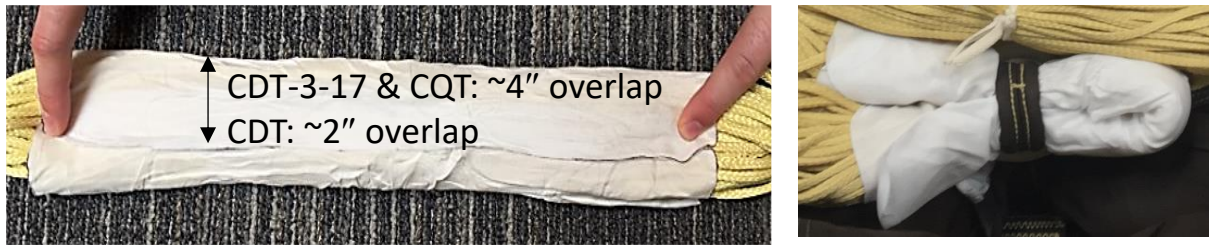
**Figure 5. CPAS bight sleeve wrapped around suspension lines with overlap (left) and stowed (right).**

The investigation quickly focused on the bight sleeves: rectangular pieces of Spectra cloth which were loosely wrapped around the suspension lines to prevent interactions with other hardware during deployment. The bight sleeves are not fastened to the suspension lines in any way, so they were expected to quickly be liberated upon parachute deployment. The high-resolution imagery on CQT-4-5 allowed for observing the majority of the bight sleeves in the air, though some remained affixed to the suspension lines, even “riding up” from their original stowed positions. This had the potential to “strangle” a parachute.

The CPAS program quickly decided in March of 2018 to remove the bight sleeves from the design altogether as they were doing more harm than good. This involved changing no less than fifteen drawings and four procedures. However, parachutes had already been packed for CQT-4-6 and Exploration Mission (EM)-1. One of the mains on CQT-4-6 did exhibit some brief binding events.

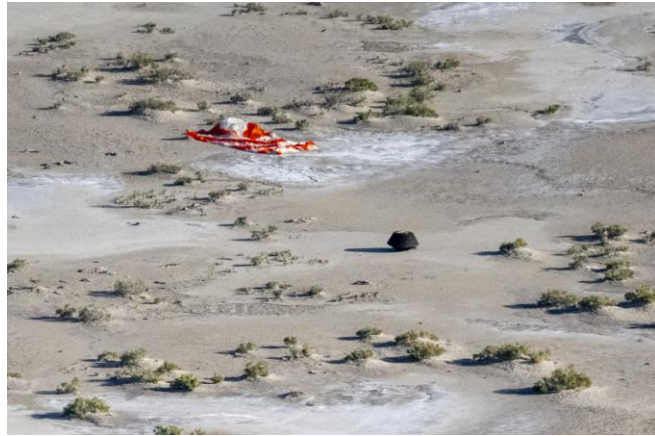
**Figure 13. OSIRIS-REx sample return capsule with recovered main parachute (NASA/Keegan Barber).**

The OSIRIS-REx sample return capsule landed under a main parachute at DPG during daylight hours on September 24, 2023. Although the SRC was successfully recovered undamaged, live video did not show drogue deployment at the expected altitude. Subsequent video analysis and hardware inspection allowed for a fairly rapid investigation of the anomaly.<sup>27</sup> The likely cause was mis-connected wires due to different definition of the word “main” by different competencies. The pyrotechnic community uses “main” to indicate the first event (i.e. drogue mortar fire) while parachute personnel expect it to refer to the final recovery parachute. The signal intended to activate the drogue mortar was instead routed to cut away the non-deployed drogue parachute. Later the drogue cut-away signal instead activated the drogue mortar. The severed drogue immediately separated without inflating and the main parachute deployed. Despite the high dynamic pressure, the main parachute survived and completed the mission. The OSIRIS-REx main parachute was recovered (Figure 13) and inspected but the drogue was lost.
