Status of the Advanced Oxygen Generation Assembly

Future Exploration missions will require an Oxygen Generation Assembly (OGA) to electrolyze water to supply oxygen for crew metabolic consumption. The system design will be based on the International Space Station (ISS) OGA but with added improvements based on lessons learned during ISS operations and technological advances since the original OGA was designed and built. The goal of these improvements will be to reduce spares mass and crew maintenance time while increasing reliability. Over the past year, the team has performed additional design reviews, testing and analysis in an effort to optimize upgrade efforts and achieve the best value that meets Exploration mission requirements. Upgrades that will be incorporated include: redesign of the electrolysis cell stack, redesign of the hydrogen dome, replacement of the hydrogen sensors, redesign of the recirculation loop deionizing bed, and incorporation of recirculation loop nitrogen purging and water flushing. The ISS OGA will be upgraded to an Advanced OGA (AOGA) configuration and its operation demonstrated in a relevant flight environment.

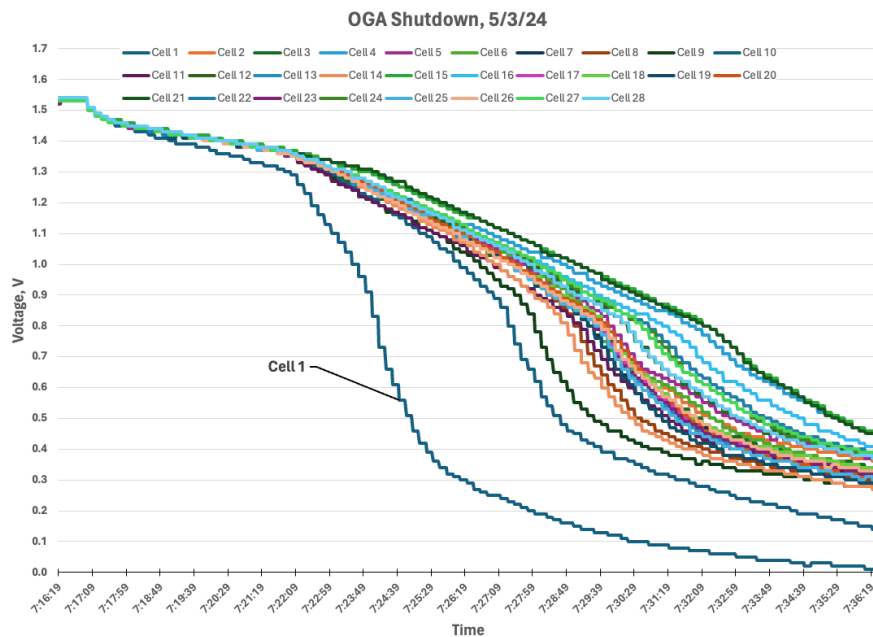
Figure 6. Cell Voltages Upon Shutdown (Hydrogen ORU SN 4)

Hydrogen ORU SN 4 is currently installed. Starting in March 2024, the voltage of Cell 1 upon startup and shutdown has shifted out of family. The shutdown voltage profile from May 3, 2024 is shown in Figure 6. Upon removal of power to the cell stack, Cell 1 discharges faster than the other cells. This behavior started to appear after ~2.5 years of operation. Previously, with Hydrogen ORU SN 2 and 3, this startup/shutdown behavior started to appear after ~4 years of operation, with voltage instability during operation (Standby) appearing ~2 months later. The startup/shutdown voltage behavior of Cell 1 in Hydrogen ORU

SN 4 is similar to that of SN 2 and 3, although appearing sooner. The concern with the Hydrogen SN 4 cell stack is that this startup/shutdown voltage signature could be indicative of membrane thinning, and eventually lead to a leak or hotspot. The OGA team has agreed to keep Hydrogen ORU SN 4 installed until voltage instability appears during operation (in Standby). This is similar to the previous guidance for Hydrogen ORU SN 2 and 3. The OGA team will continue to closely monitor cell voltages. Meanwhile, the procedure to replace the Hydrogen ORU is being updated should it be needed soon. There are two spare Hydrogen ORU's on ISS (SN 1 and 5).

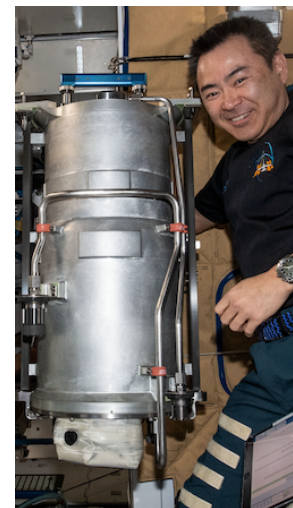
Figure 8. Hydrogen ORU

The legacy OGA design houses all the hydrogen containing components (including the electrolysis cell stack, RSA, motor, 4 solenoid valves, 2 relief valves, a back pressure regulator, heater, relay, 9 pressure sensors, 5 temperature sensors, tubing, and wiring) within a single vacuum dome referred to as the Hydrogen ORU (see Figure 8). The Hydrogen ORU is installed in the bottom right of the ISS OGS rack (see Figure 1). The Hydrogen ORU weighs ~300 lb (136 kg) in its launch configuration and has a high packing efficiency and tight tolerances when fitted together with the dome. This precludes maintenance of any of the internal components by the crew. The failure of a single internal component requires replacement of the entire ORU. The Hydrogen ORU can only be repaired on the ground since the dome reinstallation requires specialized tooling, precision alignment and verification of specification leakages of the two independent seals to space vacuum to ensure proper operation on-orbit.

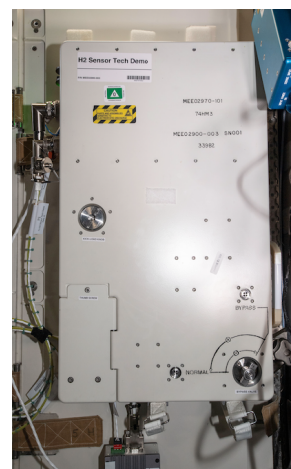
Figure 10. H2ST Integrated With OGA

Issues with the legacy OGA hydrogen sensors are described in Reference 5. Due to these issues, half of the legacy hydrogen sensor fleet (8 of 16) has been retired. The Hydrogen Sensor Technology Demonstration (H2ST) will demonstrate the performance of four new COTS hydrogen sensors for at least 3 years while connected to the ISS OGA's oxygen outlet line to monitor for hydrogen. The H2ST design is described in References 2 and 3. H2ST was first powered up in a standalone mode in April 2022 (attached to the LSR Rack), and was successfully integrated with OGA in September 2022 (see Figure 10), after the OGA was moved from Node 3 to the US Lab. H2ST is installed on the right side of the OGS Rack.

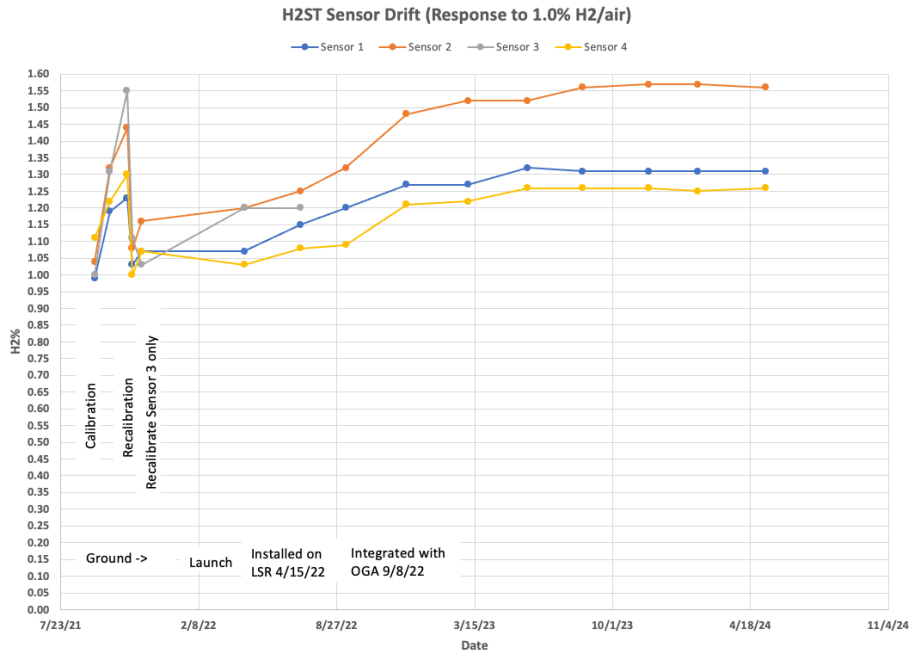
Figure 11. H2ST Drift Checks

Every 90 days, a drift check is performed: the crew flows calibration gas (1.0% H₂/air) through the H2ST sensors for 1 minute, and the sensor response is recorded. There have been 10 drift checks performed so far. The drift of the sensors over time is shown in Figure 11. After H2ST was first installed on-orbit, an upwards drift was noted. For the past year, no upwards drift has been noted on the three good sensors. When exposed to 1.0% H₂/air, Sensor 1, 2 and 4 currently report 1.31%, 1.57% and 1.26% respectively. This overreporting of H₂% is conservative, although not desirable as it could eventually lead to nuisance shutdowns. The legacy ISS OGA hydrogen sensors are known to drift downwards over time (under-reporting H₂%), limiting their installed time to 201 days. H2ST has been installed for 684 days, and counting.
