# NASA Exploration Hardware Status and Crew Feedback from Artemis-2 Demonstration

ICES-2024-071

# Universal Waste Management System (UWMS)

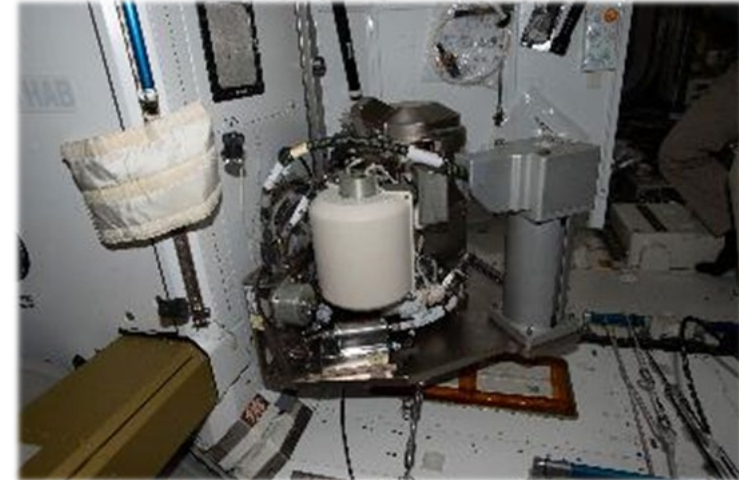
**ISS UWMS installed in Node 3, ISS**

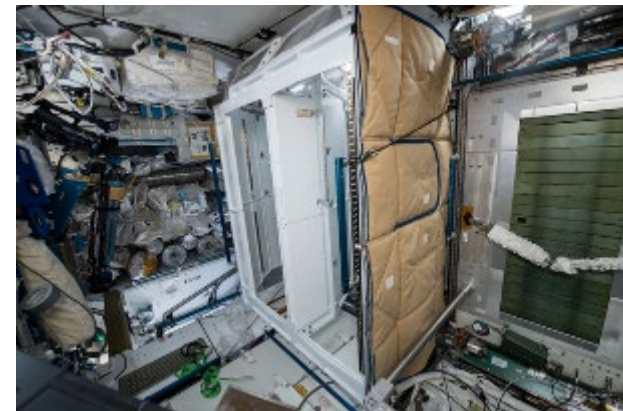
**Toilet Integration Hardware Stall installed in Node 3, ISS**

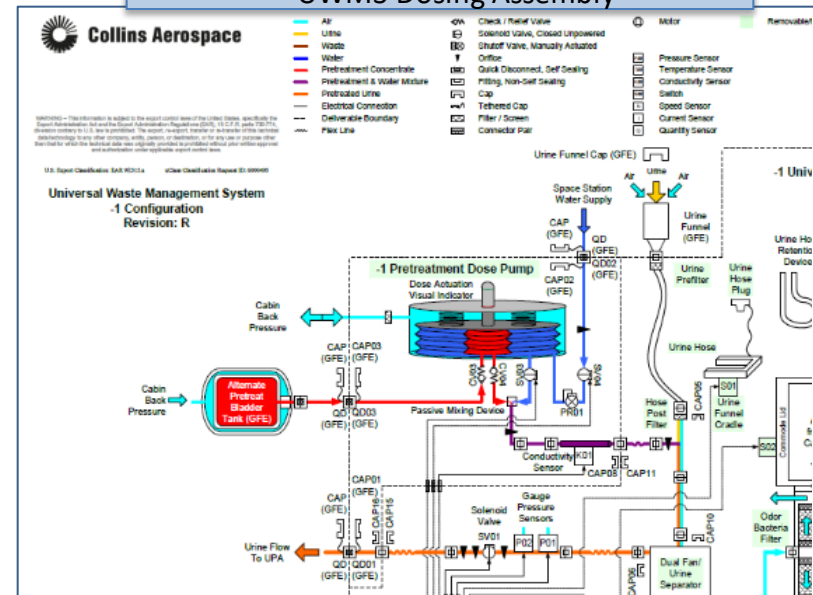
UWMS schematic

- Urine collected with UWMS is planned for recycling after checkout
- Pretreat Concentrate/Water added to urine stream
- Pretreatment stabilizes urine and prevents fungal and microbial growth in system
- Pretreat Hose connects Tank and Dose Pump
- Dispensed with nested bellows Dose Pump
- Quality evaluated by Conductivity Sensor downstream of pump

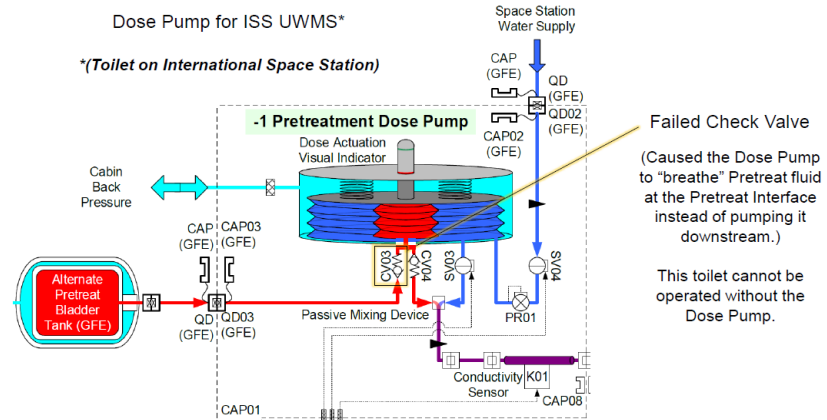
❑ Inspection showed PEEK shroud in inlet check valve failed catastrophically and broke apart

- Shroud pieces from CV03 found downstream in CV04 and in Bellows

Other SN0013 Shroud Fragments

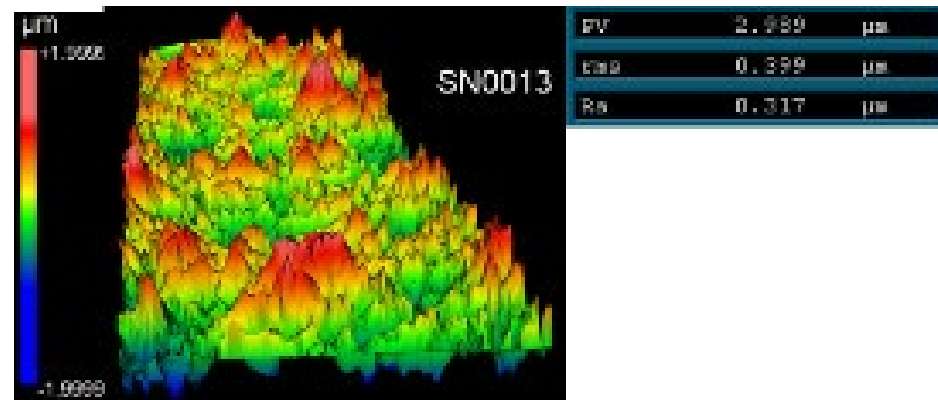
- ❑ Failed PEEK part's surface appears etched in comparison to pristine PEEK part (no exposure to pretreat concentrate).
- ❑ Embrittlement caused by exposure to Pretreat concentrate was suspected.
- ❑ Some parts showed ductility.
- ❑ Exposure to pretreat concentrate may cause embrittlement that can be reversed if removed and dried.
- ❑ Undetermined swelling of PEEK due to pretreat exposure and tight shroud-poppet clearances may result in persistent tensile stresses in shroud
- ❑ **Conclusion:** Exposure to pretreat concentrate caused embrittlement, swelling and combined with tight clearances as in the check valve configuration caused the parts to break apart.

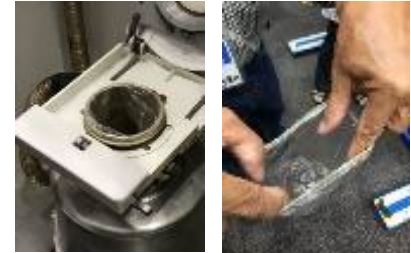
WHC/KTO Bag and Point of Use

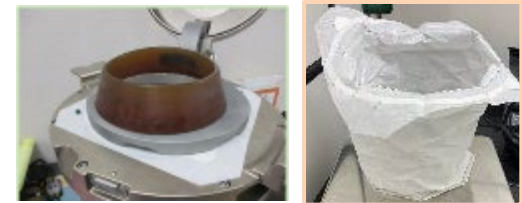
- Crew feedback resulted in redesign of Seat and Fecal Bags
  - Crew preference for 4" seat
    - UWMS originally had 4" and 5" seats
      - Crew preferred 4" seat
    - HLS LOO design uses a 4.3" seat
    - WHC ACY has a 4" opening
    - Redesigned seat with 4" opening
  - Crew comments that Fecal Bags are too big and location not optimal for adherence of fecal deposits
    - Current UWMS Fecal Bags are smaller than used on Shuttle, larger than HLS LOO and WHC ACY design
    - Redesigned Fecal Bags incorporate drawstring closure and smaller size
    - Located over redesigned seat

UWMS Seat and Bag

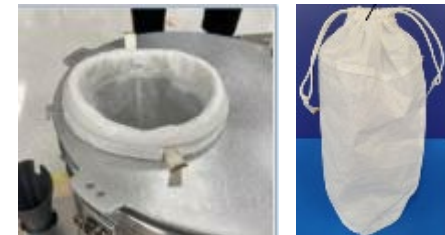
HLS LOO Seat and Bag

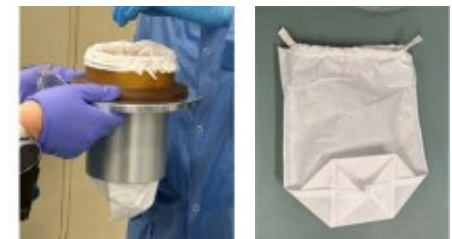
Updated UWMS Seat and Bag
