# Initial Motor Winding Insulation Lifetime Experimental Results for Electric Aircraft Applications

*NASA Glenn Research Center, Cleveland, OH, 44135, United States*

**Electric and hybrid-electric aircraft require high-performance and reliable electric motors to meet aviation performance and safety requirements. One of the most common failure mechanisms in electric motors is winding insulation breakdown. In this paper, an initial set of aging experiments are carried out on twisted pairs and motorette specimens. The twisted pairs are aged with multiple steady-temperature thermal aging cycles. The motorette specimens are thermally cycled by applying current to the windings. Partial discharge inception voltage is tracked and reported throughout the aging process. The end goal of this work is to develop methods and models for assessing the lifetime of motor winding insulation in electric and hybrid electric aircraft applications.**

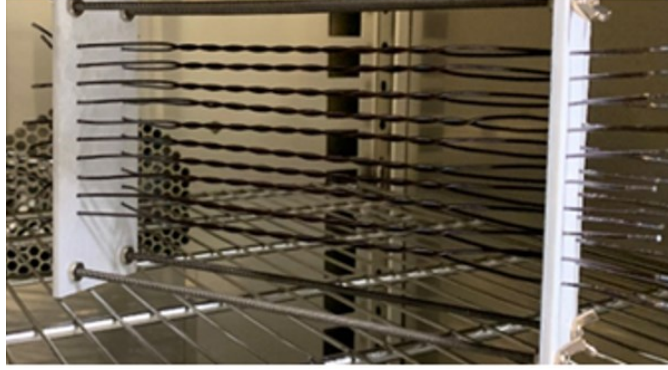
Figures 3 through 5 show photos of the 300TP samples at different points in the testing. Figure 3 shows 300TP before aging. Figure 4 shows the specimen after the first aging cycle, significant color change is visible. Figure 5 shows 300TP after 7 cycles, minimal color change relative to Figure 4 is visible.

**Fig. 4 300TP After 1st Thermal Aging Cycle - 46 Hours at 300 °C.**

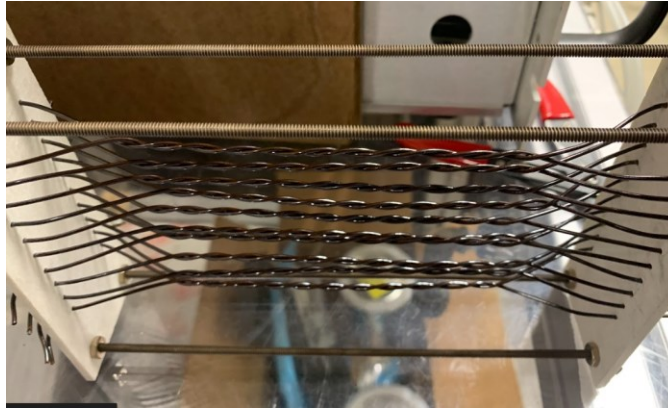
**Fig. 5 300TP after seven thermal aging cycles and 207 hours at 300 °C.**

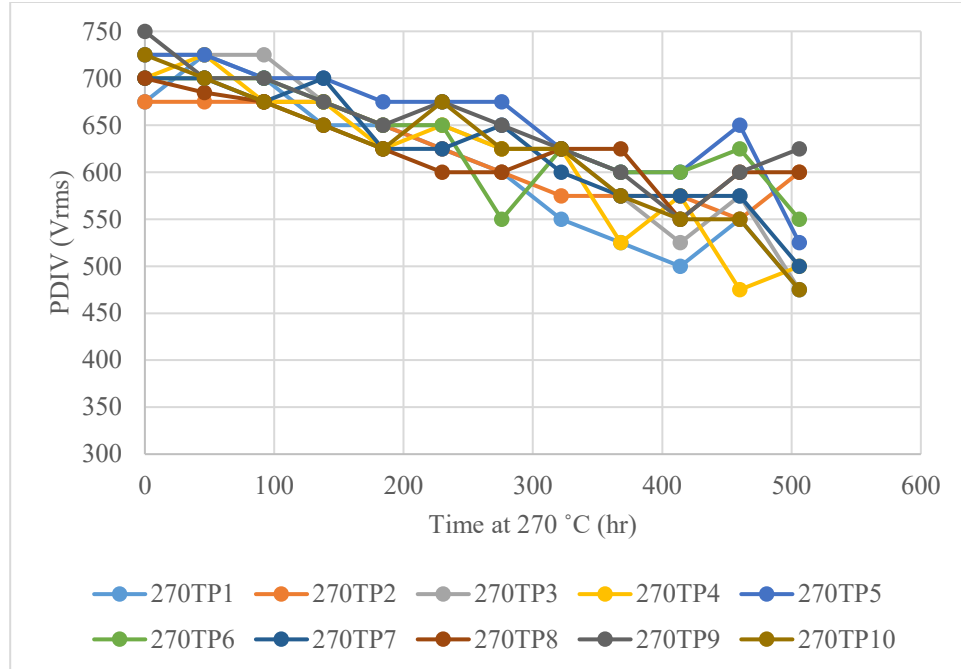
Figure 6 shows the results for the 270TP set. Degradation from an average initial PDIV value of 700  $V_{rms}$  to an average PDIV value of 532  $V_{rms}$  is shown over 500 hours of time at 270°C. This roughly 175  $V_{rms}$  drop in PDIV on average is almost equivalent to the average drop in PDIV experienced by the 300TP set over roughly the same aging time, but at 300 C. As is discussed in Section III-D, one possible explanation for this similar degradation is that the number of aging cycles (thermo-mechanical stress cycles) are roughly equivalent for the two specimen sets.

**Fig. 6 270°C aging group unimpregnated twisted pairs (270 TP) PDIV vs time at 270 °C oven set point.**

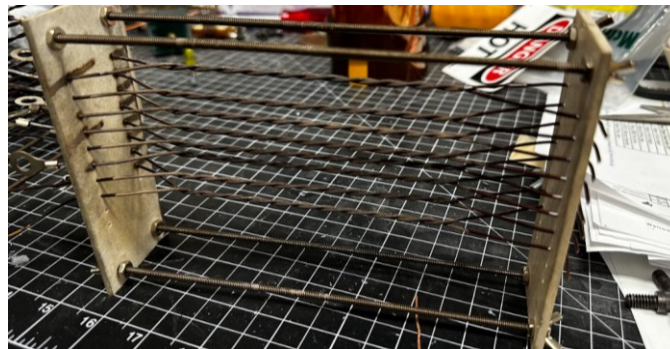
Figures 8 through 11 show photos of the 270CTP aging sets at 4 different times during the aging process. Figure 8 shows the 270CTP specimens initially with the grey epoxy and orange magnet wire insulation visible. Figure 9 shows the 270CTP set after a single aging cycle of 46 hours at 270 °C. Both the epoxy and the polyimide magnet wire are shown to have darkened significantly. Figure 10 shows the specimens after 3 aging cycles. The white ceramic filler used in the epoxy has become visible at this stage likely as the epoxy burned away. Figure 11 shows the specimens after all completed aging cycles. At the end of testing relative to after 3 cycles the specimens appear to be slightly whiter in color as more epoxy has baked away leaving more ceramic visible.

**Fig. 9 270CTP after 1 thermal aging cycle.**

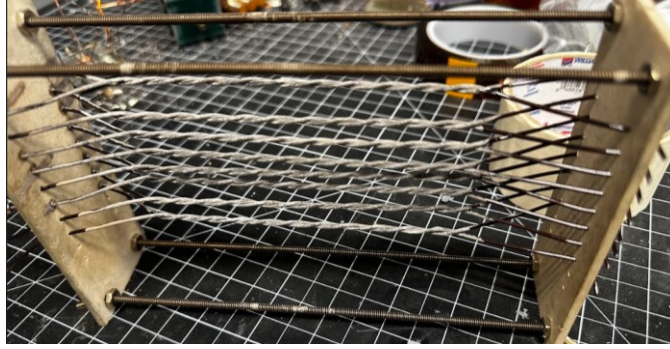
**Fig. 10 270CTP after 3 thermal aging cycles.**

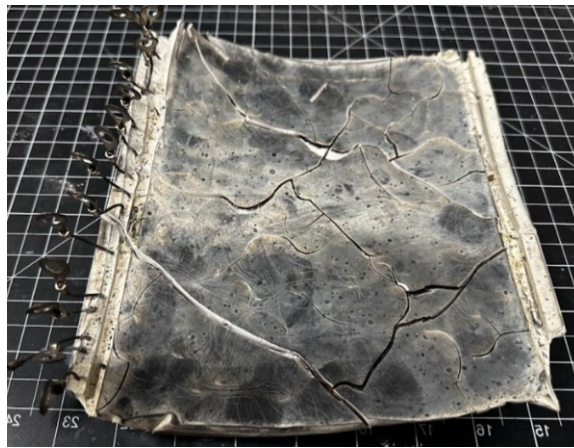
**Fig. 15 270PTP after last aging cycle.**

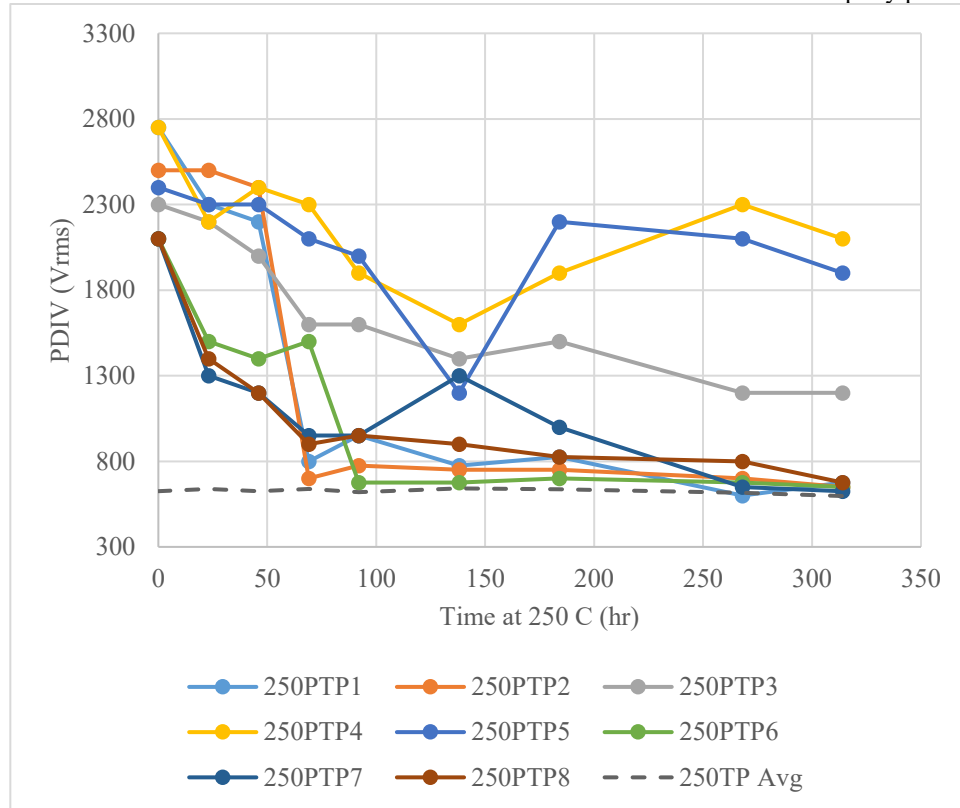
For the 250PTP sets in Figure 21, significant variation in degradation of PDIV vs cycles and time at 250 °C is shown. The significant variation in how the specimens degrade can be correlated with where and when cracks in the 250PTP twisted pair epoxy occurred. Figure 19 shows the 250 PTP set initially. Figure 20 shows the specimen after

6 cycles. Cracks are visible in the upper left and lower left corner of the specimen. In Figure 18, the PDIV results after 6 cycles (384 hours of aging) shows that all specimens except 250PTP 3, 4, and 5 have degraded such that their PDIV is less than 1 kV. This result matches with the observed location of the cracks in the epoxy plate in Figure 20.

**Fig. 18** 250 °C aging group potted twisted pair (250PTP) PDIV vs time at 250 °C.

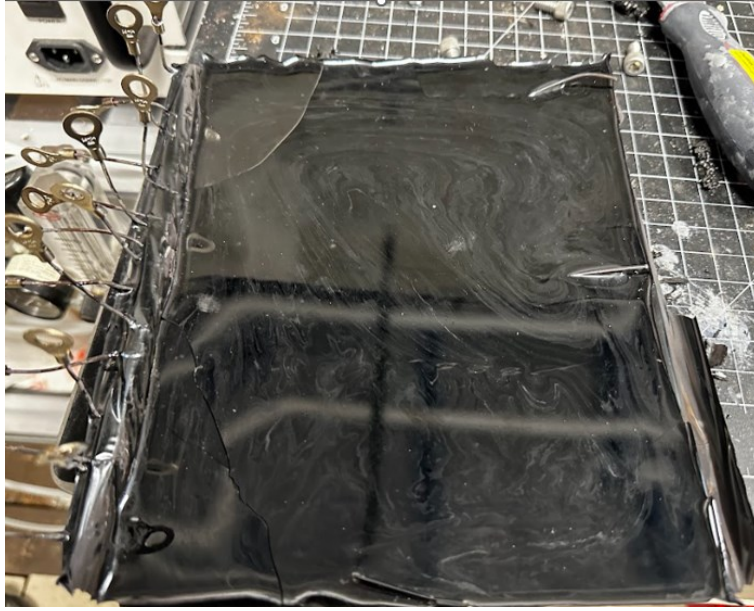
**Fig. 20** 250TP after 6 aging cycles. Pairs are numbered 1 to 8 from the top of the photo to bottom.

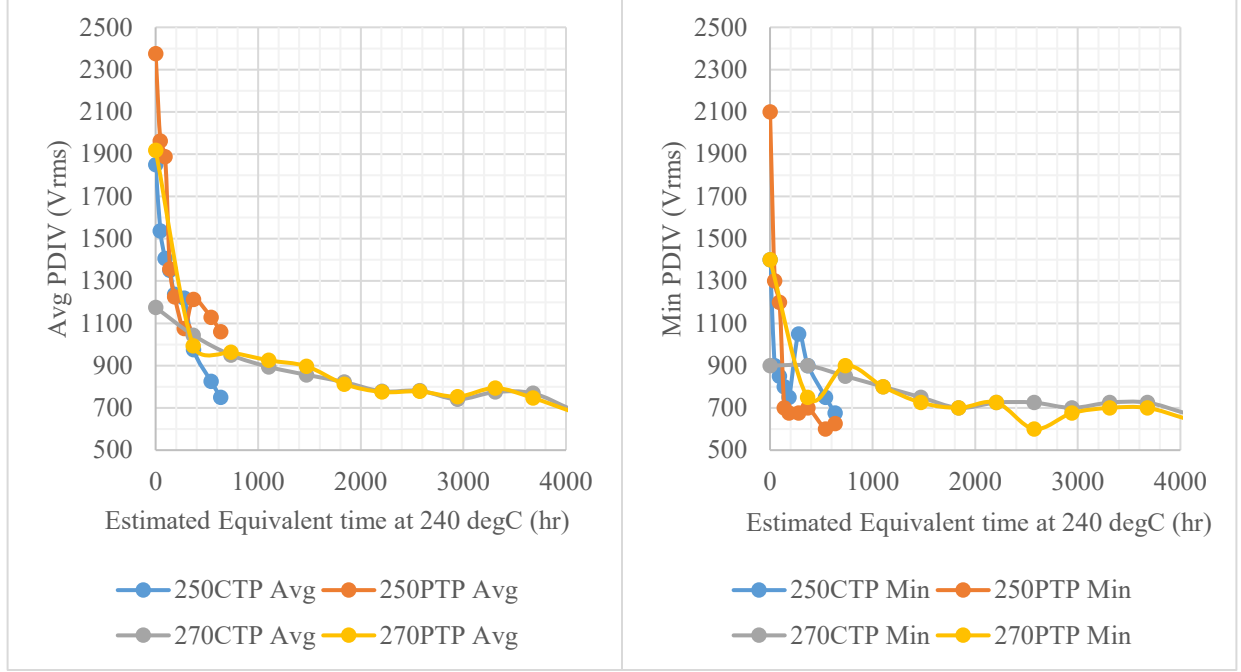
Figure 22 shows average and minimum PDIV versus estimated equivalent time at 240 °C for both 250 °C and 270 °C coated and potted twisted pairs. Figure 23 show the same PDIV data vs number of thermal aging cycles. The 270PTP set is shown to have similar average and minimum PDIV to that of the 270CTP group after the first cycle. This similarity suggests that after the cracking on the first cycle for the 270PTP group, the 270PTP aged like the coated twisted pairs. Over the first 350 equivalent hours of 240 °C aging, the 270PTP, 250CTP, and 250PTP groups all have similar average PDIV degradation curves over time, although the 270PTP group only has 2 points in that period so the curve is not well resolved. All specimen groups have similar minimum PDIV values after 3 thermal aging cycles. Extracting trends for the dependance of the epoxy aging on temperature from the available data at this time is difficult because the 250 °C and 270 °C groups used different numbers of cycles to reach equivalent levels of thermal aging. Further aging experiments at lower temperatures will use longer cycle times to match the aging points for the 250 °C aging group.

**Fig. 22 Average and minimum PDIV for 250 °C and 270 °C coated and potted twisted pair groups vs estimated equivalent aging time at 240 °C.**

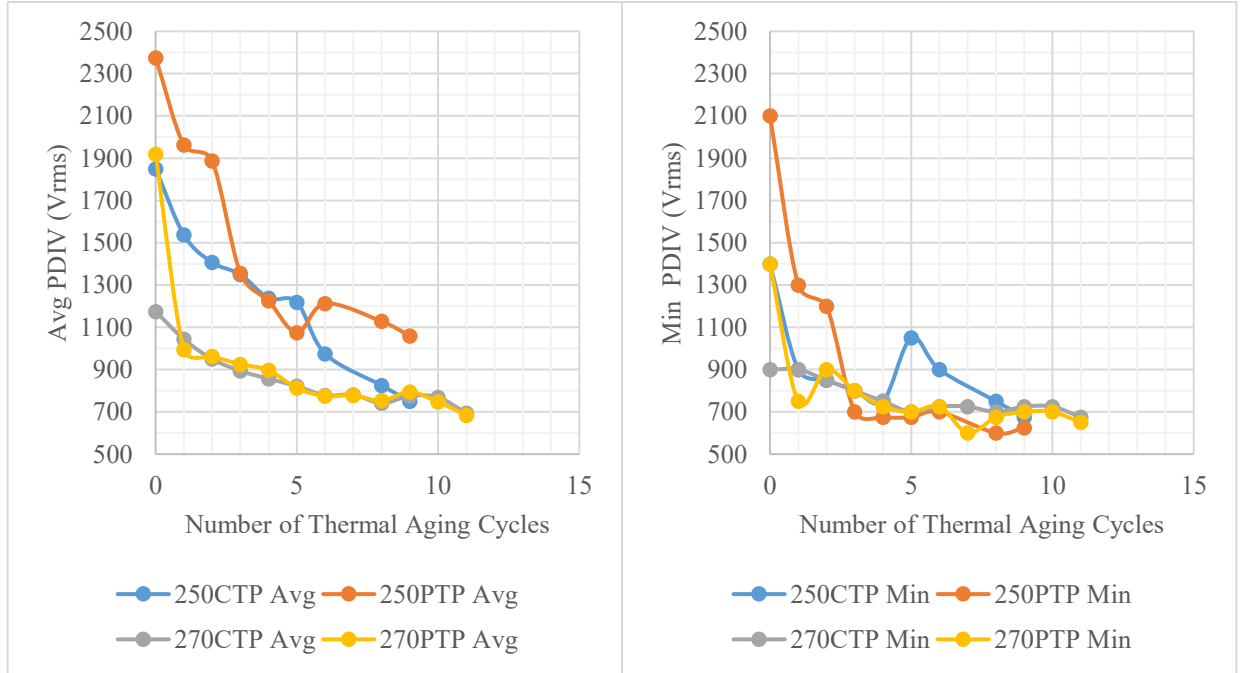
**Fig. 23 Average and minimum PDIV for 250°C and 270°C coated and potted twisted pair groups vs number of thermal cycles.**

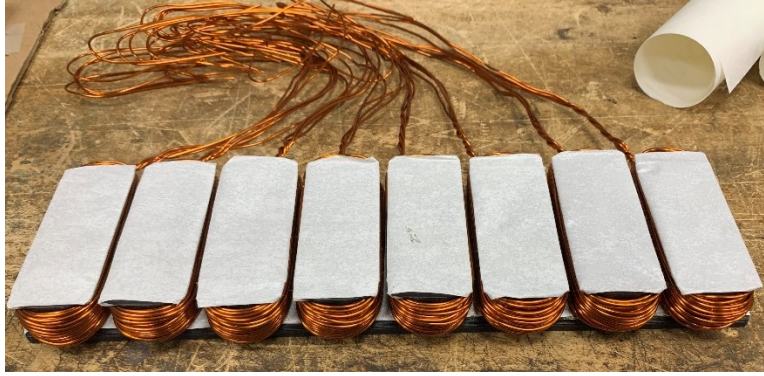
**Fig. 25 Motorette prior to potting.**

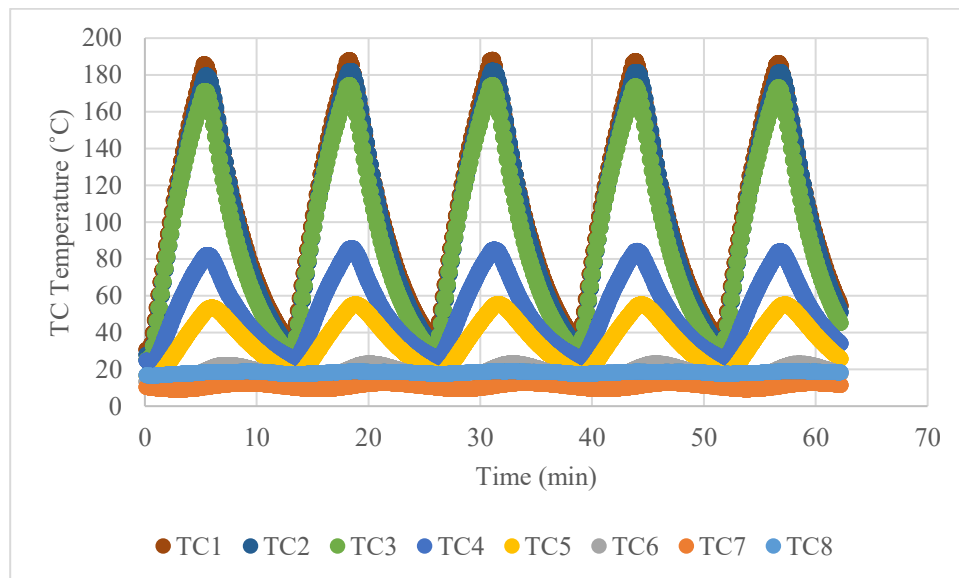
**Fig. 29 Example thermocouple data from a motorette with coils 1-4 powered and coils 5-8 unpowered.**

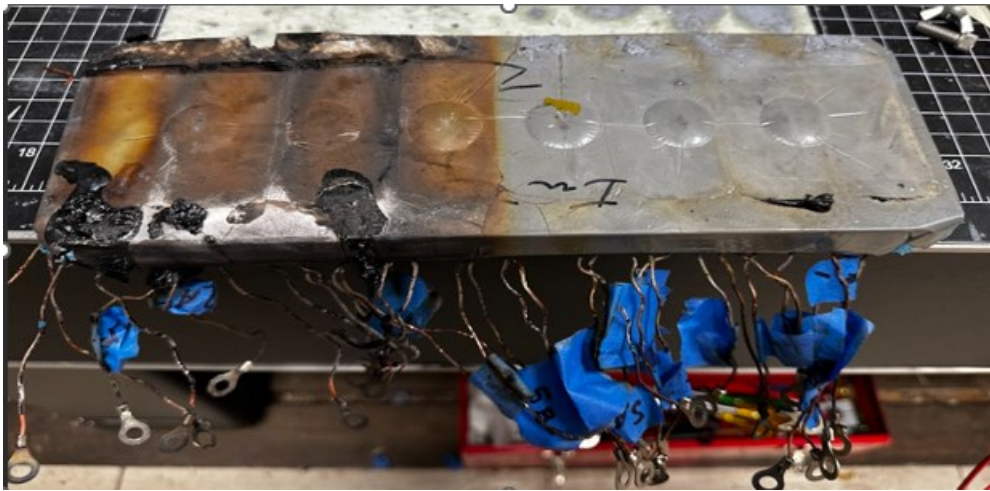
Figure 31 shows accidental additional evidence of the of thermal decoupling between the powered and unpowered windings when cycling half the windings at a time. Motorette 2 experienced an over-temperature event during a round of cycling on coils 1-4. Due to a program error, the coils were not shut down but rather held at high temperature ( $>250\text{ }^{\circ}\text{C}$ ) for  $\sim 2$  days. Due to the control program error, no thermocouple data was collected during the  $\sim 2$  days. Coils 1-4 are visibly burned and damaged while coils 5-8 show no color change, providing visual evidence that the powered coils and unpowered coils are fairly well thermally decoupled.

**Fig. 31 Motorette number 2 after an accidental  $\sim 2$  day cycle at  $>250\text{ }^{\circ}\text{C}$  on coils 1-4. Visual aging of coils 1-4 (left) vs 5-8 (right) provides additional evidence of the lack of thermal coupling between the two halves of the motorette when one half is powered.**

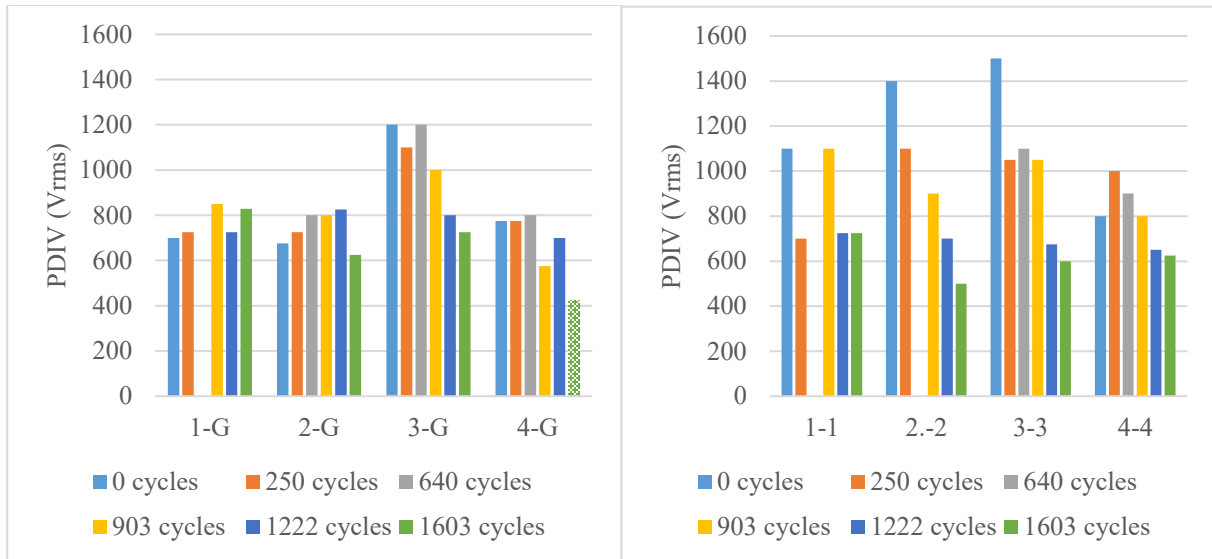
Figures 32 and 33 show the aging results for motorette 1. After cycling, significant PDIV degradation is observed in most measurements. The median turn-to-turn PDIV decreased from 1250 V<sub>rms</sub> to 550 V<sub>rms</sub> with every coil decreasing by at least 175 V<sub>rms</sub>. For the phase-to-ground insulation, half of the coils had insulation breakdown occur and three of the remaining four coils had PDIV decreases. Coils 5-8 had greater degradation in both turn-to-turn and phase-to-ground PDIV than coils 1-4 despite experiencing fewer total cycles. No further cycles were run for motorette after the insulation breakdown was observed during PDIV testing.

**Fig. 32 Motorette 1 coils 1-4 phase-to-ground PDIV measurements (Left) and turn-to-turn PDIV measurements (Right) vs cycles completed of 150 A for 3.5 minutes. Cycle counts listed for each measurement are cumulative. Cross hatched bars signify a breakdown measurement rather than PDIV.**

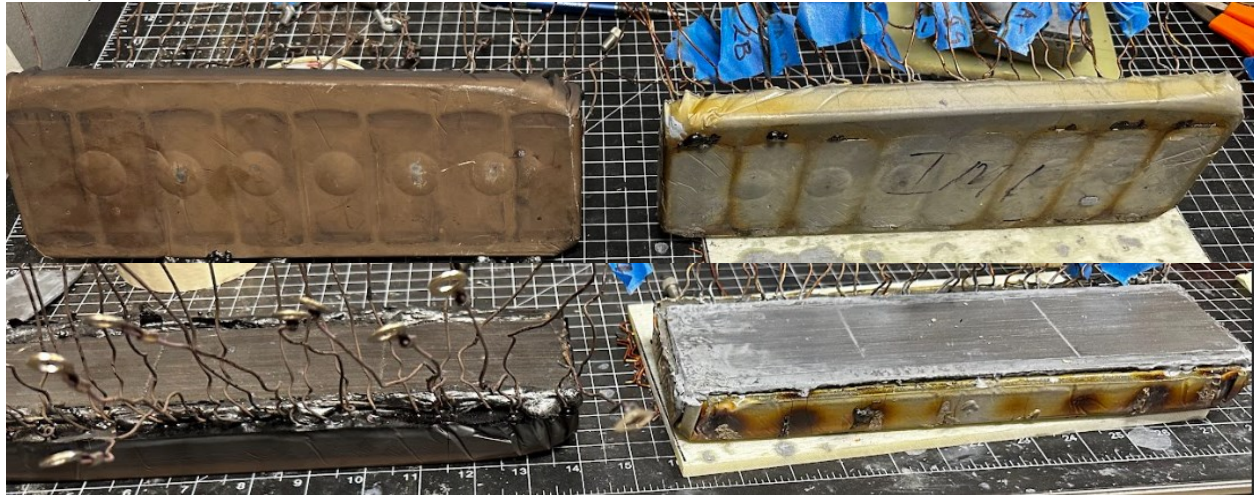
Figure 40 shows side by side pictures of Motorette 1 and Motorette 4 after all their aging cycles. Motorette 4 is darkened completely indicating appreciable thermo-chemical aging of the full motorette while motorette 1 only has some dark spot in the end windings close to the winding hotspot location. Motorette 4 had the highest modeled Von Misses stress at the hotspot and second highest stress at the ground wall indicating that high stress alone does not immediately degrade the insulation performance.

**Fig. 40 Motorette 4 (left) and motorette 1 (right) after their aging cycles.**

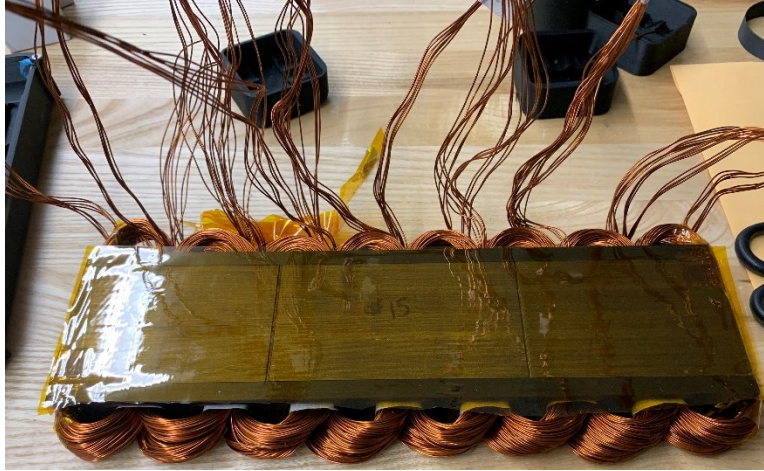
**Fig. 42** EM1 prior to potting.
