# ISS ECLS System Overview of Events 2023

Paper # ICES-2024-141

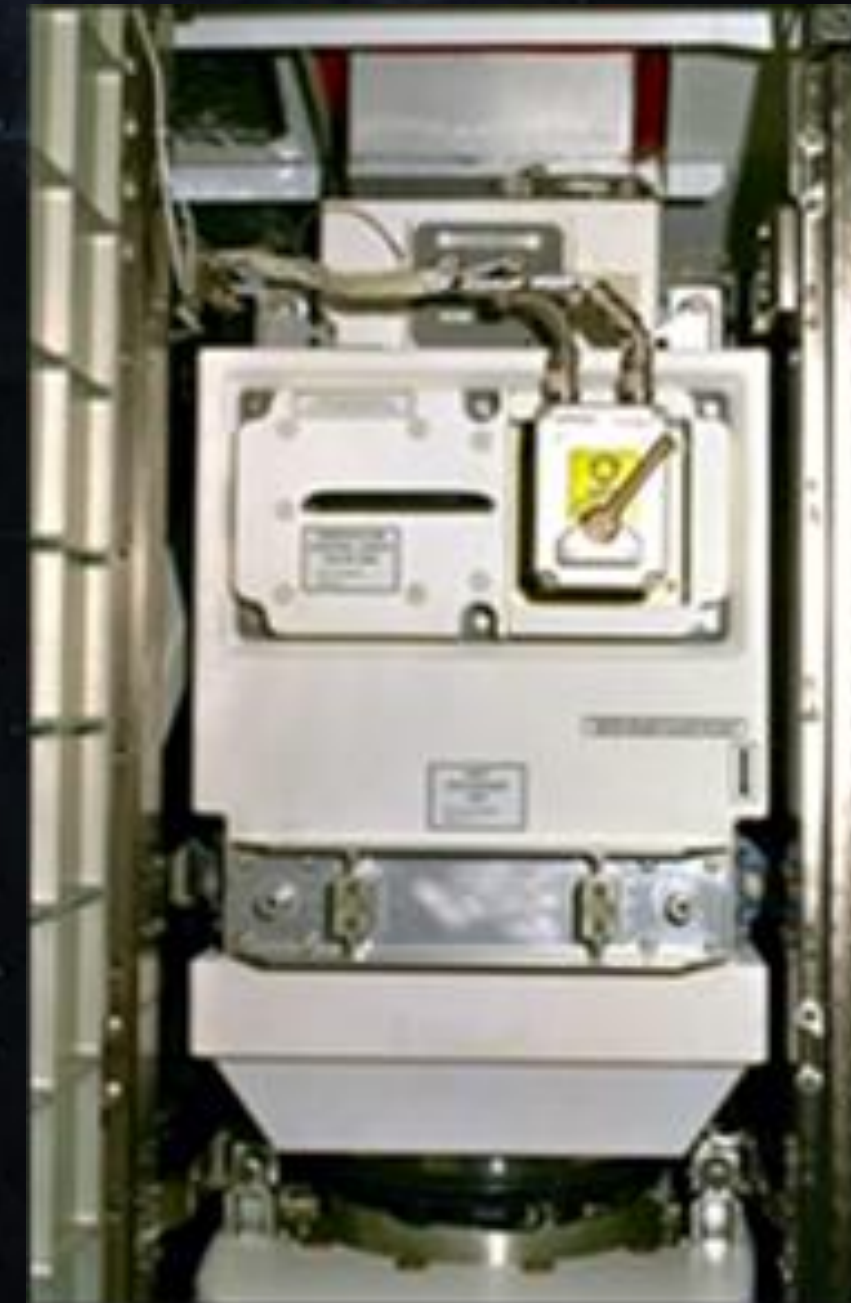
- The Heat Exchanger (HX) and Water Separator (WS) are critical components of the CCAA. The HX cools and dehumidifies the air, and the WS collects the condensate.

- Node 3 CHX started experiencing Liquid Sensor indications with increasing frequency, which is typically a sign of a degraded HX. After R&R, liquid indications continued.

- Node 3 Water Separator (WS) ORU was then R&R'd, stopping the HX wet indications. The WS had an increase in condensate pressure over a period of time, which was initially mistaken as a sensor drift. This likely led to a reduction of suction in the WS system.

- The team was concerned that the WS may have been contributing to the Node 3 HX carryovers prior to the HX R&R. Therefore, a wettability test was performed on-orbit on the removed Node 3 HX. The wettability test confirmed that the HX had enough hydrophilic properties needed to retain water.

- The unit removed from Node 3 was then installed in the Airlock, which had a degraded HX and had not been replaced since the beginning of A/L operations in 2001. This was accomplished by swapping QDs and hoses (with high torque) on-orbit, an achievement that had not been attempted before.

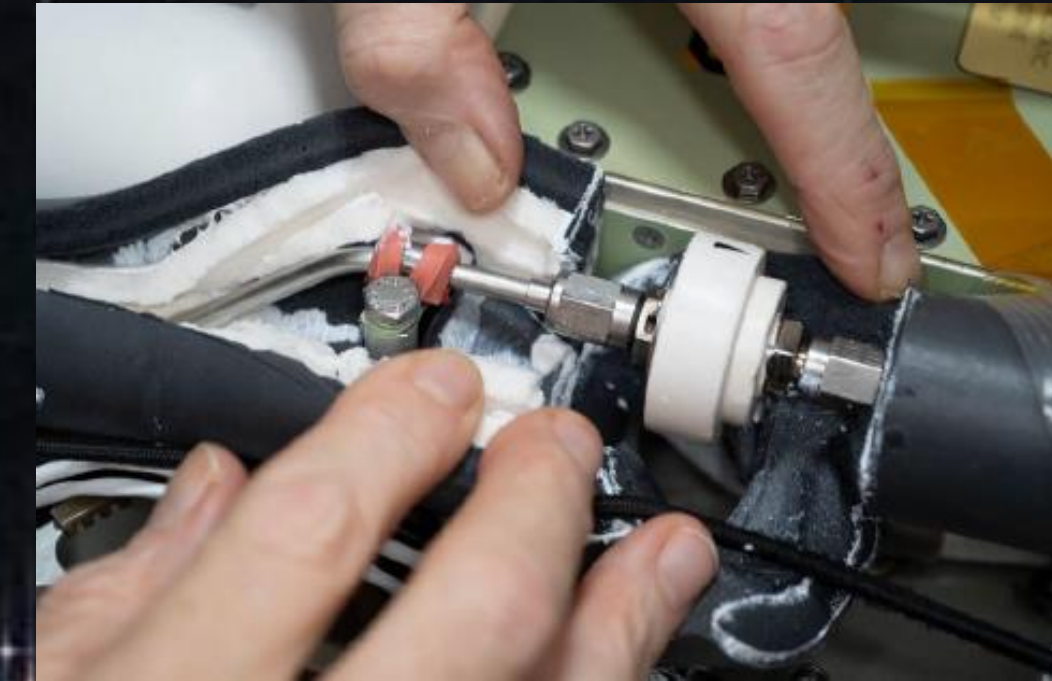
- The WS ORU's task is to pull the water from the fins of the HX and transport it to the Water Bus by means of the elevated water pressure provided by the WS Impeller. This elevated pressure is controlled by a spring check valve called the LCV, located at the interface between the WS and its internal Bus Line.

- For various reasons, the operation of this poppet valve and spring inside the LCV can be compromised so that the LCV becomes either stuck closed or open, historically causing earlier than-expected R&Rs.

- One such occurrence, when the LCV became stuck open, happened at the end of 2022 on the LAB1P6 WS. Therefore, the LAB1P6 WS LCV was R&R'd in August 2023 and the LAB1P6 CCAA reassumed control over temperature and humidity in Lab. The first analysis of water pressure in the LAB1P6 WS confirmed that the LCV R&R was successful, and the LCV also passed a visual check for the signs of leak or moisture.

- However, the new valve failed the BIT test. There could be an internal leak in the LCV between the valve diaphragm/plunger interface. Further analysis and discussion of the data is needed to understand if this is a nominal internal leak, and data analysis of a dry cycle on the WS is also needed to understand the condition of the LAB1P6 WS LCV. In the end, though, while the newly-installed LCV did fail the pressure check, the internal pressure readings do appear nominal during operation, proving that the LCV can be R&R'd on-orbit.

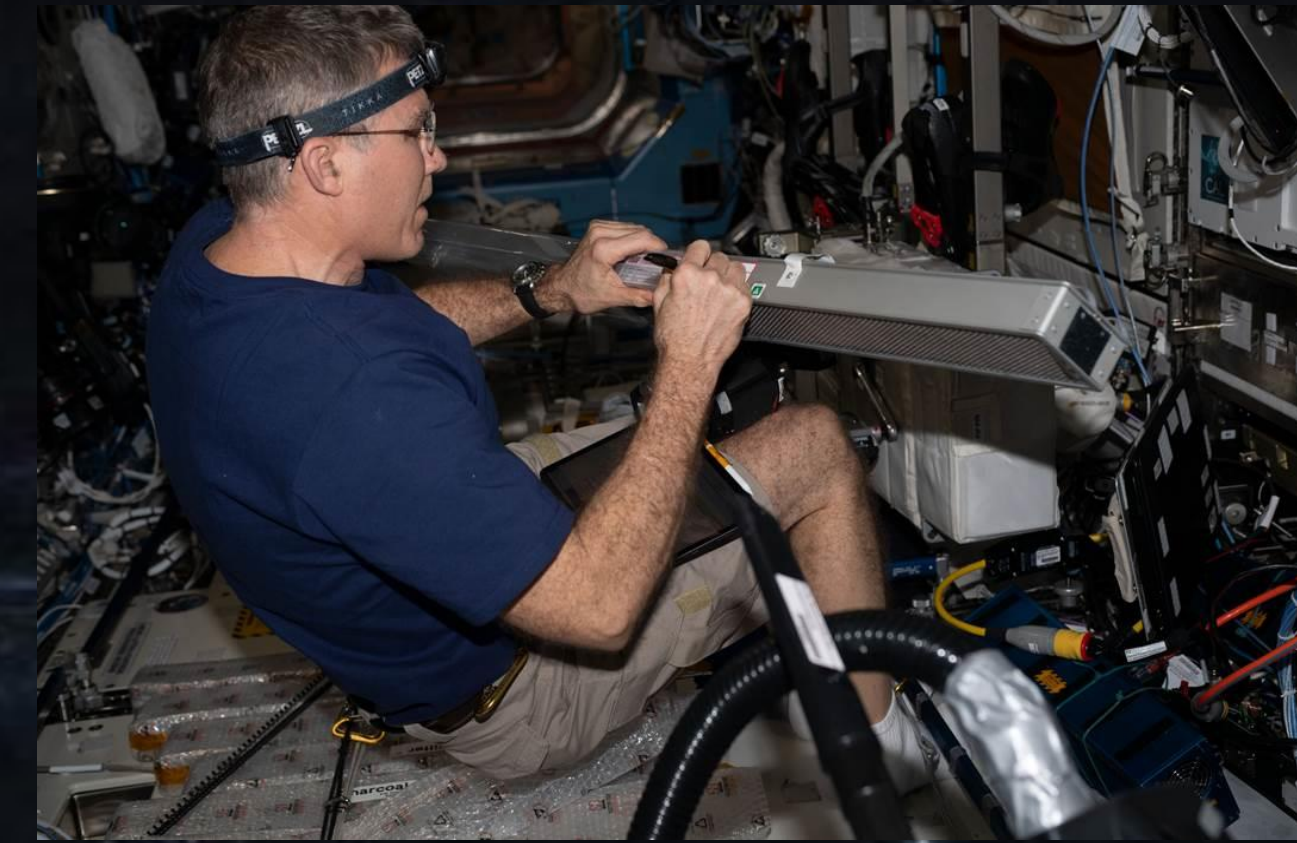
- In 2019, 21 CHIPS Filters were installed throughout the USOS, replacing the preexisting Bacteria Filters in each location. CHIPS improved upon the Bacteria Filter design by adding a Charcoal Filter to pull volatiles out of the air that are harmful to Temperature and Humidity Control (THC) and Water systems.

- The initial life expectancy for the CHIPS Charcoal Filters was 3 – 5 years and was 2 – 5 years for the CHIPS HEPA Filters, depending on location. The HEPA Filter life was then extended to 3.5 – 5 years based on data trending and results from on-orbit filter inspections.

- The health of the Charcoal Filters is monitored by dimethylsilanediol (DMSD) levels measured in the potable water and total organic carbon (TOC) breakthroughs in the Multifiltration (MF) Bed. The health of HEPA Filters is monitored through CCAA/Cabin Fan pressure differentials.

- In August 2023, the Charcoal Filters across Station and the Node 3 HEPA Filters were R&R'd due to trends in on-orbit data. The rest of the HEPA Filters across the USOS were inspected and cleaned.

- Based on this set of inspections and continued ORU Inlet Fan pressure differential trending, the lives of the HEPA Filters will be extended to be 5 years in every module.

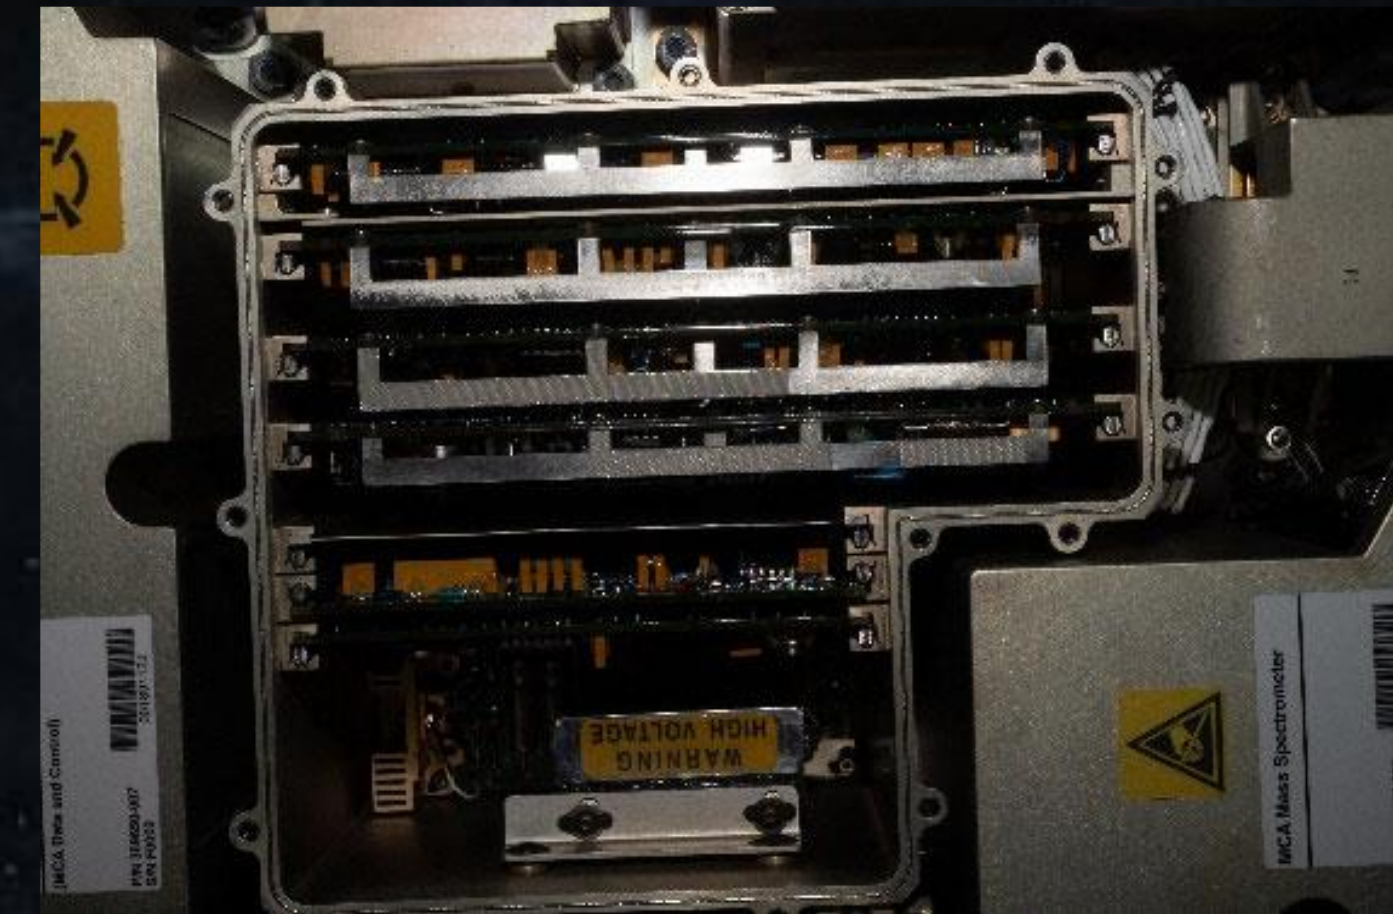
**MCA Interface CCA**

- Failed in late 2022 due to a filament failure in ORU 02 and was R&R'd in June
- Upon activation, there was various error codes that made the MCA unusable.
- Troubleshooting determined that there was an intermittent connection of the Interface CCA in the electronics assembly. The Interface CCA is responsible for communications between ORU 01 and ORU 02 and for the communications internal to ORU 02.
- In January, this year, the CCA cards were reseated and two of the CCA cards were found to be loose.
- Lab MCA is currently operational again.

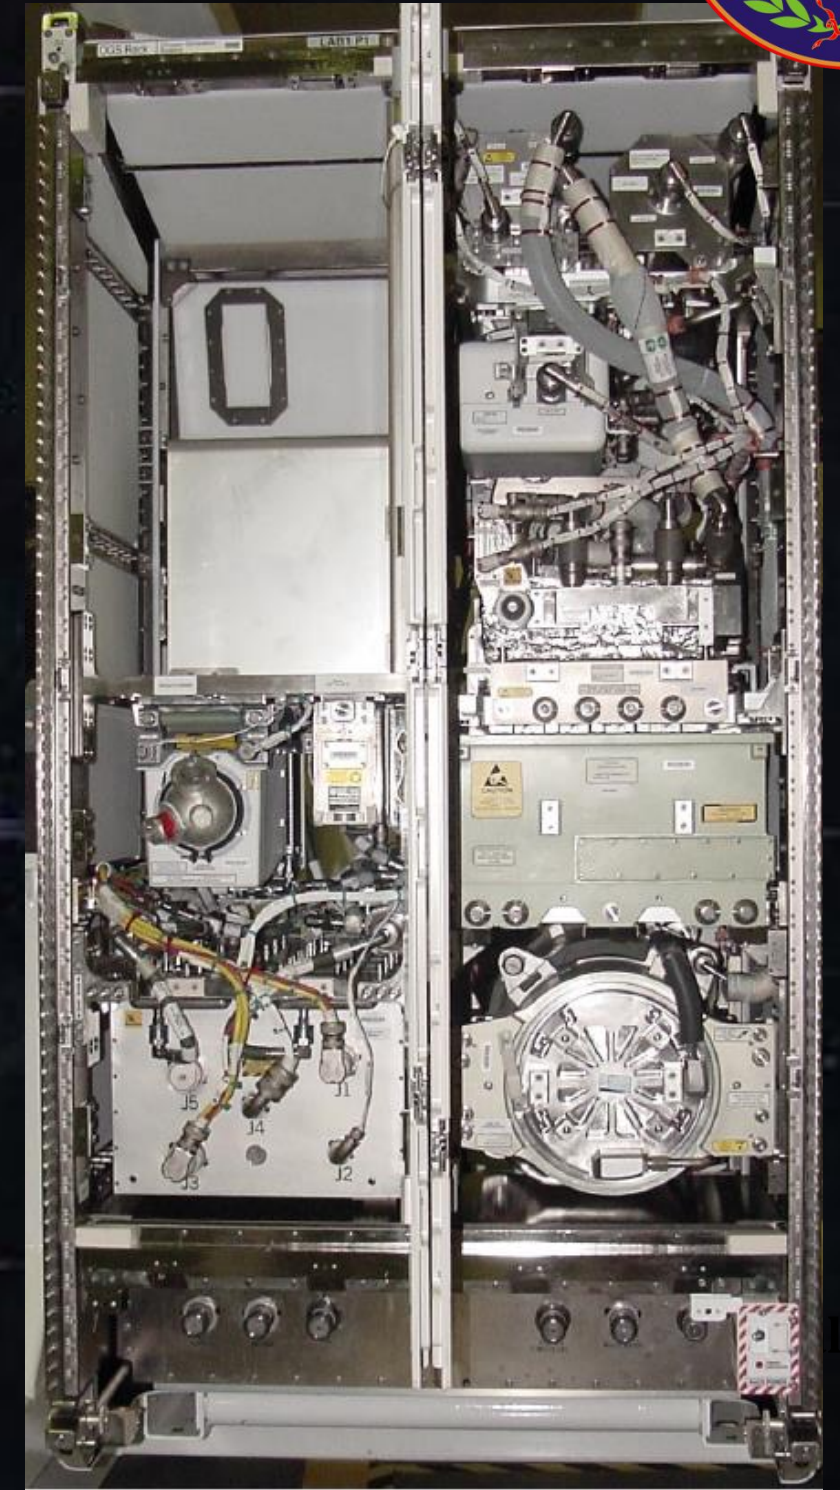
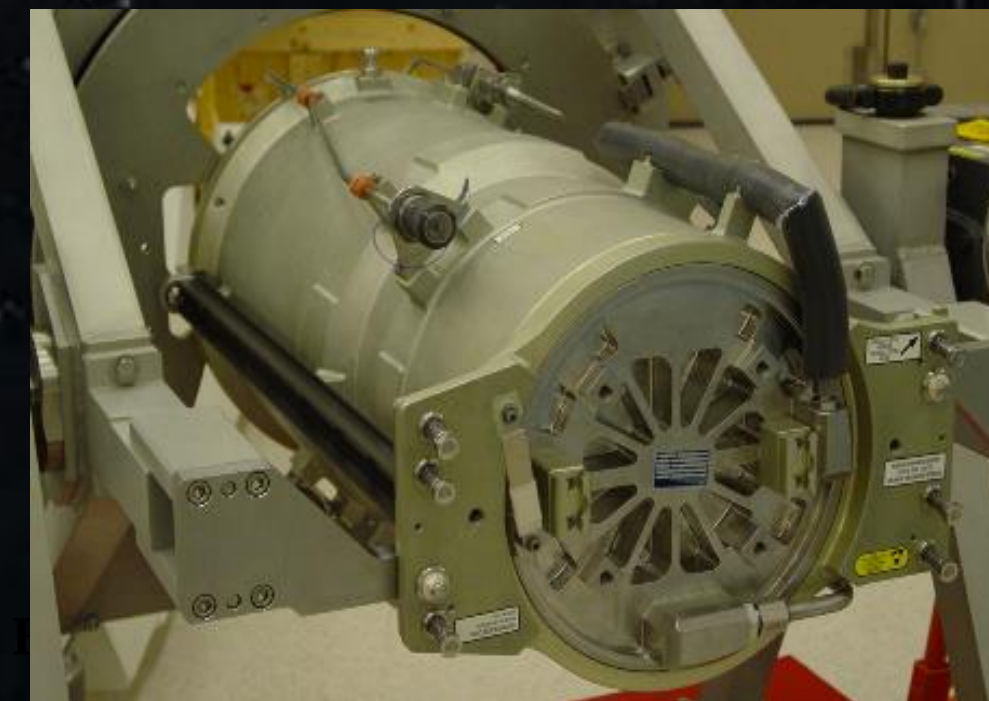
- The Oxygen Generation System (OGS) rack was launched July 2006 on STS-121/ULF1.1, activated in U.S. Lab in July 2007, moved to Node 3 in 2010 and relocated back to U.S. Lab in September 2022 to enable co-location of Exploration demo air string systems
- OGA in Process mode at 100% oxygen production rate produces 20.4 lbm O<sub>2</sub> per day (~10.88 U.S. crew average metabolic use) and is commandable from 22 to 100% in 1% increments in Process mode
- As of June 3, 2024, OGA accumulated 13.95 years of run time with an average O<sub>2</sub> production rate of ~5.78 lbm /day (~ 3.08 crew) and has produced approximately 29,422 lbm of O<sub>2</sub> and 3,678 lbm of H<sub>2</sub>

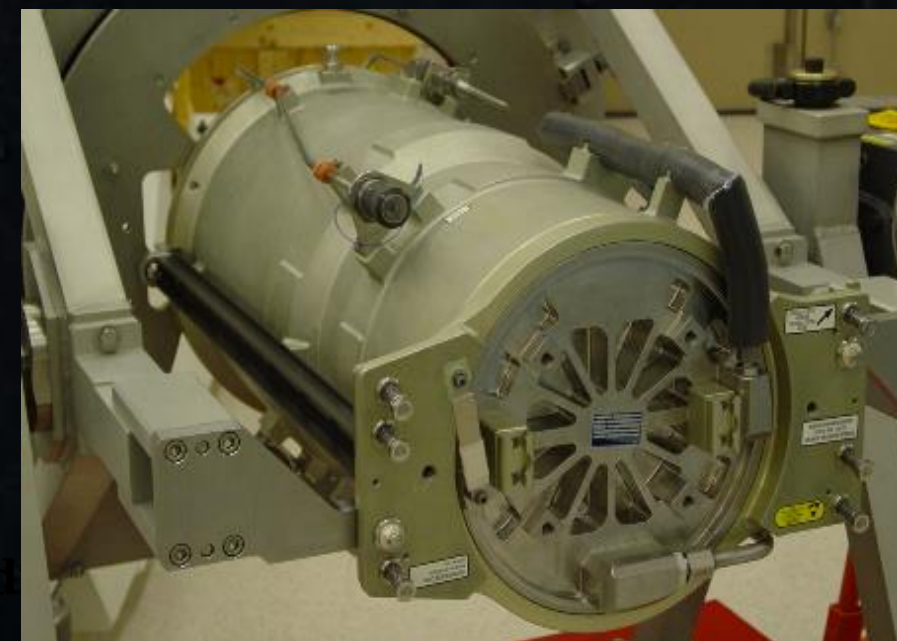
- TT&E and failure investigation of two failed Pump ORUs (SNs 3 & 5) determined gear lockups were due to precipitation of nickel phosphate caused by wetted QD internal electroless nickel coating degradation

- Refurbished ORUs have no electroless nickel coatings on QD internal wetted surfaces (SN3 launched SpX-30)
  - In May 2023 crew installed SN2 into OGA to maintain ORU viability since susceptible to gear lockup (old QDs)

- Oct 2021 installed S/N 4 H2 Dome ORU continues to exhibit anomalous hydrogen Back Pressure Regulator (BPR) performance causing low and erratic recirculation loop pressure after transitioning into Standby. Software override is maintained for reducing low pressure shutdown limit to 19 psia (default 20.5 psia) to enable OGA operation

- TT&E of SN3 H2 ORU's anomalous BPR determined poor passivation and corrosion of the tightly toleranced poppet shaft and guide was the root cause of erratic pressure regulation.

- Future builds of BPRs will incorporate improved passivation methods into BPR components to mitigate corrosion
- H2 ORU SN 3 was returned to the ground in Jan 2022 due to Cell 1's declining voltage in Standby, indicating possible membrane thinning and a partial short. Program has deferred cell stack failure investigation given this is a known end of life signature and is identical to SN2 H2 ORU cell stack failure

- - Team is closely monitoring SN4 H2 ORU's individual cell voltages while in Standby and during OGA activations / deactivations to identify any early cell failure signatures due to membrane thinning and material loss due to electrolysis given cell stack has been under compression for over 13 years

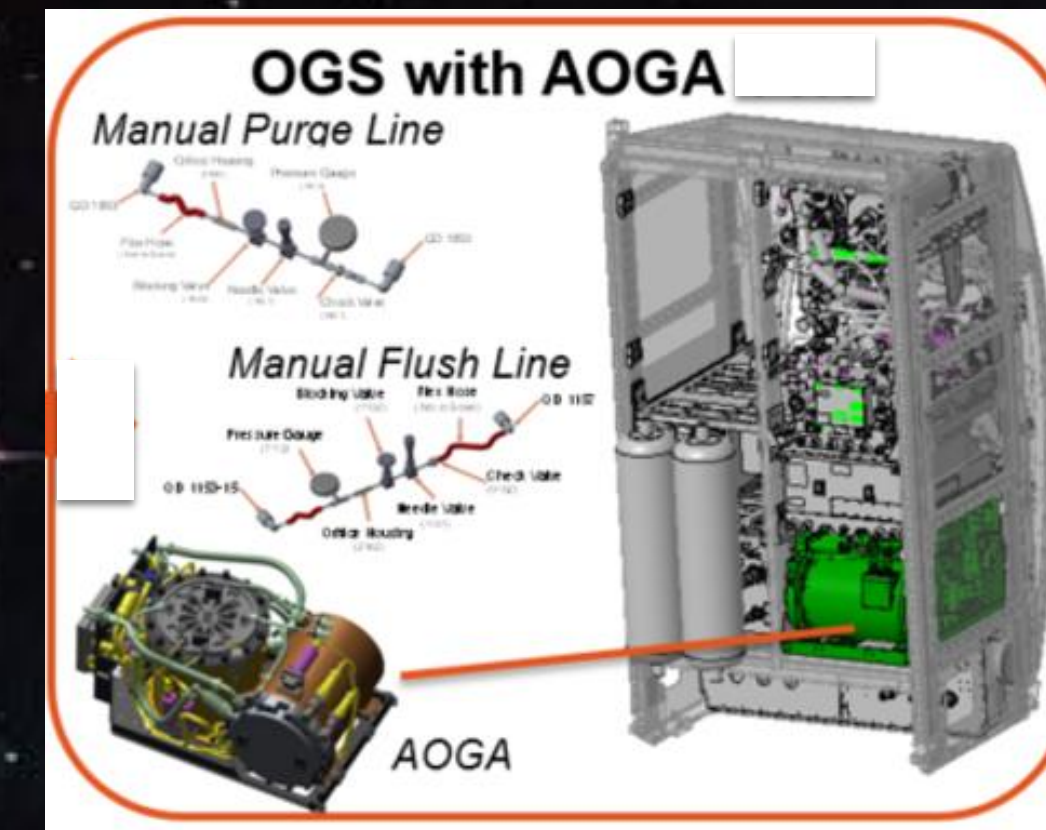
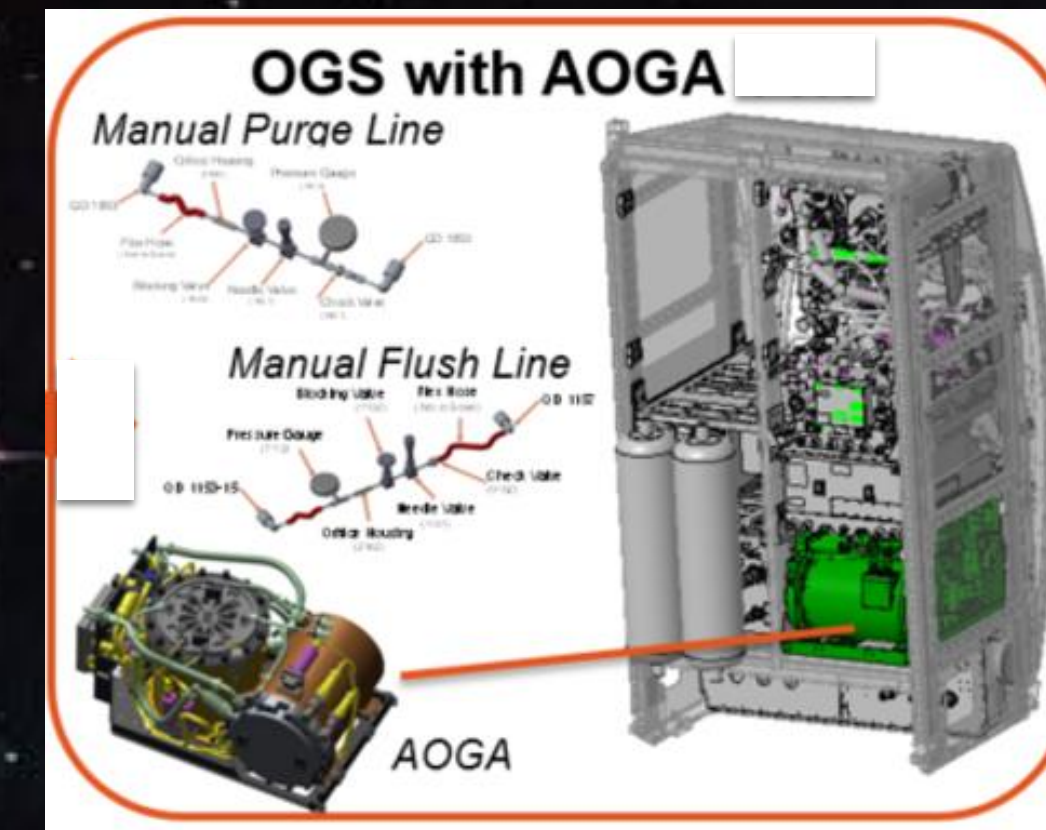
OGS rack with AOGA OHDA installed

- The OGS rack will be modified to include a 9 inch bumpout assembly attached to rack by Velcro straps replacing the left side closeout door on the rack to allow more volume for an expanded Sabatier 2.0 design for better maintainability and new CO2 accumulator tanks.

- A new AAA inlet port with an integral screen is located on the aft side of the bumpout with a larger diameter to compensate for additional length and bend of passageway to the legacy muffler filter block.

- New replacement H2/N2 Vent Hose and Waste Water Hose Assemblies with contingency tee QDs for alternate venting and scarring for potential future flushing of the OGA recirculation loop water to the waste bus (instead of to a CWC-I) will be installed within the LAB1P1 standoff volume.
