# *Columbia Crew Survival Investigation Report*

What happened to the  
STS-107 *Columbia* crew  
and what can be learned from it.

Nigel J. Packham,  
Ph.D.  
Associate Director  
JSC S&MA

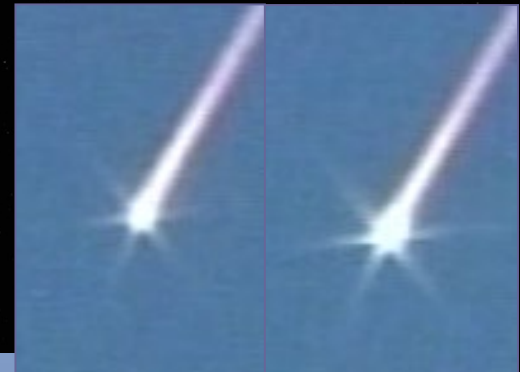
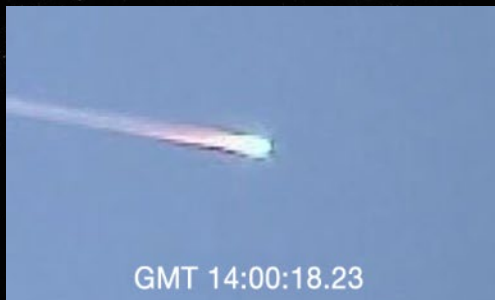
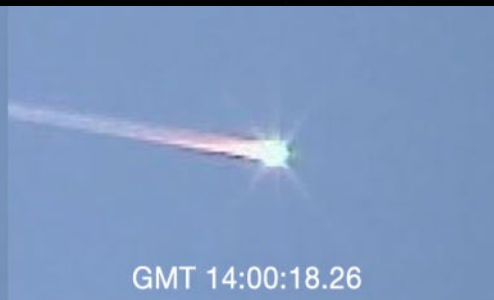
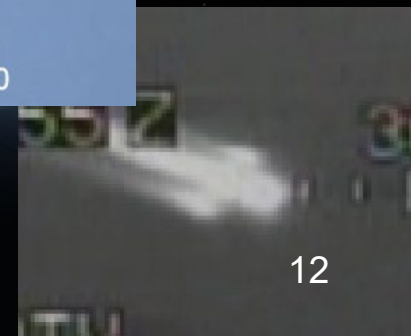
- Video anchored key events
  - Loss of Control
  - Vehicle breakup
  - Forebody breakup

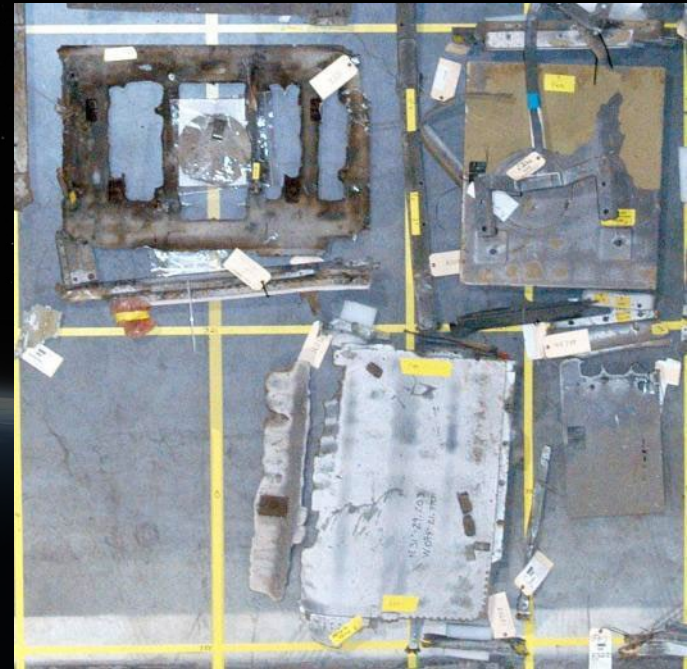
- Debris analysis proved to be immensely complicated
  - Easy to develop a false scenario from one or two pieces of debris

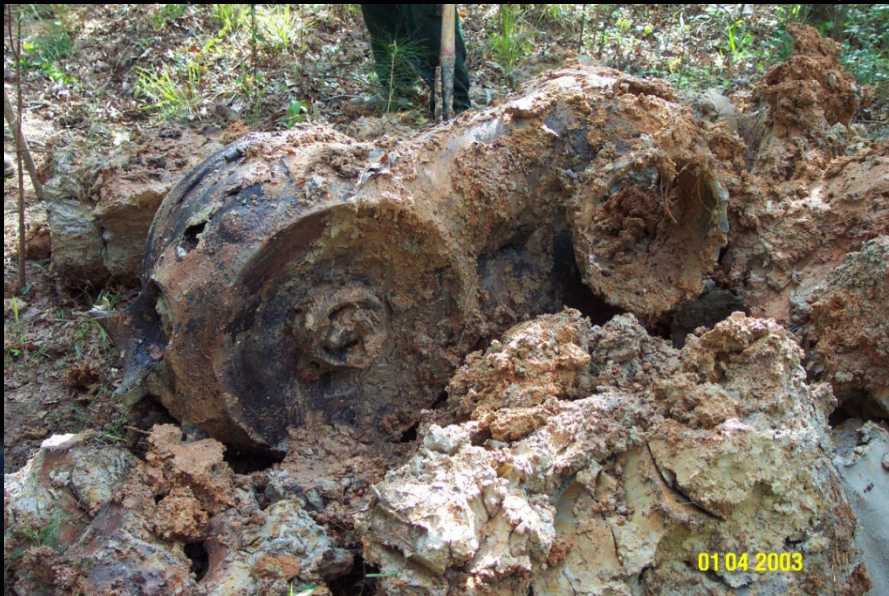
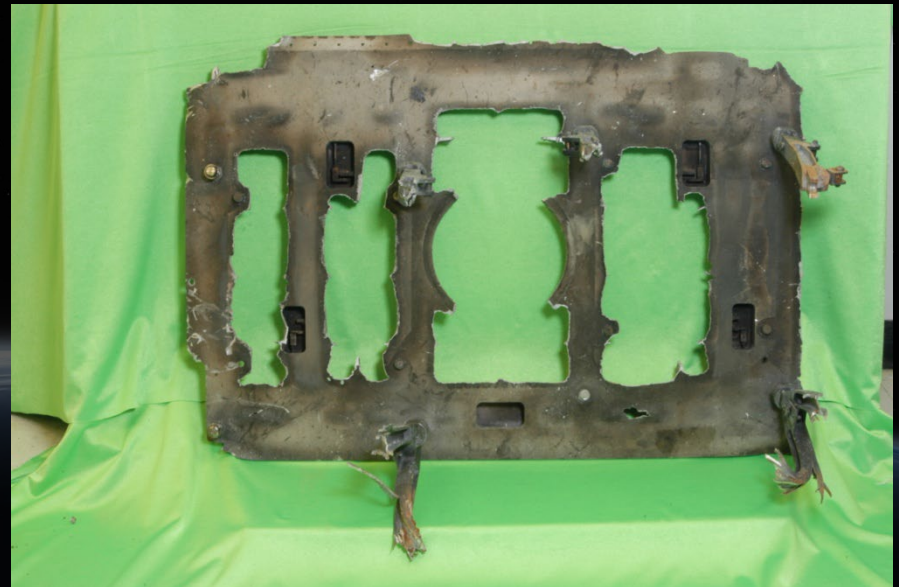
- Key point to understand is the ballistic number
  - Difficult to determine ballistic number for complex shapes
  - Ballistics analysis cannot account for cascading failures/intermediate configurations

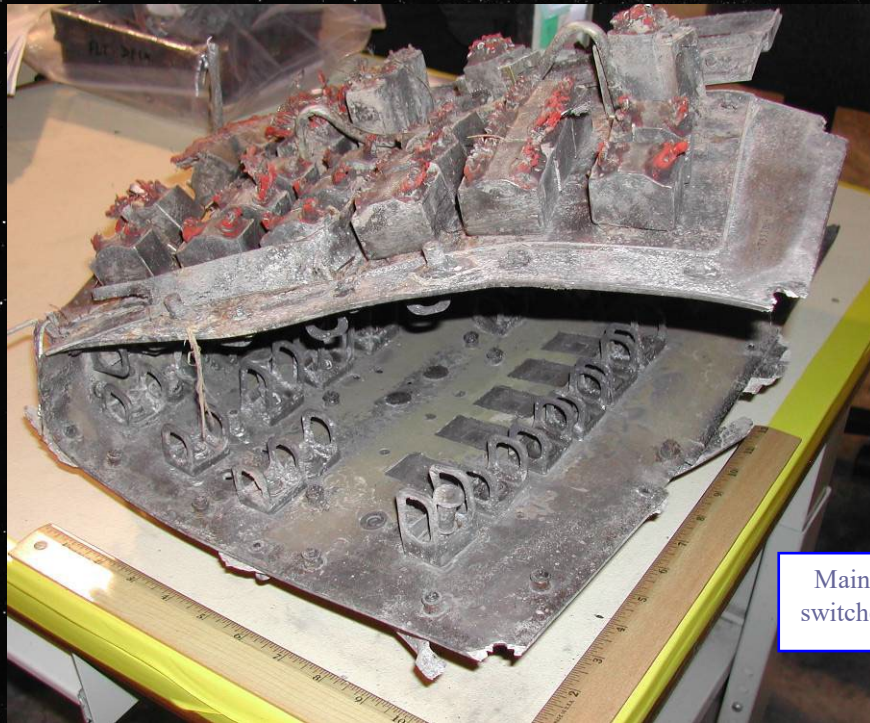
# Panel R2 APU switches

- 14:00:03 - 14:00:05 – RGPC2 data indicate cabin parameters were normal, auxiliary power units (APUs) were running but hydraulic pressures and quantities were zero
  - Panel R2 APU switches

Main engine-related switches (paddle-type)

APU Operate switches for APUs 2 and 3 (lever lock type)

Hydraulic circulation pump switches for hydraulic systems 2 and 3 (paddle-type)
