A Screening Method Using Pulsed-Power Combined with Infrared Imaging to Detect Pattern Defects in Bulk Metal Foil or Thin Film Resistors

Jay Brusse

SSAI/NASA Goddard Space Flight Center

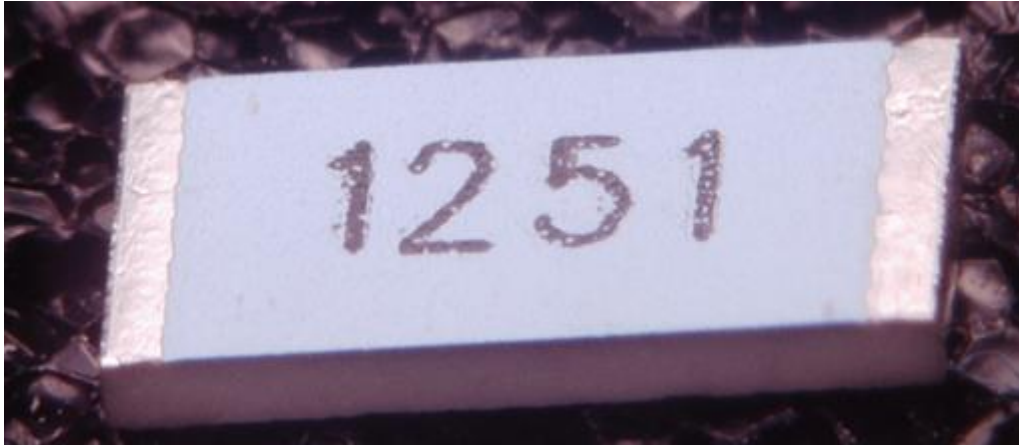
Basic Construction of a SMT Foil Resistor

- Resistor element is made from foil sheets of NiCr-based alloys
- Resistor gridline patterns are created by photolithography and electrochemical etching
- Resistor foil is adhesively-bonded to an alumina substrate
- Precise resistance values achieved by laser or mechanical cutting of combinations of “trim tabs” connected in parallel with resistor pattern segments of different values
- Various resistor termination options exist
- Polymeric and epoxy coatings protect the resistor element

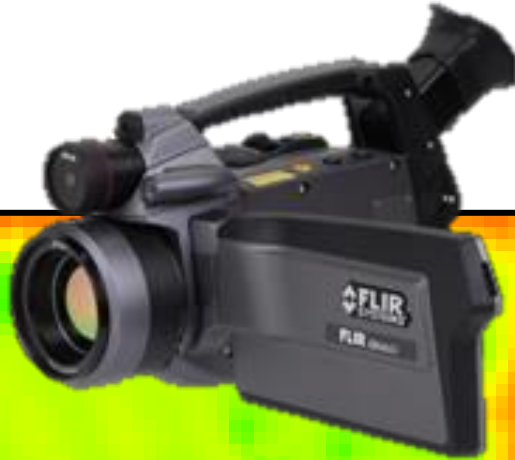
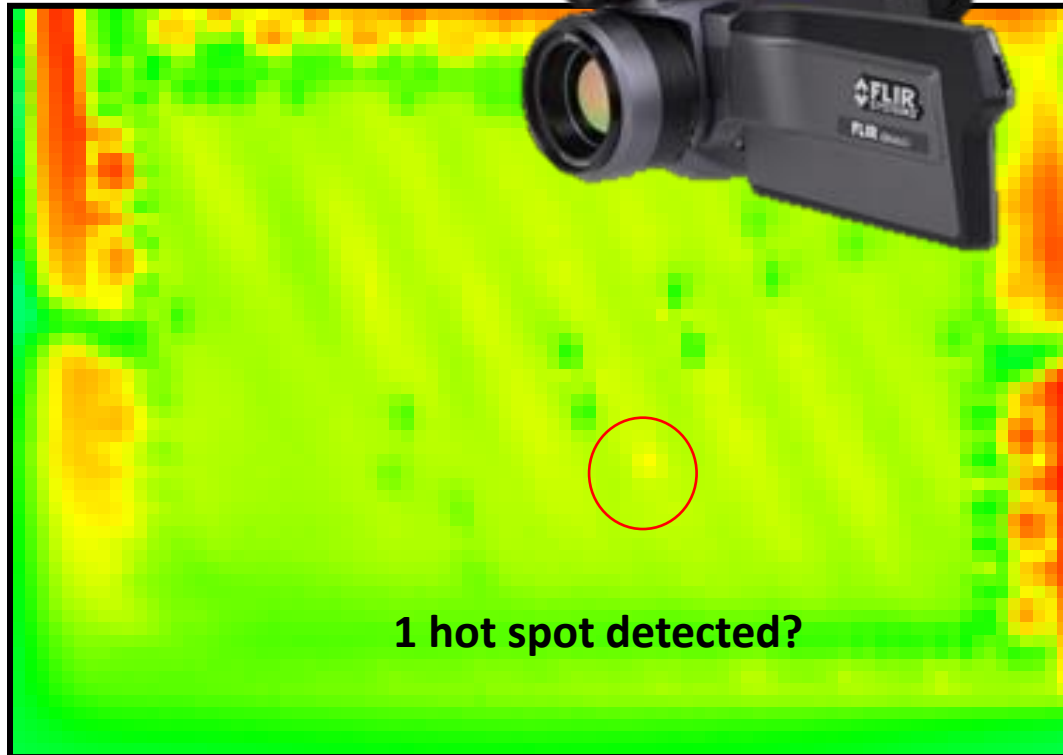
FLIR SC660

Inspecting the same resistor with 2 constriction defects while applying power pulses

~25 μm per pixel

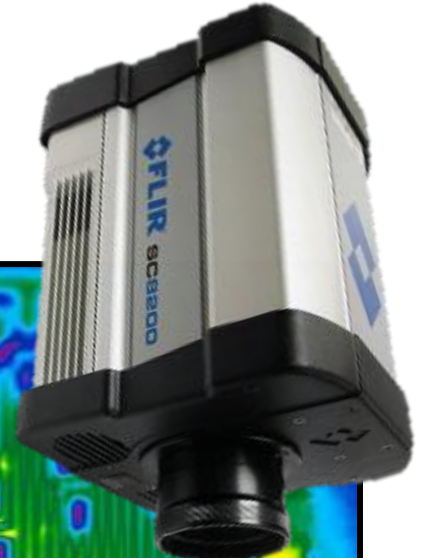
FLIR SC8300HD + 4x Lens

~5 μm per pixel

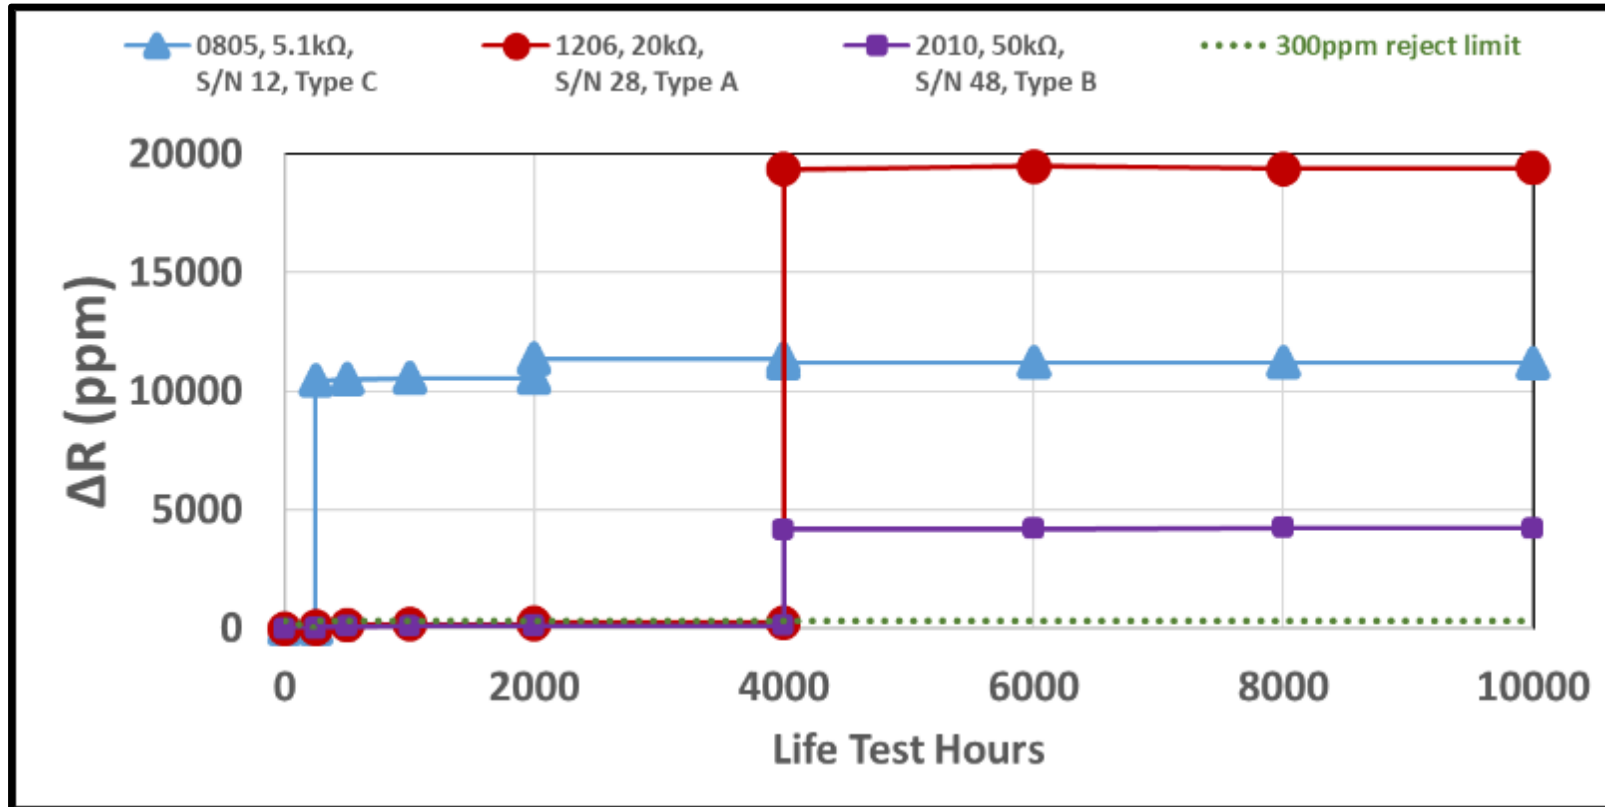
Abrupt Positive Resistance Shift Failure Modes

* *S/N 12 exhibits 2 distinct positive shifts during life test*

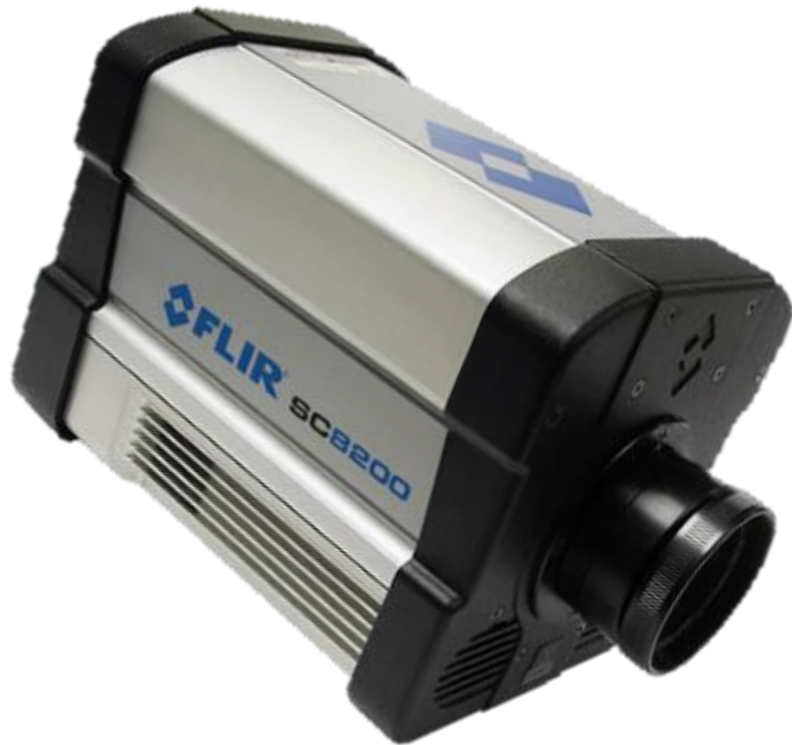
FLIR SC8200, SC8300 Series

High Resolution Infrared Camera with 4x lens option

Parameter	Specification
Detector	InSb
Spectral Range	3 μm to 5 μm
Measurement Temperature Range	-20°C to +350°C
Field of View	~4.6mm x 5.6mm (> 1 million pixels)
Resolution	~ 5 μm per pixel
Focal Working Distance	~25mm
Frame Capture Rate	>100 frames per second (fps)

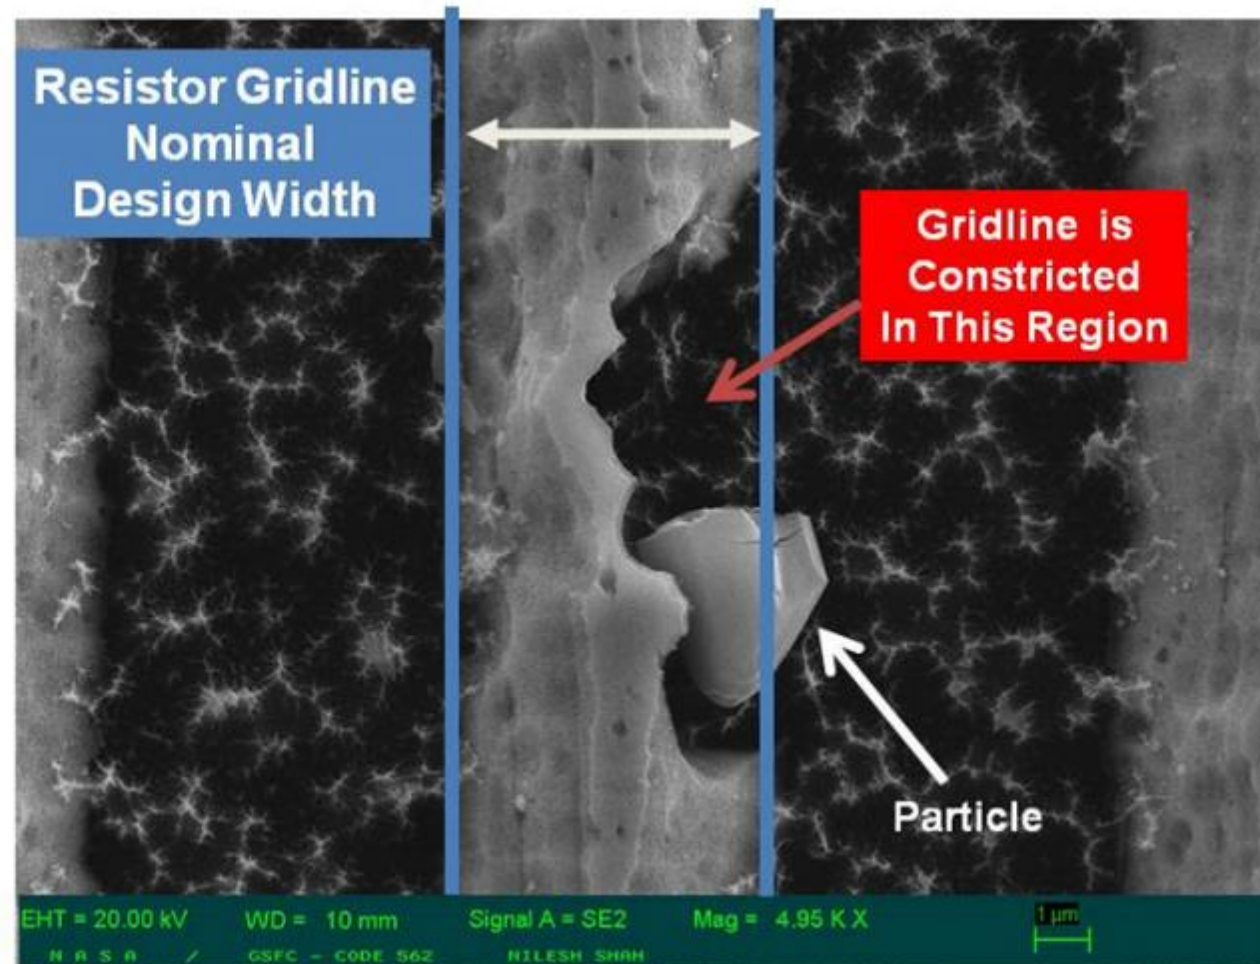
Foil Resistor with Notch Defect Associated with Embedded Particle
