Thermal Protection System P50 Cork Char Response Characterization to Ascent Flight Shear and Heating Environments

Manish Mehta^{1*}, David A. Brewer^{1†}, Jacob A. Parton^{1‡} and Ron D. Beshears^{1§}

¹NASA Marshall Space Flight Center, Huntsville, AL 35812

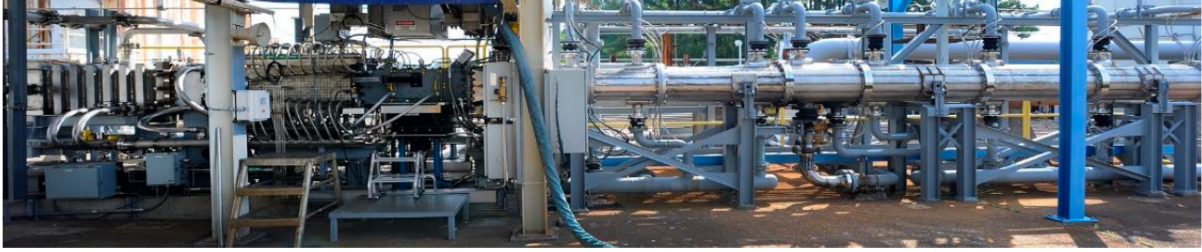
Figure 5. Photograph of the entire Hot Gas Facility (top); schematic of Hot Gas Facility wind tunnel components (bottom).

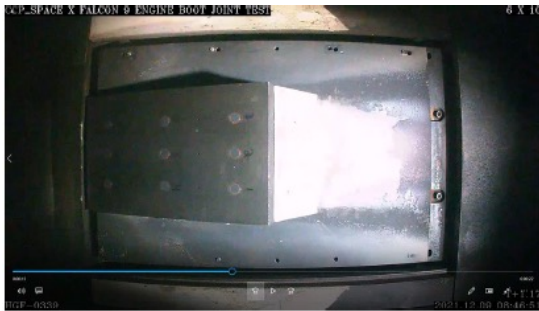
Figure 6. HGF calibration plate (left); TPS cork sample in the HGF (right).

Figure 6 shows the placement of a HGF calibration plate and TPS sample within the test section. The sample and calibration plate were placed on a wedge to augment the convective heating rates. The calibration plate was used to ensure that the target conditions were satisfied in both convective heating, radiant heating, pressure and shear stress. Once the target conditions were met based on the appropriate wind tunnel mixing ratio, radiant arc lamp output, TPS placement wedge angle and chamber pressure, this condition was replicated with the TPS sample.

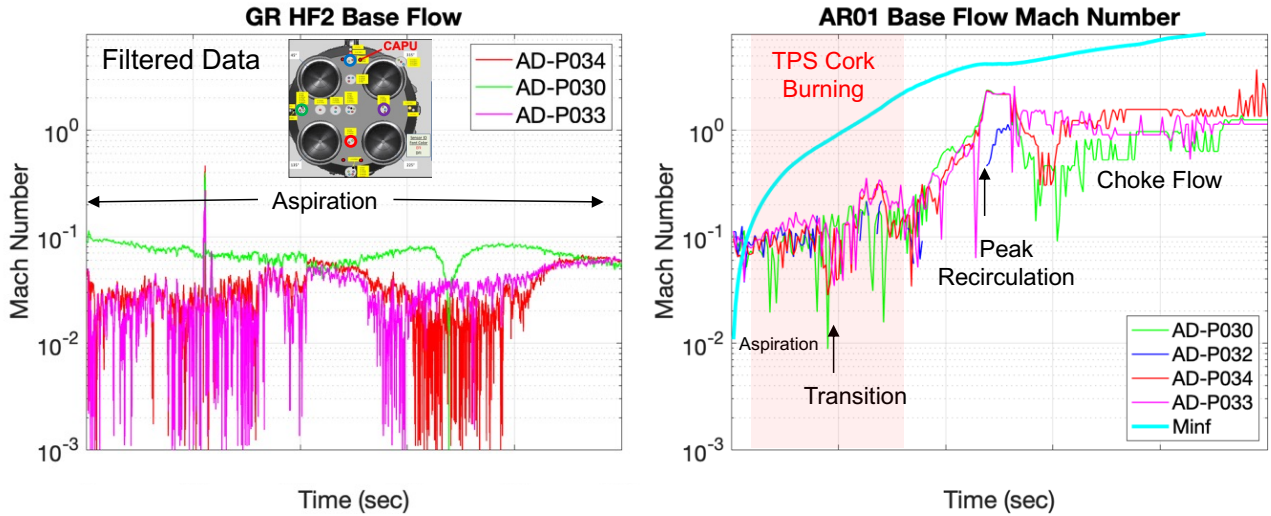
Figure 12. Base vent flow Mach number vs. time at various locations on the Core Stage base heat shield during Green Run Hot-Fire 2 (left) and Artemis I flight (right).

Figure 12 shows a comparison of the average base vent flow Mach number along the Core Stage base heat shield during Green Run Hot-Fire 2, and Artemis I flight¹⁻². There was a significant difference between the base flow Mach number between the two conditions. During the static test fire of the four RS-25 engines at NASA Stennis B-2 test stand, there was only aspiration of the freestream toward the center of the base. The entrained base air flow Mach number was calculated from the aspiration model to be between Mach 0.03 and Mach 0.07. This was observed from three flight measurements along the Core Stage base periphery as shown in Figure 12 (left panel). During Artemis I flight, the Core Stage base flow went through multiple flow regimes such as aspiration, transition, peak recirculation and choked flow. The transition flow regime occurred when the freestream entrained flow was balanced by the initial plume-plume interaction recirculated flow, leading to a base pressure differential ($P_b - P_{inf}$) of zero²⁻³. There was a local minimum during base flow transition as observed in Figure 12 (right panel). Peak recirculation led to the highest base flow Mach number which accelerated above Mach 1. As expected, the freestream Mach number (shown in blue in Figure 12, right panel) was much higher than base vent flow velocities. The choked flow regime had base flow gases accelerating at an average of Mach 1. This average base flow velocity was calculated between the RS-25 engines near the periphery of the base heat shield (usually termed as the vent exit regions) where sensors were collocated. Figure 12 shows that the flight regime exhibited approximately two orders of magnitude higher base vent flow velocities than during the static Green Run test. The region highlighted in red in Figure 12 denotes the base heat shield P50 cork combustion regime during Artemis I²⁻³. During the Green Run, depending on the base location, deflagration of the heat shield was observed from T+100 sec to RS-25 engine shutdown (\sim T+500 sec)¹.

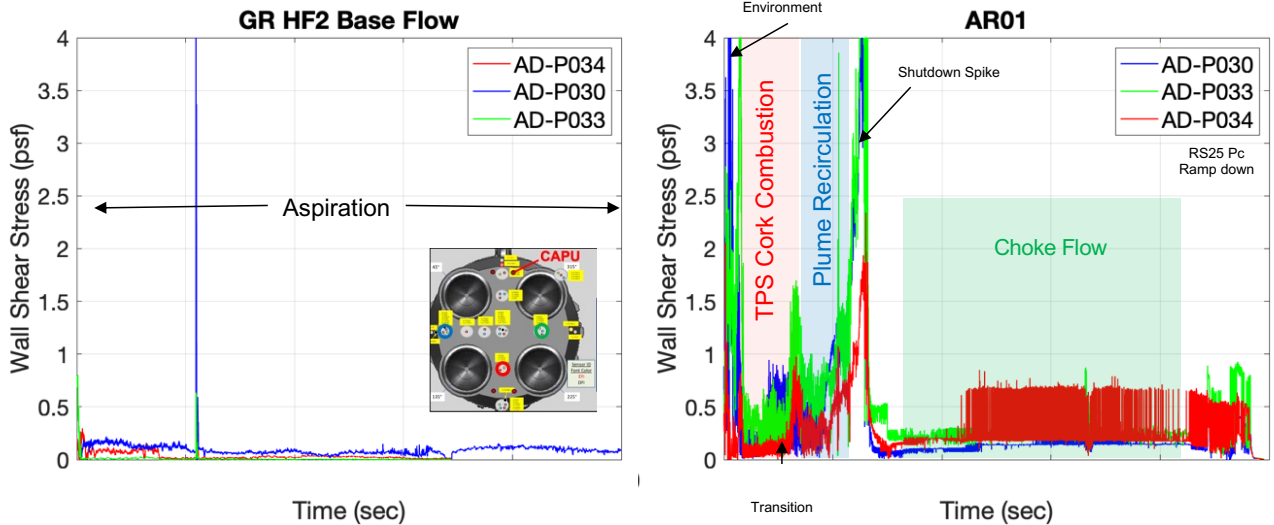
Figure 13. Base wall shear stress vs. time at various locations on the Core Stage base heat shield during Green Run Hot-Fire 2 (left) and Artemis I flight (right).

Similar to comparisons with base vent flow Mach number, Figure 13 shows the base heat shield wall shear stress vs. time between the Green Run static fire test and Artemis I flight at the three DFI island locations¹⁻³. The base flight shear stress loads are broken into three regimes: (1) cork combustion; (2) peak recirculation; (3) choke flow. More than two-orders of magnitude higher average shear stress were observed during flight as compared to the static-fire test series. This was because the convective base heating and flow velocities were substantially higher for flight than Green Run. This large difference in shear stress for flight has an impact on TPS recession and performance and provided rationale to investigate cork TPS response to flight environments.

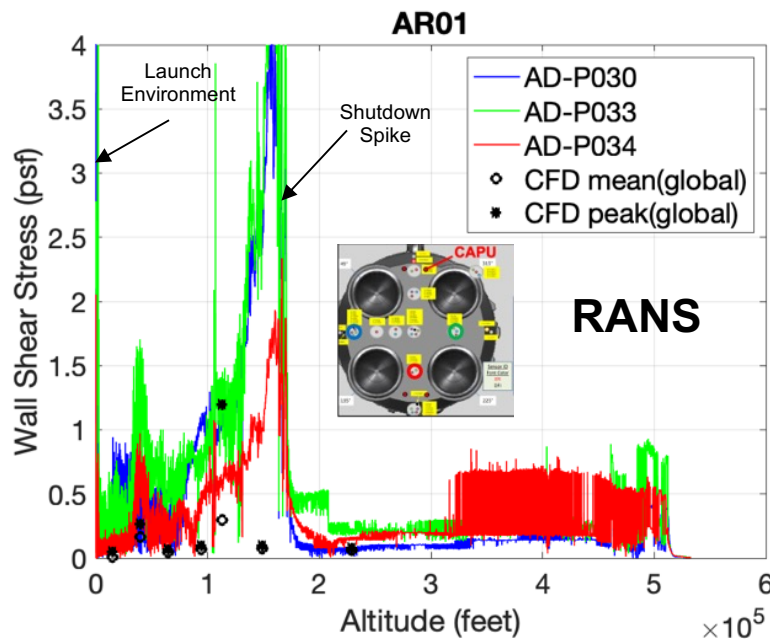
Figure 15. Base flow wall shear stress vs. altitude at various locations on the Core Stage base heat shield during Artemis I flight. Flight data derived estimates compared to CFD RANS solutions.

Figure 15 shows comparisons between flight data derived methodologies of wall shear stress with computational fluid dynamics (CFD) simulations (shown as black and white dots in the figure) as a function of altitude. These steady-state simulations were conducted using smooth-wall Reynolds-Average Navier Stokes (RANS) turbulence modeling. Two CFD data points were provided: (1) mean wall shear distribution in the general DFI zonal location shown as black dots; (2) peak wall shear stress values in the general DFI zonal location shown as white dots. There was generally good agreement between the CFD simulations and the flight data-derived calculations. CFD simulations slightly underpredicted the flight data derived calculations during aspiration, P50 cork combustion and recirculation regimes, but showed very good agreement during the choked flow regime. It should be noted that a rough TPS wall caused by ablation will induce higher shear stress. It can be seen from both CFD and flight data derived calculations that the flight base wall shear stress could vary between 0.2 psf and 1.5 psf across the full flight regime. This was an important metric in conducting a ground test that investigated the effect of char recession due to flight shear environments. All the RANS CFD calculations were performed by M. Elizabeth Arceneaux and Dr. Francisco Canabal of the MSFC Aerosciences Branch.

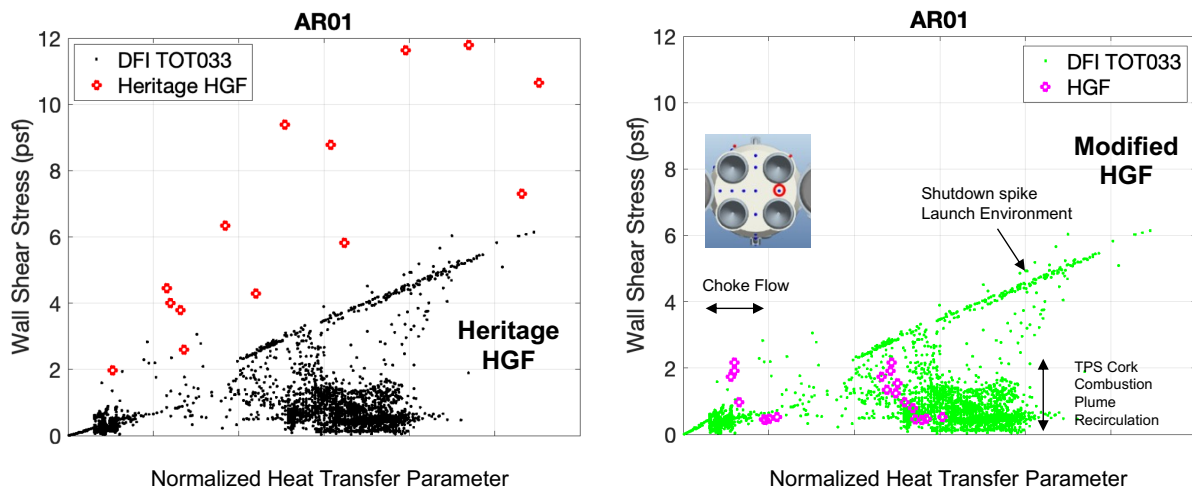
Figure 18. Comparisons of base flow wall shear stress vs. normalized heat transfer parameter at the RSRB facing Core Stage base heat shield during Artemis I flight with heritage operations of the Hot Gas Facility (left) and modified operation of the Hot Gas Facility (right).

The heritage HGF operation produced Mach 4 high enthalpy flow conditions, resulting in shear stress measurements significantly higher than the estimated flight-representative values developed in Section III A (Figure 18). Figure 18 (left panel) shows a comparison of heritage HGF wall shear stress measurement (shown as red dots) with flight data derived calculations (shown as small black dots) for the whole Artemis I SLS flight regime. It can be seen that the wall shear stress measurements in the heritage HGF operational mode were significantly higher than the predicted values from flight. The high shear stresses likely lead to virgin and cork recession rates which are higher than what would be obtained using more flight-representative values. This is prudent for a conservative TPS design methodology but makes it challenging to assess the true performance of an ablator in a flight environment. Hence, a

modified operation of the HGF was used to assess char recession in a shear and heating environments more like flight. As can be seen in Figure 18 (right panel), the modified HGF shear stress and normalized heat transfer parameter measurements (magenta dots) were more in-family with flight environments (small green dots). The normalized heat transfer parameter is defined as a ratio of the total heat flux to a reference peak total heat flux for that location. This enabled assessment of the char recession effects to flight-like environments. This was the first time this mode of HGF operation was done to assess TPS char/virgin response.

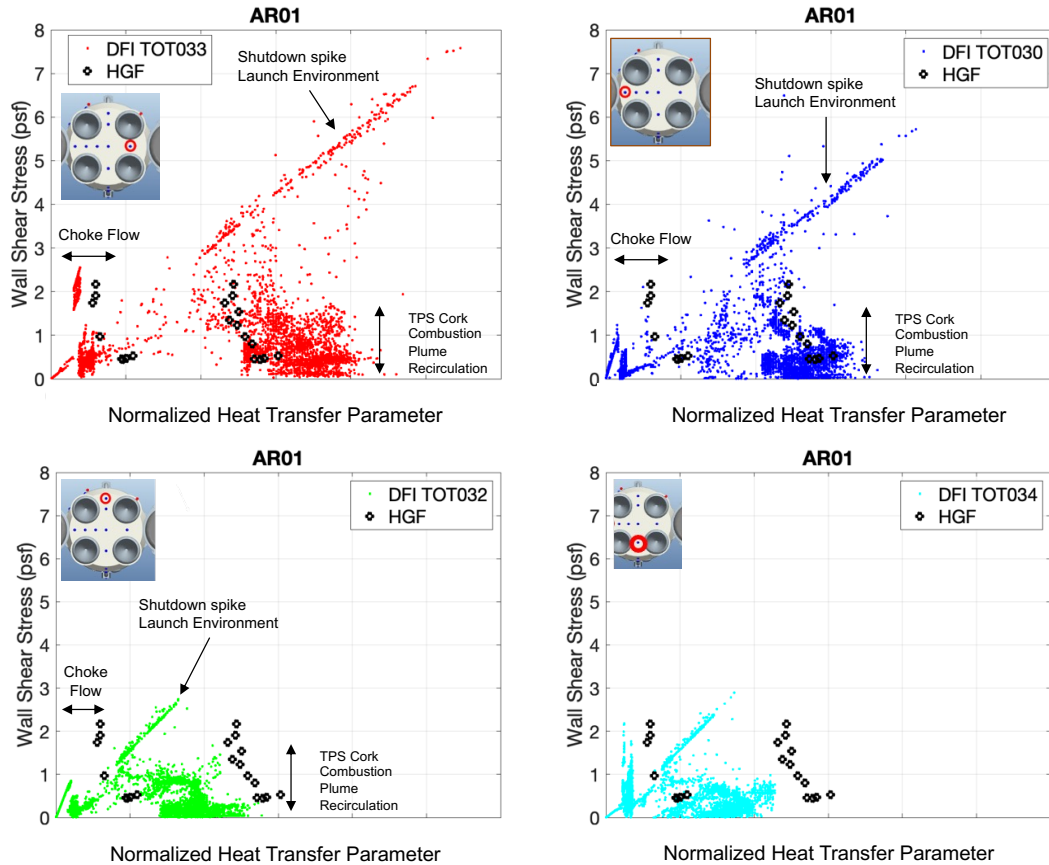
Figure 19. Comparisons of base flow wall shear stress vs. normalized heat transfer parameter at the various locations on Core Stage base heat shield during Artemis I flight with modified operation of the HGF. Right SRB facing (top-left); LSRB facing (top-right); between E1 and E4 near the CAPUs (bottom-left) and between E2 and E2 near CAPUs (bottom-right).

Figure 19 shows the comparisons of the modified HGF shear and normalized heat transfer parameter with Artemis I flight environments at four DFI islands on the base heat shield. The four islands were located towards the periphery of the base heat shield and between the RS-25 engines¹⁻³. Once again, good agreement between the modified HGF environments with flight environments was observed. This was the main goal behind the modified HGF testing. The total heating from the modified HGF was established with a combination of both radiant and convective heating contributions. It should be noted that majority of the heating to the sample was generated from a radiant arc lamp for the ground test. Both radiant and convective heating were major contributors of surface heat transfer during flight.

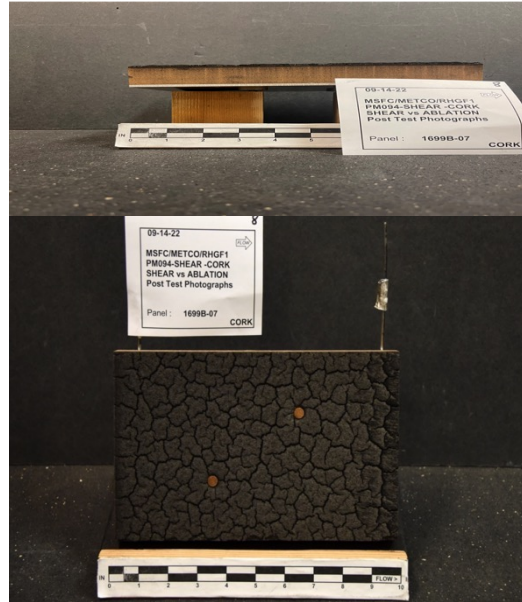
Average Total Heating = 2.9 BFS
Average Shear Stress = 1.7 psf

Figure 22. HGF Run 9: Pre-HGF test TPS sample top-down and side images (left) and post-HGF test TPS sample images (right).

A subset of pre-HGF and post-HGF TPS panel imagery data is shown below in Figures 20 – 22. The rest of the TPS panel imagery data sets are shown in Appendix A (Figures A2 and A3). The subset image data set show the gross differences of the TPS response due to changes in the heating and shear environments. An external side and top-down views of the TPS panels are shown in the figures. All pre-HGF TPS panels showed burning effects with a developed thick char layer from TVC testing⁹ and Figure 20 shows the Hypalon paint burned and shredded apart with the char layer exposed. The char formed black honeycomb cells at the top surface layer based on the top-down view images. One notable observation between Figure 20 and Figure 22 showed that the high heating and shear environments substantially reduced the honeycomb cell diameter. This reduction in the char honeycomb cell diameter topology was a stronger function of the heating than shear stress based on findings from Figure 22 and Figure A2 (Run 2). The reduced char honeycomb cell observation (Figure 20) showed a smoother feature than the large char honeycomb cell diameter topology (Figure 22). Qualitatively it seemed that the shear stress in a high thermal environment uniformly eroded the char layer, and this was further supported by imagery data within Appendix A. Since one of the main objectives of this test series was to look at various sensitivities for TPS response, it was found that a threshold in TPS erosion/ablation was noted for Run 7 (Figure 21). The post-test TPS image showed regions of minimal char erosion/ablation and other areas of substantial erosion. Higher char erosion was noted along the leading edge of the TPS cork panel. There was no side view visible imagery data collected for Run 9 (Figure 22).

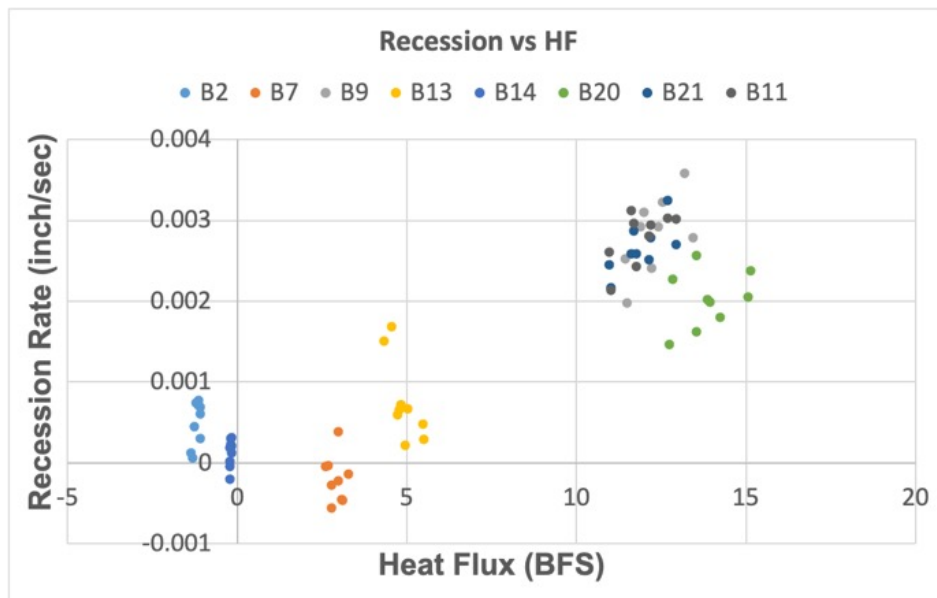
Figure 26. Char recession rate vs. applied heat flux.

Figure 26 shows char recession rate measurements as a function of total heat flux measurements for 8 charred cork samples. It should be noted that B20, B21 and B22 (not shown) were Hypalon-coated P50 cork char TPS panels and the rest were with bare P50 cork. The char recession rate was calculated using X-Ray CT measurements of the top-surface of the TPS panel between pre-HGF and post-HGF testing. The char recession measurements were made at all the calorimeter and shear stress gauge locations that were instrumented on the calibration plate. Since some of the calorimeter and shear stress gauges were close to each other, the shear stress and total heating rate values were inferred based on proximity. The total char recession at each of these sensor locations due to HGF testing was divided by the total test duration to estimate the recession rates. Figure 26 shows a linear trend in char recession rate with increasing total heat flux. There was data scatter, but a qualitative linear trend could be assessed from this plot. There appeared to be a heating threshold point of about 4 BFS where the cork char recession rates began to linearly increase with heat rate and below this threshold the recession rate was approximately zero.

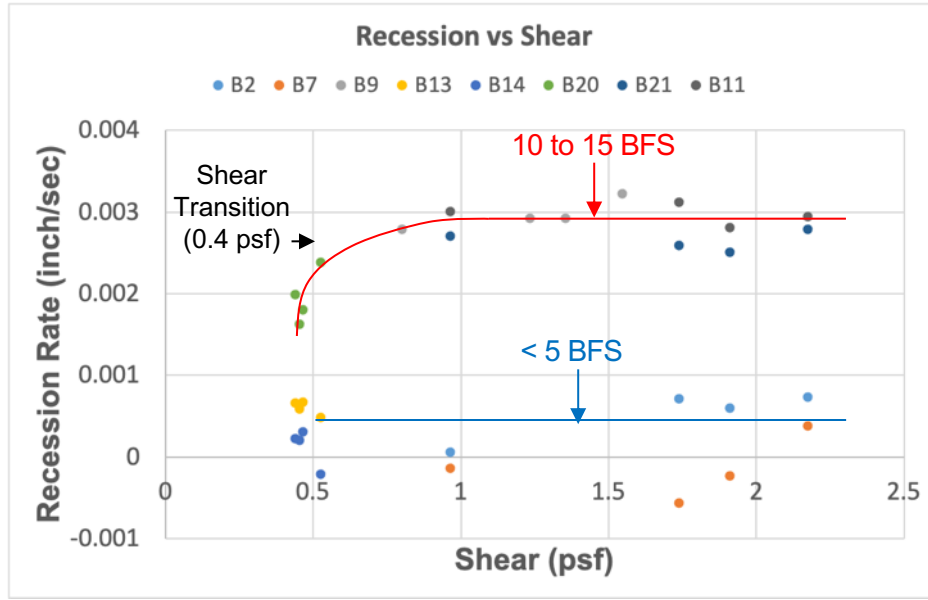
Figure 27. Char recession rate vs. applied wall shear stress.

Figure 27 shows char recession rate measurements as a function of wall shear stress measurements for 8 charred cork samples. It was seen that the char recession rate vs. shear stress curves had a bimodal distribution where there was one trend for total heating rates greater than 10 BFS and another distribution below 5 BFS. The recession rate for total heating trends above 10 BFS showed an increase in recession rates above a shear stress of 0.4 psf which then approached an asymptote above a shear stress of 1 psf (red curve in Figure 27). This asymptotic behavior was expected since there was only a finite char layer developed during the TVC cork combustion process which was then stripped away by the high shear and heating environments from HGF testing. Based on the limited dataset available, the char recession rate transition or threshold point occurred at a shear stress of 0.4 psf at high heating environments. Low heating environments less than 5 BFS led to a low constant char recession rate over large range in shear stress (blue curve in Figure 27).

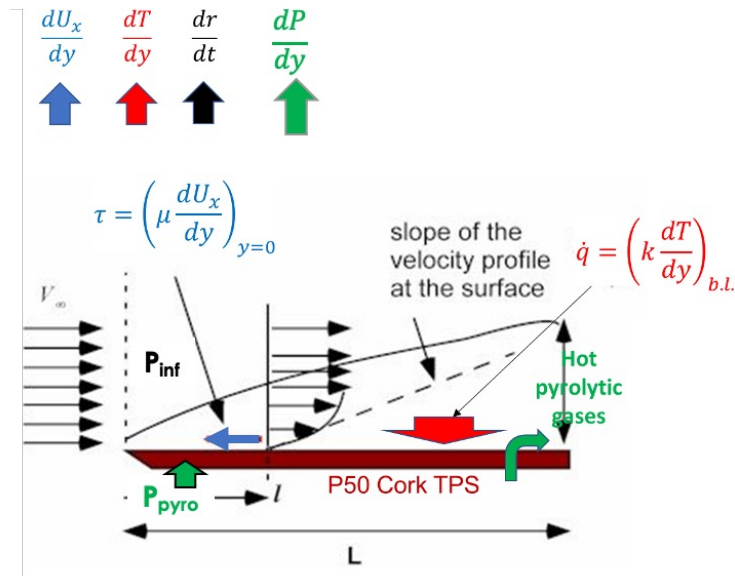
Figure 28. Schematic of the flow physics observed with a TPS ablator.

Based on the recession/erosion characteristics of the cork char observed from Figures 26 - 27, a hypothesis on the high char erosion/recession rates were postulated using the schematic shown in Figure 28. This schematic shows the interplay of heating, shear and pressure within the TPS material and freestream. As noted in Figure 26, it was seen that the heating rates had a first order impact on char recession. There was a shear stress threshold which led to a shear load which could mechanically erode the char layer as shown in Figure 27. Mechanical erosion of the char layer was clearly observed by the X-Ray CT scans shown in Figure 29 and Appendix A. Heating rates of greater than 10 BFS and above the shear stress threshold led to almost full erosion of the char layer. X-Ray CT at these heating rates, but shear stress on the order of 1 psf resulted in the entire char layer being stripped away with a very small rind of char layer formed (Figure A1). At very low heat rates and high shear stress, the cork char structural integrity was maintained, and minimal erosion was observed from both Figures 26, 27 and 29. The theory is that as the pyrolytic gases were being formed due to external heating and the TPS pore pressure increased relative to its' surface pressure (dP/dy increases), this induced a normal force load on the char layer from the bottom of the char. This pressure gradient further increased as the TPS surface pressure decreased as observed during ascent flight. The TPS surface pressure from HGF was on the order of 2.2 psia for the Mach 0.1 test runs and 4.9 psia for the Mach 0.6 to Mach 0.8 test runs based on the calibration plate measurements. This normal force load outward on the char enabled a small shear load to easily liberate and erode the char layer. Without this internal normal force load induced by surface heating, shear loads above a threshold were not able to strip the char layer from the pyrolytic zone. This suggested that both total heating rates, shear stress and the surface pressure were drivers in mechanical shear erosion of the char layer.

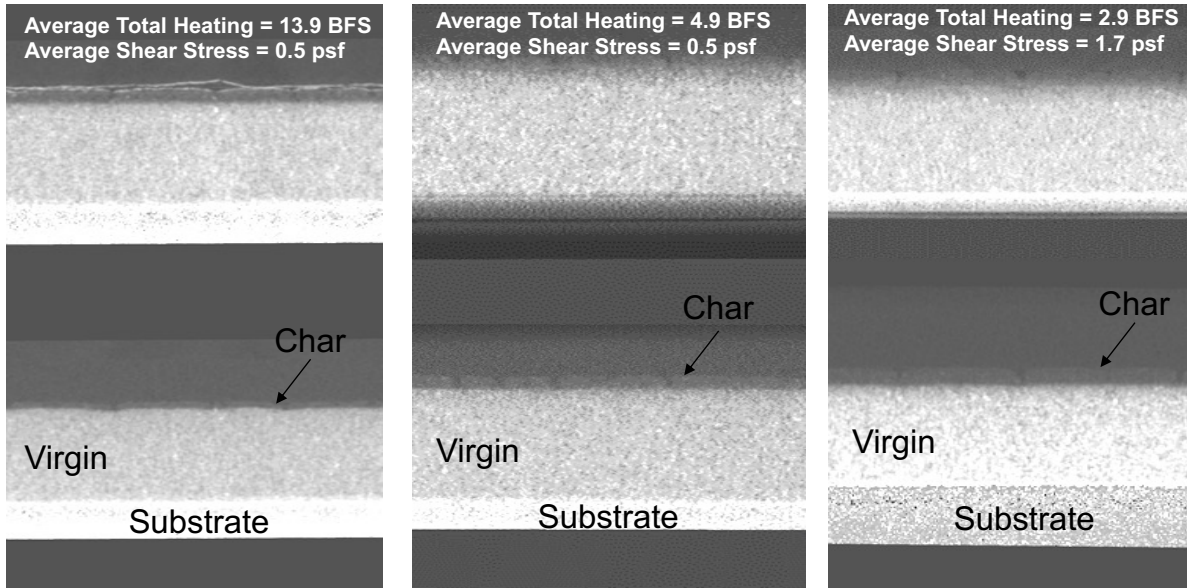
Figure 29. X-Ray CT images of the effects of applied heat flux and shear stress to the P50 cork char and virgin layers. Pre-HGF test scans (top) and post-HGF test scans (bottom).

It should be noted that the conservative recession rate was calculated by recording the char recession measurements with the addition of the char layer. The char layer and the pyrolytic zonal layer (where easily defined) were measured by X-Ray CT imaging analysis at each calibration sensor location. This thickness was then divided by the total test duration to obtain the conservative recession rate. Conservative recession rate was determined by stripping the TPS sample from the pre-HGF testing thickness down to just the post-HGF testing virgin layer. The modified HGF char recession test results were compared to the heritage HGF results for virgin P50 cork. The conservative recession rate was applied to both sets of data from the virgin cork (heritage source) and cork char (this study) samples. The conservative recession rates for cork char were considerably higher than for virgin cork for total heating rates and wall shear stress greater than 4 BFS and 0.4 psf, respectively. This suggested that the cork char layer was quite friable to flight environments when the threshold was exceeded and would ablate/erode readily. Understanding the structural integrity of the char layer was critical in estimating TPS performance.

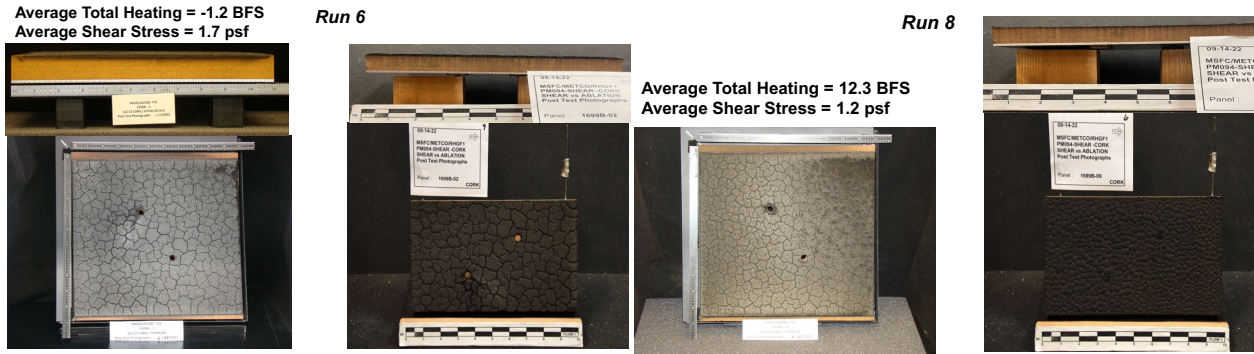
Figure A3. HGF Runs 6 and 8: Pre-HGF test TPS sample top-down and side images (left) and post-HGF test TPS sample images.

Figure A1 shows the X-Ray CT scan of one of the highest applied heating rates and shear stress on the TPS sample. This led to the uniform mechanical erosion of the entire char layer, leaving a cork char rind of minute thickness on the surface. Figures A2 and A3 show visible imagery datasets of the side and top-down views of the pre-HGF and post-HGF test TPS panels for Runs 1 – 3, 5 – 6 and 8.
