NASA/CR-20250002768

Hybrid Thermally Efficient Core (HyTEC) High Temperature CMC Vanes Final Report

*John Shaw, Evan Benjamin Callaway, and David Litton
Pratt & Whitney, East Hartford, Connecticut*

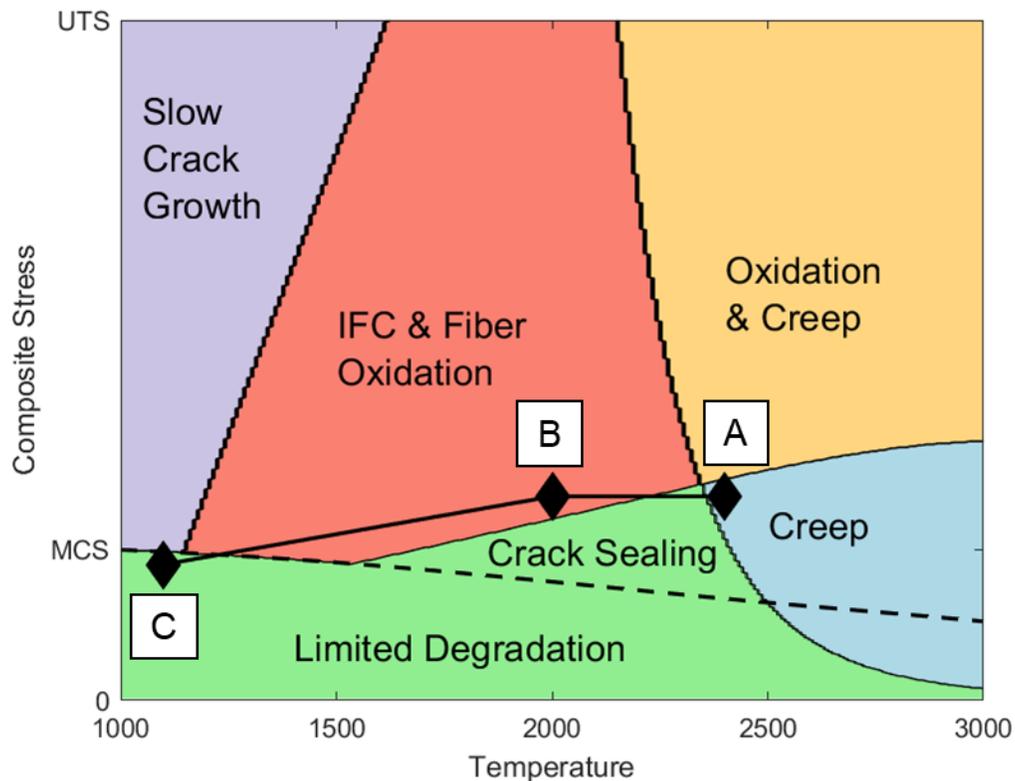
Figure 1. Degradation mechanism map for CMCs at high temperature. Overlaid lines indicate approximate stresses and temperatures of (A) takeoff, (B) cruise, and (C) idle conditions

SiC/SiC CMCs are commonly accepted to have a pecking regime which relates to relative rates of oxidation of their constituent phases. At high temperatures (>2200°F) the oxidation of SiC is relatively rapid, allowing any cracks in the matrix – so long as they are sufficiently small – to seal with oxidation product before the bulk of the substrate is compromised. However, creep becomes a concern for prolonged exposure at elevated temperatures. At intermediate temperatures (~1200°F-2000°F) oxidation of SiC is sluggish, allowing oxygen ingress through open cracks to attack a C- or BN-based interface coating and compromise the strength of the composite. At lower temperatures oxidation of all phases is sluggish and no time-dependent effect on properties is expected. The presence and size of matrix cracks, controlled by the in-plane stress on the composite, also controls the rate of oxidation – at sufficiently low applied stress, no matrix cracks should be present, and no oxidative degradation is expected to occur. These regimes of material behavior are summarized in Figure 1.

of these oxidation mechanisms. The short, high temperature exposures may be sufficient to seal matrix cracks and prevent pesting during the long, intermediate temperature exposures. This regime is labeled as “Matrix Crack Sealing” in Figure 1.

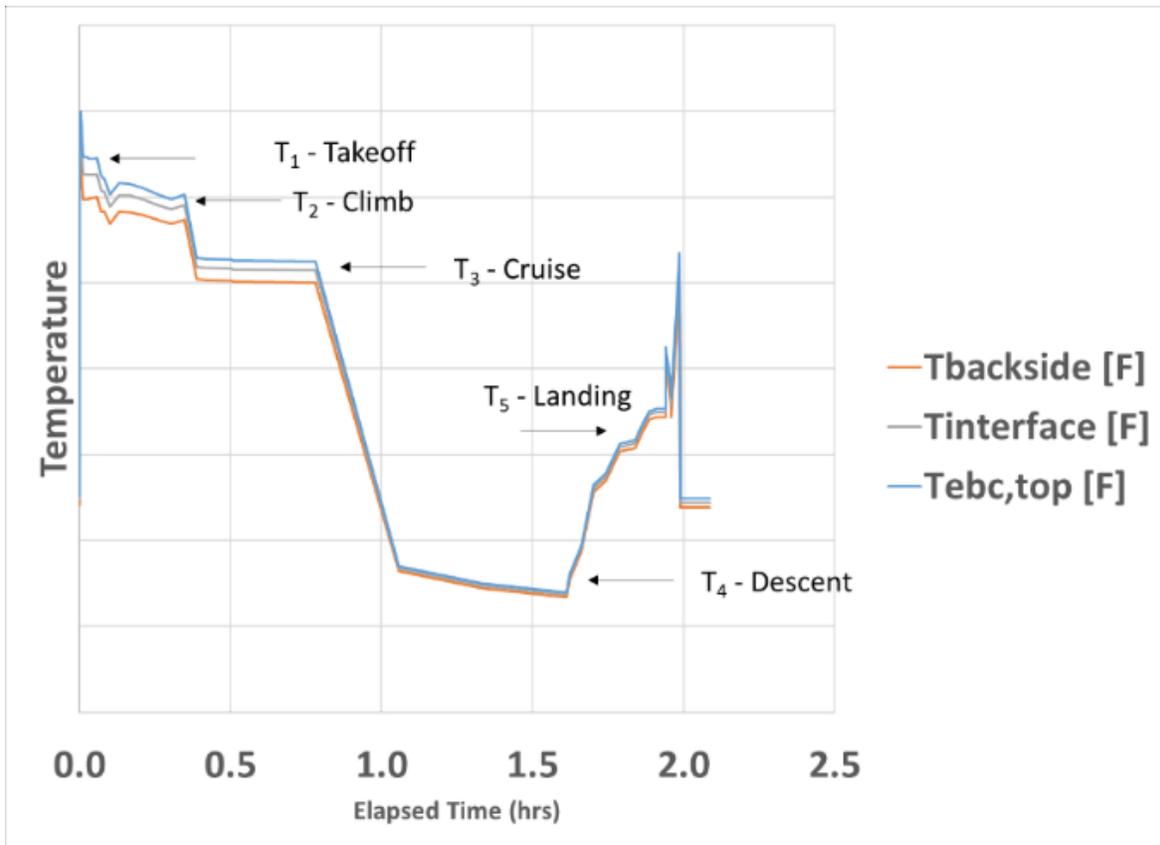
Figure 2. Notional commercial mission cycle and corresponding material temperatures for an uncooled CMC high-pressure turbine vane

A model was built to simulate a commercial mission cycle of an uncooled CMC high-pressure turbine vane to assess whether and where the above mechanisms were likely to occur. The relative temperatures at the Environmental Barrier Coating (EBC) surface, the EBC/CMC interface, and the backside of CMC as a function of elapsed time in one mission are shown in Figure 2. The highest temperatures occur over the first 5 minutes during takeoff. Temperature then decreases somewhat for 15 minutes of climb before decreasing to cruise temperatures for roughly 30 minutes. Temperatures then drop off sharply for a slow descent for roughly an hour, then rise slowly for maneuvering for landing. Short term temperature spikes occur at the end of the mission when thrust reversing is deployed.

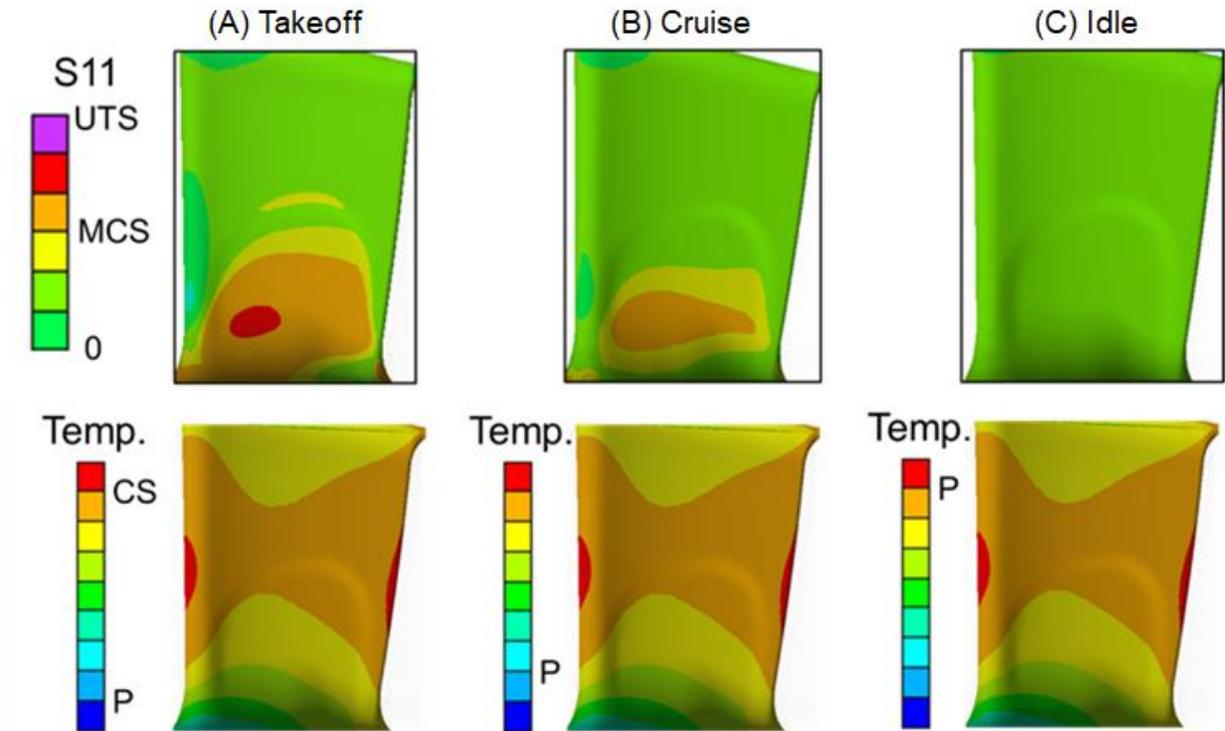
Figure 3. Predicted stresses and temperatures on the pressure side cavity wall at (A) takeoff, (B) cruise, and (C) idle. The colormap for stress (S11) is normalized by the matrix cracking stress (MCS) and ultimate tensile strength (UTS) at room temperature. The colormap for temperature is normalized by the lower bound onset of peeling (P) and the onset of crack sealing (CS) of the matrix.

In conjunction with thermal data, a preliminary structural analysis was performed on a vane for the takeoff, cruise, and idle thermal boundary conditions. This is the second input in an assessment of the degradation behavior of a component. Stress and temperature maps are shown in Figure 3. This analysis identifies regions of the interior cavity of the vane that would be above the matrix cracking stress during cruise and takeoff conditions at surface temperatures that straddle the pesting and crack sealing temperature regimes. Furthermore, since this interior region of the vane is exposed to cooling circuit air and not gas path air, the analysis and testing are simplified – water vapor content is lower, and CMAS would not be present. The stress, temperature, and environmental conditions of this region form the basis of the test campaign described in Section 3.

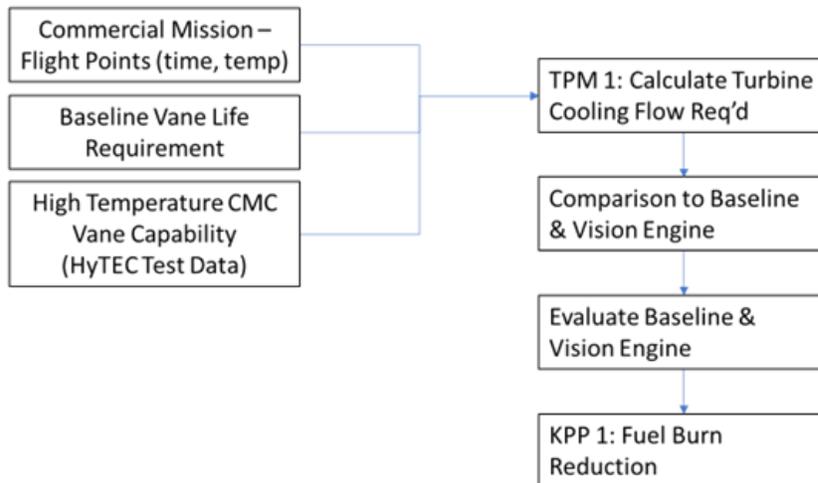
Figure 4. KPP #1 relationship to TPM #1.

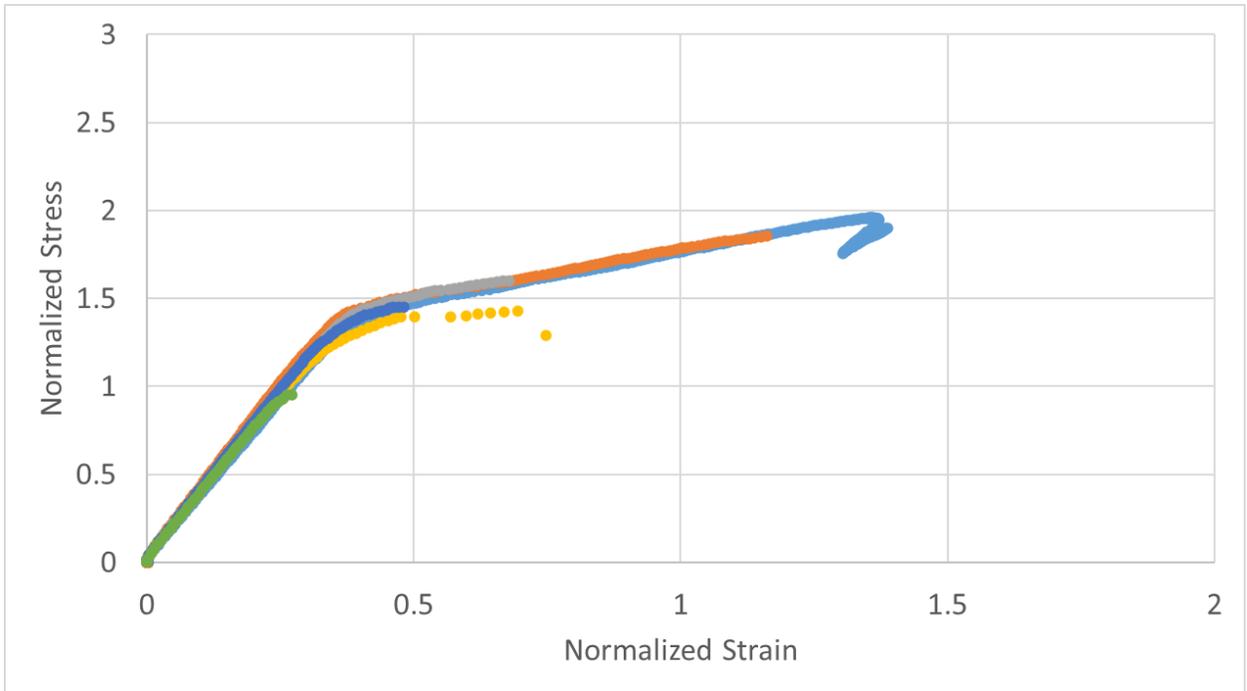
Figure 8. Residual tensile behavior of specimens exposed for 100 hours at load P1 and temperature T3

The testing described in Table 1 was completed successfully with all specimens surviving the target exposure time. Specimens exposed to T3 were expected to see peeling conditions, with degradation of material properties over the duration of the exposure. Figures 8 and 9 show the residual tensile properties at load P1 and temperature T3 for one hundred (100) hours and five hundred (500) hours, respectively. In both cases the material retains composite behavior after exposure, but strain to failure falls with increasing exposure time.

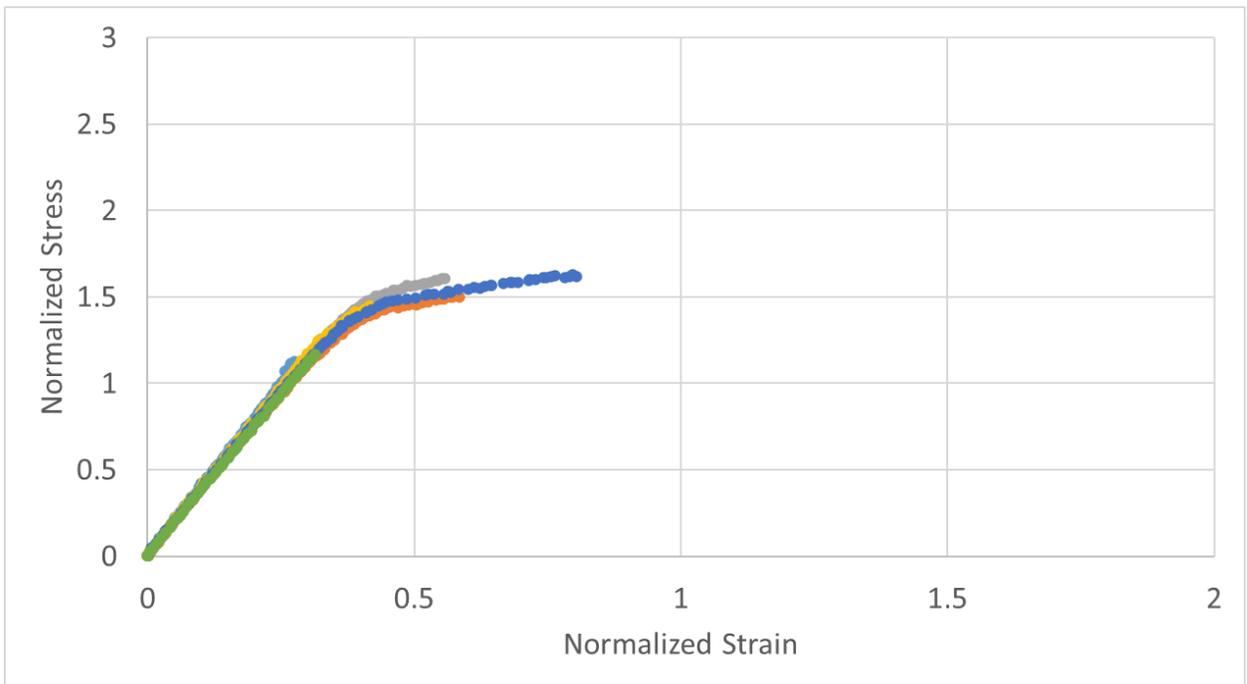
Figure 9. Residual tensile behavior of specimens exposed for 500 hours at load P1 and T3.

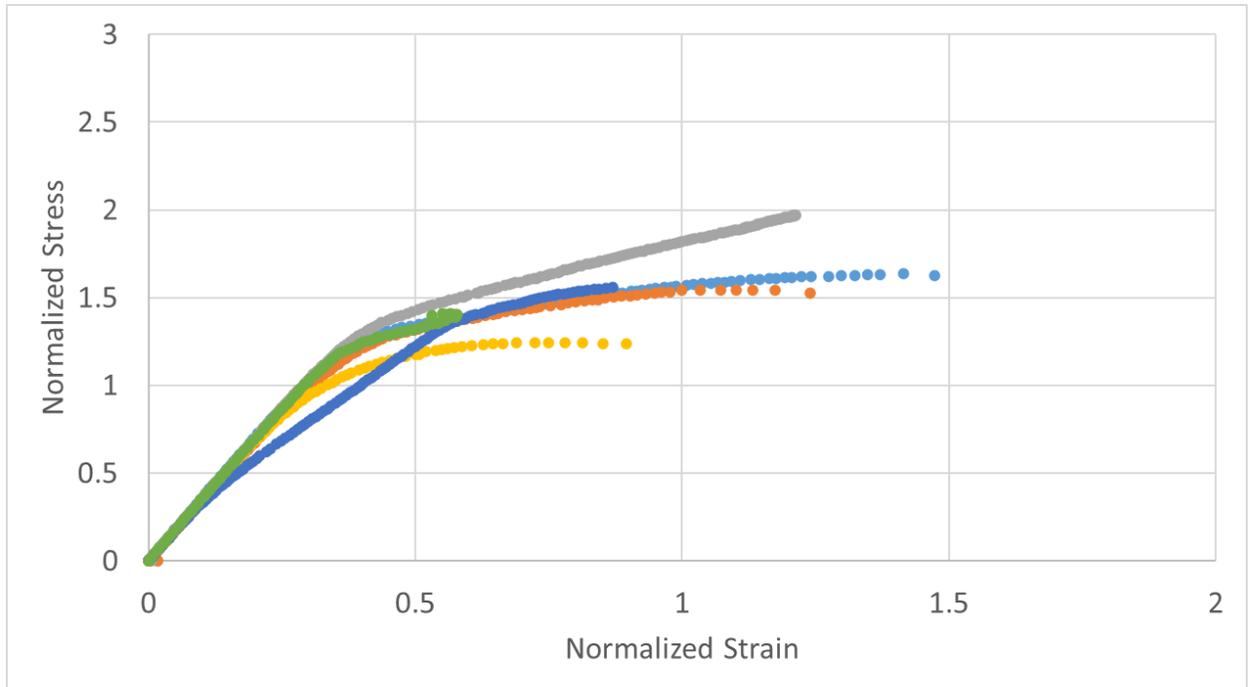
Figure 10. Residual tensile behavior of specimens exposed for 100 hours at load P1 and temperature T1.

Specimens exposed to T1 at load P1 are expected to be in a regime where matrix cracks may seal with oxide. Figure 10 shows the post-exposure tensile behavior of specimens exposed for 100 hours. The strain to failure of these specimens exceeds those of specimens exposed at T3, consistent with expectations.

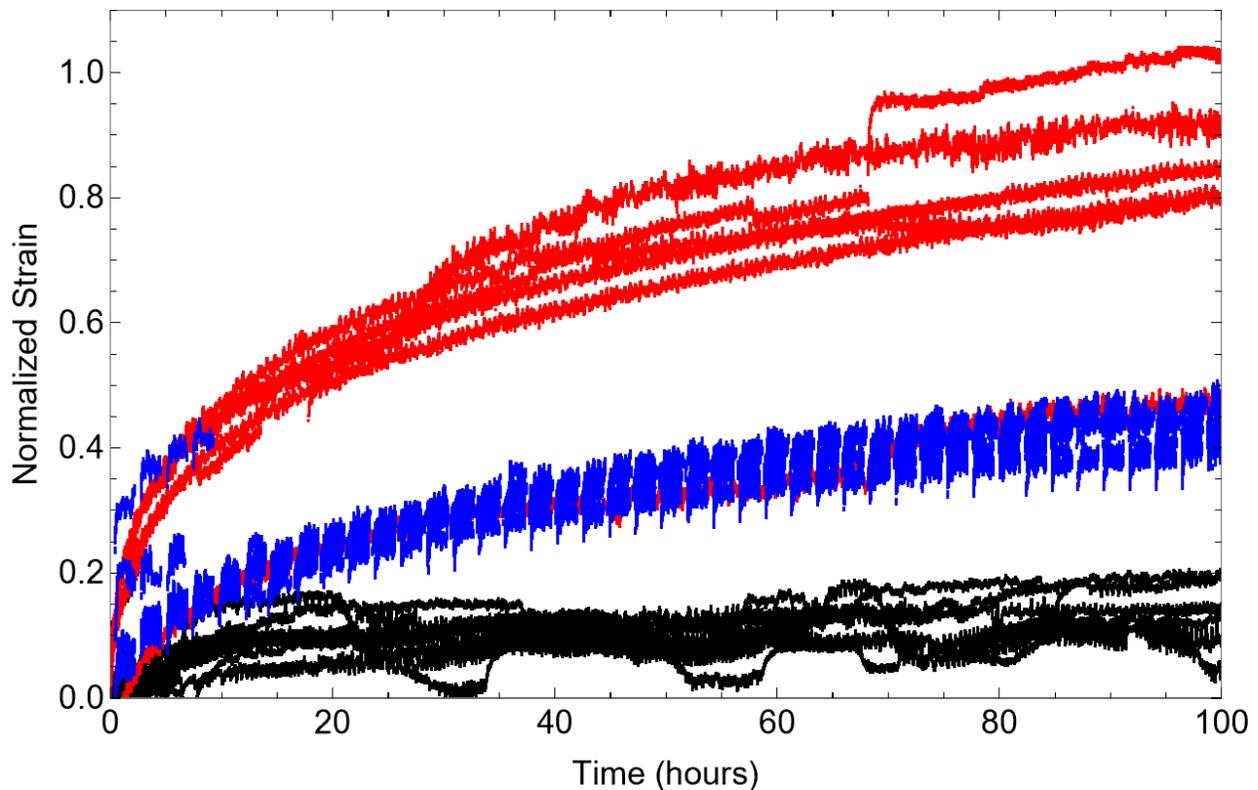
Figure 11. Creep strain for 100 hours isostatic (P1) exposures at: T3 (black); T1 (red); and cyclic conditions (blue). Note that mechanical strain from loading, and thermal strain from heating, are excluded from this plot. Additionally, strain is only plotted for the T3 dwell portions of the cyclic exposure.

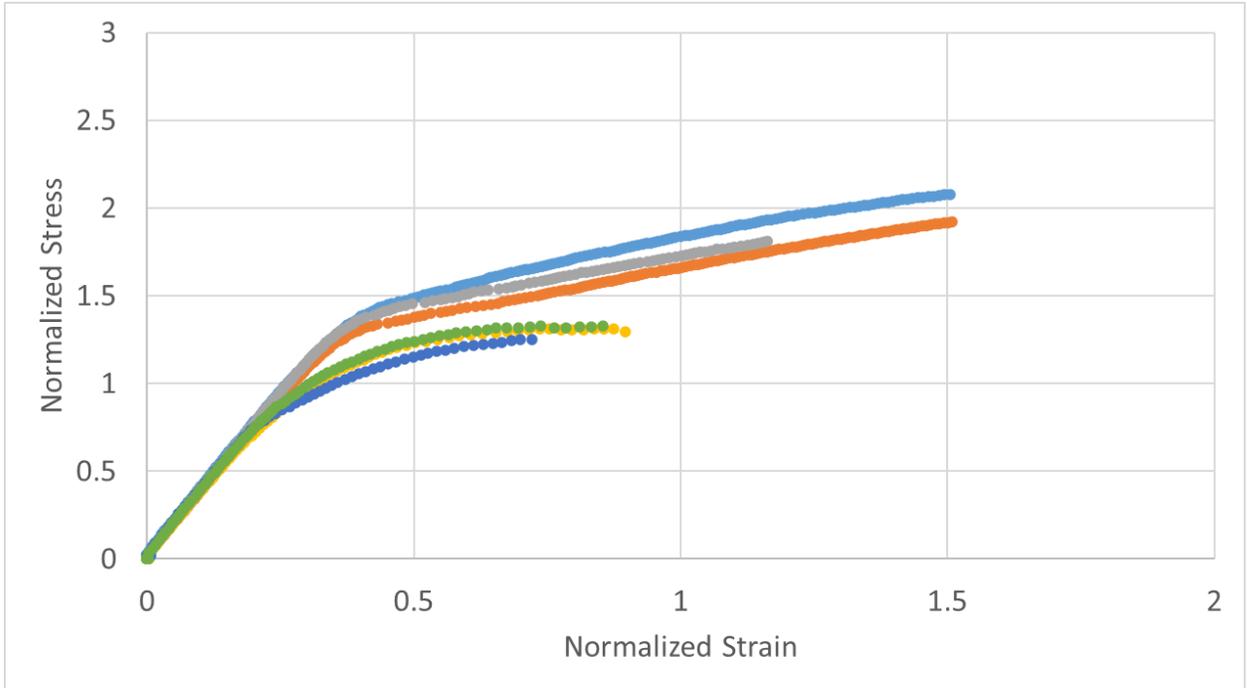
Figure 12. Residual tensile behavior of specimens exposed for 43 cycles at load P1 and cyclic thermal loading at T1 and T3.

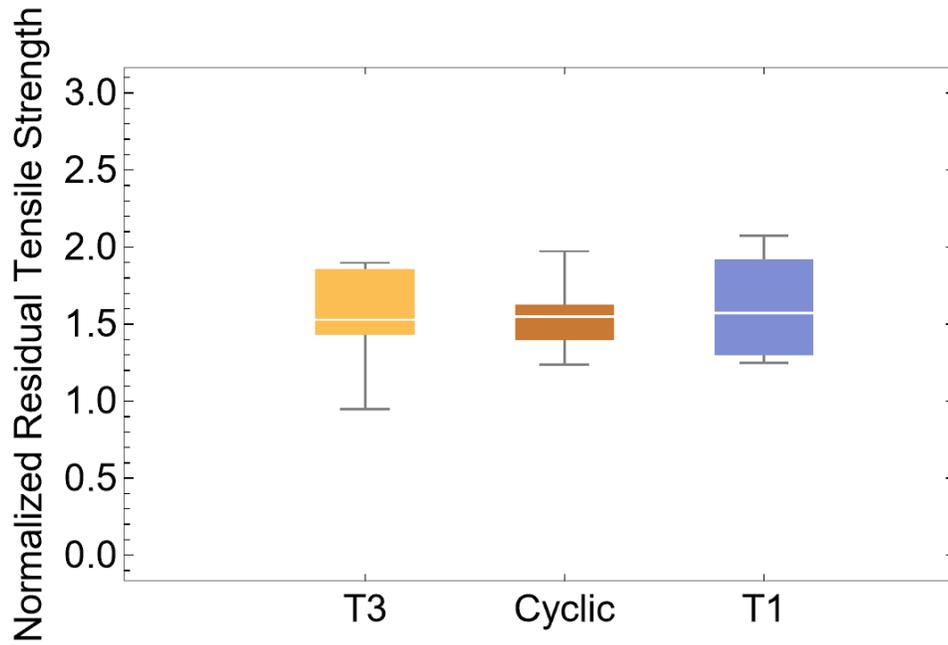
Figure 13. Residual tensile strength for three ~100 hour creep exposures: T3 isothermal; T1 isothermal; and thermal cyclic.

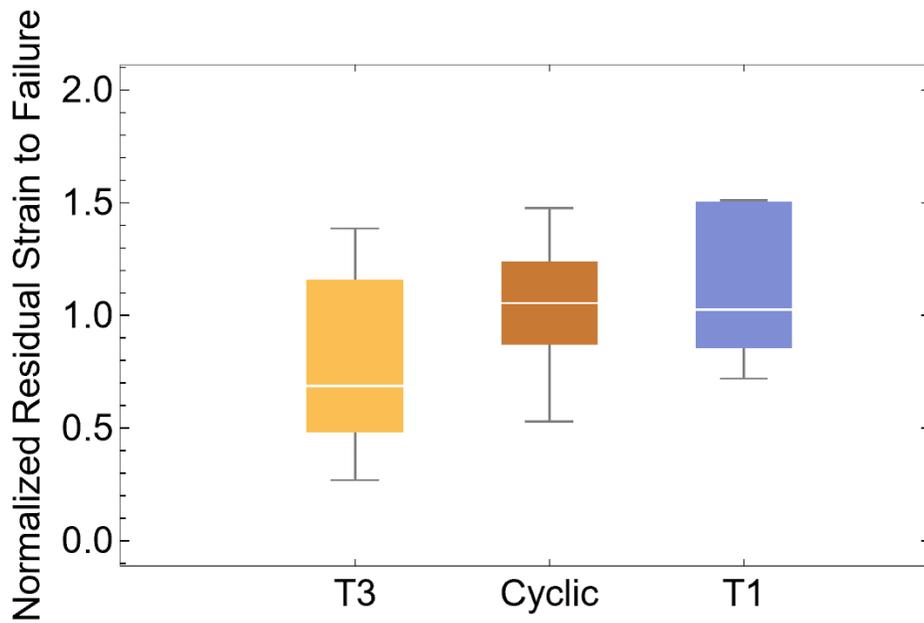
Figure 14. Residual strain to failure for three ~100 hour creep exposures: T3 isothermal; and thermal cyclic, and T1 isothermal.

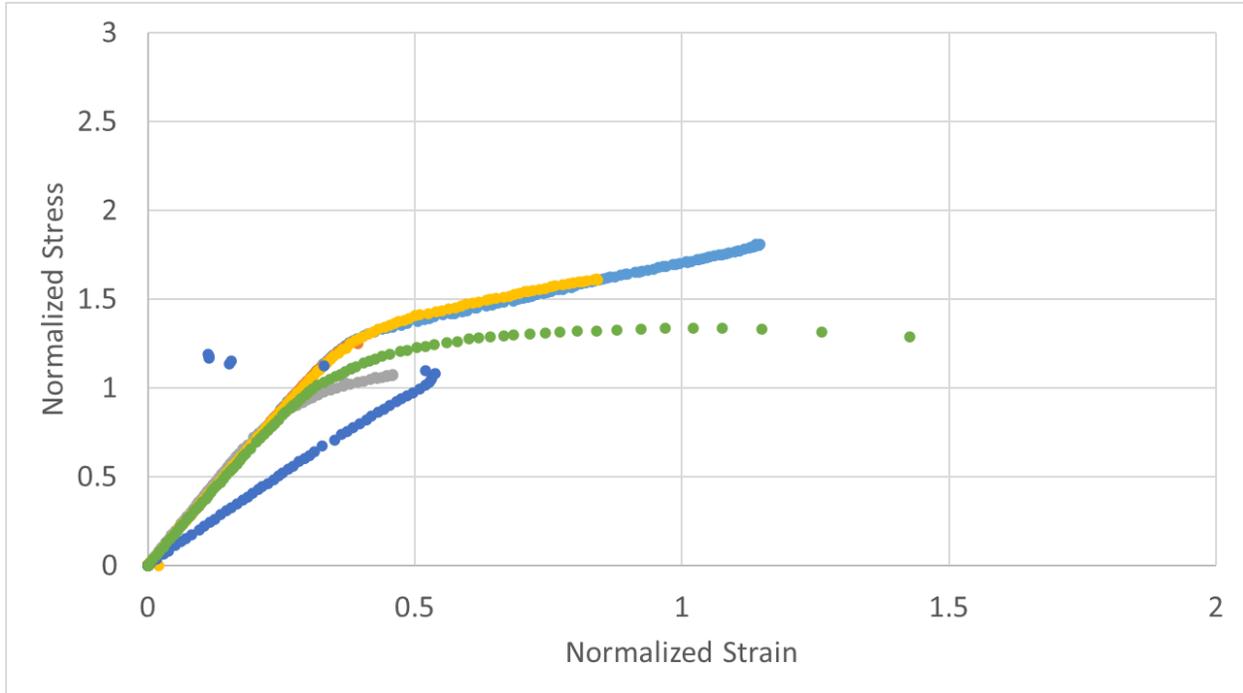
Figure 15. Residual tensile behavior of specimens exposed for two hundred fourteen (214) cycles at load P1 and cyclic thermal loading at T1 and T3. (Note: Failure strain from anomalous specimen not included in population summaries)

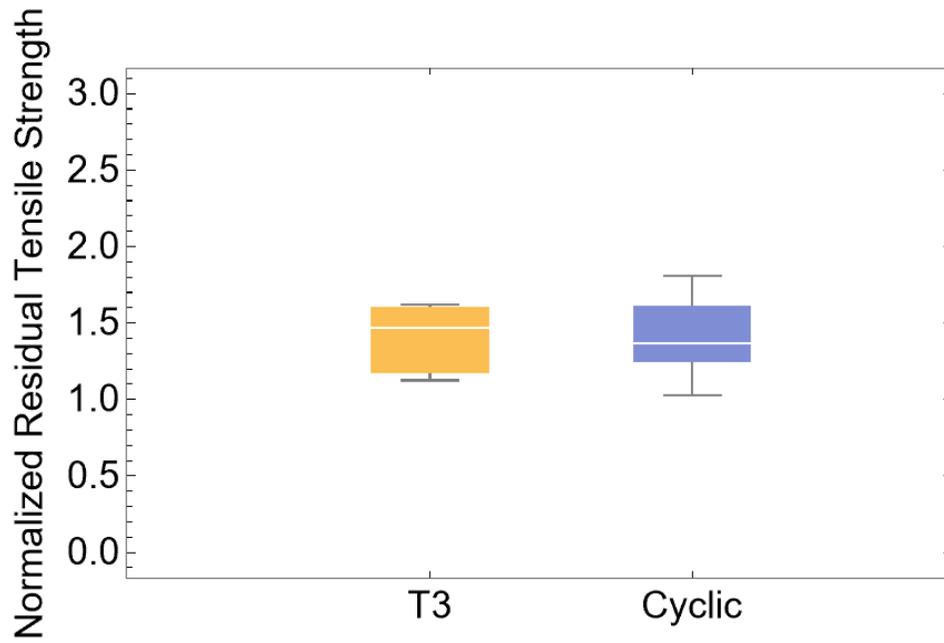
Figure 16. Residual tensile strength of specimens exposed to: 500h isothermal exposure at T3 and P1; and specimens exposed to thermal cyclic loading for two hundred fourteen (214) cycles at load P1.

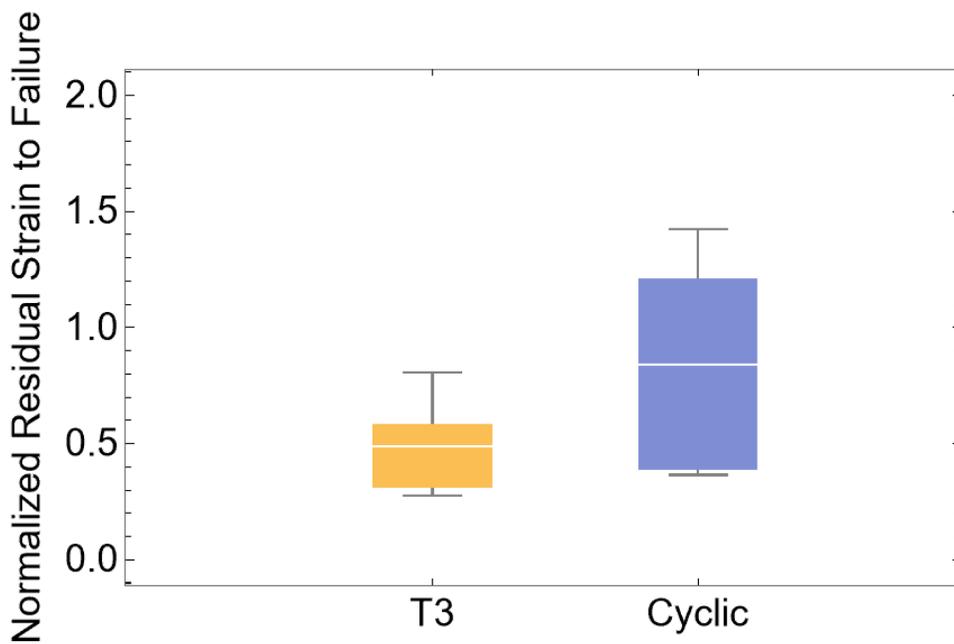
Figure 17. Residual strain to failure of specimens exposed to: 500h isothermal exposure at temperature T3 and load P1; and specimens exposed to thermal cyclic loading for two hundred fourteen (214) cycles at load P1.

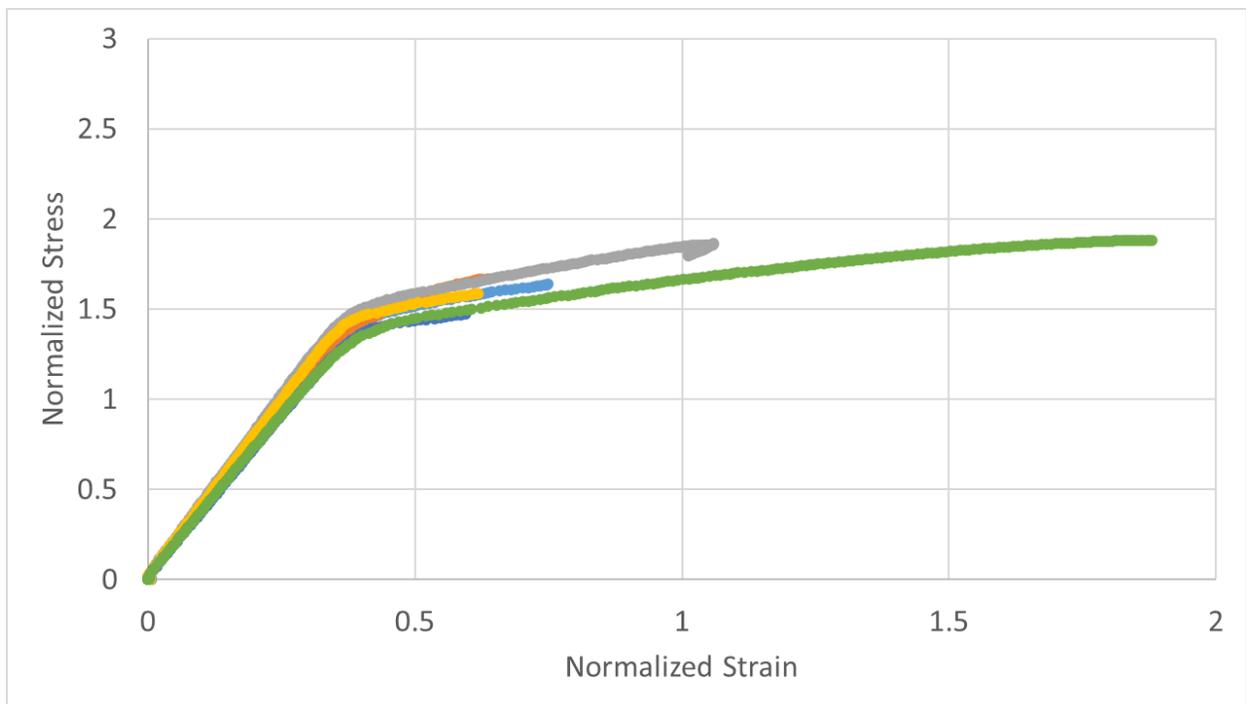
Figure 18. Residual tensile behavior of specimens exposed for forty-three (43) cycles of fatigue loading where the temperature was increased before load

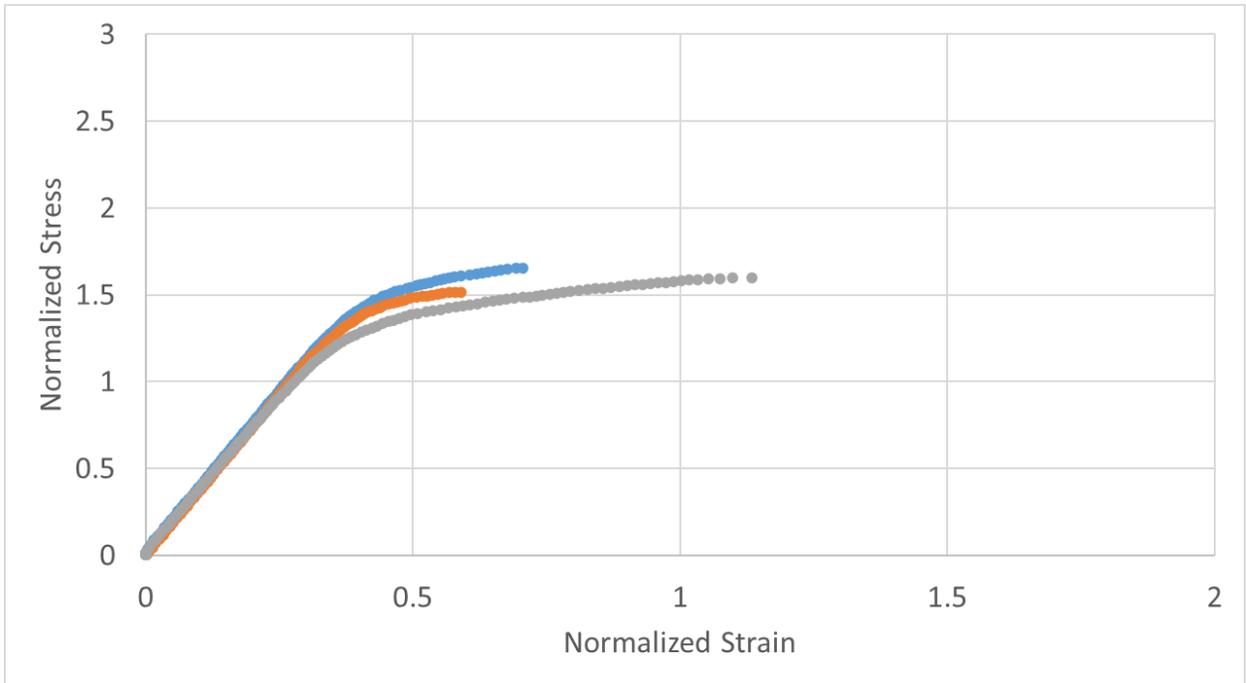
Figure 19. Residual tensile behavior of specimens exposed for forty-three (43) cycles of fatigue loading where the load was increased before temperature. Note that only three of six specimens survived the exposure condition.

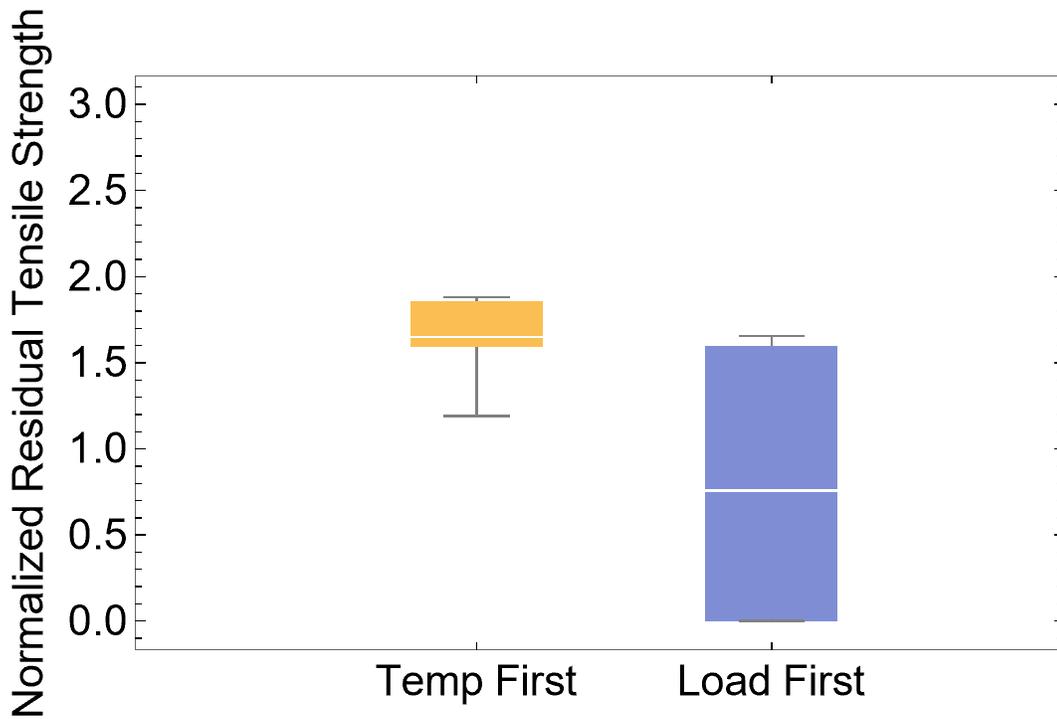
Figure 20. Comparison of residual tensile strength for specimens exposed to forty-three (43) cycles of fatigue in the “temperature first” and “load first” conditions.

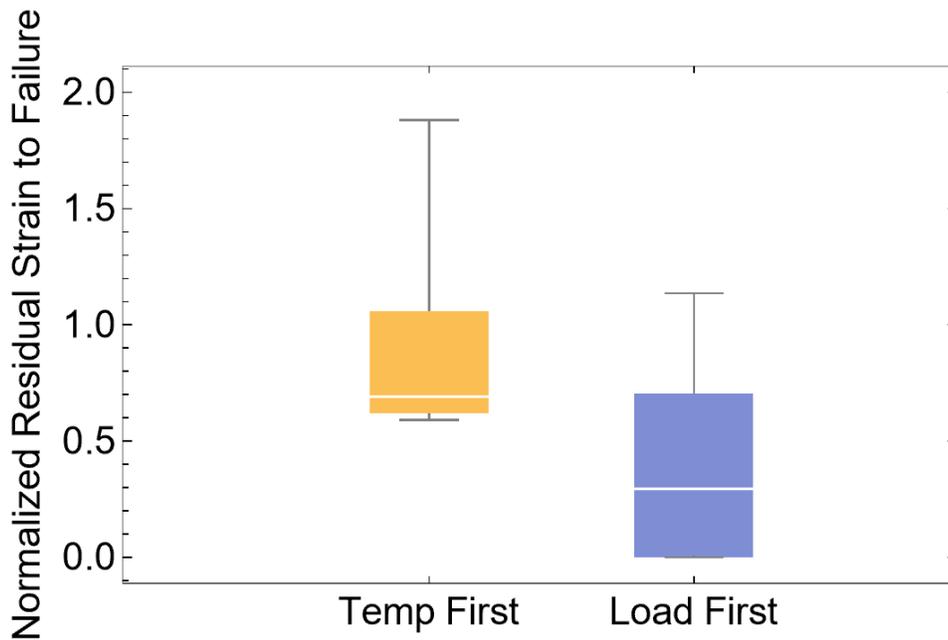
Figure 21. Comparison of residual strain to failure for specimens exposed to forty-three (43) cycles of fatigue in the “temperature first” and “load first” conditions.

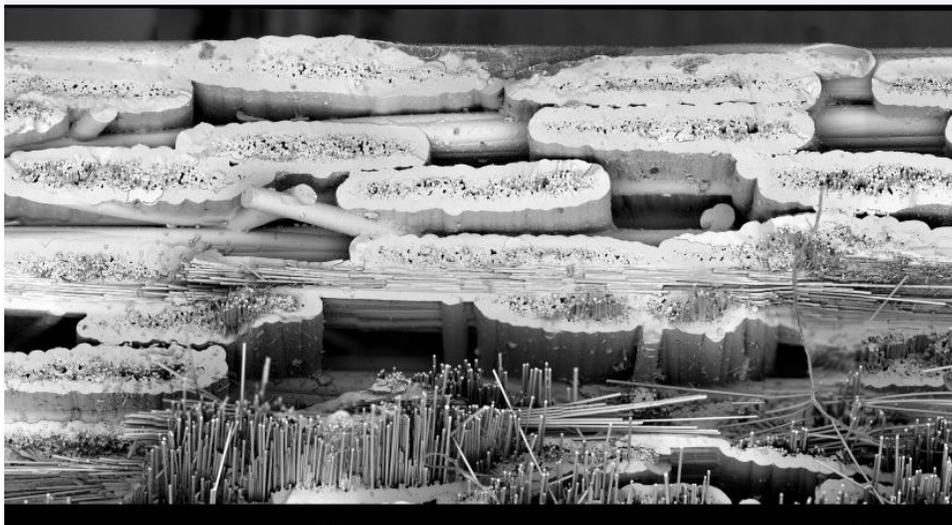
Figure 22. Fracture surface of specimen exposed to “load first” condition that failed during exposure.

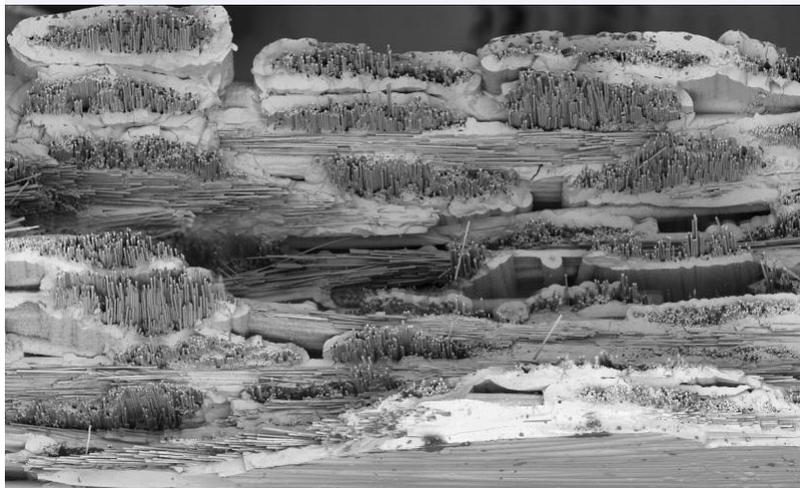
Figure 23. Fracture surface of specimen exposed to “temperature first” condition.

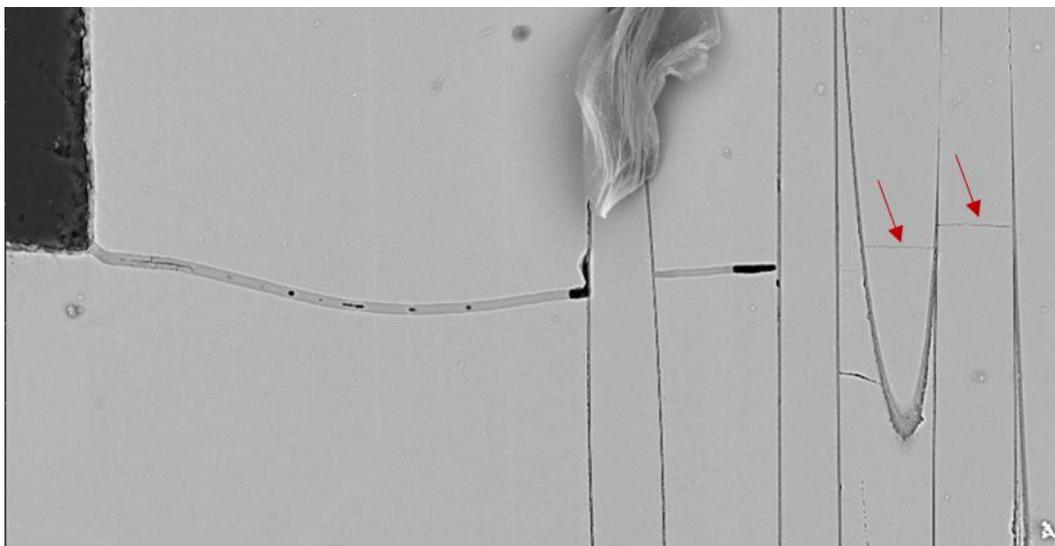
Figure 24. SEM micrograph of “load first” specimen that hit the runout condition and was tested for residual tensile performance. Red arrows indicated cracked fibers ahead of matrix crack. Specimen surface is at left edge of image.

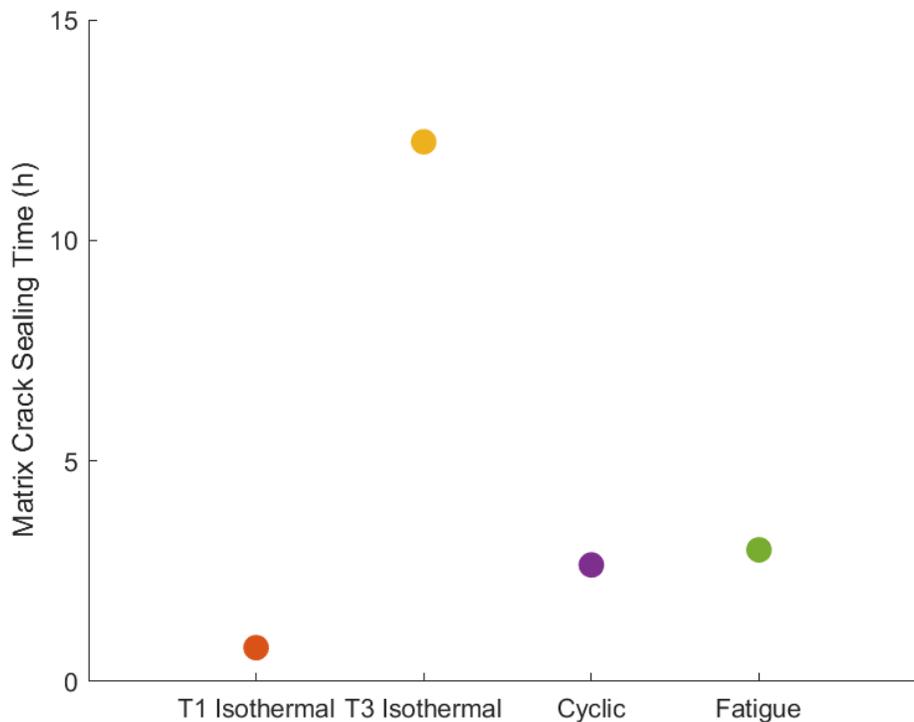
Figure 25. Simulated crack sealing time for the four test conditions.

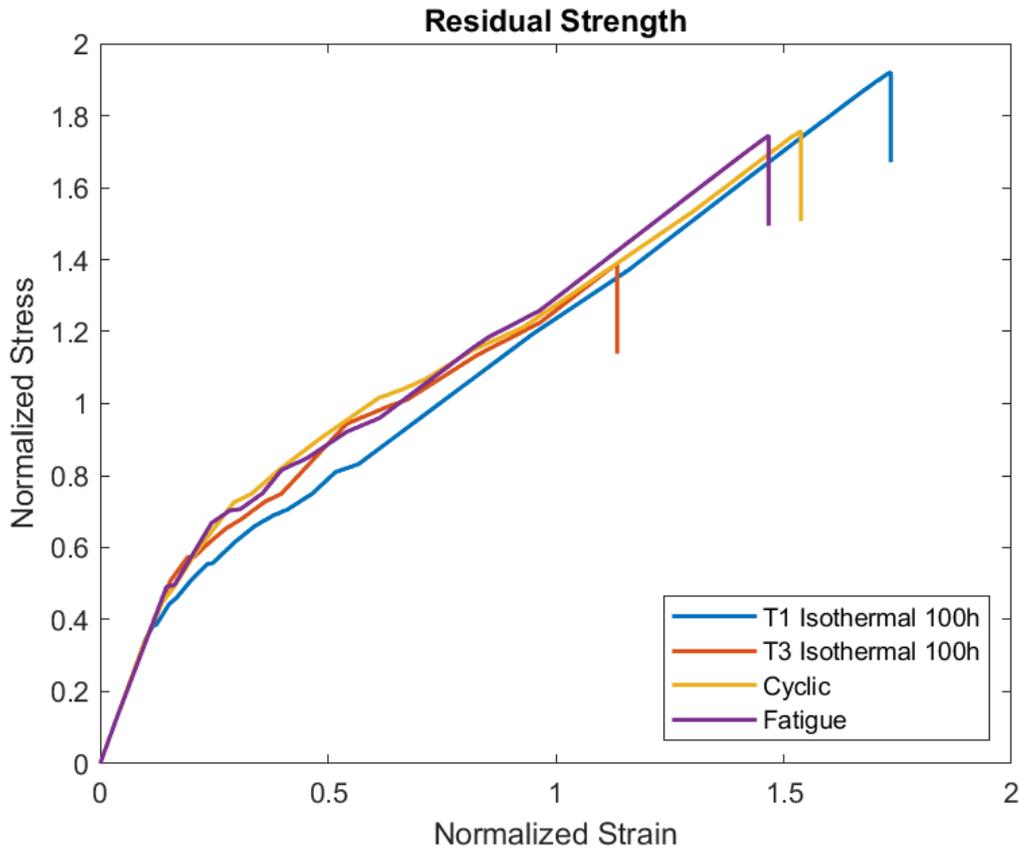
Figure 26. Simulated residual stress-strain response

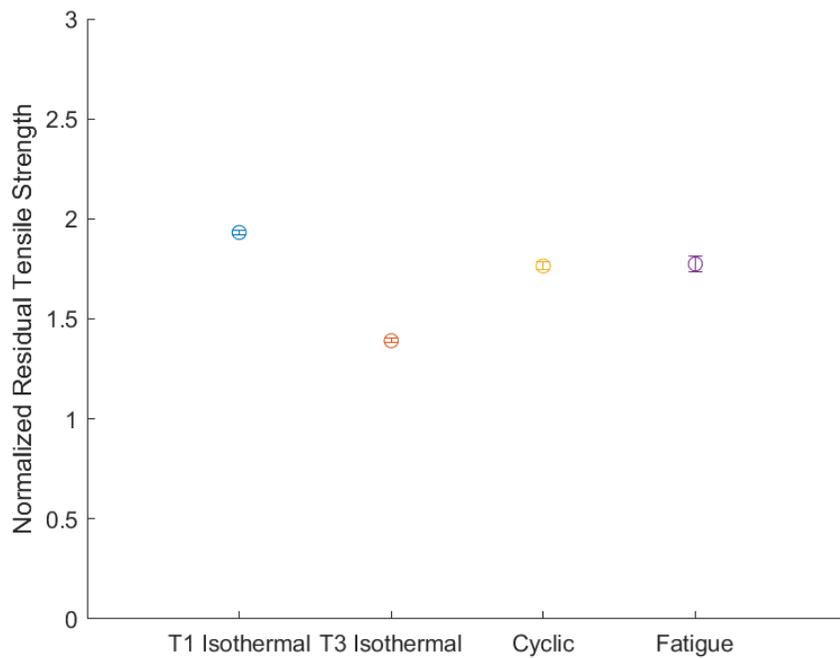
Figure 27. Simulated residual tensile strengths. Circles denote the mean with error bars representation +/- 1 standard deviation

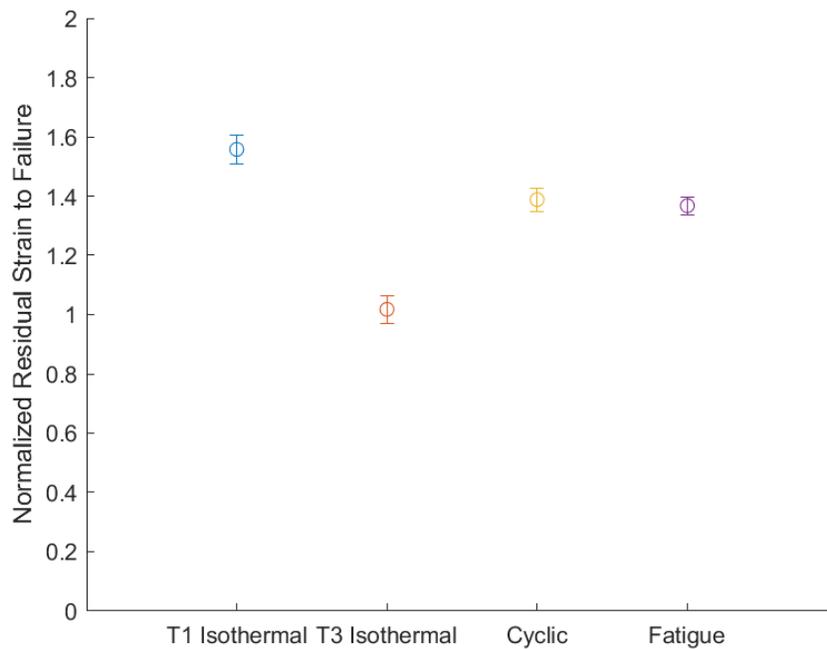
Figure 28. Simulated residual failure strains. Circles denote the mean with error bars representation +/- 1 standard deviation

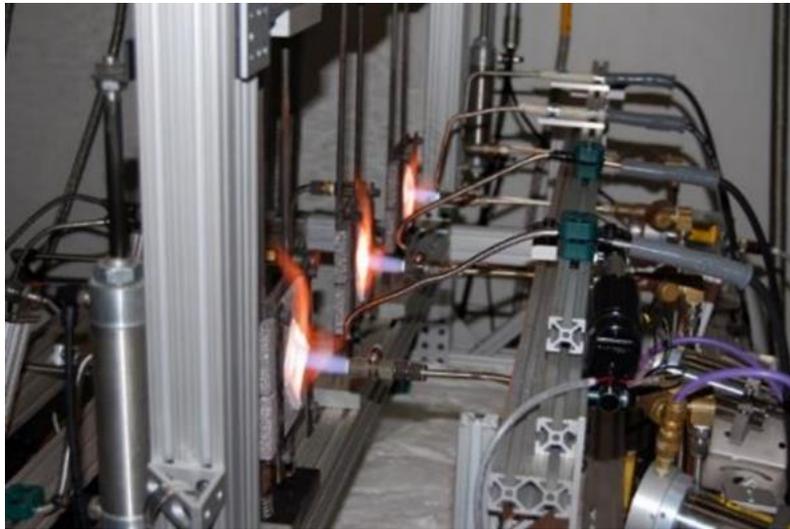
Figure 30. Photograph of the RTRC gradient burner rig

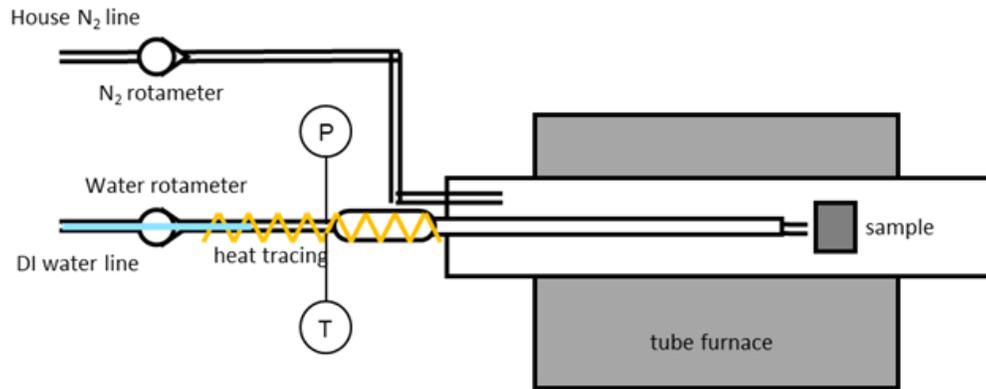
Figure 31. Schematic diagram of the RTRC high velocity steam rig

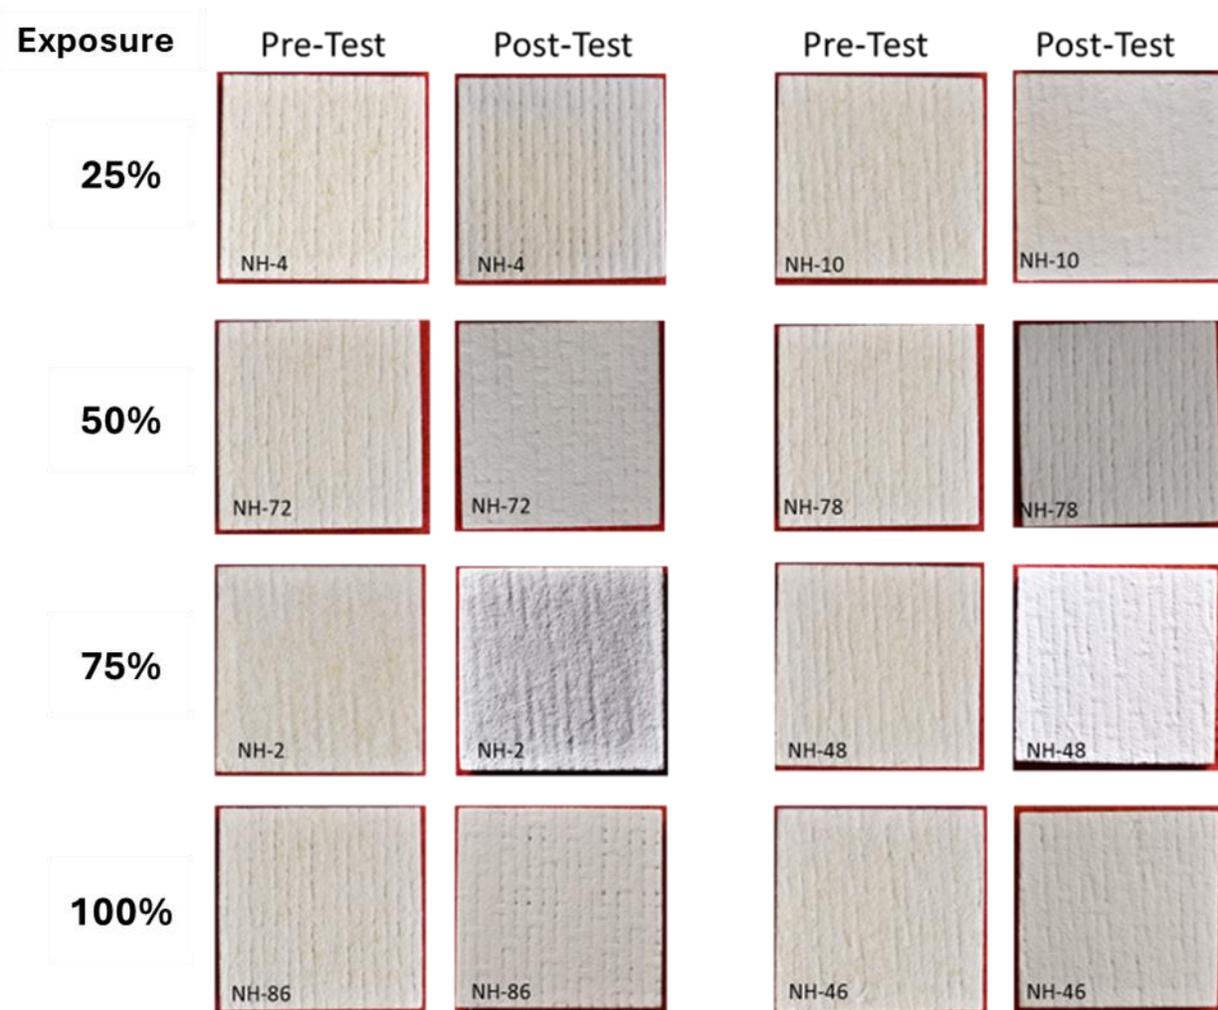
Figure 32. Photographs of samples before and after the T1 static ambient furnace test

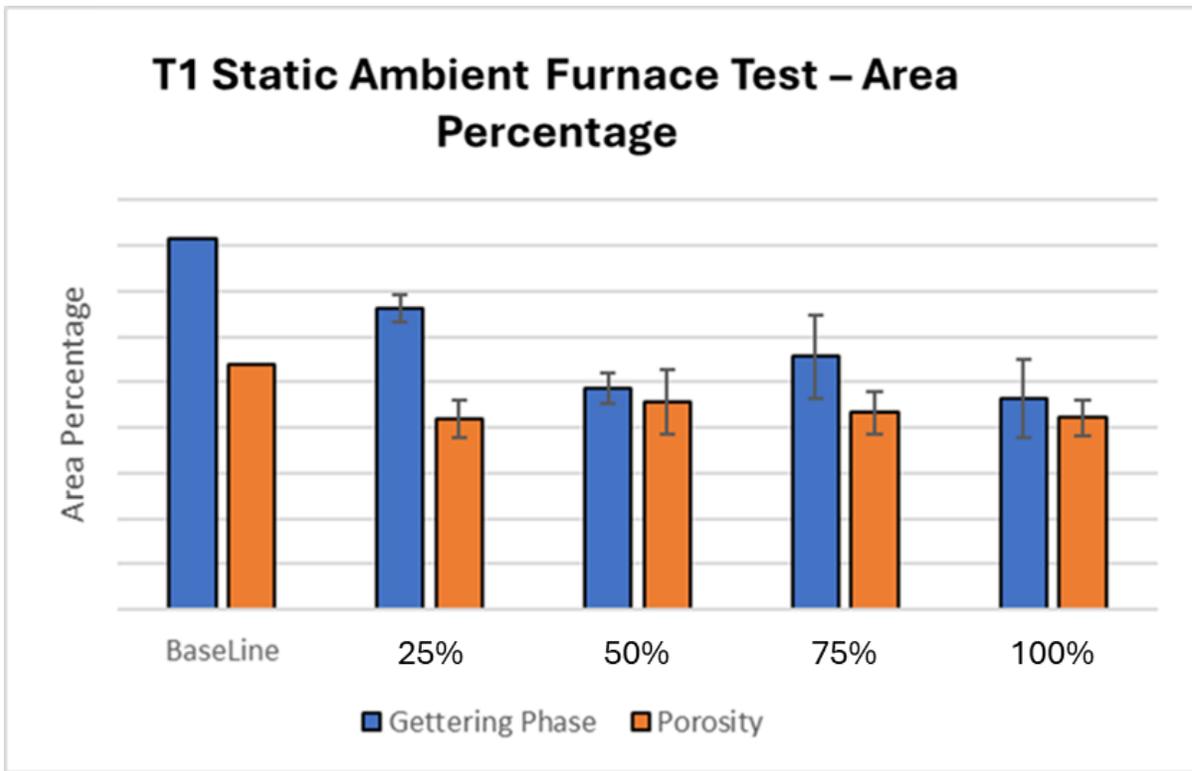
Figure 33. Average area percentages of gettingting phase and porosity for each T1 static ambient furnace test duration compared to as-processed baseline measured by image analysis
