NASA/CR-20250002768

Hybrid Thermally Efficient Core (HyTEC) High Temperature CMC Vanes Final Report

*John Shaw, Evan Benjamin Callaway, and David Litton
Pratt & Whitney, East Hartford, Connecticut*

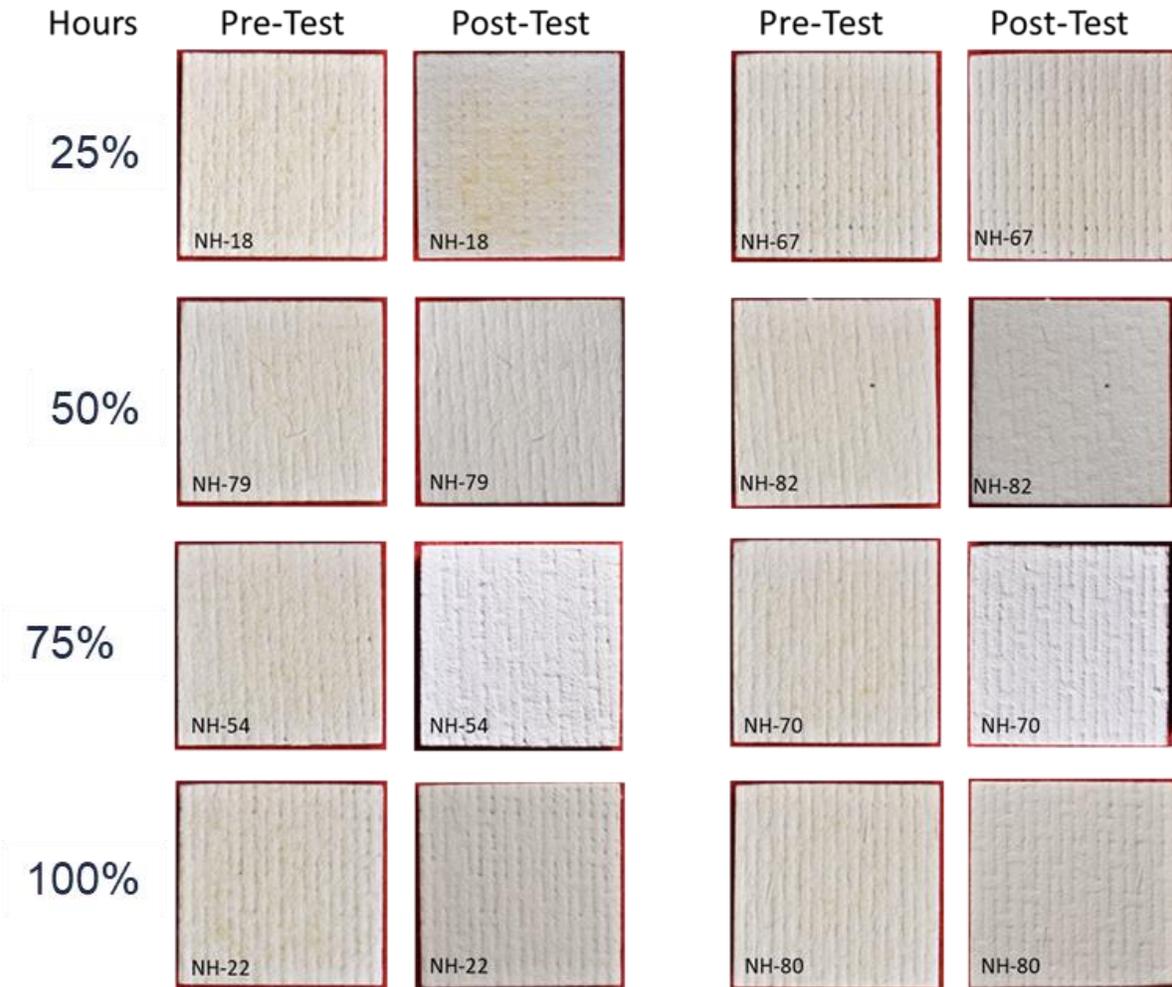
Figure 34. Photographs of samples before and after exposures in the static ambient air furnace test at T2

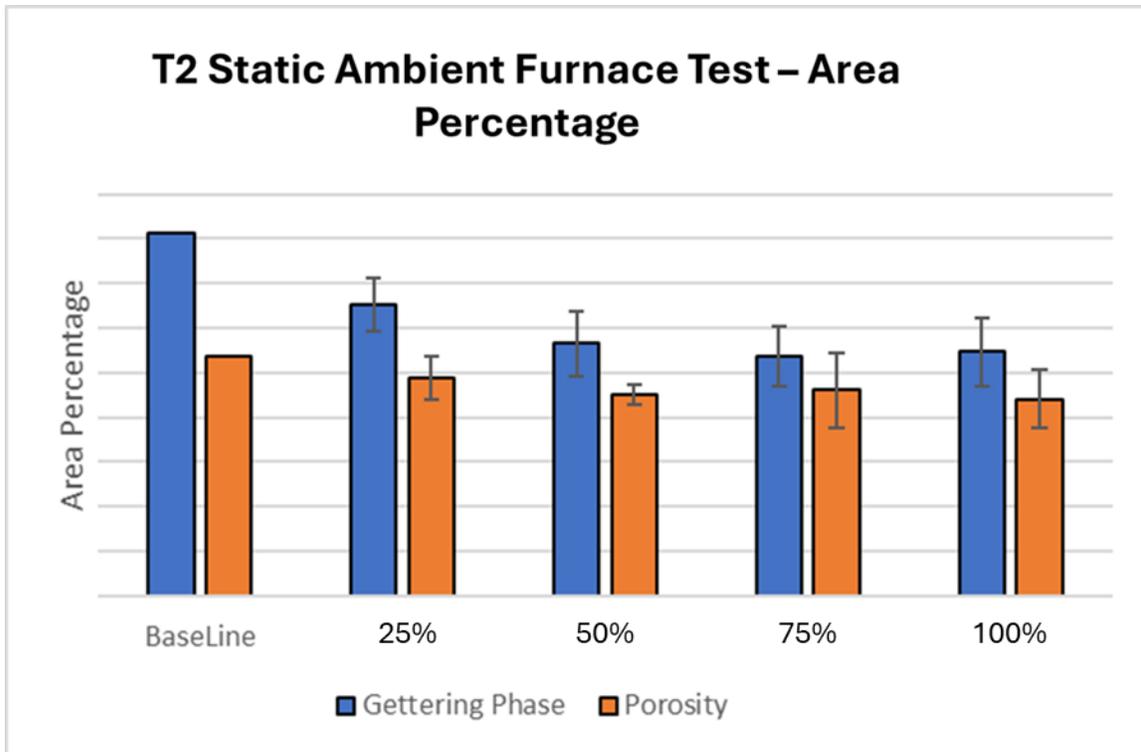
Figure 35. Average area percentages of gettingting phase and porosity for each T2 static ambient furnace test duration compared to as-processed baseline measured by image analysis

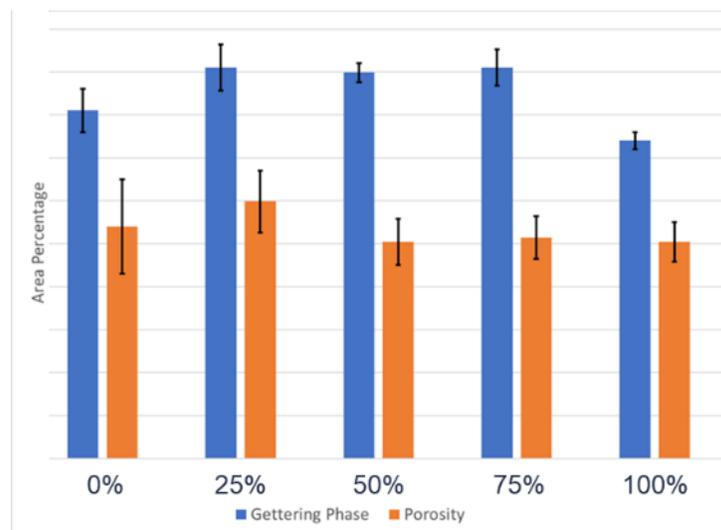
Figure 36. Average area percentages of gettering phase and porosity for each T3 static ambient furnace test duration compared to as-processed baseline measured by image analysis

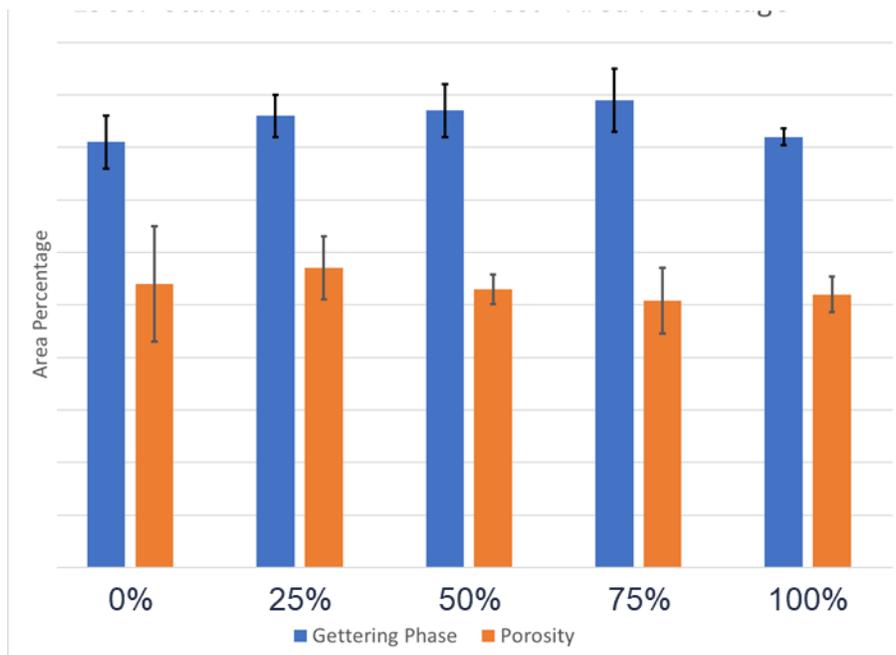
Figure 37. Average area percentages of gettinging phase and porosity for each T5 static ambient furnace test duration compared to as-processed baseline measured by image analysis

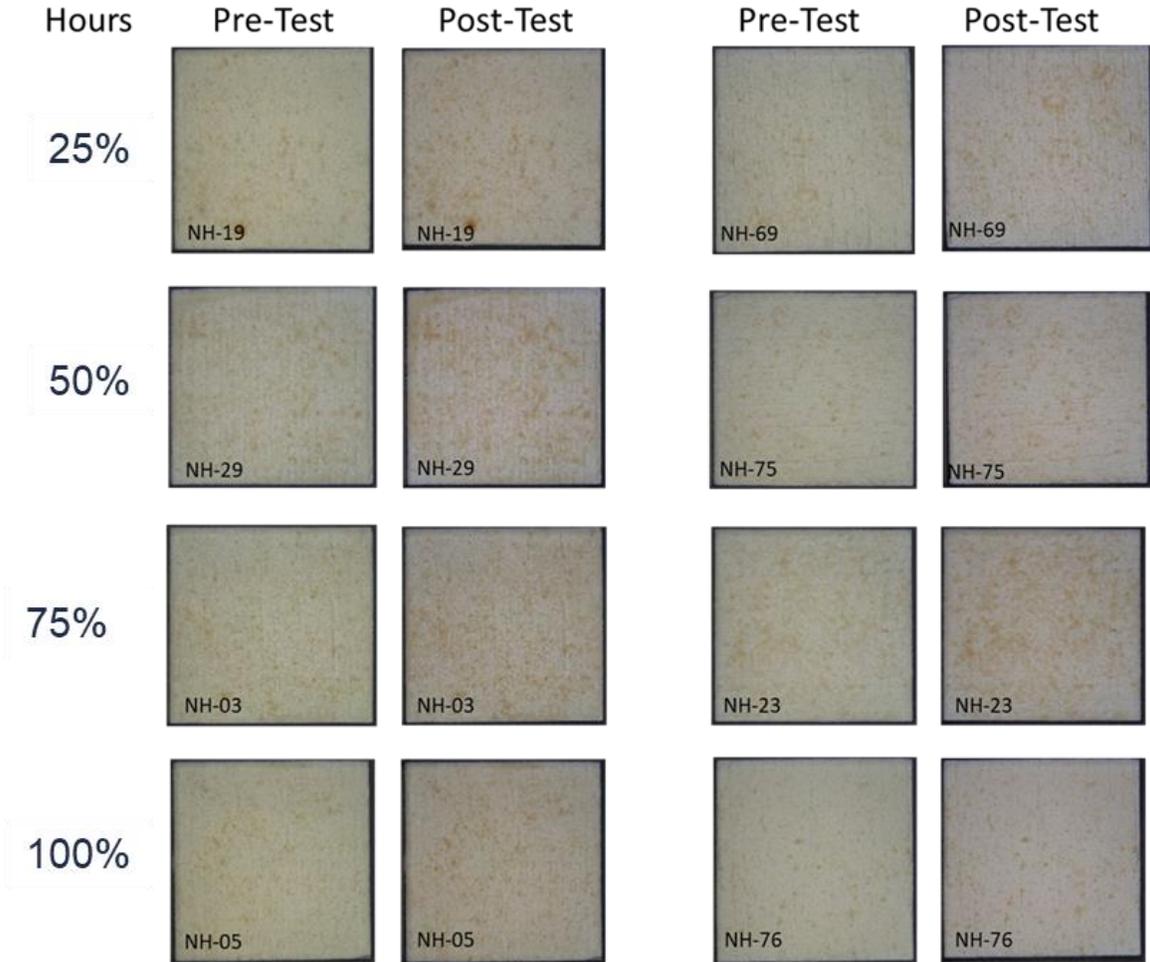
Figure 38. Photographs of samples before and after T5 static ambient furnace testing

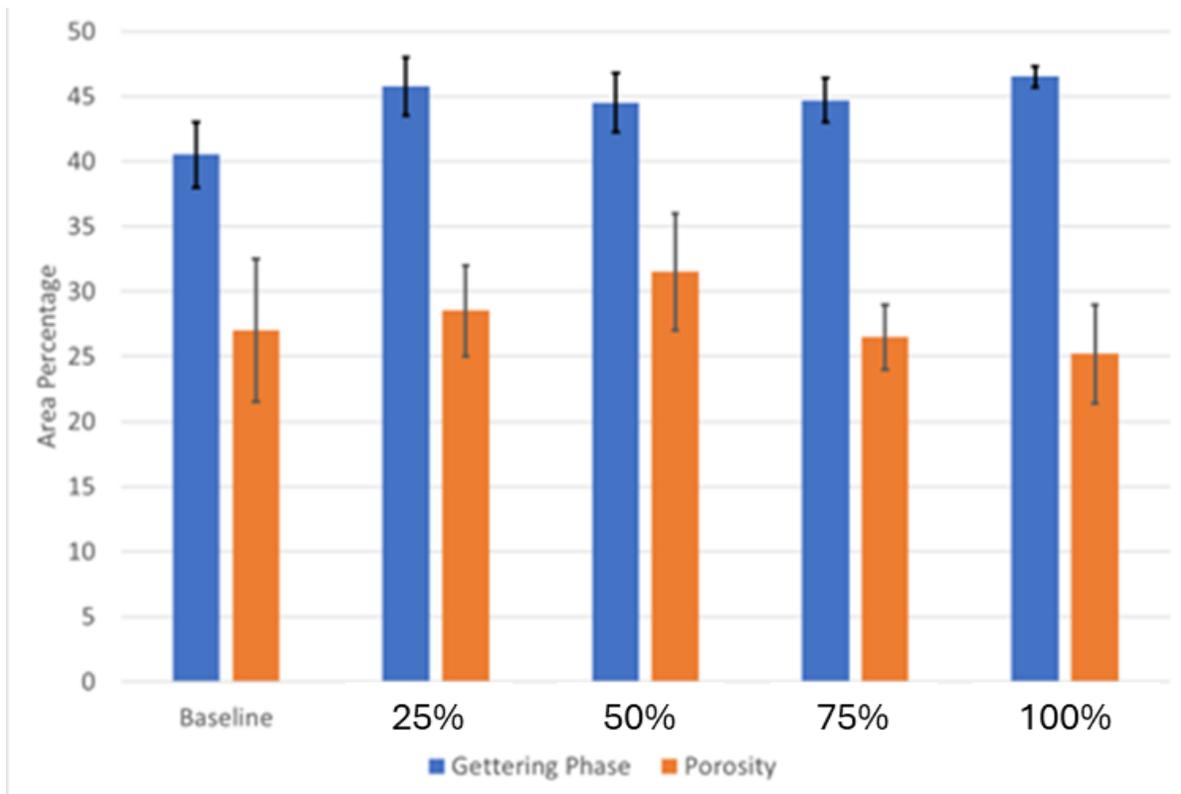
Figure 39. Average area percentages of gettering phase and porosity for each T4 static ambient furnace test duration compared to as-processed baseline measured by image analysis

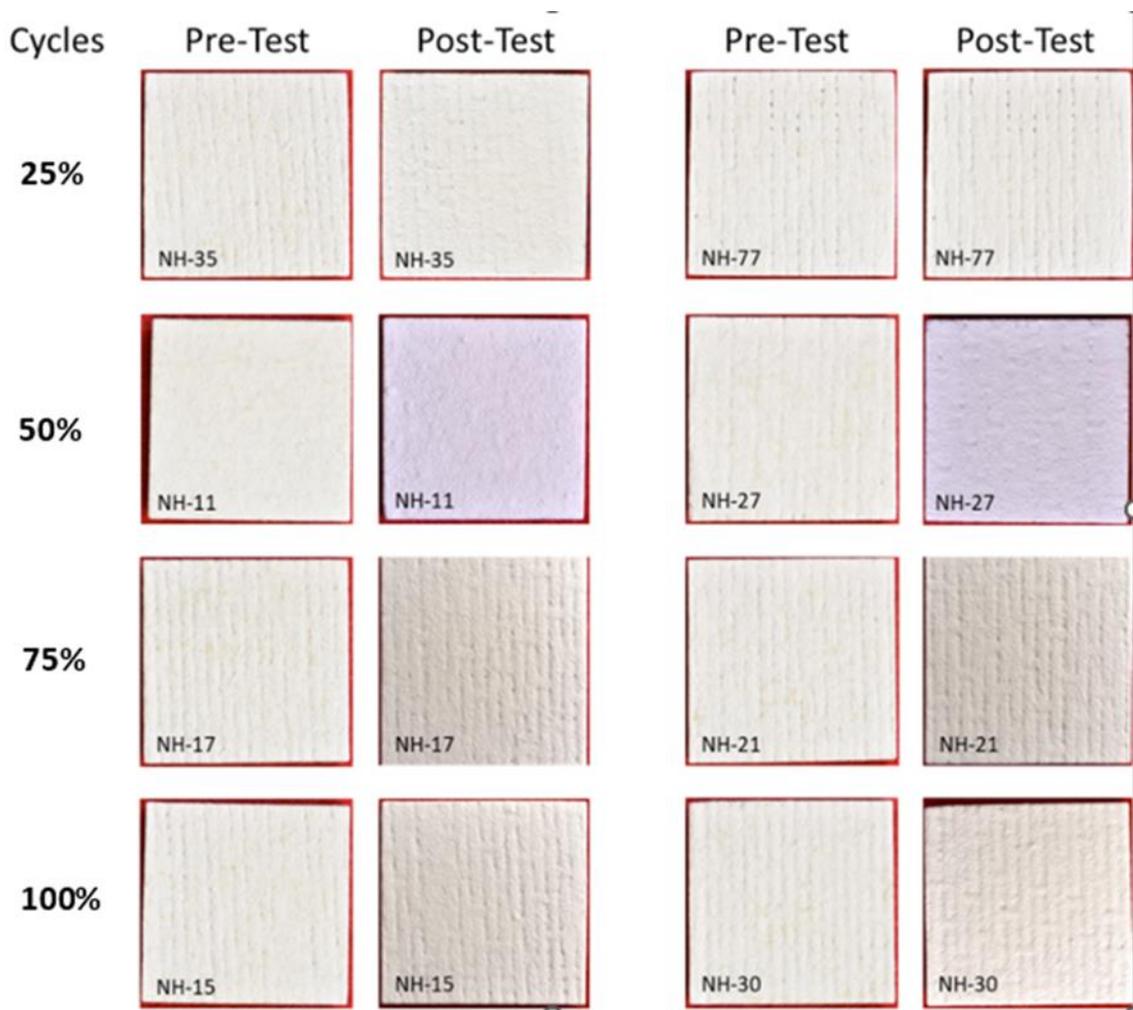
Figure 40. Photographs of samples before and after the T1 ambient furnace cycle test

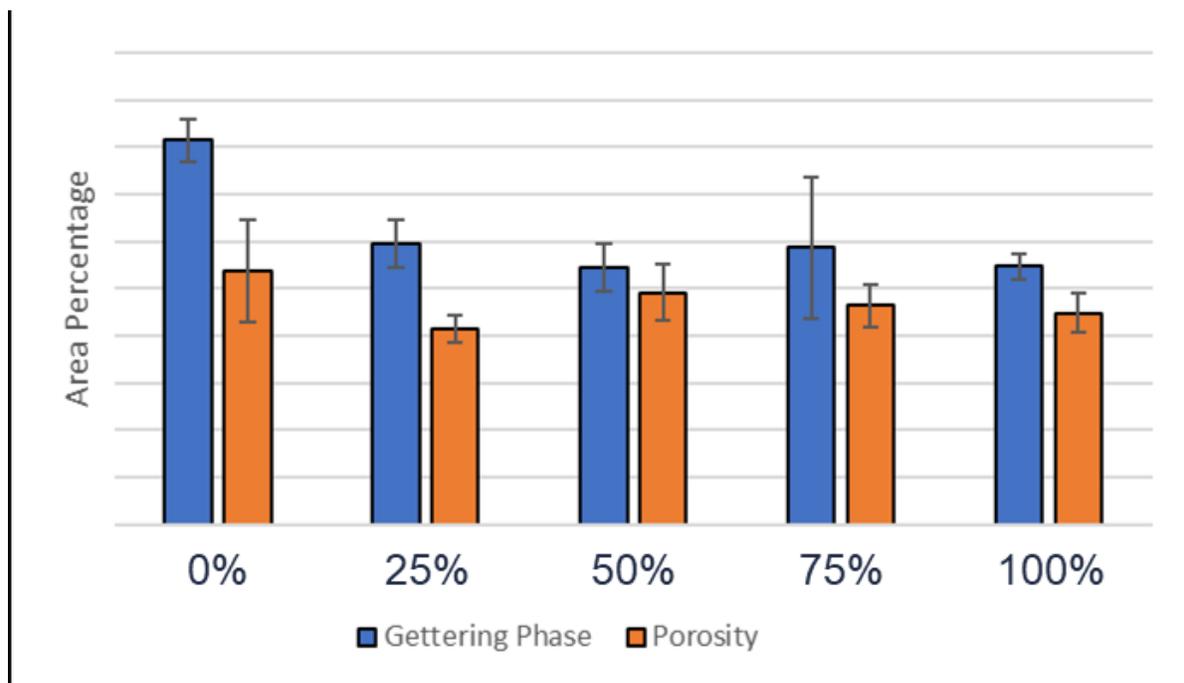
Figure 41. Average area percentages of gettering phase and porosity for each T1 FCT test duration compared to as-processed baseline measured by image analysis

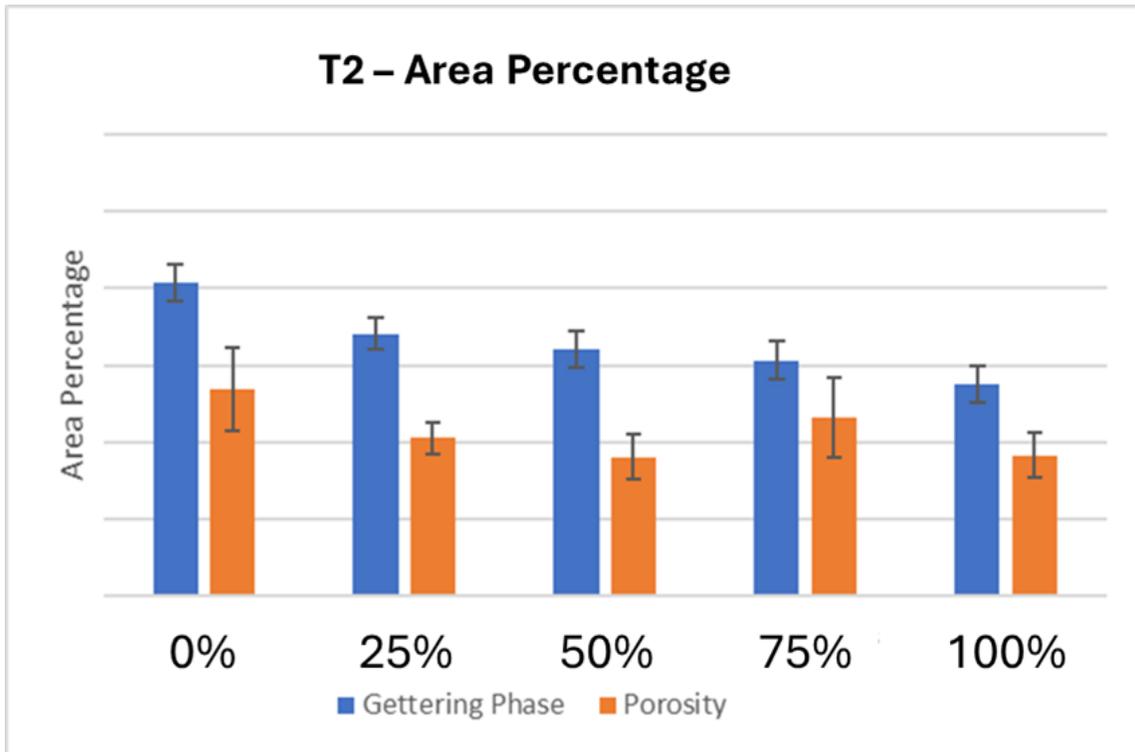
Figure 42. Average area percentages of gettering phase and porosity for each T2 FCT test duration compared to as-processed baseline measured by image analysis

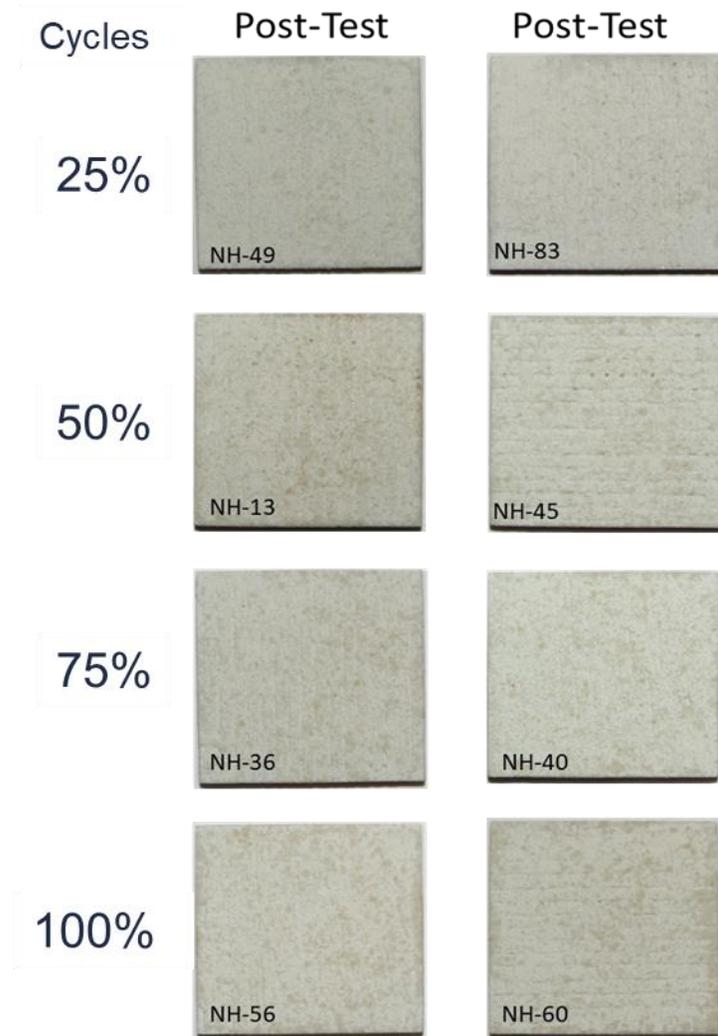
Figure 43. Photographs of samples taken after the T3 ambient furnace cycle test

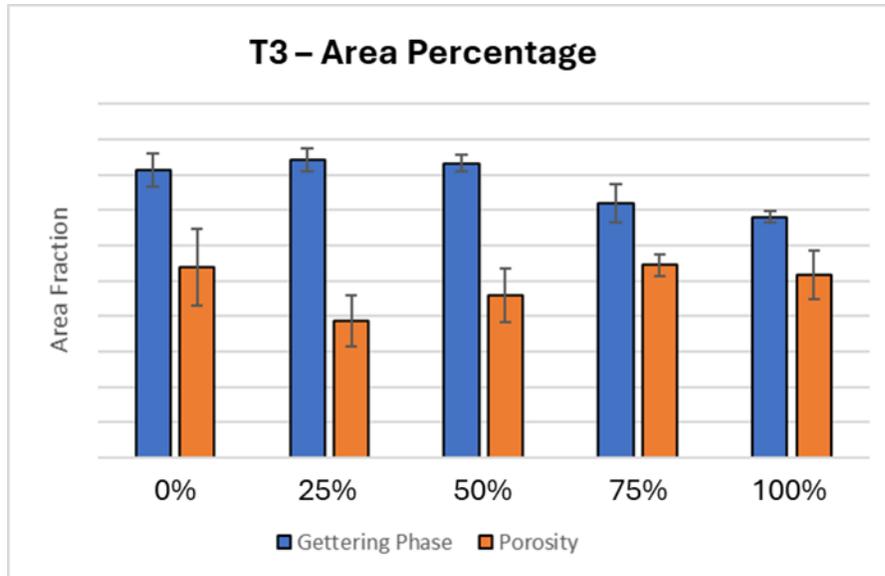
Figure 44. Average area percentages of gettering phase and porosity for each T3 FCT test duration compared to as-processed baseline measured by image analysis

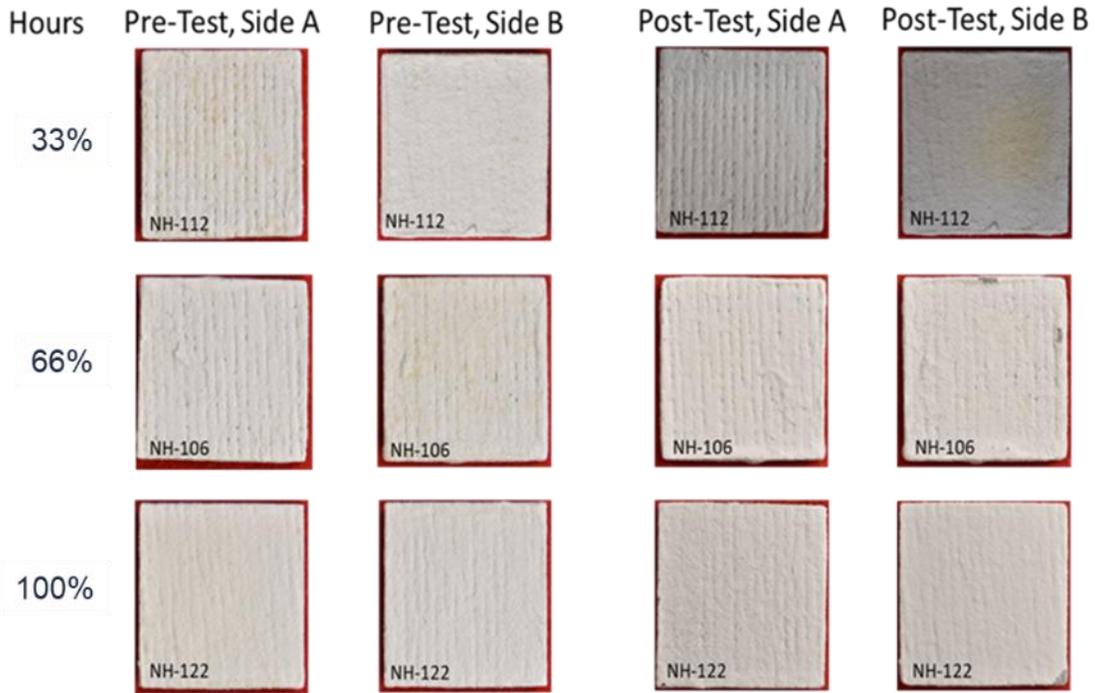
Figure 45. Photographs of both sides of the samples before and after T1 static steam furnace testing

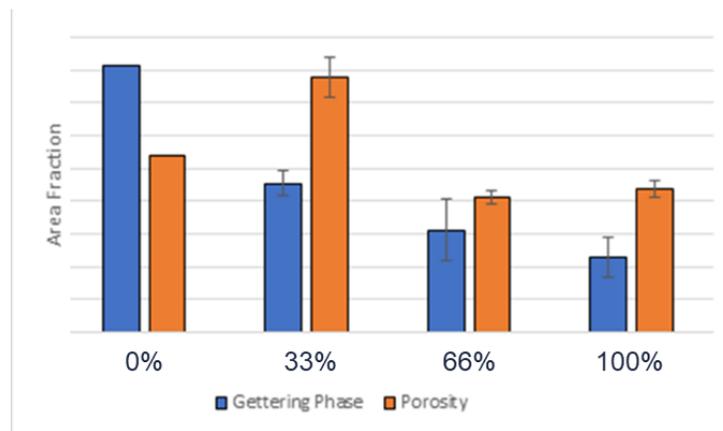
Figure 46. Average area percentages of gettering phase and porosity for each T1 static steam furnace test duration compared to as-processed baseline measured by image analysis

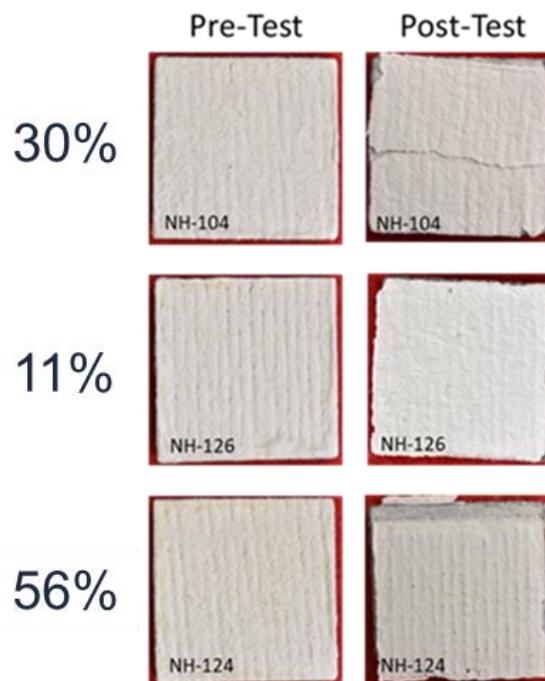
Figure 47. Photographs of samples before and after the T1 + 100 F steam furnace cycle test

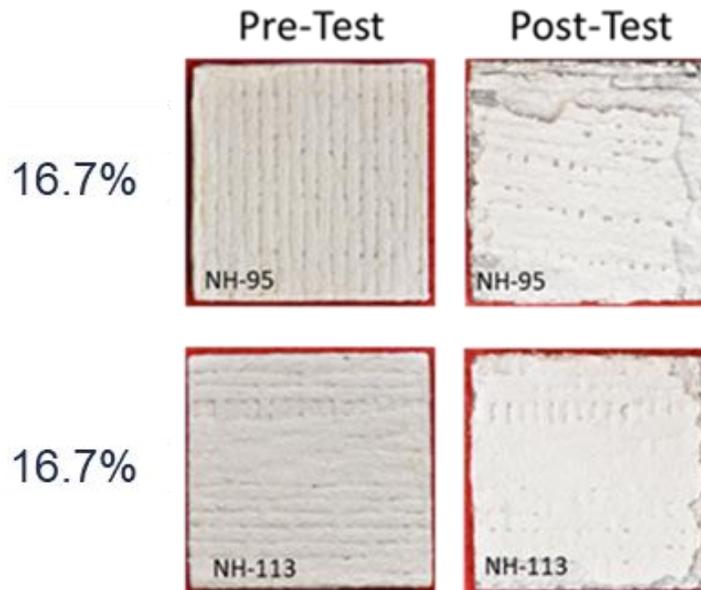
Figure 48. Photographs of samples before and after the T2 steam furnace cycle test

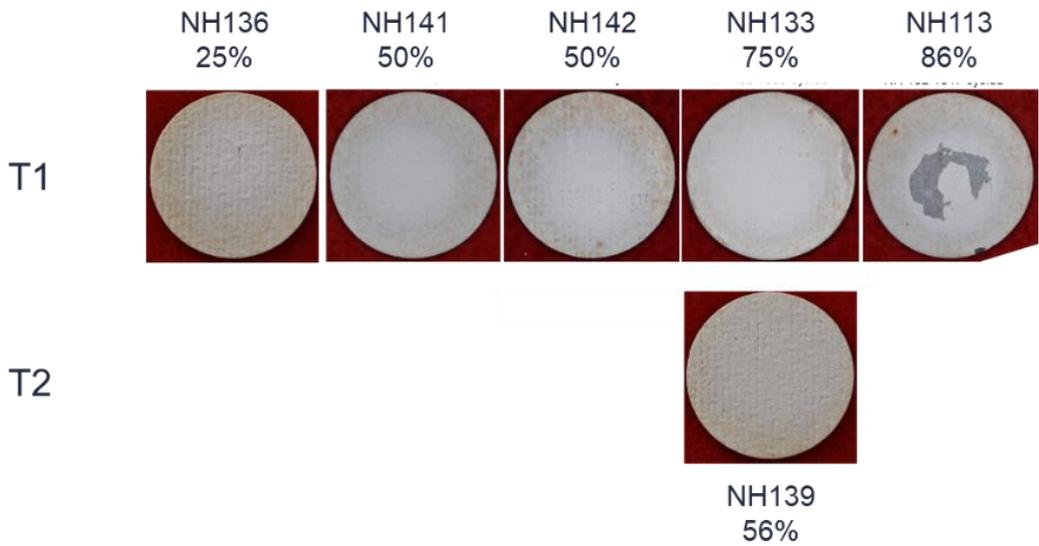
Figure 49. Photographs of samples after gradient burner rig testing

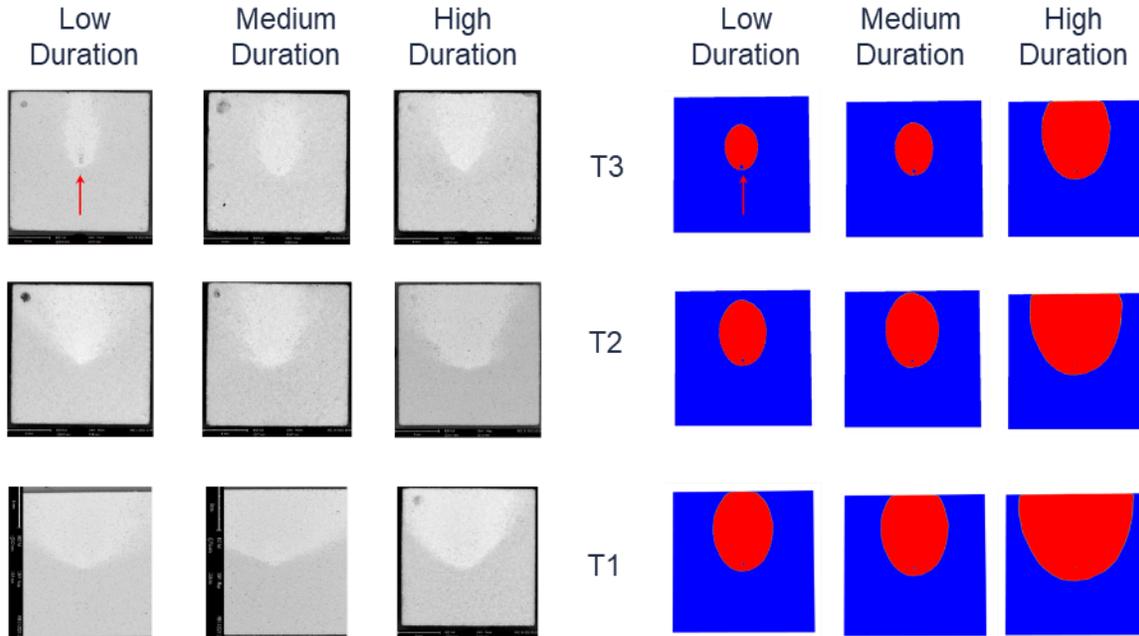
Figure 50. Comparison of BSE SEM images of samples that were tested in the high velocity steam jet rig with the higher water flowrates (left) to CFD-predicted recessed areas (right)

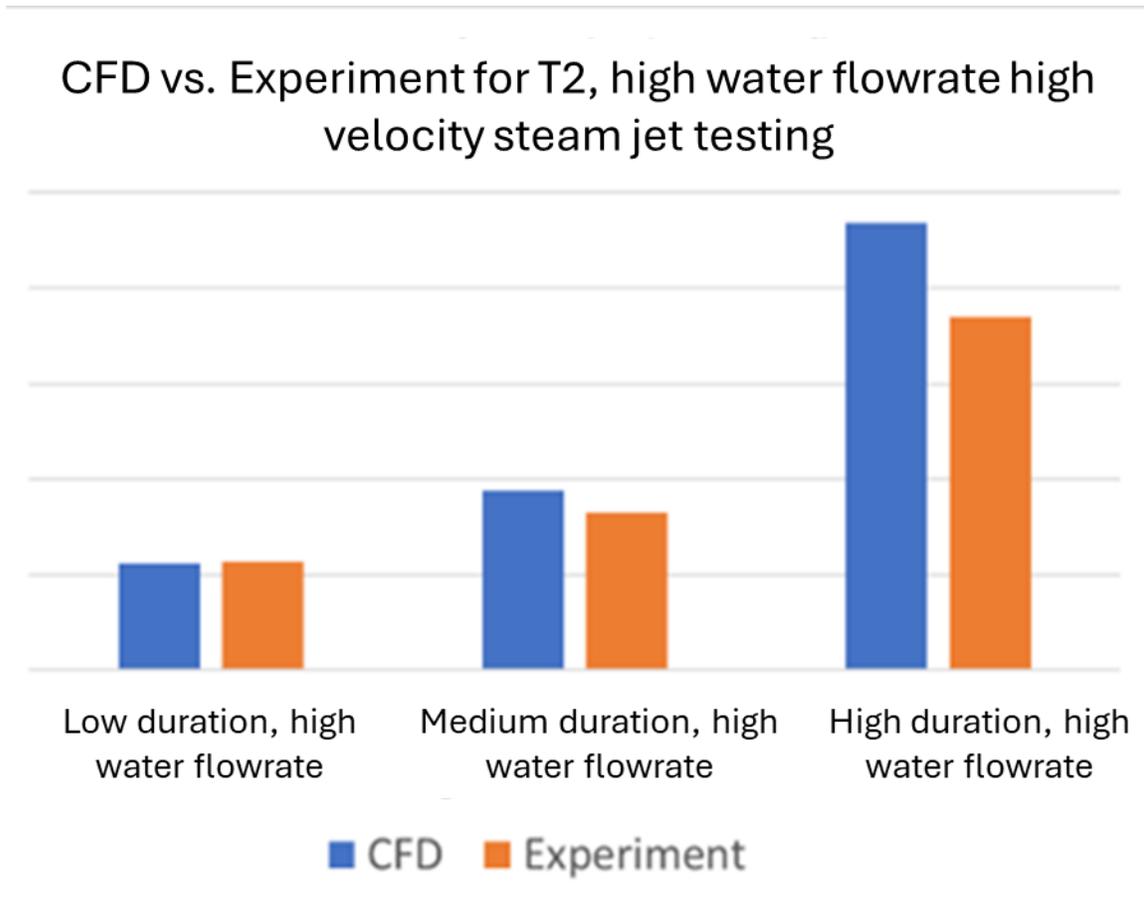
Figure 51. Comparison of experimentally measured penetration depth at T2 and the high level of water flowrate to the penetration depth predicted by the calibrated CFD model

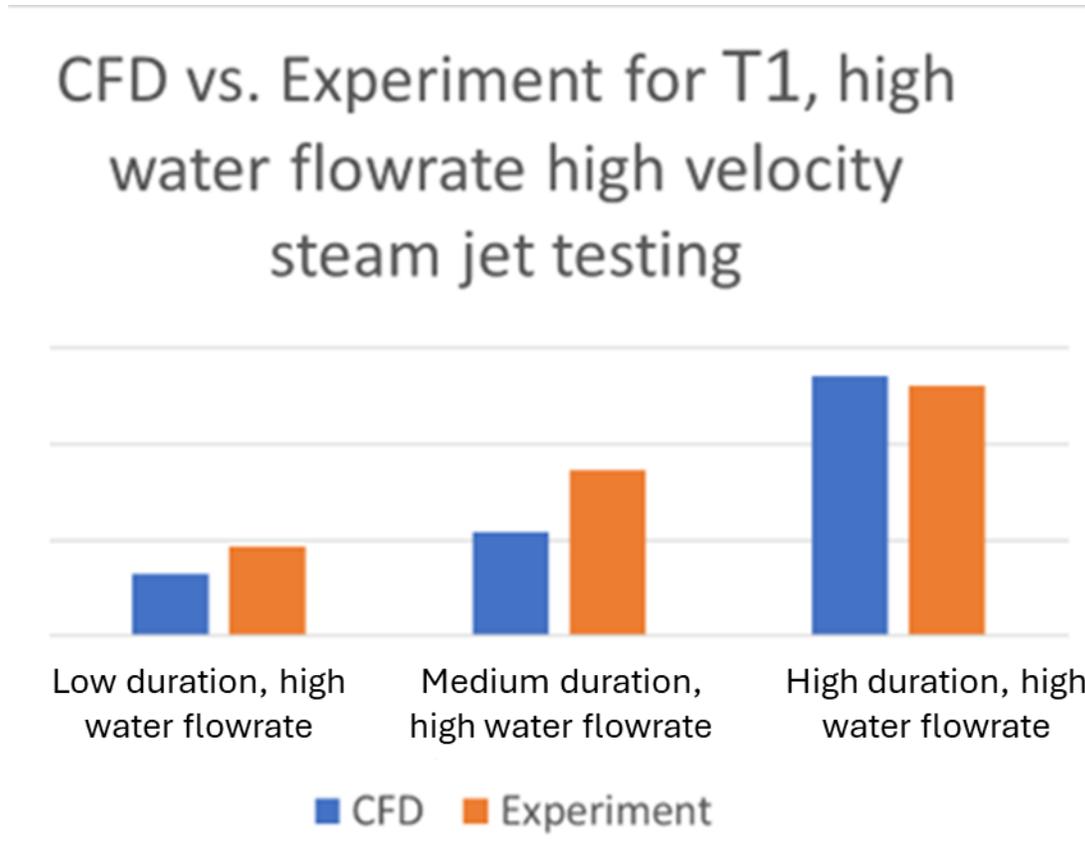
Figure 52. Comparison of experimentally measured penetration depth at T1 and the higher level of water flowrate to the penetration depth predicted by the calibrated CFD model

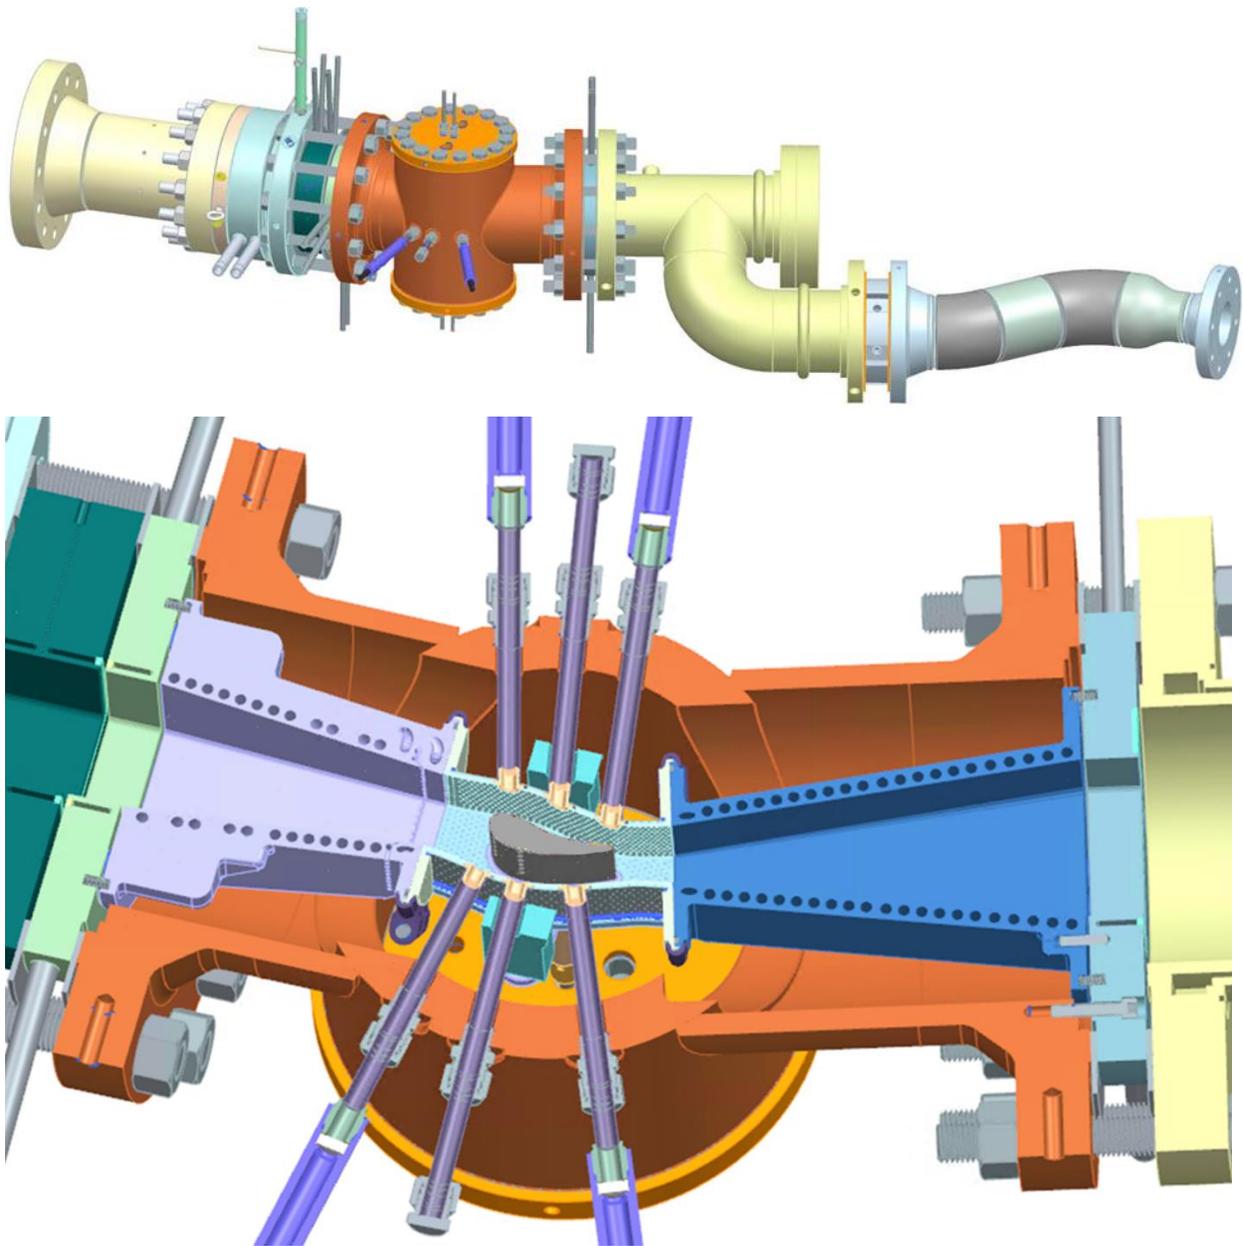
Figure 53. Solid model of HPTC rig overview (top) and cross-section (bottom)

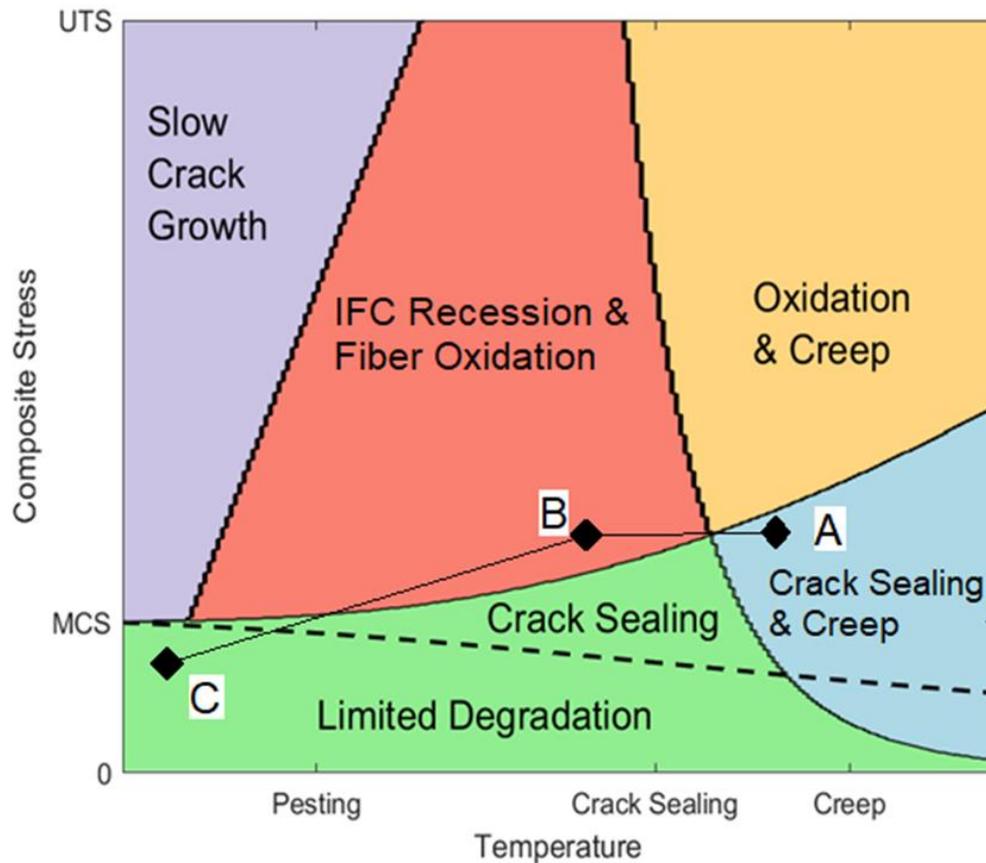
Figure 54. Illustration of regimes of CMC damage mechanisms as a function of temperature and composite stress and thermo-mechanical cycles

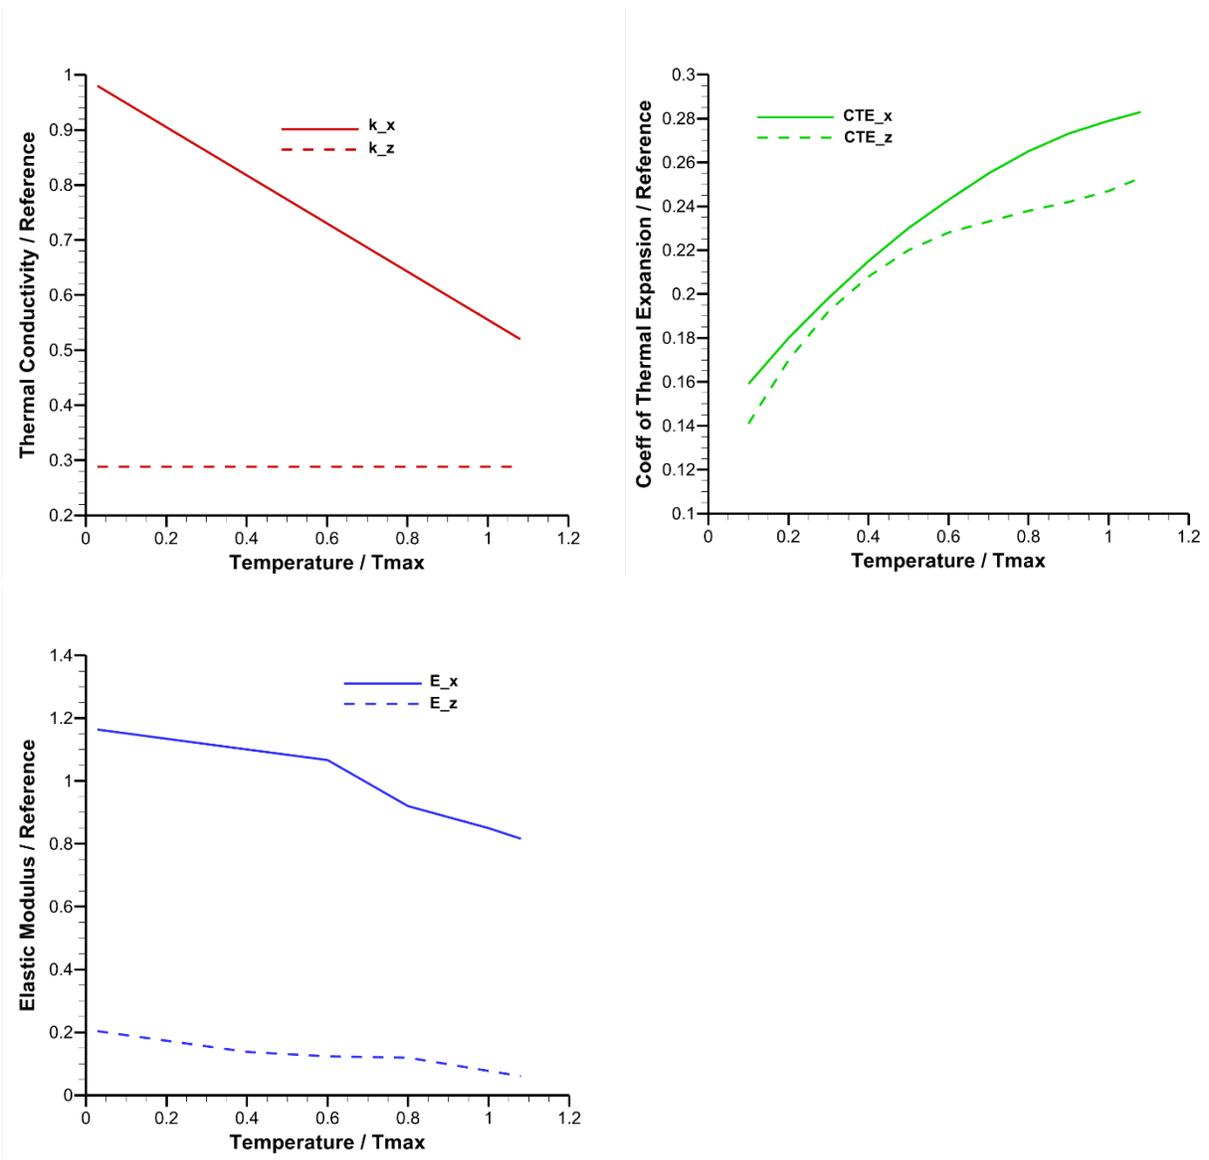
Figure 55. Materials properties of P&W's Gen1.2 (TRL/MRL4) SiC-SiC CMC normalized by a reference alloy property versus temperature normalized by maximum CMC temperature

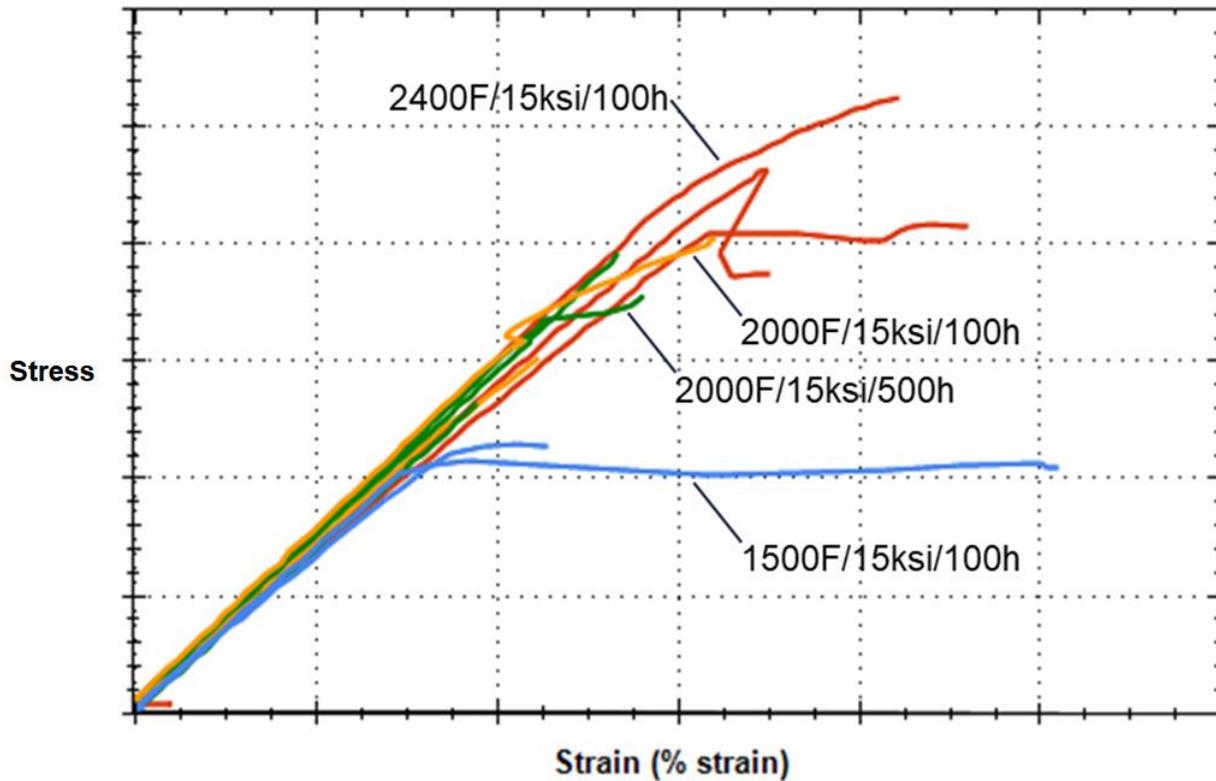
Figure 56. Stress-strain curves of P&W's Gen 1.2 (TRL/MRL-4) SiC-SiC CMC

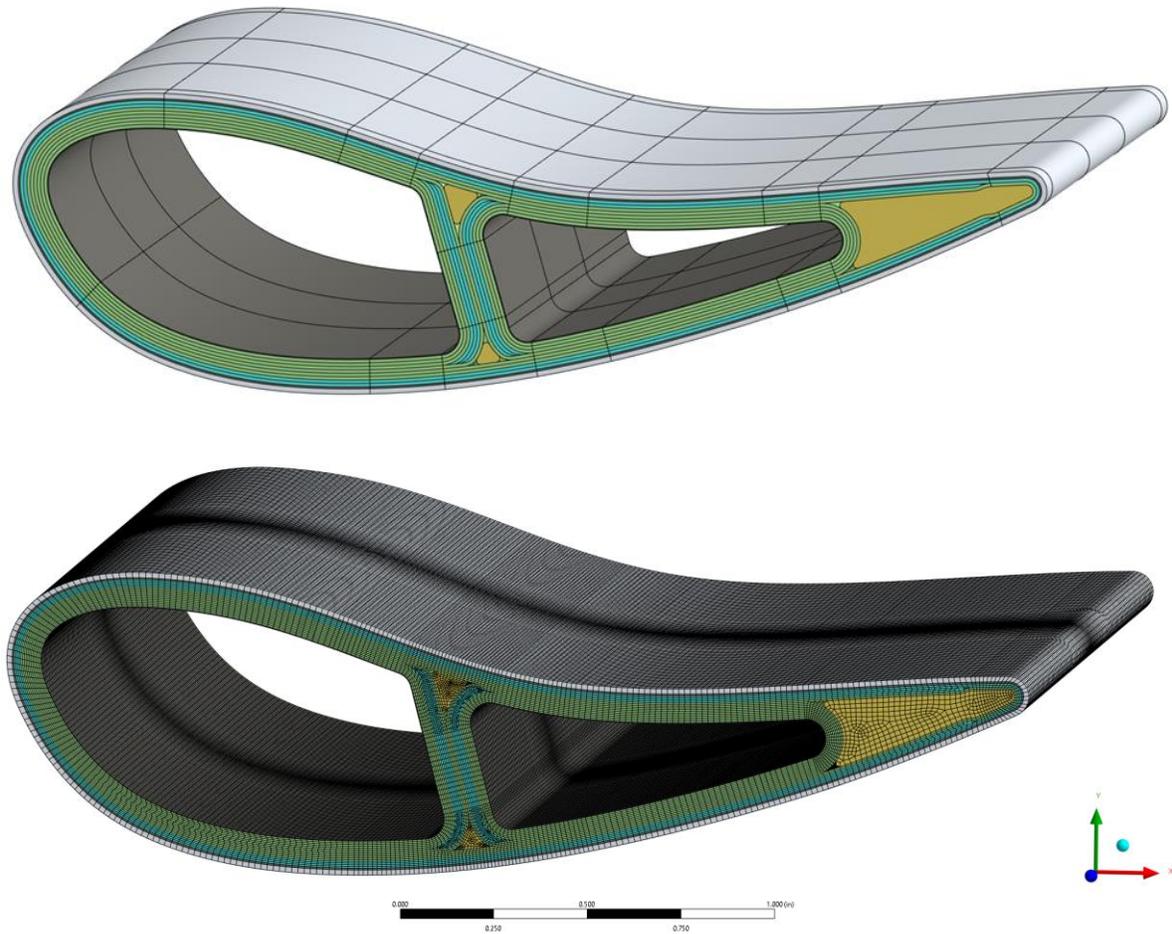
Figure 57. CAD model and finite element mesh showing plies, fillers, and layered bodies of CMC vane for HPTC rig testing.

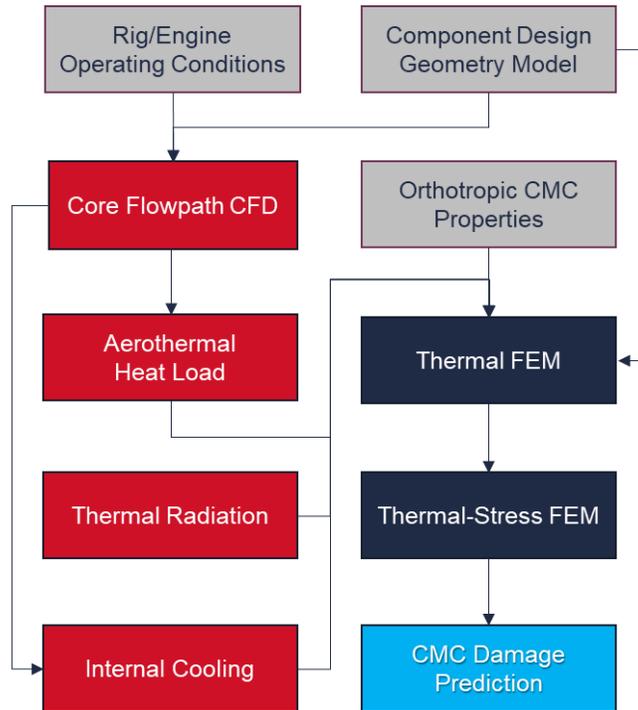
Figure 58. Procedure for thermal-stress predictions in CMC test articles

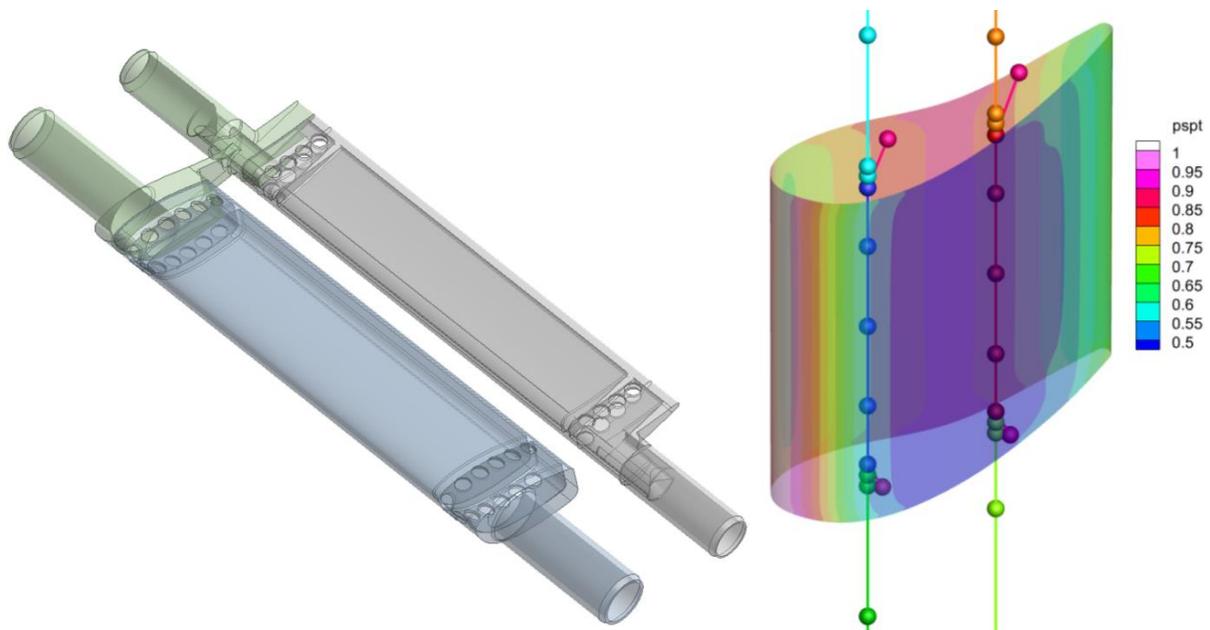
Figure 60. Internal cooling flow model and static pressure distribution on CMC airfoil surface
