NASA/CR-20250002768

Hybrid Thermally Efficient Core (HyTEC) High Temperature CMC Vanes Final Report

*John Shaw, Evan Benjamin Callaway, and David Litton
Pratt & Whitney, East Hartford, Connecticut*

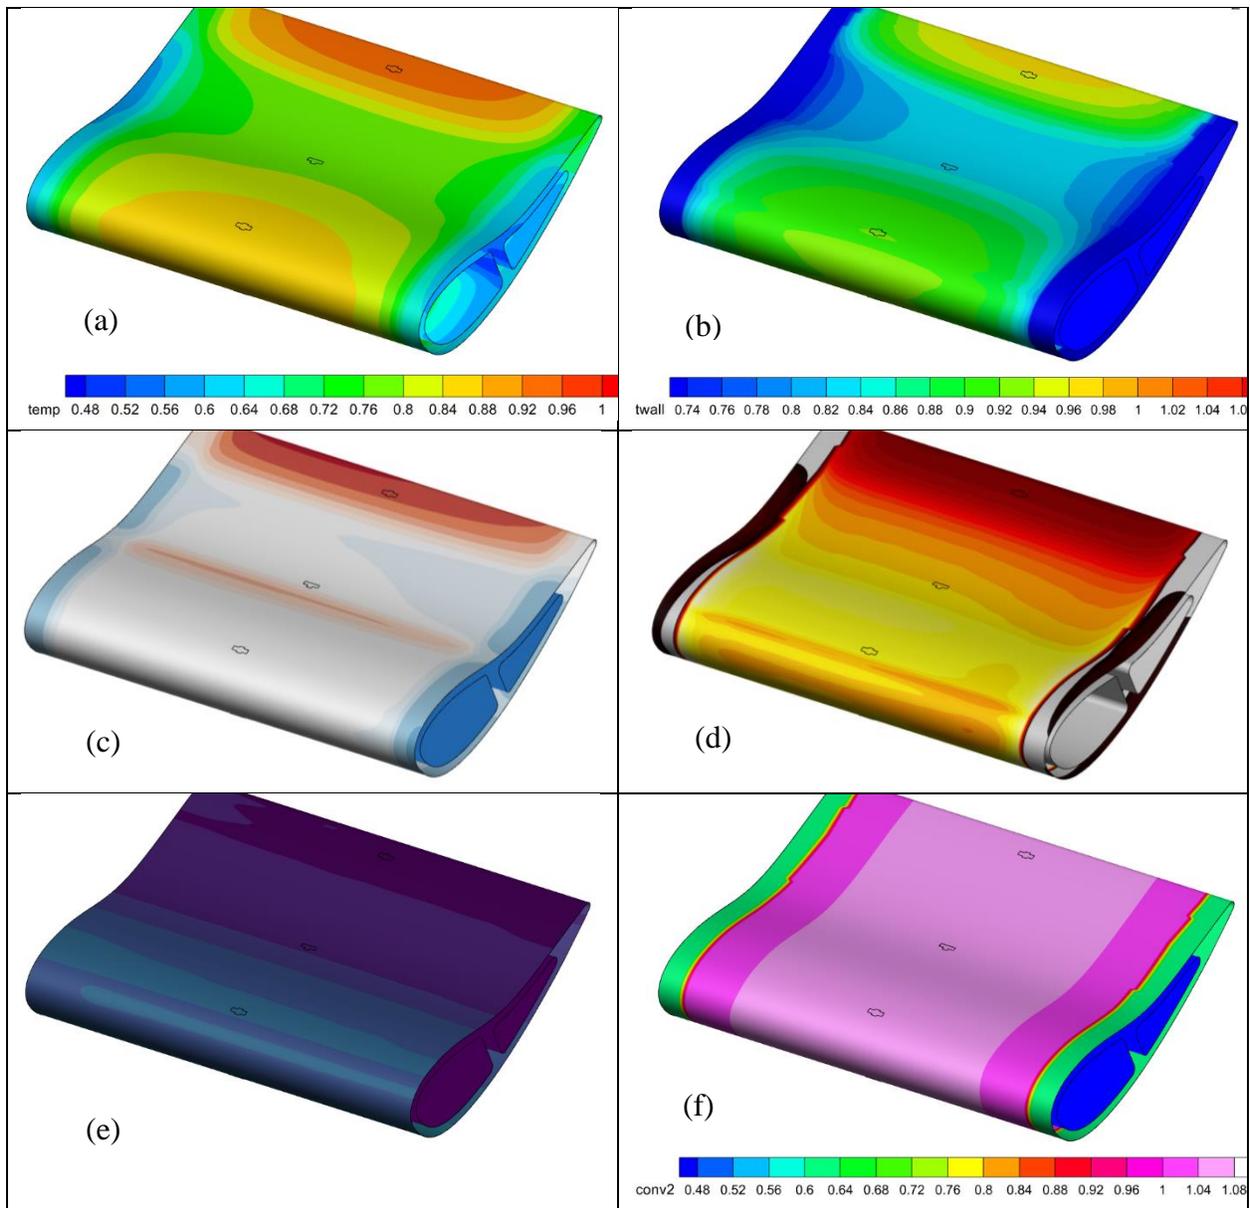
Figure 61. Results of thermal analysis of CMC test article in HPTC rig at the Climb 1A operating condition; (a) CMC/EBC interface temperature, (b) EBC topcoat temperature, (c) temperature difference between inner and outer surface of CMC, (d) wall heat flux, (e) convective heat transfer coefficient, (f) convective hot gas temperature.

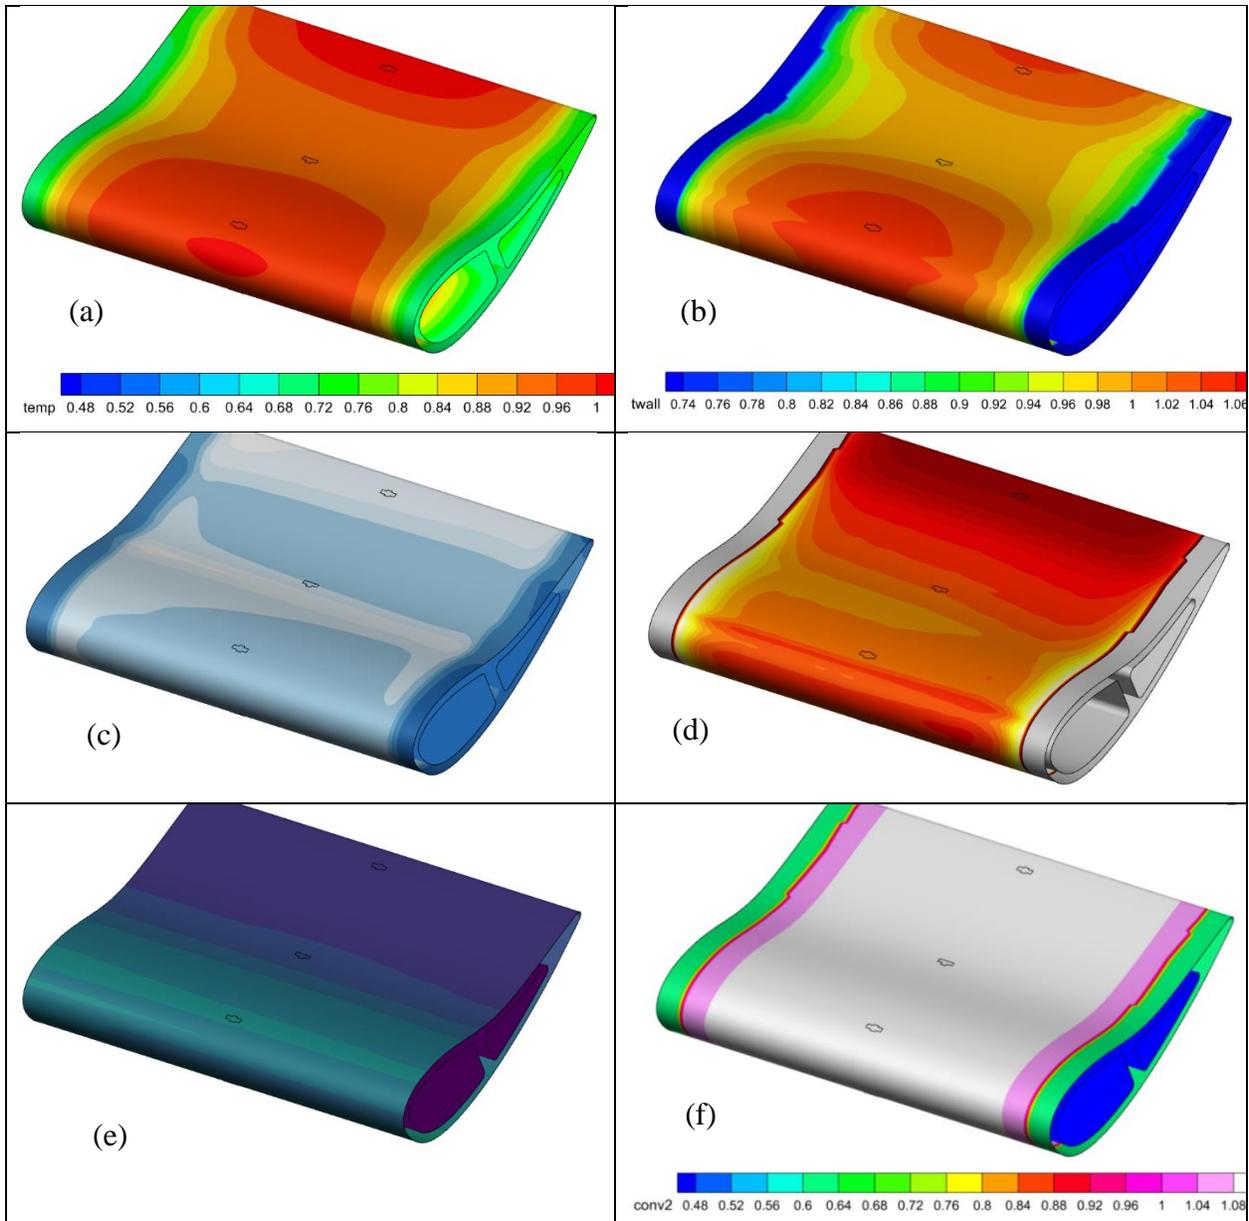
Figure 62. Results of thermal analysis of CMC test article in HPTC rig at the DDP 2B operating condition; (a) CMC/EBC interface temperature, (b) EBC topcoat temperature, (c) temperature difference between inner and outer surface of CMC, (d) wall heat flux, (e) convective heat transfer coefficient, (f) convective hot gas temperature.

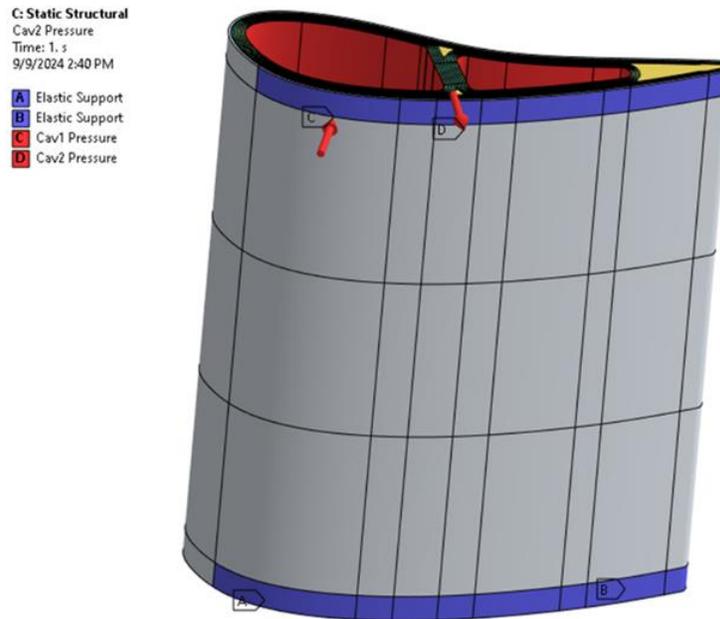
Figure 63. Boundary conditions applied to thermal stress analysis of CMC airfoil.

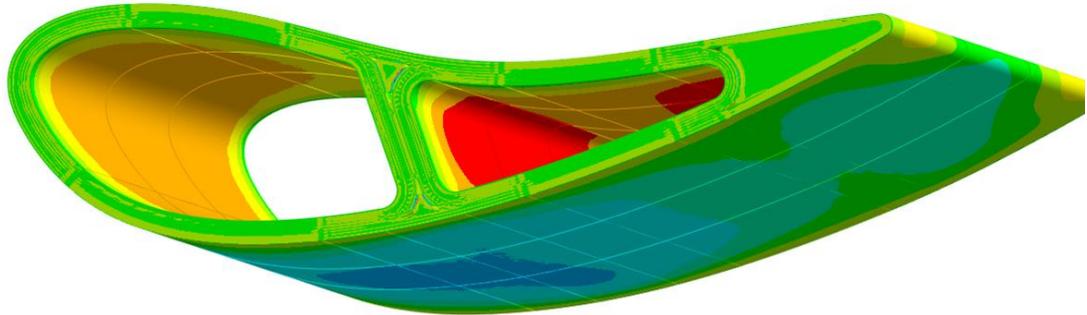
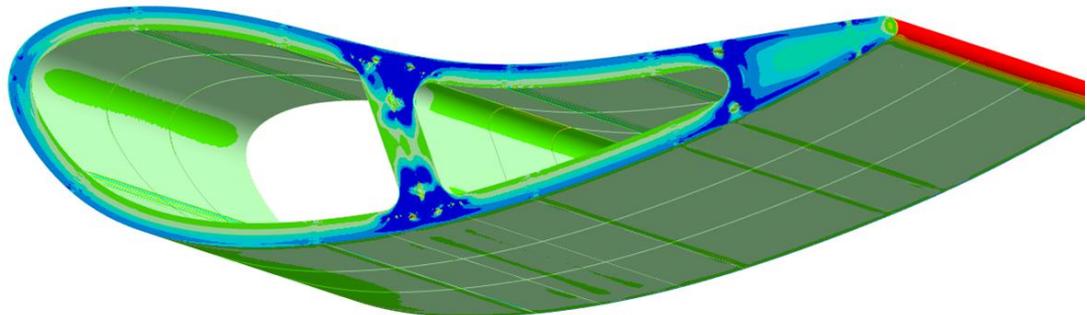
C: Static Structural
Normal Stress - Hoop
Type: Normal Stress(Y Axis)
Unit: psi
Solution Coordinate System
Time: 1 s
Deformation Scale Factor: 0.0 (Undeformed)

Figure 64. Linear elastic stresses in CMC vane test article in HPTC rig at the Climb 1A operating condition with nominal cooling. Shown are the normal stresses in the locally radial/spanwise (x), hoop (y) and interlaminar (z) directions

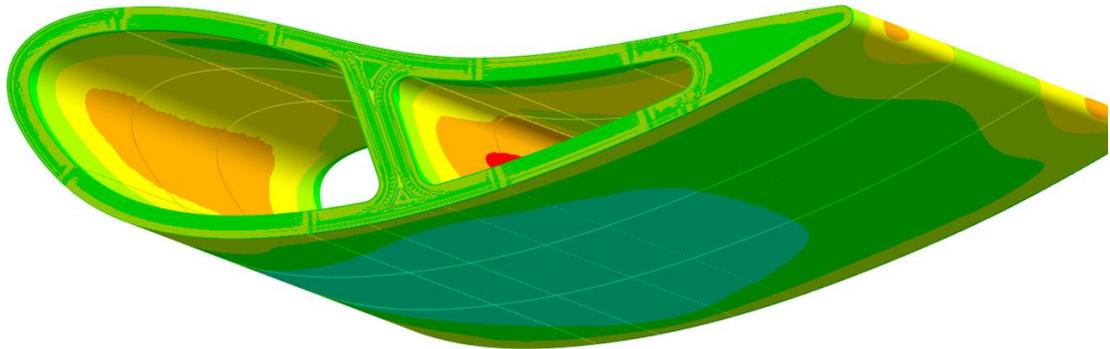
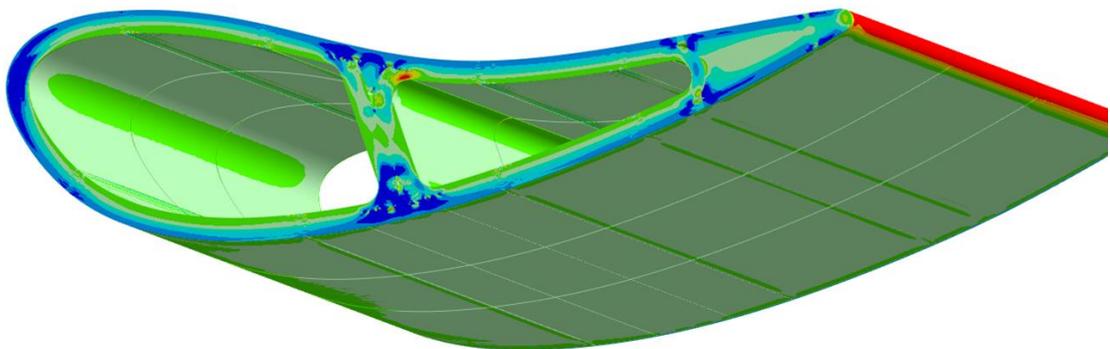
C: Static Structural
 Normal Stress - Hoop
 Type: Normal Stress(Y Axis)
 Unit: psi
 Solution Coordinate System
 Time: 1 s
 Deformation Scale Factor: 0.0 (Undeformed)

Figure 65. Linear elastic stresses in CMC vane test article in HPTC rig at the DDP 2B operating condition with nominal cooling. Shown are the normal stresses in the locally radial/spanwise (x), hoop (y) and interlaminar (z) directions

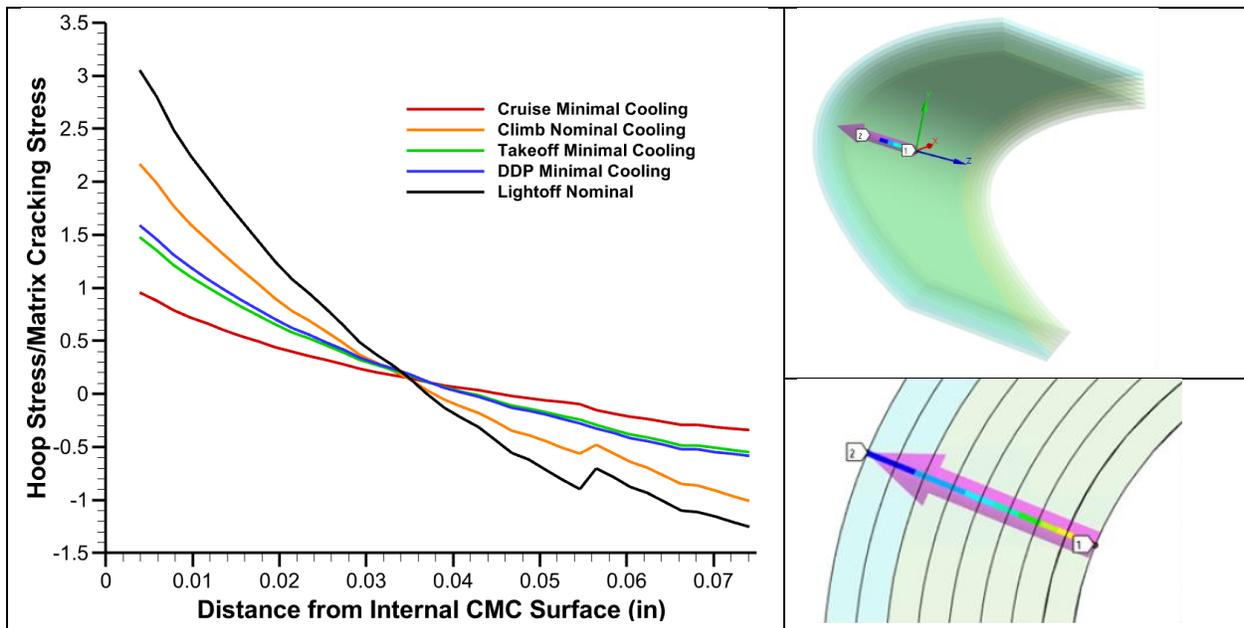
Figure 66. Variation of hoop stress through CMC plies at vane leading edge at test conditions in HPTC rig

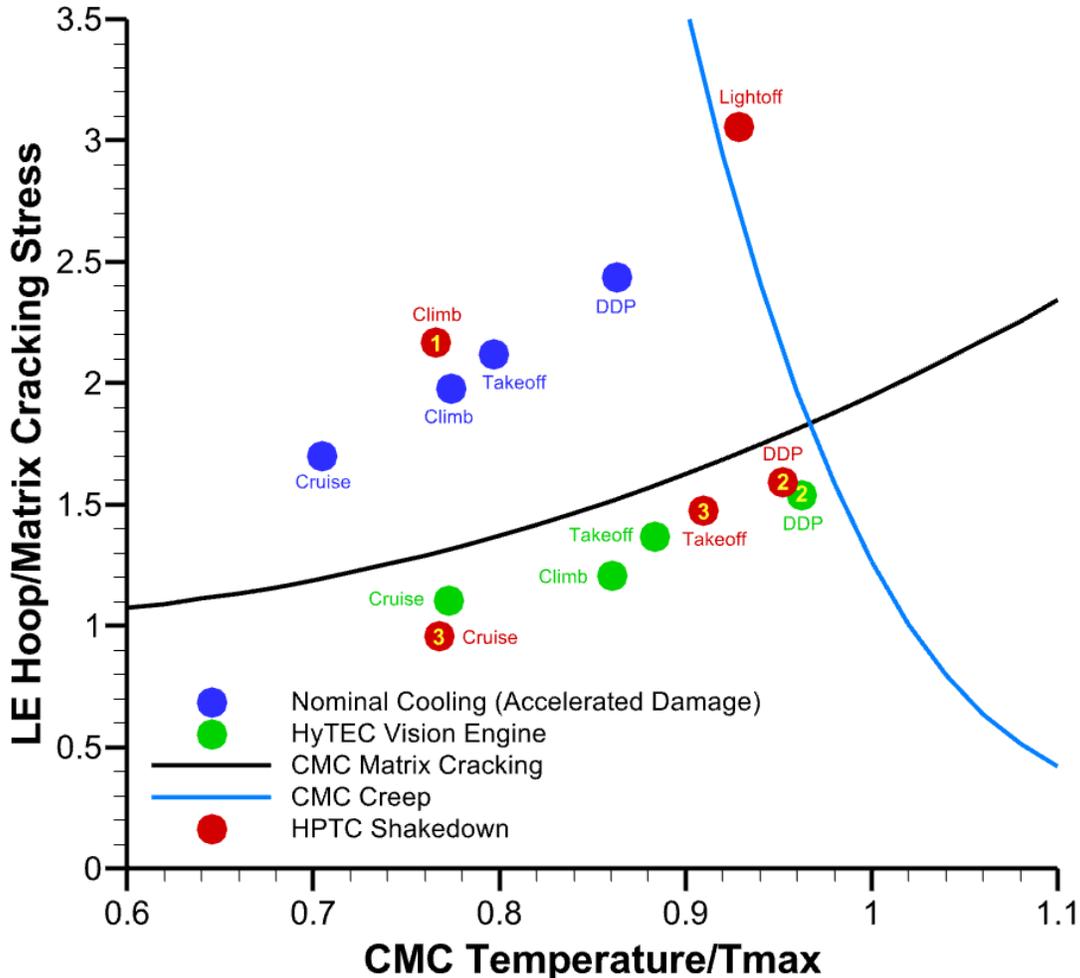
Figure 67. Summary of pretest predictions for hoop stress versus temperature at the internal surface of the CMC vane leading edge. Shown are results for the HyTEC Vision Engine cycle for both nominally cooled and minimally cooled CMC 2nd vanes and the equivalent test points planned for the HPTC rig

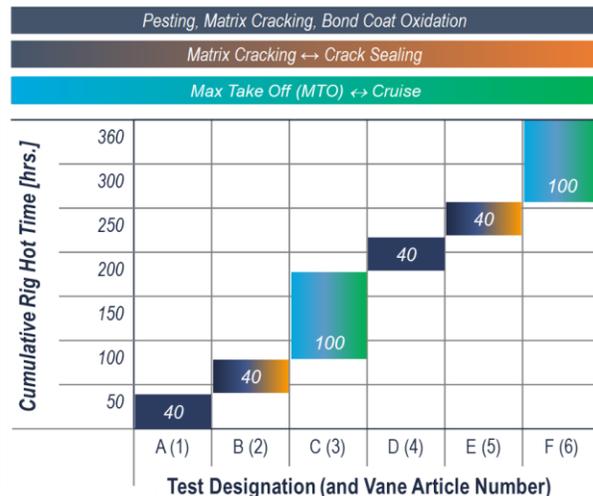
Figure 68. Planned test approach in the HPTC test rig

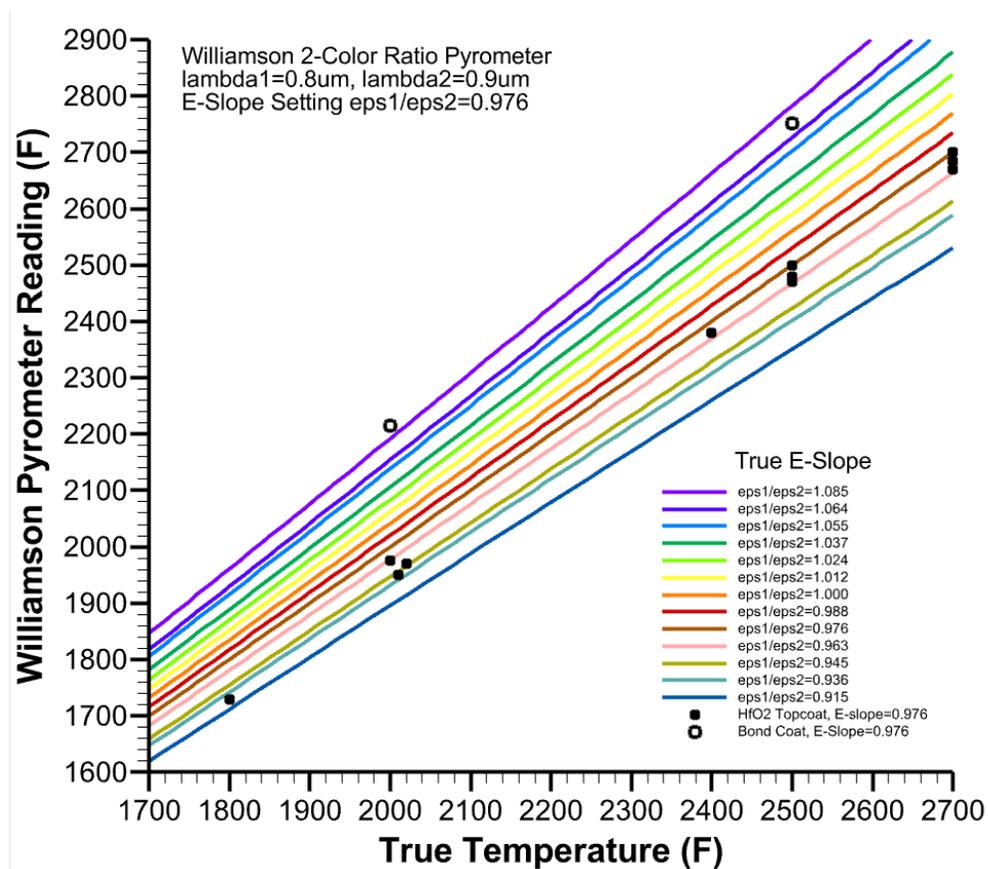
Figure 70. Data from RTRC procedure for measuring CMC and EBC emissivity and e-slope for Williamson dual wavelength pyrometers

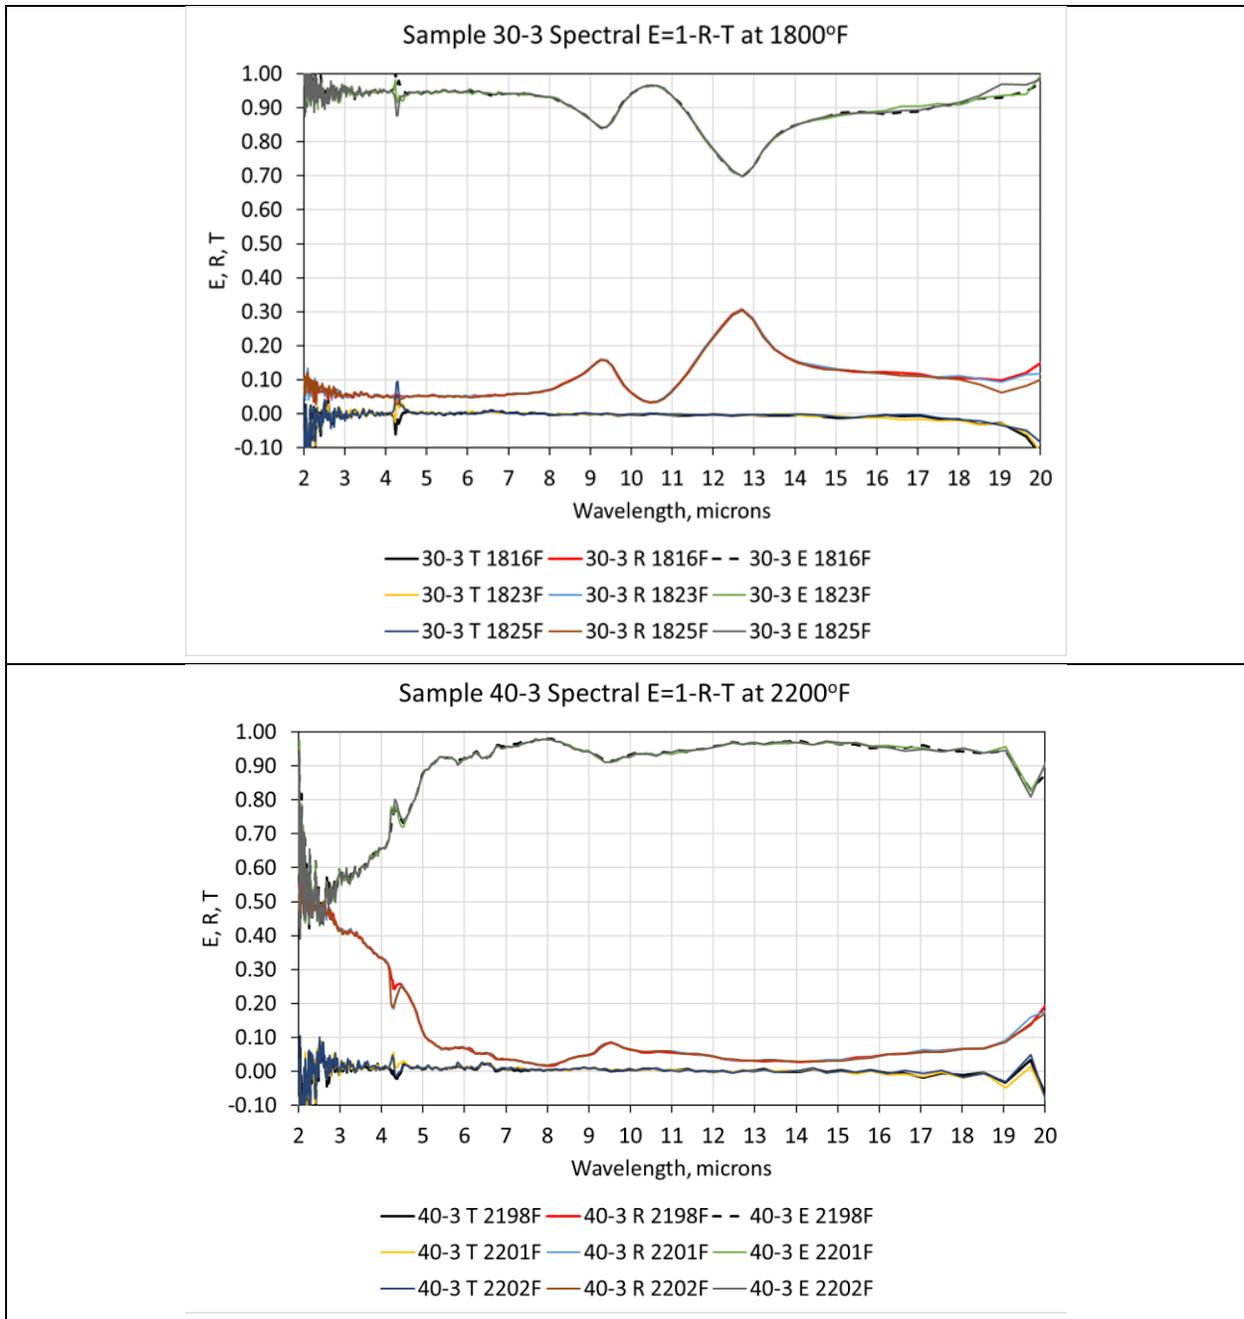
Figure 71. Spectral emittance, E, reflectance, R, and transmittance, T, of bare and coated CMC coupons measured by a spectral emissometer in 2-20 μm optical range.
