Test Results, Analysis, and Fluid and Structural Modeling of Noncontacting Finger Seals

*Margaret P. Proctor, Maria A. Kuczmarski, James C. Johnston, and Amy R. Stalker
Glenn Research Center, Cleveland, Ohio*

NASA/TM-20250003317

May 2025

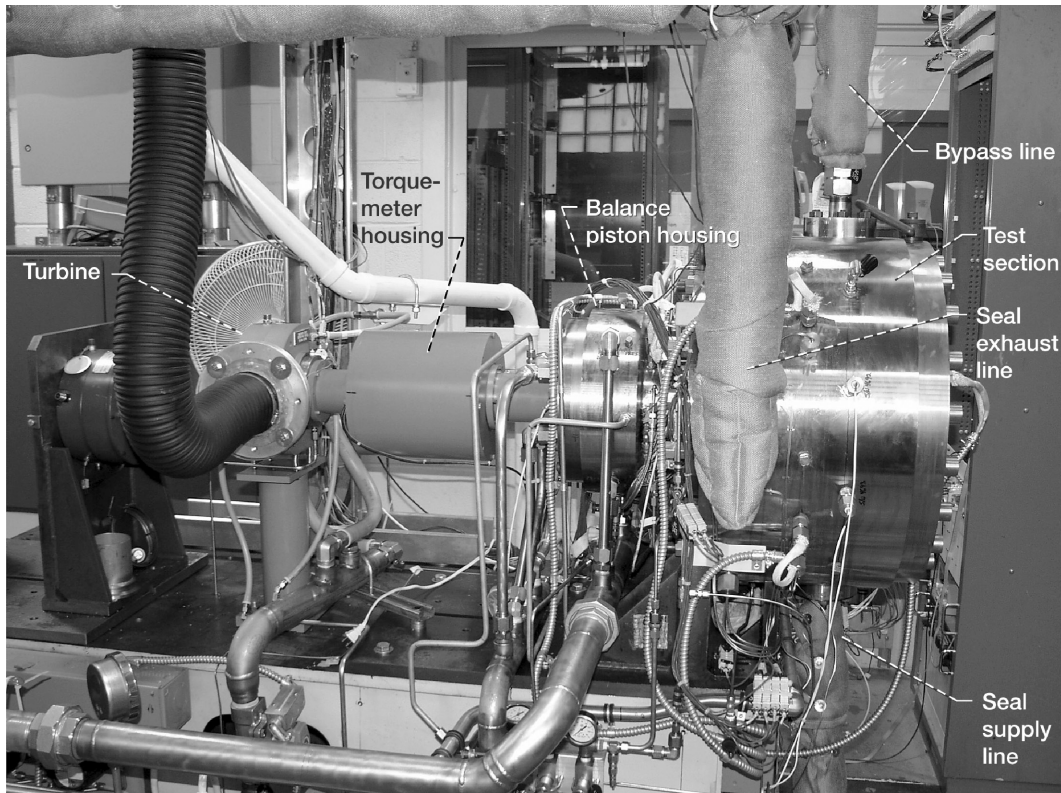
Figure 7.—High-Temperature, High-Speed Turbine Seal Rig.

Testing was conducted in the NASA High-Temperature, High-Speed Turbine Seal Test Rig shown in Figure 7 and located at the NASA Glenn Research Center in Cleveland, Ohio. The turbine seal test rig consists of a 21.6-cm-diameter test rotor mounted on a shaft in an overhung configuration. The shaft is supported by two oil-lubricated bearings. A balance piston controls the axial thrust load on the bearings from the pressure loads on the test rotor. An air turbine drives the test rig. A torque meter is located between the air turbine and the test rig and is connected to each by a quill shaft. The test seal is clamped into the Grainex Mar-M-247 seal holder as shown in Figure 8. A C-seal located at the holder-test seal interface prevents flow from bypassing the test seal at its OD. The seal holder is heated to approximately match the thermal growth of the rotor and prevent a damaging change in radial clearance. Heated, filtered air enters the bottom of the test rig and passes through an inlet plenum that directs the heated air axially toward the seal-rotor interface. The hot air either leaks through the test seal to the seal exhaust line or exits the rig before the test seal through a controlled bypass line at the top of the rig. If seal leakage is low, the bypass line must be open to maintain sufficient flow through the test rig to keep the rig hot.

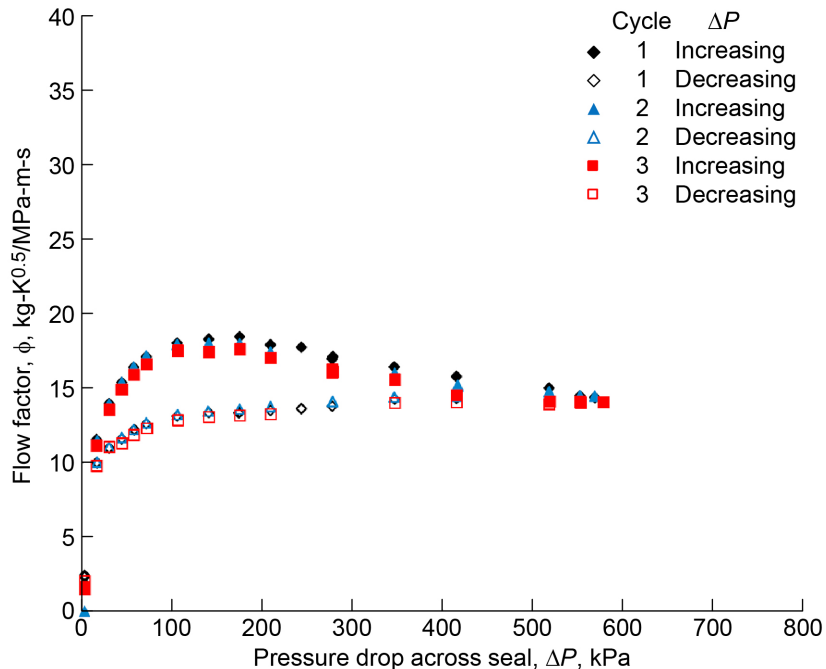
Figure 9.—Static leakage performance of baseline NCFS Build 1 at 276 to 294 K average inlet air temperature.

Comparison of Builds 1 and 2 seal leakage performance (Figure 9 and Figure 10, respectively) shows the effect of blocking the pinholes between the aft fingers; as expected, the flow factor for Build 2 is less than that of Build 1. Also, Build 2, which nearly completely blocks the gaps between the aft fingers, has less hysteresis than Build 1. Similarly, by comparing Figure 11 and Figure 12, one can see that Build 4, which also nearly completely blocks the gaps between the aft fingers, has lower leakage and less hysteresis than Build 3.

The effect of the axial thickness of the aft finger on leakage performance can be seen by comparing the leakage performance of Build 3 to Build 1 (Figure 11 and Figure 9, respectively). Build 3, which has an axial aft finger thickness nearly twice that of Build 1, shows much more leakage and hysteresis at the lower pressure differentials. However, for decreasing pressure differential, the Build 3 flow factor was less than that measured for Build 1. In Figure 11, the peak at ~ 35 kPa when decreasing the pressure differential for Build 3 is of particular interest. Also, the loop in cycle 2 resulted from an operator error that increased pressure differential when it should have been further decreased. Having an aft finger axial thickness nearly double that of Build 1, the Build 3 aft finger radial stiffness is twice that of Build 1, and the axial stiffness is 8 times greater. This greater finger stiffness may explain the Build 3 behavior. As pressure is first applied, the higher stiffness of Build 3 fingers would more greatly resist the pressure closing force than Build 1 and would result in higher flow factors. Once the pressure load moves the fingers to their closed or bound positions, frictional forces hold them in place. When the pressure is then decreased to the point that frictional forces are overcome, the higher spring rate of the finger causes a greater opening of the seal. The lower flow factor with decreasing pressure differential may be attributed to the smaller radial clearance for the aft finger in Build 3 compared to Build 1. The as-built radial clearance of the aft finger is $6.35 \mu\text{m}$ smaller for Build 3 than Build 1. Additionally, the axial length of the seal land on the lift pads of Build 3 is 1.36 times that of Build 1. From laminar flow theory it is known that the mass leakage rate is inversely proportional to the length of the seal land. Thus, the seal with the longer land would leak less.

Comparing Figure 9 for Build 1 to Figure 13 for Build 5a gives insight to the effect of the herringbone grooves since Build 5a is the same seal as Build 1, but on a smooth rotor. Note that the radial clearances for Build 5a are smaller than for Build 1. Despite this, Build 5a leakage levels out at a higher flow factor than Build 1 and has less hysteresis at about 150 kPa differential pressure than Build 1. The higher flow factors for Build 5a result because the smooth rotor has less resistance compared to the relatively rough herringbone grooves.

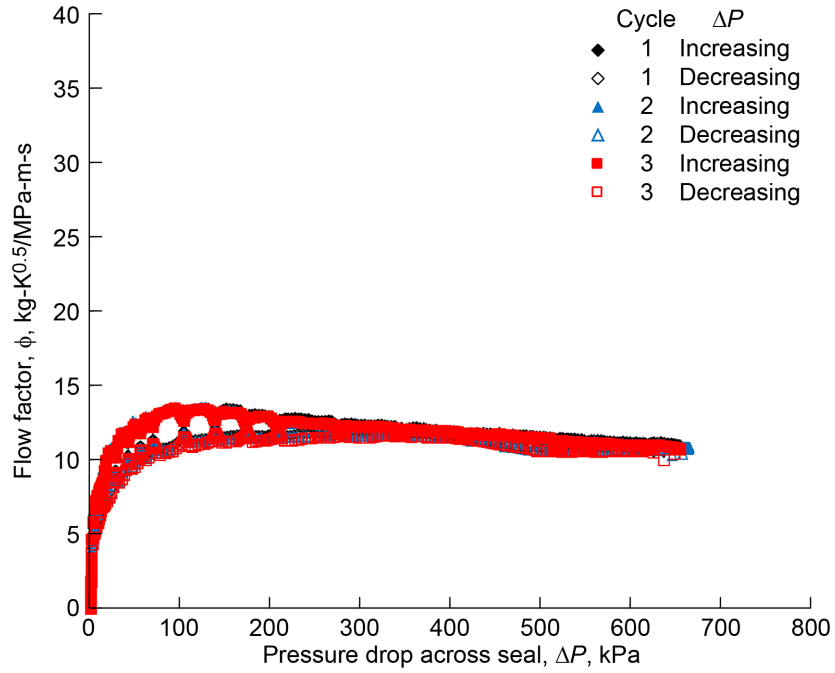
Figure 10.—Static leakage performance of NCFS Build 2 at 297 to 299 K average inlet air temperature.

Comparing the leakage performance of Build 2 to Build 4 (Figure 10 and Figure 12, respectively) also should reveal the effect of the aft finger axial thickness on leakage performance. Similar to the comparison of Builds 3 and 1, the at-build radial clearance of the aft finger is 6.35 μm smaller for Build 4 than Build 2, the aft axial finger thickness of Build 4 is nearly twice that of Build 2, and the axial length of the seal land on the lift pads of Build 4 is 1.36 times that of Build 2. Noting that the total flow area (Table II) for Build 4 is greater than for Build 2, one would expect the flow factors for Build 4 to be greater than those for Build 2. In fact, the data show the opposite. This result is attributed to the smaller aft finger radial clearance and longer seal land of Build 4. Further, the greater stiffness of the aft fingers likely reduces axial deflections or twisting that could change the flow area.

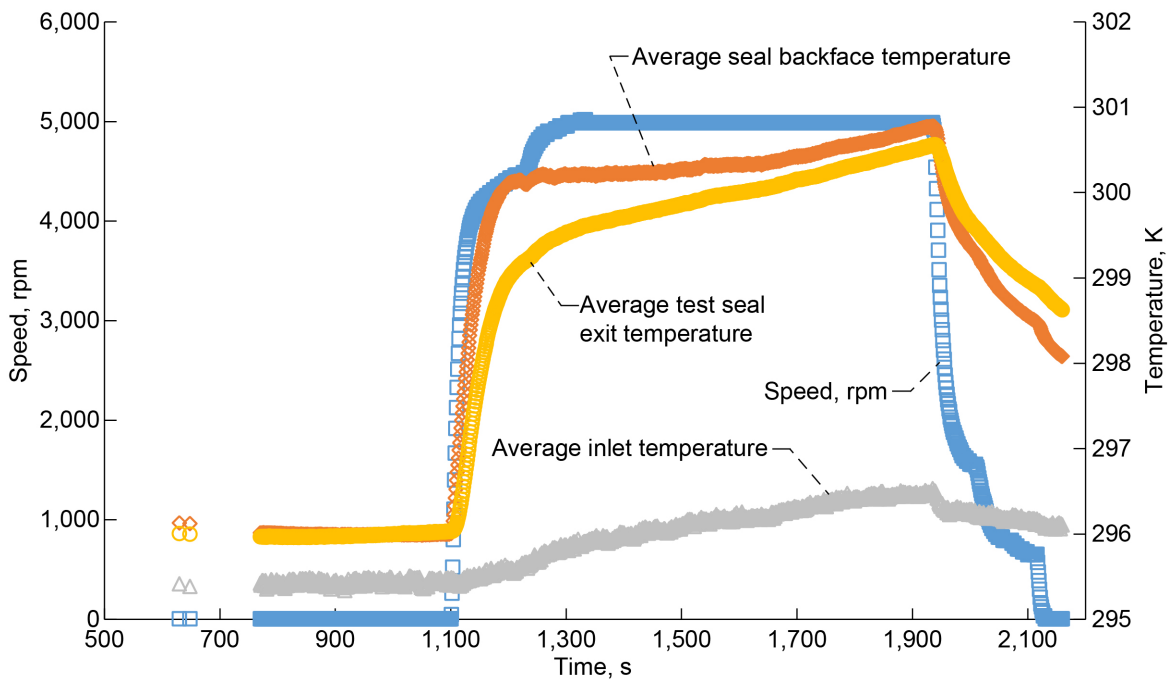
Figure 26.—Time history of speed and temperatures during lift-off test for NCFS Build 2.

The time history of the speed, average test seal inlet and exit air temperatures, and the average seal backface temperature during the lift-off test is shown in Figure 26. The seal backface temperature initially rises from 296 K to about 300 K, or about 4 K, over 100 s while the speed was increased from 0 to 5,000 rpm. It then continues to climb another 0.8 K even though the speed was constant to approximately 300.8 K, just before the speed was decreased. The heating observed is due to windage, and the continued increase in temperature at constant speed is expected since the test chamber is insulated. If rubbing wear occurred there would have been an initial spike in temperature followed by a decrease in temperature once the interference was worn away.

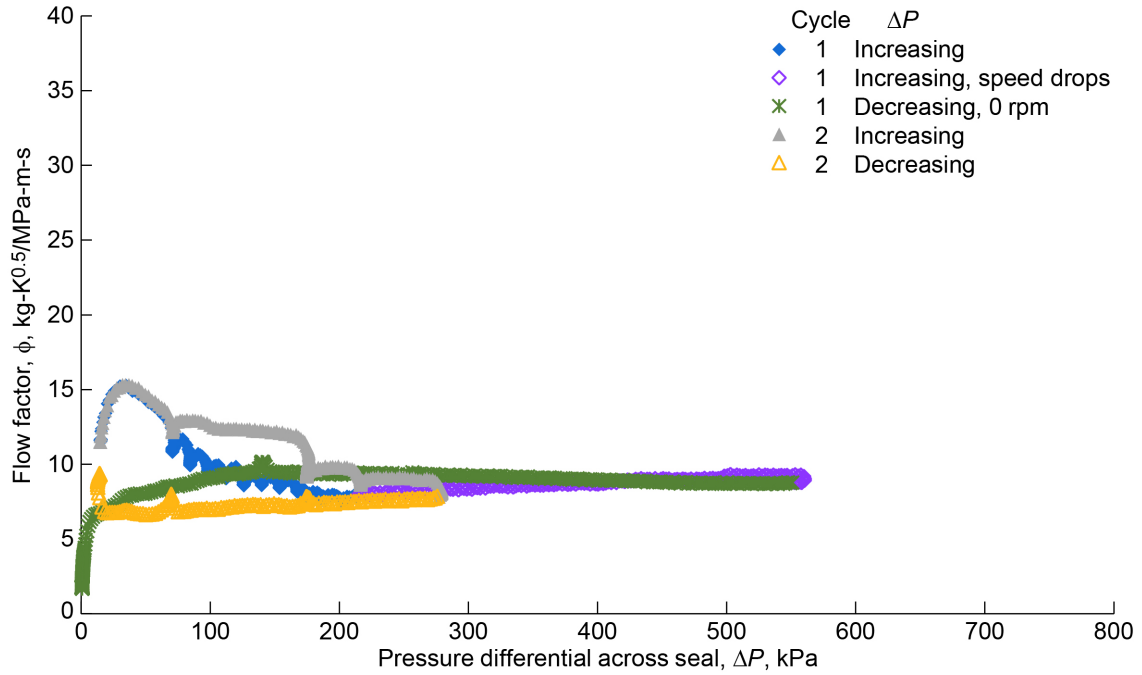
Figure 29.—Leakage performance of NCFS Build 7 at 5,000 rpm and average seal inlet air temperature of 291 K.

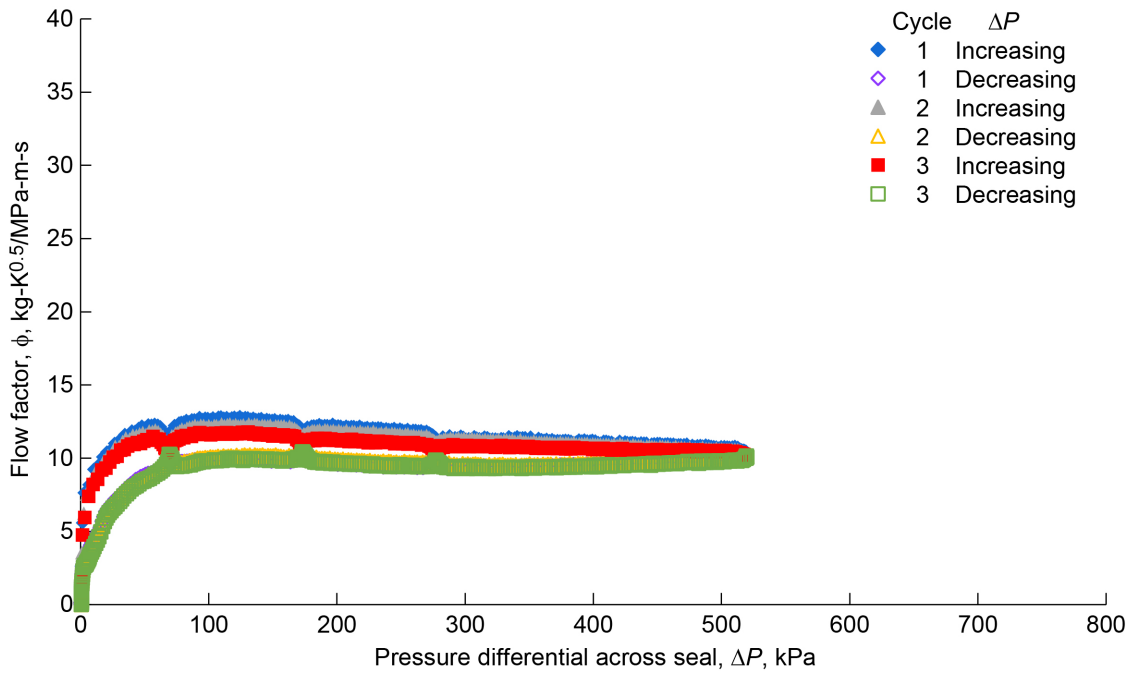
Figure 33.—Static leakage performance of NCFS Build 4 with new finger elements at average inlet air temperature of 289 K.

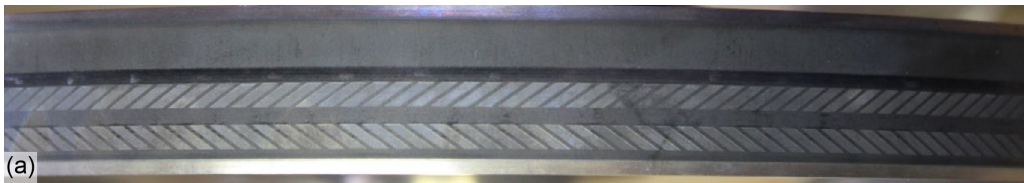
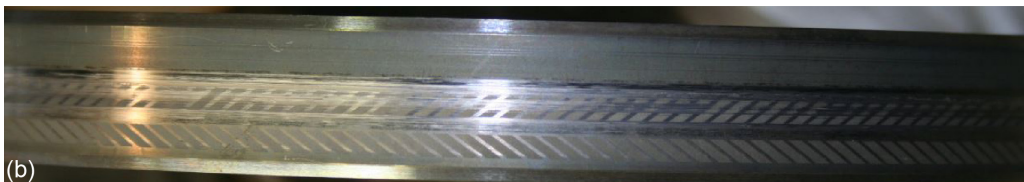
Figure 40.—Herringbone-grooved rotor used with NCFS Build 2. (a) Prior to static and dynamic performance tests. (b) After room-temperature performance test at 69 kPa pressure differential.

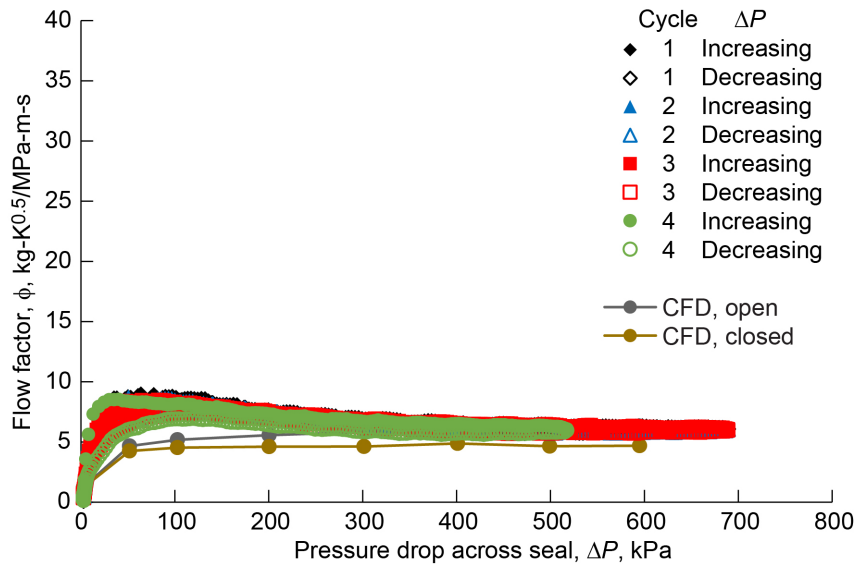
Figure 58.—Comparison of predicted and measured leakage performance of NCFS Build 4.
