Composite Overwrapped Pressure Vessel (COPV) Energetic Rupture and Intentional Burst Test Series

US Army Combat Capabilities Development Command (DEVCOM)

NASA/CR–20250004304

Final Report for
Composite Overwrapped Pressure Vessel (COPV)
Energetic Rupture and Intentional Burst Test Series

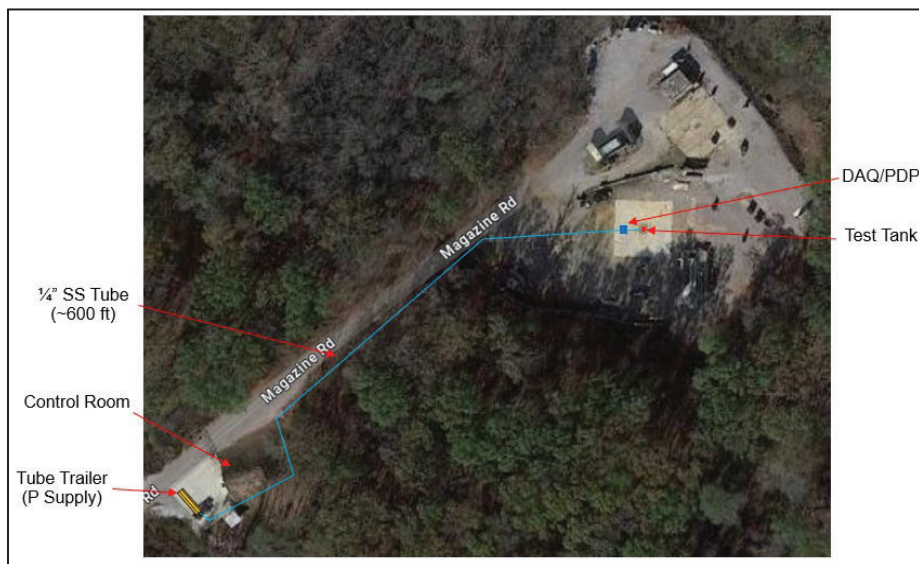
A significantly hazardous operation of this test series was the remote filling process of the gaseous nitrogen into the COPVs. Due to the hazardous nature of handling these COPVs once pressurized, it was decided that the COPVs would be filled at their desired rupture location. To accomplish this, the AvMC team decided to park the NASA-loaned nitrogen supply truck near the Snake Pit's control room and proceed to run ¼" stainless steel pressure tubing from the supply truck all the way down to the rupture location down-range. This distance was approximately 600ft and was routed in such a way to minimize any range vehicles from accidentally rolling over it. See below in Figure 4 for a schematic of this overall pressure filling system.

Figure 4: Schematic of COPV N₂ Fill System

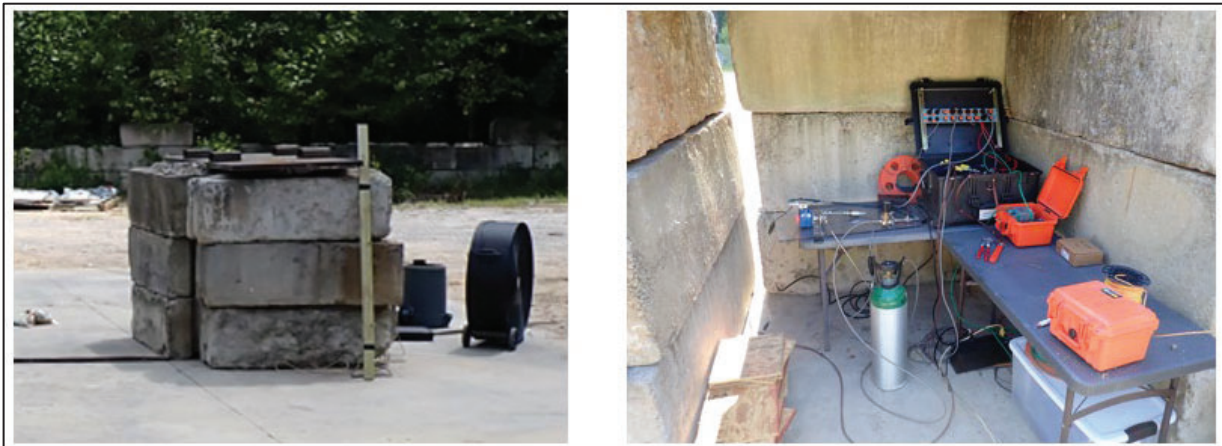
Due to the nature of this test series, fragments from the COPVs could be launched vertically and, on descent, impact this critical piece of equipment. Therefore, a protective bunker was erected using concrete ecology blocks and a thick steel plate roof to house and protect these critical components. Apart from the DAQ system, this protective bunker also housed the pressure distribution panel (PDP), a network switch, as well as other needed tools and supplies for conducting the test series. See below in Figure 8 for pictures of the outside and inside of this protection bunker.

Figure 8: Equipment Protection Bunker, Outside (L), Inside (R)

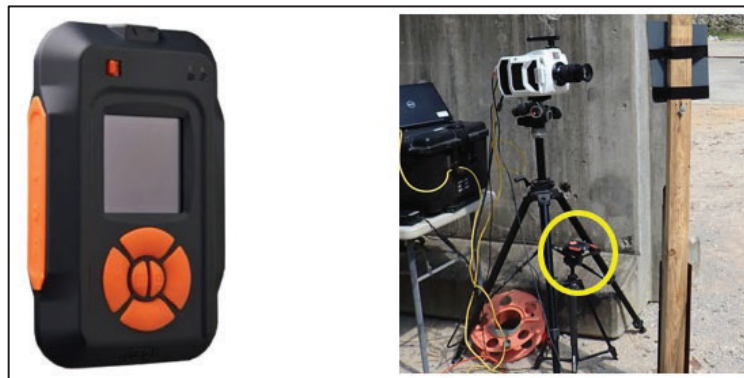
Figure 16: MIOPS Acoustic Trigger System (L), and Implementation (R)

Depending on the type of test, one of two different camera triggering systems were used. For the intentional rupture testing, the digital trigger sequencer that's built into the Data Acquisition System (DAQ) was used to simultaneously trigger the cameras, the data recorder, and the detonator initiation system. For the pressurize-until-burst testing, the team had no idea when the tank would eventually burst so a passive camera trigger system was used for these tests. The MIOPS® camera trigger system is a commercially available product that has various built-in features to allow for different external inputs to tell a camera to trigger. In this case, the test team used its acoustic trigger feature that will sense a loud noise event and subsequently send the trigger pulse to the cameras. Within the acoustic trigger feature, a sensitivity level is set based on how loud the event is expecting to be. In order to properly dial this ideal sensitivity level in, the system was studied during the intentional rupture testing to get the sensitivity level dialed in to a reliable zone. This acoustic trigger feature ended up successfully triggering cameras for each of the pressurize-until-burst tests, resulting in full data capture throughout the whole test series. See below in Figure 16 for a picture of the MIOPS® acoustic trigger system and how it was implemented with the high-speed cameras.

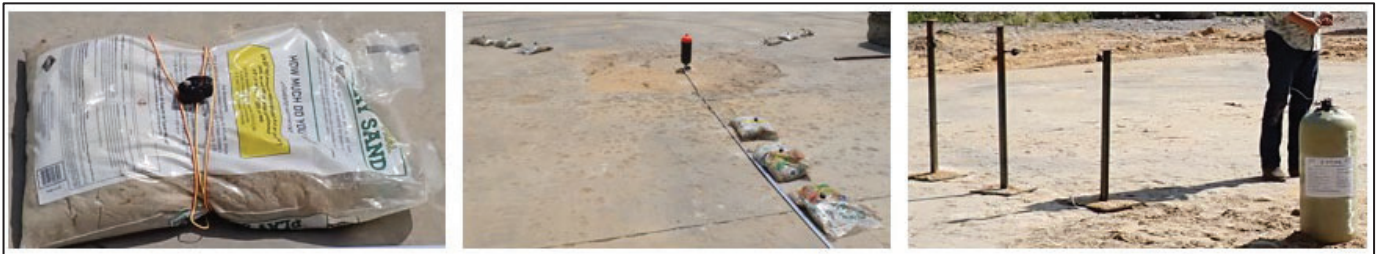
The first type of measurement device used is the commercially available Black Box Biometrics Inc's Blast Gauge System®. The AvMC test team refers to these devices as BOP sensors. These BOP sensors were developed for soldiers to wear during combat operations to passively collect data on blast overpressure events for tracking traumatic brain injury trends. As such, BOPs are incredibly rugged, battery powered, and store all blast overpressure event data using an onboard storage system. The sensors are programmed to automatically and passively record the pressure waveform when they experience a pressure event greater than 0.5 psi. One downside of this system is that they are factory calibrated so it's hard to verify that the data that they've recorded is accurate. These devices were used for COPV tests 1-16. For some of the tests, the BOP sensors were tied to sandbags (to limit movement from blast wave) and placed at ground level in three (3) different arrays of three (3) sensors at differing distances from the tank. For some of the later tests, when additional blast overpressure measurement devices were used, they were mounted to a 3 ft tall post at similar distances from the tank. See below in Figures 17 and 18 for images of the BOP sensor features as well as how they were implemented for this test series.

Figure 18: BOP Sensor Implementation Methods: Mounted to Sandbag (L), BOP Sensor Array (C), Mounted to Poles (R)

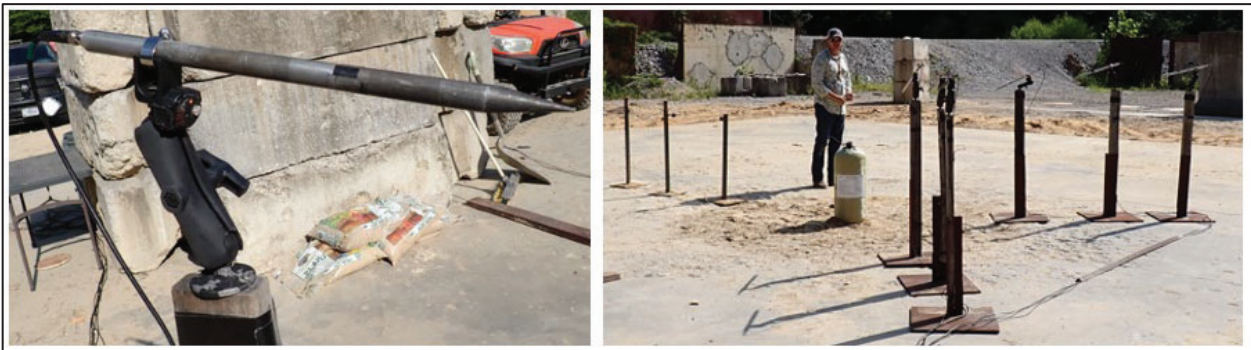
The second type of blast overpressure measurement used is the PCB Inc's piezoelectric pencil gauge system. The AvMC team refers to these as pencil gauges. Effectively, it's a long aluminum rod with a pointed tip and a piezoelectric pressure sensor mounted on a machined flattened surface of the rod that runs the length. When a blast wave passes down the length of the gauge, any disruptions caused by wrapping around the shaft are dissipated by the point on the front and the resultant pressure wave recorded by the sensor is a true representation of pressure versus time. These gauges are the industry standard for measuring free field blast overpressure events. These pencil gauges were AvMC calibrated to NIST standards within 1 calendar year of their use. The gauges utilize a PCB signal conditioner system to provide excitation voltage to the sensor and the resultant data is recorded on AvMC's National Instruments Data Acquisition (DAQ) chassis at 1 million samples/second. These sensors were used for tests 10-16 of this COPV test series. Each pencil gauge was mounted to a 4ft tall pole with an adjustable ball joint arm and, as recommended, each of the pencils were aimed directly at the source of the overpressure event (the COPV tank). Six (6) pencil gauges were utilized for each test, in two (2) arrays of three (3) sensors each. See Figure 19 below for an image of the mounting setup and sensor array for these pencil gauges used in this test series.

Figure 19: Pencil Gauge Mounting Hardware (L), Sensor Array (R)

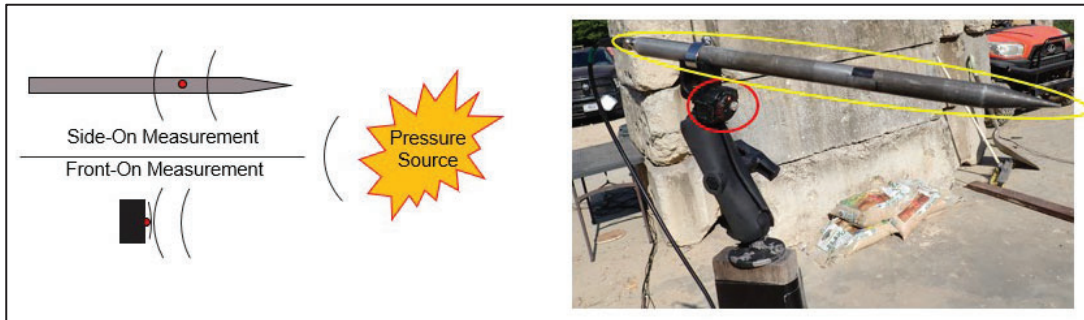
pressure source. For these tests, it is highly likely that compression stacking occurred on the BOP sensors and the resulting BOP pressure data will read higher values than the data recorded on the nearby pencil gauge. See Figure 20 below for a visual schematic showing the difference between front-on and side-on configuration, as well as a picture of this BOP/pencil mounting method.

Figure 20: Side-On vs Front-On Measurement (L), Pencil/BOP Combo Mount (R)

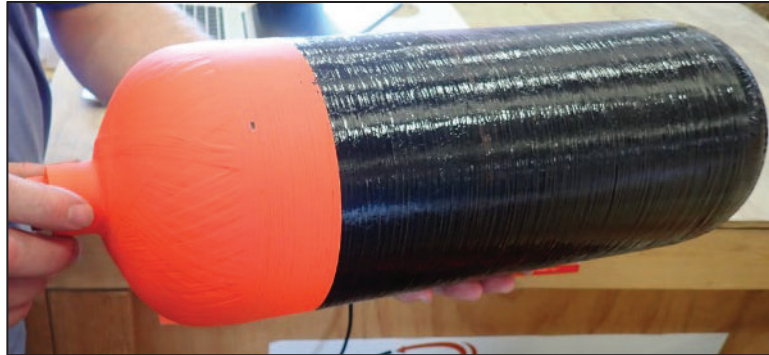
Figure 22: General Dynamics Type III COPV

In all, six (6) different Composite Overwrapped Pressure Vessels (COPVs) were tested in this test series. The first one tested was manufactured by General Dynamics and was considered a Type III COPV (contains an aluminum liner with a carbon fiber composite overwrap). The volume of this General Dynamics tank is 8.2L (2.16 Gal), has a rated working pressure of 4,300

psi and a design burst pressure of 6,450 psi. See Figure 22 below for an image of this General Dynamics COPV.

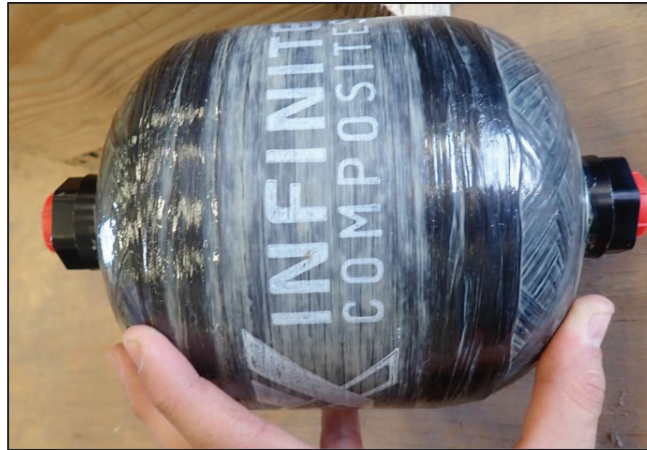
Figure 24: Infinite Composites Small Type IV COPV

The next type of COPV tested was manufactured by Infinite Composites and was considered a Type IV COPV (contains plastic liner with a carbon fiber composite overwrap). The volume of this Infinite Composites tank is 1.9L (0.5 Gal) and is the smaller variant of the Infinite Composites tanks tested in this series. Since there is another model of Infinite Composites tanks being tested, this variant will be referred to as Infinite Composites Small COPV. This tank has a working pressure of 4,496 psi and a design burst pressure of 8,992 psi. See Figure 24 below for an image of this Infinite Composites Small COPV.

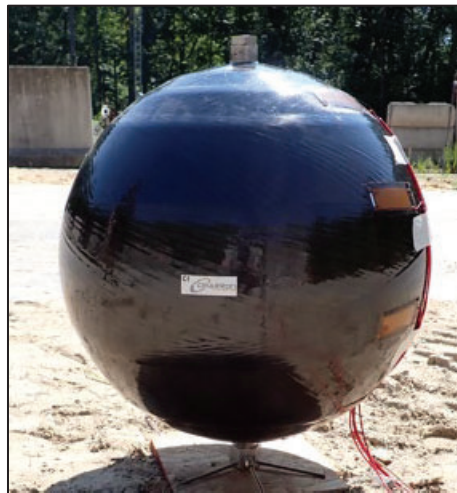
Figure 25: Cimarron Type V COPV

The next type of tank tested was manufactured by Cimarron and was considered a Type V COPV (contains no inner liner, except for metallic bosses, and is purely a carbon fiber composite overwrap). The volume of this Cimarron tank is 113.6L (30 Gal), has a rated working pressure of 500 psi and a design burst pressure of 1,000 psi. See Figure 25 below for an image of this Cimarron COPV.

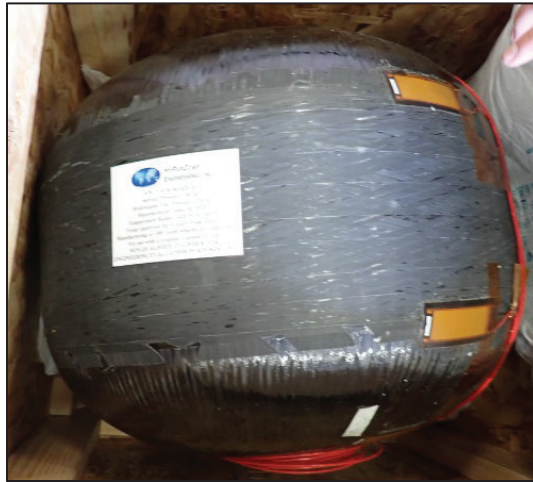
Figure 26: HyPerComp Type V COPV

The next type of tank tested was manufactured by HyPerComp and was considered a Type V COPV (contains no inner liner and is purely a carbon fiber composite overwrap). The volume of this HyPerComp tank is 128.7L (34 Gal), has a rated working pressure of 50 psi and a design burst pressure of 100 psi. The reason the rated pressure levels are so low is because this particular model was designed and intended for high cycle usage. By rating the tank at a lower pressure level, they could get a longer life cycle out of each tank before wear and tear occurs. In actuality, these tanks can hold higher pressures than this. See Figure 26 below for an image of this HyPerComp COPV.

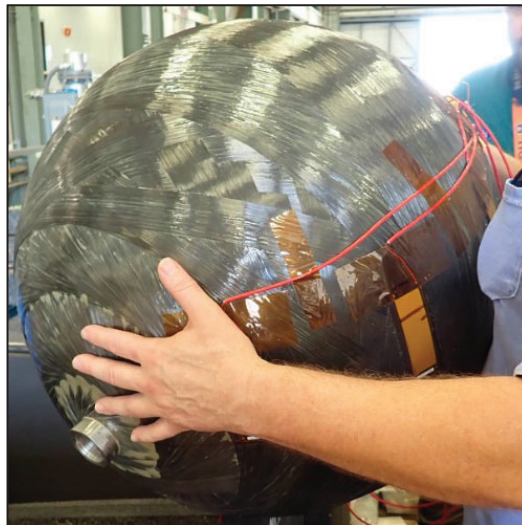
Figure 27: Infinite Composites Large Type IV COPV

The final tank tested was manufactured by Infinite Composites and is also a Type IV COPV (plastic inner liner with carbon fiber composite overwrap). The volume of this tank is 113.6L (30 Gal) and will be referred to as the Infinite Composites Large COPV for the remainder of this report. The rated working pressure of this Large COPV is 500 psi and the design burst pressure is 1,000 psi. See Figure 27 below for an image of this Infinite Composites Large COPV.

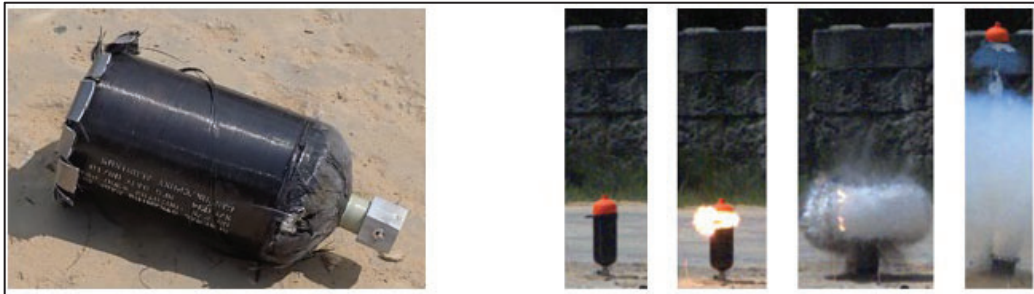
Figure 28: Test 1 General Dynamics Tank Post-Test (L) and During Separation (R)

The energetic rupture test event occurred at 1408 CDT under partly cloudy skies, 86.7°F, 65% relative humidity, and a wind-speed of 4.2 mph SSE. The det cord successfully ruptured and separated the tank, as desired. See Figure 28 below for images of the tank during and after test.

Essentially, the top boss separated in-tact and was propelled upwards. The rest of the tank and valve components were driven down into the sand pit so no velocity calculations were generated for them. Though the top boss was not recovered, the mass was estimated to be 1,080 grams (based on the pre-test mass subtracted by the remaining post-test frags) and was estimated to be approximately 6.5” diameter and 7” long. See Table 5 below for a chart of the test’s frag velocity summary.

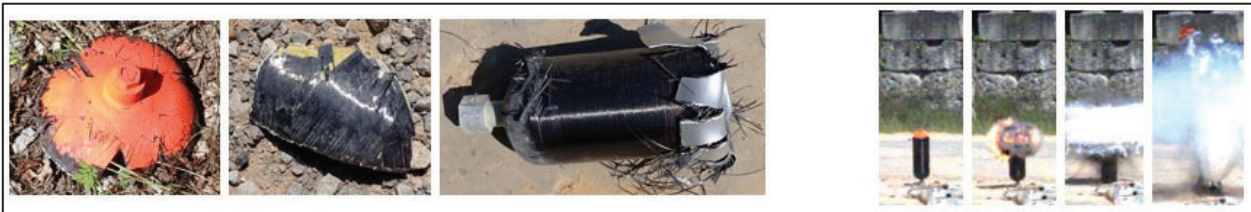
Figure 31: Test 2 General Dynamics Tank Post-Test (L) and During Separation (R)

The energetic rupture test event occurred at 1042 CDT under partly cloudy skies, 84.7°F, 52% relative humidity, and a wind-speed of 0.3 mph W. The det cord successfully ruptured and separated the tank, as desired. See Figure 31 below for images of the tank during and after test.

Upon post-test evaluation, the head boss fragmented into three fragments that were propelled upwards, while the remaining tank and valve components were driven down into the sand. These three propelled fragments were successfully recovered in the area after the test so a full analysis of mass, size, and velocity can be derived. See Table 6 below for a chart of the test's frag velocity summary.

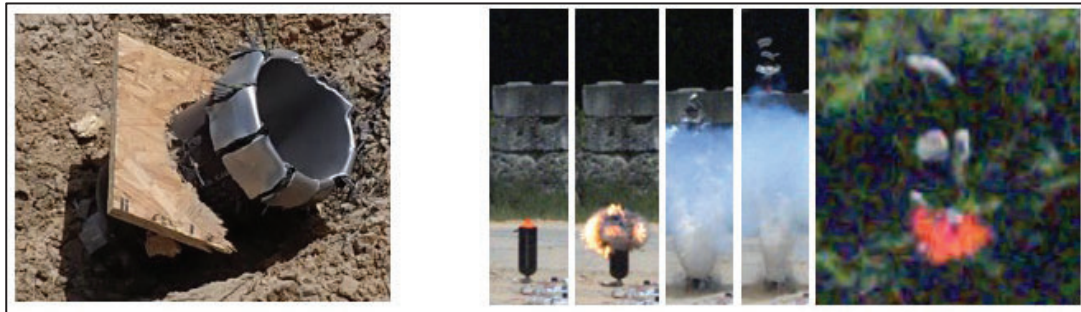
Figure 34: Test 3 General Dynamics Tank Post-Test (L) and During Separation (R)

The energetic rupture test event occurred at 1204 CDT under mostly cloudy skies, 87.8°F, 47% relative humidity, and a wind-speed of 2 mph NW. The det cord successfully ruptured and separated the tank, as desired. See Figure 34 below for images of the tank during and after test.

Upon post-test evaluation, the head boss fragmented into four separate fragments that were propelled upwards, while the remaining tank and valve components were driven into the sand. These four propelled fragments were not recovered after the test, as they had been likely thrown outside the immediate test area. Therefore, no mass or size can be deduced from the fragments. See Table 7 below for a chart of the test's frag velocity summary.

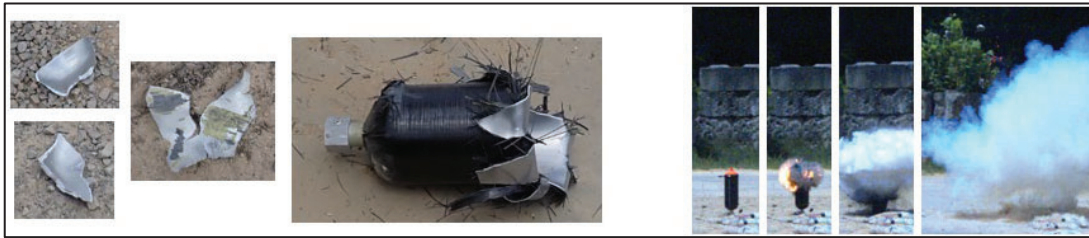
Figure 37: Test 4 General Dynamics Tank Post-Test (L) and During Separation (R)

The energetic rupture test event occurred at 1320 CDT under mostly cloudy skies, 86°F, 53% relative humidity, and a wind-speed of 0.5 mph S. The det cord successfully ruptured and separated the tank, as desired. See Figure 37 below for images of the tank during and after test.

Upon post-test evaluation, the head boss fragmented into four fragments that were propelled upwards, while the remaining tank and valve components were driven down into the sand. Three of the four fragments were recovered post-test so a full analysis of mass, size, and velocity can be derived for those. The one frag that was not recovered was assumed to be the remaining weight left over from the total initial weight minus the recovered frags and size dimensions were assumed for it as well. See Table 8 below for a chart of the test's frag velocity summary.

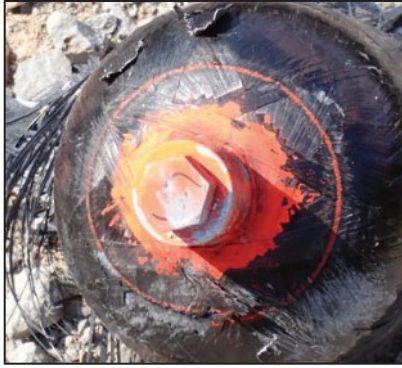
Figure 43: Test 5 Det Cord Impression on COPV Dome

One of the fragments collected after the bullet impact was the top dome area. The line that the det cord sat on is still visible and clearly did not make much of a dent in penetrating the aluminum liner underneath. As the liner approaches the top boss end, the aluminum material gets progressively thicker. In all of the prior tests, the det cord was placed at locations where the liner was much thinner and resulted in successful rupture events. See Figure 43 below for an image of the det cord impression made on the COPV dome.

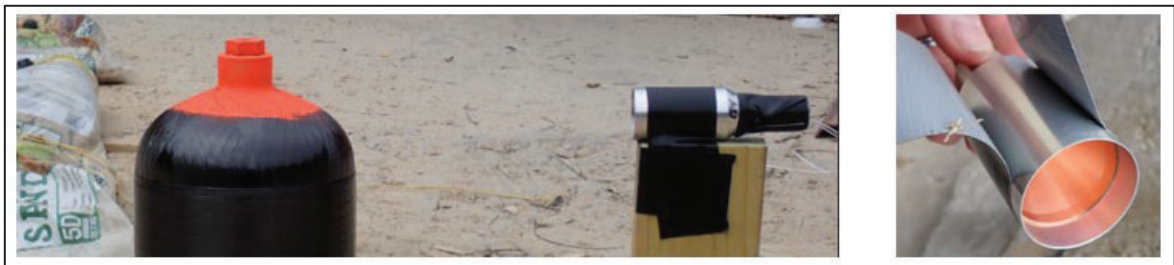
Figure 44: Test 6 Conical Shaped Charge Setup (L) and Standalone Picture (R)

Since, in the prior test, the det cord was not successful in penetrating that thicker aluminum area, the AvMC and NASA teams collectively agreed upon a new plan to change the cutting charge for the successive test. The team chose to utilize a more traditional conical shaped charge to guarantee a hole punched through the tank. The AvMC team chose the smallest conical shaped charge in their inventory, a small precursor munition from an Army missile system. A conical shaped charge is similar to the mechanism in flex linear, except that the penetrating charge starts off as an inverted cone of malleable metal (typically copper), with explosive material packed behind it. Upon detonation of the explosive material, the cone is rapidly deformed into a linear jet and is propelled forwards at high speed. This style of shaped charge is commonly used in military applications as armor penetrating warheads for punching deep holes in heavy armor.

Test 6 was, therefore, an energetic rupture test on the General Dynamics COPV, with a conical shaped charge being the energetic rupture mechanism aimed right at the boss layer. See Figure 44 below for images of this conical shaped charge and how it was oriented for the test.

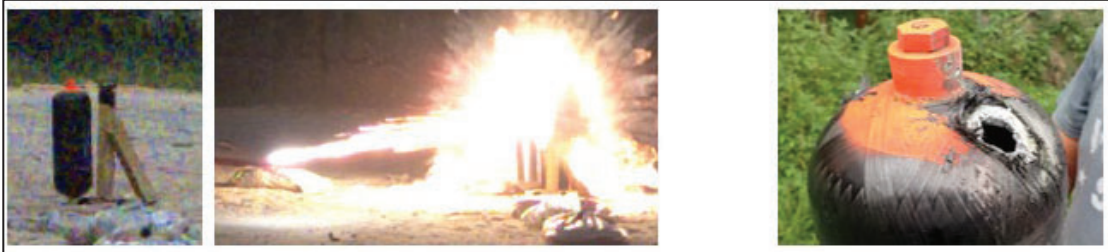
Figure 45: Test 6 General Dynamics Tank During Penetration (L) and Post-Test (R)

The energetic rupture test event occurred at 1116 CDT under cloudy skies, 79.1°F, 77% relative humidity, and a wind-speed of 0.1 mph NNW. The shaped charge jet successfully penetrated the tank, leaving entry and exit holes, but did not cause a rupture. See Figure 45 below for images of the tank during and after test.

As seen in the above Figure, the jet was successful in penetrating straight through the entire tank at the desired rupture location. However, since it was more of a straight hole-punch mechanism, the COPV now had two holes (jet entry and exit) from which to quickly purge the nitrogen gas inside. The purging of nitrogen through these two holes caused a diverging nozzle effect, which propelled the tank away from the rupture location. Effectively, the tank was first propelled downward into the sand but, upon impact with the ground, spun around and was propelled out of the immediate test area. The tank was found about 80 feet away in tall grass near the perimeter of the test area. The velocity of this secondary propulsion event was indeed captured and documented below in Table 9.

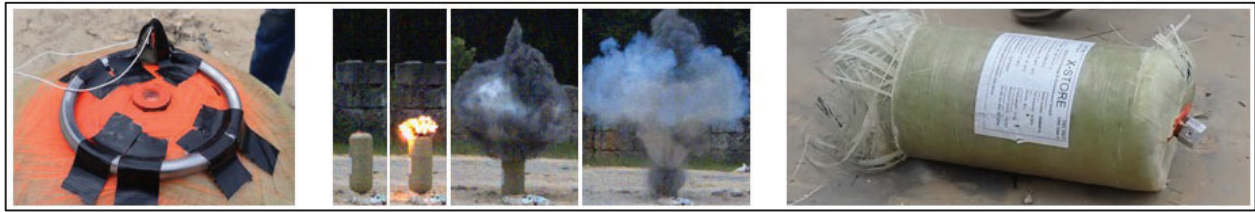
Figure 54: Test 8 Xperion Tank Pre-Test (L), Mid-Test (C), and Post-Test (R)

The energetic rupture test event occurred at 1504 CDT under mostly cloudy skies, 83.1°F, 60% relative humidity, and a wind-speed of 0.2 mph WNW. The flex linear was successful in cutting open the tank, as desired. See Figure 54 below for images of the tank before, during, and after the test.

Upon post-test evaluation, the head boss fragmented into a few very small fragments propelled upwards but most of the tank was driven straight down into the sand. The fragments that were seen flying upwards were not positively recovered so no size or mass measurements can be derived. See Table 13 below for a chart of the test's frag velocity summary.

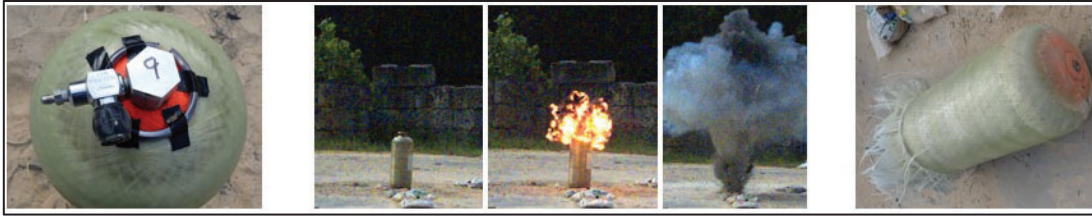
Figure 57: Test 9 Xperion Tank Pre-Test (L), Mid-Test (C), and Post-Test (R)

The energetic rupture test event occurred at 1618 CDT under mostly cloudy skies, 83.1°F, 63% relative humidity, and a wind-speed of 0.5 mph S. The flex linear was successful in cutting open the tank, as desired. See Figure 57 below for images of the tank before, during, and after the test.

Upon post-test evaluation, the manifold boss fragmented into a few small fragments propelled upwards but most of the tank was driven straight down into the sand. Some of the fragments seen flying upwards were not positively recovered but they appeared to be the broken ball valve and knob, as captured in previous tests. Therefore, assumed sizes and masses were applied to their respective velocities. Additionally, the main boss/manifold was not positively identified in either camera 1 or 3 because the nitrogen cloud occluded the view. However, it was positively identified in camera 4 because the view was zoomed out enough to see the whole cloud. Therefore, 2-dimensional velocity and angle were derived from that view. See Table 14 below for a chart of the test's frag velocity summary.

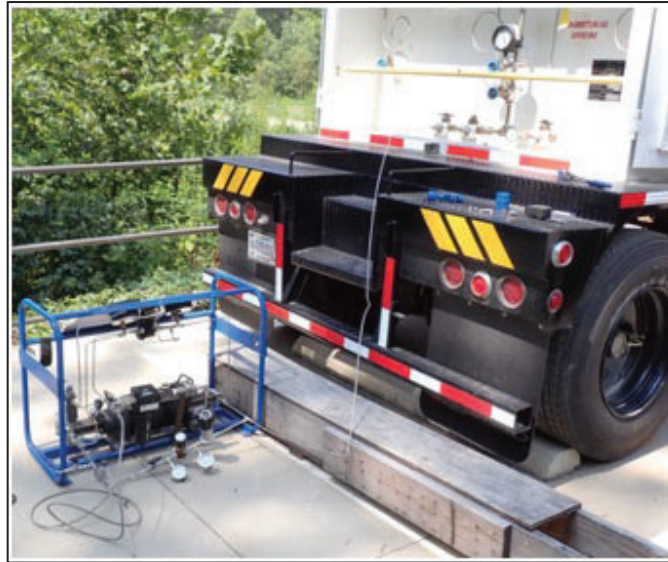
Figure 72: N₂ Supply Truck with Pressure Intensifier

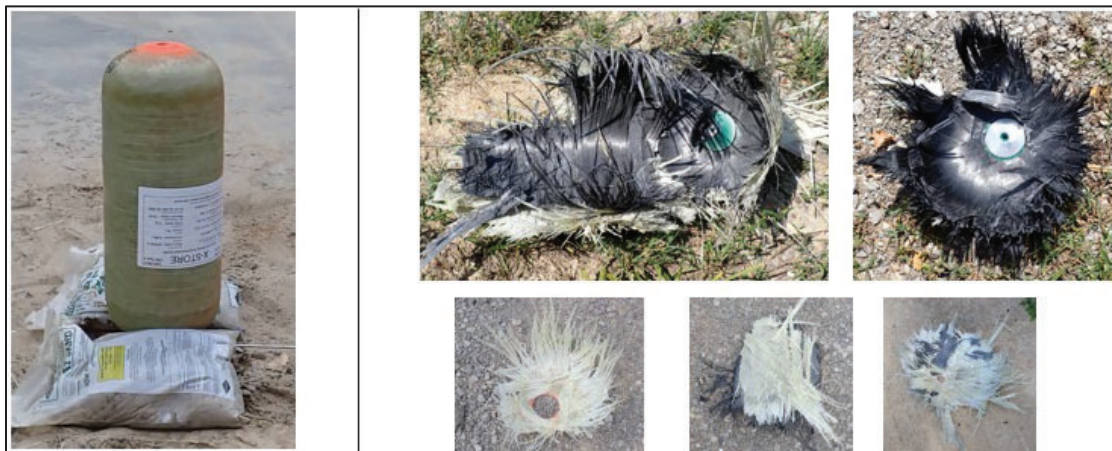
Figure 77: Test 25 Xperion Tank Pre-Test (L) and Post-Test (R)

See below in Figure 77 for images of the tank before and after test.

The burst event was significantly more violent than the energetic rupture tests. The head boss, plastic liner and composite layers were positively identified in the video and recovered post-test. However, many other smaller fragments of liner and composites were thrown in all directions and were significantly harder to analyze or recover. Three fragments were positively identified in the high-speed video views and Table 20 below shows a chart of the resulting frag velocity summary.

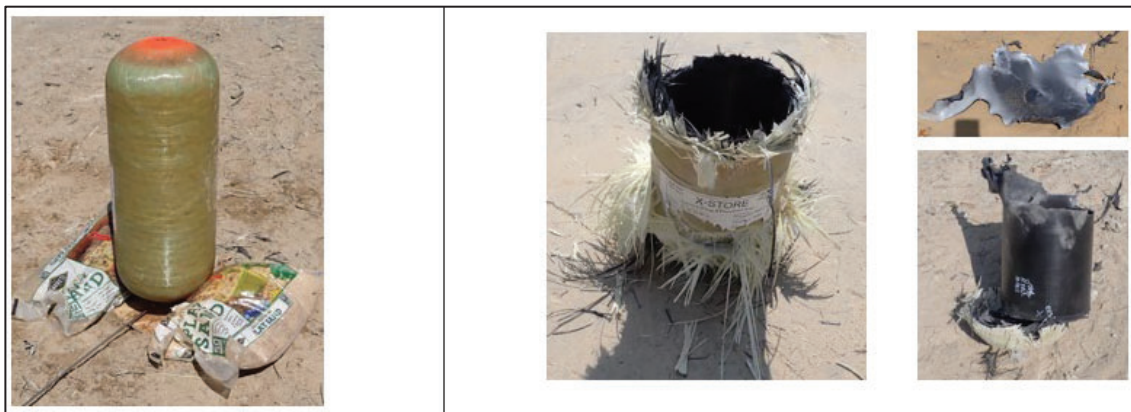
Figure 80: Test 26 Xperion Tank Pre-Test (L) and Post-Test (R)

The burst event was significantly more violent than the energetic rupture tests. The head boss, plastic liner and composite layers were positively identified in the video and recovered post-test. However, many other smaller fragments of liner and composites were thrown in all directions and were significantly harder to analyze or recover. Three fragments were positively identified in the high-speed video views and Table 21 below shows a chart of the resulting frag velocity summary.

See below in Figure 80 for images of the tank before and after test.

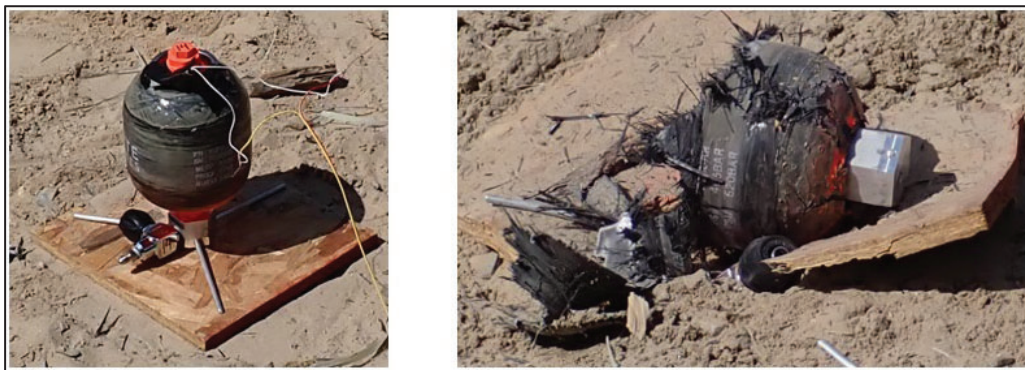
Figure 82: Test 14 Infinite Composites Small Tank Pre-Test (L) and Post-Test (R)

Upon post-test evaluation, the head boss fragmented into three fragments propelled up and outwards, while the remaining tank and valve components were driven down into the sand. The two composite fragments were not positively recovered, therefore, only velocity magnitudes

The energetic rupture test event occurred at 1520 CDT under mostly cloudy skies, 88.9°F, 51% relative humidity, and a wind-speed of 1 mph SSE. The flex linear was successful in cutting open the tank, as desired. See Figure 82 below for images of the tank before and after the test.

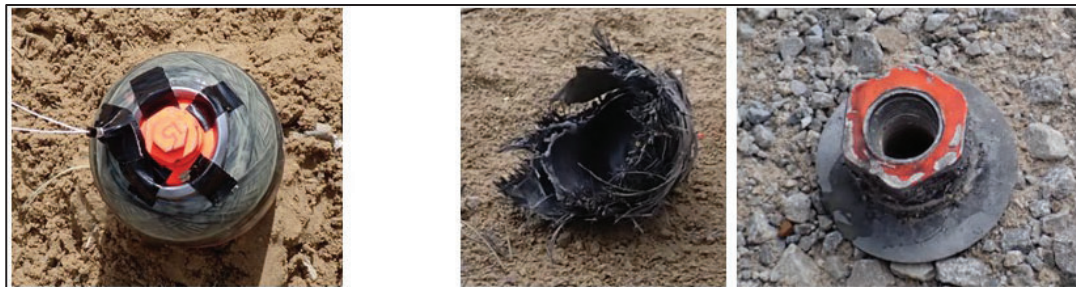
Figure 85: Test 15 Infinite Composites Small Tank Pre-Test (L) and Post-Test (C) (R)

Upon post-test evaluation, the head boss fragmented into five fragments propelled up and outwards, while the remaining tank and valve components were driven down into the sand. The top metallic portion of the boss was indeed recovered, but the composite portions were not. The plug that was installed in the top boss was also separated and seen as a frag in the high-speed video. Though it was not recovered, the pre-test knowledge of the plug allowed the team to assign a realistic mass for it. See Table 24 below for a chart of the test's frag velocity summary.

The energetic rupture test event occurred at 1013 CDT under partly cloudy skies, 78.6°F, 69% relative humidity, and a wind-speed of 2 mph SE. The flex linear was successful in cutting open the tank, as desired. See Figure 85 below for images of the tank before and after the test.

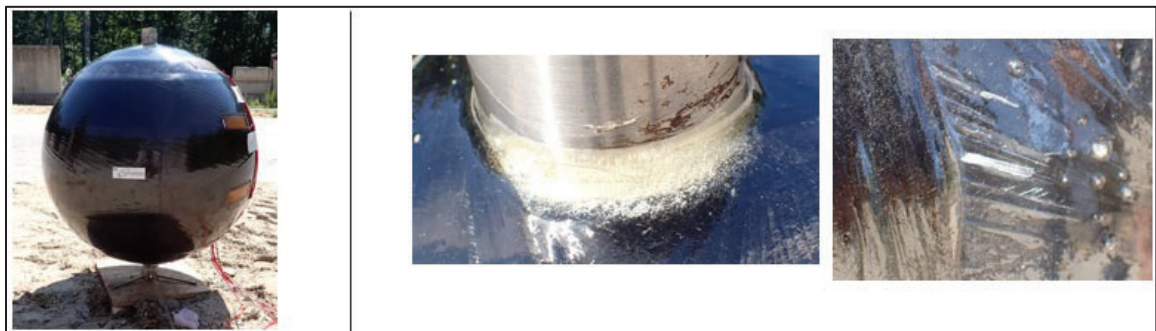
Figure 92: Test 18 Cimarron Tank Pre-Test (L) and Post-Test Stress Cracks (R)

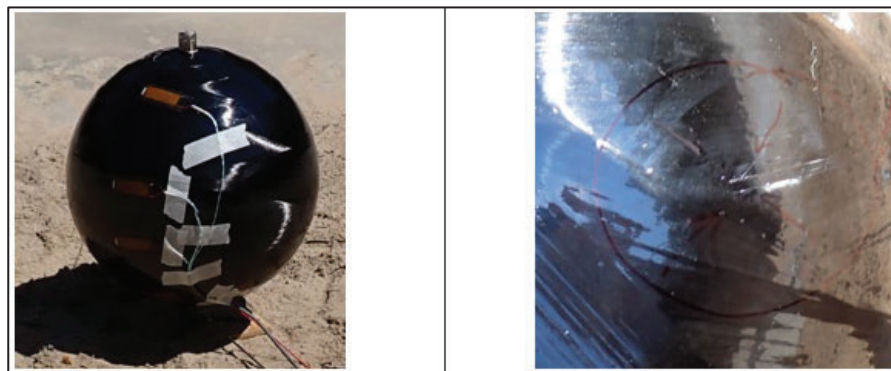
Figure 94: Test 21 Cimarron Tank Pre-Test (L) and Post-Test Stress Cracks (R)

See below in Figure 94 for images of the tank before the test and zoomed-in image of some of the stress cracks formed during test.

The fill process was started on 8/21/24 at 1420 CDT and took 46 minutes to run through the stepped increase process and then build pressure to a high enough level that it could no longer increase further, forming stress cracks and leaks in the composite that prevented a violent burst event. At the time of leaks forming (approximately 1507 CDT), the weather conditions were fair skies, 80.9°F, 43% relative humidity, and a wind speed of 0.45 mph E. The maximum pressure recorded inside the tank at the time that the leaks formed and could no longer contain the pressure was 1,433 psi. See Figure 93 below for the pressurization curve, as recorded by the AvMC DAQ system.

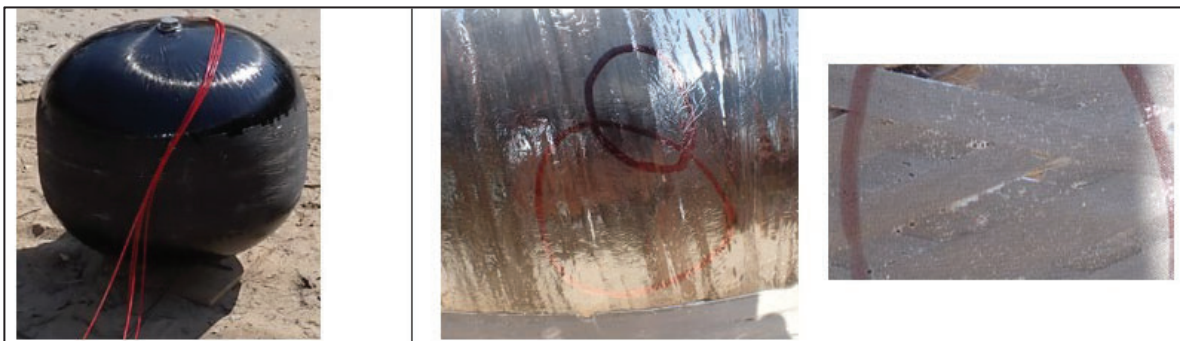
Figure 98: Test 22 HyPerComp Tank Pre-Test (L) and Post-Test Stress Cracks (C)(R)

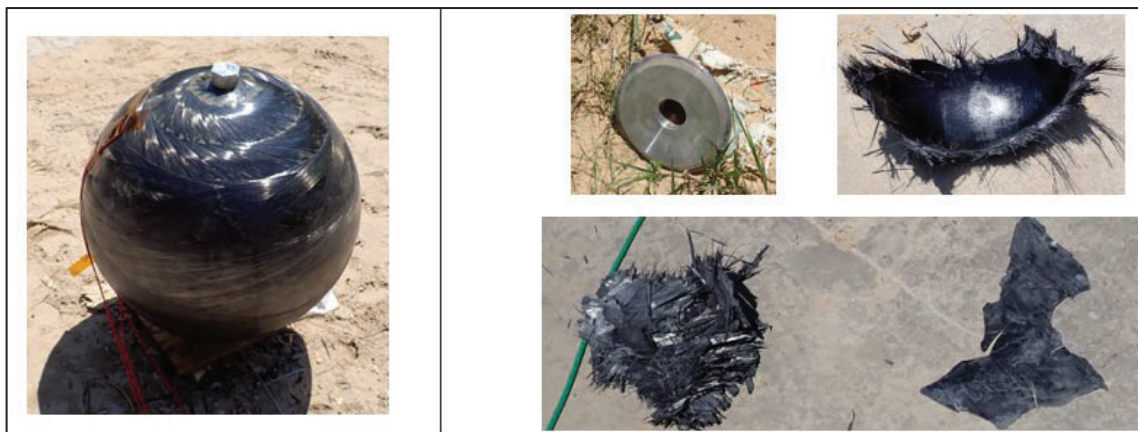
Figure 100: Test 20 Infinite Composites Large Tank Pre-Test (L) and Post-Test (R)

The burst event split the tank into a combination of large and small fragments. The head boss, plastic liner and larger composite pieces were positively identified in the video and all but one were recovered post-test. However, many other smaller fragments of liner and composites were

See below in Figure 100 for images of the tank before and after test.

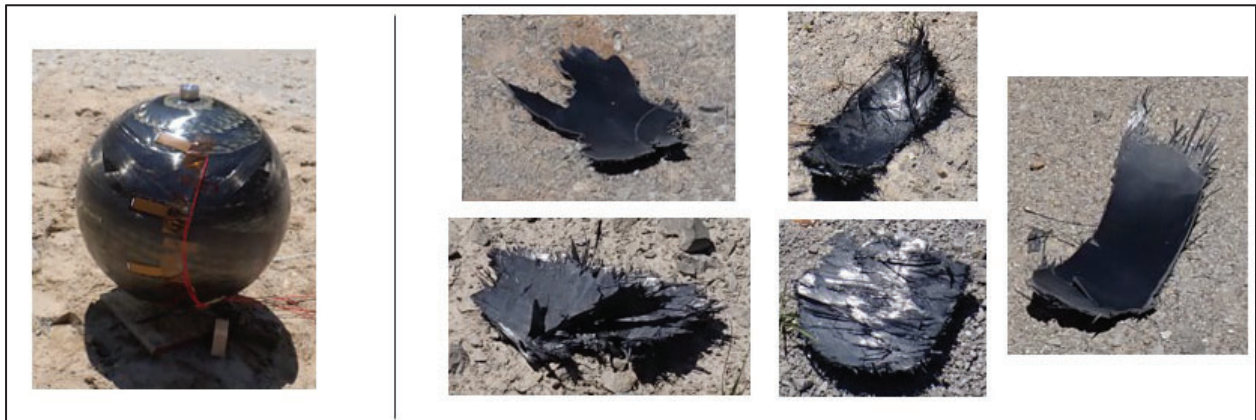
Figure 103: Test 23 Infinite Composites Large Tank Pre-Test (L) and Post-Test (R)

The burst event split the tank into a combination of large and small fragments. The head boss, plastic liner and larger composite pieces were positively identified in the video and all but one were recovered post-test. The metallic top-boss was not recovered, but mass and size estimates were assumed to be the same as recovered in the previous test and were supplemented accordingly. However, many other smaller fragments of liner and composites were thrown in all directions and were significantly harder to analyze or recover. Table 30 below shows a chart of the resulting frag velocity summary.

See below in Figure 103 for images of the tank before and after test.

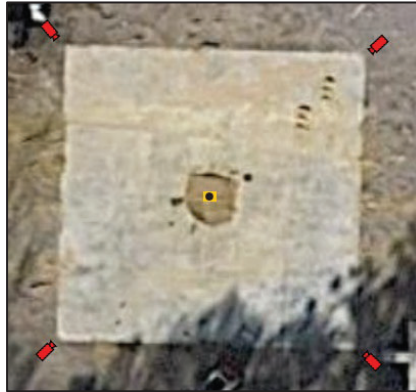
Figure 115: Proposed 360 Degree High-Speed Camera Coverage Schematic

to capture velocities of fragments that were otherwise occluded in this test series. See example schematic below in Figure 115 for proposed camera positions for future tests.

Regarding velocity measurement, the 90-degree separation between cameras indeed allowed 3-dimensional velocity vectors to be calculated. However, since only two of the cameras met this criteria, then any fragments that were thrown in the opposite direction from them and or were occluded by the expanding gas smoke cloud were not captured. For future testing, a full set of (4) cameras should be used, each 90 degrees apart, to be able to capture the full picture around each fragmenting tank. This would allow for full 360-degree coverage of each test event

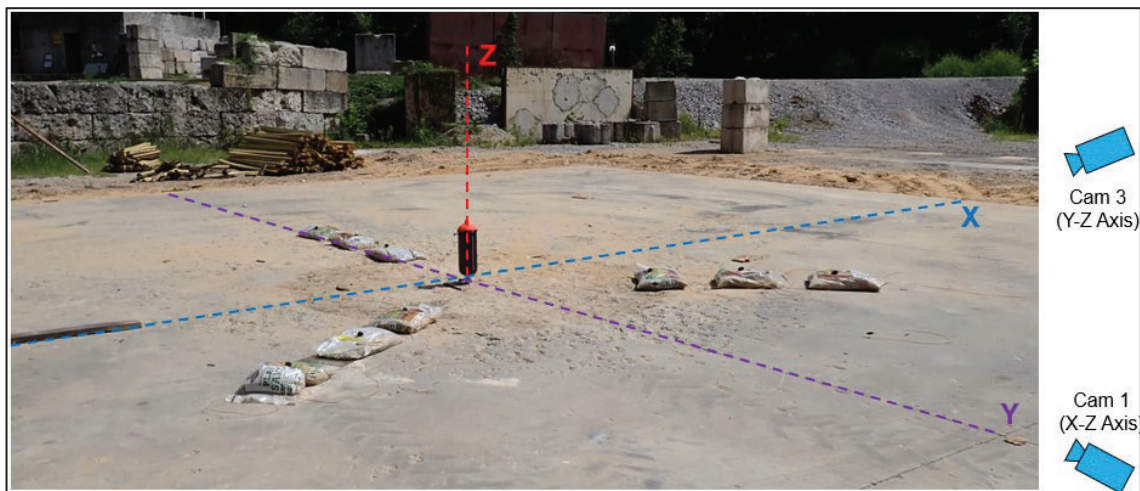
Figure 117: COPV Frag Velocity Geometric Space
