NASA/TM-20250004725

Testing of Sunscreen-Protected Silicone Seals From MISSE–12 and MISSE–13 On-Orbit Flights

Janice L. Mather
The University of Akron, Akron, Ohio

Kim K. de Groh and Henry C. de Groh III
Glenn Research Center, Cleveland, Ohio

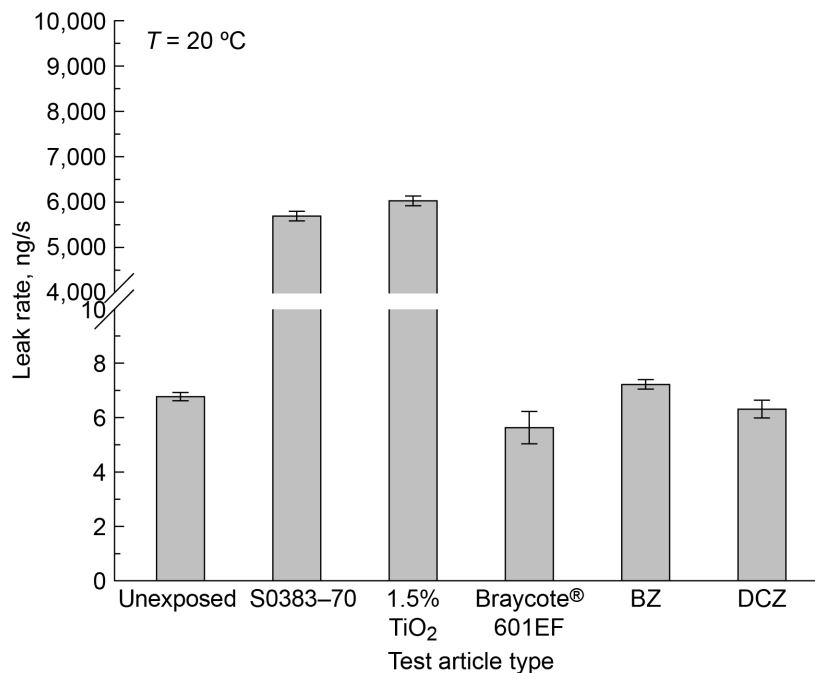
Figure 83.—Leak rates for unexposed baseline material test article and wake-facing test articles.

Postflight leak rate tests of the exposed test articles were completed in June and July 2023. Figure 83 compares the leak rates of the test articles exposed to space environments in the wake-facing direction, and Figure 84 compares the leak rates of the test articles exposed in the zenith-facing direction. As shown in the figures, the leak rates of the S0383-70 and 1.5% TiO₂ test articles were significantly greater than the leak rate for an unexposed test article—840 to 1,360 times as great. For both exposure directions, the 1.5% TiO₂ test articles had the largest measured leak rates, with the zenith-facing test article having a leak rate greater than that of the wake-facing test article. Exposure to UV radiation is known to cause damage to silicone elastomers, and the increase in leak rate from the baseline values was attributed to this exposure. In addition, the larger leak rates for the zenith-facing test articles provided more evidence that the Aegis-reported values for UV exposure were probably low. The leak rates for all coated space-exposed test articles were not significantly different from the leak rates for the unexposed baseline material. Leak rates for the Braycote® 601EF-coated and BZ-coated zenith-facing test articles were only 3 to 6% greater than the average unexposed test article leak rate. In the wake-facing direction, the

DCZ-coated and Braycote® 601EF-coated test articles had leak rates slightly less (approx. 10%) than the average leak rate of the unexposed test articles. The leak rate of the BZ-coated test article was slightly more than the unexposed average leak rate value (approx. 7%). For each material type, the leak rates for the different exposure conditions were compared (Figure 85 through Figure 89). As shown in the figures, the coated test articles outperformed the S0383–70 baseline material and 1.5% TiO₂ material.

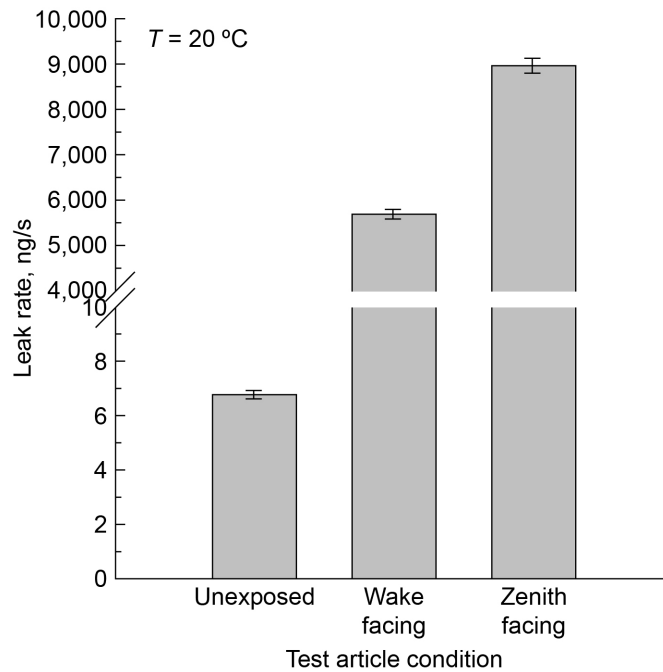
Figure 85.—Leak rates for unexposed baseline material, wake-facing baseline material, and zenith-facing baseline material test articles.

Leak rate performance results showed that the coatings protected the S0383–70 material. The leak rate of the baseline material exposed to space environments significantly increased to an unacceptable level, from 6.79 ± 0.15 to 5700 ± 110 ng/s (wake-facing direction) and 8980 ± 160 ng/s (zenith-facing direction). The leak rates of the exposed BZ flat rings were no different than the leak rates of the unexposed BZ flat rings for both the wake-facing and zenith-facing directions. Likewise, the wake-facing flat ring coated with DCZ showed no difference in leak rate compared to the unexposed DCZ-coated flat ring. There was a measurable increase in leak rate for the DCZ zenith-facing flat ring, from 6.71 ± 0.25 to 14.89 ± 1.16 ng/s. The reformulated silicone compound with TiO₂ embedded in the material to block the UV radiation was not successful at eliminating or minimizing damage. The leak rates of the 1.5% TiO₂ test articles were in-family with the uncoated exposed baseline material ($6,040 \pm 110$ and $9,250 \pm 170$ ng/s for wake facing and zenith facing, respectively); the concentration of the TiO₂ particles was not great enough to protect the material.

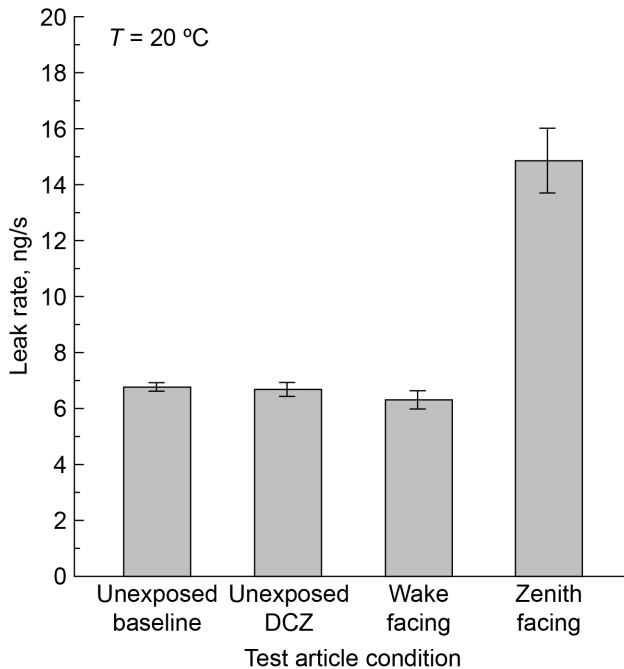
Figure 89.—Leak rates of unexposed baseline material, unexposed DCZ-coated, wake-facing DCZ-coated, and zenith-facing DCZ-coated test articles.

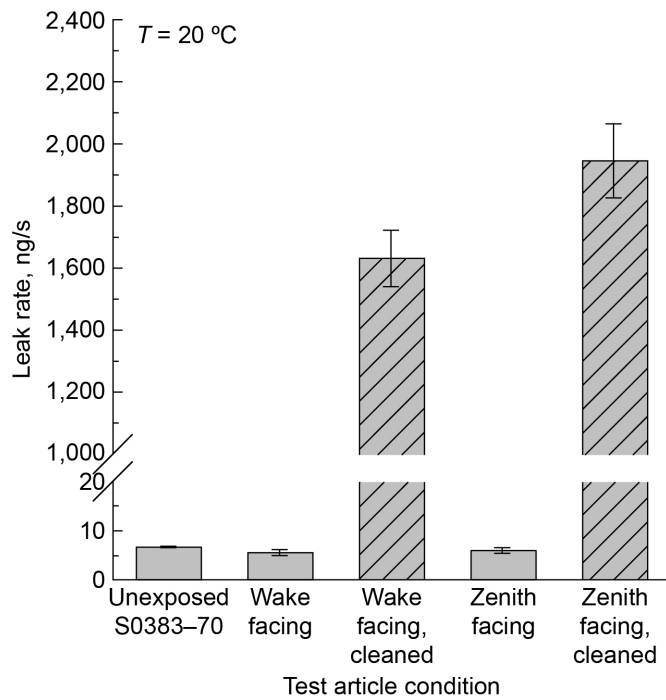
Figure 92.—Leak rates from wake-facing and zenith-facing Braycote® 601EF-coated test articles postflight and after surface cleaning.

After the postflight leak rate tests, the coatings were cleaned from the flat ring surfaces to evaluate (1) the durability of the coating, (2) whether the underlying material was damaged, and (3) if the leak rate of the cleaned flat ring was in-family with the leak rate of the unexposed uncoated baseline material. Refer to Section 5.0 for the evaluation of the coating and inspection of the cleaned surfaces. As shown in Figure 90 and Figure 91 for the S0383–70 and 1.5% TiO₂ materials, respectively, the leak rates for the cleaned surfaces were less than the postflight leak rates for both the wake-facing and zenith-facing test articles. However, the leak rates were still significantly greater than those measured for the unexposed test articles. In other studies of S0383–70 exposed to UV radiation, it was observed that as the damaged elastomer surface remained compressed, the leak rate decreased until it reached some steady-state value. Therefore, it was not surprising to see decreases in the leak rates of the cleaned flat rings. The measured leak rates for the cleaned wake-facing and zenith-facing Braycote® 601EF flat rings (approx. 1,600 and 1,900 ng/s, respectively) were unexpected given that the postflight leak rates were in-family with leak rates of the unexposed test articles (Figure 92). Each flat ring and leak test system was inspected at the end of the test; no gross physical damage (e.g., cuts or scratches) or FOD was found. The flat rings were retested, and the second leak rate results were in-family with the first measurements (1,600 and 1,900 ng/s). Because no damage or FOD was found, the increase in leak rates was attributed to damage to the elastomer material that resulted in interface leak paths. The leak rates of the cleaned BZ and DCZ flat rings were in-family with the postflight leak rates, as shown in Figure 93 and Figure 94.
