Dynamic Drop Testing of eVTOL Energy Storage Systems Part 1: Drop Test Data Summary

Justin Littell Ph.D., Nathaniel Gardner Ph.D.
Research Aerospace Engineer
NASA Langley Research Center

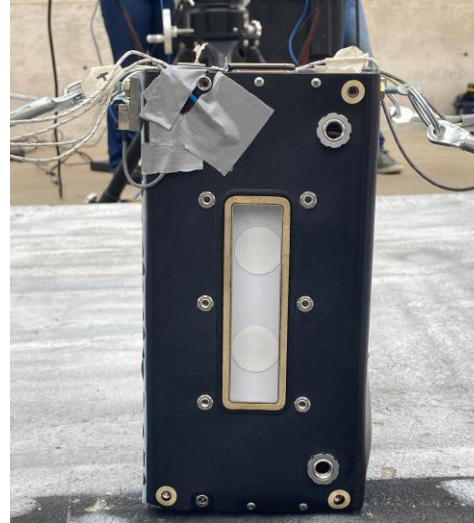
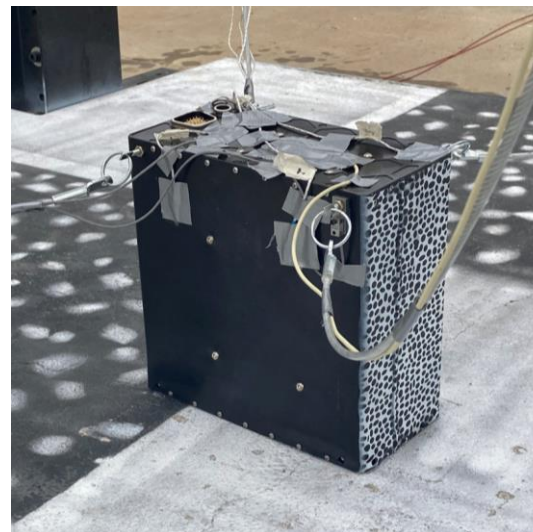
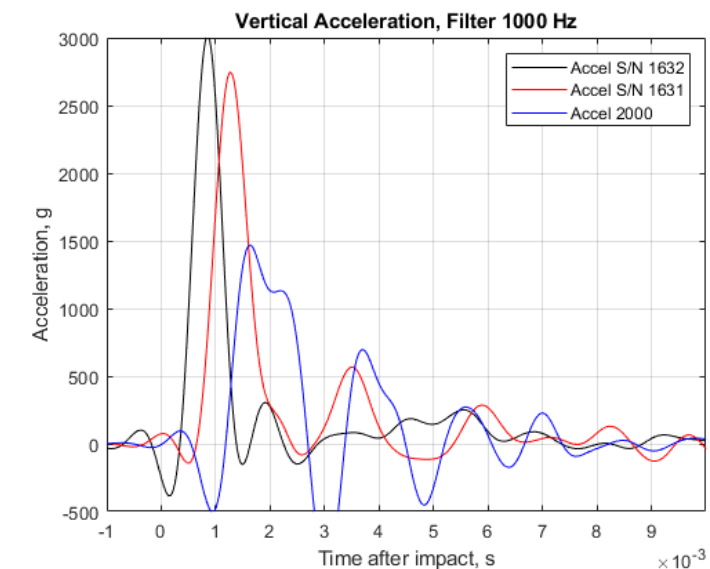
Result Discussion – Impact Conditions
