# Dynamic Drop Testing of eVTOL Energy Storage Systems Part 2: Deformation and Post-Test Forensics Results

**Justin Littell Ph.D., Nathaniel Gardner Ph.D.**  
Research Aerospace Engineer  
NASA Langley Research Center

**Vertical Flight Society 81<sup>st</sup> Annual Forum  
and Technology Display**

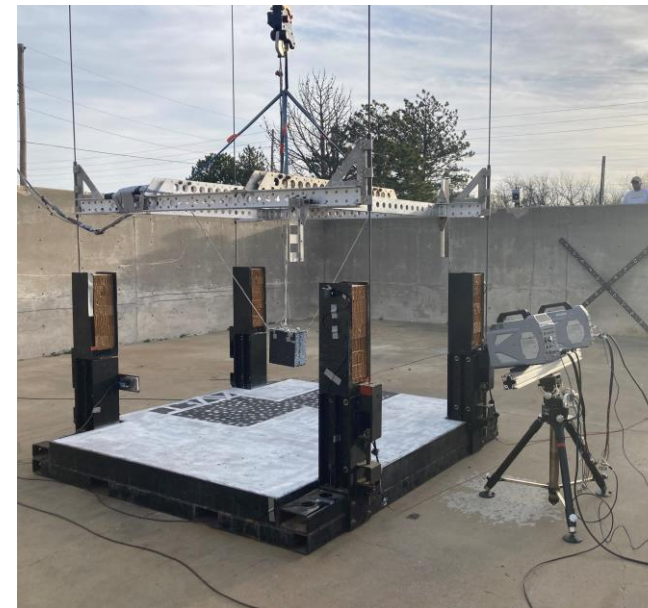
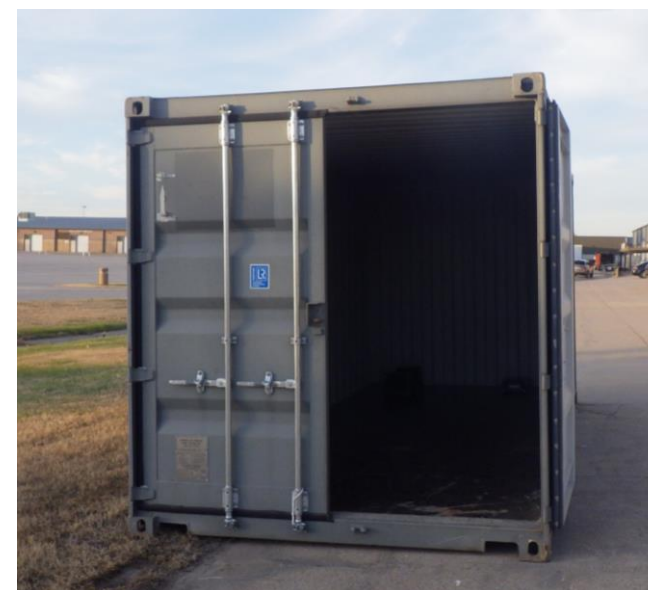
- Tests conducted at National Institute for Aviation Research (NIAR) outdoor test cell
- Pre-test checks on health of module recorded
  - Voltage
  - Temperature
  - Verify module is at ZSOC, and functional
- Raise 50 ft, drop, collect impact data and video
- Post-test – Monitor/record post-test t+1 hour
  - thermal runaway (TR)/ delta Temperature
- Move to covered storage and inspect at t+24 hours for long term changes

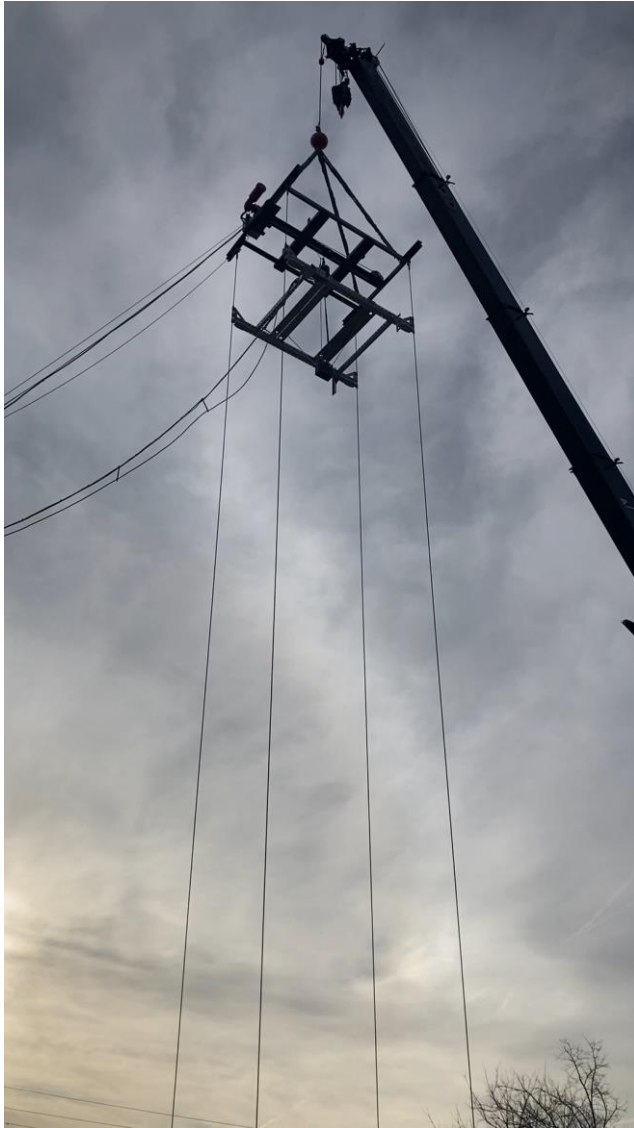
Realtime Camera – Sideways Test

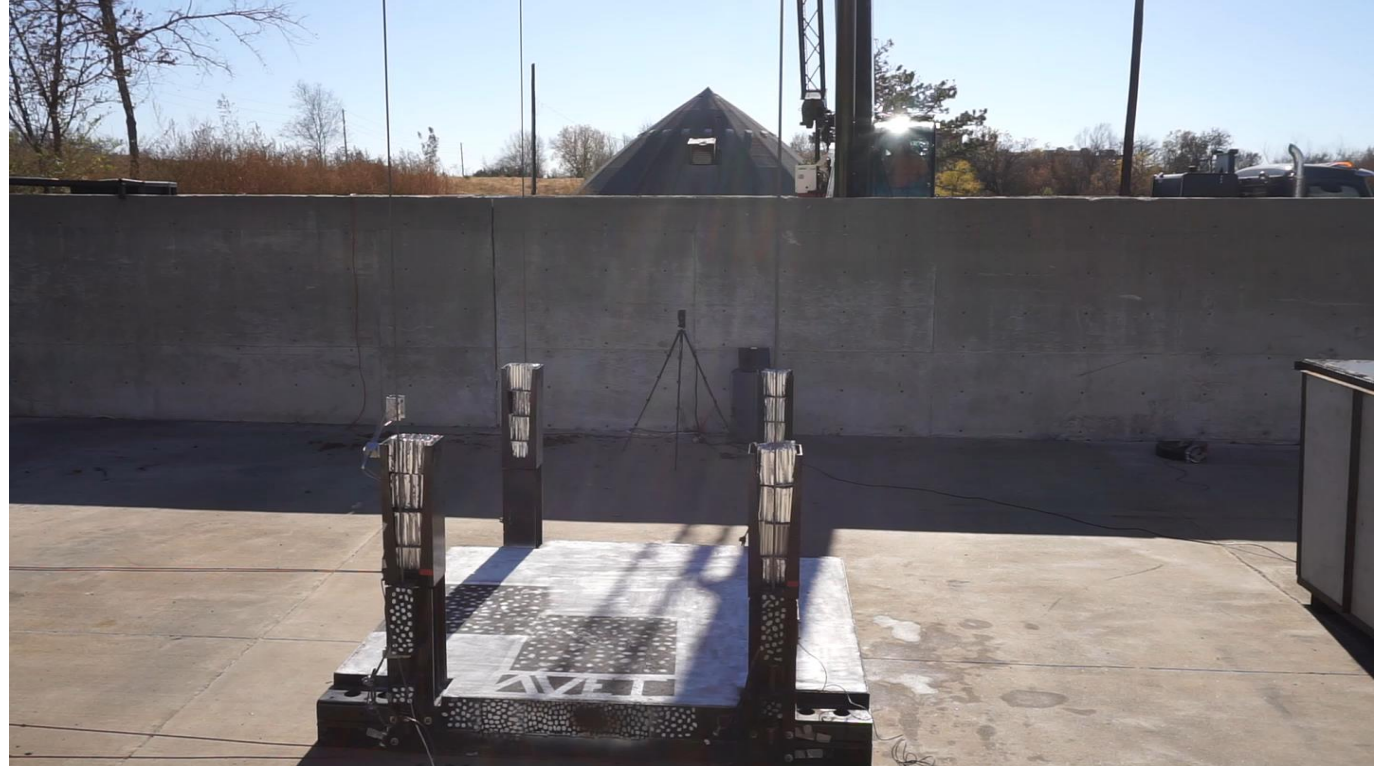
Realtime Camera – Flatwise Test

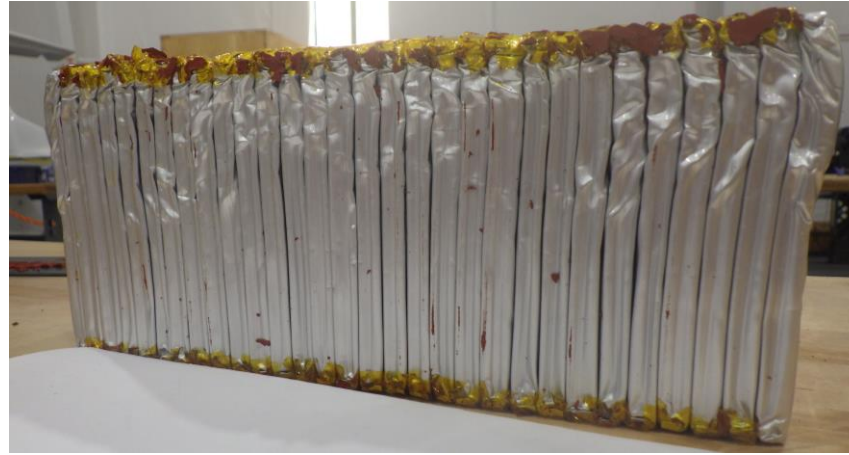
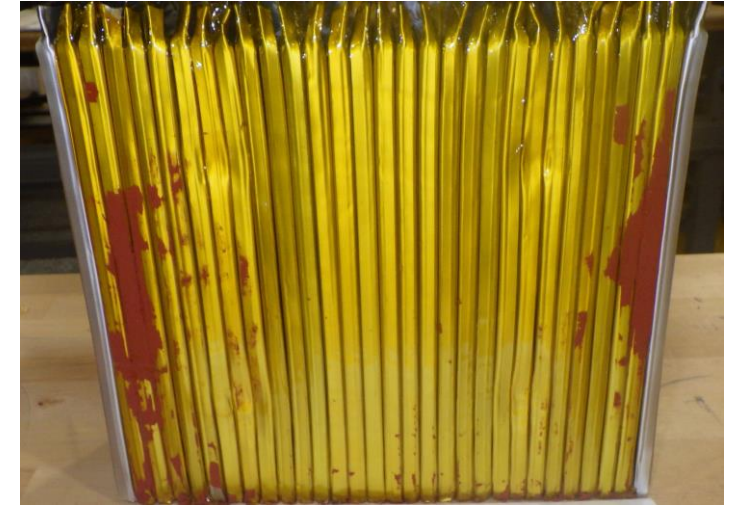
- All cells received damage from the drop test in the form of compression in the lower corner
- Some slight deformation from the case on the impact side of the cells
- Enclosure assembly sustained minimal damage, Containment and Cell assemblies sustained medium amounts of damage

| Orientation | Assembly Level | Cell Level | Total |
|---|---|---|---|
| Flatwise | 11 | 130 | 141 |

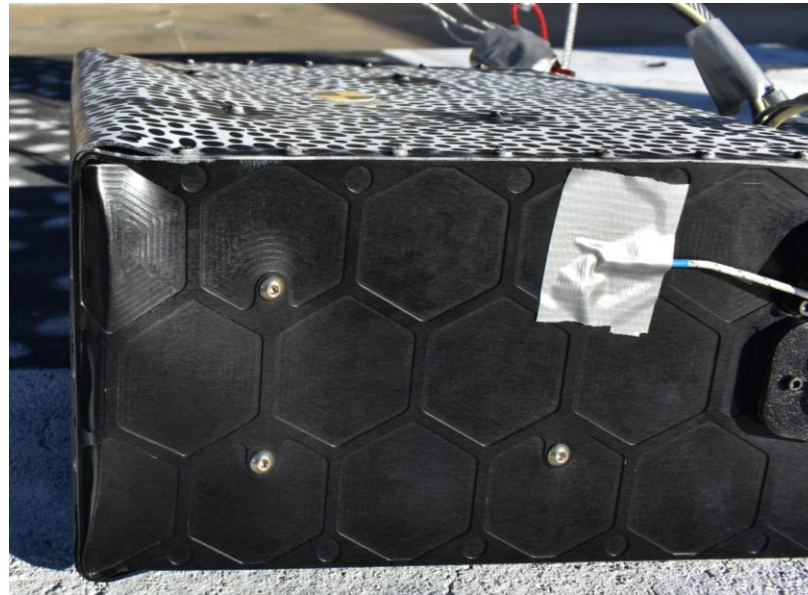
- Bottom, impact surface deformed upward resulting in bulging of the sidewalls
- Fastener orientation changed during impact
- Appeared deformation was localized to the impact location
- Localized vertical and out of plane deformations developed

Vertical Deformation

Out of Plane Deformation

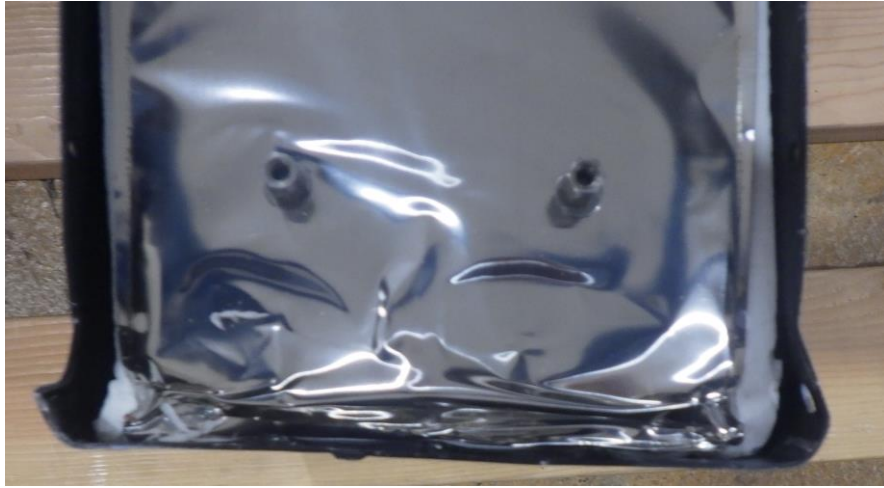
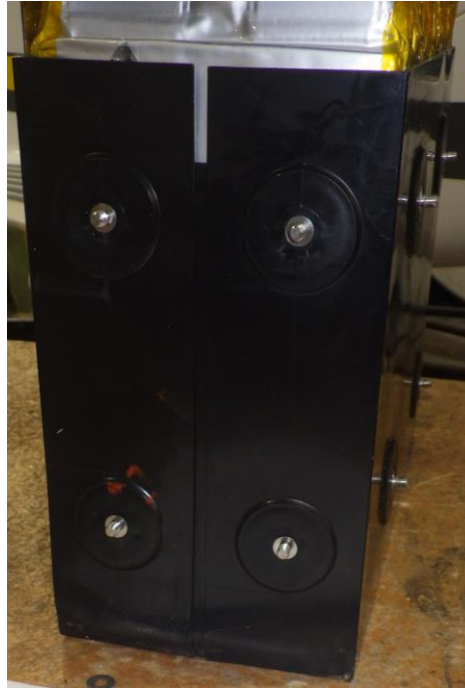
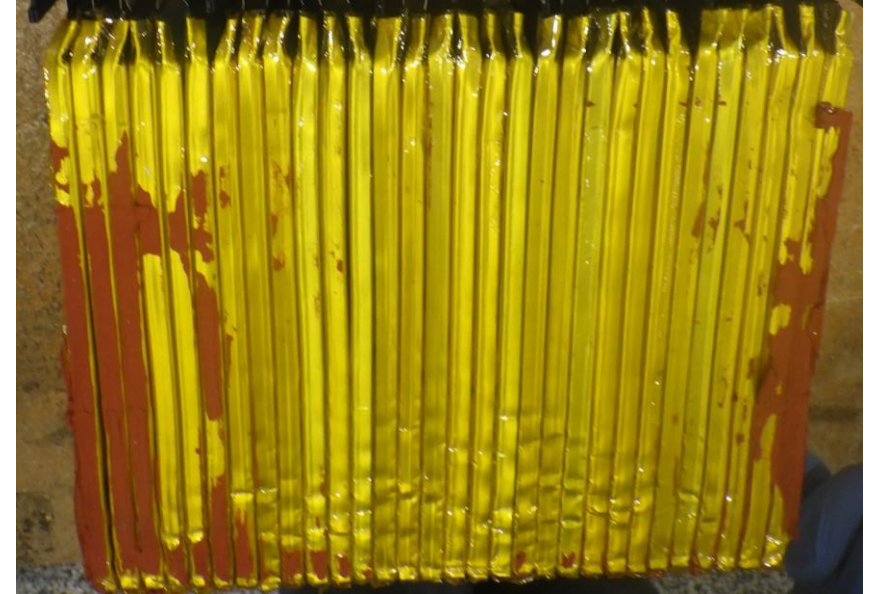
- All cells deformed, electrolyte smell present
- No puncture or breaches visible
- Compressive crushing of pouch cells
- Enclosure assembly sustained medium damage, Containment and Cell assemblies sustained low amounts of damage

| Orientation | Assembly Level | Cell Level | Total |
|---|---|---|---|
| Rightside Up | 7 | 130 | 137 |

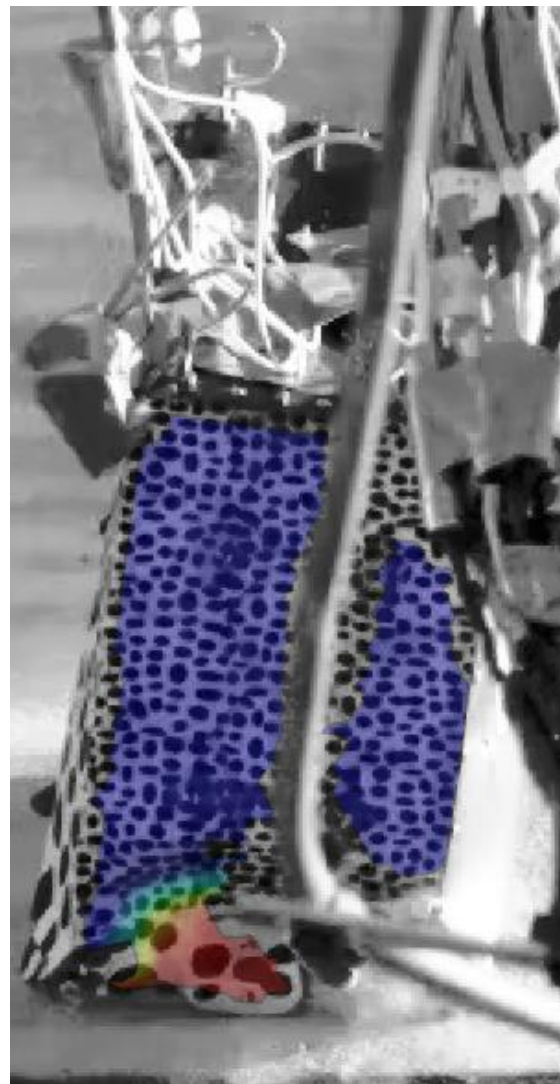
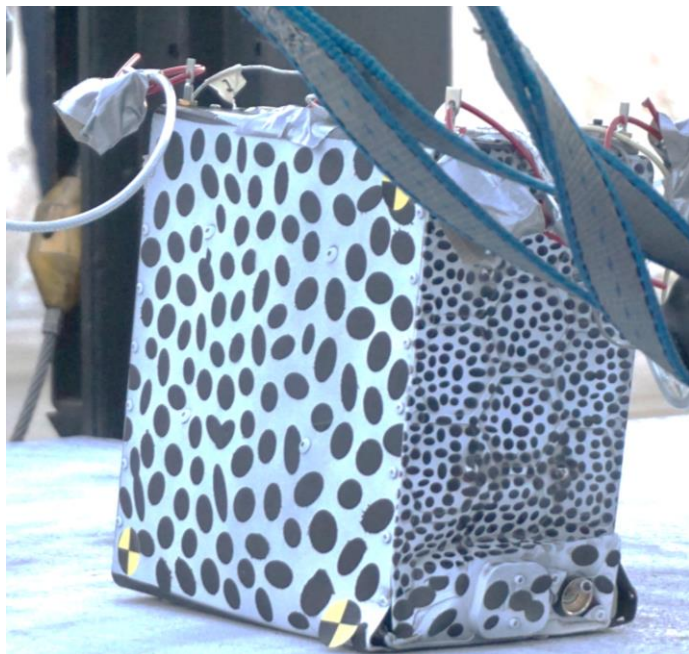
- Non-symmetric impact led to greater deformation on the north side
- Large amounts of crushing on impact side
- Localized vertical and out of plane deformations developed

Vertical Deformation

Out of Plane Deformation

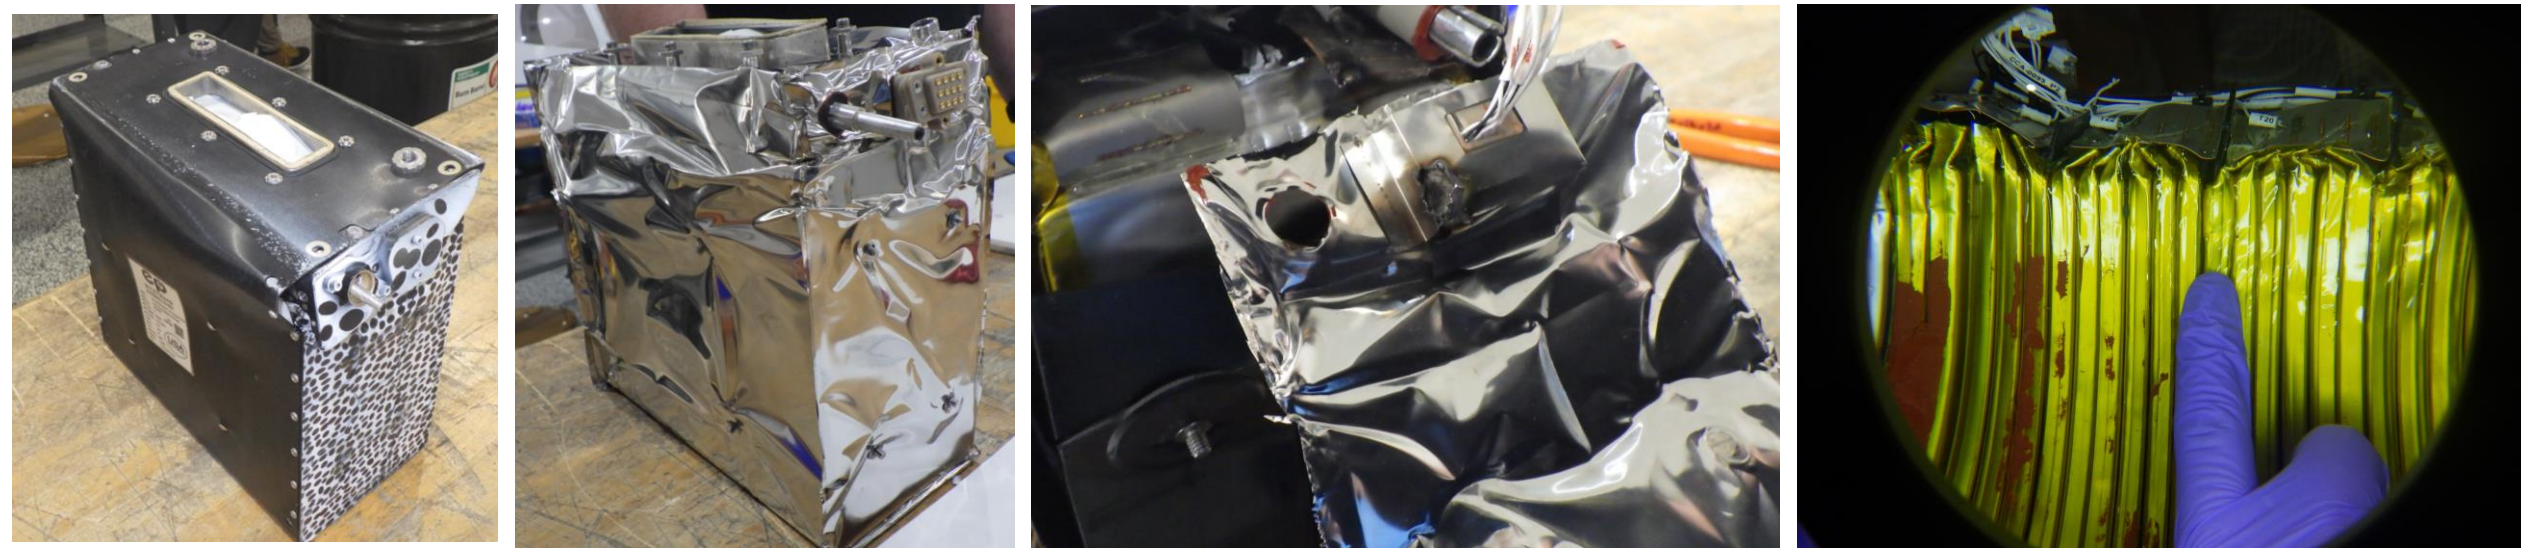
- Internal shorting from cells to enclosure
- Electrolyte smell present
- Cell punctures present
- Significant damage in containment assembly, fastener rotation, punctures in assembly itself
- Generally opposite behavior seen in Right-side up test

| Orientation | Assembly Level | Cell Level | Total |
|---|---|---|---|
| Upside Down | 18 | 147 | 165 |

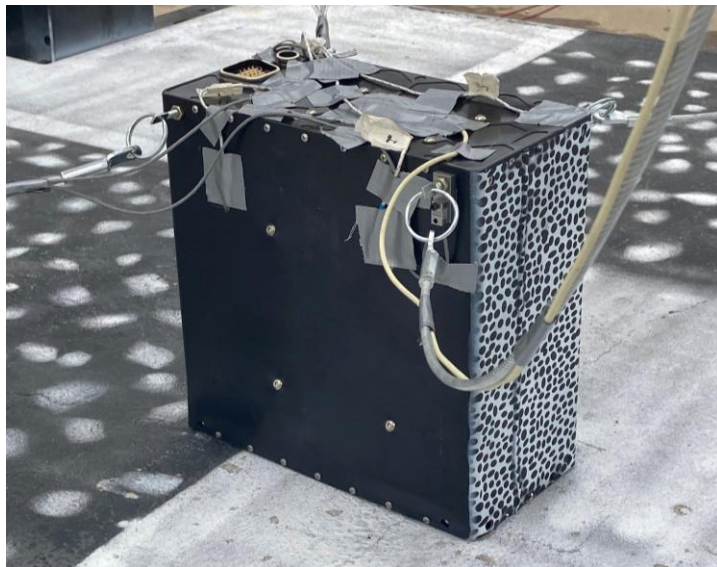
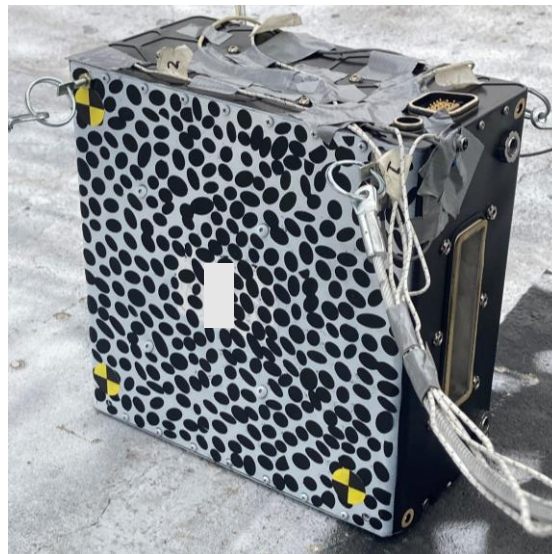
- Sparks observed during testing
- Minimal outer bulging on sidewalls, little deformation on impact face
- Vertical deformations limited to one corner Did not propagate around the edge
- Out of Plane deformation shows flexing

Vertical Deformation

Out of Plane Deformation

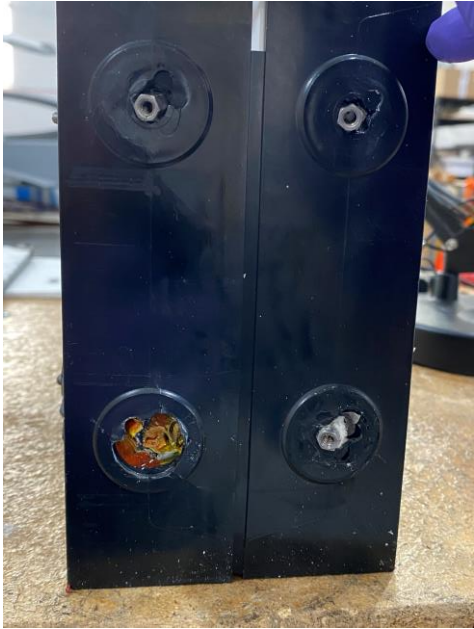
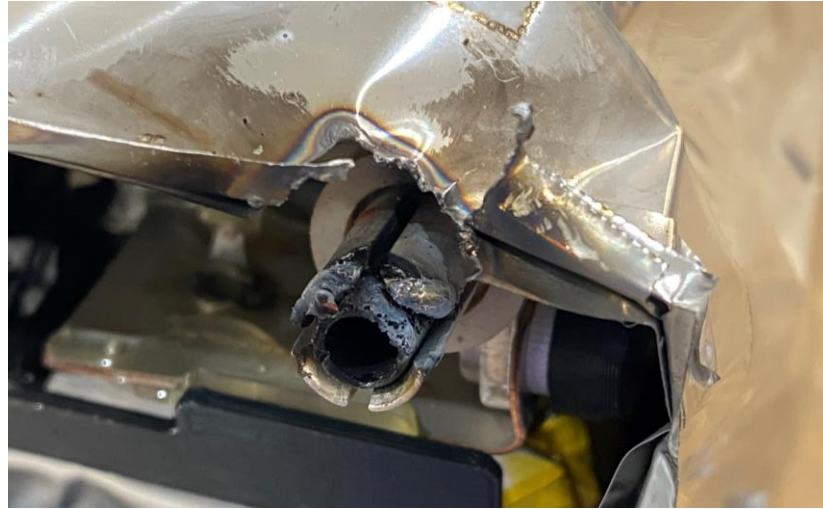
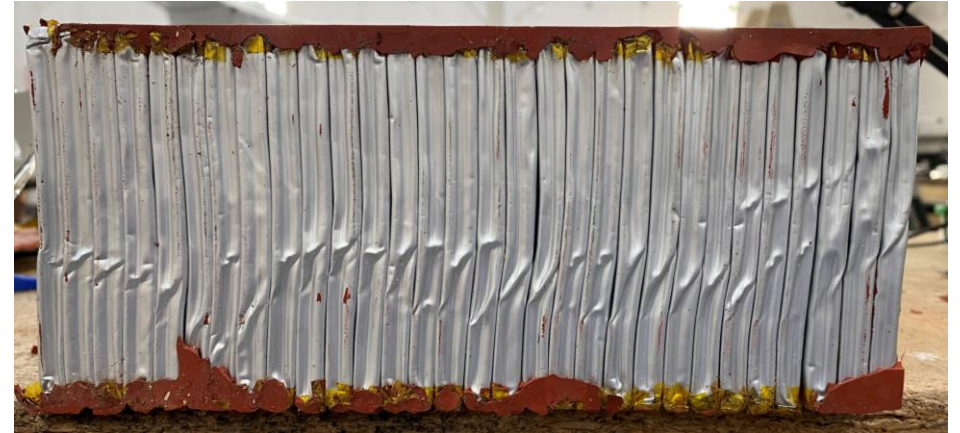
- Positive electrode short to containment assembly
- Standoff compression into individual cells
- Strong presences of electrolyte
- Cell punctures present

| Orientation | Assembly Level | Cell Level | Total |
|---|---|---|---|
| Sideways | 20 | 235 | 255 |

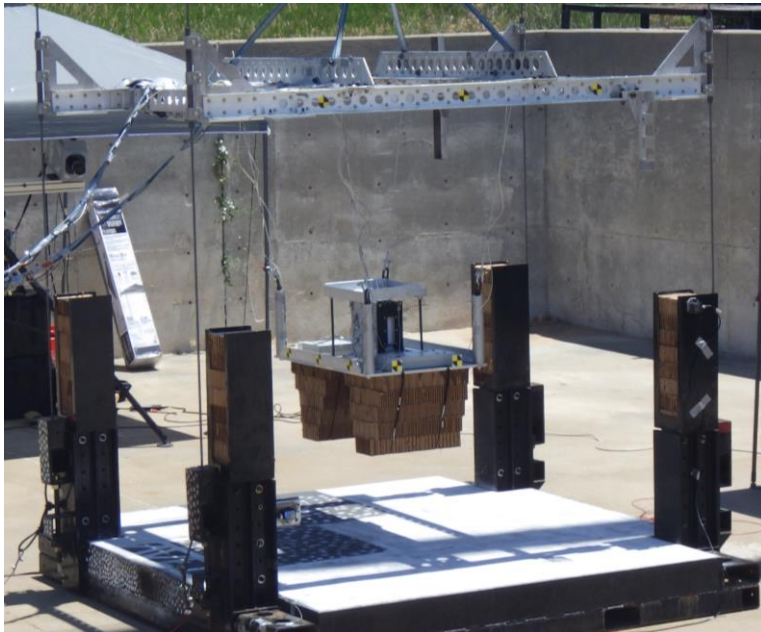
Phase 2 Test Setup

- Data from one design tested under one type of condition for Phase 1
- Phase 2 – tested two module orientations under two loading magnitudes
  - Attenuation present to bring loading conditions back into crash-type pulses
  - 80 g and 220 g
