Status of the Advanced Oxygen Generation Assembly

Future Exploration missions will require an Oxygen Generation Assembly (OGA) to electrolyze water to supply oxygen for crew metabolic consumption. The system design will be based on the International Space Station (ISS) OGA but with added improvements based on lessons learned during ISS operations and technological advances since the original OGA was designed and built. The goal of these improvements will be to reduce spares mass and crew maintenance time while increasing reliability. These improvements will be incorporated into the Advanced OGA (AOGA), which will be launched to ISS in 2026 and its operation demonstrated in a relevant flight environment for at least 3 years. AOGA upgrades include: redesign of the electrolysis cell stack, redesign of the hydrogen dome, replacement of the hydrogen sensors, redesign of the recirculation loop deionizing bed, and incorporation of recirculation loop nitrogen purging and water flushing. AOGA design reviews, analyses, and

development tests are now complete. Currently, AOGA flight hardware components are being manufactured. The design, build and plans for the AOGA will be reviewed in this

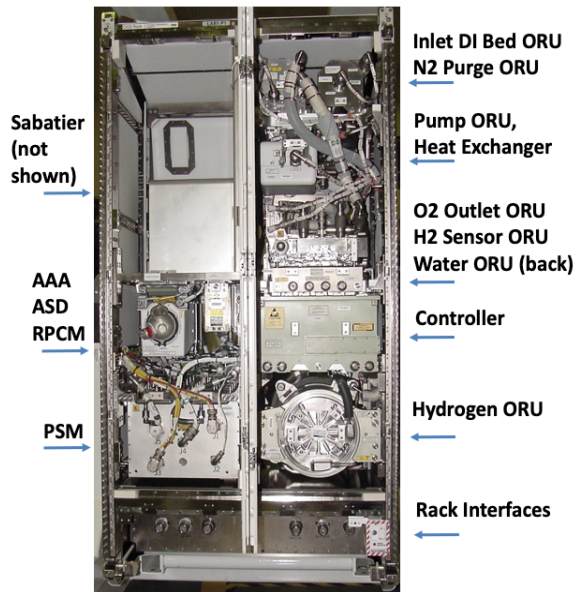
Figure 1. ISS OGA

The ISS OGA is shown in Figure 1 and the simplified schematic is shown in Figure 2. The OGA consists of the following nine Orbital Replacement Units (ORUs): Water, Inlet Deionizing Bed, Hydrogen, Pump, Nitrogen Purge, Oxygen Outlet, Hydrogen Sensor, Power Supply Module (PSM), and Process Controller. Feed water from the ISS potable water bus enters the OGA through the Water ORU and flows through an Inlet Deionizing Bed, which serves as an iodine remover and as a coalescer for any oxygen gas bubbles that may be present in the feedwater. If gas bubbles are detected by the gas sensor downstream of the deionizing bed, the feedwater is rejected by a three-way valve to the wastewater bus. This prevents any oxygen that may be present in the feedwater from mixing with the hydrogen in the Rotary Separator Accumulator (RSA). The wastewater interface includes a check valve to prevent backflow of wastewater into the OGA and Microbial Check Valve to prevent microorganisms in the wastewater from contaminating the feedwater. Water is electrolyzed by the cathode feed cell stack to produce oxygen and hydrogen. The RSA separates the cathode side product gaseous hydrogen from the water. The Hydrogen ORU consists of a dome

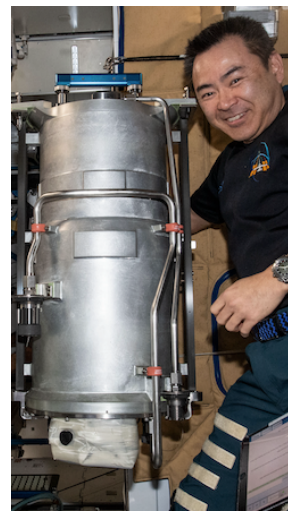
Figure 3. Hydrogen ORU

The cell stack is contained in the Hydrogen ORU, shown in Figure 3. The low cell voltage failure of the cell stack in Hydrogen ORU serial number (SN) 2 in 2016, and TT&E results are described in Reference 1. The low cell voltage failure of the cell stack in Hydrogen ORU SN 3 in 2021 is described in Reference 2. In both instances, Cell 1's voltage in Standby continued to trend downwards out of family, indicating possible membrane thinning and a partial short. This legacy OGA cell stack design includes non-chemically stabilized membranes, screens for membrane support, and an obsolete Membrane Electrode Assembly (MEA) processing method.² A test, teardown, and evaluation (TT&E) of failed cell stack SN 5 (installed in Hydrogen ORU SN 2, 2010 – 2016) identified excessive thinning of the cell membranes as the root cause of the low cell voltage.¹ A TT&E of failed cell stack SN 4 (installed in Hydrogen ORU SN 3, 2016 – 2021) is on hold, due to other funding priorities, and the likelihood that its failure is similar to cell stack SN 5.

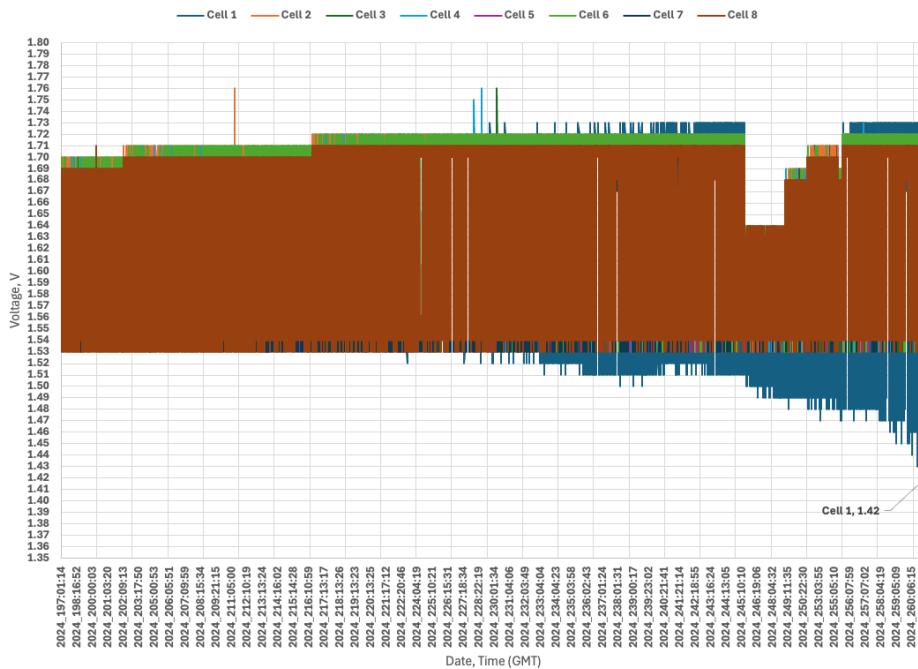
Figure 4. Cell Voltages for Hydrogen ORU SN 4 (2024)

Hydrogen ORU SN 4 was installed in 2021. Starting in March 2024, the voltage of Cell 1 upon startup and shutdown shifted out of family.² This behavior started to appear after ~2.5 years of operation. Previously, with Hydrogen ORU SN 2 and 3, this startup/shutdown behavior started to appear after ~4 years of operation, with low voltage instability during operation (Standby) appearing ~2 months later. The startup/shutdown voltage behavior of Cell 1 in Hydrogen ORU SN 4 is similar to that of SN 2 and 3, although appearing sooner. The OGA Team hypothesized that because Hydrogen ORU SN 4 was operating at a higher production rate than SN 2 or 3 (due to larger crew size), the voltage degradation appeared sooner. During August 2024, the OGA Team noted that Cell 1's voltage during Standby was decreasing, dropping from the nominal ~1.53 V. On September 16, 2024 (GMT 260), the voltage dropped to 1.42 V (below the 1.48 V thermoneutral electrolysis voltage). A graph of cell voltages (cells 1 – 8) is shown in Figure 4. As mentioned in Section II, OGA transitions from Process to Standby every 100 minutes for 5 minutes, so both the Process voltage and Standby voltage are shown for each cell. Cell voltage in Process can vary based on current/production rate. Cell voltages in Standby should typically be at ~1.53 V, but cell 1's Standby voltage (in blue) is shown decreasing out of family to 1.42 V on GMT 260. At this point, the ISS Program directed that the Hydrogen ORU be removed and replaced (R&R'd), even though the default shutdown low limit is 1.0 V and there were 12 crew aboard at the time. Given the rapidly decreasing voltage, Hydrogen ORU SN 4 did not appear to have much longer to safely operate, without creating a localized hotspot and pinhole leak in Cell 1's membrane. If a leak and combustion were to occur, there would be a risk of failing other ORU's. The OGA was shut down on September 16, 2024. On September 17, 2024, the crew performed flushing of the recirculation loop and other hoses, to remove trace

contaminants that may have built up over 3 years. On September 18, 2024, Hydrogen ORU SN 4 was removed and SN 5 was installed. As expected, the RSA outlet Quick Disconnect (QD) did not fully engage, indicating only one of two seals being in effect. This QD did not fully engage in prior Hydrogen ORU R&R's. Prior to starting OGA, the Vent Dome command is issued. This command evacuates the dome of gases and water (that may have diffused out of the internal components during years of storage) and brings the dome pressure to ~0.1 psia (689 Pa). This Vent Dome command was unsuccessful. After the third attempt, the command successfully completed. The cause was eventually understood to be due to issuing the command too early, before the dome 0.6 psia pressure sensors were in the proper range. Another issue was noted during the initial activation. With the pump off, the pump delta pressure (dP) sensor should be reading ~0 psid, however it was reading -1.3 psid (-8.96 kPa delta) after the Hydrogen ORU R&R. The cause for this is unknown and will need to be investigated further if the pump is returned to the ground in the future. The first Standby command was successful. The initial cell voltages were a little lower than expected (~1.47 V) during this first Standby. This was understood to be caused to be due to the membranes being well hydrated after years of storage. After several days, the Standby voltages increased to their nominal 1.53 V. The first Standby attempt ended with an unexpected Fast Shutdown, due to removing an override too early. On September 19, 2024, a second Standby was successful. After this, OGA was successfully commanded to Process. As of May 2025, the Hydrogen ORU SN 5 and cell stack continue to operate nominally. However, during several shutdowns in 2025, cell 1's voltage decay trend has appeared to be slightly out of family compared to the other cells. The OGA team will continue to monitor the cell voltage trends closely. As a precaution, the OGA team has recommended suspending on-orbit polarization scans (which slowly ramp up the current to 100% and check the corresponding voltage response) and also limiting production above 60% when practical. These steps may help extend the life of the cell stack, by reducing the chances of creating dry spots in the membranes.

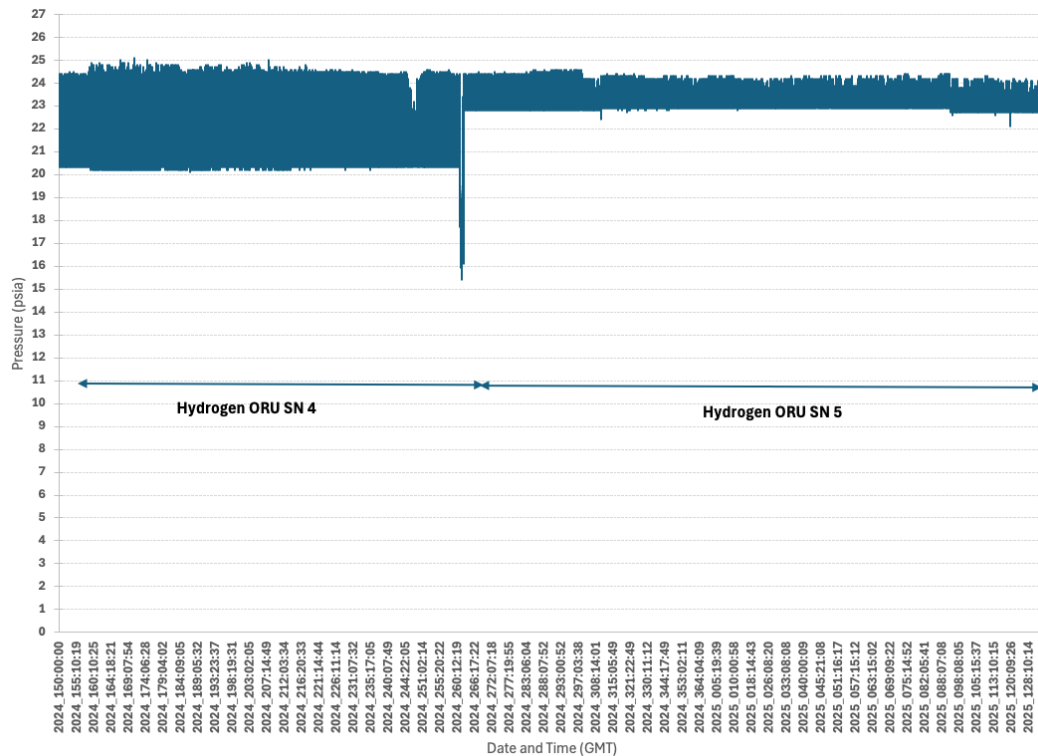
Figure 5. OGA Recirculation Loop Pressure

Nominally, the water recirculation loop pressure should be ~24 psia (165.5 kPa) while in Standby and Process. The pressure is maintained by the hydrogen back pressure regulator, which is integral to the Hydrogen ORU. The default software low limit shutdown value is 20.5 psia (141.3 kPa), to ensure the cell stack hydrogen pressure is maintained above the oxygen pressure so that cross cell leakage can be detected via the oxygen outlet pressure sensors and hydrogen sensors. Past issues with low recirculation loop pressure are described in Reference 2. While Hydrogen ORUs SN 1 and 2 were installed, the pressure was stable at around 23 psia in Standby. However, while Hydrogen ORU SN 3 was installed (2016 – 2021), the recirculation loop pressure was degrading over time, causing a shutdown. The low shutdown limit had been reduced to 19 psia (131 kPa) to allow system operation to continue. Hydrogen ORU SN 4 was installed October 20, 2021 through September 17, 2024. During this time the recirculation loop pressure was consistently low, at around 20.5 psia, as partially shown in Figure 5. Once Hydrogen ORU SN 5 was installed, on September 18, 2024, the recirculation loop has been fairly stable at 22.7 psia in Standby, as shown in Figure 5. Because Hydrogen ORU SN 5's back pressure regulator was from the same lot as SN4's, the OGA Team was expecting SN 5's recirculation loop pressure to be low, similar to SN 4. The OGA team will continue to monitor the pressure. If the good performance continues, the overrides might be removed.

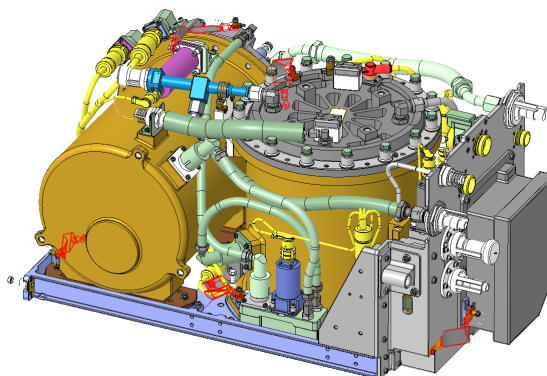
Figure 7. OHDA

The OGA will be upgraded to the AOGA configuration by replacing the Hydrogen ORU with the OHDA. The OHDA will have the same fluid and electrical interfaces as the legacy Hydrogen ORU. The OGS rack structure will need to be modified by the crew to accommodate the OHDA. The OHDA design will allow the crew to remove each dome to replace internal components without the need for specialized tools or alignment fixtures. This component level maintenance approach (rather than ORU level maintenance) will reduce spares mass and volume, as previously mentioned. The cell stack will be housed in one removable dome with the pressure sensors and PSM interface on the outside for access. The RSA, hydrogen backpressure regulator and associated sensors will be housed in the other removable dome, with the pressure sensors mounted externally.

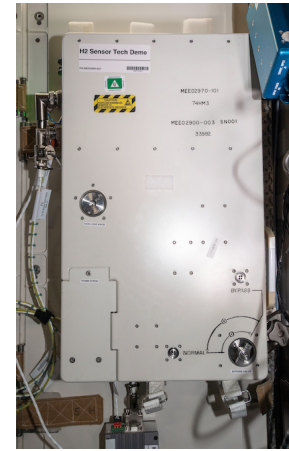
Figure 8. H2ST Integrated with OGA

Issues with the legacy OGA hydrogen sensors are described in Reference 1. Due to these issues, half of the legacy hydrogen sensor fleet (8 of 16) has been retired. The Hydrogen Sensor Technology Demonstration (H2ST) will demonstrate the performance of four new Commercial off the Shelf (COTS) catalytic bead hydrogen sensors for at least 3 years while connected to the ISS OGA's oxygen outlet line to monitor for hydrogen. The H2ST design is described in References 5 and 6. H2ST was first powered up in a standalone mode in April 2022 (attached to the LSR Rack), and was successfully integrated with OGA in September 2022 (see Figure 8), after the OGA was moved from Node 3 to the US Lab. H2ST is installed on the right side of the OGS Rack.

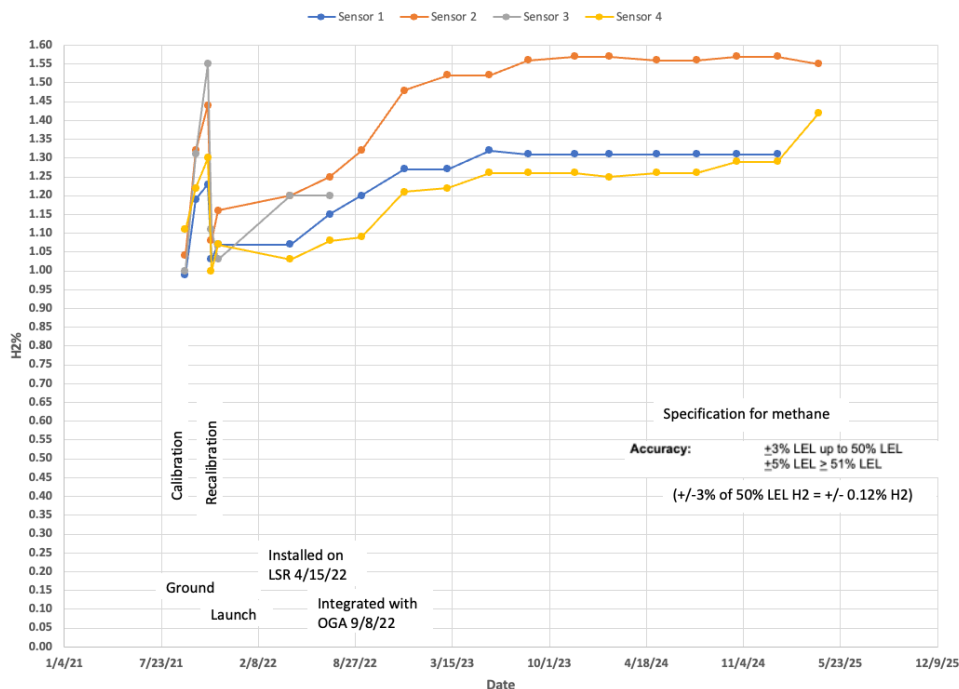
Figure 9. H2ST Drift Checks

Every 90 days, a drift check is performed: the crew flows calibration gas (1.0% H₂/air) from a drift check kit bottle through the H2ST sensors for 1 minute, and the sensor response is recorded. There have been 14 drift checks performed so far, as of May 2025. The drift of the sensors over time is shown in Figure 9. After H2ST was first installed on-orbit, an upwards drift was noted. From May 2023 to Jan 2025, no upwards drift was noted with the functioning sensors. When exposed to 1.0% H₂/air, Sensors 2 and 4 currently report 1.55% and 1.42% respectively. This overreporting of H₂% is conservative, although not desirable as it could eventually lead to nuisance shutdowns. The legacy ISS OGA hydrogen sensors are known to drift downwards over time (under-reporting H₂%), limiting their installed time to 201 days. H2ST has been installed and powered on for 3.03 years, and counting.

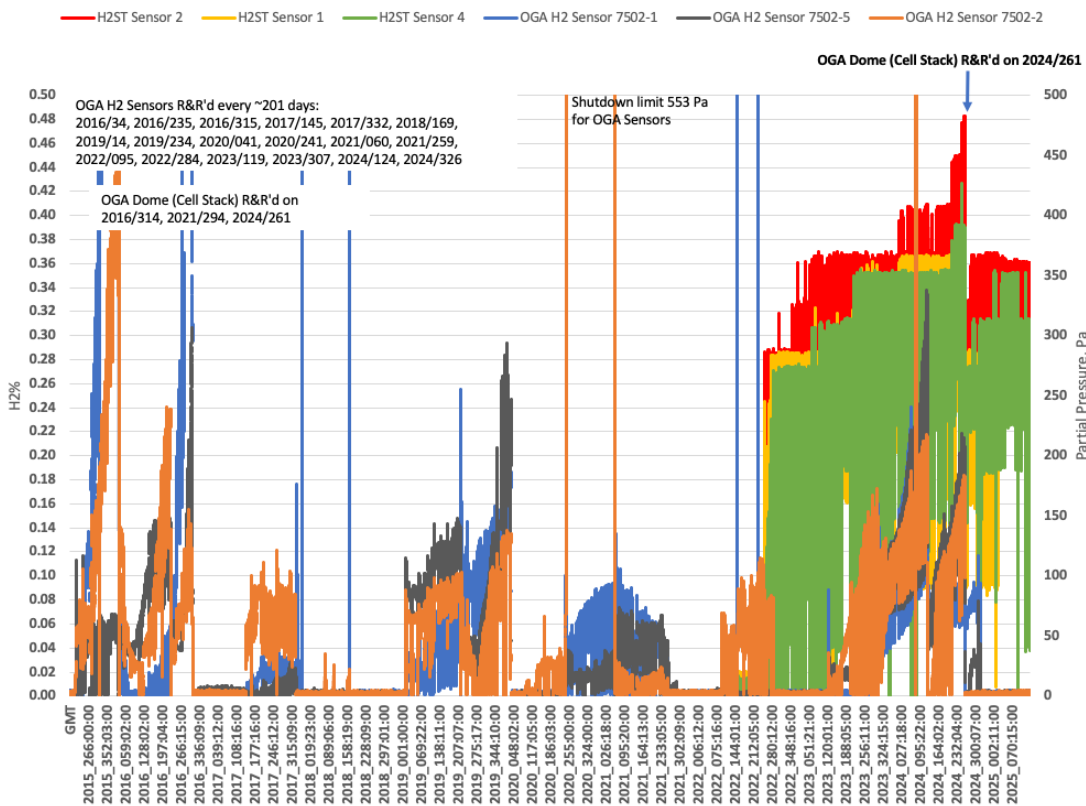
Figure 10. H2ST (H₂%) and Legacy OGA H₂ Sensor (ppH₂) Response

Cell Stack SN 6 (installed in Hydrogen ORU SN 4) was R&R'd from OGA on Sept 18, 2024 (GMT day 261) due to low cell voltage (see Section III-A above). Prior to the R&R, the H2ST sensors (red, yellow, and green lines in Figure 10) were gradually increasing. In addition, the legacy OGA hydrogen sensors (blue, orange, and gray lines in Figure 10) were also gradually increasing. The decreasing cell voltage was suspected to be due to membrane thinning, which could potentially be allowing some small amount of cross cell leakage (hydrogen into oxygen). After the failed cell stack was replaced with a new cell stack (in Hydrogen ORU SN 5), a small but noticeable decrease in the H2ST sensor readings and legacy OGA hydrogen sensors is evident. The currently installed cell stack (SN 7) was acceptance tested in 2010, and 0.10% H₂/O₂ was recorded.

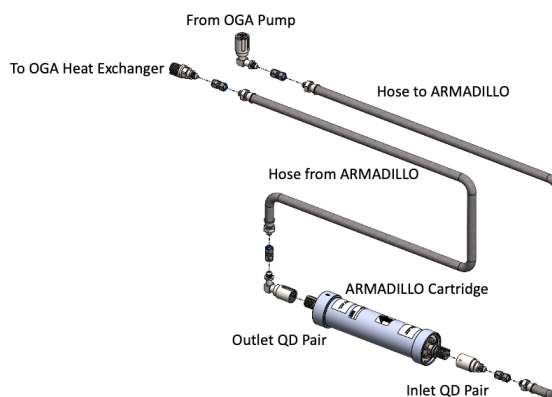
Figure 11. ARMADILLO Design

The ARMADILLO design is shown in Figure 11. It will consist of a cartridge, inlet hose and outlet hose. The cartridge will contain the resin media, a new integral particulate filter, and QD's to allow the crew to remove and replace. The ARMADILLO design addresses the issues related to the legacy ACTEX design. The ARMADILLO will have a significantly reduced dP, contain redundant seals, and be properly designed to handle MDP. The design has eliminated welds to ease manufacture and refurbishment. ARMADILLO is projected to have a 3 year life, with a 30% remaining capacity at the end of life.
