A Summary of Results from Phase 2 Dynamic Drop Testing of Energy Storage Systems for electric Vertical Take-off and Landing (eVTOL) Vehicles

Justin D. Littell, Nathaniel W. Gardner, Matlock M. Mennu

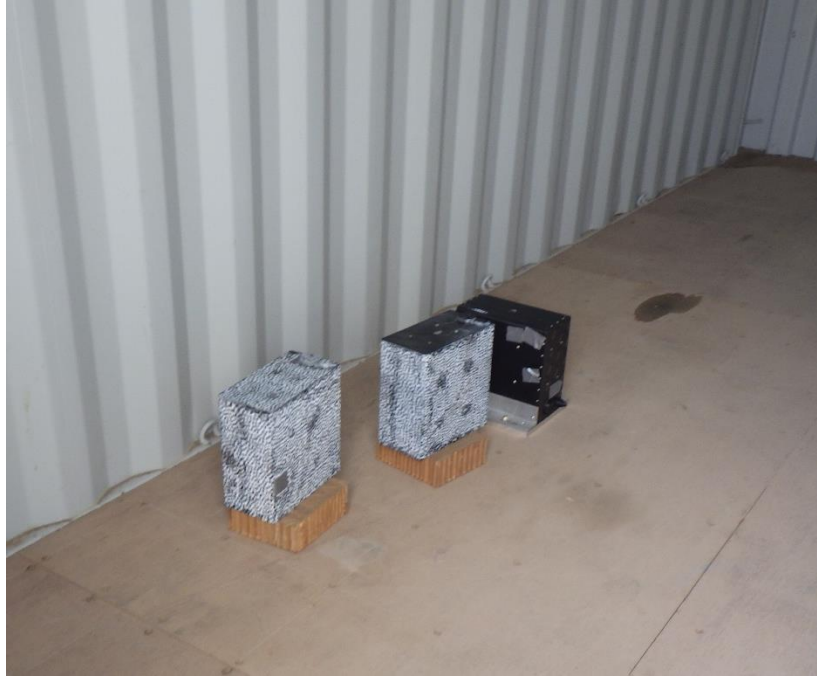
Figure 4. Test articles in outside storage

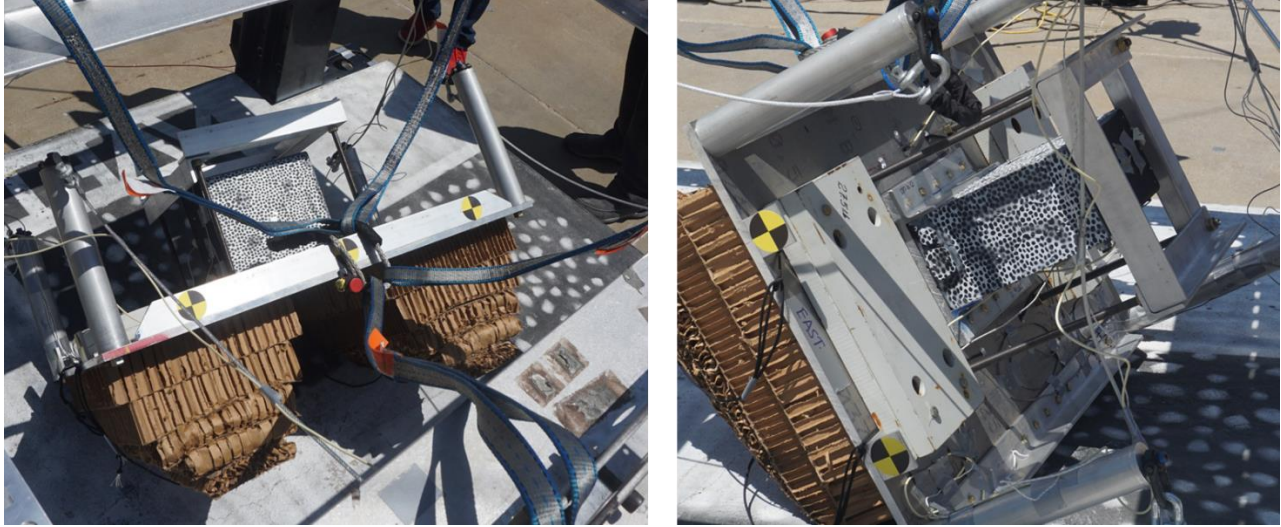
Figure 8. Upside Down test article post-test pictures

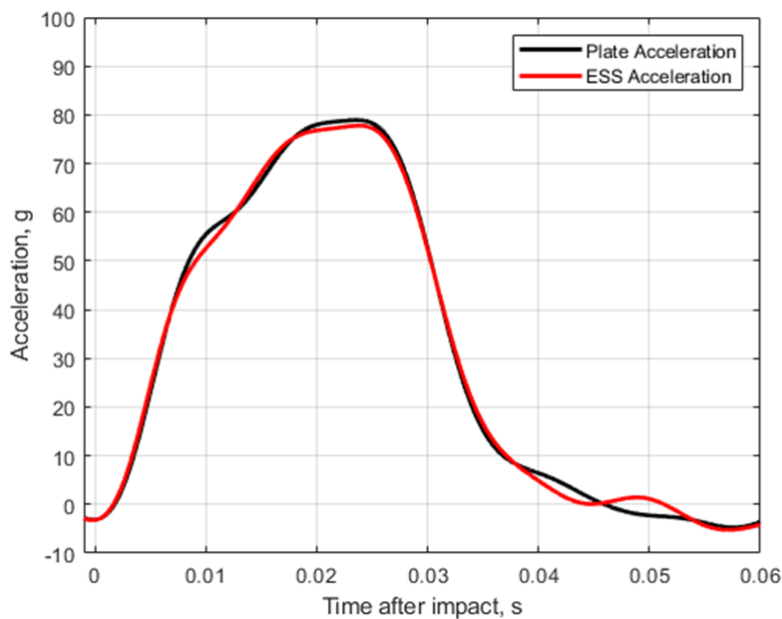
Figure 9. Upside Down test acceleration

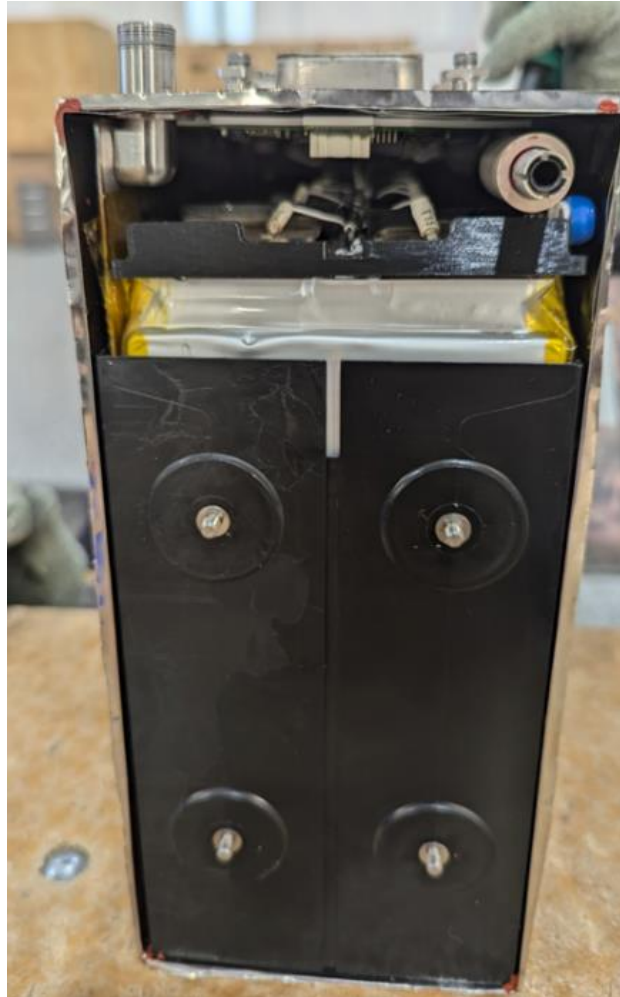
Figure 15. Upside Down Cell Assembly (forward face) and Containment Assembly (other faces)

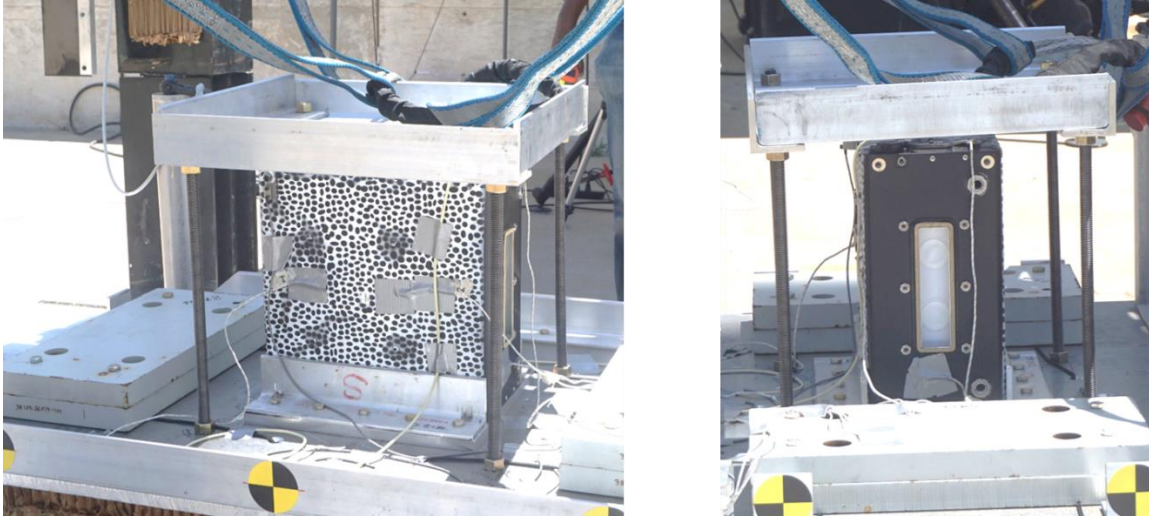
Figure 18. Sideways test article post-test pictures

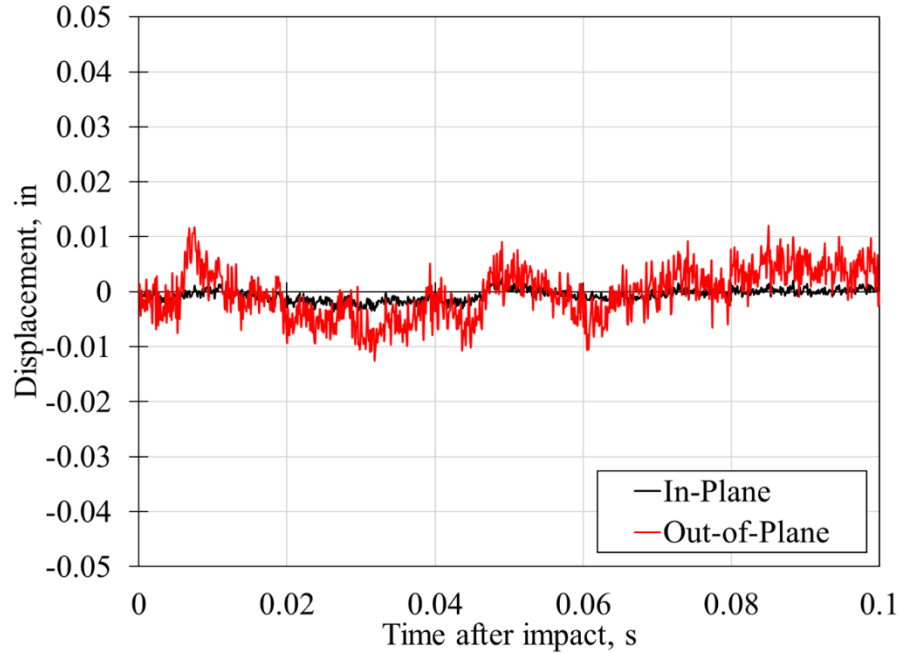
Figure 22. Sideways in-plane and out-of-plane displacement time-history plots

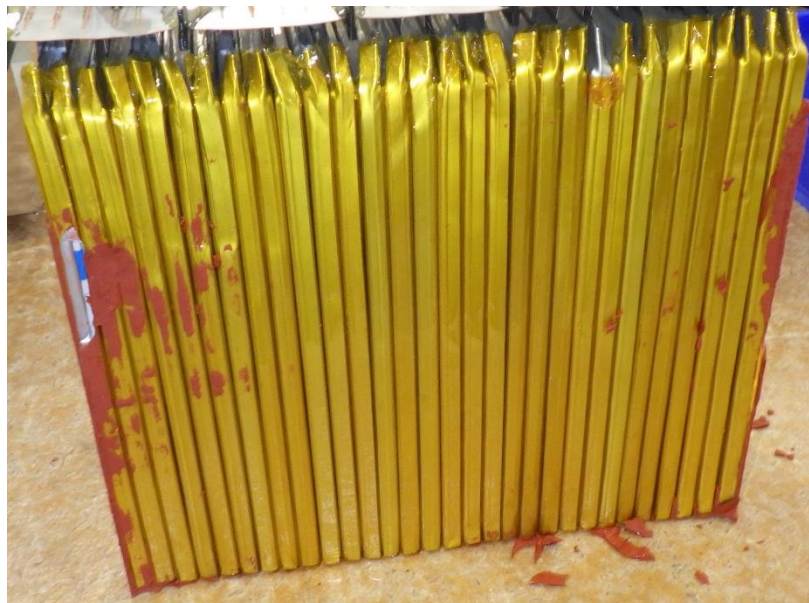
Figure 25. Sideways cells

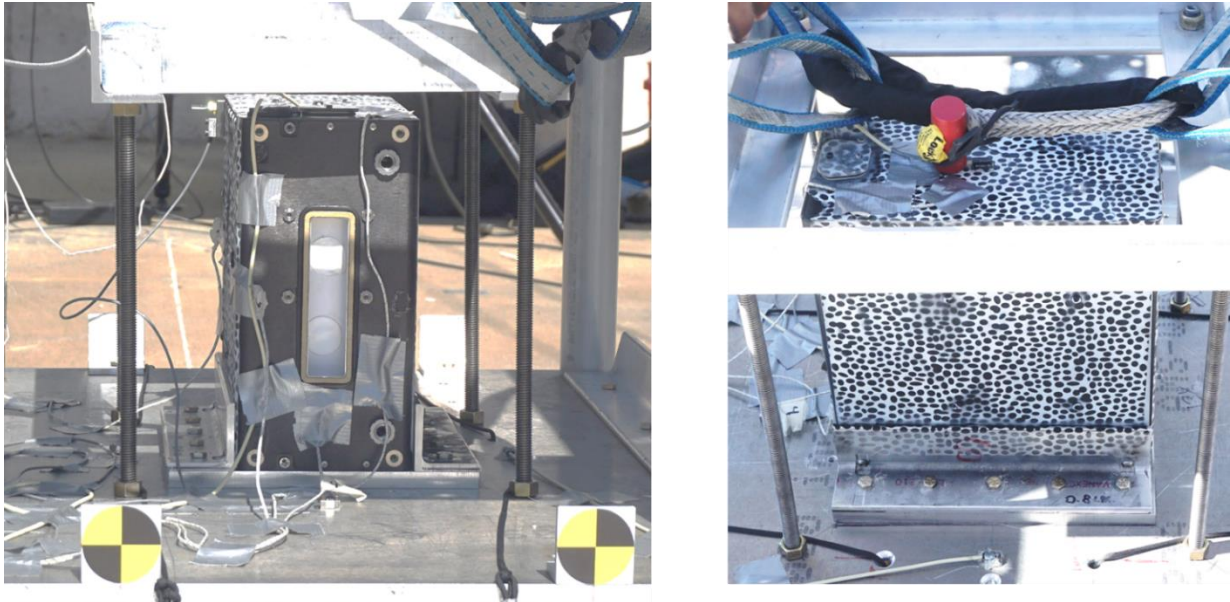
Figure 27. Sideways higher loading condition test article post-test pictures

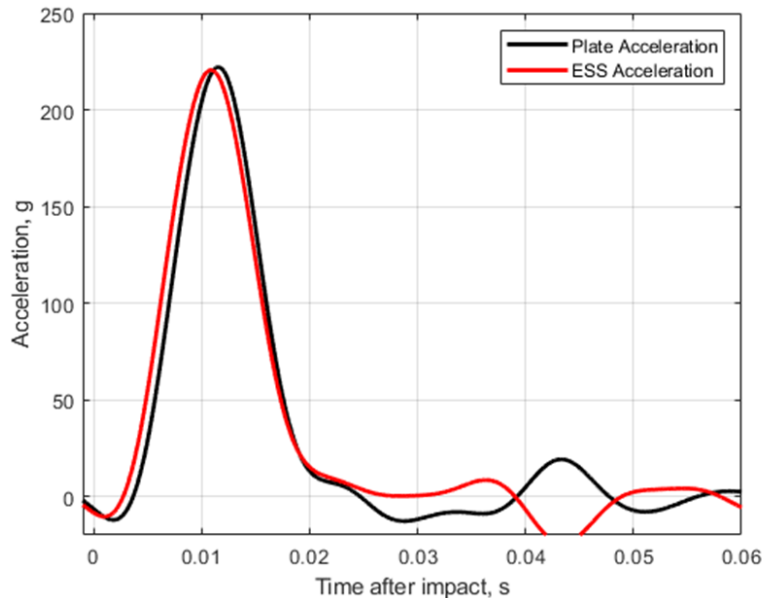
Figure 28. Sideways higher loading condition acceleration

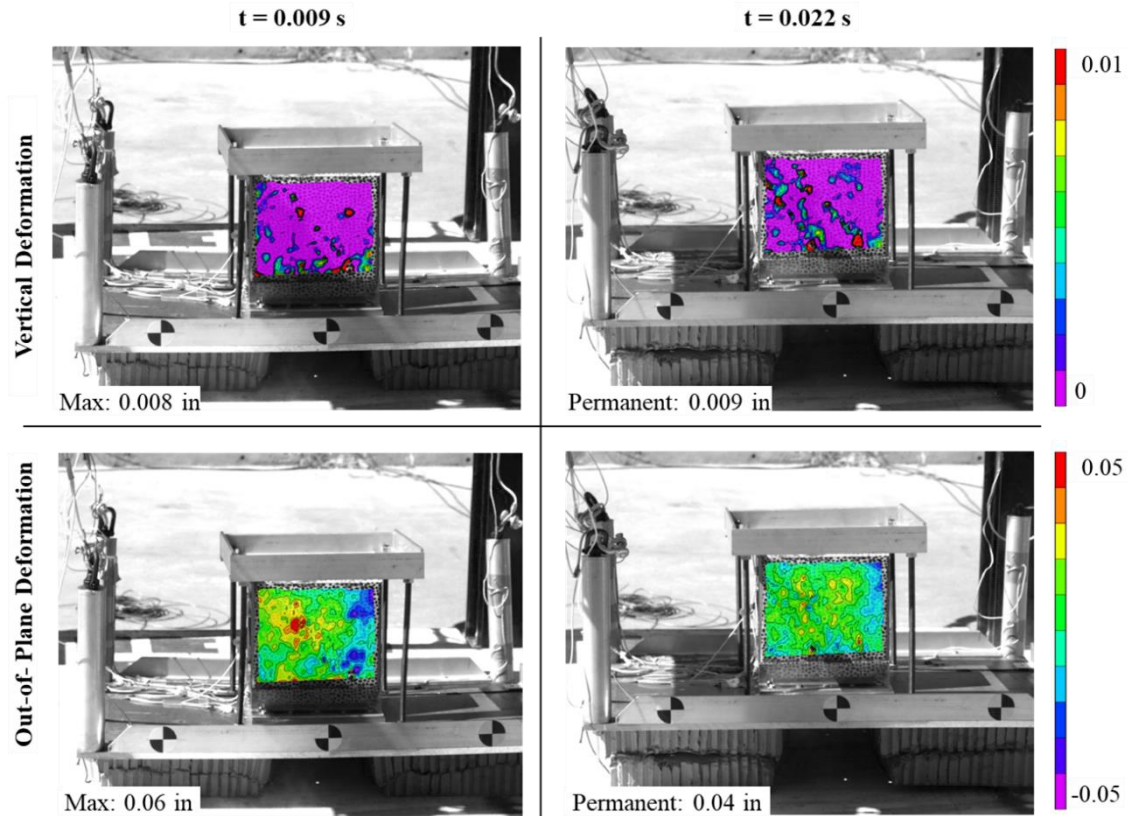
Figure 31. Sideways higher loading condition in-plane and out-of-plane deformation contour plots

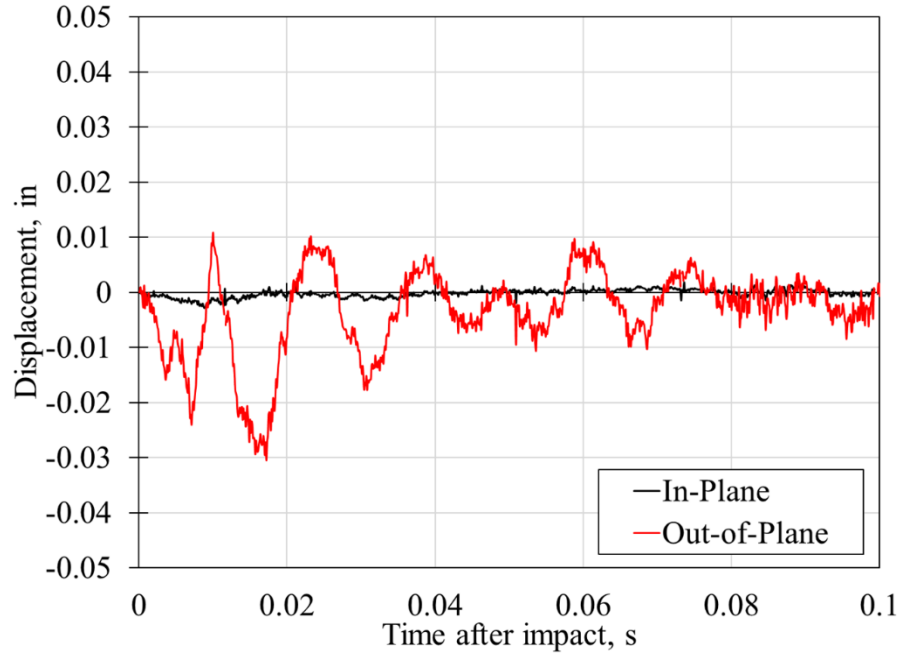
Figure 32. Sideways higher loading condition in-plane and out-of-plane displacement time-history plots

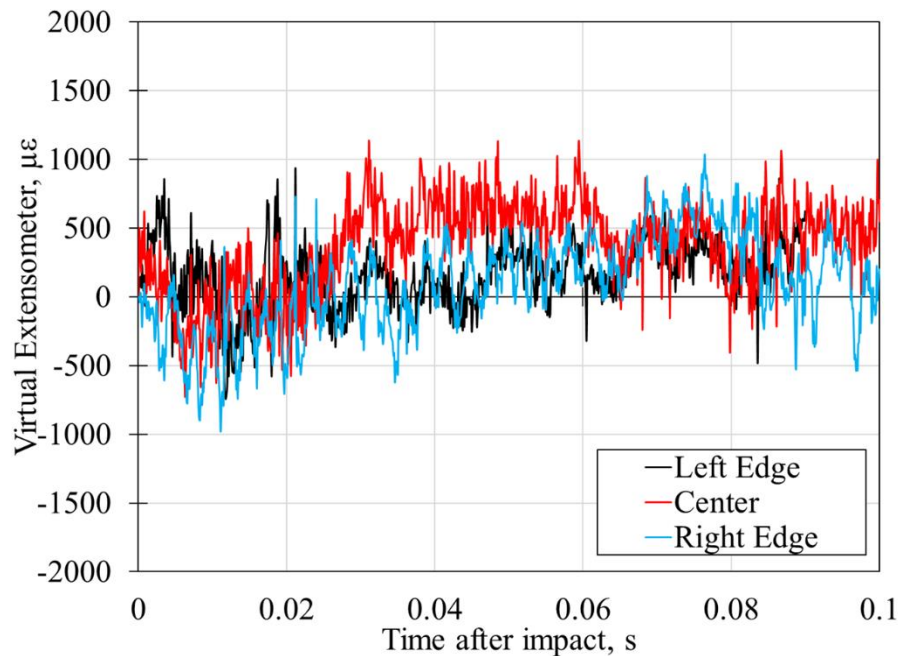
Figure 33. Sideways higher loading condition virtual extensometer time-history plots

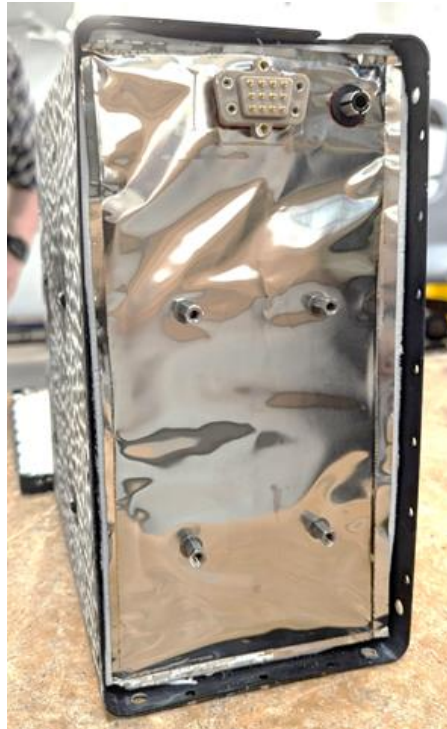
Figure 34. Sideways higher loading condition Containment Assembly

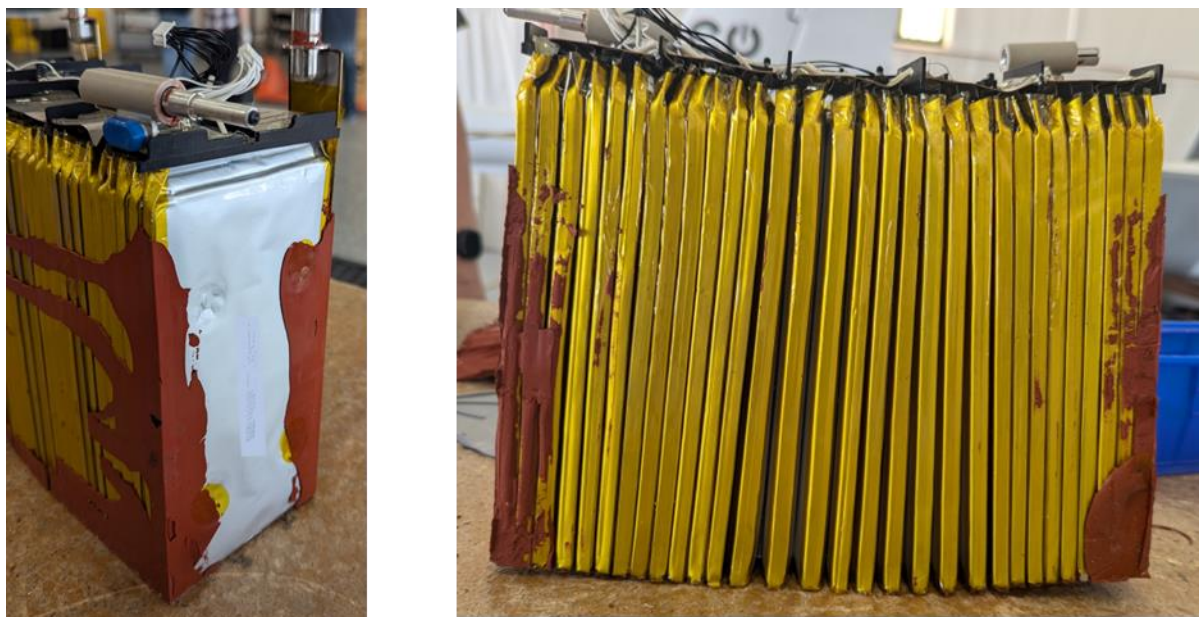
Figure 35. Sideways higher loading condition cells – end view (left) and side view (right)

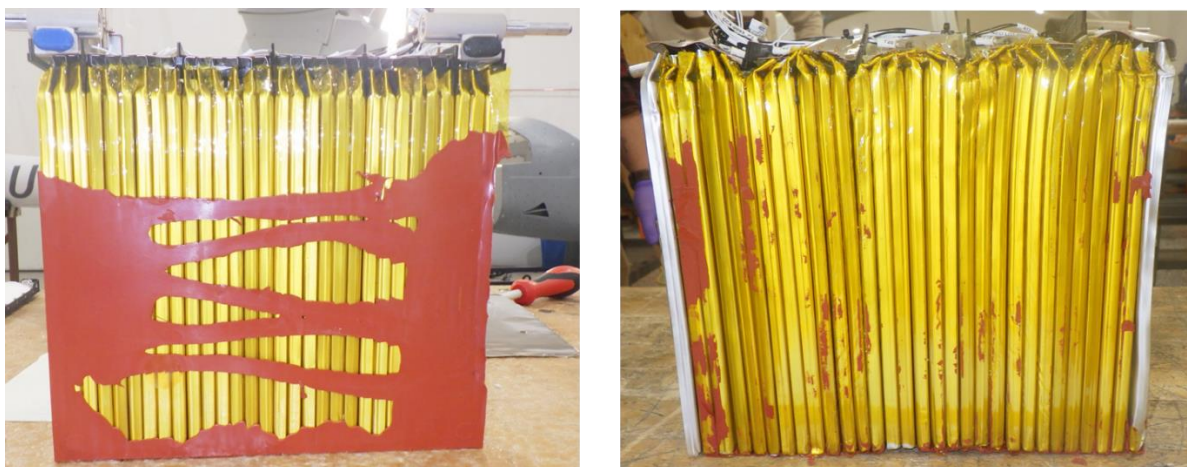
Figure 36. Upside Down test results. Phase 2 80 g (left) and Phase 1 743 g (right)

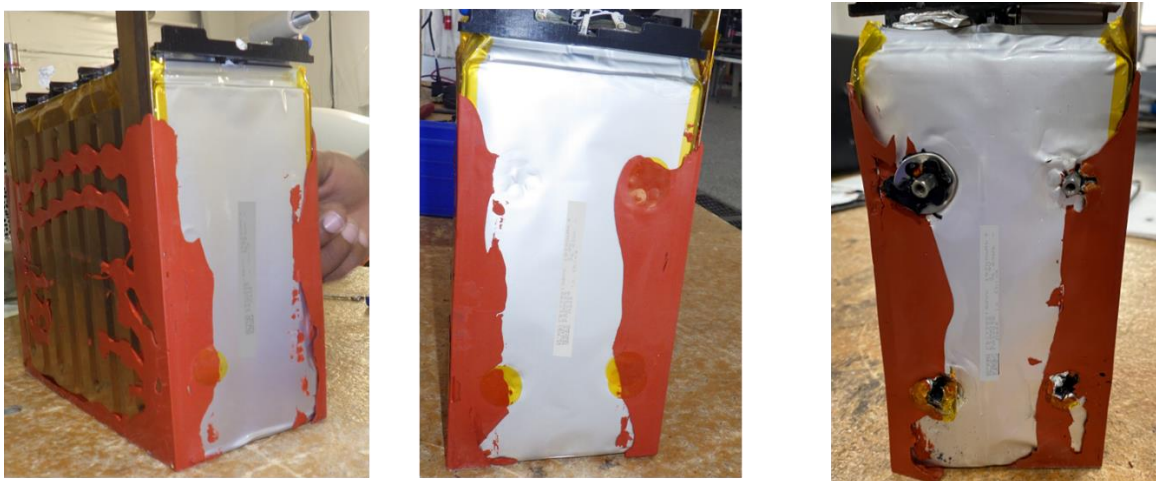
Figure 37. Sideways cell results. Phase 2 80 g (left), Phase 2 220 g (middle), Phase 1 (right)
