# **System-Level Single Event Effects Test Report - PIRT 1280MVCam InGaAs Infrared Camera**

NASA/TM–20250006620

*Test Date: 10/29/2024*

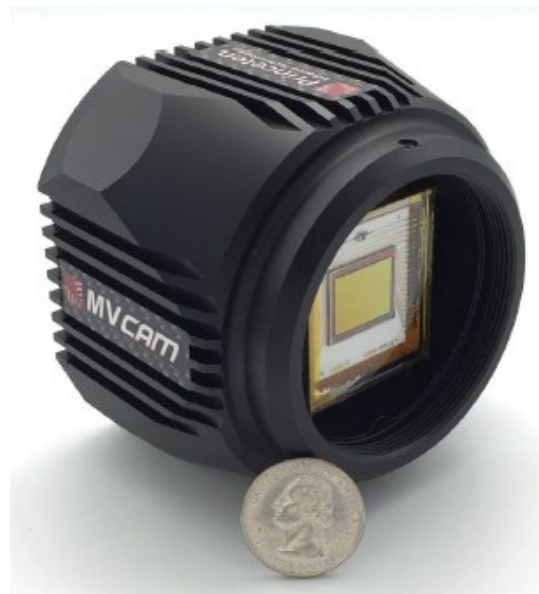
**Figure 1.** Picture of the 1280MVCam in a standard package. The camera that was evaluated during this test campaign had a custom aluminum enclosure.

Princeton Infrared Technologies’ (PIRT) 1280MVCam is a shortwave infrared (SWIR) imager (1.7  $\mu\text{m}$  cutoff wavelength) integrated with support electronics into an aluminum housing to provide an all-in-one imaging system. The system utilizes a backside illuminated, substrate-removed InGaAs focal plane array (FPA) with a 12  $\mu\text{m}$  pixel pitch and 1280x1024 resolution. Presumably each pixel is indium bump-bonded to a Si CMOS read-out integrated circuit (ROIC) based on a capacitive transimpedance amplifier (CTIA) with a 14-bit analog-to-digital conversion. A single stage thermoelectric cooler (TEC) is included to stabilize the temperature of the FPA within a user defined temperature range.

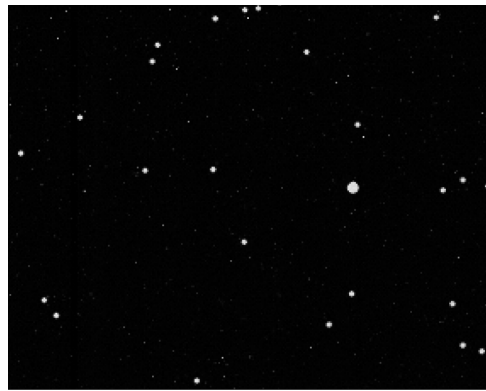
**Figure 7.** A subregion of an image captured during a beam spill. Note that an individual ion's generated charge may be collected within an individual pixel or across clusters of pixels.

During irradiation, ions passing through the FPA will deposit energy in the detector material and be captured in the image frames similar to the infrared photons that the system is designed for. This single-event transient pixel behavior is typically not subject to scrutiny as ion fluxes during missions are much lower than in a ground-based heavy ion tests and are considered to impact single frames of image data. Figure 8 provides a sub-region of the FPA to demonstrate the distribution of pixel cluster sizes that the ionizing particles can create when striking at normal incidence; in some applications SEE data can be used to discriminate between the intended photon measurements and incident ionizing particles. For system-level radiation testing, histograms can be used to identify more rapidly SEFI signatures in the image capture and discriminate between ions being captured in individual frames (Fig. 8) and persistent errors (Fig. 9). The persistent behavior identified in Fig. 9 strongly resembles image data before the resolution of the ADC is modified to 12 bits and is therefore indicative of either an upset in the configuration logic or a system power reset induced return to the 14-bit resolution configuration that is automatically set at start up.
