# 2025 AIAA WGSS PHPK PV-60 Cryogenic Valve Failure

Cody Drum (NASA GRC)

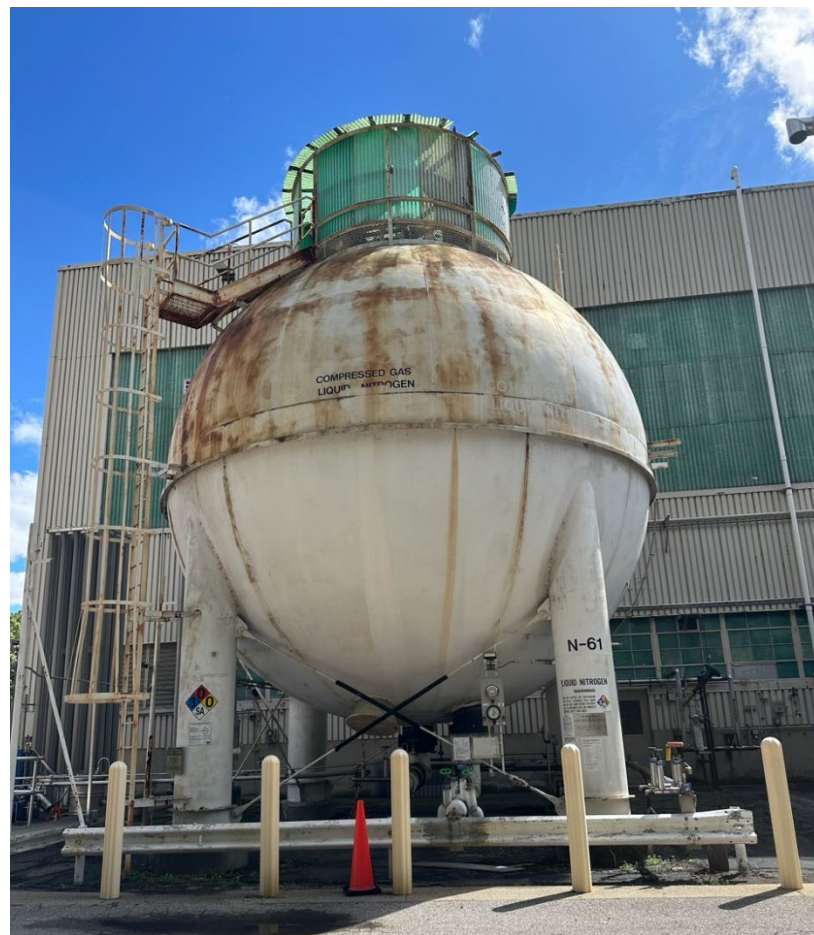
- 60,000 Gal LN2 Dewar
- Put in place in the 60s with little maintenance since then
- Supplies LN2 to building 301 and provides LN2 for high pressure GN2 generation

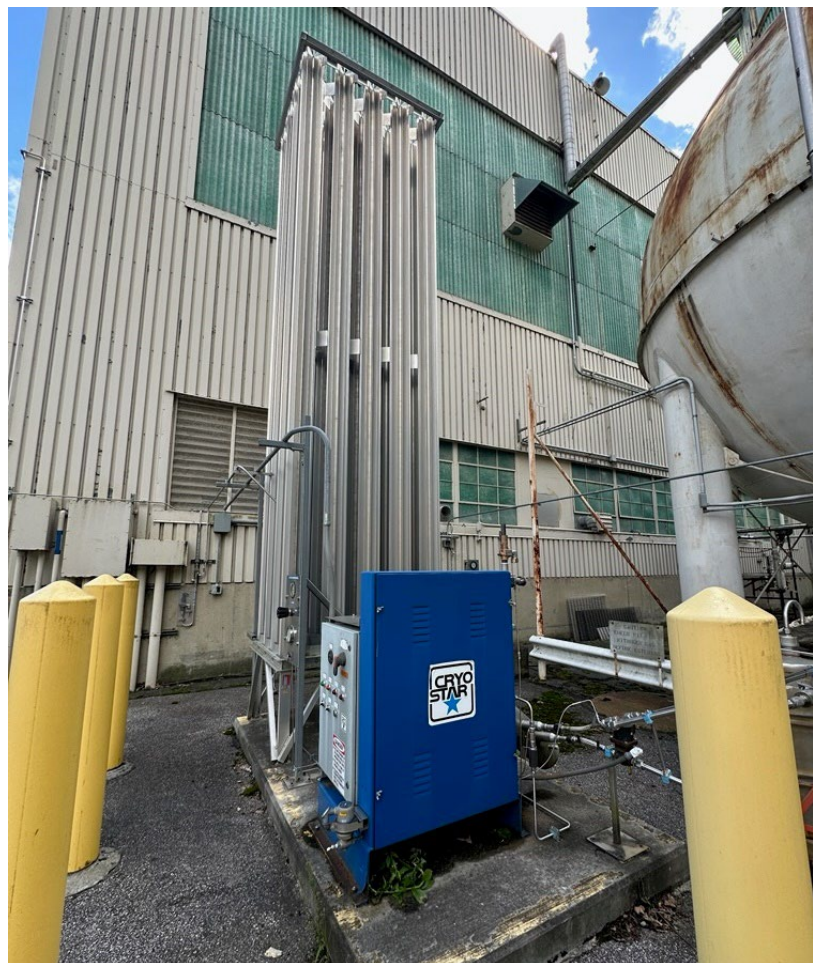
- CryoStar is the building source for high pressure GN2
- Takes LN2 from dewar and converts it to 1600 PSIG GN2
- Excess LN2 is dumped back into the dewar

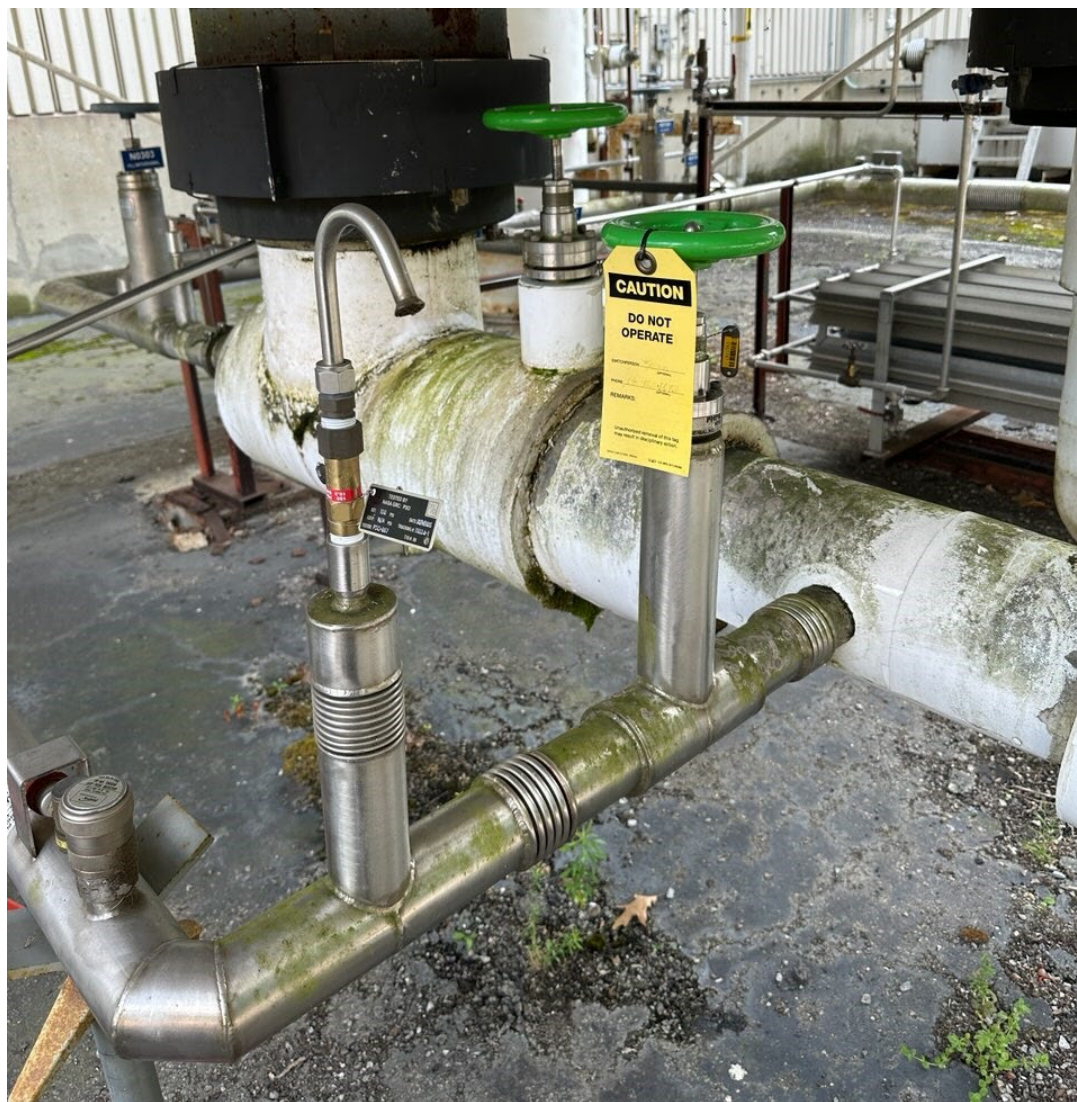
- PHPK PV-60 Cryogenic Globe valves
- Used to isolate the dewar from various systems
- 12 of these valves are installed at our building and were installed in the early 2010s

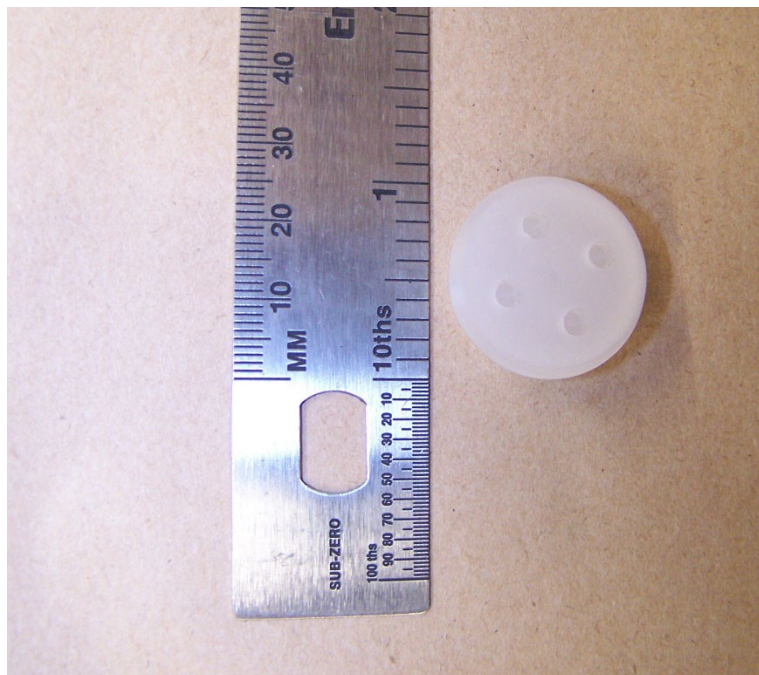
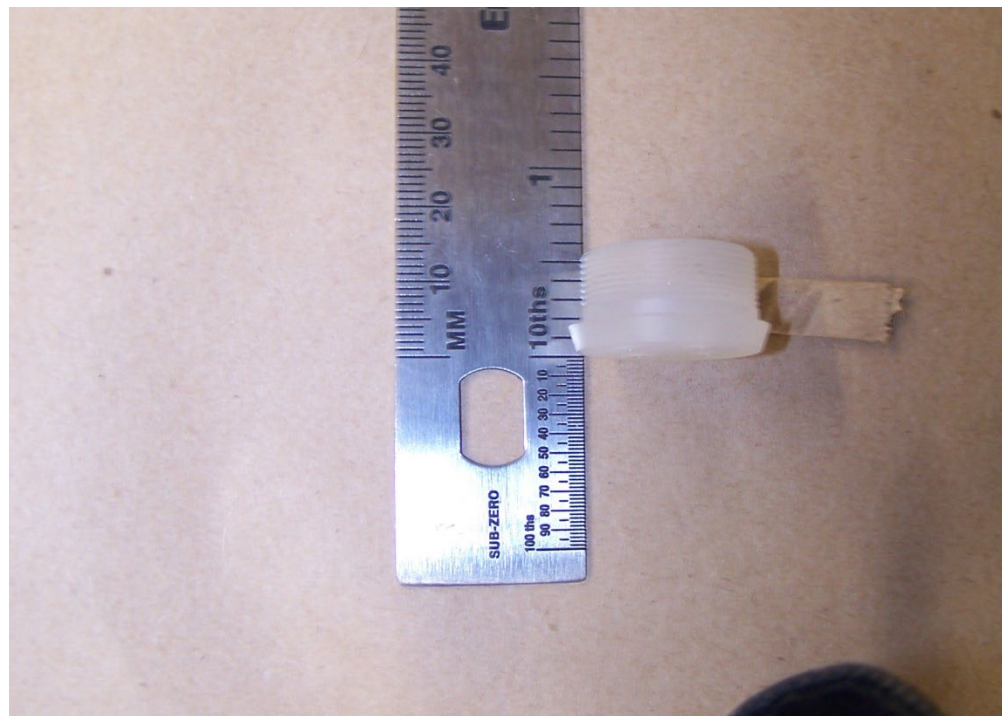
- Near this same time Building 77, lost LN2 mid test for unexplained reasons
  - We put a borescope down the line and found a strange blockage

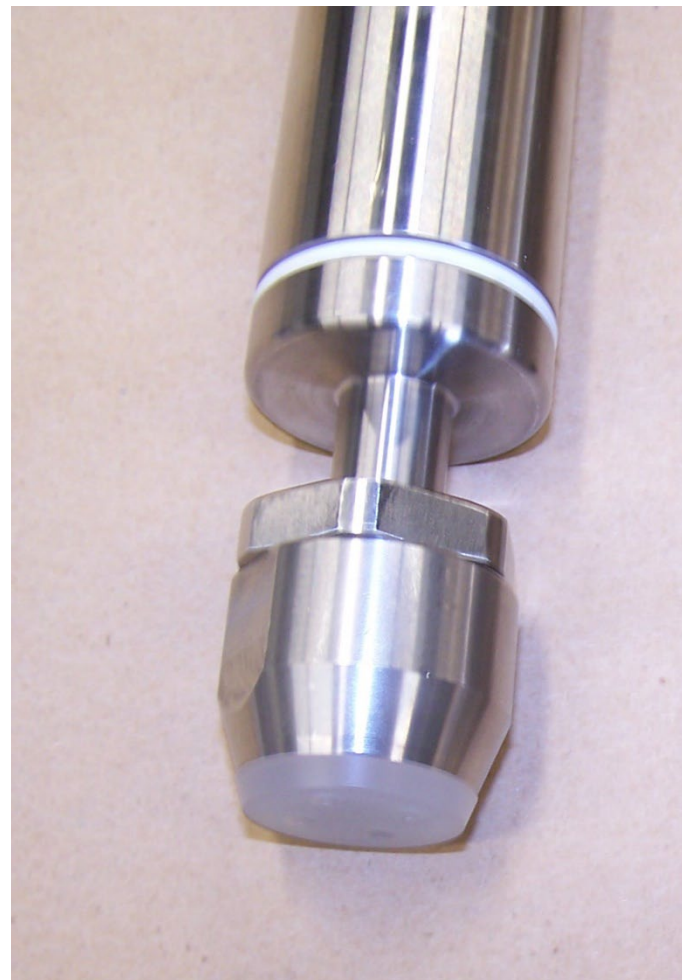
- It was found that this was the Kel-F seats that are in the PHPK PV-60 valves
- At building 77, 5 of these seats were found broken off in the LN2 system and had jammed themselves in the pipe blocking all flow

- Use a borescope to identify and remove all broken seats
- Replace the innards of your valve with the PHPK PV-70 which has this seat captured and cannot break off in your system

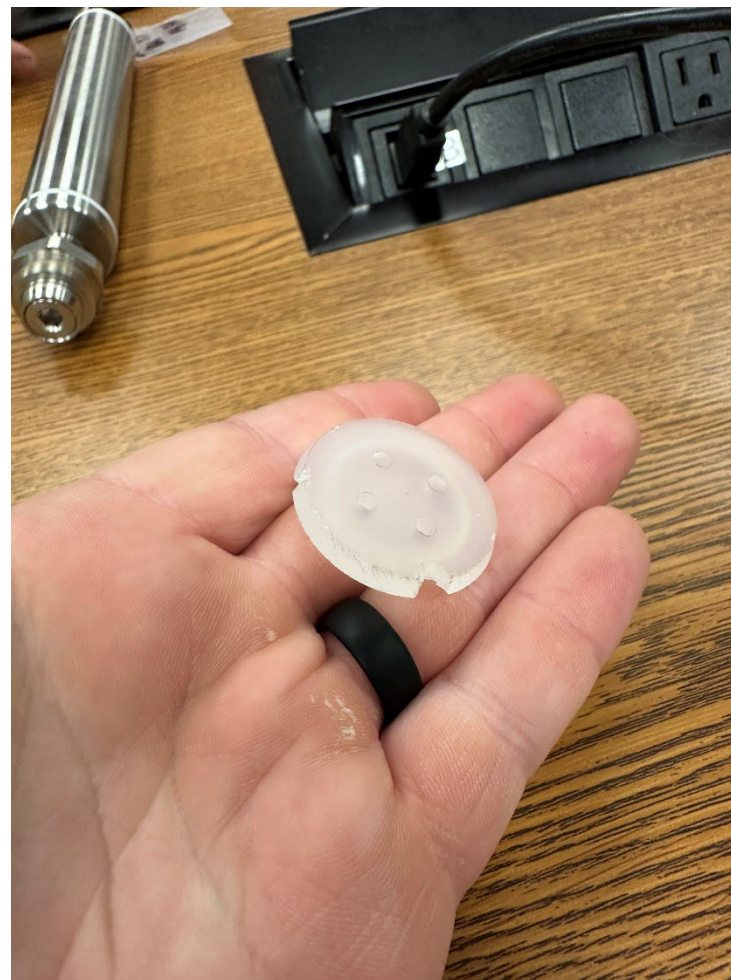
- In the CryoStar line, the seat had gotten jammed between the valve and our relief valve causing excessively high pressure in our line
- The seat was ejected from the line at high speed and cracked the Kel-F seat on impact

- Lack of LN2 flow to facilities where this seat has wedged itself
- High pressure in LN2 lines where the seat has blocked the relief valve
- Failure of equipment reliant on LN2 such as the CryoStar
- Damage to LN2 Dewars
  - It was found that the annulus pressure spikes were because the high pressure GN2 from a blocked relief valve caused a crack to form in the CryoStar return line. This will need to be repaired in our next LN2 shutdown

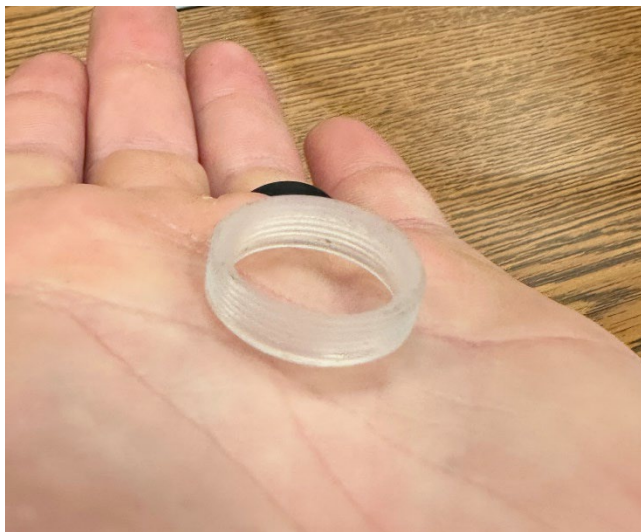
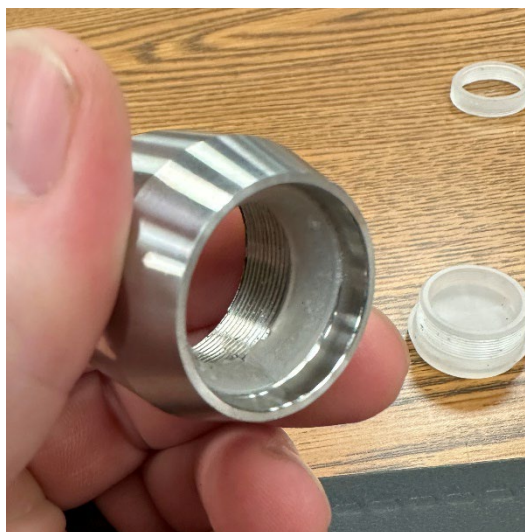
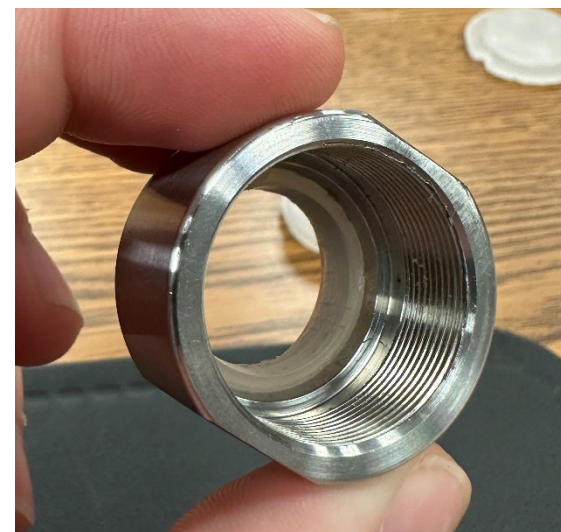
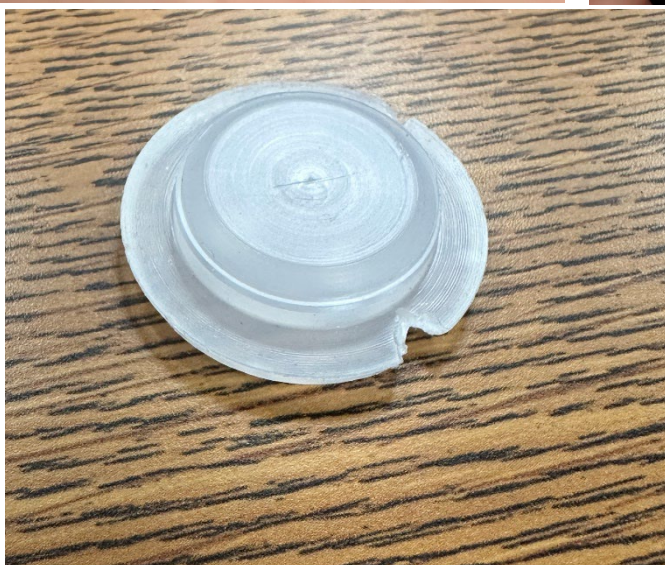
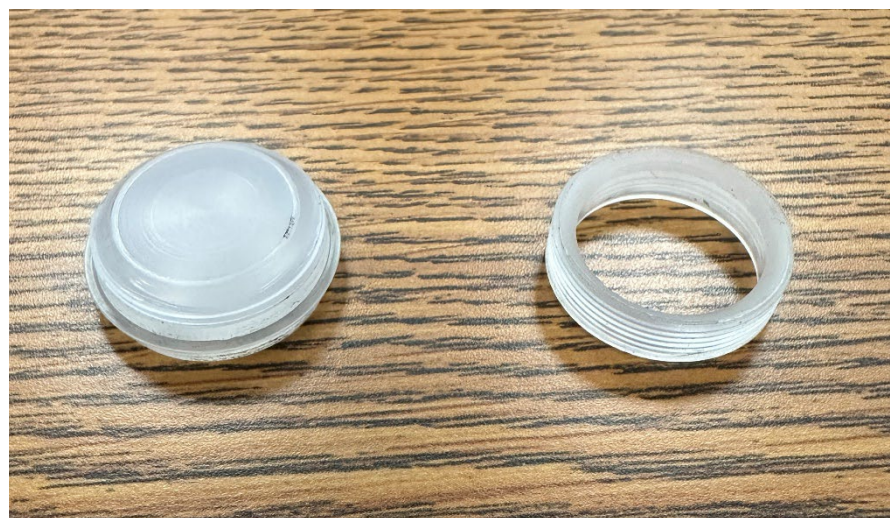
# Broken Seat Photos

- At building 301, a borescope was used on our system to check the same valves
- It was found that all 12 PHPK PV-60 valves had seats broken off in our system
- With some seats that were found in the line to the CryoStar as well as some that are still missing in our pipes
