NASA/TM–20260002810

# Results from a Pack-Level Drop Test of Energized Energy Storage System Hardware

*Justin D. Littell, Matlock M. Mennu, Nathaniel W. Gardner  
Langley Research Center, Hampton, Virginia*

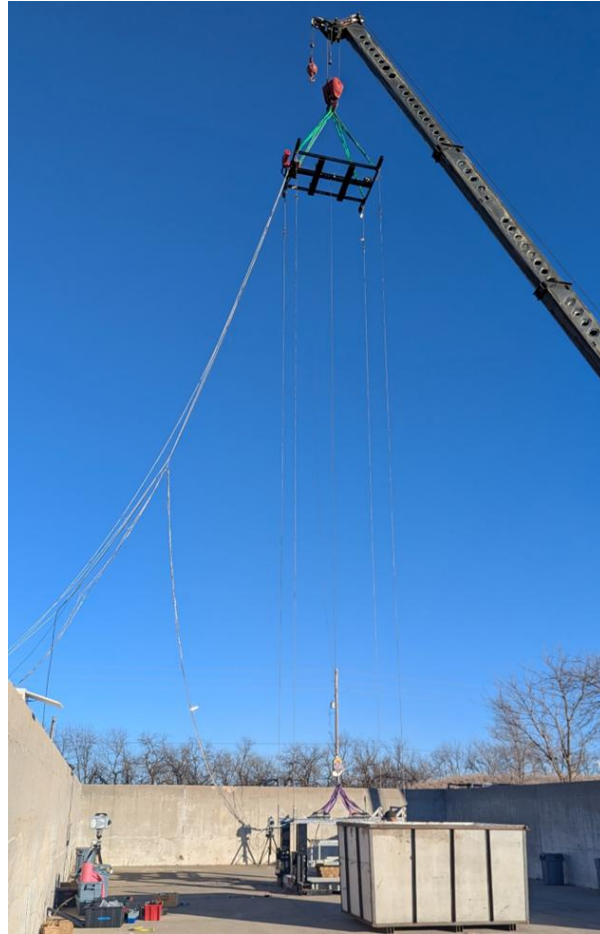
The test was conducted at the National Institute for Aviation Research (NIAR) utilizing NIAR test equipment and personnel. This setup was conducted in similar matter to the previous phases of tests, which suspended the test article by several cables to a guided trolley that would be released from a height of 50 feet onto a rigid impact surface. The test was conducted in a large outdoor concrete pit to contain potential hazards, should they occur. The test article and trolley were lifted by an overhead hoist and released via a release hook. When released, the test article and trolley would fall freely, guided by wires through the trolley, until contact between the test article and impact surface occurred. The test article was attached such that when contact occurred, the cables connecting the test article to the trolley would go slack and the influence of the trolley motion would be removed. The trolley was stopped via a separate arrestment system which did not interfere with the test article response. This setup is shown in Figure 2.

Figure 2. NIAR Test Setup

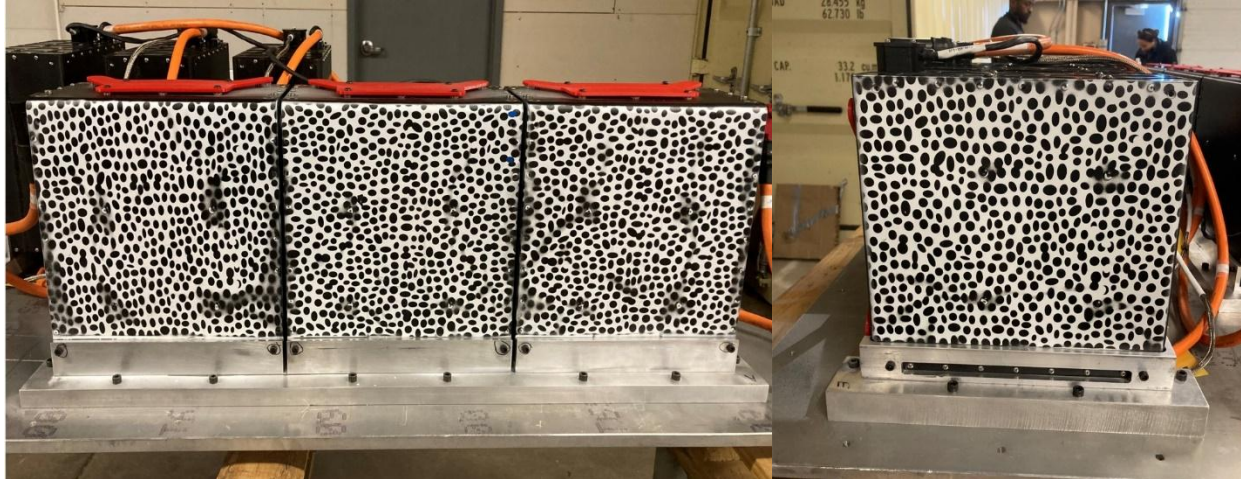
Specimen preparations were completed to allow for the 3D-DIC data to be obtained. Prior to testing, the modules were wiped clean to minimize any surface contamination. A thin base coat of white paint was applied, providing a uniform high-contrast background. Note, the surface of the modules, as well as all terminals, connection points, venting tubes, BMU and MPD, were masked off to prevent overspray contamination. A random, black stochastic speckle pattern was applied to the surface using a custom-made vinyl stencil pattern with a speckle size ranging from approximately 1/8 to 1/4 in. The speckle patterns on the Rightside Up and Sideways battery modules are shown in Figure 6.

Figure 6. Speckle pattern on battery modules for 3D-DIC. Rightside Up (Left) and Sideways (Right)

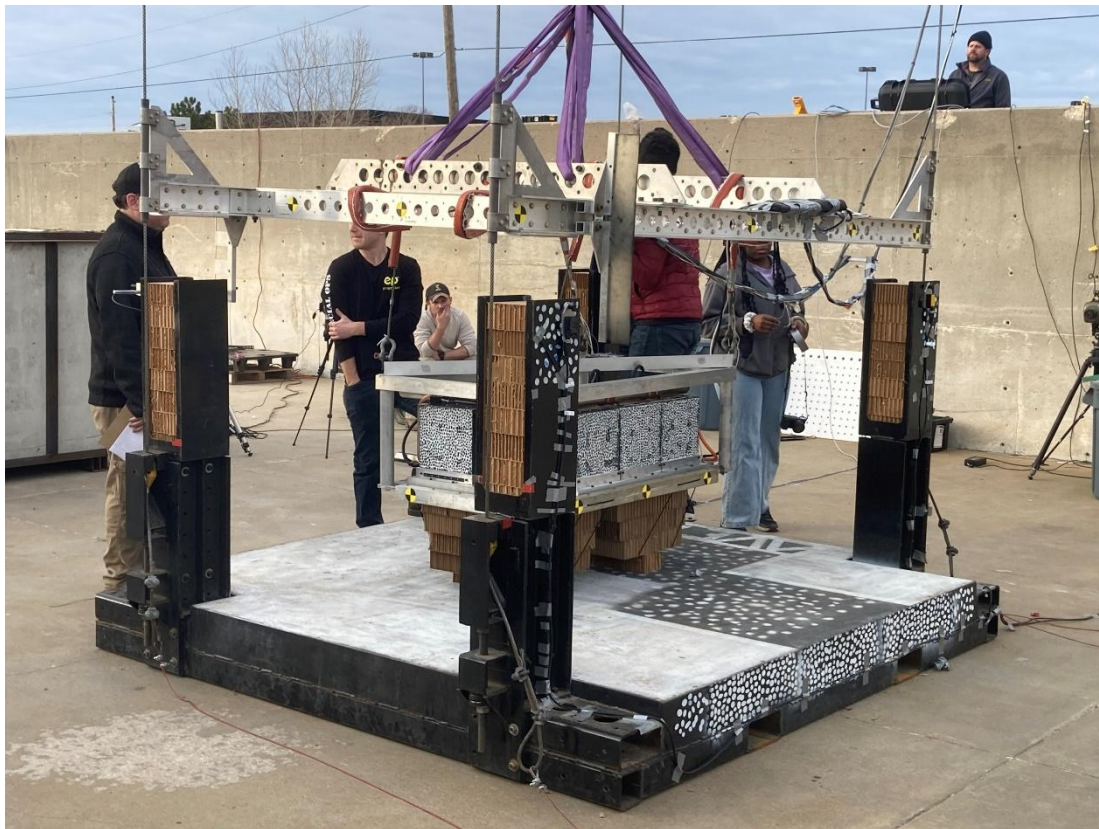
Once the speckle pattern was applied, and sufficient time had passed to allow for the paint to dry, yellow and black bowtie markers were positioned at specific locations for marker tracking. Bowties were positioned on the ESS hardware and the guided drop trolley, as shown in Figure 7. After the bowties were positioned and affixed, the distances between each bowtie were carefully measured and recorded.

Figure 7. Bowtie marker positions on guided drop trolley and ESS hardware

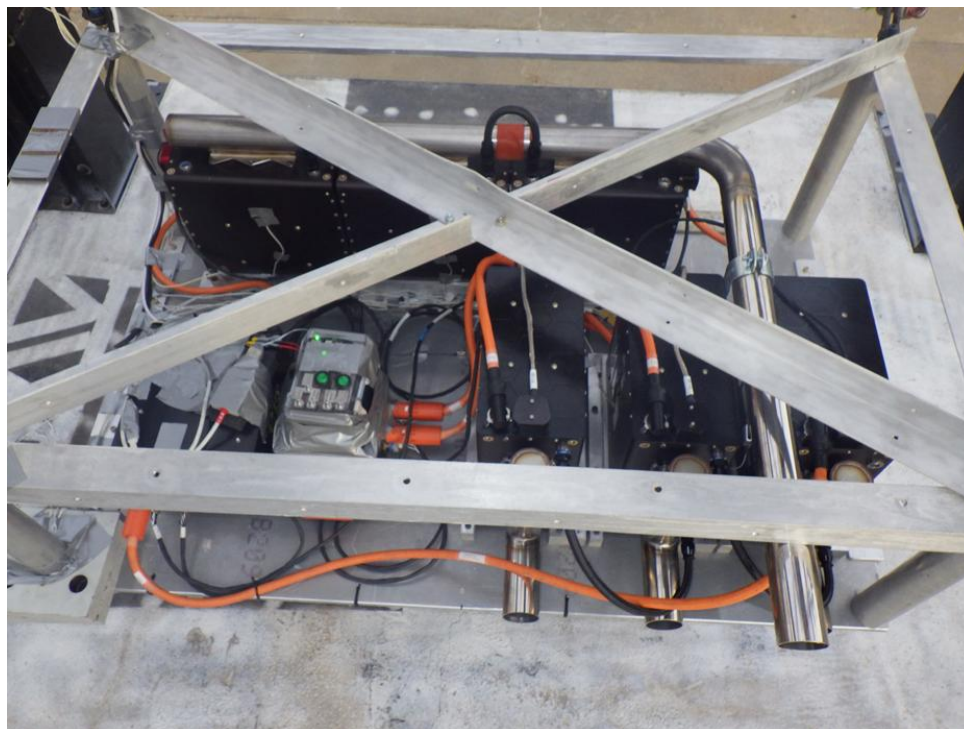
Figure 10. Test article - Top

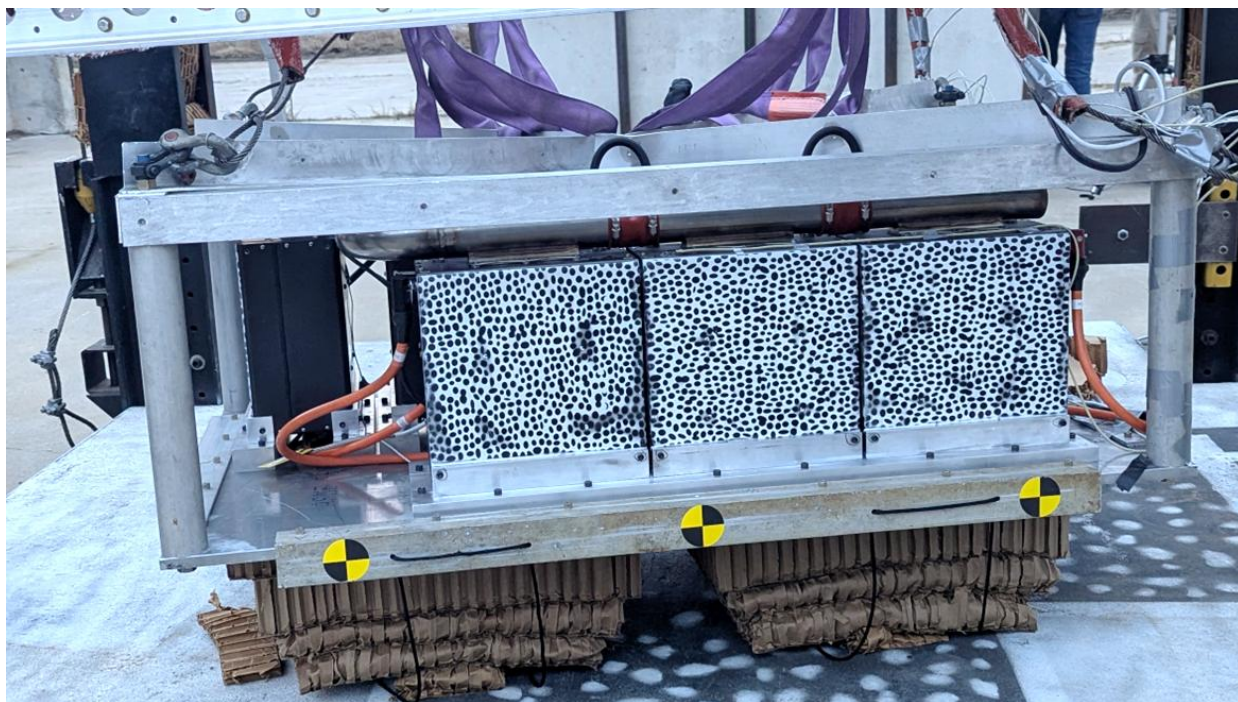
After the impact and the active post-test monitoring, the test article was approached and visual inspections occurred. An image of the East side of the test article is shown in Figure 13. The West and South faces are shown in Figure 14, and the North face is shown in Figure 15.

Figure 13. Test article - East face, post test

The visual inspections post-test revealed no major damage in the test article, other than some bending in the top of the protective cage. As noted previously, this was likely from the base plate flexing during the honeycomb crush. However, it appeared this bending did not affect module response, and the cage was still capable of acting as a protective barrier for the drop hardware associated with the drop trolley. All the modules, BMU, and MPD, along with cables appeared to be undamaged during the visual inspections and none of the mounting hardware, which included both the bolts and the brackets, was loose or missing. The overall first impression was that the test article remained intact from the test. However, post-test processing of the data would validate or invalidate this conclusion. The vertical acceleration data were first examined. The filtered acceleration data are shown for all four locations in Figure 16. Note that all acceleration data presented are filtered using standard filters as defined in SAE J211 [18].

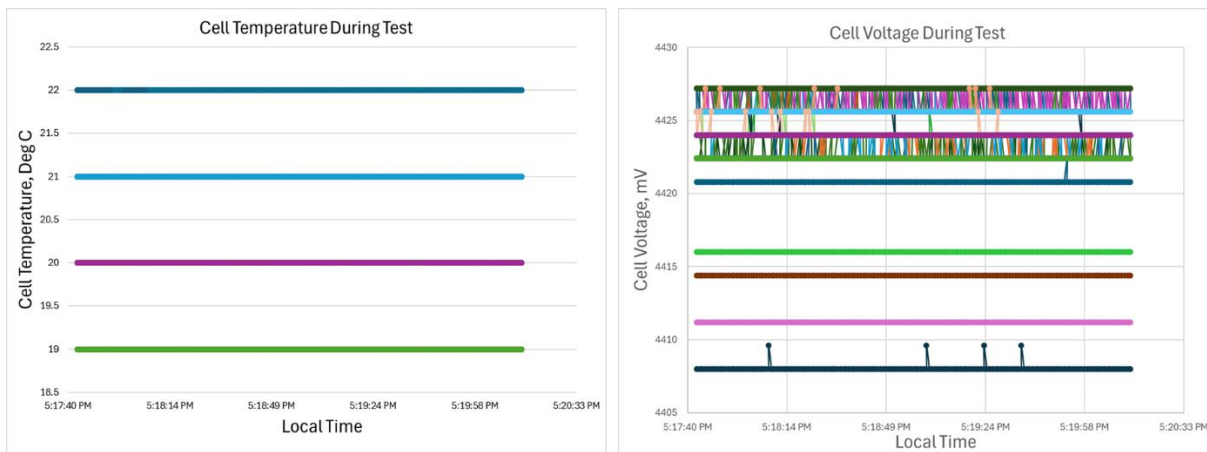
Figure 27. BMU data at impact. Cell temperature (left), and voltage (right)

Note the BMU data shows results from all 60 individual cells (10 per module, with 6 modules tested). The cell temperature data are shown on the left. Note all 60 cells are represented in the plot, with each of the cells falling to be one of the four temperatures measured, which ranged between 19- and 22-°C. There were no spikes or any other data that could be considered abnormal in the individual cell temperature responses around the time of impact, according to what was recorded in the BMU. The BMU also recorded individual cell voltage, is shown on the right graph. Again, all 60 cells are plotted, with cell voltages ranging between 4405 and 4420 mV, with multiple cells represented by each trace. As with the temperature data, there were no severe spikes or otherwise abnormal events that occurred at the time of impact. However, there were some cells that alternated between two voltage measurements, which is most visible in the bottom blue trace in the plot. However, these four spikes in the data were only an artifact of the BMU recording resolution and not from the test itself. The BMU recorded voltage with a resolution of 0.4 mV, so data having two distinct voltage values that alternated back and forth indicated voltage in the

cell was somewhere between the two alternating values. No large spikes or jumps spanning multiple volts were evident in any of the data logged from the BMU.

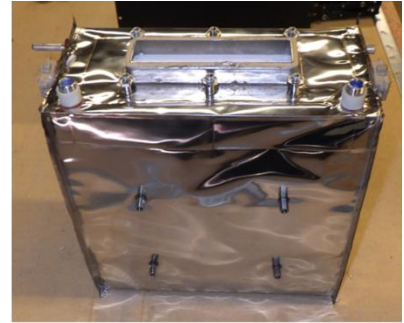
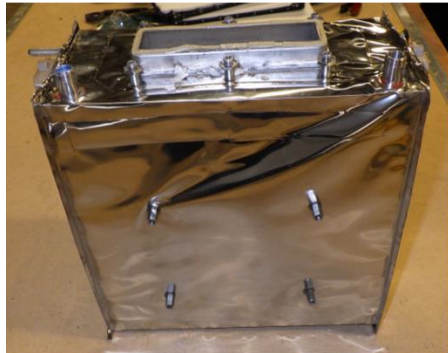
Once the enclosure assembly was removed, the containment assembly was revealed, which showed the encapsulation designed to house the cells and serve as a thermal runaway propagation barrier. To access the containment assembly, the metallic foil layer was cut, thereby exposing the underlying thermal insulation material. Inspection of the mounting interfaces revealed no signs of material yield or fastener pull-out failure. The fasteners were all intact, with no protrusion, thread stripping, or localized indentation observed, which are shown in Figure 33. Furthermore, the thermal insulation layer remained intact, displaying no distinguishable abrasions or tears that would indicate damage from the impact.

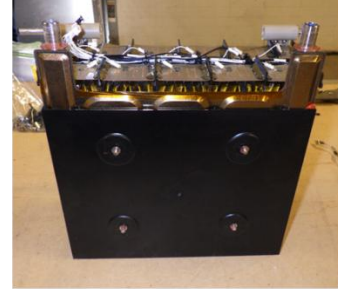
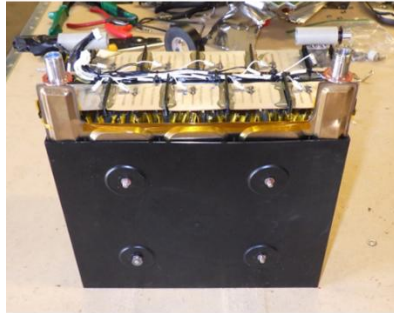
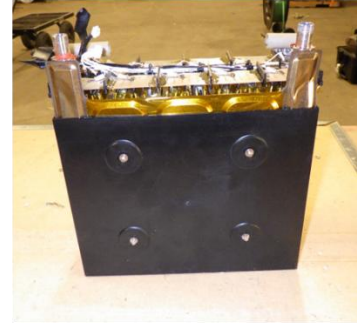
After the removal of the containment assembly, the cell assembly was examined. The cell assembly included the internal bus bar network, the terminal lead ends of the module, the active coolant channel, and the internal plastic enclosure. The internal bus bar assembly, including electrical voltage and temperature leads, showed no external damage or connection severing. The primary module terminal leads also did not show signs of any visible damage. The internal plastic shell case known as the cell assembly appeared largely undeformed. Additionally, the metal inserts molded into the sides of the plastic enclosures remained seated, showing no signs of pull-out or protrusion. The module cell assemblies are shown in Figure 34.

Figure 34. Post-test forensics. Cell assembly
