# Improvement of Odor Control for the UWMS Hard-Sided Fecal Canister and the Alternate Fecal Canister

**On longer range exploration missions, the mass and volume of critical hardware and consumables required to support crew will pose a big stowage challenge. This includes the hardware for the collection and storage of human metabolic solid waste. The amount of stowage needed for this hardware both before (empty) and after (full) use will be a significant burden on the overall spacecraft habitable volume, layout, and design. To help with this challenge, the National Aeronautics and Space Administration (NASA) Mars Campaign Office (MCO) Logistics Reduction (LR) Portfolio has developed a collapsible canister for the collection and containment of fecal deposits. The Alternate Fecal Canister (AFC) is a collapsible alternative to the exploration toilet Hard-sided Fecal Canister (HFC). The AFC in its empty state has a volumetric benefit to smaller vehicles on longer missions. The current designs for HFC and AFC were tested with human fecal material for odor containment at White Sands Test Facility (WSTF) where the tests on both were unsuccessful. The source of the lack of**

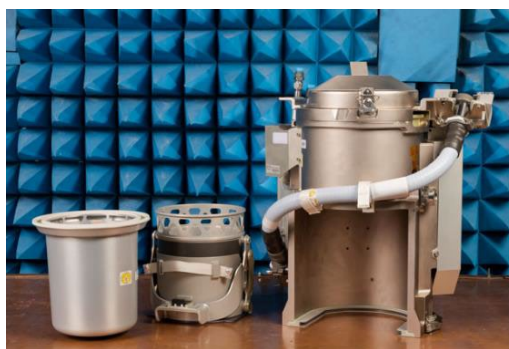
Figure 1. Orion's UWMS with HFC and Lifting Mechanism.

The UWMS was initially designed by Collins Aerospace [1] [2] using a Hard-sided Fecal Canister (HFC) (see Figure 1) which is essentially a machined aluminum can which interfaces with the toilet itself as well as the venting, odor controlling lid. Because the body of the component is a single, machined piece it is very effective for odor control but is heavy and takes up space with an empty volume inside of the unfilled configuration. Although they partially nest, there is still a large stowage space allotment needed. The sizing of the canister requires replacement as often as every other day and for a Mars mission, a large quantity would be needed.

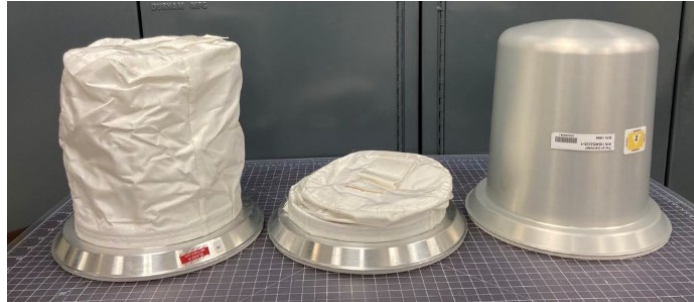
**Figure 2. AFC in full configuration, empty (stowed) configuration and Hard-sided Canister.**

As part of the on-going work to optimize metabolic waste collection and storage, NASA developed an Alternate Fecal Canister (AFC) which utilizes a flexible material for the main body of the bag which when empty and compressed reduces the volume by 90% and provides a mass reduction of 45%. Reductions of mass and volume can be seen in Table 1 and Figure 2. [3]

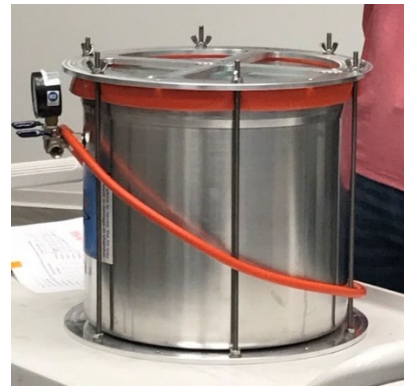
**Figure 8. Odor Testing Apparatus for AFC.**

Testing at JSC in 2021 utilized a custom-made testing apparatus, Figure 8, to enclose the AFC with odor containing materials. Early testing used banana oil as a substitute for fecal material. This material degraded the gasket material very quickly and was not suited for this type of testing. Additional testing was done with human fecal material donated from the test subject pool for this purpose. Testing included opening a valve to expose the gas which was surrounding the AFC with lid. Testers “sniffed” this gas and rated the odor using the scale defined in Test 6 and used at WSTF.

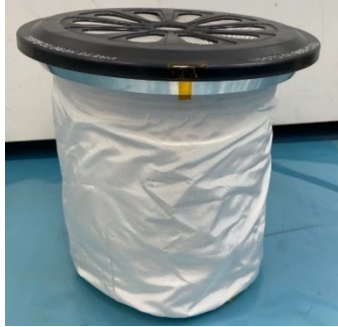
**Figure 9. AFC filled for initial odor testing at WSTF.**

After successful screening testing at JSC, in 2022 an AFC test article (Figure 9) was filled with fecal material and driven to WSTF for official testing. The requirement was originally less than 1.5 based on the 0 to 4 odor testing scale (Table 2). This was found to be overly restrictive and not representative of other odor testing and was changed to less than 2.5 for the most recent testing. The first sample resulted in a failed test at 30 days with an average rating of 2.7. The test article was examined and it was determined that the source of the odor leak was at the gasket between the lid and the AFC. This gasket and interface are identical to the HFC used in the UWMS.

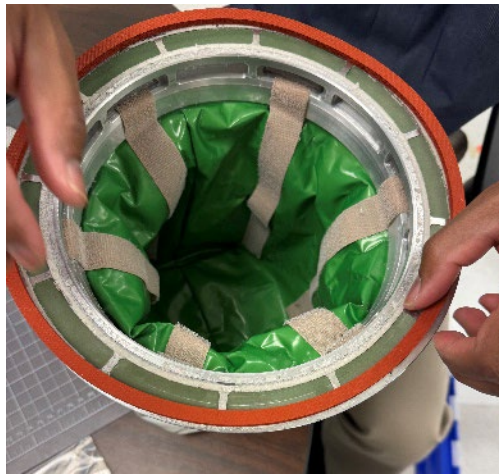
**Figure 11. Gasket Images (a) Thinnest gasket candidate (1/8" thick HT-1240 solid silicone gasket) being applied to the AFC assembly.**

The design of the filter lid and AFC interface ring introduced several challenges to the gasket selection process. Because the lid fits onto the canister like plastic food storage containers, where the dimensions of the lid and canister allow the lid to snap into place atop the canister without a locking mechanism, it is difficult to estimate the compressive force that the lid exerts on the gasket. The engineering drawing from Collins states that a maximum compressive force of 57 lbf can be applied between the lid and the gasket before the lid will pop off of the canister. This means that the lid could be pushing down on the gasket with a force anywhere from 0 to 57 lbf, and this number would change depending on the thickness and compressibility of the gasket material. Because of this uncertainty, the team aimed to find the thickest, most dense material possible that would approach this 57 lbf without exceeding it and causing the lid to pop off the canister, configuration seen in Figure 11.

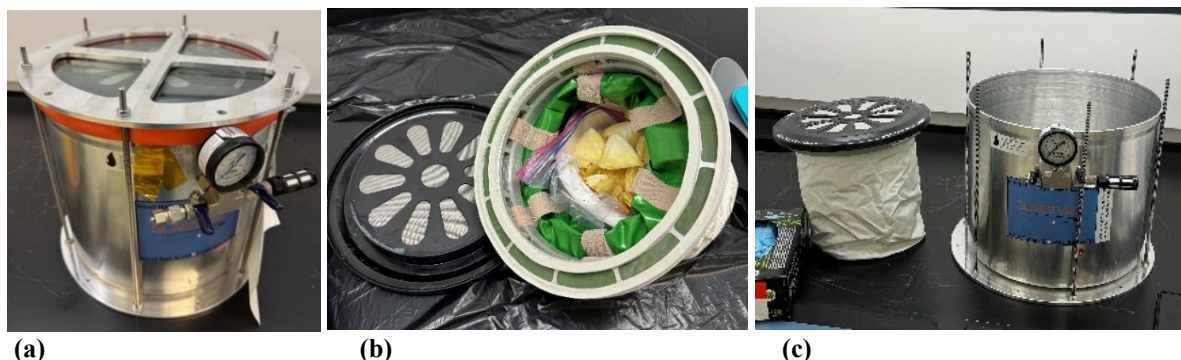
**Figure 14. HFC gasket testing in small chamber (a) Top view, (b) AFC opened upon onion test conclusion (c) chamber opened under Hab Lab fume hood for fecal testing.**

Once a gasket passed its water test, that gasket would be removed from the AFC and a spare of the same type would be added in its place. This was done to avoid using a potentially saturated gasket during odor testing, as the water may occupy space that odor would normally escape through under normal use conditions (assuming the gasket was a foam or sponge material). From there, the gasket would undergo its first odor containment test in a small test chamber shown in figure 14. For all of the odor tests at JSC, project team used the protocol and scale from NASA-STD-6001B but are not certified as are the WSTF team. The first odor tests performed in this chamber began in July

of 2024 using onions as the odor media, which was switched to fecal samples in November of 2024 to more closely represent the AFC use conditions. The goal of this initial round of odor testing in the small chamber was for the assembly to contain odor below an average smell rating of 1.5 for two months. Nearly all of the gaskets tested failed this requirement, with most gaskets lasting about two weeks before a strong odor could be detected. The only gasket to conclusively pass this requirement was the Kynar® (PVDF) gasket, which lasted about 2.5 months in the small test chamber with no detectable smell. One inconclusive result was the Viton™ (FKM) gasket, as it released an unpleasant odor from the chamber and was initially deemed a failure, but upon opening the chamber and inspecting the assembly it was found that the smell was seeping through the lid filter media and no smell could be detected around the gasket interface. It's unknown whether this lid filter had become saturated with odor after multiple odor tests, or if this was the only time it failed. The potential failure of the filter media was not noticed until the conclusion of the building 33 odor testing detailed below. It also raised concerns that previous gaskets may have been deemed failing because of the failure of the filter lid media. But in most cases of gasket failure the odor was detected around the gasket's interface with the canister. This initial testing in the small test chamber was concluded in December of 2025 when the Kynar® (PVDF) gasket and AFC/HFC assembly were taken to WSTF for final odor testing.

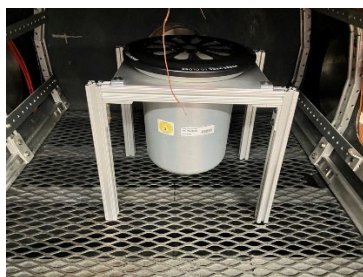
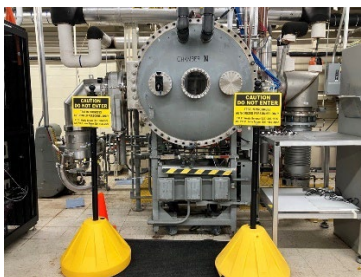
**Figure 17. Odor Screening testing at JSC (a) test article in chamber, (b) Chamber N with door closed, (c) “sniff” testing.**

To increase the likelihood of successful testing at WSTF, a screening test was done at JSC in a similar chamber as that used at WSTF. Testing was done with the F30 Kynar® (PVDF) gasket in JSC Building 33 Chamber N. After 30 days the project team's evaluation of odor detectability was essentially "0." A test setup very similar (but not officially meeting the NASA standard as defined in NASA-STD-6001B. ) was used. The test was continued past 30
