NASA/TM–20260003620

# A Summary of Test and Analysis Results from a Second Lift+Cruise Full-Scale Drop Test

*Justin D. Littell, Jacob B. Putnam, Emilie R. Baker, Nathaniel W. Gardner, Matlock M. Mennu  
Langley Research Center, Hampton, Virginia*

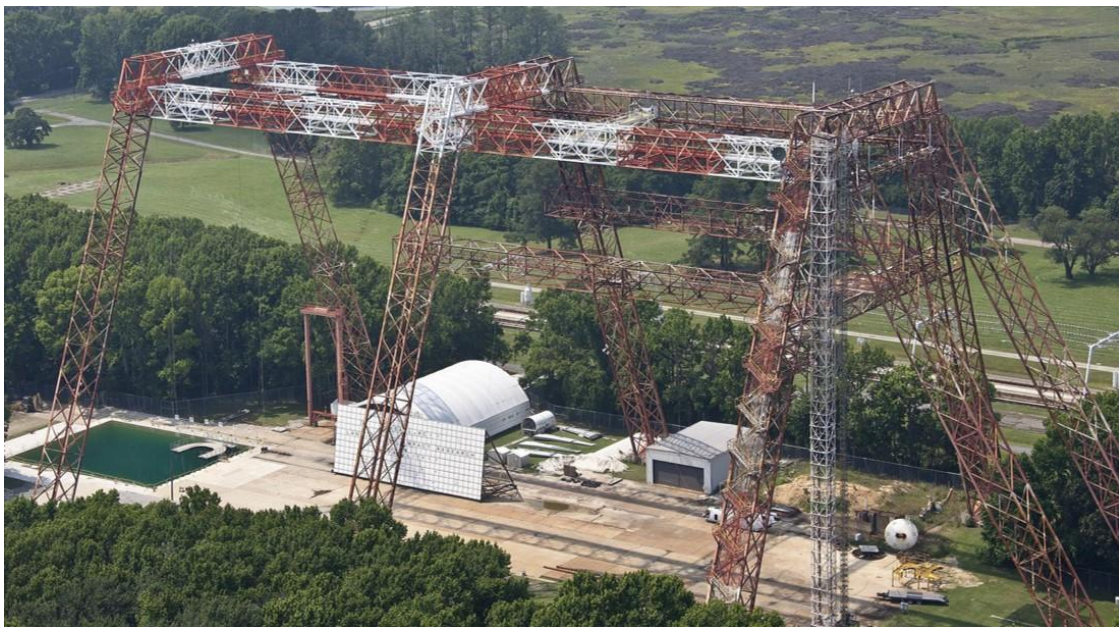
Figure 1. LandIR facility

The test was conducted at the Landing and Impact Research Facility (LandIR), located at NASA LaRC. This facility is a 240-ft tall, 400-ft long, steel structure capable of lifting and swinging full-scale aircraft for crash testing under a variety of impact orientations, velocities and surfaces. A picture of the LandIR facility is shown in Figure 1.

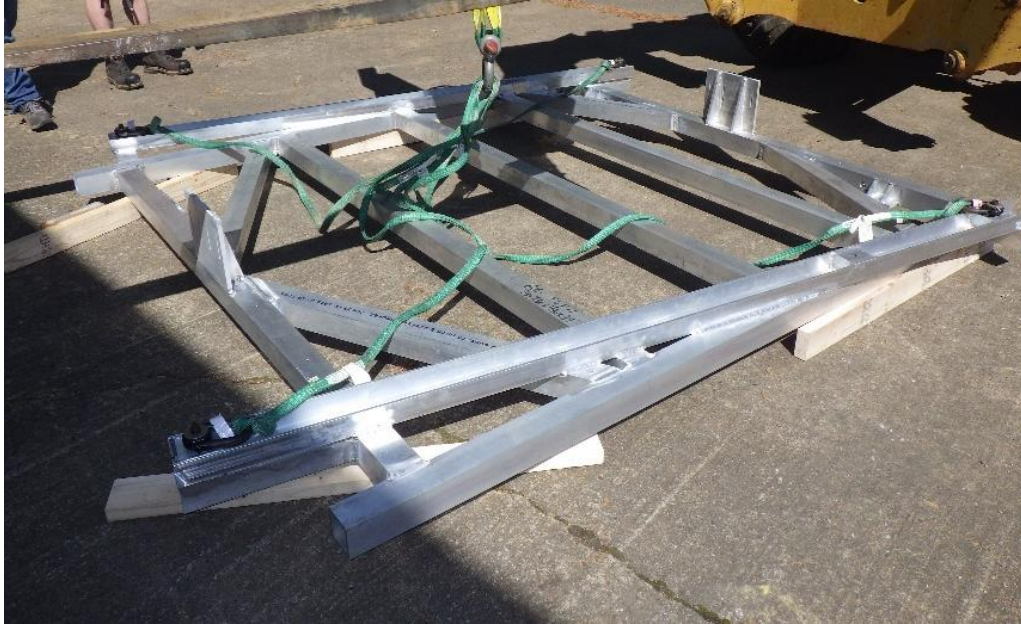
Figure 4. Lifting hardware

The assumed impact conditions for L+C #2 differed from the first test in that they included a 10-degree yaw. This change necessitated the addition of components to the lifting structure that would orient the test article at a 10-degree nose-South angle as referenced to the test flight path velocities. A picture of the lifting hardware, prior to installation is shown in Figure 4.

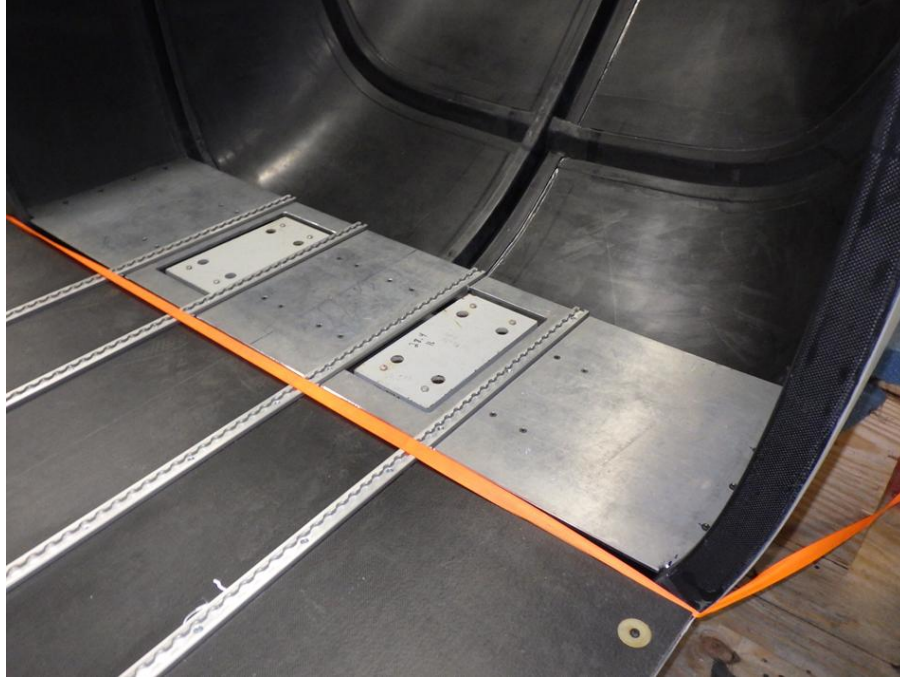
Figure 5. ESS mounting fixture and ballast mass

One area of research under the RVLT project included the study of the performance of Energy Storage System (ESS, a.k.a. battery) components under dynamic impacts at the ESS component level [16][17]. For this reason, an underfloor ESS installation was added to the test as a way of obtaining data to compare and contrast to data obtained at the component level. Since there are hazard issues in performing experiments on live, fully charged ESS systems, the decision was made to include the ESS experiment as a mass addition simulating a small ESS pack. A rigid fixture was developed and mounted below the rear rows of seats, which simulated the inclusion of this small pack. The top of the fixture represented the floor section and had two openings in which ballast mass could be added. Since actual ESS configurations may differ in their total mass, this configuration allowed the addition of variable amounts of mass depending on what configuration was desired. For the specific test configuration, the ESS ballast mass was 110 lb. on each side, with the floor structure weighing 92 lb., bringing a total underfloor weight to 312 lb. This addition also allowed for the examination of the effect of an underfloor ESS installation on occupants seated above. It was hypothesized that the rigidity of the ESS ballast mass and fixture would increase the loading levels experienced in the occupants. The ESS fixture and ballast mass is shown in Figure 5.

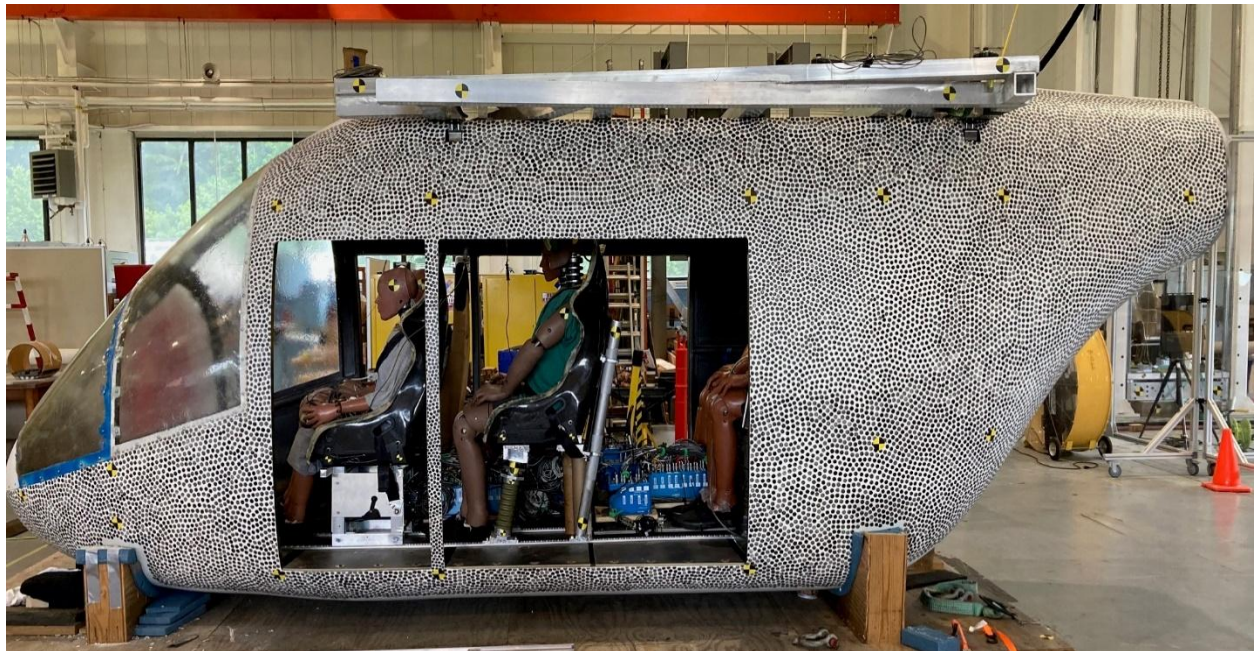
Figure 11. Speckle pattern on port-side of vehicle for 3D-DIC

Prior to testing, the port side of the vehicle was wiped clean with a cloth to minimize any surface contamination. A thin base coat of white paint was applied via a paint roller, providing a uniform high-contrast background. A random, black stochastic speckle pattern was applied to the surface using a custom-made rubber stamp with a speckle size of approximately 3/8 in. The speckle pattern on the port side of the vehicle is shown in Figure 11.

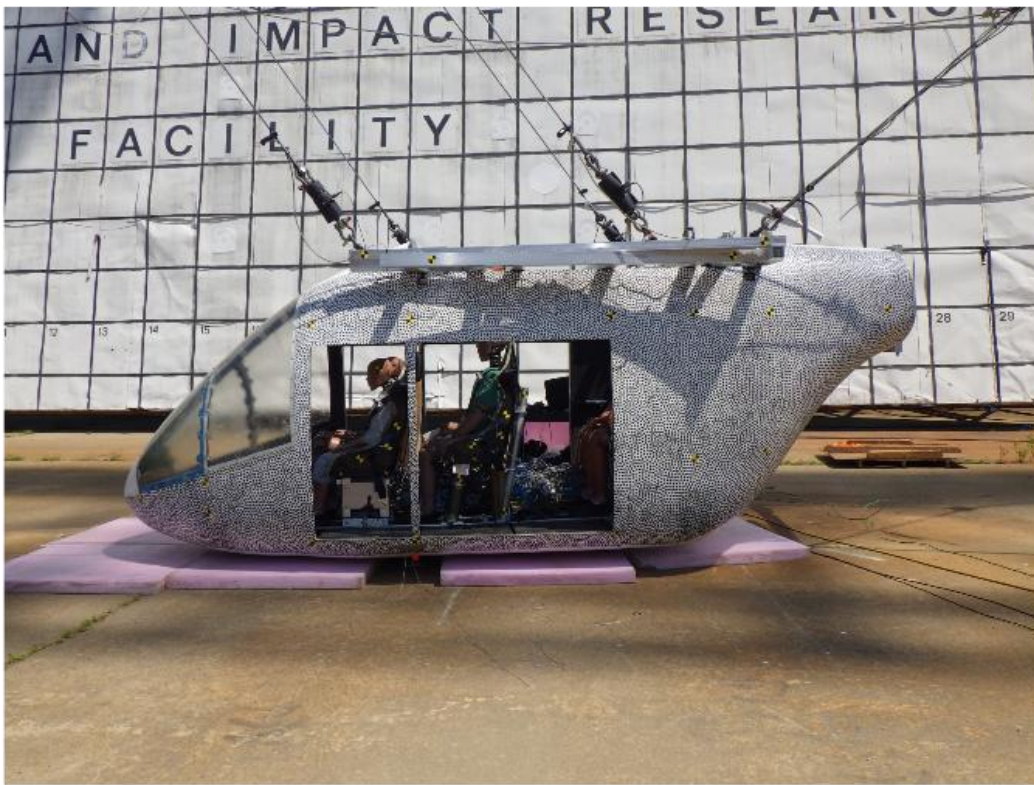
Figure 13. Test article prior to testing.

The test article was connected to the LandIR facility cables utilizing the lifting hardware on the top of the section. The cabling systems lifted the test article up to the required 35 feet of drop height and the test sequence began. A picture of the test article in its test configuration just prior to lifting is shown in Figure 13.

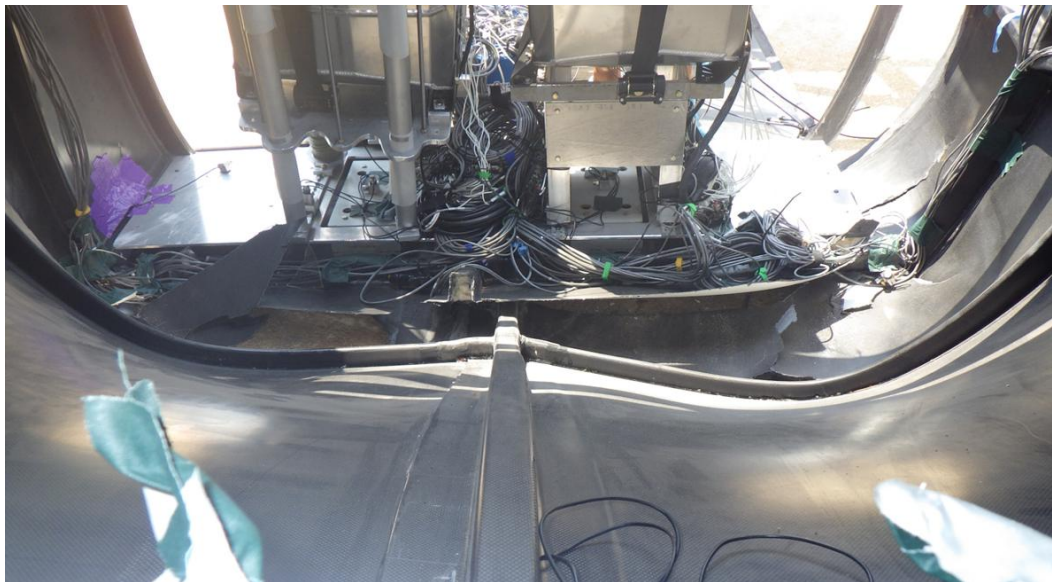
Figure 18. Aft Section split

The interior of the test article is next shown examining the split that occurred aft of the rear rows of seats. This image of the split, which is depicted next in Figure 18, is taken from a view looking forward from the tail of the test article.

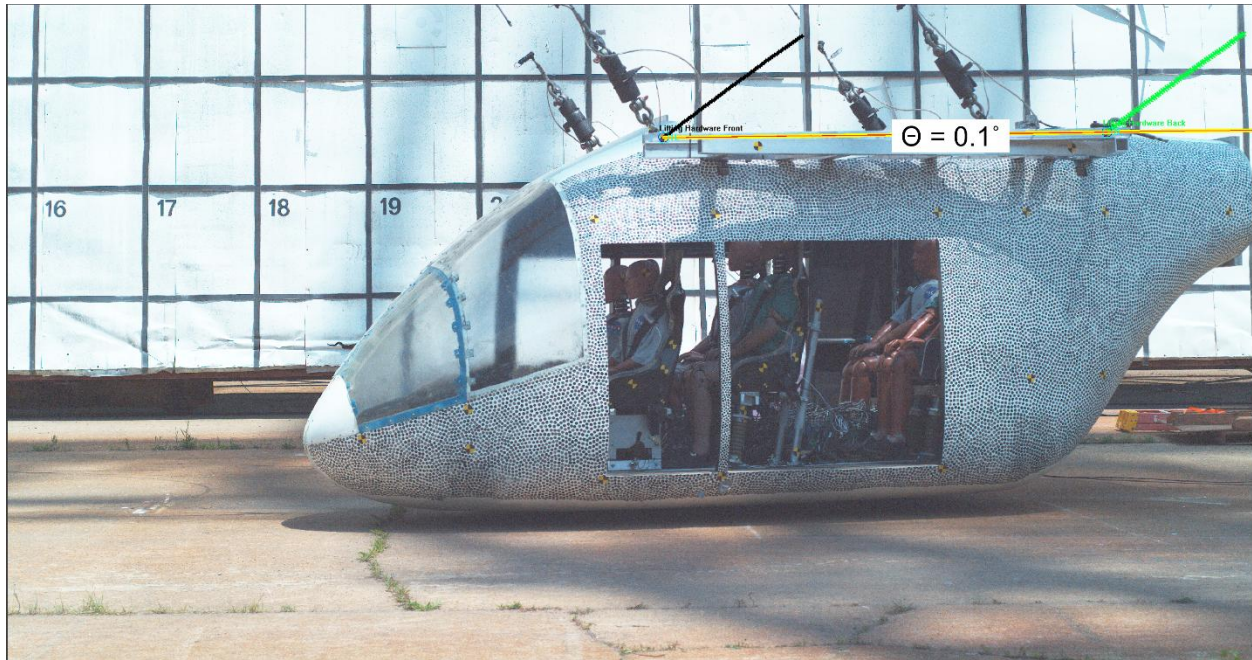
Figure 26. South (port-side) view showing pitch angle at impact

The individual bowtie targets were tracked throughout the time-history of the event, including the swing, impact and subsequent deformation and vehicle slide out. Typical marker tracking analysis is shown in Figure 26. Using the port-side camera system, the vertical and horizontal velocities, as well as the pitch angle, were calculated by tracking the bowties that were positioned on the lifting hardware. The East-view camera system was positioned to view the tail of the vehicle, which provided the vertical velocity and the roll angles, as shown in Figure 27. The yaw angle was measured and calculated using a combination of the East-view (tail) and West-view (nose) camera systems, along with the centerline of the LandIR facility.

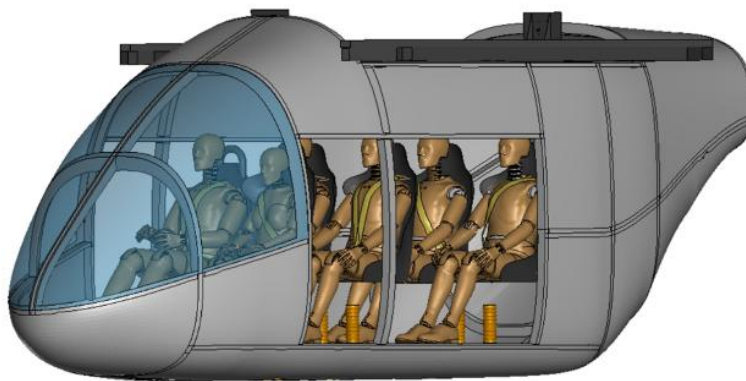
Figure 52. Complete L+C #2 test article FEM

The L+C #2 test was simulated using the test-measured impact conditions of the vehicle which included horizontal velocity, vertical velocity, pitch, yaw, and roll. To conduct the simulation, the vehicle model was first oriented to match the measured impact angles. Next, the vehicle FEM was pre-loaded under gravity for 0.1 seconds in order to properly load the ATD occupants into the seats prior to impact, and the vehicle was held in place by rigid enforcement at the lifting hardware attachment points. After the preload phase was complete, velocity was applied to the complete test article FEM, matching the impact speeds measured in the test. To simulate the impact environment a representative concrete surface model was generated below the initial vehicle location. Simulation of the updated L+C test article model was performed using LS-DYNA MPP version 14.0 on a Linux Computer cluster. The simulation was carried out to a termination time of 0.4 seconds using 24 processors and had a run time of 115 hours.
