# Quantifying Primary Arc-induced Degradation of Perovskite Solar Cells

<sup>1</sup> NASA Glenn Research Center, Cleveland, OH, 44135, USA

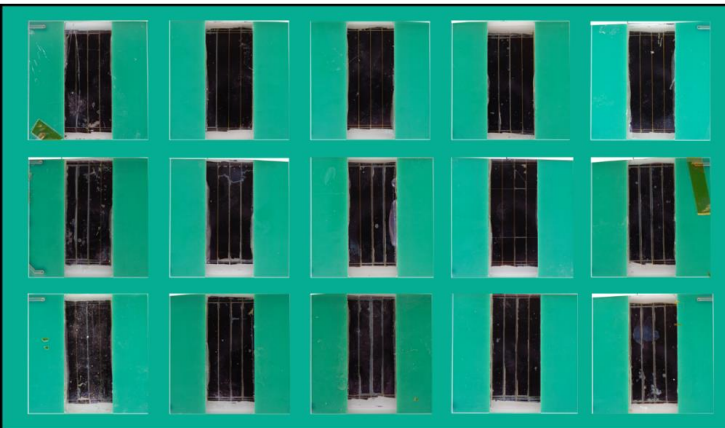
**Post ESD – Front Side**

**String 1 (20 arcs)**

**String 2 (40 arcs)**

**String 3 (60 arcs)**
