# ISS Radiator Face Sheet Anomaly Investigation and Return to Function

55th International Conference on Environmental Systems

ICES-2026-281

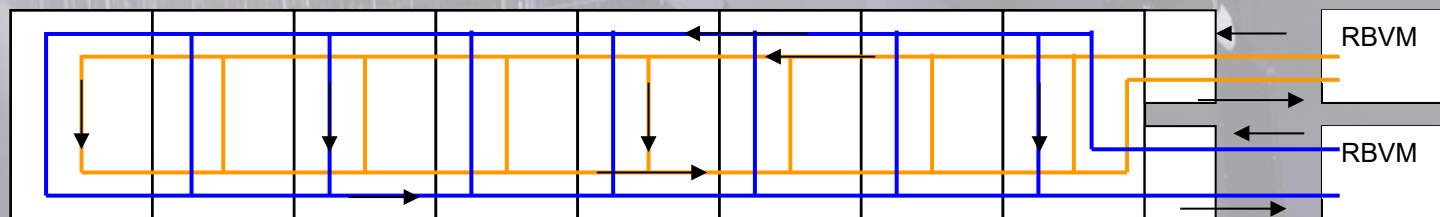
Simplified Schematic of EATCS Radiator

- EATCS rejects heat collected from the ISS Modules to space using radiators.
- Two independent ammonia loops (A-Starboard, B-Port); six radiators total, each with eight panels and two isolated flow paths per radiator.
- Each Loop also contains a pump, accumulator, heat exchangers, a TRRJ for radiator positioning, and RBVM which allows flow paths to be isolate or vented to space.

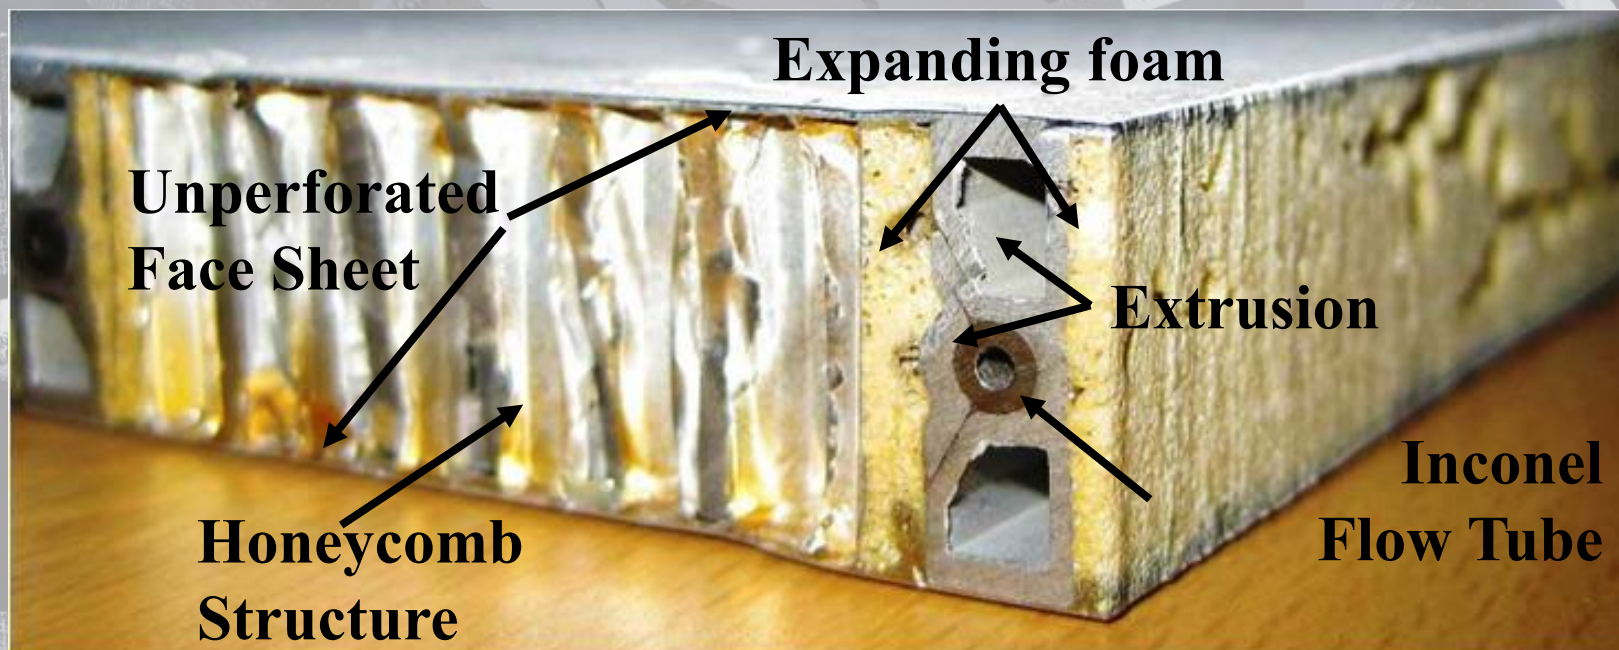
- Panel materials: aluminum face sheets + honeycomb core; 22 parallel Inconel flow tubes (11 per path) seated in aluminum extrusions; epoxy/foam bonding; Z93 coating.

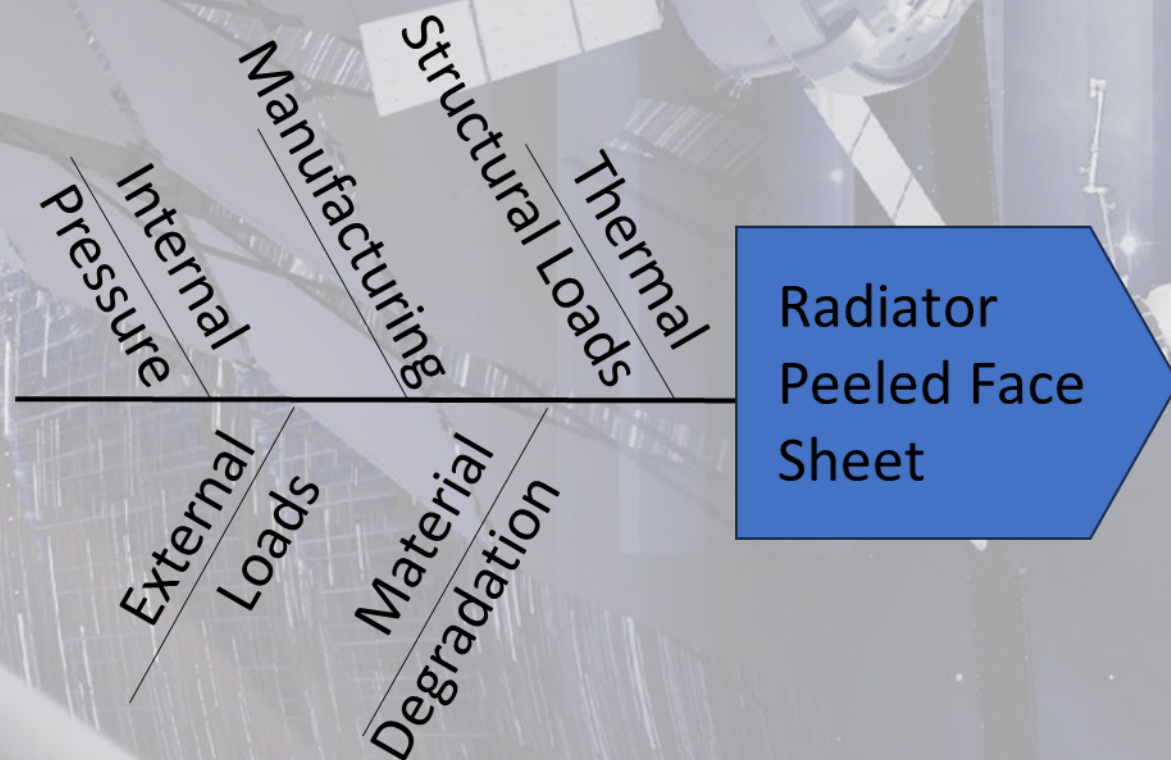
- Face sheet peel was discovered in 2008 on the Starboard Radiator
- ISS Program decided to vent radiator to prevent additional failures during upcoming dynamic ops
- Cross-disciplinary team developed fault tree and eliminated thermal and external loads as well as material degradation.

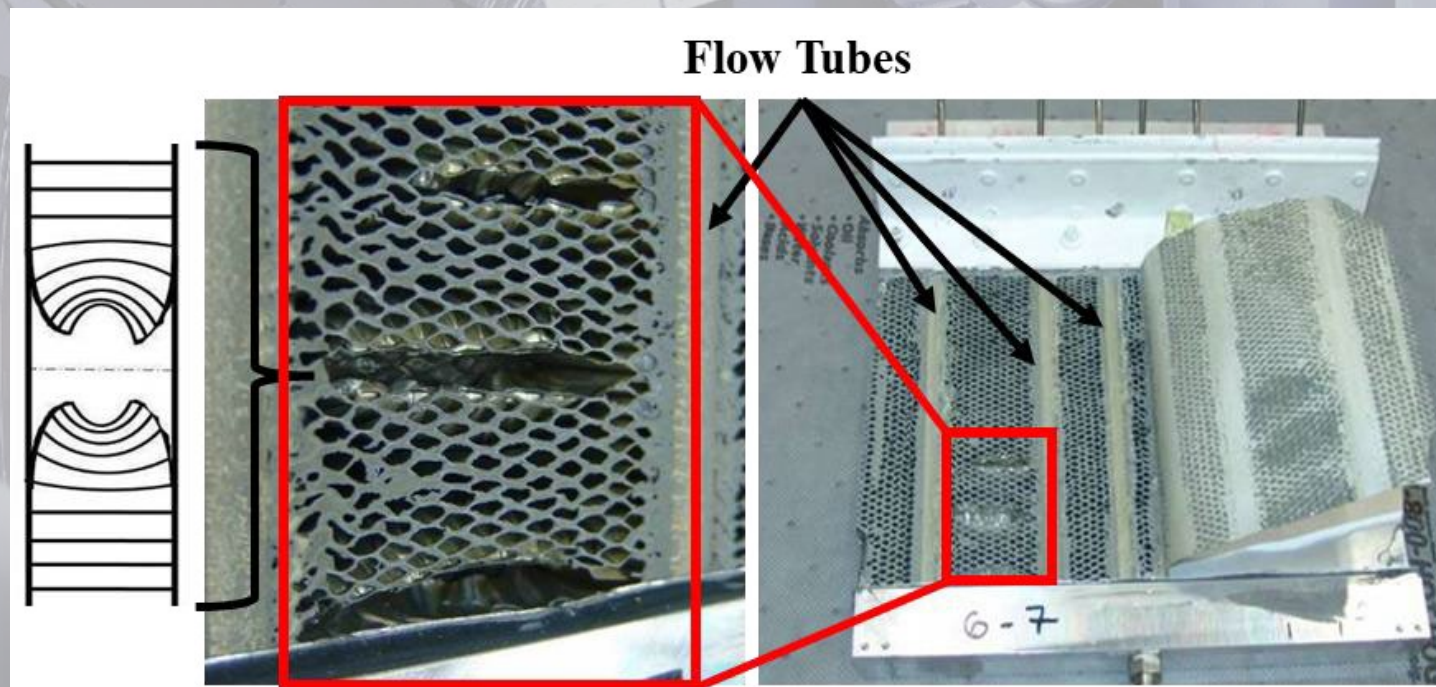
- NDE testing on Qual Radiator- tap-test, x-ray, flash thermography
  - No Delamination
- He leak test on residual tube stock-passed leak test but had small manufacturing flaws in tube wall
  - Extracted tube from Qual radiator also passed leak tests
- Pressurized Panel Section
  - Honeycomb fails before face sheet delaminates

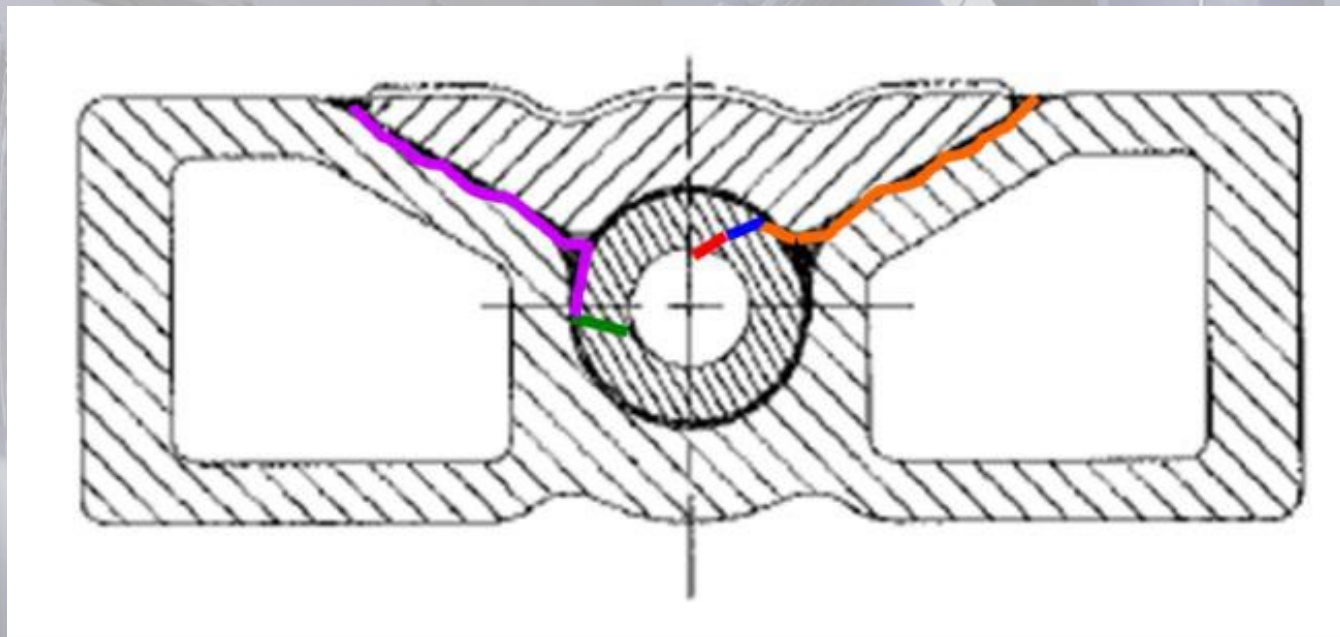
- Leak may have developed from micro-flaw in flow tube which leaked into panel
  - Possible the freeze-thaw cycle exacerbated a flaw
- Radiator had a NH<sub>3</sub> and N<sub>2</sub> flow path – pressurization could have come from either
- Leak rate too small to be detected by NH<sub>3</sub> accumulator
- Only 40% of N<sub>2</sub> leaked needed to pressurize panel and cause failure

- Preventative options:
  1. Perform He leak checks at the tube stock level(~5 miles) to catch micro-leaks
  2. Use perforated honeycomb panels to prevent any pressurization in the panels
- EATCS robustness allowed Loop A to operate at 50% capability for 16 years while investigation took place
- Added flow paths allow for full redundancy of operations and reduces flight-ops burden

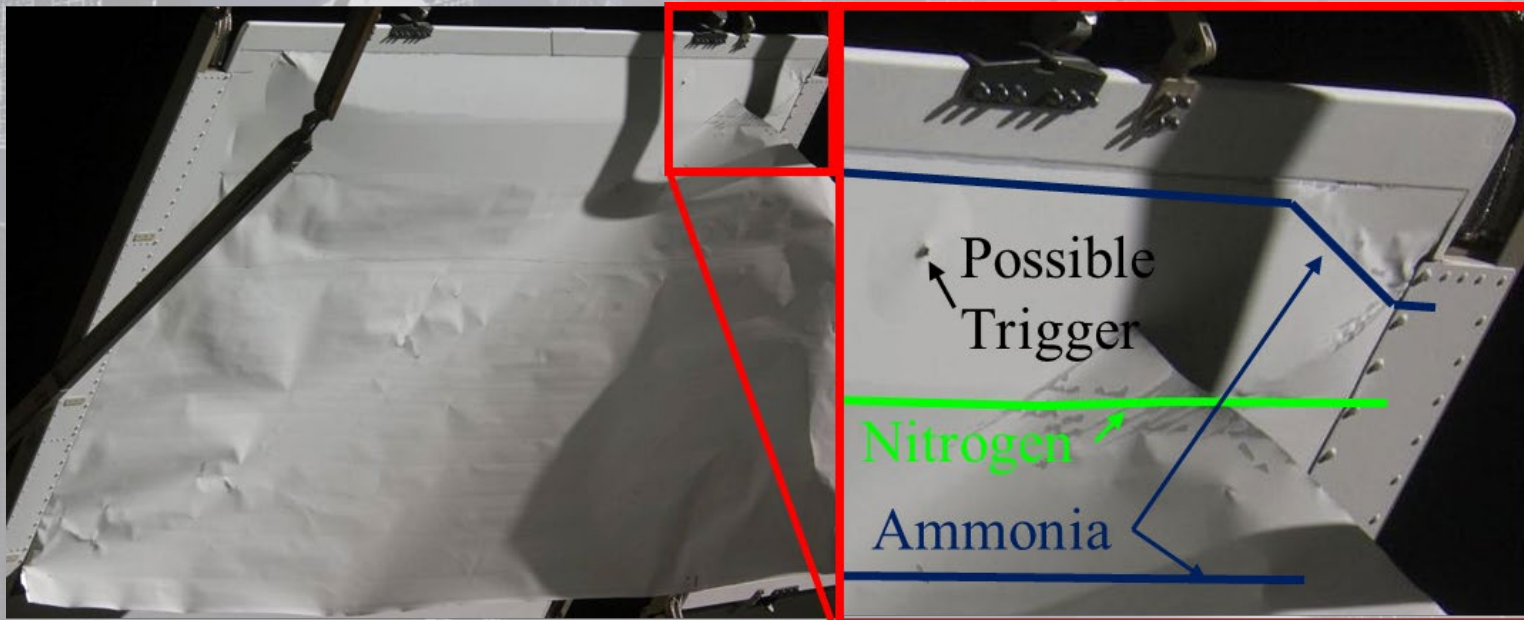
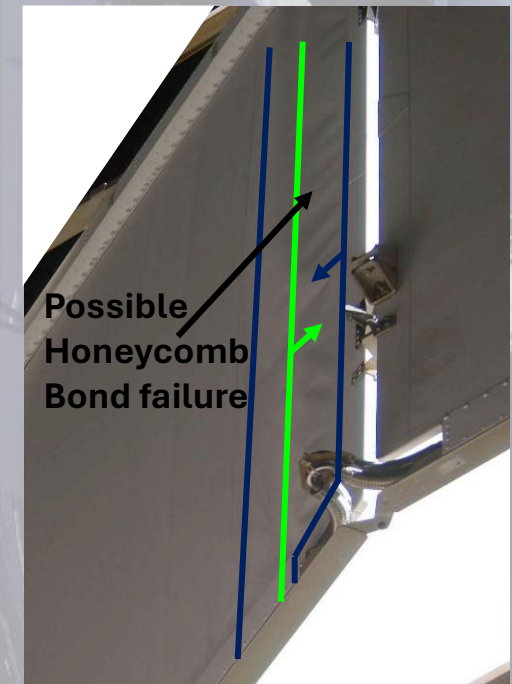
## 1. MMOD Strike

- Creates shock in gas pocket

## 2. Self-Propagating delamination

- Delamination grows, volume/pressure drops, leak adds gas, pressure rises again

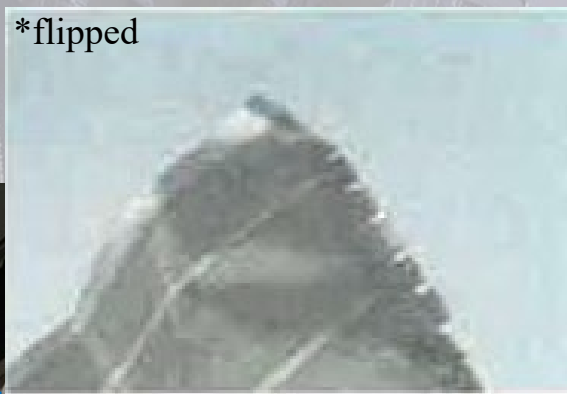
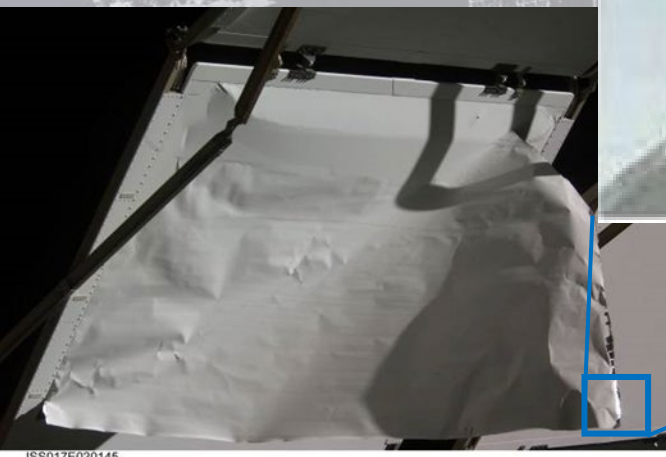
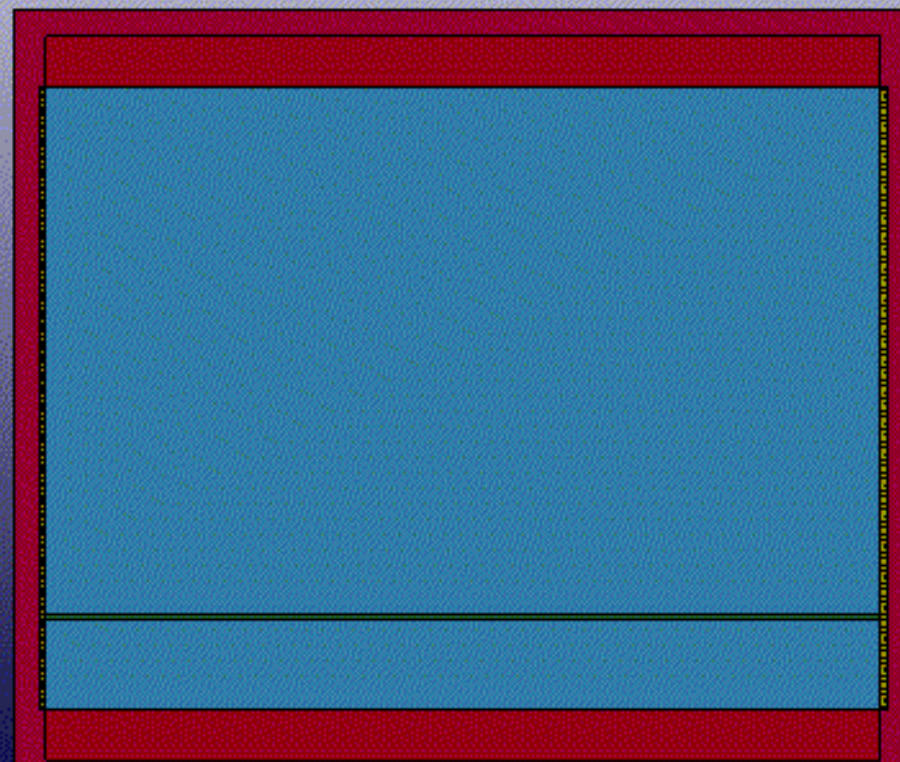
ISS017E020145

- Dynamic FEA reproduced blow-out, crinkled face sheet, and tearing at the manifold fasteners

ISS Radiator Analysis
