NASA TN D-1097

SCANNING MECHANISM FOR A SATELLITE BORNE X-RAY SPECTROMETER

Gerald L. Hempfling

Goddard Space Flight Center
Greenbelt, Maryland

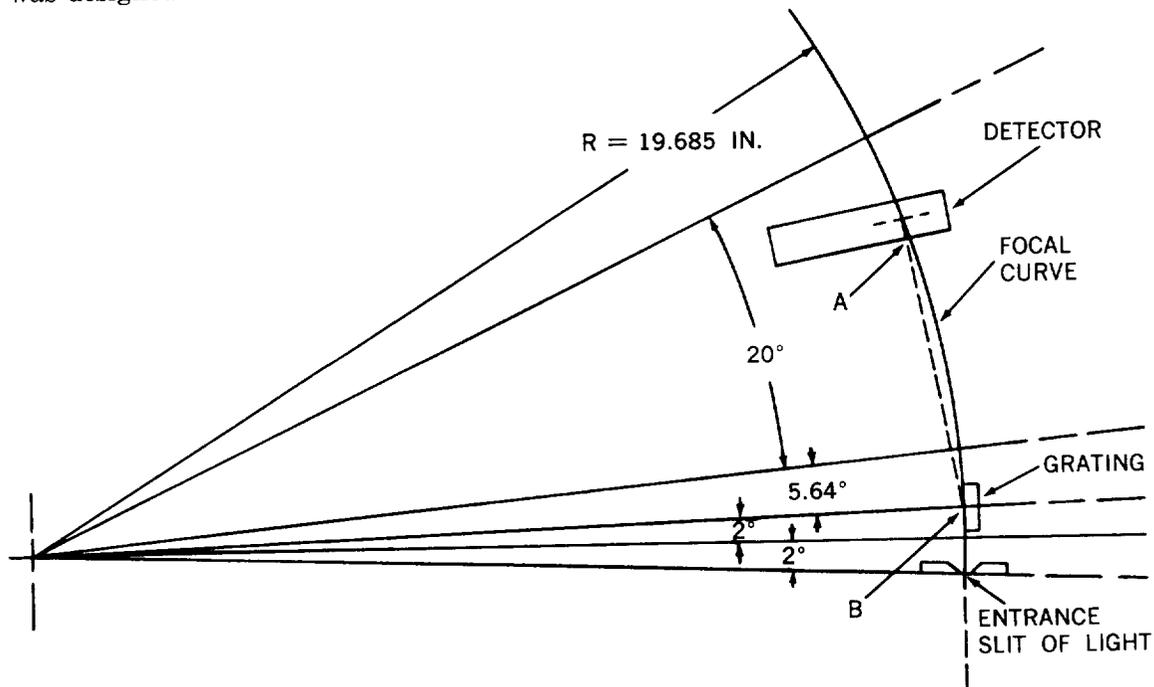
Figure 1 — Layout of detector motion. The incident light from B is perpendicular to the face of the detector at A at all points on focal curve.

The Orbiting Solar Observatory I (OSO) satellite (1962 ζ) contains an X-ray spectrometer to perform one of its experiments. Three mechanisms were designed for possible use in providing this instrument's scanning function, i.e., for moving the detector along the focal curve. An initial design requirement imposed on one of these mechanisms was that it maintain the moving detector perpendicular to the radiation beam incident from the grating (Figure 1). An engineering model of this scanning mechanism was designed and fabricated.

The operation of this mechanism may be briefly described as follows: A 6-volt dc motor rotates a drive screw, transmitting linear motion to a main transport carriage through a follower stud mounted in a housing on the carriage (Figure 2). The carriage is constrained by roller bearings between a pair of V-shaped rails which are integral parts of the main housing of the mechanism. A cross-carriage, mounted on the bottom of the main transport carriage, is constrained by grooved bearings between a pair of round rails (Figure 3). One end of the top side of the detector is bearing-mounted to this cross-carriage, allowing the detector to pivot. A bearing on the bottom side of the same end is constrained to move in the focal curve cam mounted directly on the base of the main housing. The opposite end of the detector is supported by means of a grooved bearing in a compensating cam on the main transport carriage. This cam causes the detector to maintain a perpendicular attitude to radiation incident from the grating. The grating is mounted on the base of the main housing (Figure 1).

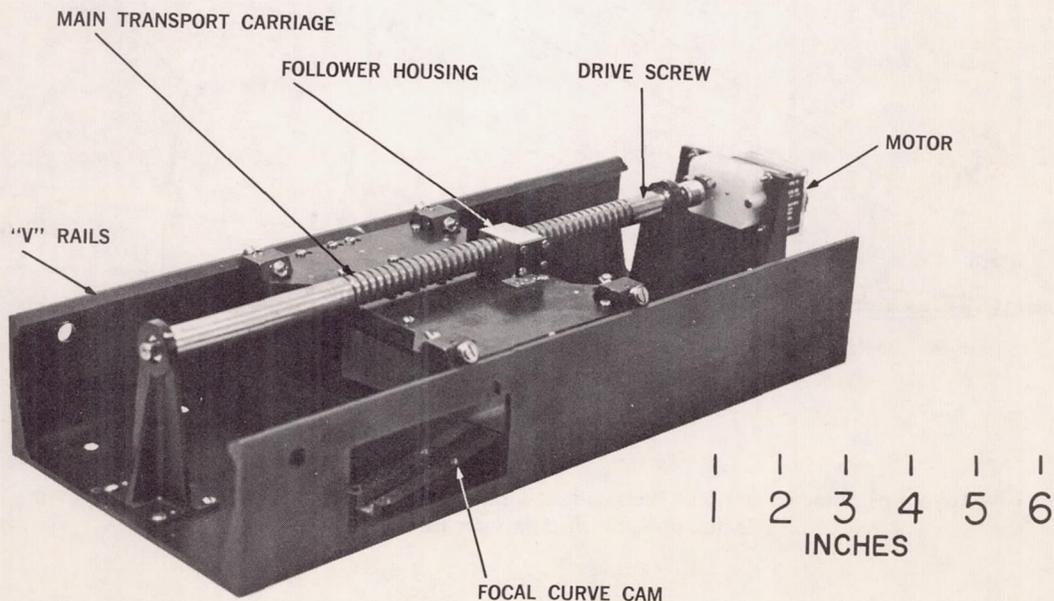
Figure 2 - Photograph of the scanning mechanism

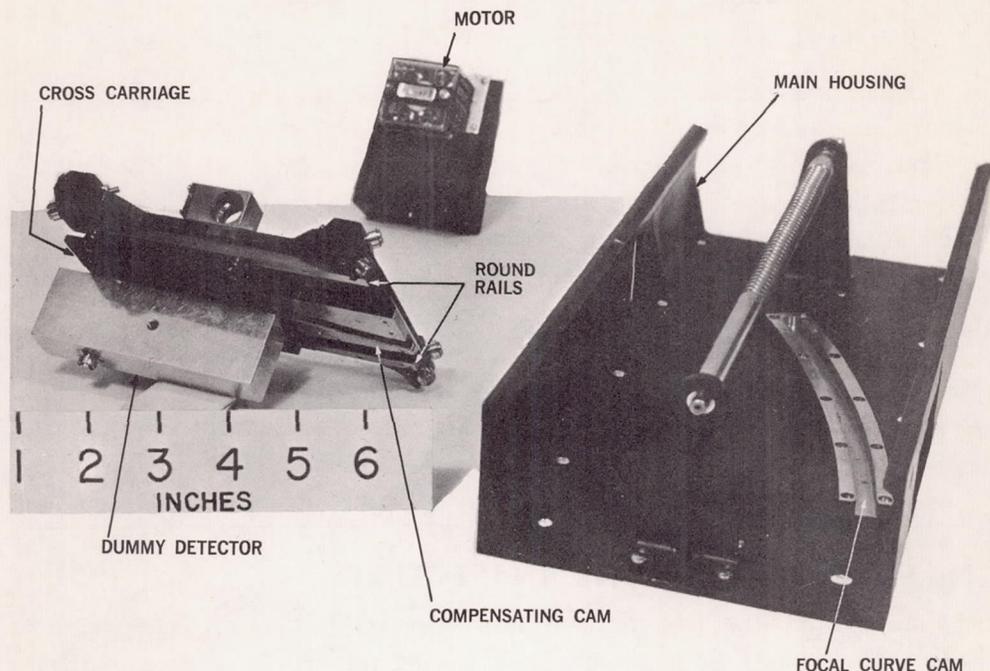
Figure 3 – Photograph of the individual components of the scanning mechanism

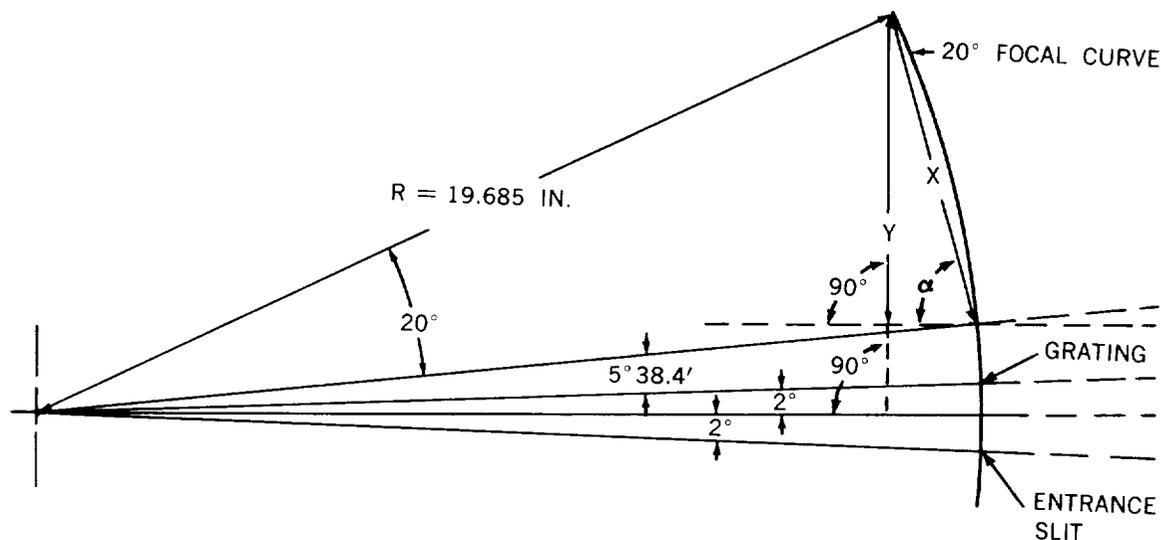
$$\alpha = 80^\circ - (5^\circ 38.4' + 2^\circ) = 72^\circ 21.6'; \quad X = R \frac{\sin 20^\circ}{\sin 80^\circ}$$

$$\text{Thread length } Y = X \sin \alpha = 6.516 \text{ inches.}$$

$$\text{Linear pitch } P = \frac{Y}{4 \frac{\text{rev}}{\text{min}} \times 10 \text{ min}} = 0.163 \text{ inch/revolution.}$$

Figure 4 – Thread length and linear pitch on drive screw

The location of the grating relative to the entrance slit (Figure 4) was such that the most desirable orientation of the drive screw was 90 degrees to the line bisecting the 4-degree angle between the grating and the light entrance slit. With this orientation the effective thread length required on the drive screw was 6.516 inches. At 4 rpm and a scanning time of 10 minutes, a pitch of 0.163 inch/revolution was required.

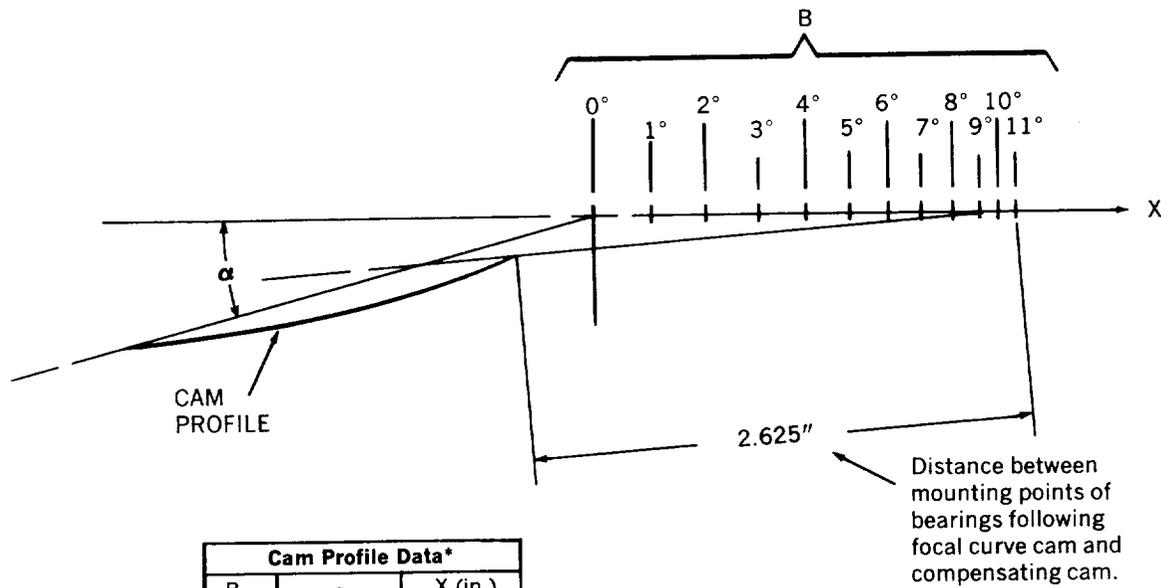
Cam Profile Data*		
B	α	X (in.)
0°	$15^\circ 4.2'$	0
1°	$14^\circ 4.2'$	0.315
2°	$13^\circ 4.2'$	0.610
3°	$12^\circ 4.2'$	0.866
4°	$11^\circ 4.2'$	1.122
5°	$10^\circ 4.2'$	1.339
6°	$9^\circ 4.2'$	1.555
7°	$8^\circ 4.2'$	1.732
8°	$7^\circ 4.2'$	1.890
9°	$6^\circ 4.2'$	2.008
10°	$5^\circ 4.2'$	2.126
11°	$4^\circ 4.2'$	2.205

Figure 6 - Compensating cam profile data

The formulas for defining the profile of the compensating cam are given in Figure 5 and the resulting cam data in Figure 6. (The value of $A = 26^\circ 8.4'$ is the sum of the 20° focal curve, the $5^\circ 38.4'$ arc, and $1/2^\circ$ for overtravel. The values of angle B were arrived at by arbitrarily dividing the focal curve into eleven equal angles with the vertex at the grating.) The cross section of the compensating cam is in the shape of a square "C". The purpose of making it in this form was to allow the groove bearings, while moving in the cam, to be used to support the detector. The focal curve cam has the shape of an open channel machined to the curvature of the focal curve.

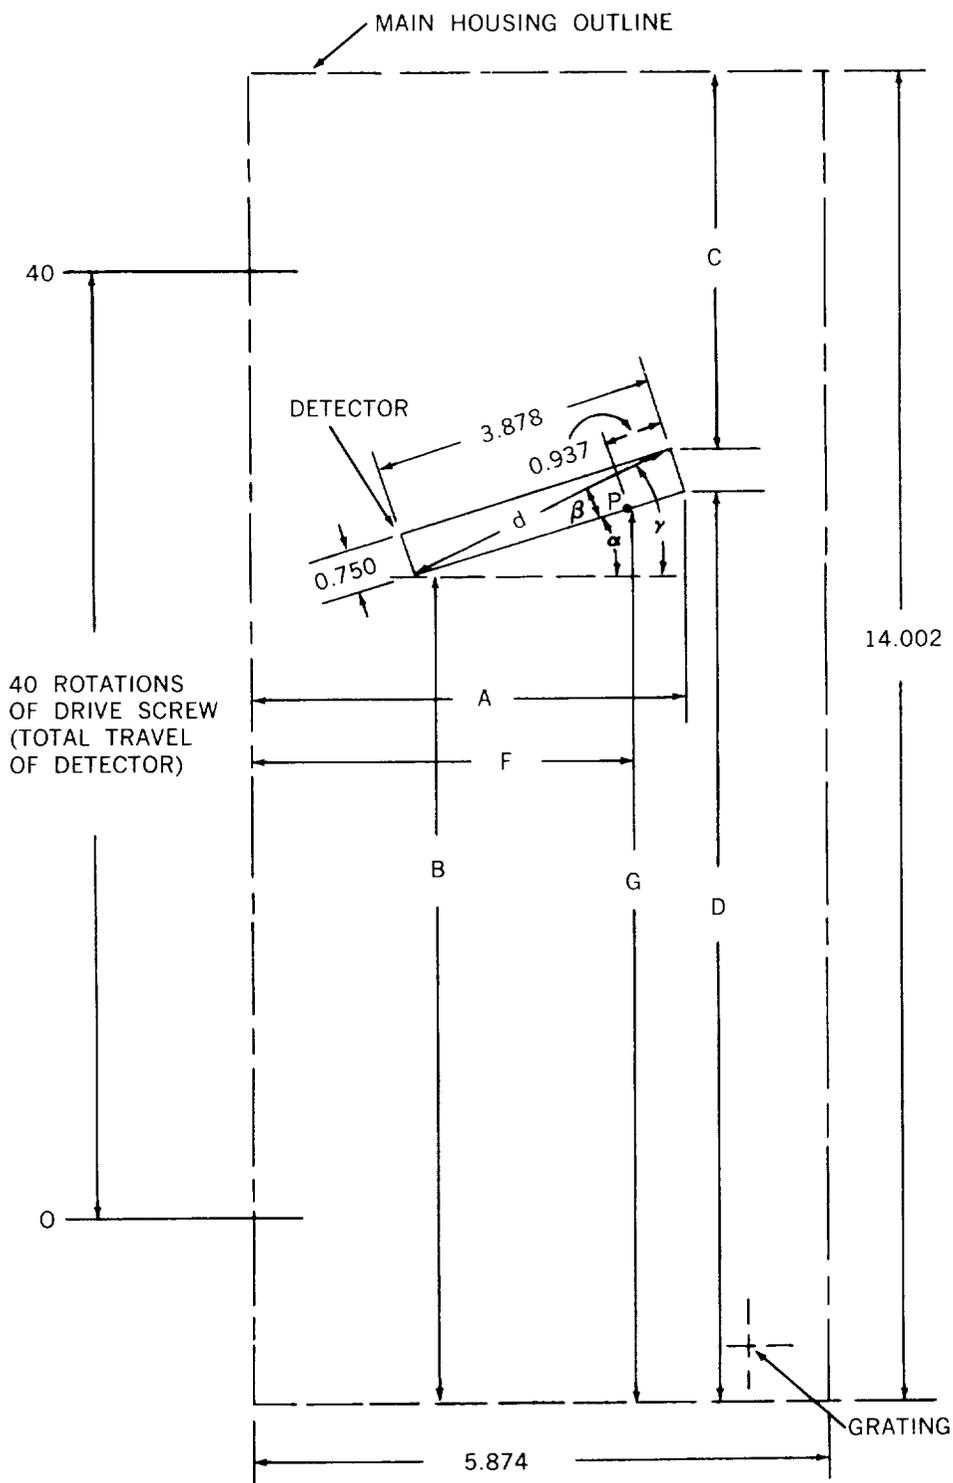
Figure A1 – Dimensions used in determining the pointing accuracy

It was necessary to measure the lettered dimensions shown in Figure A1 to calculate the pointing accuracy of the detector from rotation 0 to rotation 40. (The drive screw rotated 40 times.) Table A1 gives measured values for A, B, and C (or α), which were the only dimensions accessible.

$$\begin{aligned} \sin \gamma &= \frac{14.002 - (B + C)}{d} \\ &= \frac{14.002 - (B + C)}{\frac{0.750}{\sin \beta}} \\ &= \frac{14.002 - (B + C)}{\frac{0.750}{\sin \left[\tan^{-1} \left(\frac{0.750}{3.878} \right) \right]}} ; \\ \gamma &= \sin^{-1} \left[\frac{14.002 - (B + C)}{3.950} \right] ; \\ \alpha &= \gamma - \beta \\ &= \gamma - \tan^{-1} \left(\frac{0.750}{3.878} \right) \\ &= \sin^{-1} \left[\frac{14.002 - (B + C)}{3.950} \right] - 10^{\circ}58' ; \\ \sin \alpha &= \frac{D - B}{3.878} ; \\ D &= B + 3.878 \sin \alpha ; \\ \sin \alpha &= \frac{D - G}{0.937} ; \\ G &= D - 0.937 \sin \alpha ; \\ \cos \alpha &= \frac{A - F}{0.937} ; \\ F &= A - 0.937 \cos \alpha . \end{aligned}$$

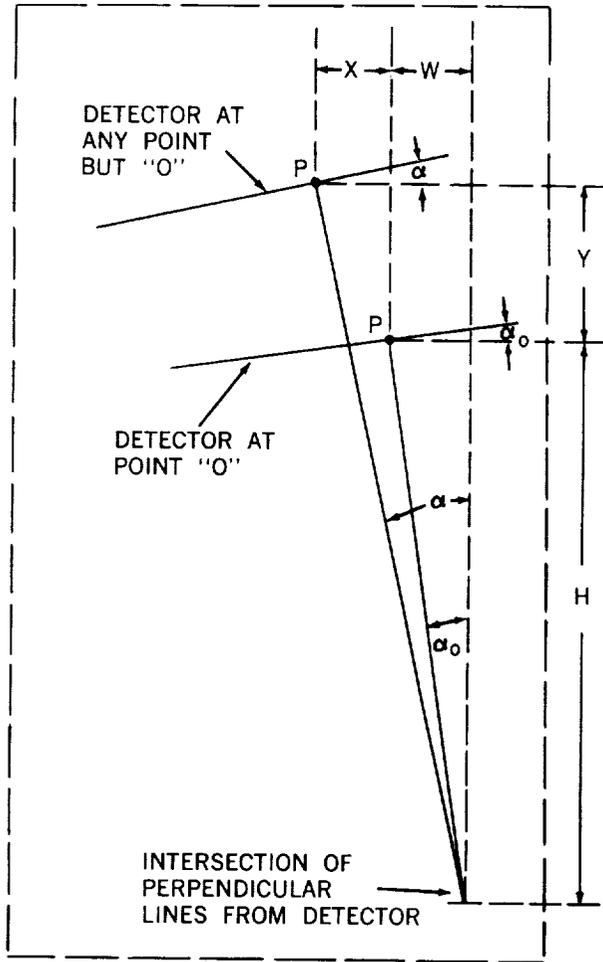
Figure A2 - Pointing accuracy

For incident light to be perpendicular to the detector at P, $\tan \alpha$ must equal $(W + X)/(H + Y)$ where H and W are constants. Also, $\tan \alpha_0 = W/H$ and thus

Calculated values of H and W show that they are not constants; therefore the incident light is not perpendicular to P at all times.

We can calculate the variation of the perpendicularity through the use of the maximum and minimum values of H and W. Calculations with these values indicate that the pointing angle is $90^\circ \pm 40'$ for all positions of the detector.
