TECHNICAL NOTE

D-1458

PRELIMINARY INVESTIGATION OF EFFECT OF HYDROGEN ON
STRESS-RUPTURE AND FATIGUE PROPERTIES OF AN
IRON-, A NICKEL-, AND A COBALT-BASE ALLOY

By Stanley J. Klima, Alfred J. Nachtigall,
and Charles A. Hoffman

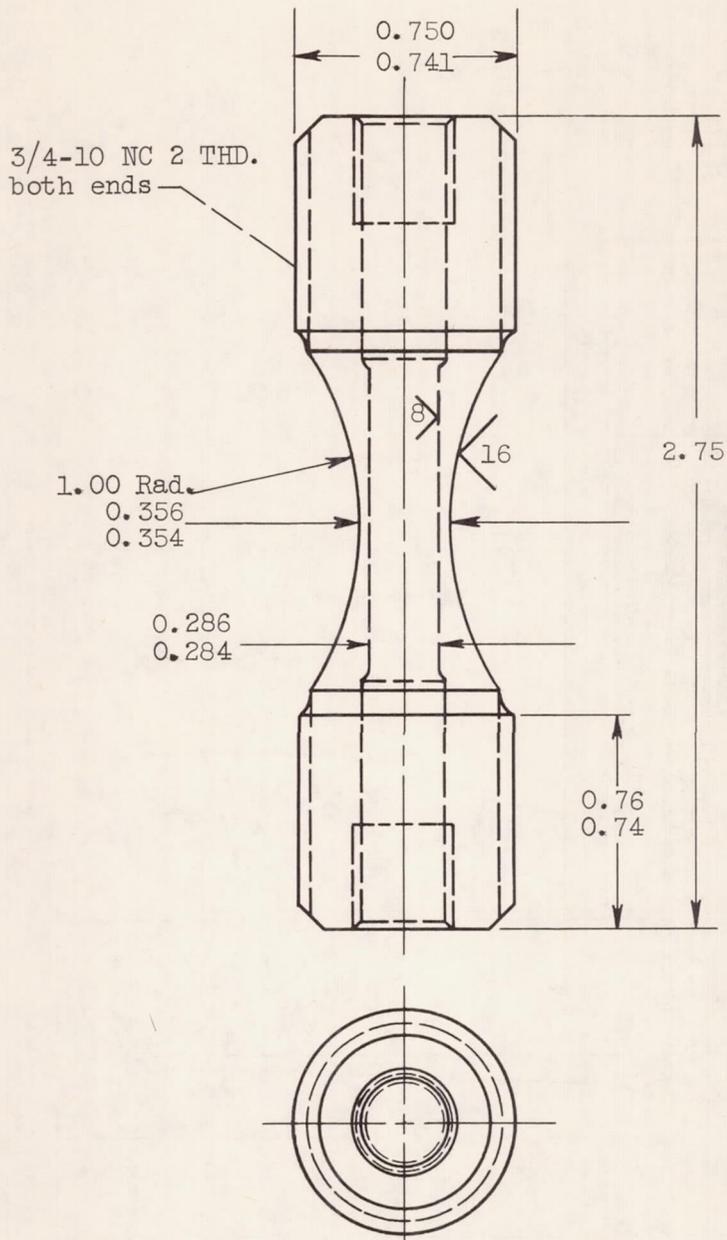
Figure 1. - Hollow fatigue and stress-rupture specimen. (All dimensions in inches.)

A tubular-type test specimen (fig. 1) was chosen in order to simulate a turbine bucket cooling configuration in which gaseous hydrogen would flow under pressure through drilled cooling passages in the bucket while its external surface was exposed to a heat source. In an effort to minimize any detrimental effects of surface condition on fatigue life, the external surface of the specimen was ground in an axial direction to a finish of 16 microinches. The internal surface was honed to an 8-microinch finish. External threads were provided for gripping. The type of specimens used was identical for both fatigue and stress-rupture tests.

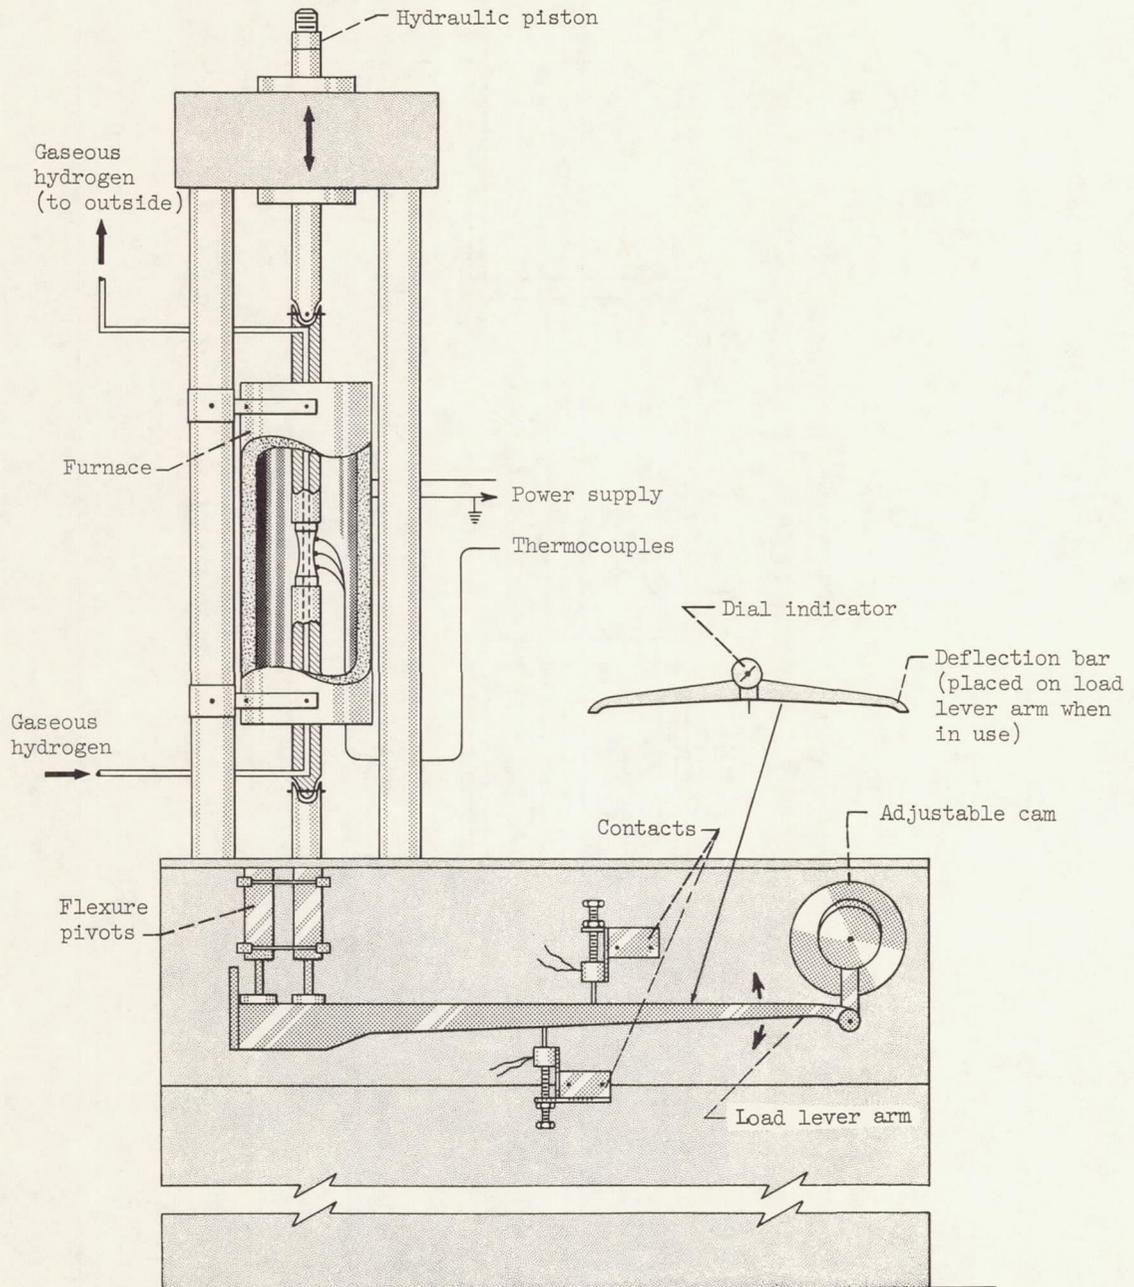
Figure 2. - Fatigue-test apparatus.

Figure 2 illustrates the fatigue test installation. The major components include a direct-tensile-stress-fatigue machine, a resistance-heated tube furnace, a tubular-type test specimen, and a gas supply train. Mean tensile loads were applied by a hydraulic piston, which also compensated for specimen elongation during test. Alternating loads were applied by a calibrated cam-operated lever arm at a frequency of 1970 cycles per minute. This frequency is a design characteristic of the machine. The test was interrupted and loads were checked at regular intervals by utilizing a dial indicator mounted on a deflection bar to measure the amount of bending in the lever arm. Universal joints were used on the loading assembly to minimize bending stresses. The gas (hydrogen or air) was introduced and removed through $1/4$ -inch stainless-steel tubes heliarc welded to each end of the specimen. Hollow grips were slipped over these and threaded to the specimen ends. Three

thermocouples were attached to each specimen, one at the center of the test section and one on each shoulder. The central thermocouple was wired to the test section and was used to control the specimen temperature, which was maintained within $\pm 10^{\circ}$ F of that desired. The shoulder thermocouples were spotwelded in place and were used to measure the temperature distribution along the length of the specimen.

Hydrogen gas (99 percent purity) and air were supplied from pressurized cylinders. A regenerative-type dryer, utilizing activated alumina, was employed in the inlet line between the gas supply and the test specimen. Before beginning each test, the dewpoint of the gas (hydrogen or air) was checked after it passed through the dryer. Test operation was initiated only when the dewpoint was -70° C or lower. The internal gas flow rate (either hydrogen or air), measured at room temperature and pressure, was 2 cubic feet per hour. The pressure inside the specimen during the test was 500 pounds per square inch. A pressure-sensitive switch was utilized to shut off both the gas flow and the timer, which logged specimen life, at the instant of specimen failure. The time of failure was defined as the moment the specimen broke or developed a crack large enough to cause a gas leak and pressure drop in the system of approximately 50 pounds per square inch.

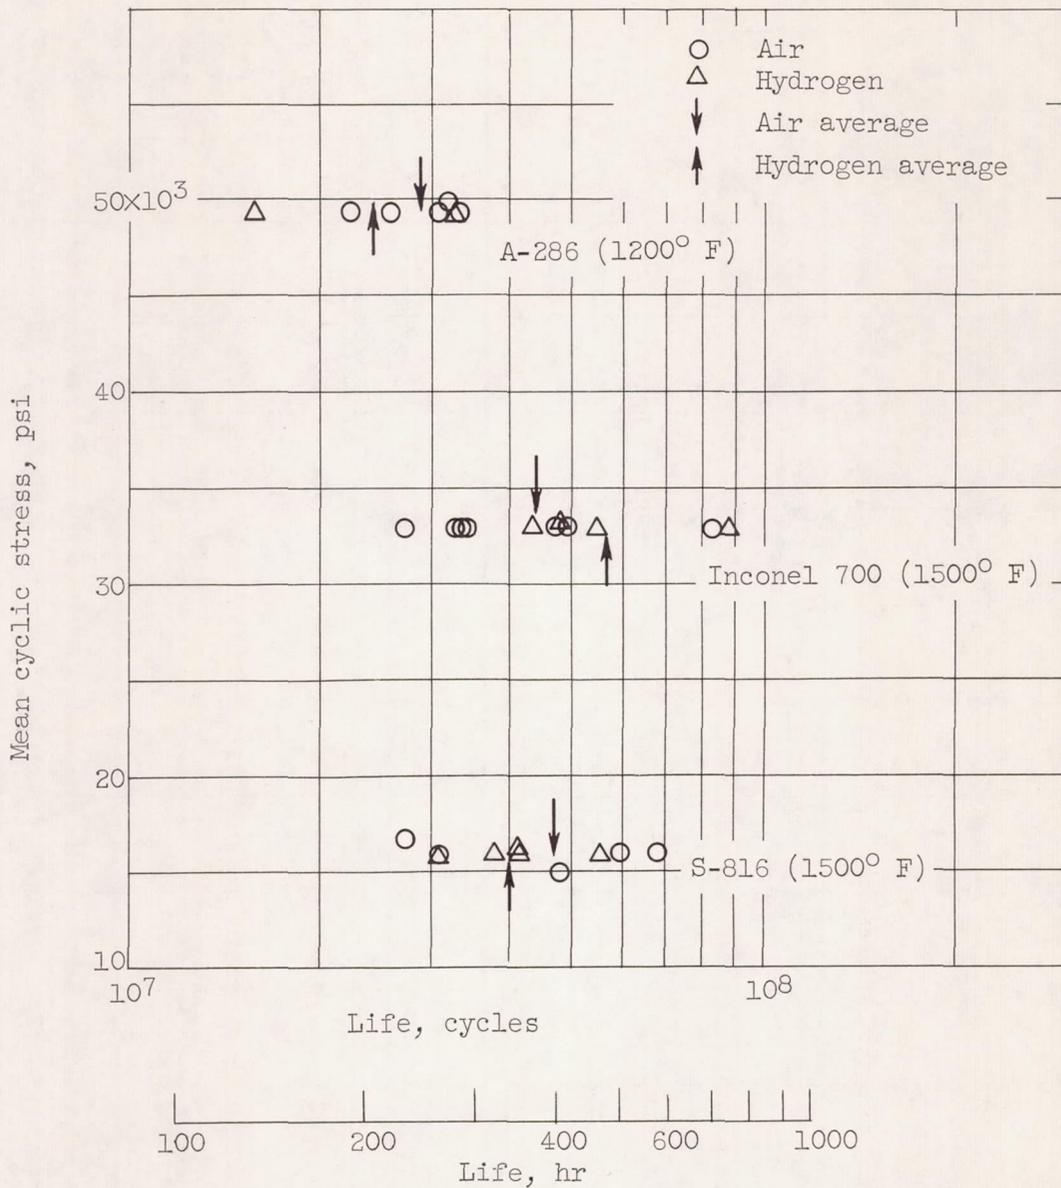
Figure 3. - Comparison of fatigue life of tubular specimens with internal surface exposed to air or hydrogen for three alloys tested at constant stress and temperature.

The results of fatigue and stress-rupture tests of A-286, Inconel 700, and S-816 alloys with either hydrogen or air as the internal gas are summarized in tables III and IV. These data are also plotted in figures 3 and 4. Photomicrographs of failed specimens are shown in figures 5 to 10.

of scatter is generally obtained in fatigue tests, and the scatter shown in figure 3 is not unique. Standard deviations for each set of data were calculated by the method of reference 12 and are also tabulated in table III. For Inconel 700, the one alloy that showed an appreciable difference in average fatigue lives as obtained in hydrogen and air tests (482 against 372 hr), the calculated standard deviations were particularly large. These large deviations would tend to cast doubt on the significance of the observed differences in average lives.

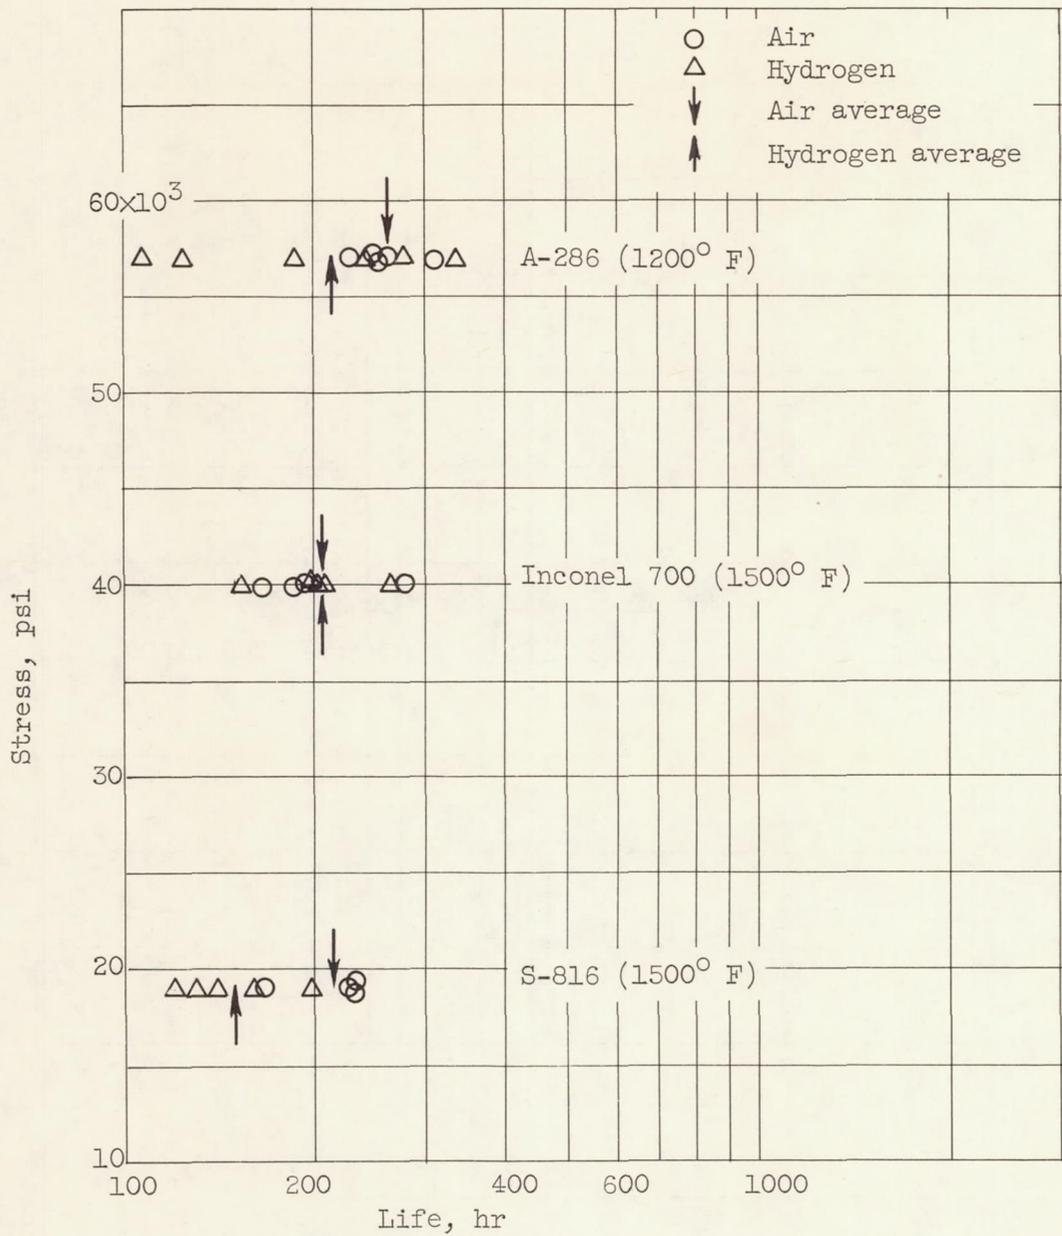
Figure 4. - Comparison of stress-rupture life of tubular specimens with internal surface exposed to air or hydrogen for three alloys tested at constant stress and temperature.

The results of the stress-rupture tests are summarized in table IV. Average lives and standard deviations are again tabulated. The average lives obtained for A-286 were 264 hours (air) against 215 hours (hydrogen); for Inconel 700, 209 hours (air) against 206 hours (hydrogen); and for S-816, 215 hours (air) against 151 hours (hydrogen). A comparison of average-life values for A-286 and S-816 shows somewhat longer stress-rupture lives in the air tests than in the hydrogen tests. The average life of Inconel 700, regardless of the internal gas, was virtually the same. Figure 4, however, suggests that only one of the alloys, S-816, demonstrated a marked tendency toward lower life for the hydrogen data. From table IV, it is evident that the standard deviations are also quite low for the S-816 hydrogen and air data, which tends to substantiate this apparent trend. Confidence levels were calculated in the same manner as for the fatigue data and these are also tabulated in table IV. The confidence levels for A-286 and Inconel 700 were less than 95 percent. For S-816, however, the confidence level was greater than 95 percent, which indicates that the observed difference between average life with air and average life with hydrogen is significant for this alloy. Thus, it would appear that the stress-rupture life of only one of the alloys (S-816) was adversely affected by hydrogen.

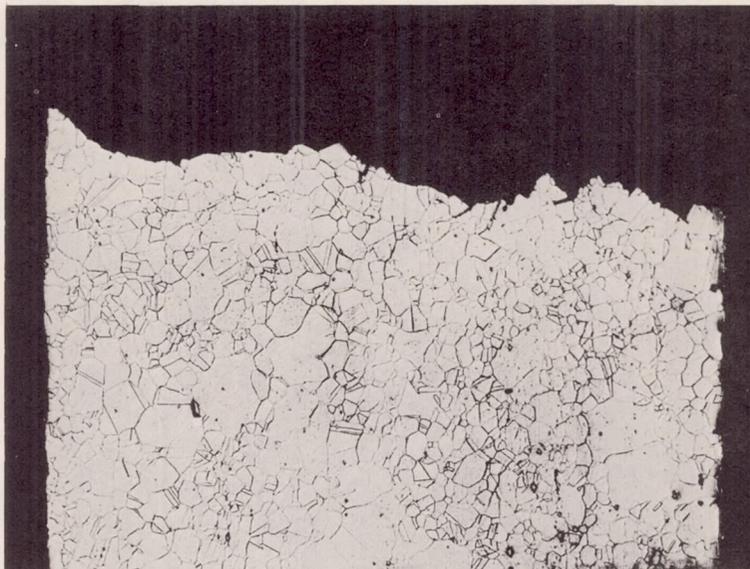
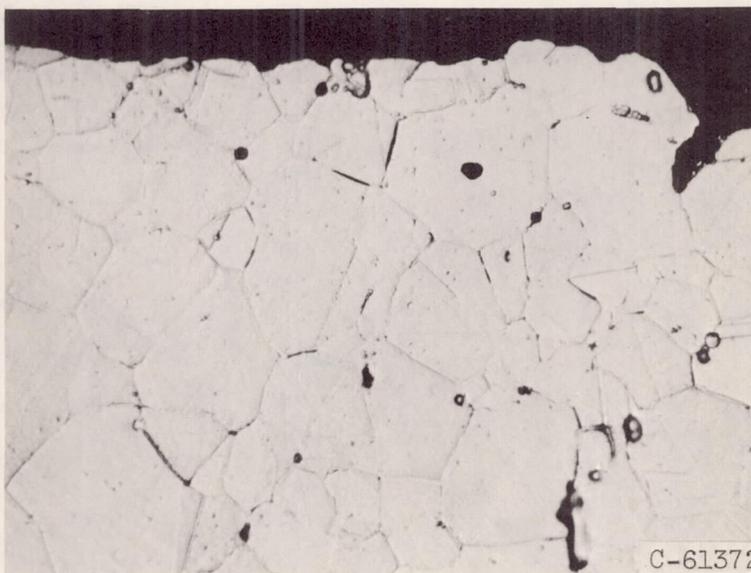
(a) A-286; internal surface exposed to air; life,
 22.6×10^6 cycles (191.2 hr).

Figure 5. - Transgranular fractures typical of
failures encountered in fatigue tests with both
air and hydrogen.

Photomicrographs of typical failures encountered in both the hydrogen and air fatigue tests for each of the alloys investigated are shown in figure 5. Similarly, photomicrographs of typical failures encountered in stress-rupture tests are shown in figure 6. As shown in these figures, the fatigue-test failures were generally transgranular, and the stress-rupture-test failures were generally intergranular in nature, regardless of the alloy or the gas passed through the specimen. It is evident from figure 6 that many small cracks generally occurred in the area immediately adjacent to the fracture surface in the stress-rupture specimens. Except for S-816 (fig. 5(c)), only a few such small cracks and frequently none at all occurred in the failure area of the fatigue specimens. Macroscopic and microscopic studies of hydrogen-tested fatigue and stress-rupture specimens indicated that these small cracks occurred on both the internal (hydrogen side) and external (air side) surfaces. Normally, they were not concentrated primarily on one surface in preference to the other.

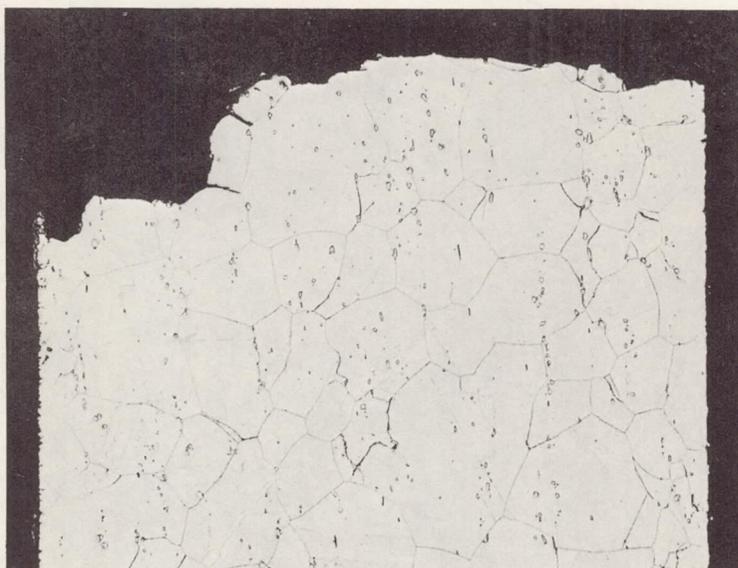
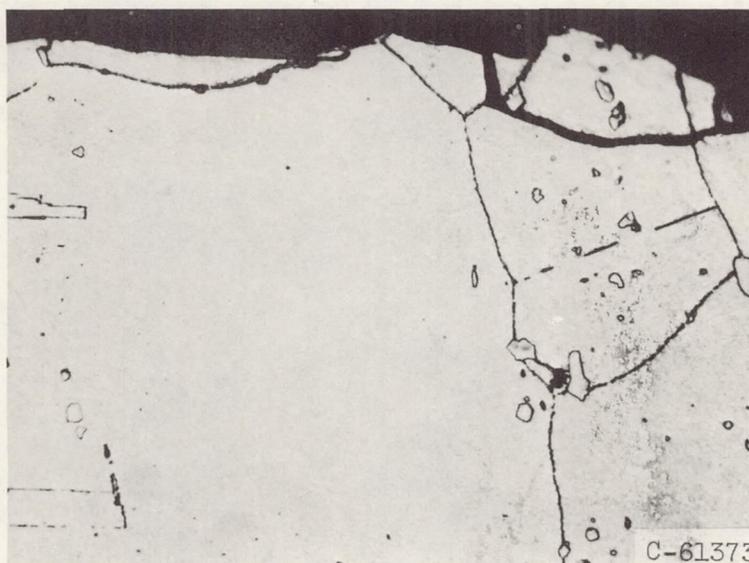
(b) Inconel 700; internal surface exposed to hydrogen;
life, 89.0×10^6 cycles (750.4 hr).

Figure 5. - Continued. Transgranular fractures
typical of failures encountered in fatigue tests
with both air and hydrogen.

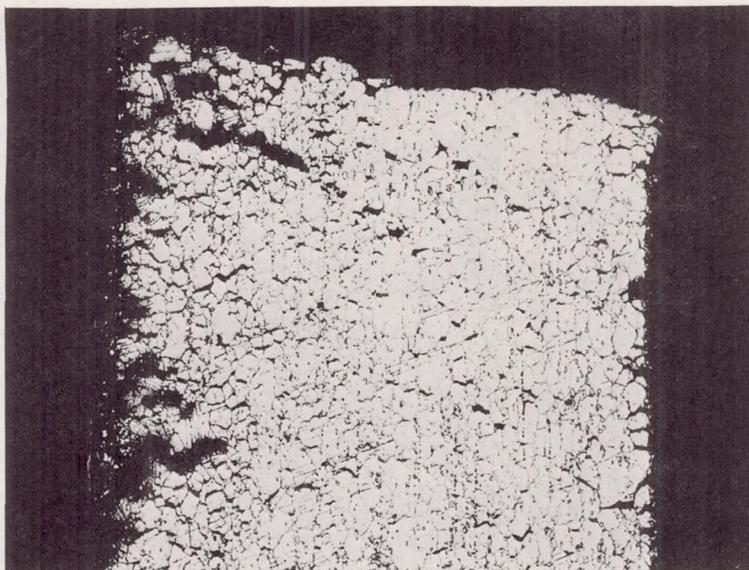
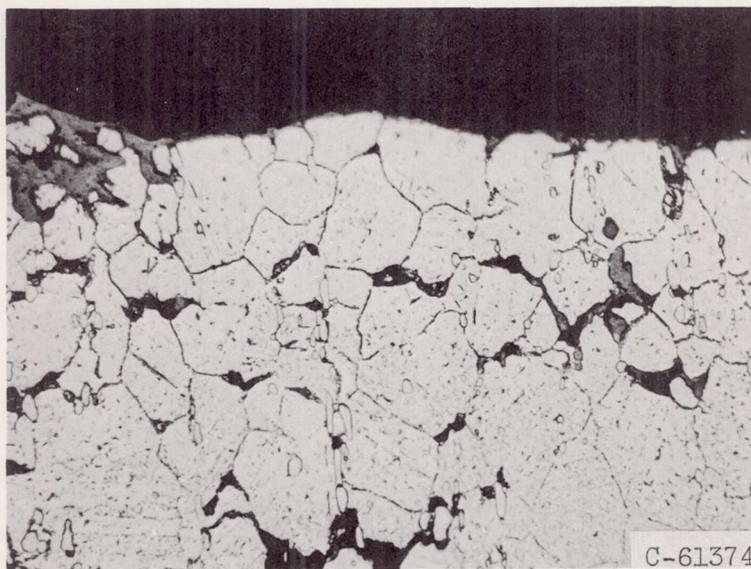
(c) S-816; internal surface exposed to air; life,
 27.5×10^6 cycles (232.9 hr).

Figure 5. - Concluded. Transgranular fractures
typical of failures encountered in fatigue tests
with both air and hydrogen

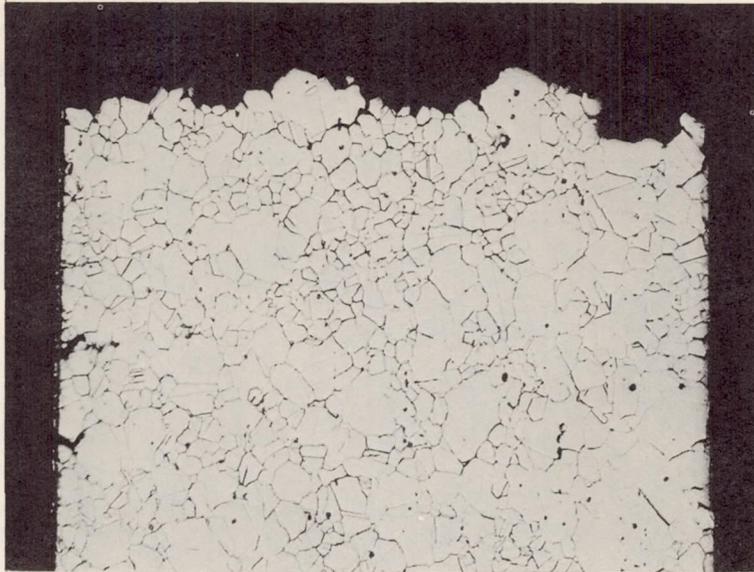
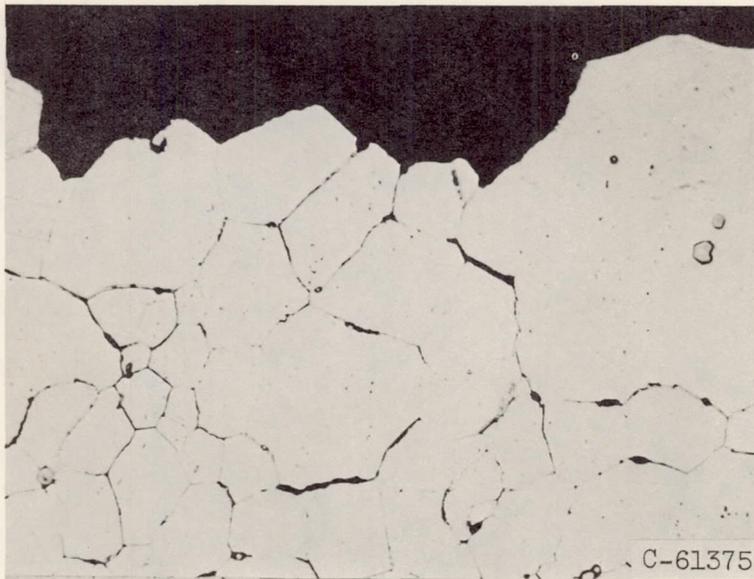
(a) A-286; internal surface exposed to air; life, 316.8 hours.

Figure 6. - Intergranular fractures typical of failures encountered in stress-rupture tests with both air and hydrogen.

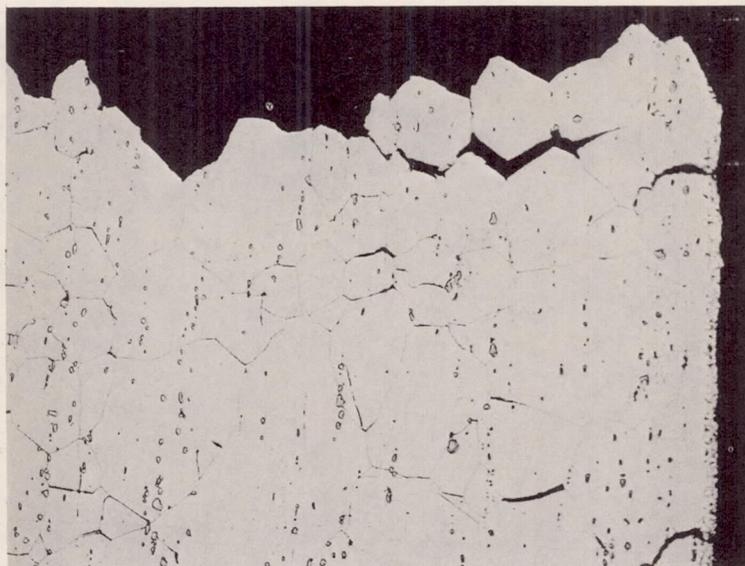
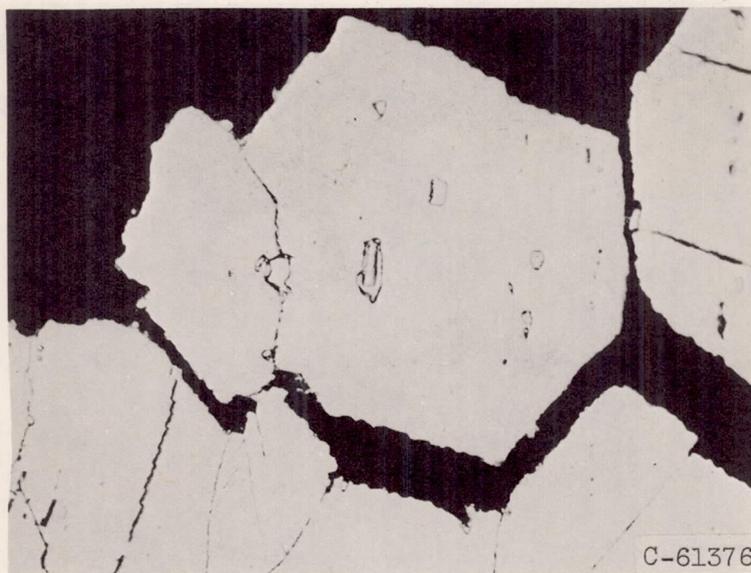
(b) Inconel 700; internal surface exposed to hydrogen; life, 198.3 hours.

Figure 6. - Continued. Intergranular fractures typical of failures encountered in stress-rupture tests with both air and hydrogen.

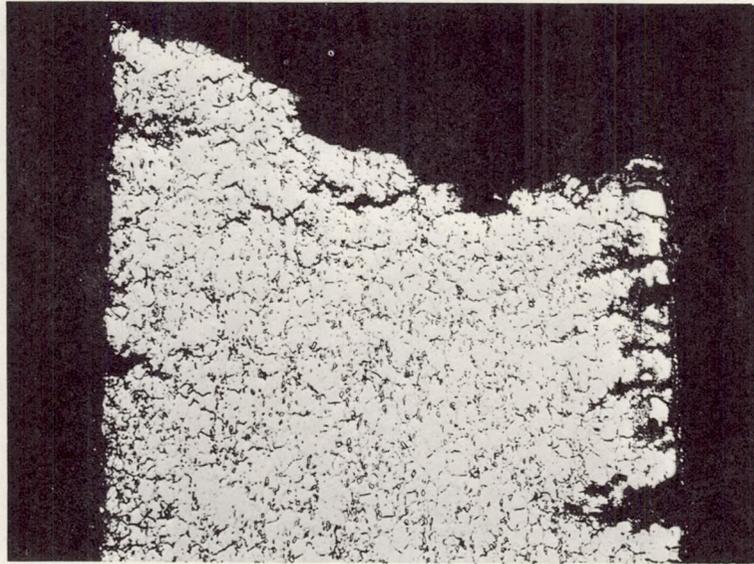
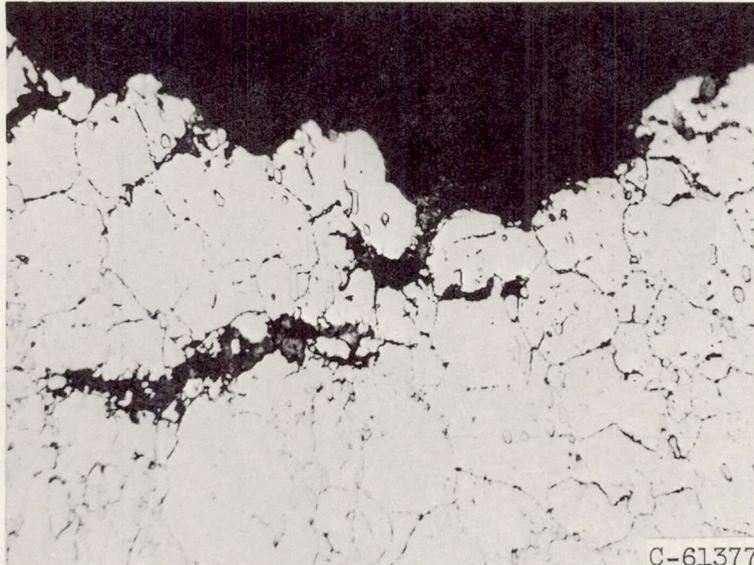
(c) S-816; internal surface exposed to air; life, 166.6 hours.

Figure 6. - Concluded. Intergranular fractures typical of failures encountered in stress-rupture tests with both air and hydrogen.

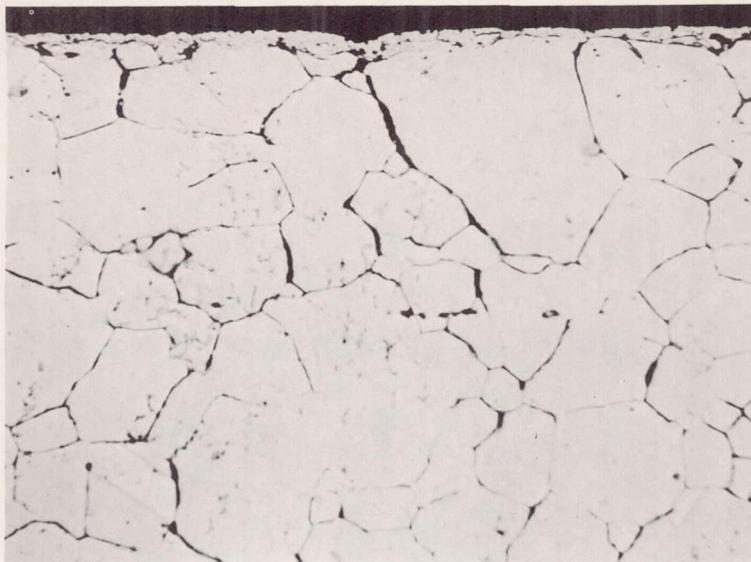
(a) A-286; stress-rupture test; life, 280 hours.

Figure 7. - Area near region of failure of typical specimens showing internal surface after exposure to hydrogen.

Figure 7 shows photomicrographs of typical tested specimens (fatigue or stress rupture) along the surface exposed to hydrogen. The area chosen was near the point of failure in all cases. Figure 8 presents photomicrographs of additional tested specimens (fatigue or stress rupture) of each alloy along the internal surface, which show areas away from the point of failure. No scale is evident on the surface exposed to hydrogen, however, the microstructure of each of the alloys was affected to varying depths beneath the specimen internal surface. The affected zone was generally continuous through both the cracked and noncracked areas. Some depletion of alloying elements may have occurred in these zones. A-286 shows the narrowest affected zone (figs. 7(a) and 8(a)). Figure 7(c) indicates that S-816 had the widest affected zone. At a magnification of 500 only the affected zone itself is observable. Its true depth is apparent from the photomicrograph at a magnification of 250. The marked absence of precipitates in the affected zone of the S-816 specimens, both within the grains and in the grain boundary regions, suggests that this material may have been decarburized and considerably weakened by the hydrogen environment. Such a weakening effect may have contributed to the reduction in average stress-rupture life and the apparent lesser reduction in fatigue life observed with this material during the hydrogen tests. It is interesting to note that numerous cracks were observed in this affected zone (fig. 7(c)). Metallographic studies, however, did not indicate that a greater amount of cracking occurred or that fracture was preferentially initiated in these zones compared with the region adjacent to the external specimen surface.

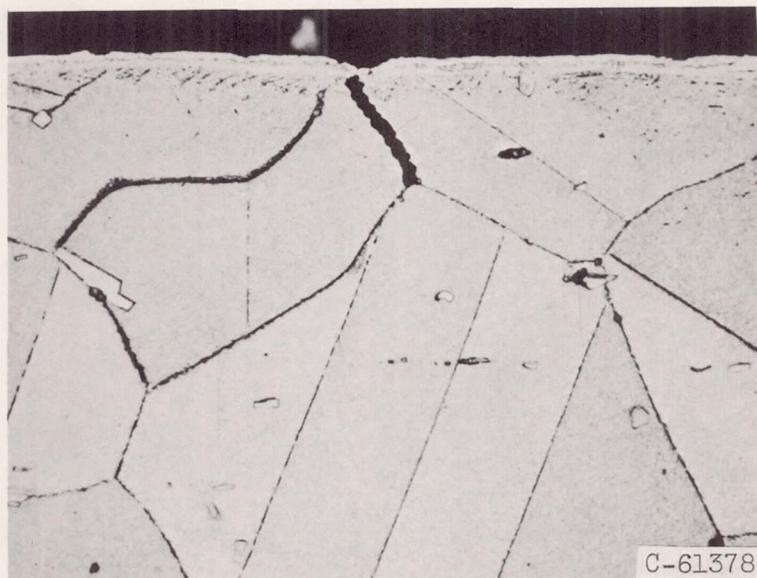
(b) Inconel 700; stress-rupture test; life, 198.3 hours.

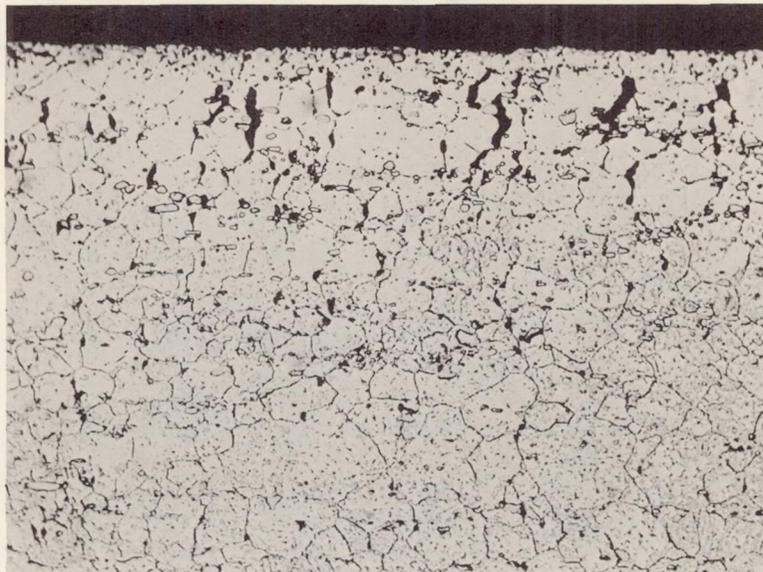
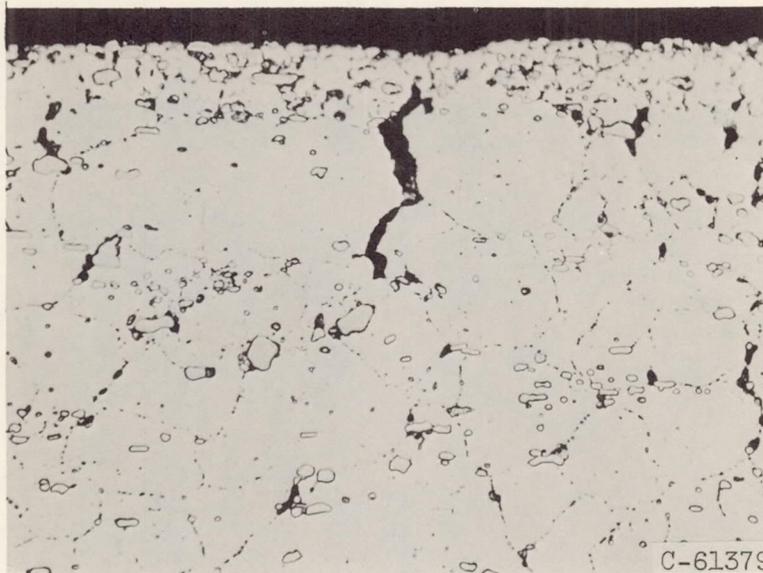
(c) S-816; fatigue test; life, 42×10^6 cycles
(357.1 hr).

Figure 7. - Concluded. Area near region of failure of typical specimens showing internal surface after exposure to hydrogen.

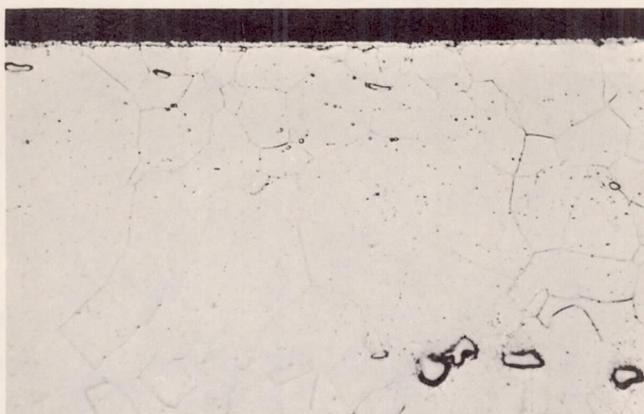
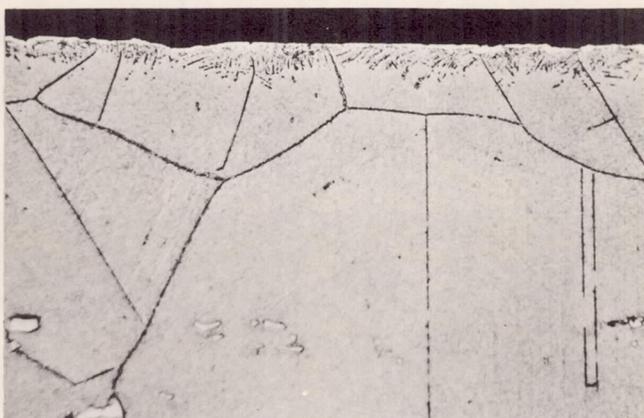
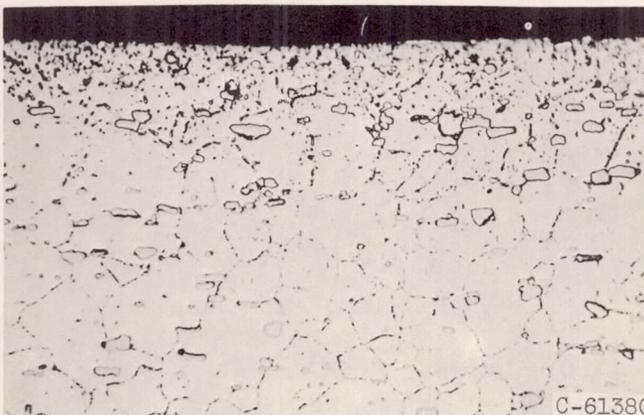
(a) A-286; stress-rupture test; life, 246.6 hours.

(b) Inconel 700; fatigue test; life, 49.0×10^6 cycles (411.1 hr).

(c) S-816; fatigue test; life, 31.0×10^6 cycles (262.2 hr).

Figure 8. - Area some distance from region of failure of typical specimens showing internal surfaces after exposure to hydrogen. X500.

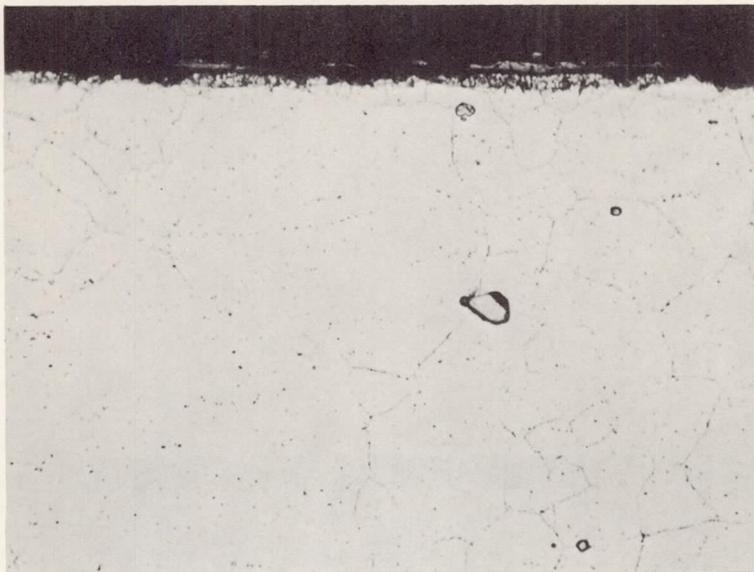
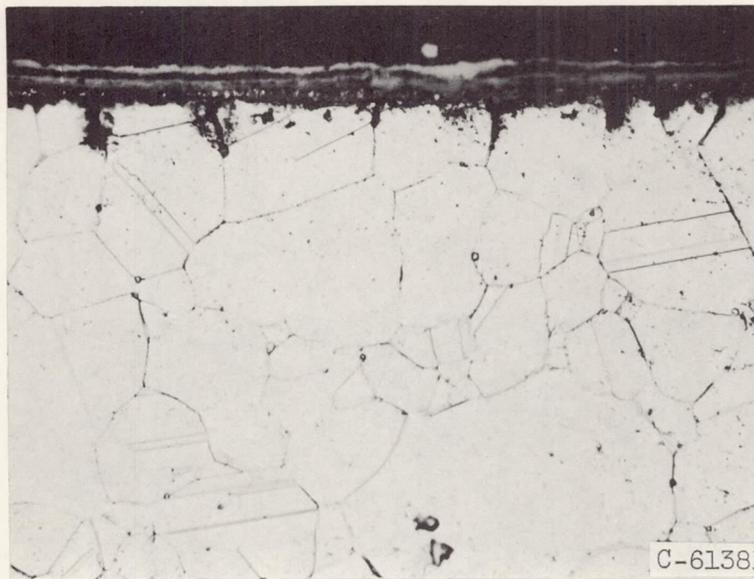
(a) A-286; fatigue test; life, 33.6×10^6 cycles
(284.2 hr).

Figure 9. - Typical specimens showing both internal and external surfaces in region of failure. Internal surface exposed to dried air; external surface exposed to relatively humid air. X500.

Figure 9 shows typical microstructures along both the internal and the external surfaces of specimens of each alloy after air tests in the areas near the specific points of failure. Figure 10 presents similar

photomicrographs of additional specimens of each alloy, which show regions away from the failure area. It is apparent from these figures that, in general, a considerably thicker scale was formed on the external surface exposed to relatively humid air rather than on the internal specimen surface exposed to dried air. This scale extended through both the cracked and uncracked areas. Microscopic examination indicated that considerable oxidation occurred in the cracks that formed near the point of failure of air-tested specimens in all the materials investigated. Oxidation occurred in the cracks that extended from the internal surface as well as those that extended from the external surface. This was most apparent in stress-rupture tested specimens and is best illustrated in figure 9(c). No oxidation occurred in the cracks that extended from the internal surfaces of specimens exposed to hydrogen.

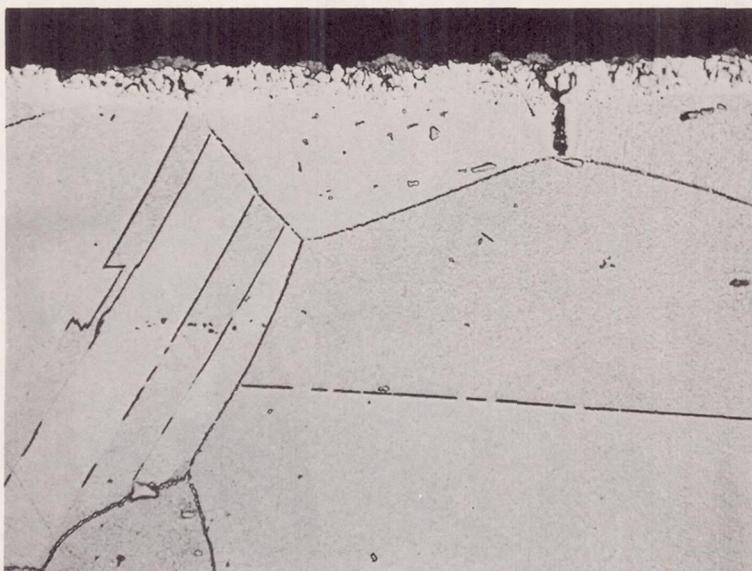
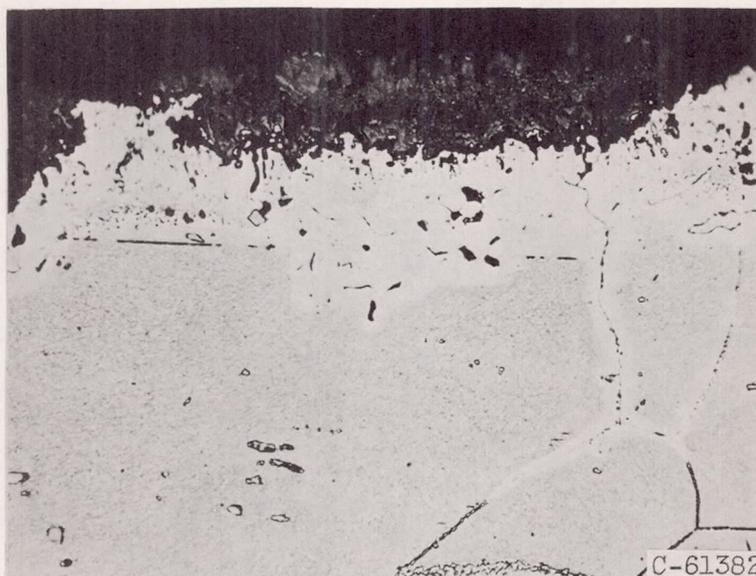
(b) Inconel 700; fatigue test; life, 83.4×10^6 cycles (705.5 hr).

Figure 9. - Continued. Typical specimens showing both internal and external surfaces in region of failure. Internal surface exposed to dried air; external surface exposed to relatively humid air. X500.

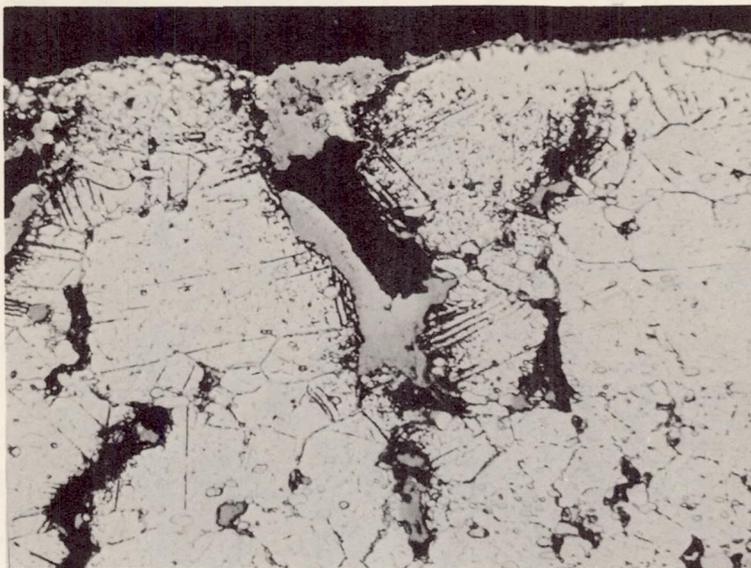
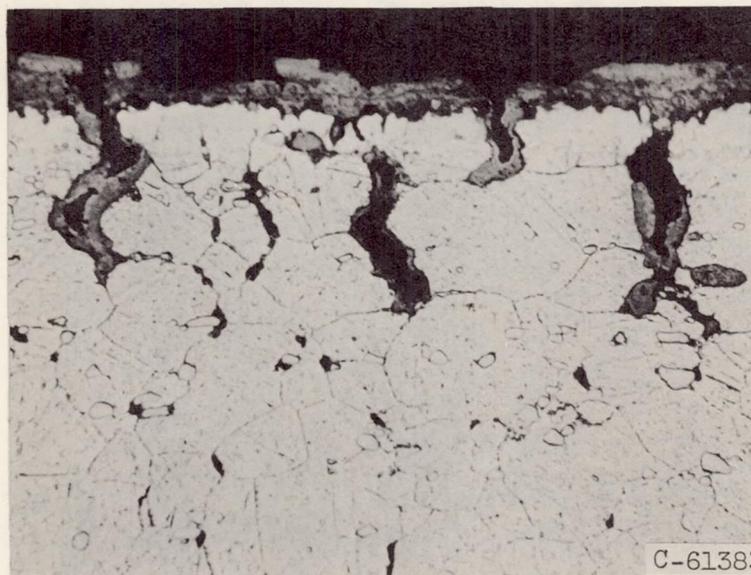
(c) S-816; stress-rupture test; life, 232.8 hours.

Figure 9. - Concluded. Typical specimens showing both internal and external surfaces in region of failure. Internal surface exposed to dried air; external surface exposed to relatively humid air. X500.

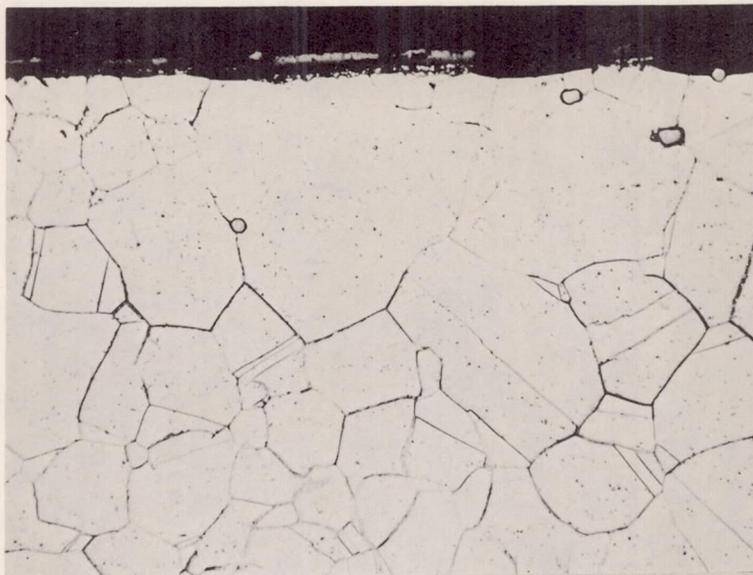
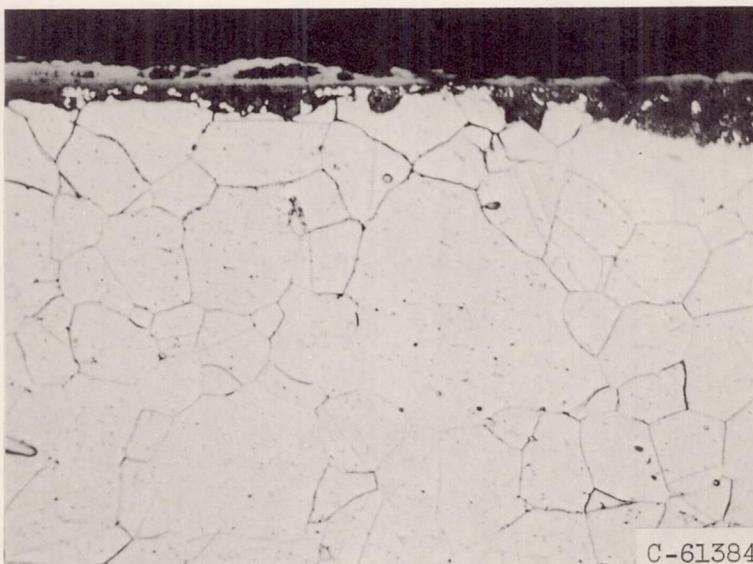
(a) A-286; fatigue test; life, 33.6×10^6
cycles (284.2 hr).

Figure 10. - Typical specimens showing both internal and external surfaces in area some distance from region of failure. Internal surface exposed to dried air; external surface exposed to relatively humid air. X500.

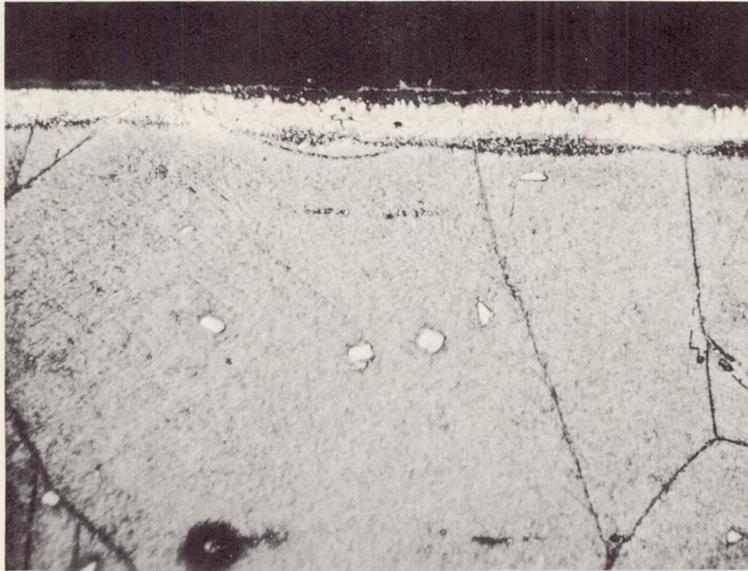
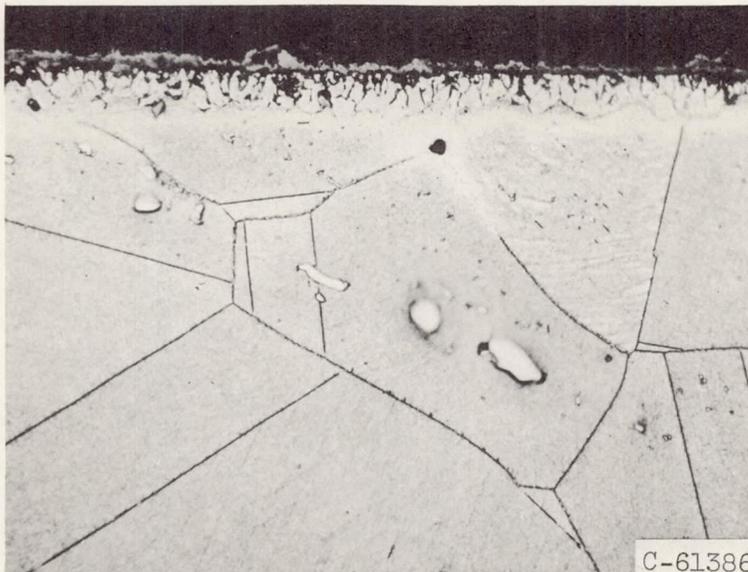
(b) Inconel 700; fatigue test; life, 47.4×10^6 cycles (401.6 hr).

Figure 10. - Continued. Typical specimens showing both internal and external surfaces in area some distance from region of failure. Internal surface exposed to dried air; external surface exposed to relatively humid air. X500.

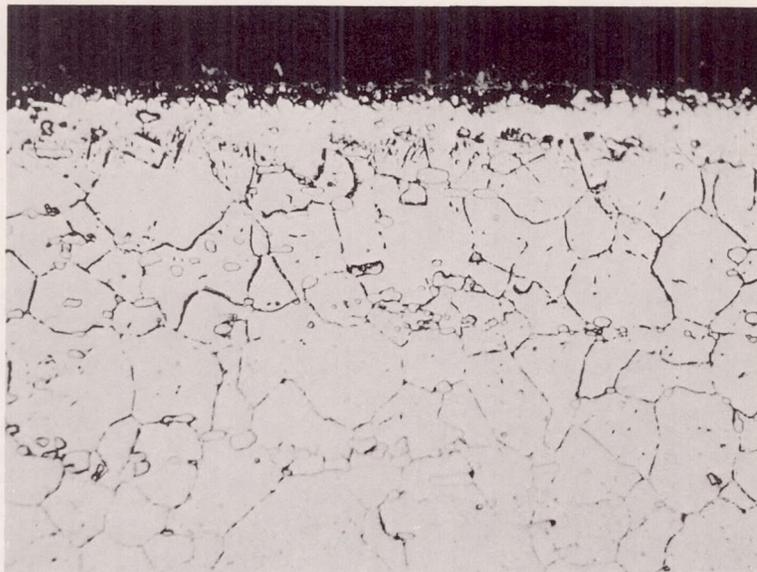
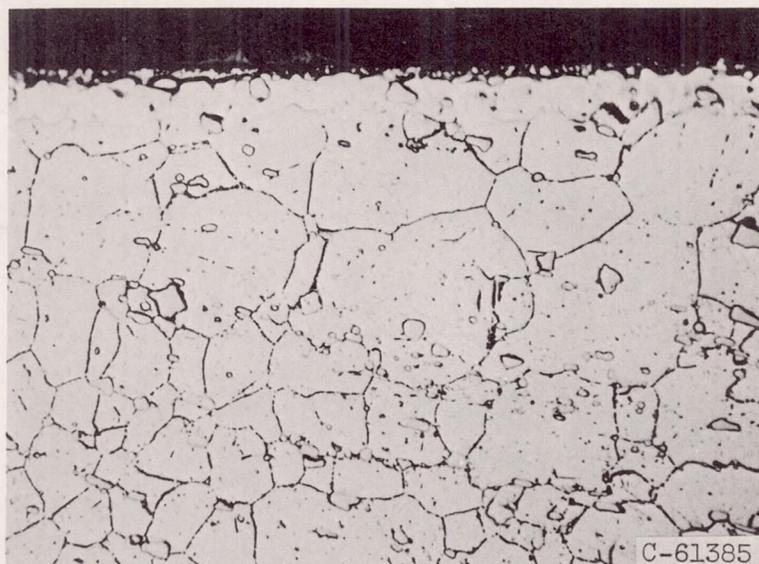
(c) S-816; fatigue test; life, 31.2×10^6 cycles
(263.8 hr).

Figure 10. - Concluded. Typical specimens showing both internal and external surfaces in area some distance from region of failure. Internal surface exposed to dried air; external surface exposed to relatively humid air. X500.
