**CORROSION PROBLEMS ASSOCIATED WITH THE USE OF TITANIUM FASTENERS
TO CONNECT ALUMINUM COMPONENTS**

MTP-P&VE-M-63-13

MATERIALS DIVISION
PROPULSION AND VEHICLE ENGINEERING LABORATORY

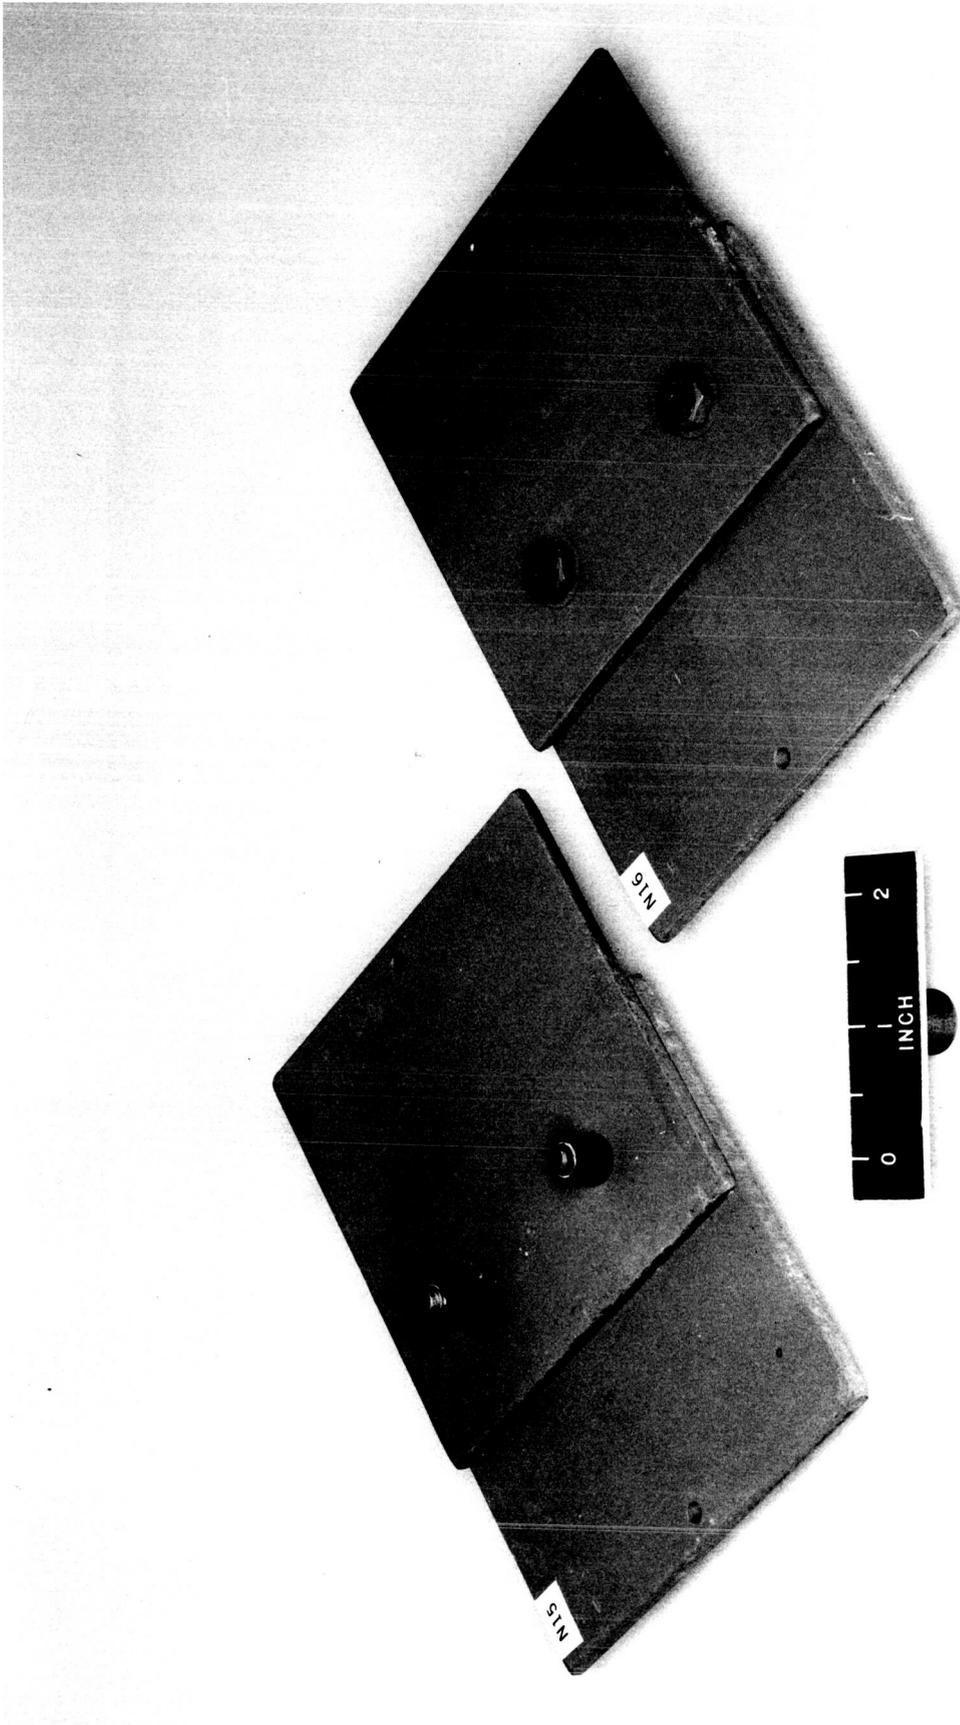
FIGURE 4 CORROSION ON ALUMINUM FASTENERS CONNECTING PAINTED 7075 ALUMINUM PANELS
AFTER 200 HOURS SALT SPRAY EXPOSURE

The second series of tests was conducted to evaluate the effects of titanium fasteners on protected aluminum panels. The panels were given a chemical conversion coating (MIL-C-5541) and one coat of zinc chromate primer (MIL-P-8585) before installation of the fasteners. The fasteners were dipped in the same primer and installed wet. Aluminum and cadmium plated fasteners were also used in this series of tests as controls. The corrosion which occurred as a result of these tests is shown in FIG 4, 5, and 6. The corrosion on the all aluminum specimens (FIG 4) was confined to the end of the broken collars, as discussed above. A little more corrosion was evident on the cadmium plated

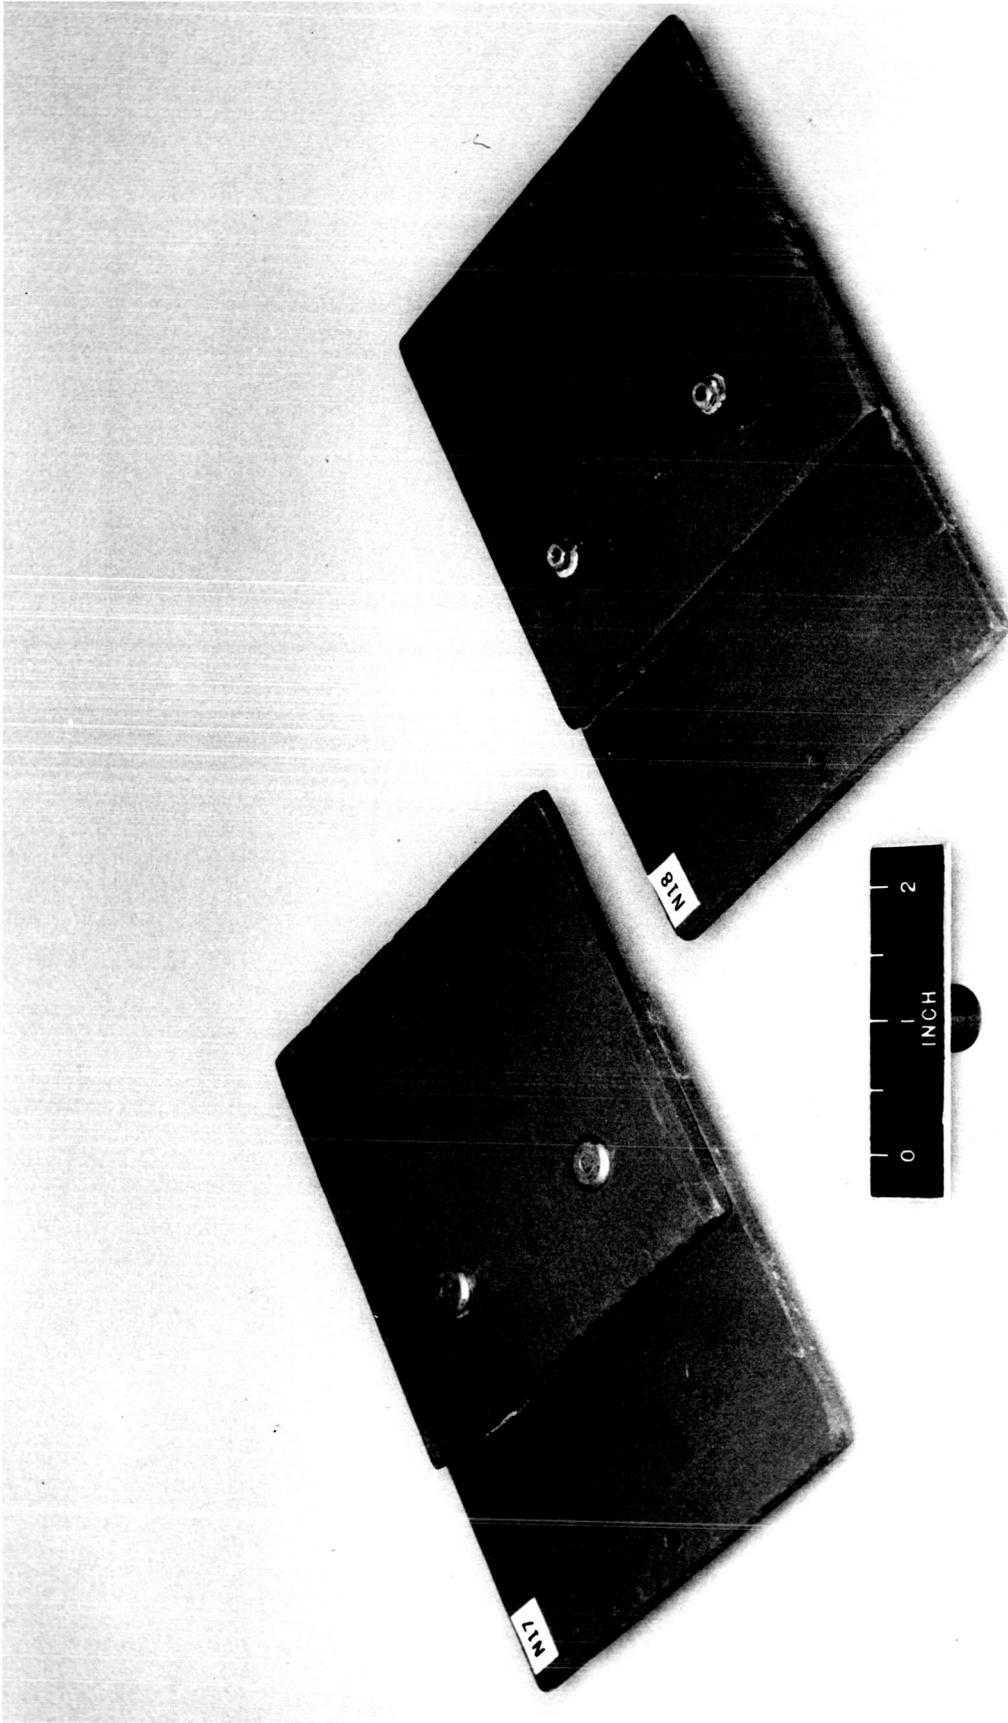
FIGURE 5 CORROSION ON CADMIUM PLATED FASTENERS CONNECTING PAINTED 7075 ALUMINUM PANELS AFTER 200 HOURS SALT SPRAY EXPOSURE

fastener, as shown in FIG 5. This fastener has an aluminum collar with a cadmium plated pin. The additional corrosion apparent on these collars, when compared with the all aluminum fasteners, was due to the slight difference in solution potential between cadmium and aluminum. Severe corrosion occurred on the aluminum collar of the titanium fastener in this series of tests, as shown in FIG 6. The amount and severity were about the same as in the first series of tests. However, this vulnerable area was the only place that any significant corrosion occurred on these specimens. The protective coatings had prevented corrosion in all other areas. Additional test specimens in which the end of the collar and titanium pin were painted with zinc chromate primer after installation were essentially free of corrosion products.

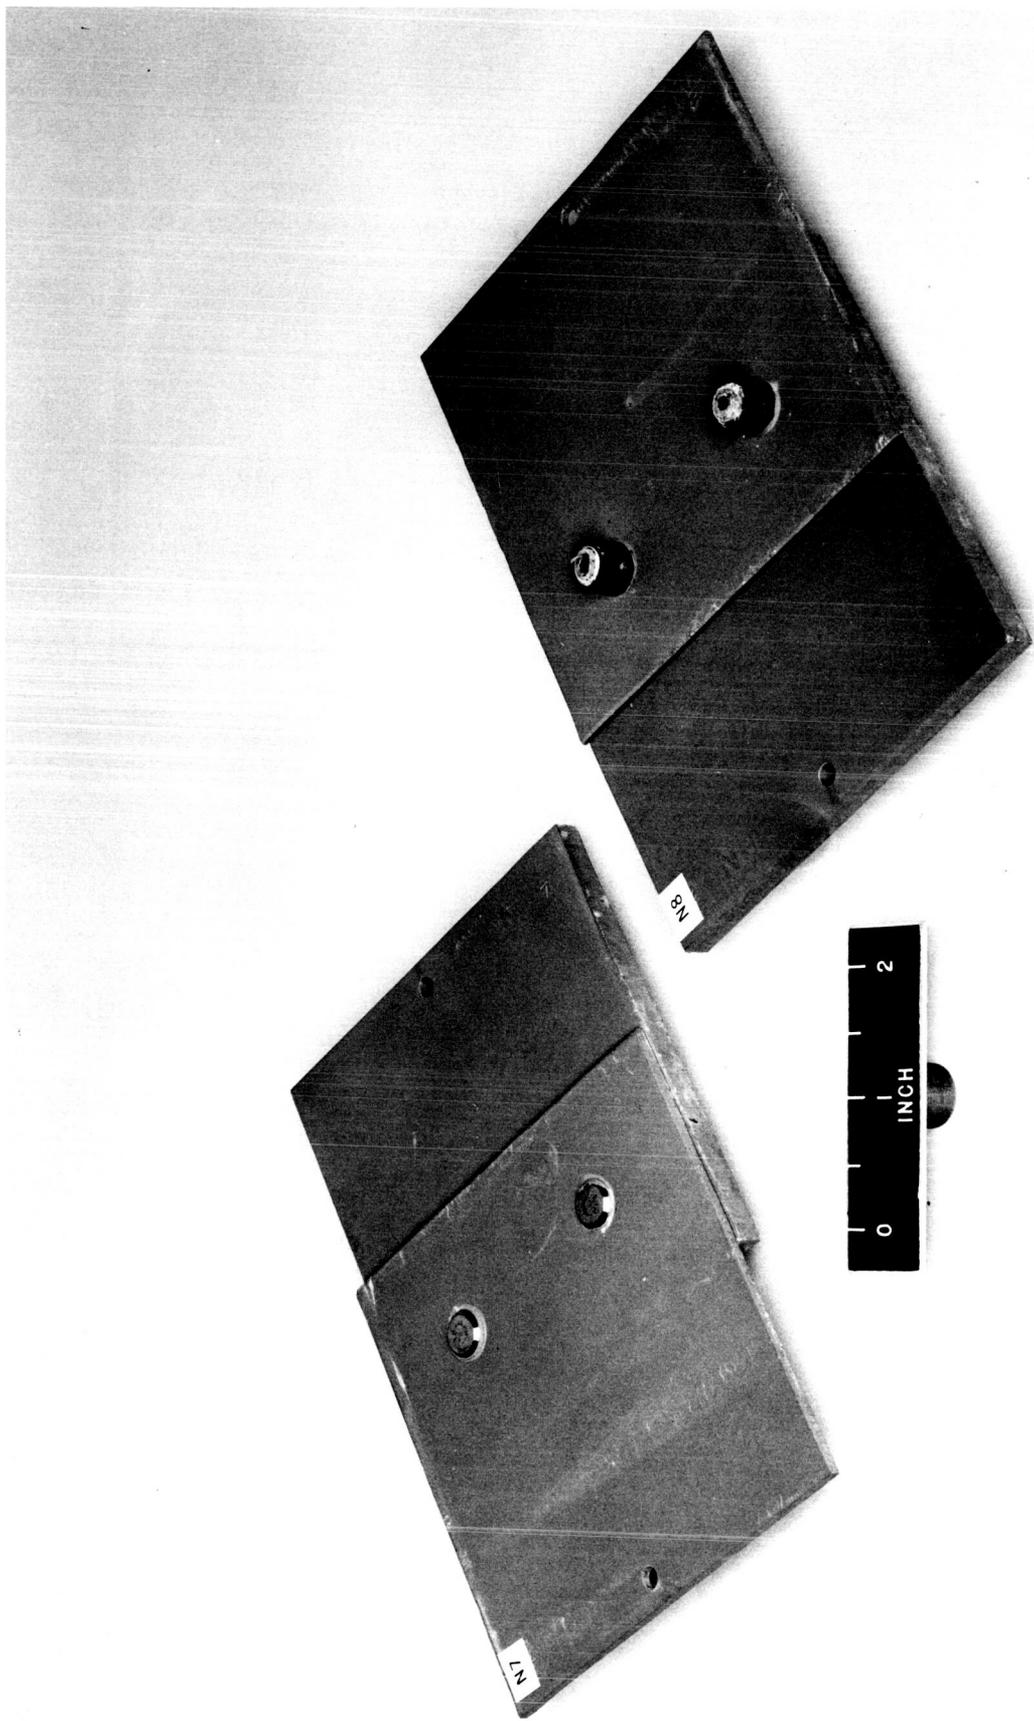
FIGURE 6 CORROSION ON TITANIUM FASTENERS CONNECTING PAINTED 7075 ALUMINUM PANELS AFTER 200 HOURS SALT SPRAY EXPOSURE
