NASA TM X-53317

STRESS CORROSION STUDIES OF AM-355
STAINLESS STEEL

By J. G. Williamson
Propulsion and Vehicle Engineering Laboratory

*George C. Marshall
Space Flight Center,
Huntsville, Alabama*

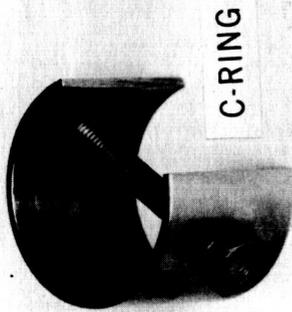
FIGURE 1. - STRESS CORROSION SPECIMENS MADE FROM AM-355 BAR AND SLEEVE MATERIAL

A "C"-ring type specimen (FIG 1) utilizing the constant deflection method explained in Appendix I was employed in this work. Specimens which were machined from one and one-half-inch bar stock were one and three-eighths inches in diameter with a wall thickness of 0.062 inch. Specimens made from sleeves were 1.6 inches in diameter and 0.048 inch in wall thickness. The specimens were degreased with acetone, stressed to the desired level, and then placed in the various corrosive environments until failure occurred or until the tests were terminated. Mechanical properties of the alloy were measured by cutting tensile specimens from each bar; minimum published values were used for specimens which were made directly from fabricated sleeves. Specimens were stressed at various levels from 25 to 100 percent of the yield strength (0.2 percent offset) of the alloy. The corrosive environments included continuous salt spray (five percent NaCl), alternate immersion (3.5 percent NaCl), and both inside and outside exposure at the George C. Marshall Space Flight Center, Huntsville, Alabama. The alternate immersion test (FIG 2) consists of 10 minutes immersion in the salt solution, followed by 50 minutes of drying each hour.

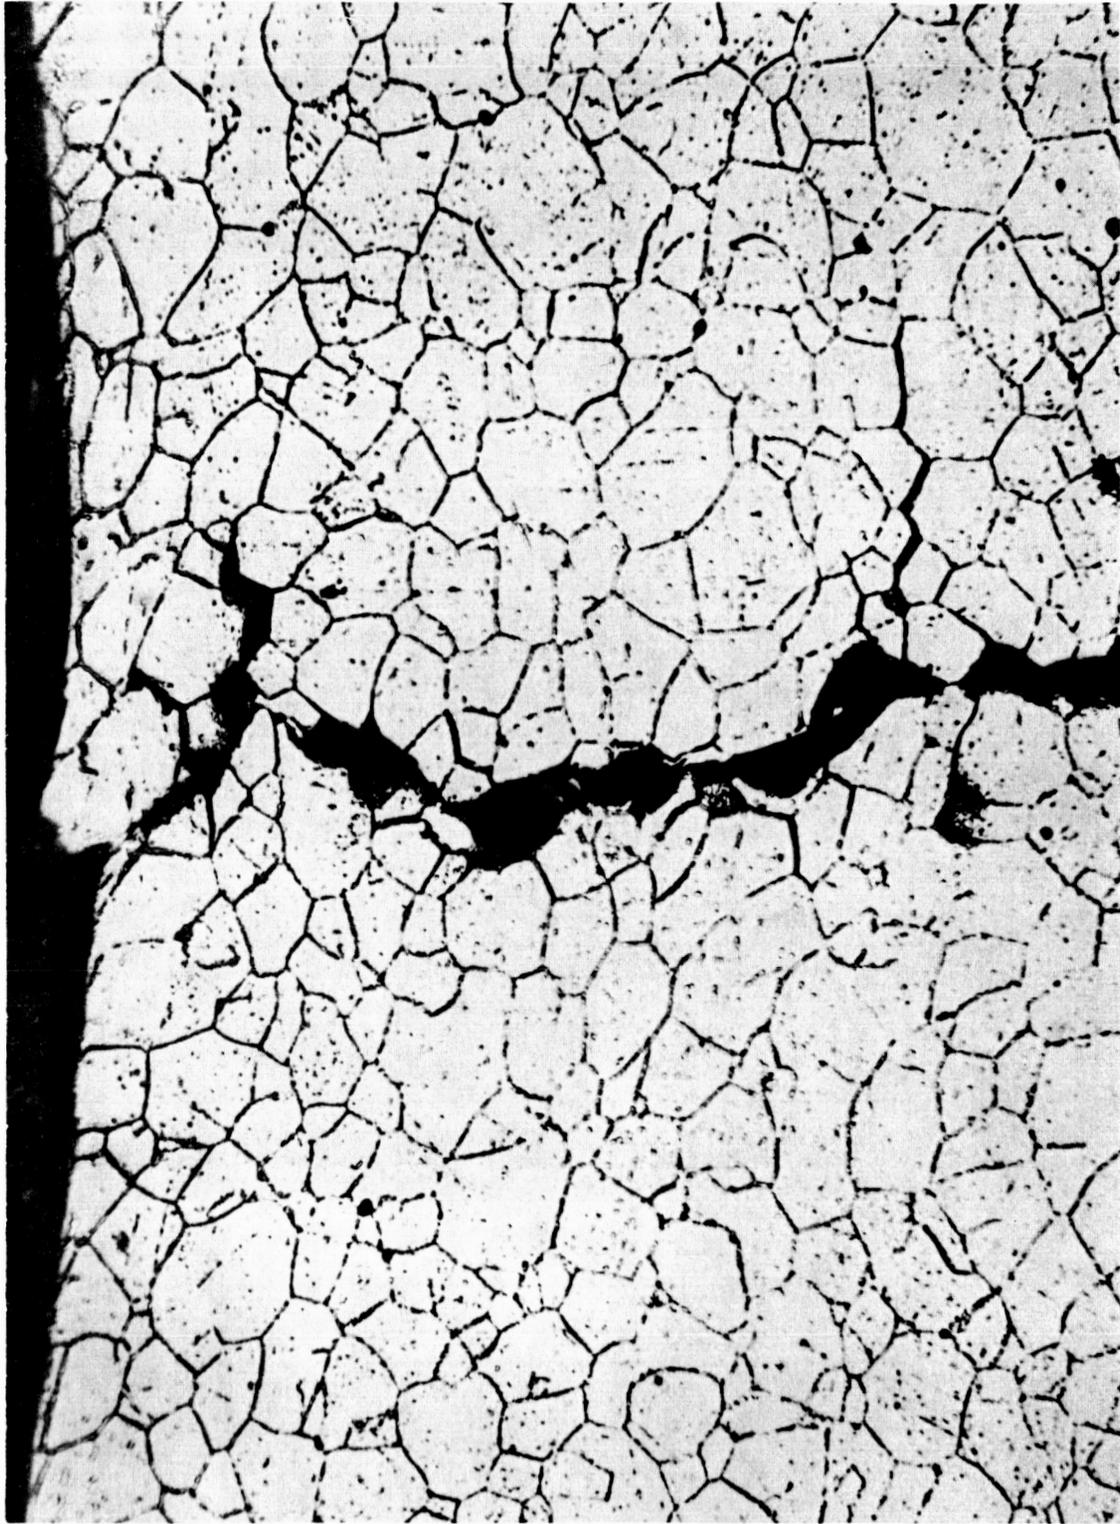
FIGURE 6. - CRACK IN AM-355 ALLOY CONTAINING CARBIDE NETWORK
