NASA TM X-1266

EXPERIMENTAL EVALUATION
OF THROAT INSERTS IN
A STORABLE-PROPELLANT
ROCKET ENGINE

by Jerry M. Winter, Larry D. Plews, and James R. Johnston
Lewis Research Center
Cleveland, Ohio

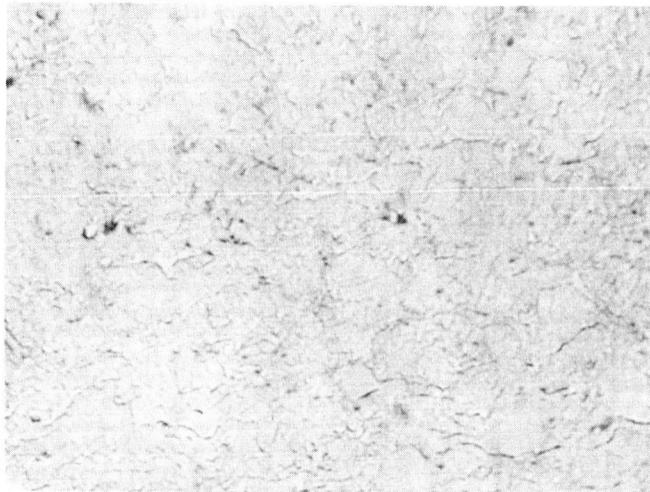
X1000

Surface erosion caused by oxidation of the tungsten had occurred in the entrance and throat sections of the nozzle. Because of the high temperatures, the laminar tungsten structure had been recrystallized. The temperature was at least 779⁰ C since the infiltrant had melted and migrated to the hot surfaces of the nozzle.

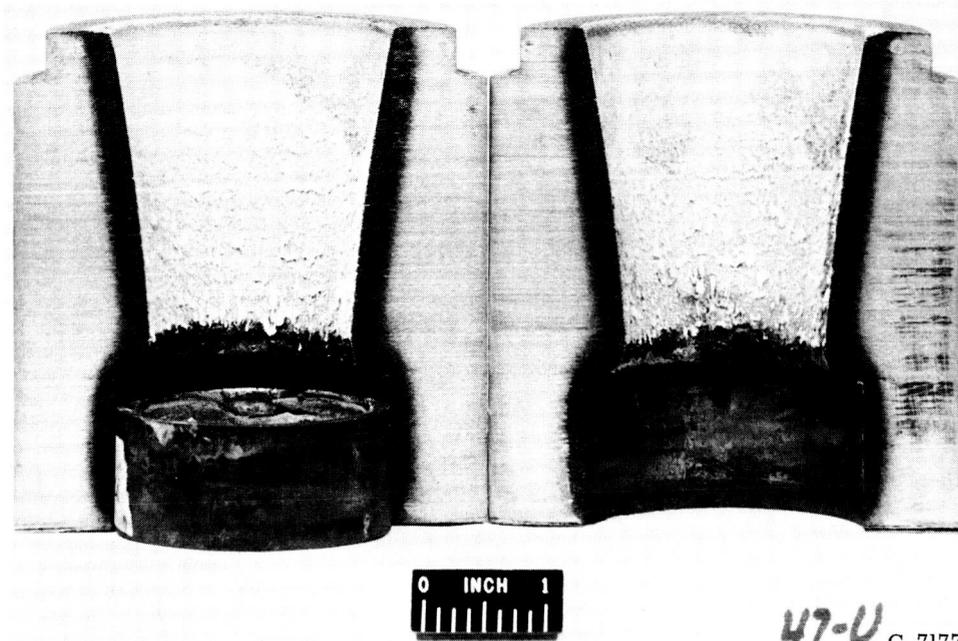
(10) Insert 10; configuration B; injector 11; characteristic length, 67; no coating

Material	Form	Manufacturer	Additional layer
Insert		TiB ₂ with ZrO ₂ filler		Caloboric	0.040-in. -thick Rokide Z, 0.125-in. -thick stainless-steel sleeve with 0.005 interference fit
Envelope		Silica phenolic (MX 2641)	Tape (90° to centerline)	Haveg	0.25-in. -thick stainless-steel shell
Run	Chamber pressure, P _c , psia	Oxidant-fuel ratio, O/F	Run time, sec	Total change in effective throat radius, ΔR, in.	Remarks
341	101 to 93	2.24	21.9	0.0465	Low chamber pressure shutdown
360	101 to 92	2.23	19.2	.1015	Low chamber pressure shutdown
366	97.5 to 92	2.20	13.6	.1345	Low chamber pressure shutdown
			54.7

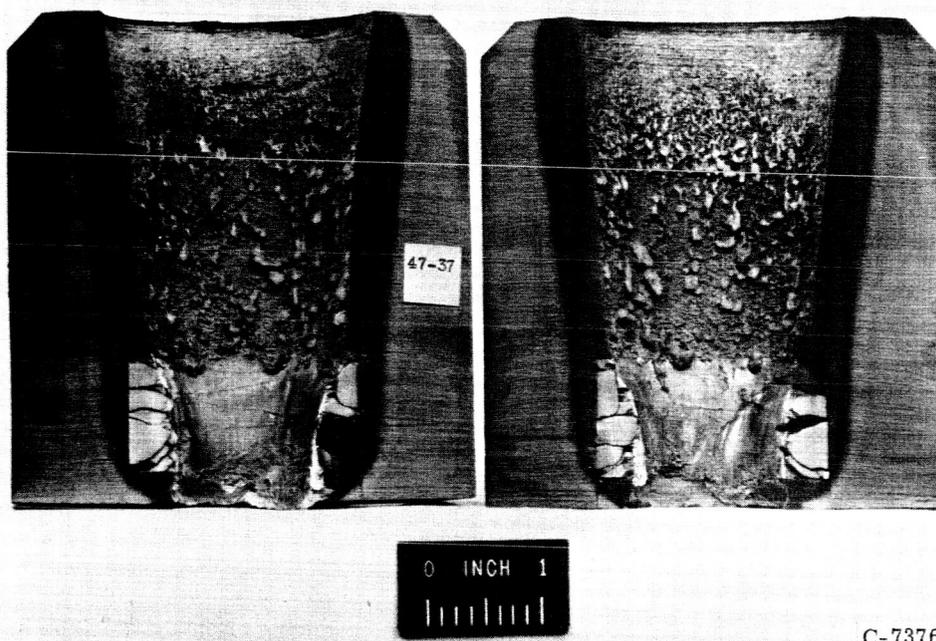
(15) Insert 15; configuration C; injector 11; characteristic length, 67; no coating

Material	Form	Manufacturer	Additional layer
Insert		65 ZrO ₂ - 35 SiO ₂	Hot pressed	Aerospace Corp	None
Envelope		Silica phenolic (MX 2641)	Cloth (90° to centerline)	Haveg	0.25-in. -thick stainless-steel shell
Run	Chamber pressure, P _c , psia	Oxidant-fuel ratio, O/F	Run time, sec	Total change in effective throat radius, ΔR, in.	Remarks
25	92.8 to 94.1	1.98	60.1	-0.033	Timer shutdown; cracks and local erosion

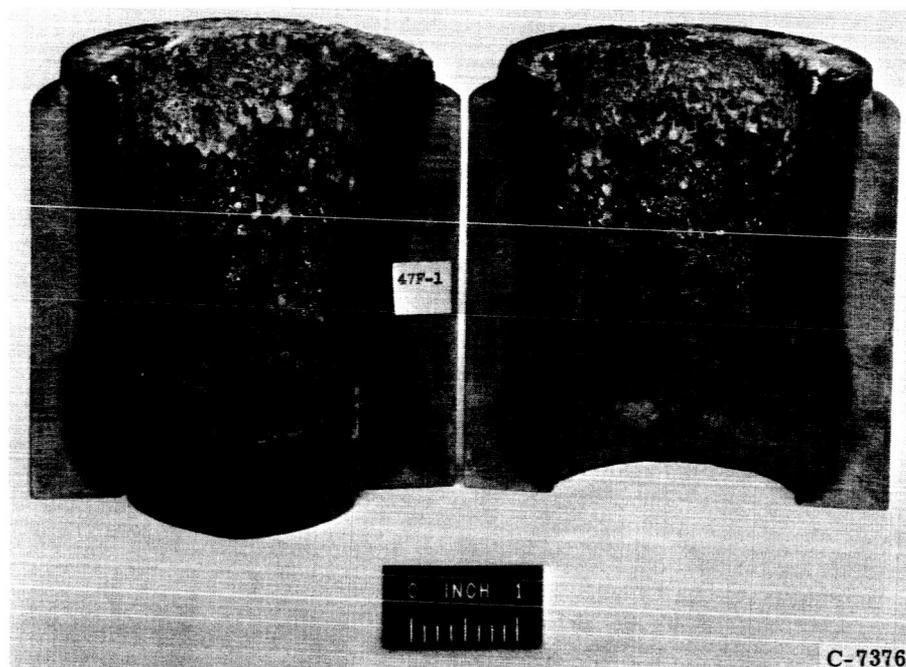
(25) Insert 25; configuration C; injector 11; characteristic length, 67; no coating

Material	Form	Manufacturer	Additional layer
Insert		SiC		Avco Corp	0.100-in. -thick Ta sleeve with 0.003 interference fit
Envelope		Silica phenolic (MX 2641)	Cloth (90° to centerline)	Haveg	0.25-in. -thick stainless-steel shell
Run	Chamber pressure, P_c , psia	Oxidant-fuel ratio, O/F	Run time, sec	Total change in effective throat radius, ΔR , in.	Remarks
16	104.4 to 102.4	1.90	60.1	-----	Timer shutdown; one circumferential crack
20	99.8 to 89.4	2.05	80.2	0.053	Low chamber pressure shutdown; Ta ring oxidized
				----- 140.3

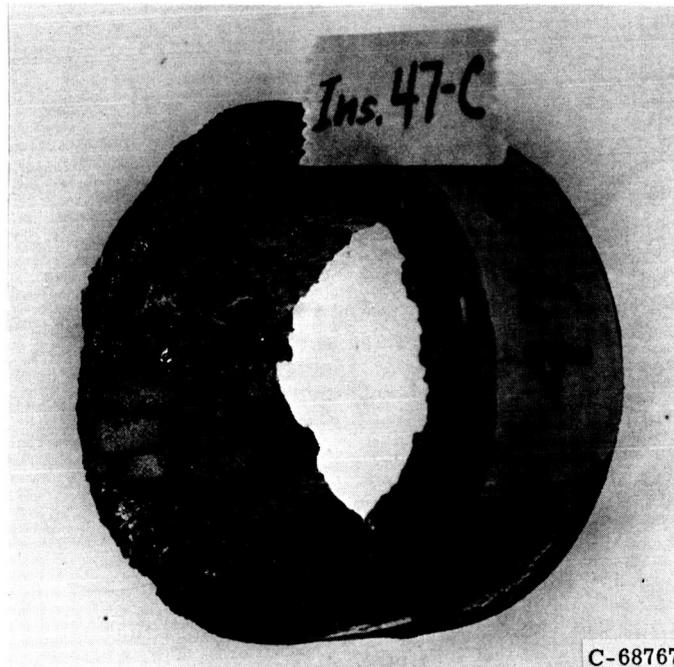
(30) Insert 30; configuration B; injector 11; characteristic length, 50; no coating

Material	Form		Manufacturer	Additional layer
Insert		W	Sintered		General Electric	None
Envelope		Silica phenolic (MX 2641)	Cloth (90° to centerline)		Fiberite	None
Run	Chamber pressure, P _c , psia	Oxidant-fuel ratio, O/F	Run time, sec	Total change in effective throat radius, ΔR, in.	Remarks	
171	99.5 to 96.5	2.05	29.5	0	Timer shutdown; no change Low chamber pressure shutdown	
172	94 to 88	1.82	51.5	.055		
			81.0

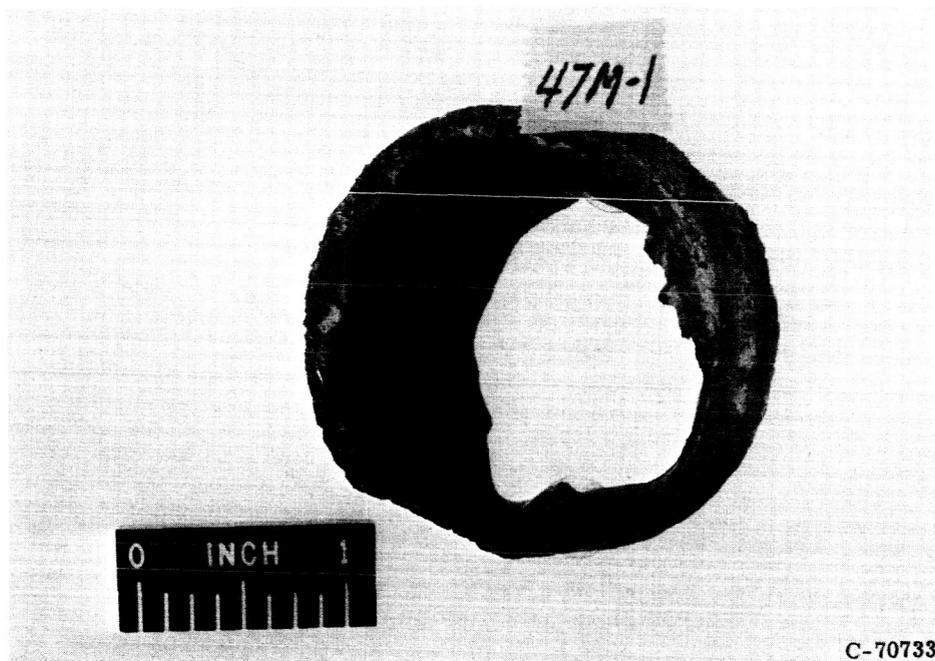
(31) Insert 31; configuration C; injector 11; characteristic length, 67; no coating

Material		Form		Manufacturer	Additional layer
Insert	Mo	Sintered		General Electric	0.04-in. -thick Rokide Z on insert outside diameter
Envelope	Silica phenolic (MX 2641)	Cloth (90° to centerline)		Fiberite	0.25-in. -thick stainless-steel shell
Run	Chamber pressure, P _c , psia	Oxidant-fuel ratio, O/F	Run time, sec	Total change in effective throat radius, ΔR, in.	Remarks
301	105.5 to 96.5	1.72	60.6	0.0145	Timed shutdown
315	107 to 89	1.83	35.1	.084	Low chamber pressure shutdown
			95.7

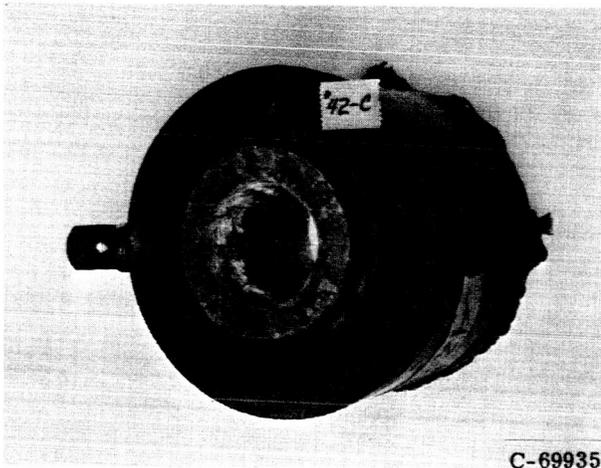
(37) Insert 37; configuration B; characteristic length, 67; no coating

Material	Form		Manufacturer	Additional layer
Insert		80 W - 20 Ag	Sintered and infiltrated		Firth-Sterling	0.030-in. -thick Rokide Z on insert outside diameter
Envelope		Silica phenolic (MX 2641)	Cloth (90° to centerline)		Fiberite	None
Run	Injector	Chamber pressure, P _c , psia	Oxidant-fuel ratio, O/F	Run time, sec	Total change in effective throat radius, ΔR, in.	Remarks
255	10	99.7 to 95.9	2.08	59.8	0.020	Leading edge eroded and ablative cracked Low chamber pressure shutdown
409	11	107.5 to 90.5	2.20	47.8	.0955	
				107.6

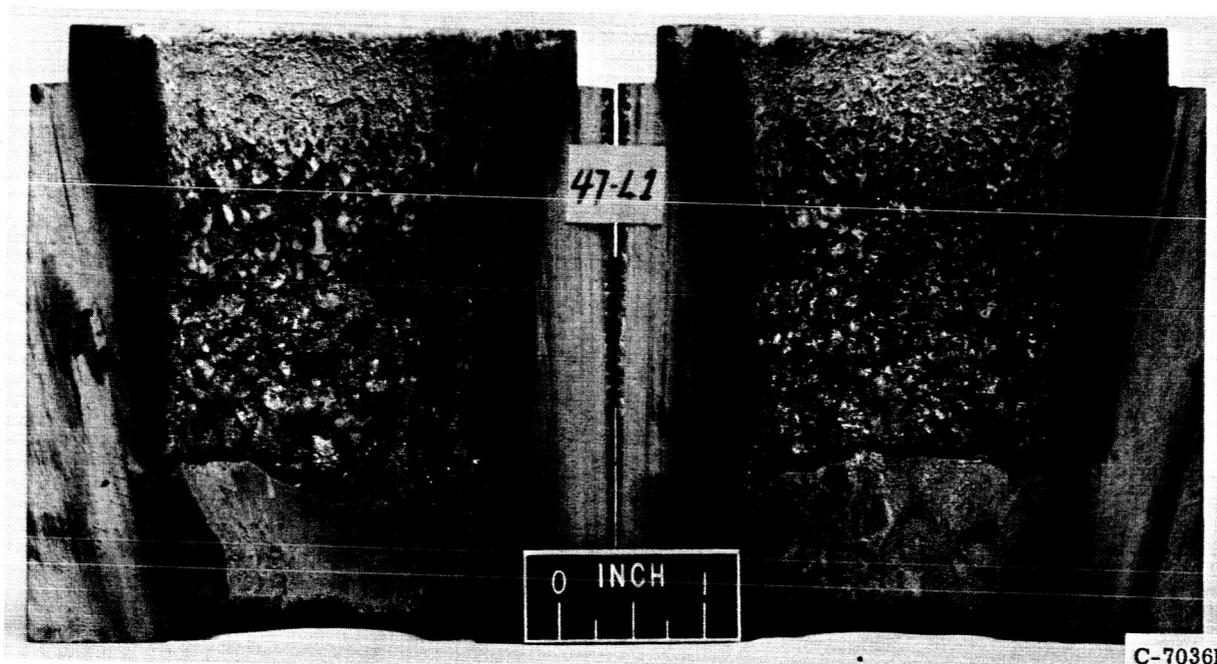
(47) Insert 47; configuration B; injector 11; characteristic length, 67; no precoating; preoxidized coating partially removed during firing

Material	Form	Manufacturer	Additional layer
Insert		JTA graphite (48 C - 35 Zr - 8 B - 9 Si)	Molding	National Carbon	0.04-in. -thick Rokide Z on in- sert outside diameter
Envelope		Silica phenolic	Molded squares	Haveg	0.25-in. -thick stainless-steel shell
Run	Chamber pressure, P_c , psia	Oxidant-fuel ratio, O/F	Run time, sec	Total change in effective throat radius, ΔR , in.	Remarks
279	104.5 to 98.5	2.04	60.2	0.007	Timed shutdown
282	100 to 92	1.83	69.3	.042	Low chamber pres- sure shutdown
			129.5
