NATIONAL AERONAUTICS AND SPACE ADMINISTRATION

*Technical Report 32-1177*

*Surveyor III Mission Report*

*Part II. Scientific Results*

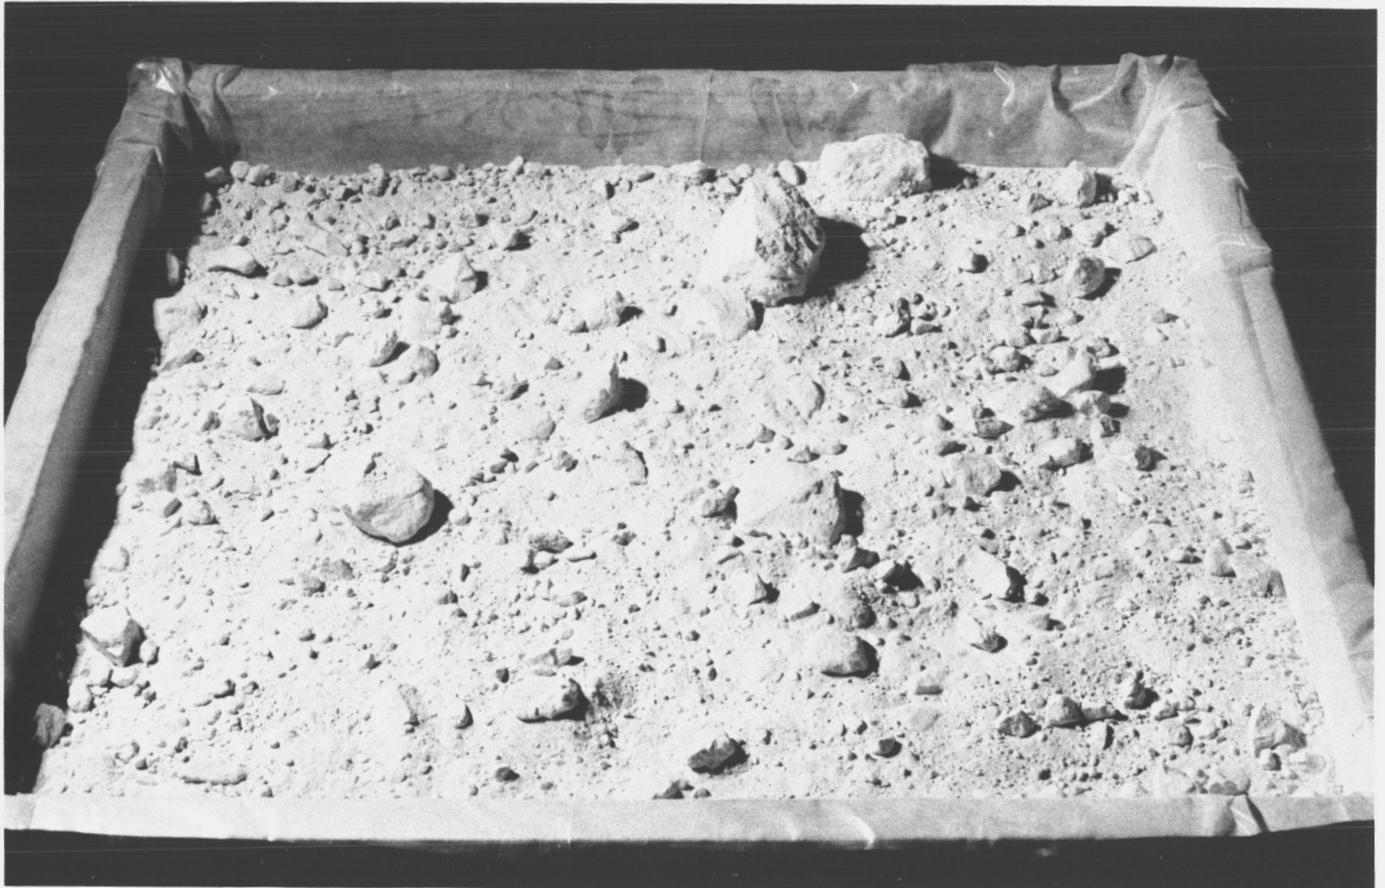
**Fig. III-27. Sample of ejected fragmental debris collected from the rim of Meteor Crater, Arizona. Area of floor of box in which sample has been placed is 1 m<sup>2</sup>. Fragments are sandy dolomite from the Kaibab formation of Permian age. Coarsest piece is 12 cm across, and finest grains identifiable in the picture are about 1 mm across. Spacing between coarser fragments resembles that observed for blocks in strewn fields around small craters at the *Surveyor III* landing site**

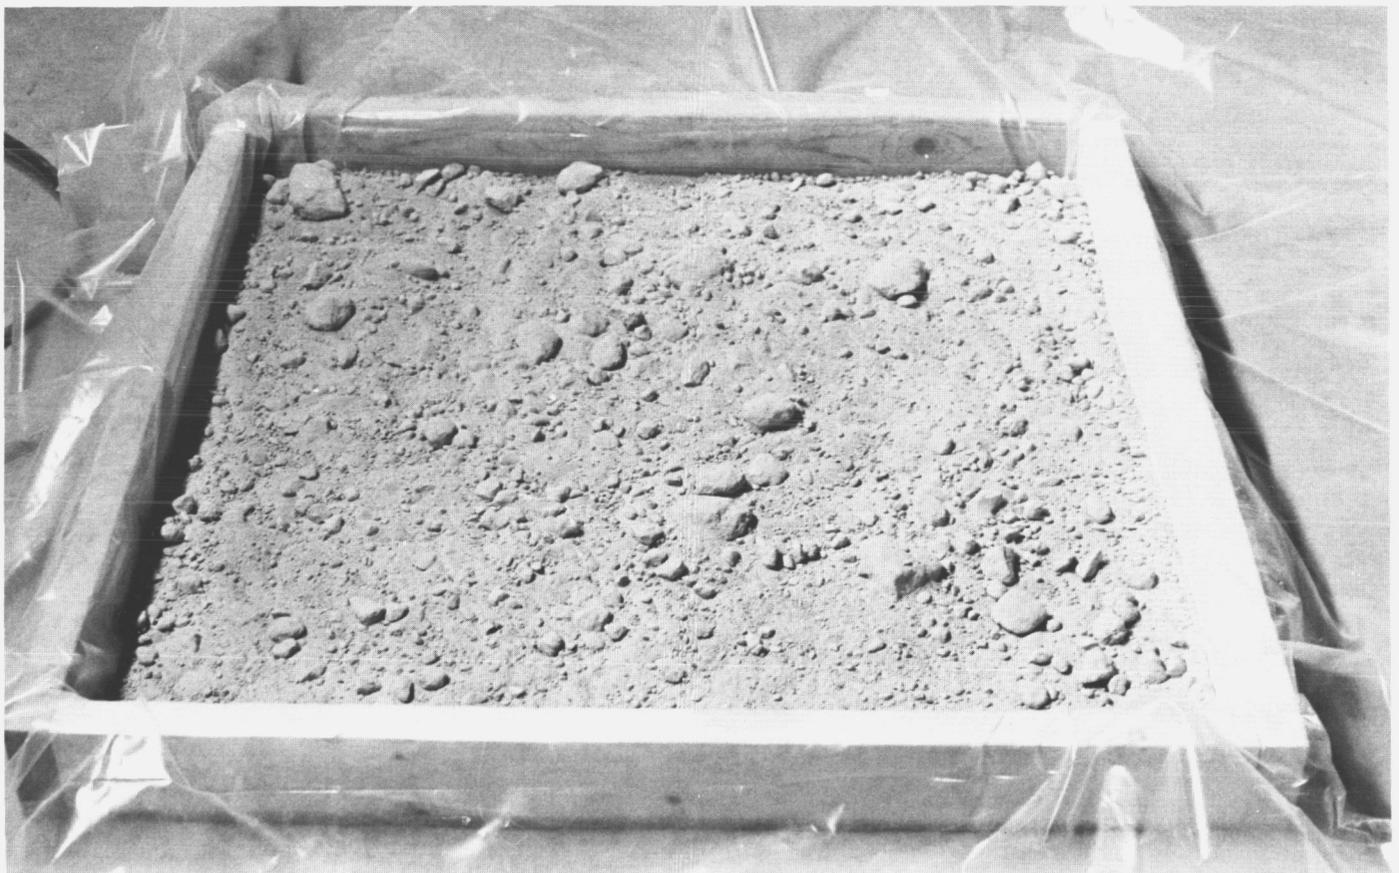
**Fig. III-31. Sample of ash and pumice from volcanic ash flow deposited in the Valley of 10,000 Smokes, Alaska, during the eruption of 1912. Area of floor of box in which sample has been placed is 1 square meter. Coarsest fragments of pumice in sample are 4 to 5 cm across; finest grains identifiable in the picture are about 1 mm across**

entire layer. Among the different materials studied were samples of ash and pumice from the volcanic ash flow deposited in the Valley of 10,000 Smokes in Alaska during the eruption of 1912 (Fig. III-31). The difference between the particle distribution obtained by measurement and counting of grains from pictures and by mechanical sieving for this sample is shown in Fig. III-32. It may be seen that the number of small particles counted in pictures of the surface layer of fragments tends to be much lower than the number of small particles found by sieving the entire layer. A similar difference was observed in the study of fragment size distribution of dolomite ejecta from Meteor Crater, Arizona. Theoretically, for each decrease by a factor of ten in size, the number of small fragments per unit volume should increase ten times as rapidly as the number of recognizable small fragments per unit area exposed at the surface. On this basis, the volumetric size/frequency distribution of

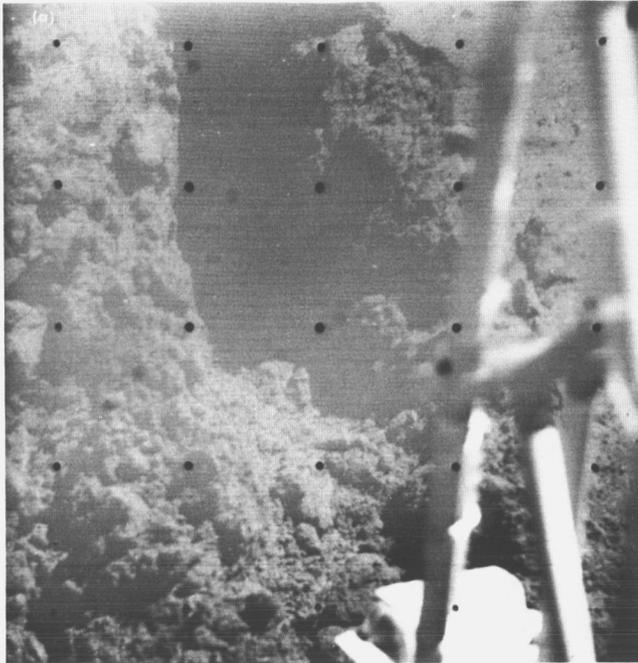
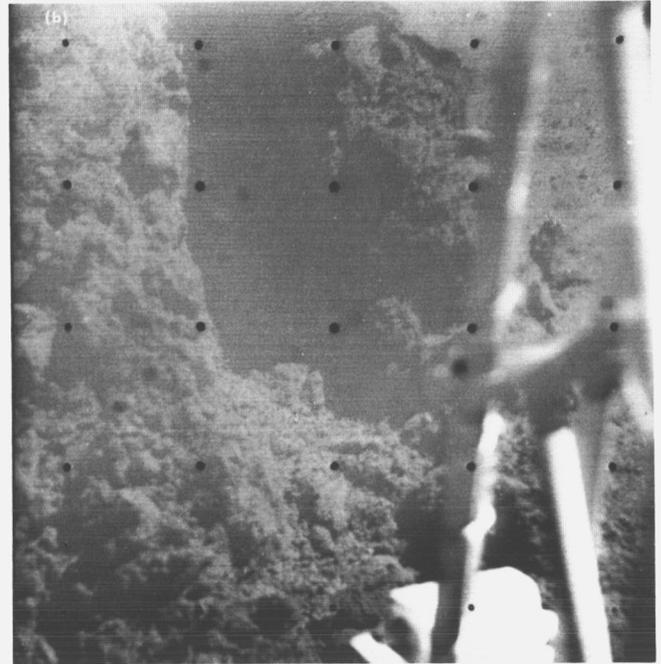
**Fig. III-41. Narrow-angle Surveyor III pictures of SMSS trench observed on Day 114: (a) through  $\bar{x}'$  filter (red), 05:19:23 GMT; (b)  $\bar{y}'$  filter (green), 05:15:18 GMT; and (c)  $\bar{z}'$  filter (blue), 05:20:20 GMT**

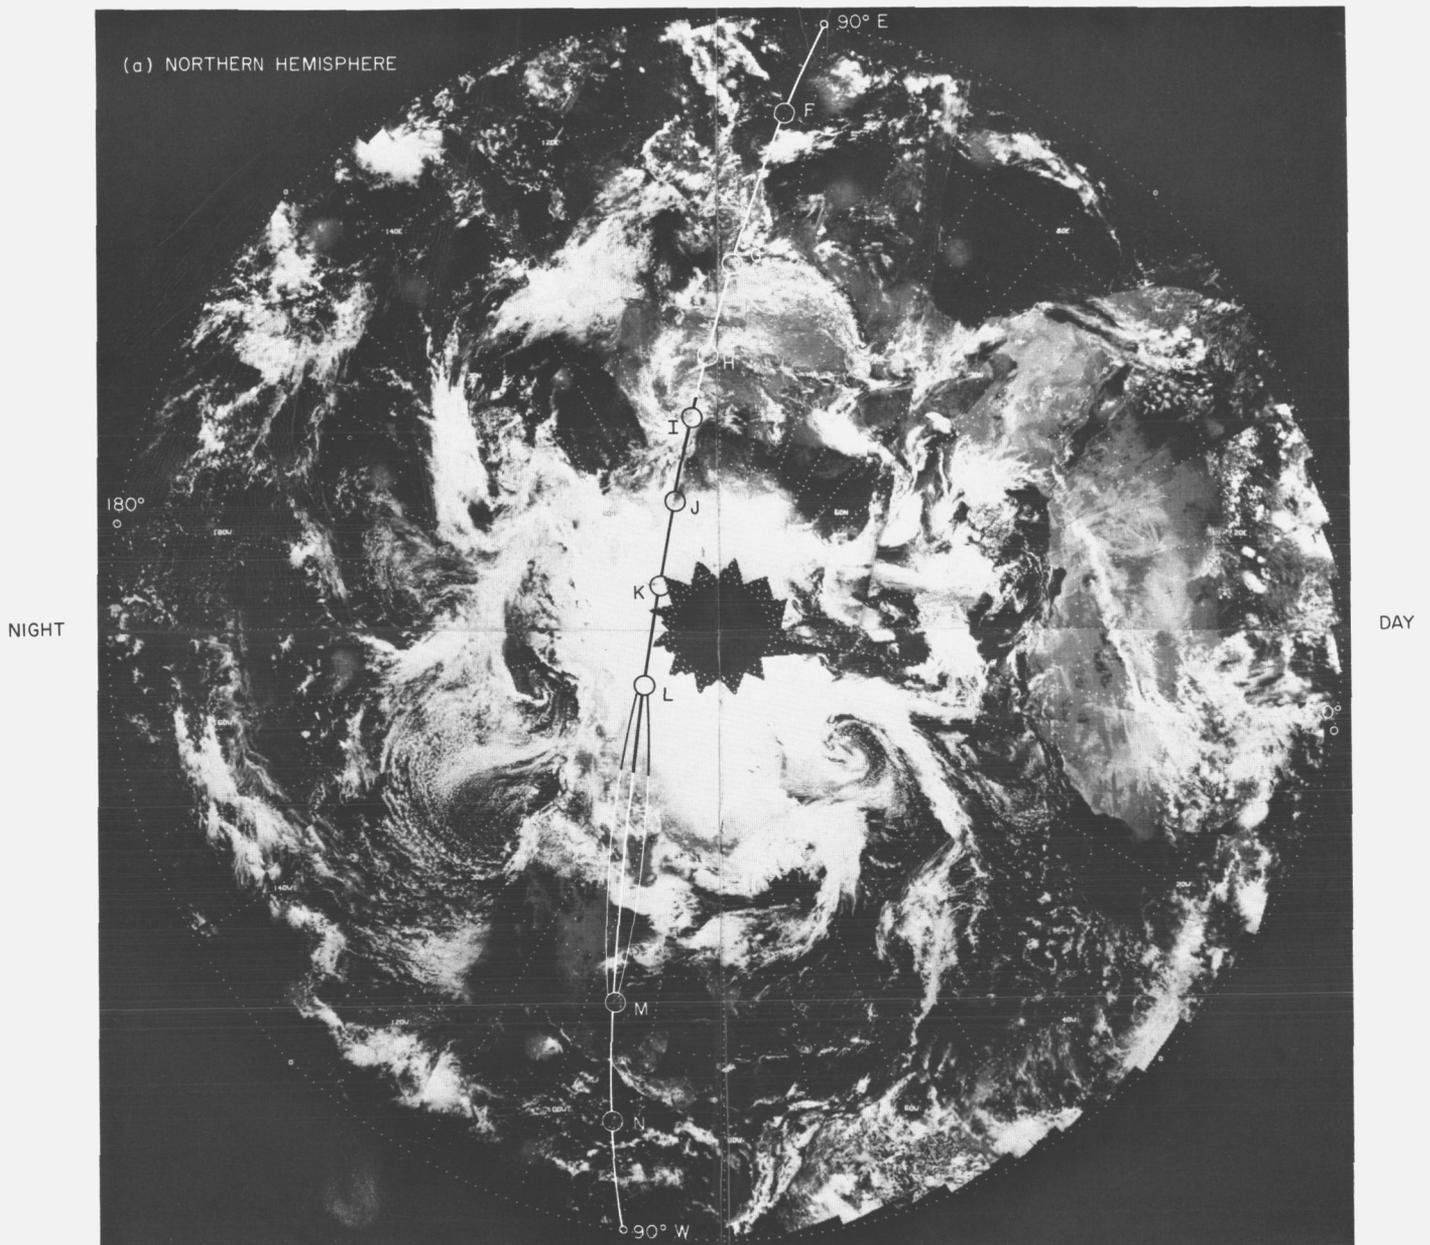
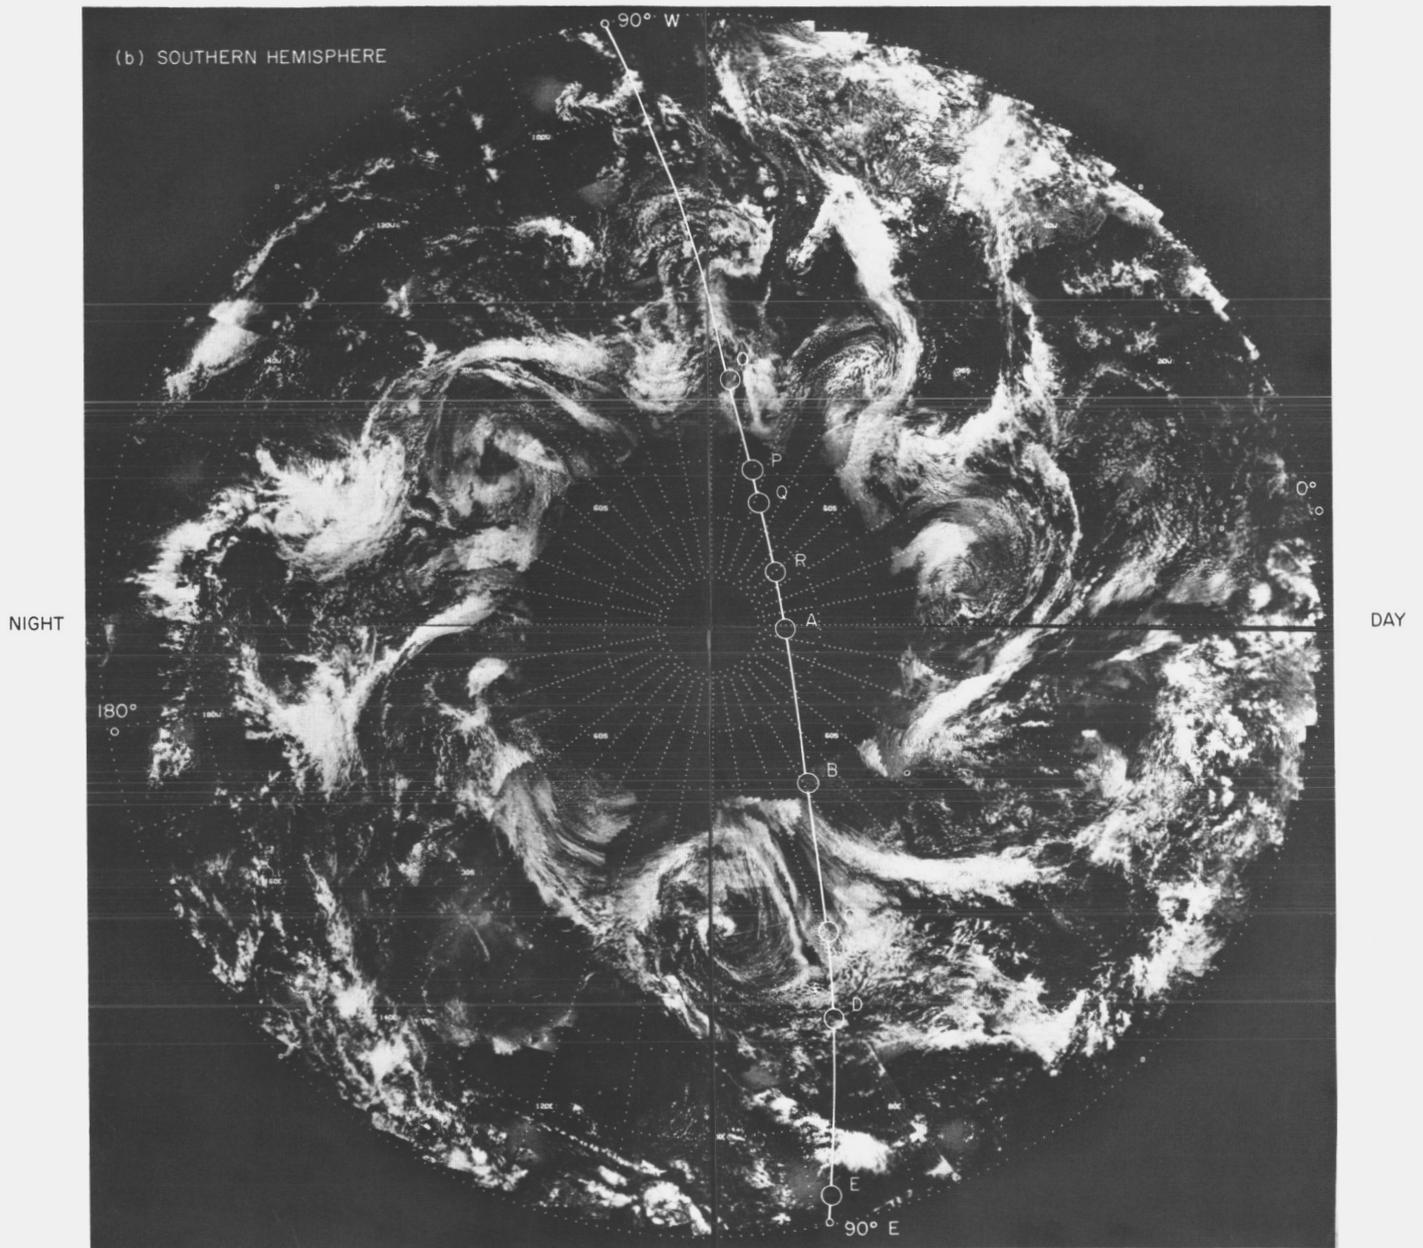
Fig. III-44 (contd)

**Fig. III-44. Stereographic mosaics of ESSA 3 pictures of (a) northern and (b) southern hemispheres of the earth. Pictures taken on the day preceding the eclipse. Bright areas are clouds and, in mountainous regions and the Arctic, snow fields; dark areas are clear. Note position of African continent, which may be seen in the clear areas on right-hand side of (a). Trace of limb of earth, as seen from the moon, and positions of beads and the bright region in the refraction halo of the earth observed in the second series of eclipse pictures taken by *Surveyor III* are shown by the white circles and lines that extend from 90° west to 90° east. Beads occur in areas that are largely clear. Letters beside symbols for beads correspond to letter identification of beads in Fig. III-43 (mosaic of ESSA 3 pictures provided through the courtesy of Dr. David S. Johnson, National Environmental Satellite Center, ESSA)**

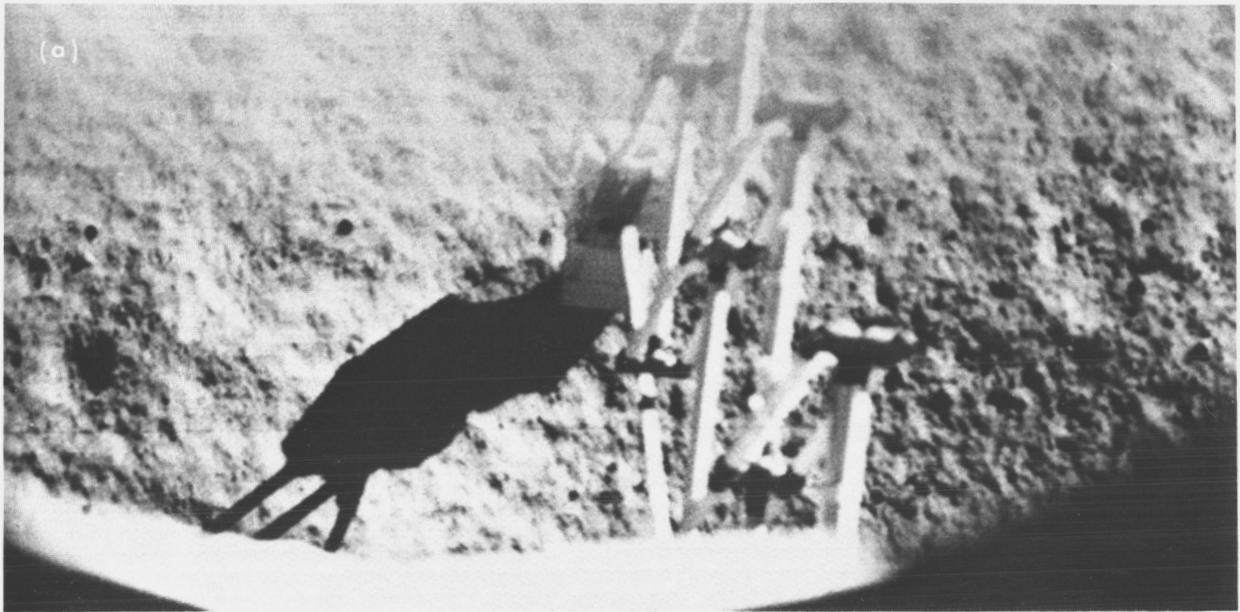
Fig. IV-24. Picture showing SMSS on Day 112:(a) before (05:07:01 GMT) and (b) after completion of first lunar surface bearing test (05:17:27 GMT)

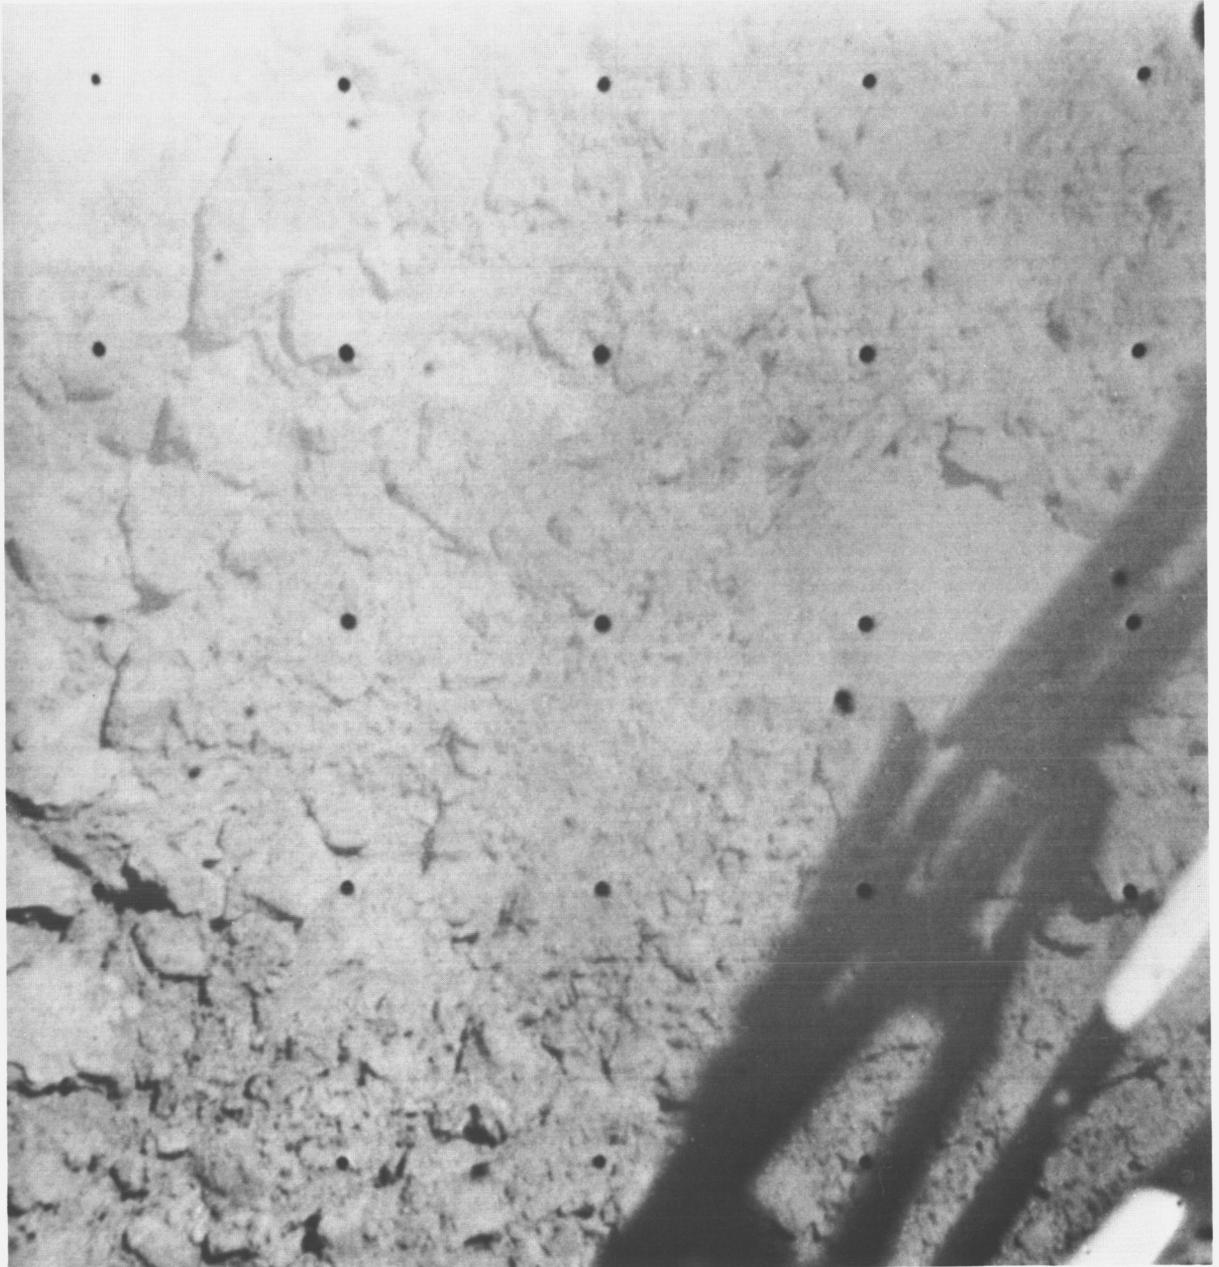
**Fig. IV-30. Bearing test 4 impression in bottom of trench 3 at a depth of 5.1 to 7.6 cm below lunar surface. Depth of impression estimated from shadow. Broken-up soil from trenching operation is visible (Day 118, 13:35:22 GMT)**

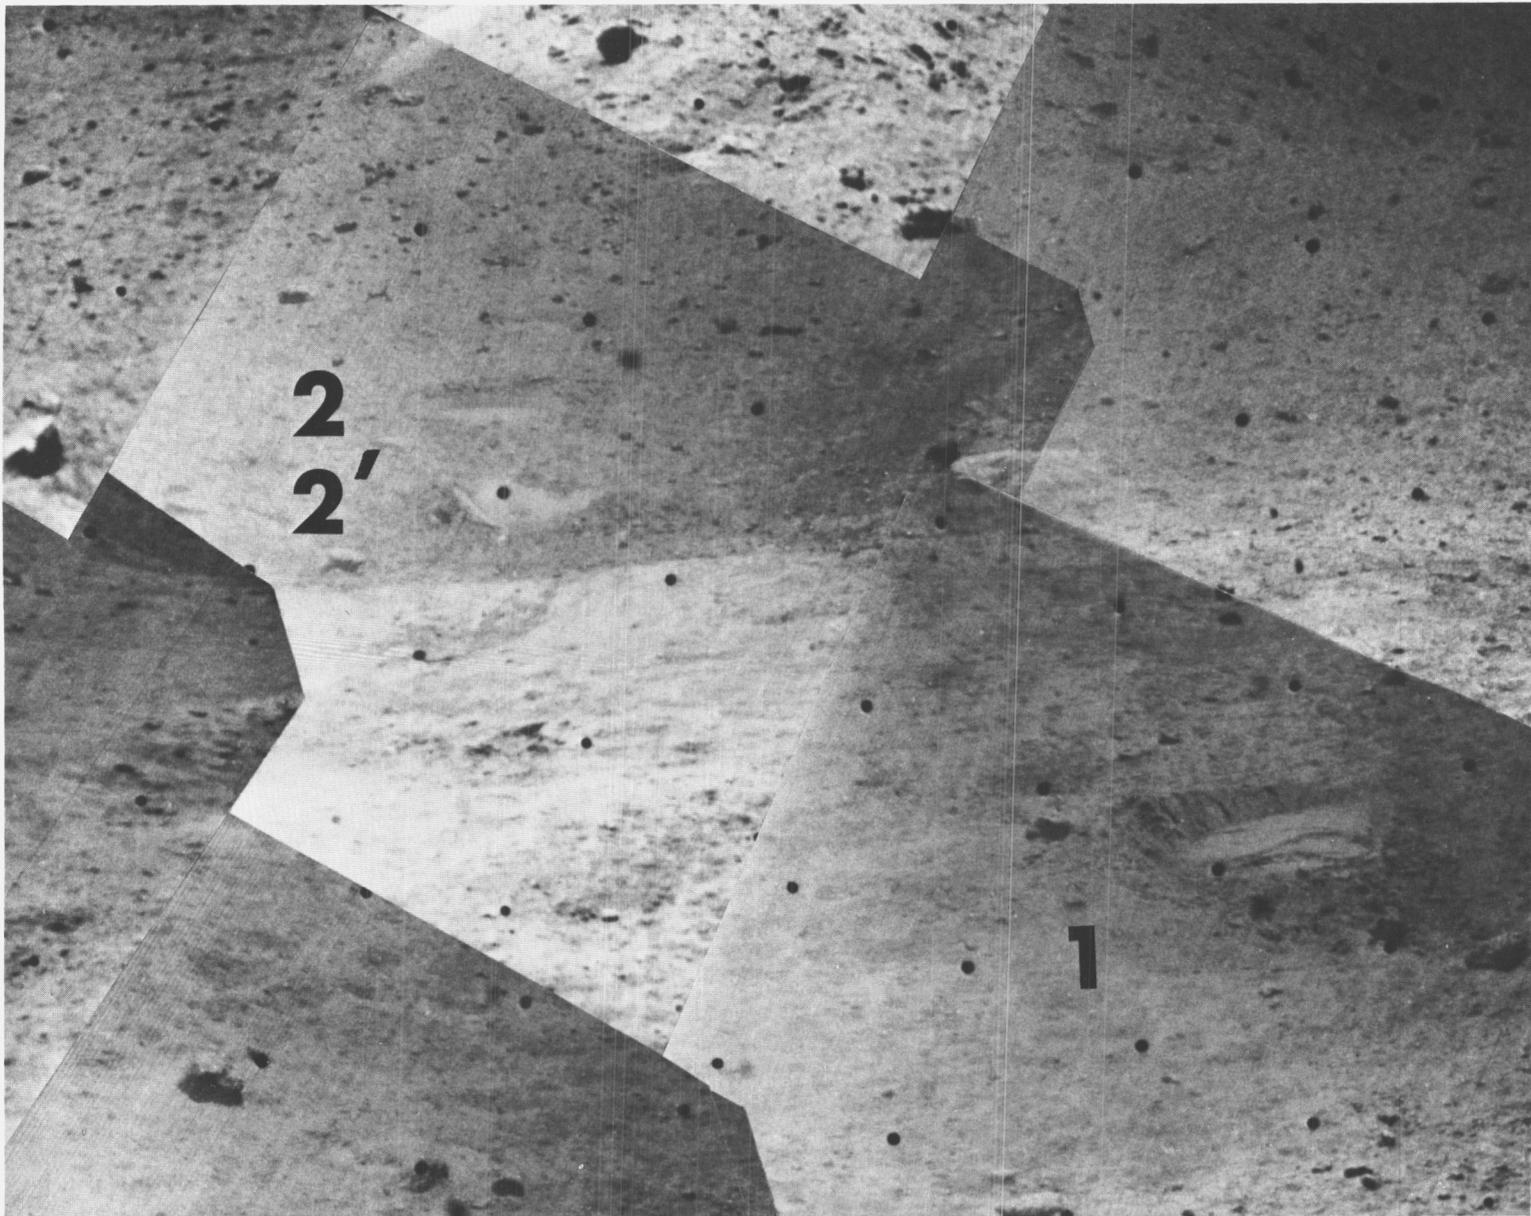
Fig. V-26. Narrow-angle picture of landing event 2 imprints of footpads 1 and 2. This figure is an enlargement of portion of Fig. V-10 (Day 116, 08:37:36 GMT)

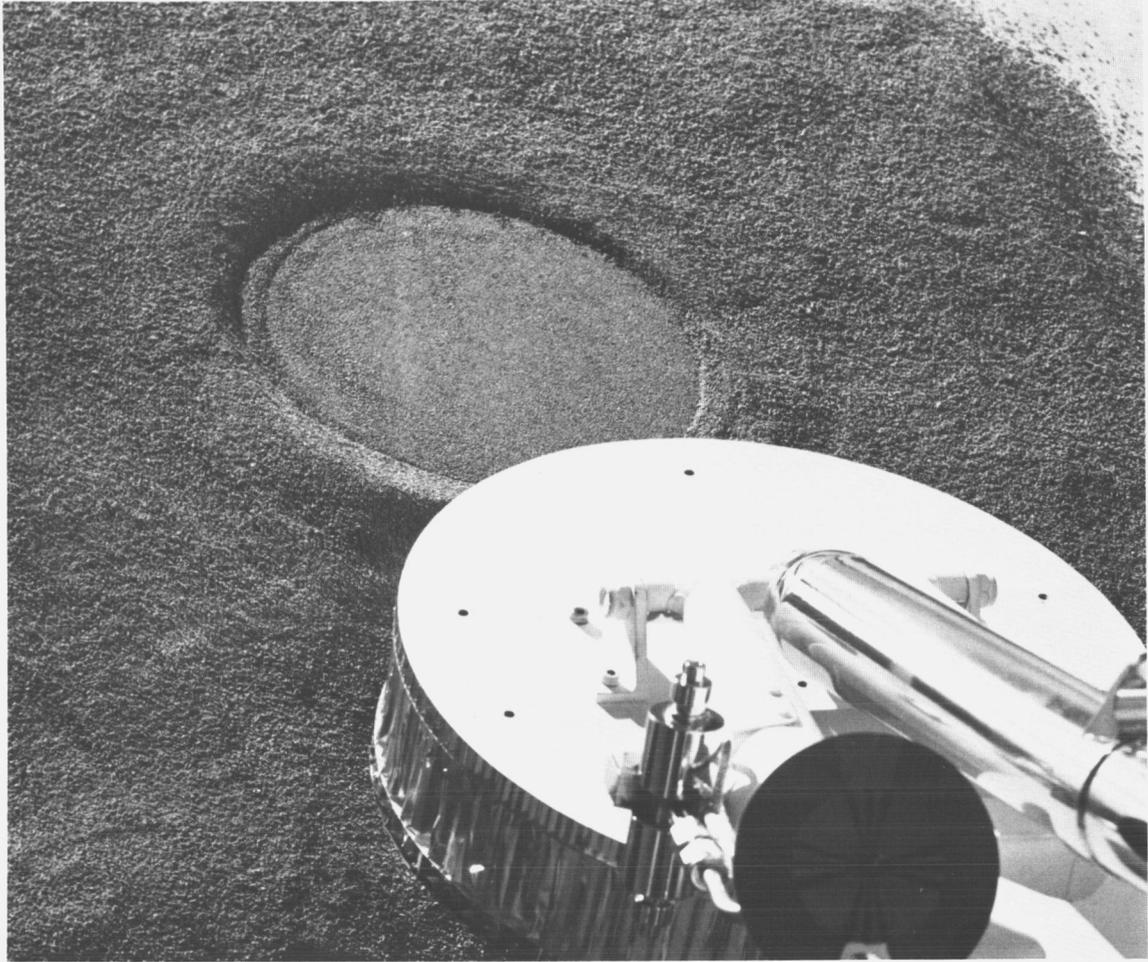
**Fig. V-29. Laboratory simulation of footpad and imprint, made on earth with full-scale model of Surveyor. Surface material: crushed basalt, particle size in sand range only. Lighting angle similar to that of Fig. V-8**
