NATIONAL AERONAUTICS AND SPACE ADMINISTRATION

*Technical Report 32-1150*

*A 2000°F Lithium Erosion and Component  
Performance Experiment*

**JET PROPULSION LABORATORY  
CALIFORNIA INSTITUTE OF TECHNOLOGY  
PASADENA, CALIFORNIA**

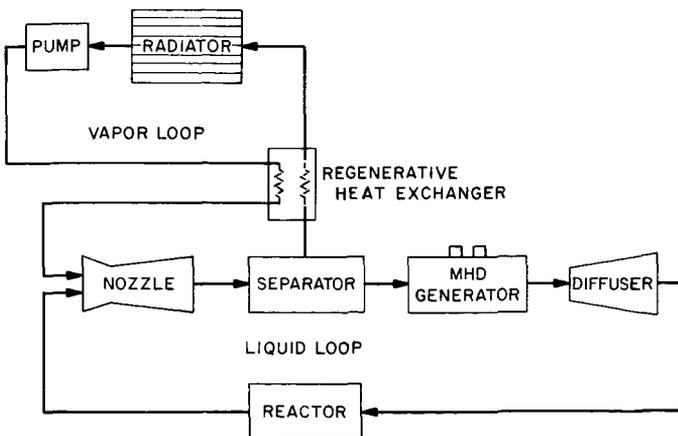
Fig. 1. Liquid MHD power conversion system

separates from the lithium in the separator, and returns to the radiator through the regenerative heat exchanger. The lithium leaves the separator at high velocity (typically 500 ft/s), decelerates through the production of electric power on the MHD generator, and leaves the generator with sufficient velocity (typically 300 ft/s) to return through a diffuser to the reactor (or reactor-loop heat exchanger) where the lithium is reheated.

The separator component utilizes the inertial forces of the impinging, high velocity, lithium droplets for separation from the cesium vapor and coalescence into a coherent stream. The successful operation of this component has been demonstrated with high velocity nitrogen-water mixtures (Ref. 1). However, some erosion of separator materials has been observed for these non-corrosive fluids at velocities lower than the final liquid metal system (Ref. 2). The combined corrosive and erosive environment of high velocity lithium at the temperature of interest ( $\sim 2000^\circ\text{F}$ ) is a problem which must be resolved for long term system operation.

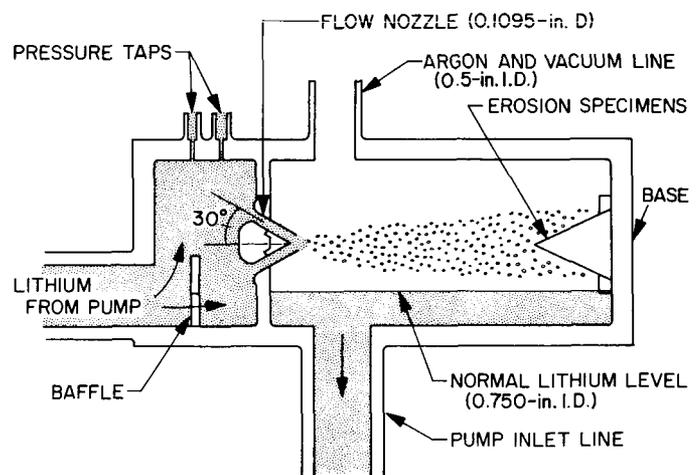
Fig. 3. Schematic of lithium erosion test section

The test section geometry is illustrated in Fig. 3. Lithium flowing from the pump at high pressure entered the upstream section through a flow baffle. The flow was accelerated through two impinging flow nozzles to high velocities and formed a stream of droplets or a submerged jet which impinged upon five wedge-shaped test specimens.

The test materials were Cb-1%Zr, W-2%ThO<sub>2</sub>, TaC, TiC, and ZrC. They were retained on a base by a tack-welded Cb-1%Zr holder. The carbides were fabricated from high purity powder by vacuum hot pressing at about 1700°C. Spectrochemical analyses of these carbides after pressing indicated a slight carbon deficiency from the stoichiometric amount. This is contrasted to the powder analysis which indicated about 5% free carbon. The carbon deficiency was probably caused by reaction of the carbon with residual oxygen and carbon monoxide during the hot pressing operation. The principal impurities present and their percentages were silicon, 70 ppm, nitrogen 40-70 ppm, and oxygen 380-720 ppm. The Cb-1%Zr and W-2%ThO<sub>2</sub> conformed to accepted purity standards for liquid metal usage: oxygen < 300 ppm, nitrogen < 200 ppm, carbon < 300 ppm, hydrogen < 15 ppm.

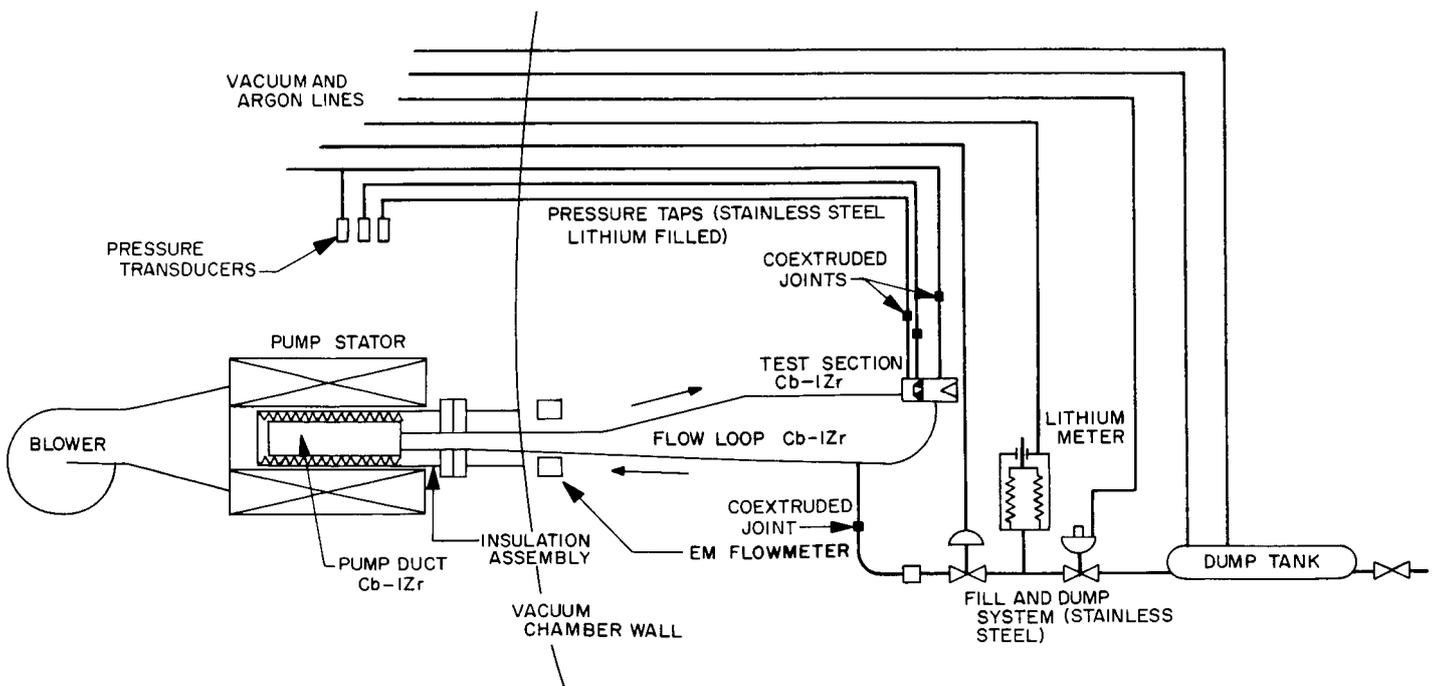
Fig. 4. Schematic of lithium erosion test loop

The primary flow loop and test section were fabricated of Cb-1%Zr alloy which requires a vacuum or inert gas atmosphere for operation at 2000°F. A schematic diagram of the flow circuit and auxiliary lines is shown in Fig. 4. Lithium was introduced to the test loop through two air actuated valves and a sintered stainless-steel filter. The lithium volumetric meter shown in Fig. 4 was used initially but proved to be unsatisfactory. A lithium-argon level was maintained in or above the test section and the rest of the loop was filled with lithium. Activation of the helical induction pump produced a flow of up to 11 gal/min of lithium through the flow meter section to the test section at a maximum pressure of 270 psia. Acceleration of the lithium to a maximum velocity of 270 ft/s in the two impinging flow nozzles was accomplished by maintaining the argon back pressure at about 25 psia. After impinging on the test specimens, the lithium was returned through the 1.0 in. OD pipe to the pump. Photographs of the loop before welding and after final installation are shown in Figs. 5 and 6.

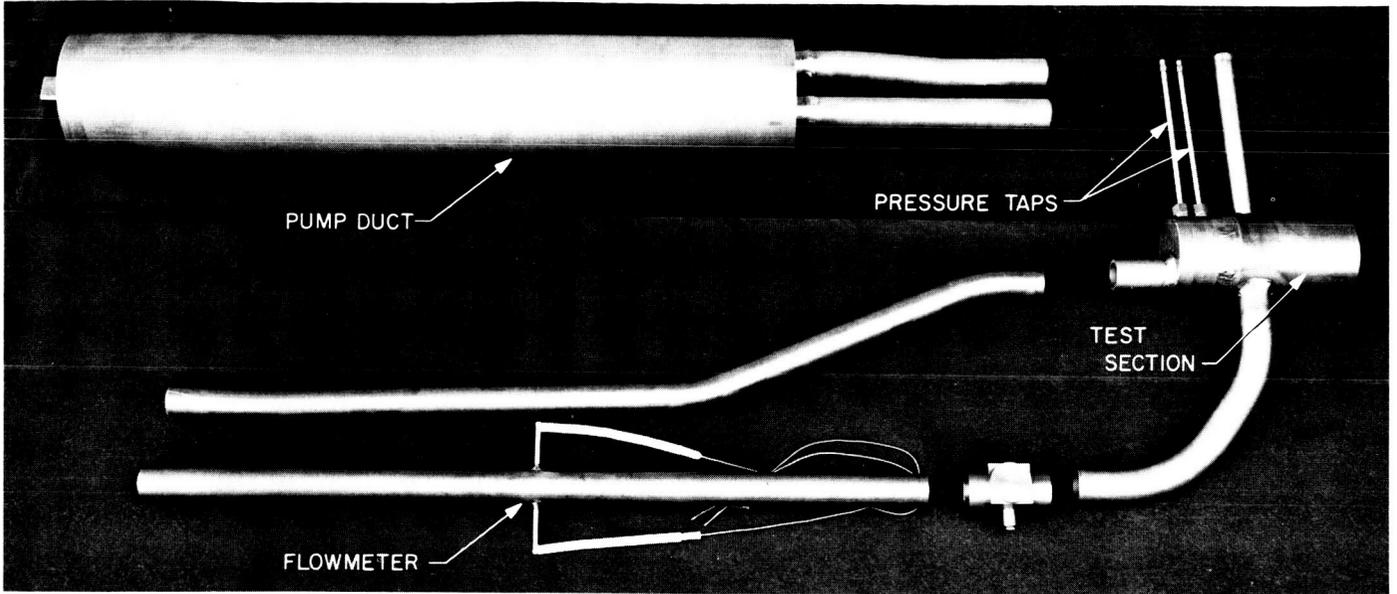
Fig. 5. Test loop before welding

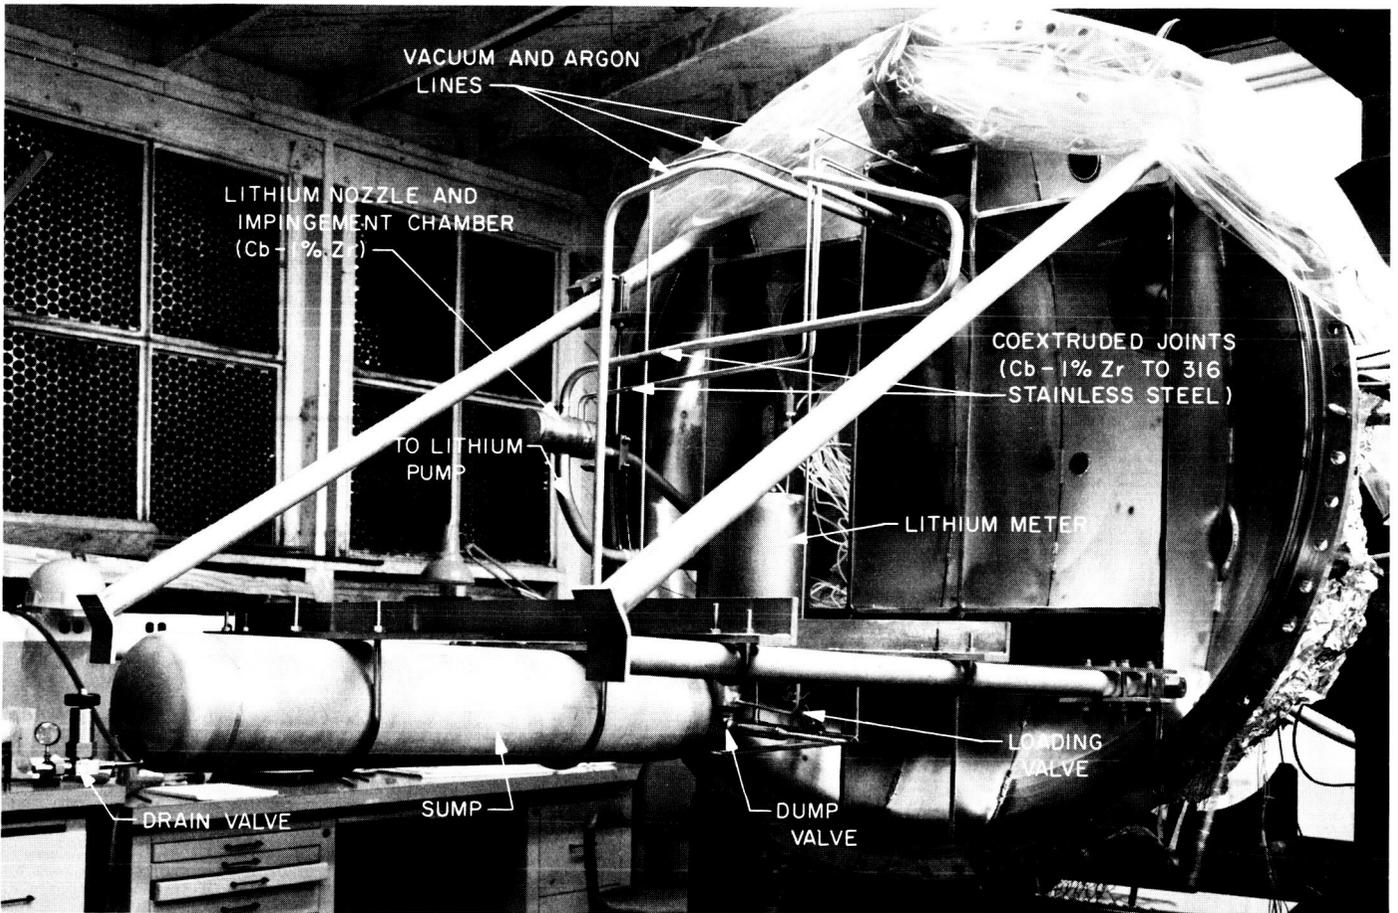
Fig. 6. Lithium erosion loop installed on door of vacuum chamber

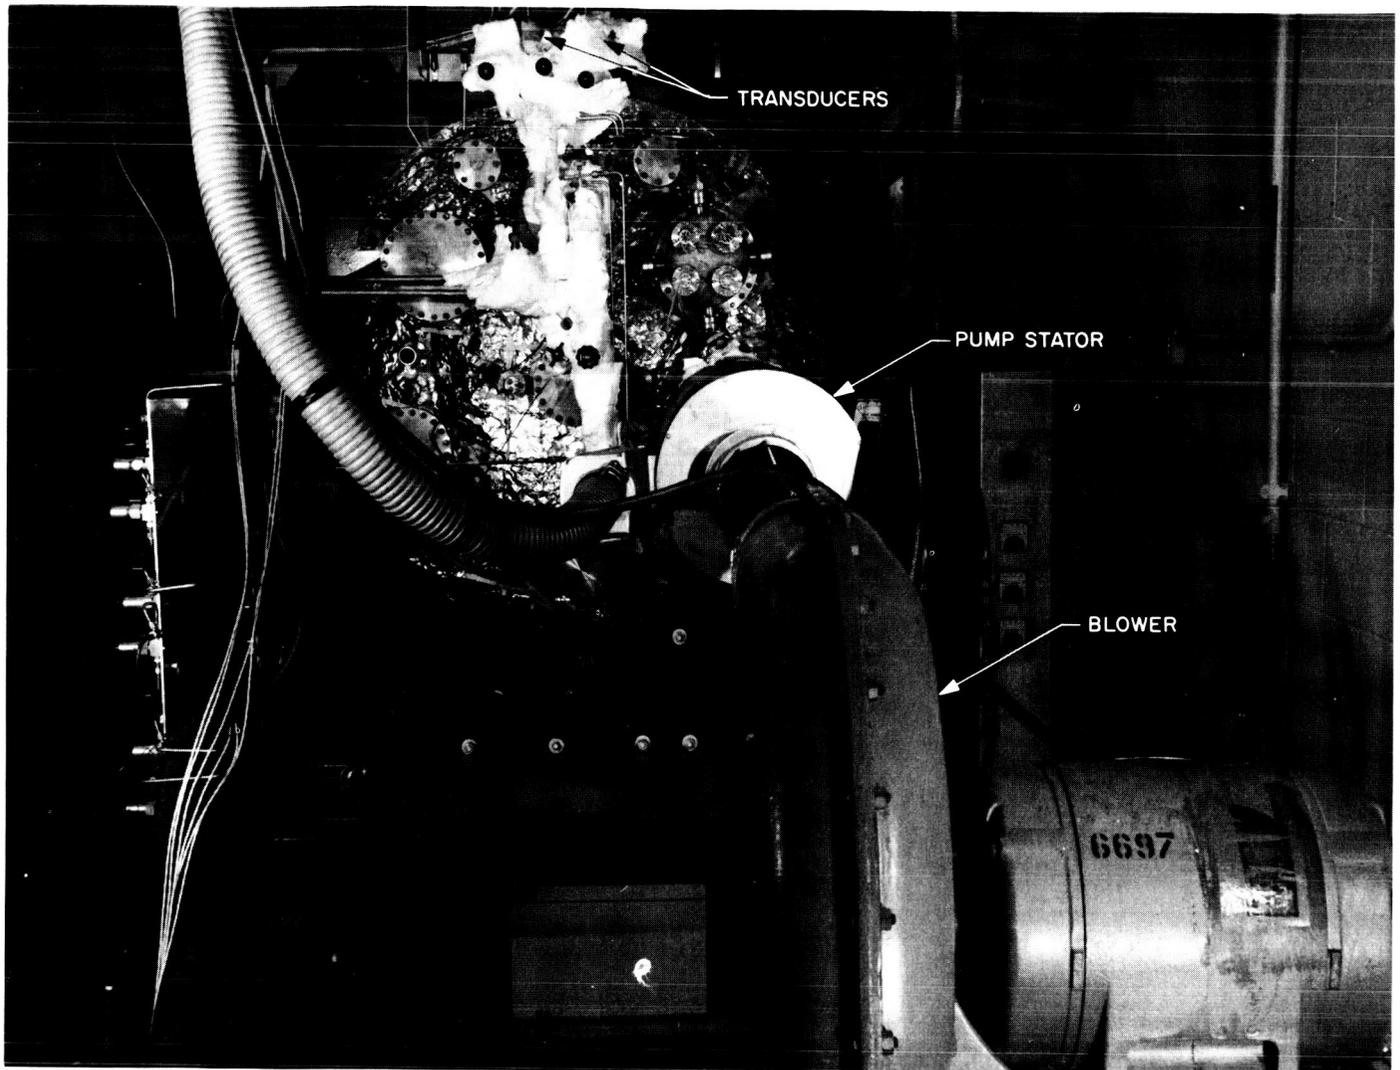
**Fig. 7. Helical induction pump stator and blower**

The most complex component of the flow loop was the helical induction electromagnetic pump supplied by General Electric Company. The design point for this pump at 2000°F is 270 psi pressure rise at a lithium flow rate of 16 gal/min. Basically the pump consisted of a Cb-1%Zr flow duct, an insulation assembly, and a three-phase stator. The insulation assembly in which the columbium alloy duct was contained served as an extension of the vacuum chamber. The stator was positioned on the outside of the insulation assembly and was air-cooled as shown in Fig. 7. For this test the pump also served as the heater. The test loop was designed so that the radiant heat loss at 2000°F would be equal to the induction heat input of the pump (~25 kW) at its design point. The radiant heat transferred from the loop was absorbed by cooling air circulating on the outside wall of the vacuum chamber.

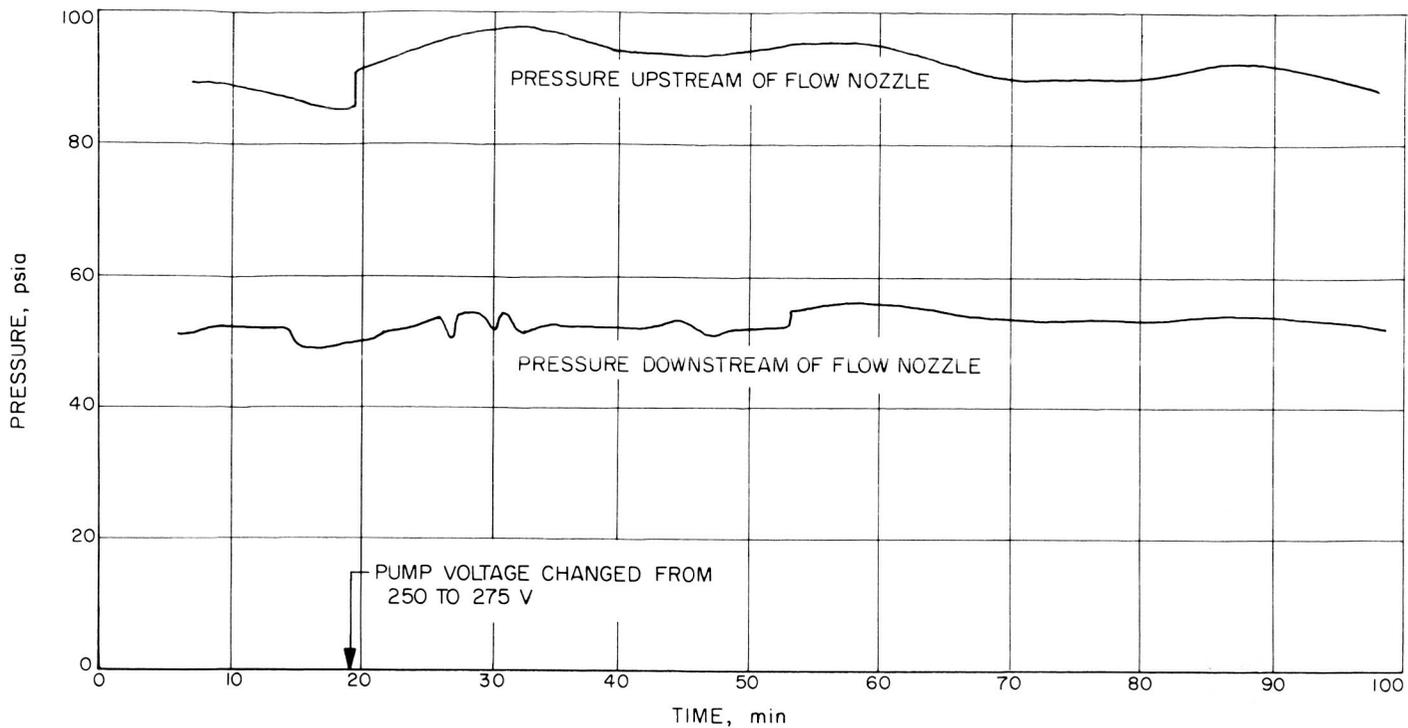
**Fig. 9. Lithium loop pressures as a function of time**

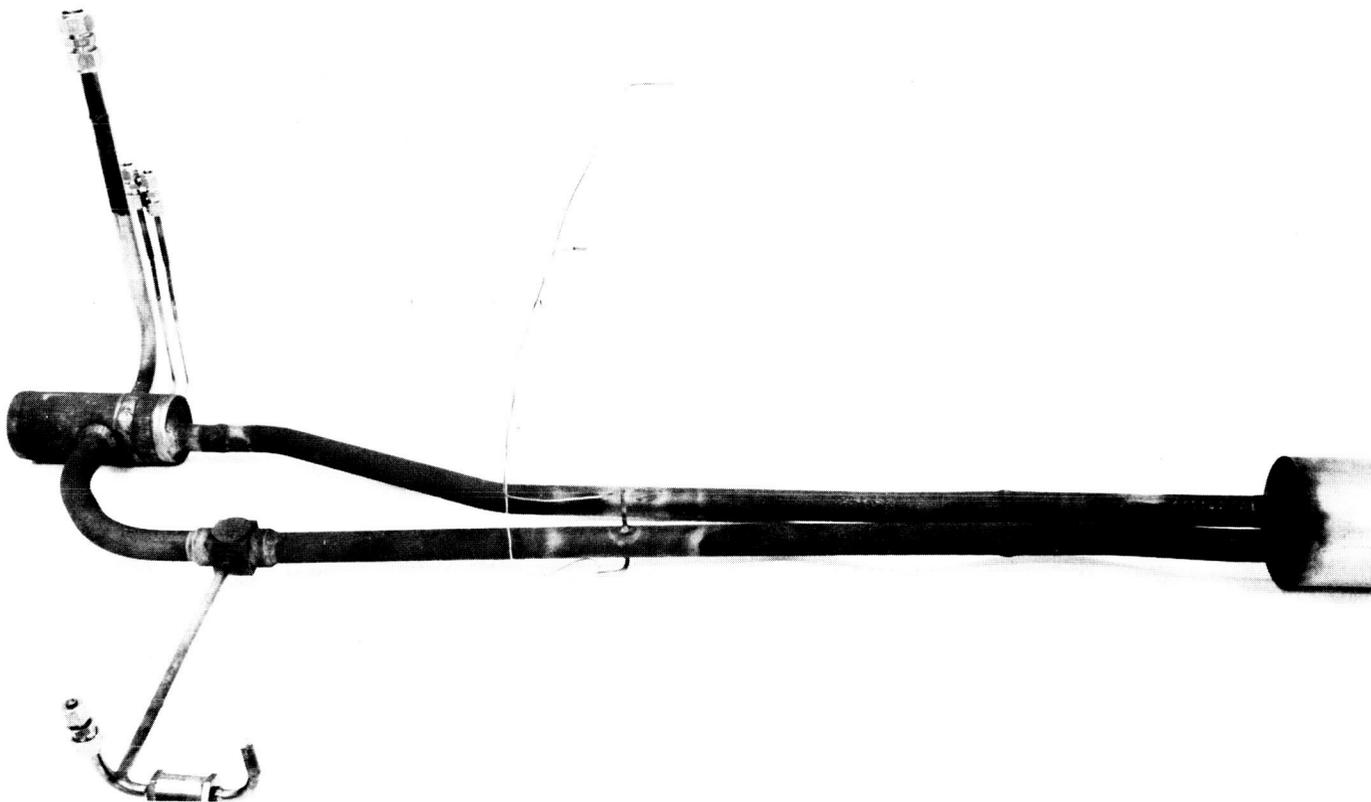
**Fig. 10. Lithium test loop after oxidation at 1700°F**

overheating of the copper gasket at this location. A rapid shutdown was made but the loop was severely oxidized. Figure 10 is a view of the test loop after this event.

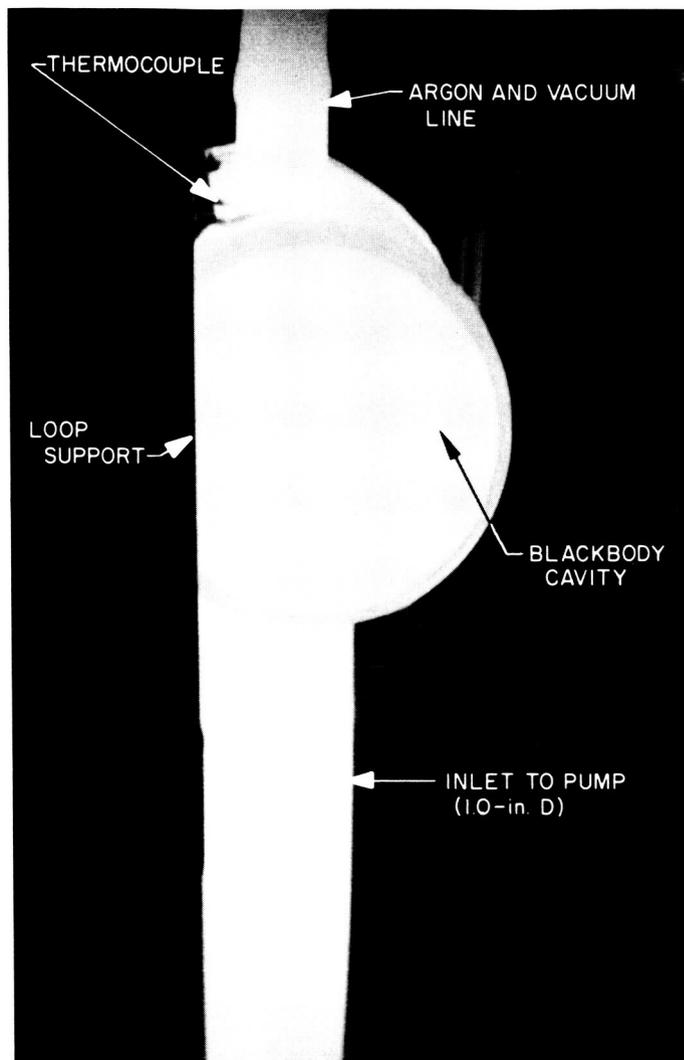
Fig. 11. Lithium test section at 1700°F

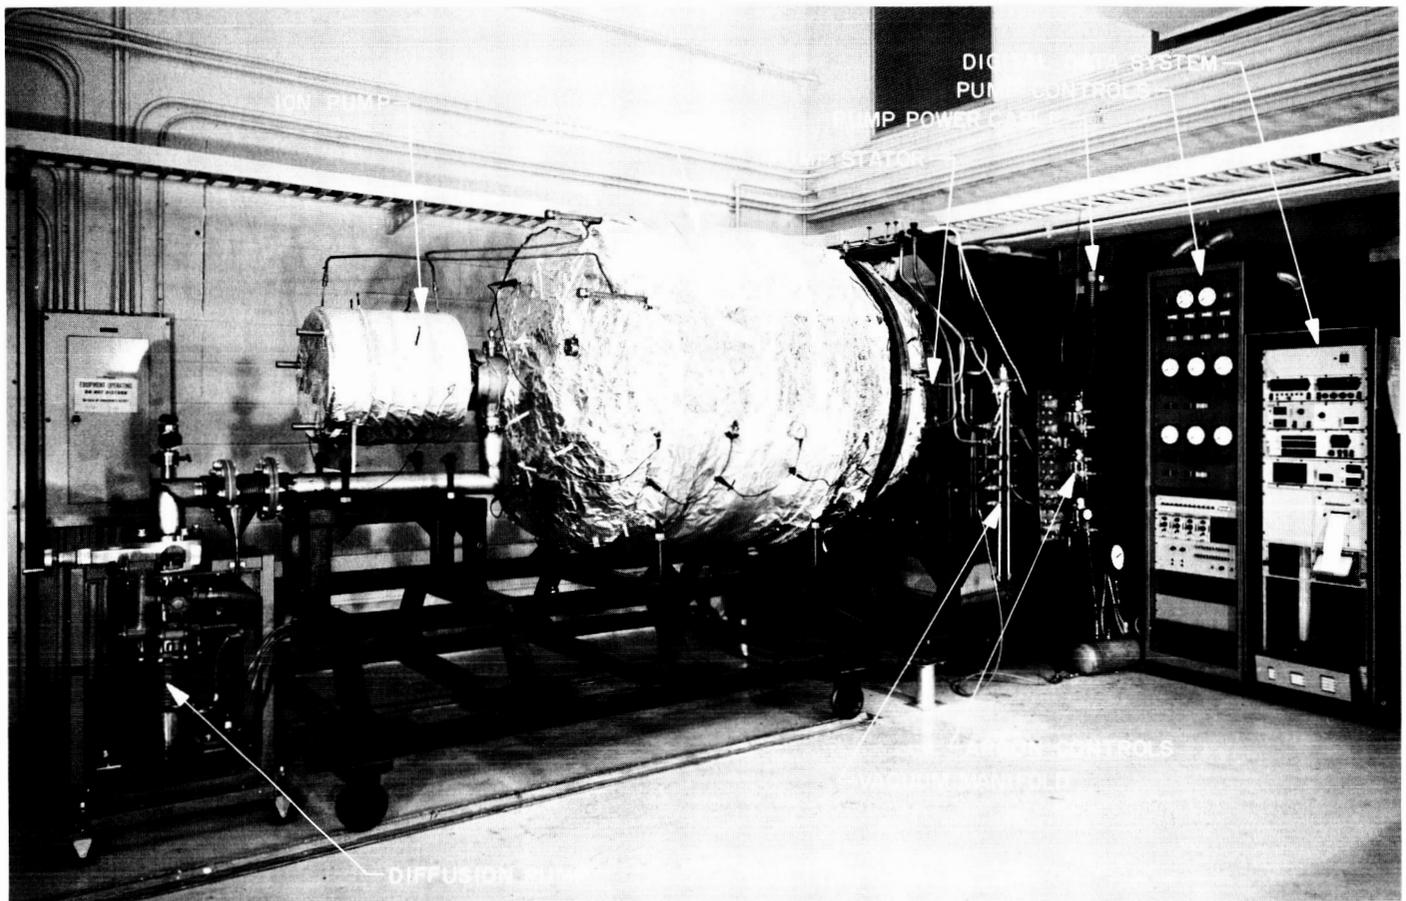
Fig. 8. Lithium erosion test facility

The vacuum chamber door formed the structural mounting for all test loop components. The chamber body, getter-ion pump and diffusion pump were installed on tracks for easy access to the test loop. The containment system, which is shown in Fig. 8, utilized all-metal

seals, except for the door O-ring which was Viton-A with water cooling. The vacuum chamber was traced with heaters and cooling lines. This enabled the chamber body to be maintained at 400–500°F during the test, eliminating the need for trace heaters on the loop to keep the lithium molten. The getter-ion pump, which was manufactured by General Electric Company, had a capacity of 1000 liter/sec. The Heraeus-Englehard diffusion pump, which was used for operation in the  $10^{-3}$  to  $10^{-4}$  torr range, had a capacity of 800 liter/sec.

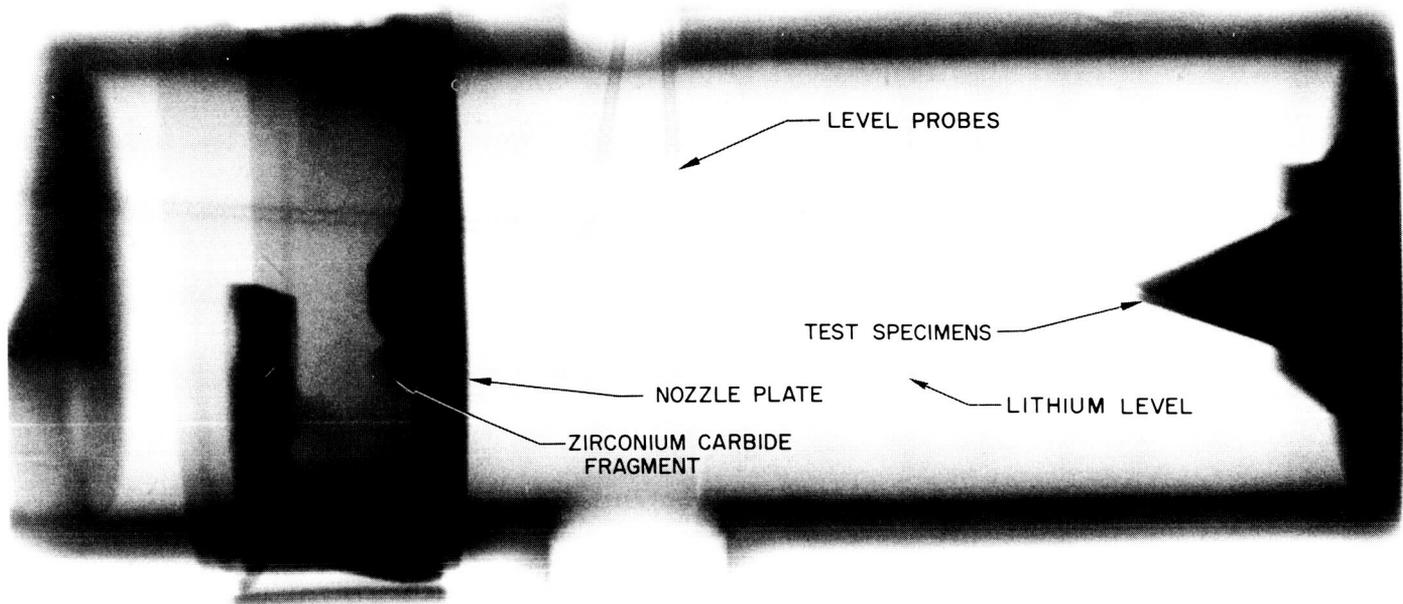
Fig. 12. Radiograph of test section showing plugged nozzle

examination revealed the source of this disturbance to have been a piece of one of the test specimens which had broken off, circulated through the loop, and plugged one of the nozzles. Figure 12 is a radiograph of the test section taken after the test showing the piece of zirconium carbide plugging the nozzle.

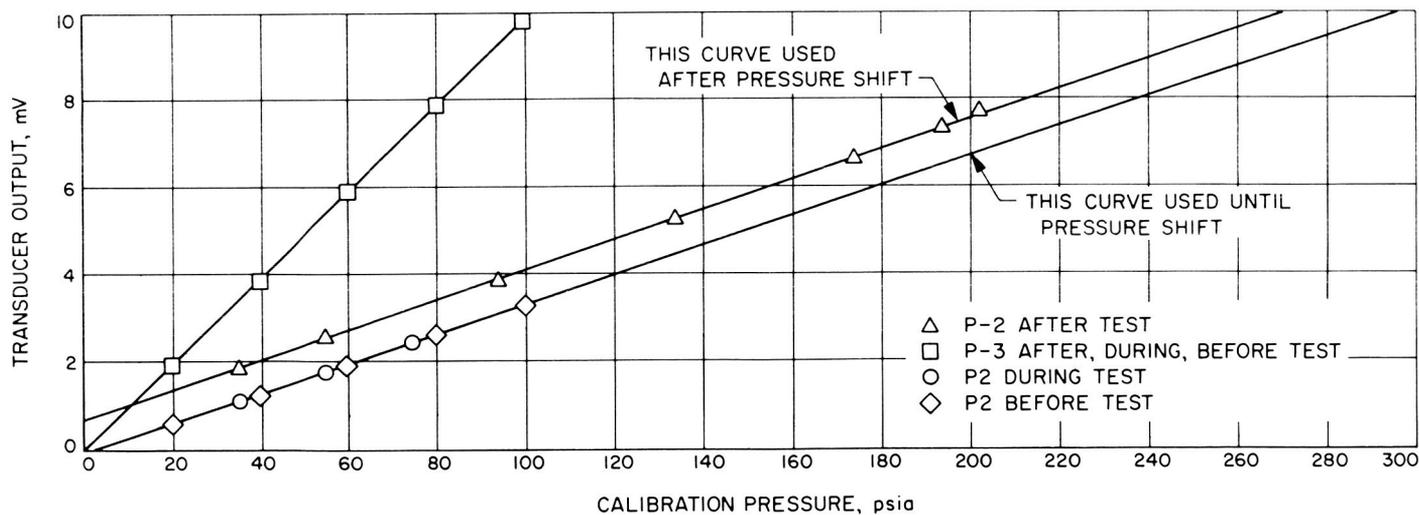
Fig. 13. Pressure transducer calibration curve

wards, so no loss of accuracy was encountered. The transducer outputs were linear and repeatable to within the reading uncertainty of about 1/2% of full scale for the calibrated Bourdon gauge used as the standard.

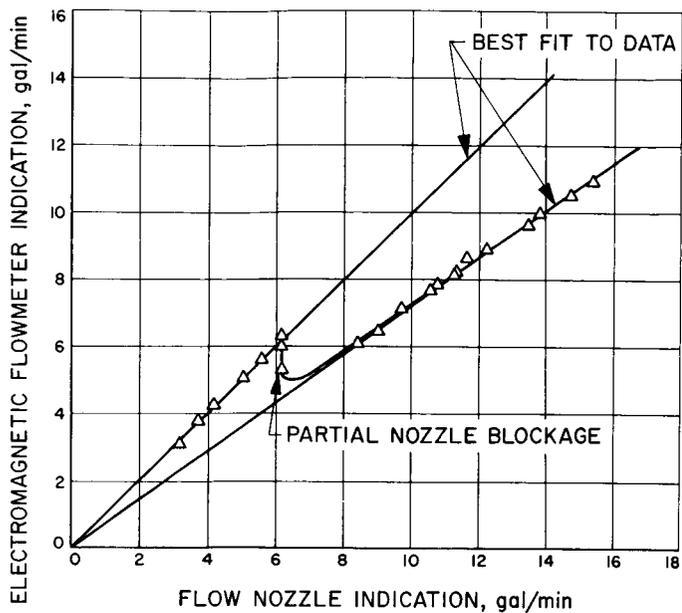
Fig. 14. Electromagnetic flowmeter calibration curve

The flowmeter was calibrated using the transducer readings and the known discharge coefficient of the flow nozzles (0.930); Fig. 14 compares the flowrate indicated

by the electromagnetic flowmeter output using the curve supplied by the manufacturer with the flow indicated by the flow nozzle. Agreement to within 1% of the full scale readings was seen until the nozzle blockage described above occurred. The linearity of the curve before and after blockage and the zero origin of both curves lend confidence to use of the flowmeter reading instead of the flow nozzle indication after blockage.

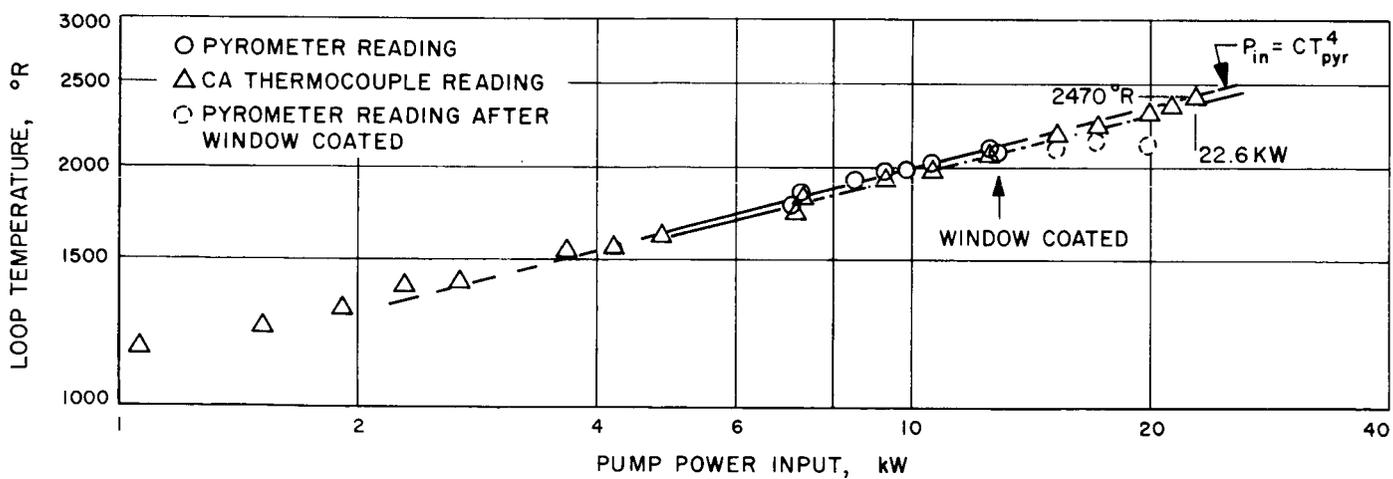
Fig. 15. Lithium temperature vs pump input power

The dependence of lithium temperature on the power input to the induction pump is shown in Fig. 15. As expected, the temperature is proportional to the  $\frac{1}{4}$  power of the input power at higher temperatures. The maximum temperature of 2010°F was attained with a power input of 22.6 kW.

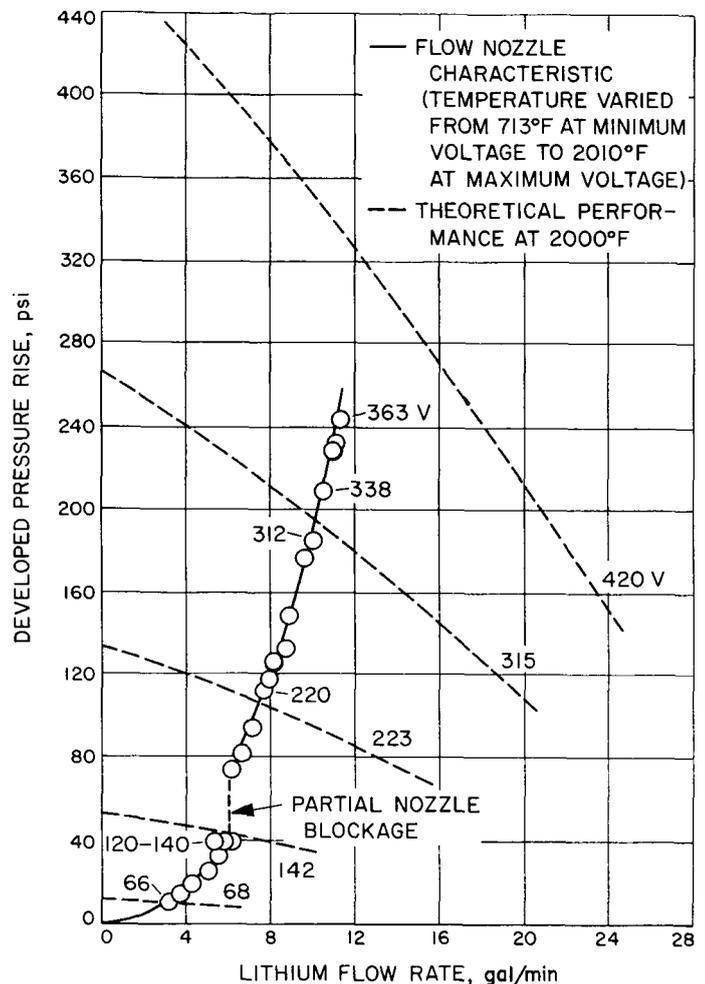
Fig. 16. Performance of lithium pump

The helical induction pump provided completely satisfactory performance for the duration of this test. The output was smooth and controllable and conformed closely to the manufacturer's predictions. In Fig. 16 the relationship between measured pressure rise and lithium flow is superimposed on the calculated pump characteristic curves of pressure rise vs flowrate. The test points for 66 V, 140 V, 220 V and 321 V fall close to the theoretical curves for 68 V, 142 V, 223V, and 315 V, respectively. Since the nozzles had a fixed area and no valves were used it was not possible to vary the flow rate at constant voltage for a full comparison with the curves. The maximum pressure rise was 244 psi with an input voltage of 363 V. The applied voltage and pressure rise limit was

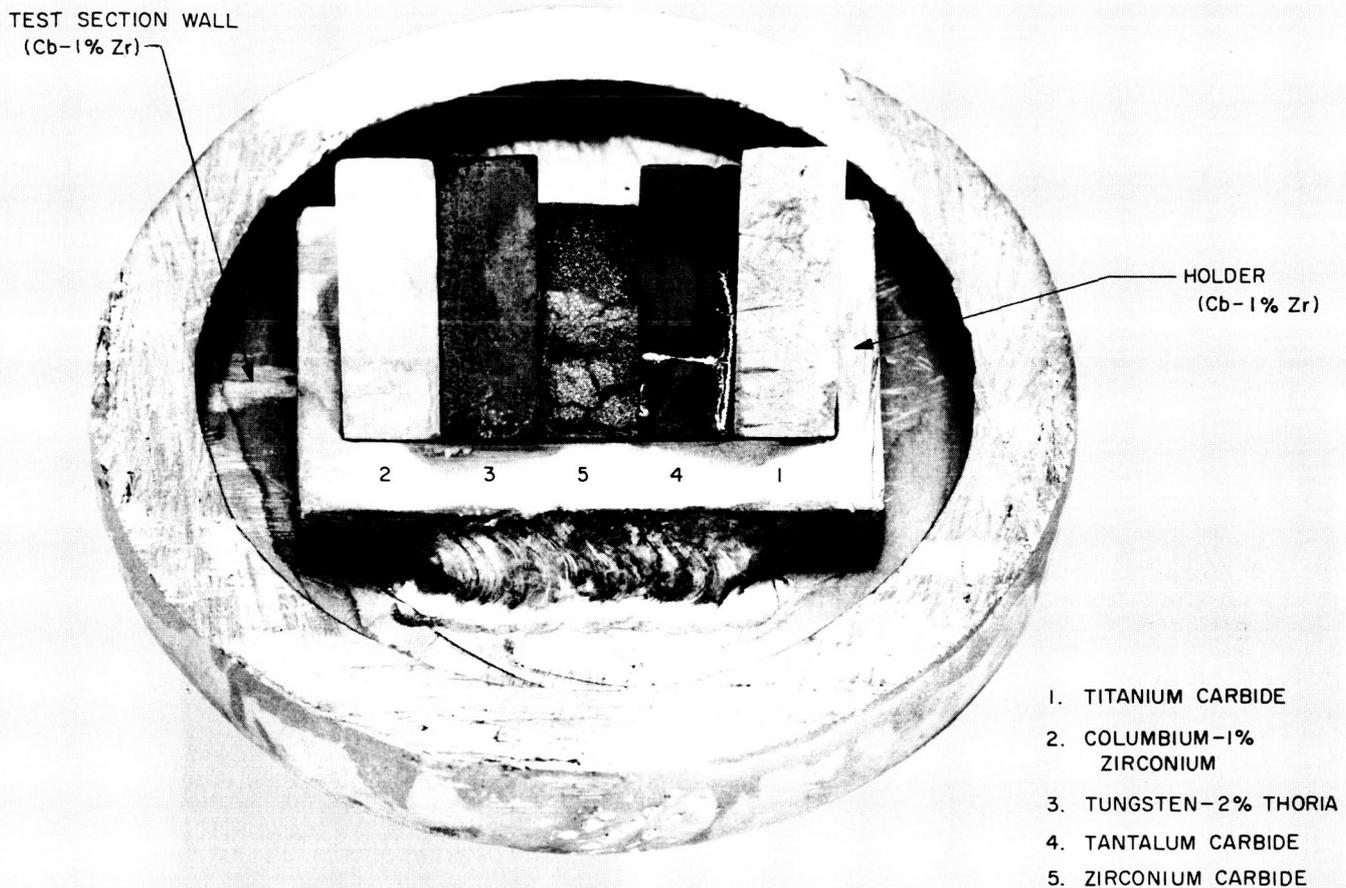
**Fig. 17. Erosion test specimens after exposure to high-velocity lithium for 100 hr at 2000°F**

The effects of high velocity lithium impingement on the test materials may be seen in Fig. 17. The only material which was relatively unaffected by 100 hours of exposure was Cb-1%Zr, which is number two in the figure. The thoriated tungsten specimen, number three, lost about 60 mils of material from the tip and was discolored. Specimen number five, (zirconium carbide), lost the entire top portion of the wedge. In addition the surface was discolored and heavily cracked. The tantalum carbide, number 4, lost about 30 mils from the tip and was discolored and cracked. The smooth appearance of

the tip and post-test analyses show that the lithium reacted with the tantalum carbide. The remaining material, titanium carbide number 1, lost only a few mils from the tip but was heavily cracked and underwent damage on the inclined surface. The slightly greater mass flux of liquid to the center wedges may be a factor in their heavier damage. However, the impingement on the Cb-1%Zr specimen should have been identical to that on the titanium carbide, which was heavily damaged.

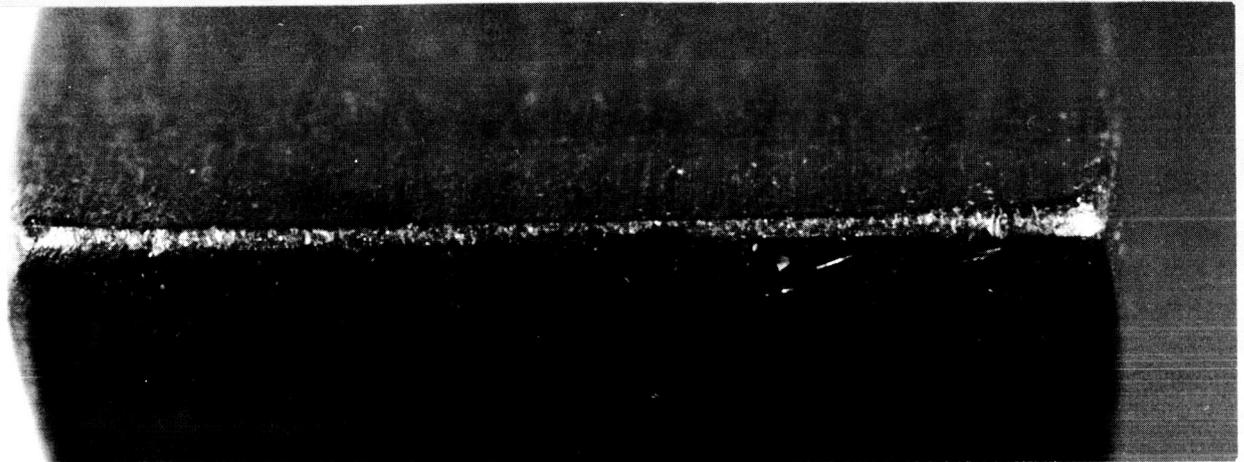
**Fig. 18. Columbium-1% zirconium wedge tip before and after exposure to high-velocity lithium for 100 hr at 2000°F**

Figures 18-22 provide magnified views of the tips of all the materials before and after exposure to lithium and Figs. 23-27 show the inclined face after exposure. The exception is zirconium carbide which only has the before view of the tip since massive failure occurred.

width of the tip to be the same. A small chip is missing which may have been due to an existing defect in the material. The grinding marks, although somewhat dulled, still are evident over the entire inclined surface.

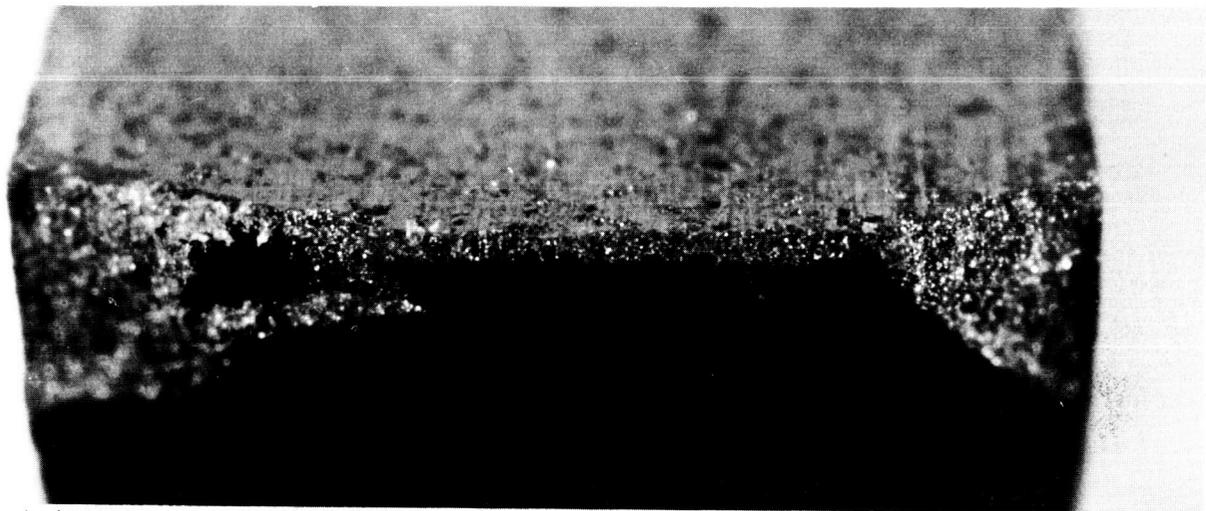
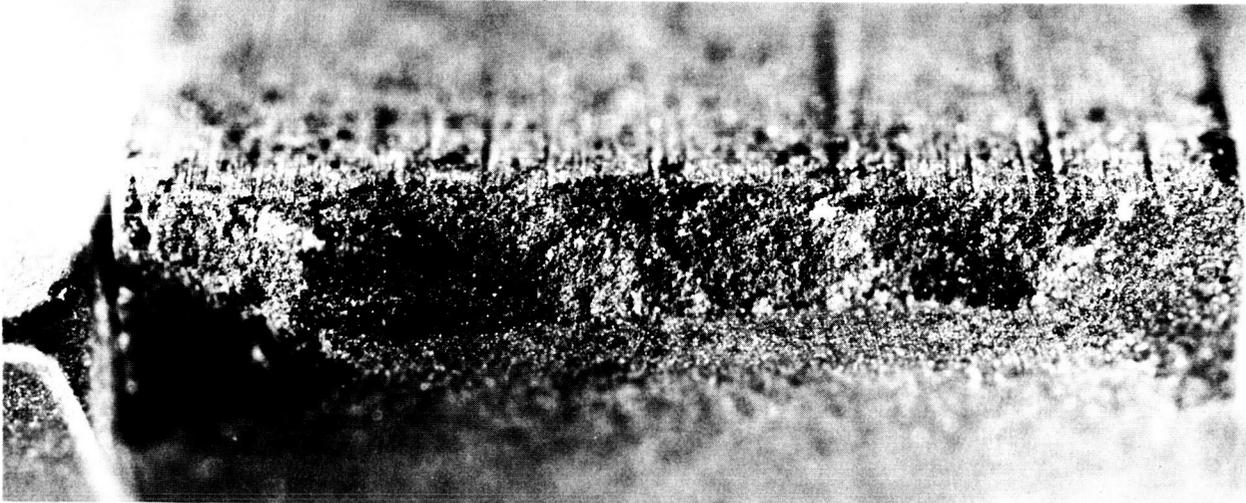
**Fig. 19. Tungsten-2% thoria wedge tip before and after exposure to high-velocity lithium for 100 hr at 2000°F**

The remaining structure of the W-2% ThO<sub>2</sub> specimen Figs. 19 and 24 has a jagged appearance, suggesting that the attack was predominately mechanical in nature. An electron micro-probe analysis of this specimen and the zirconium carbide specimen indicated the presence of tantalum on the discolored surfaces. The grinding marks exist to the broken surface.

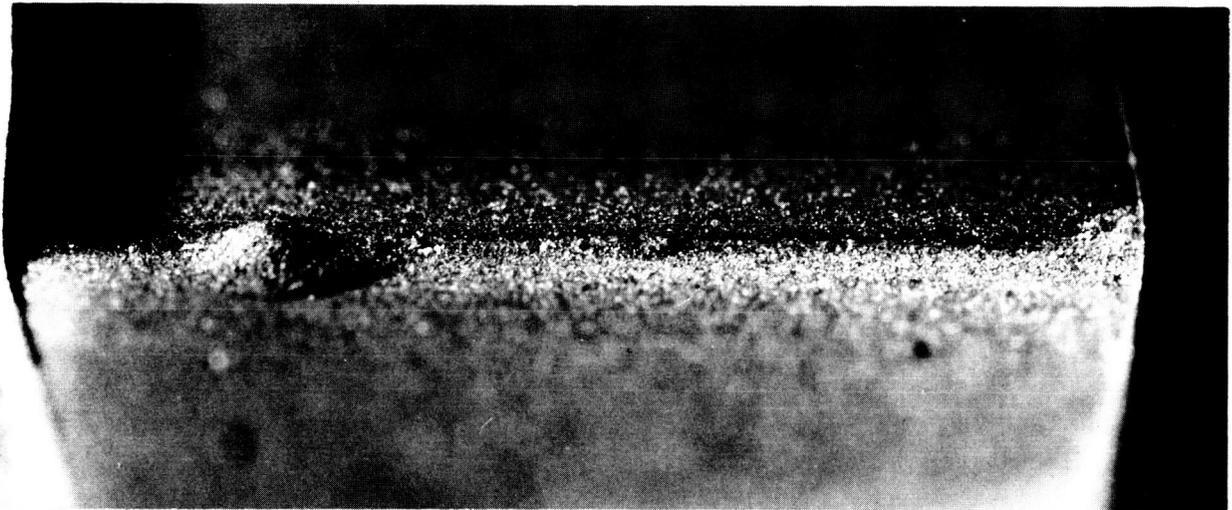
Fig. 21. Tantalum carbide wedge tip before and after exposure to high-velocity lithium for 100 hr at 2000°F

The tantalum carbide appeared to have reacted chemically with the lithium to give an overall dissolution of the material. Examination of Figs. 21 and 26 reveals a smoothed and rounded tip as opposed to the more jagged features of the tungsten or zirconium carbide. The high percentage of tantalum in one of the post-test lithium analyses and tantalum deposits on the tungsten and zirconium carbide specimens indicate an extensive reaction. Whereas the discoloration of the tungsten and the zirconium carbide was a change from a silvery to gold color the surface of the tantalum carbide lost its normal gold color and became blackened.

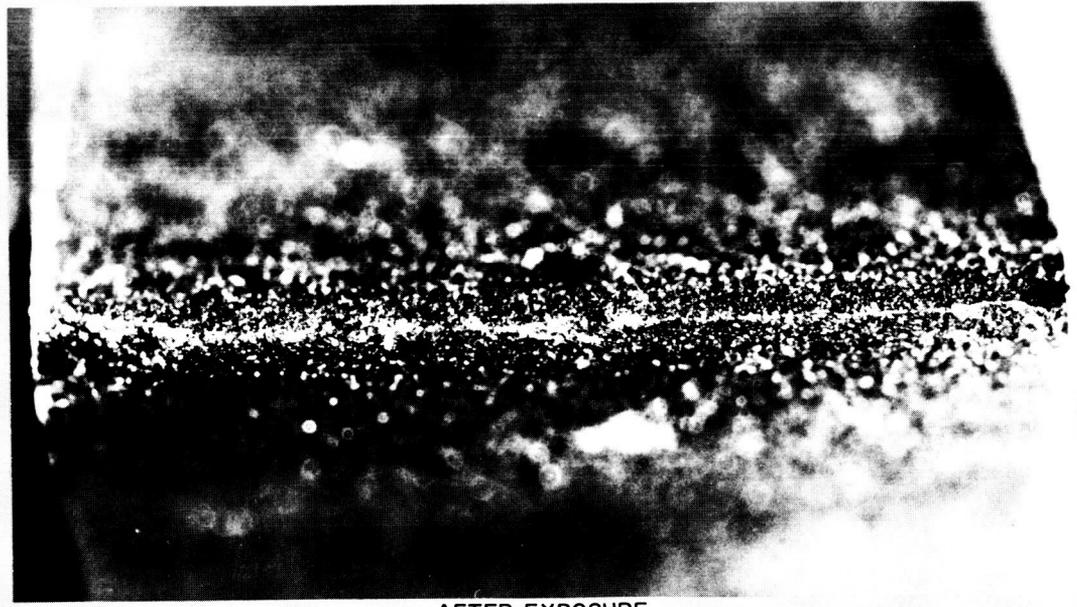
Fig. 22. Titanium carbide wedge tip before and after exposure to high-velocity lithium for 100 hr at 2000°F

Perhaps the least damaged carbide was the titanium carbide which had very little material loss from the tip. However, as can be seen in Figs. 22 and 27 extensive cracking and flaking occurred. The microstructure before and after exposure is shown in Fig. 28 and can be compared to the microstructure resulting from long term static exposure, Fig. 29. The attack was intergranular. The rounded corners along the cracks suggest that dissolution of impurities which segregated at the grain boundaries may have occurred.

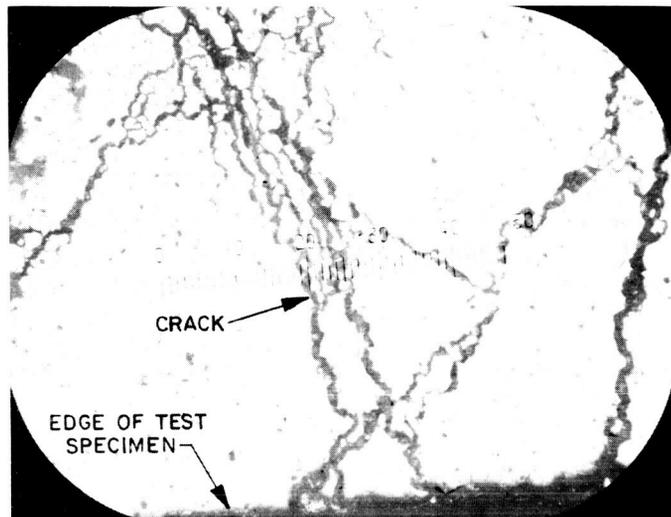
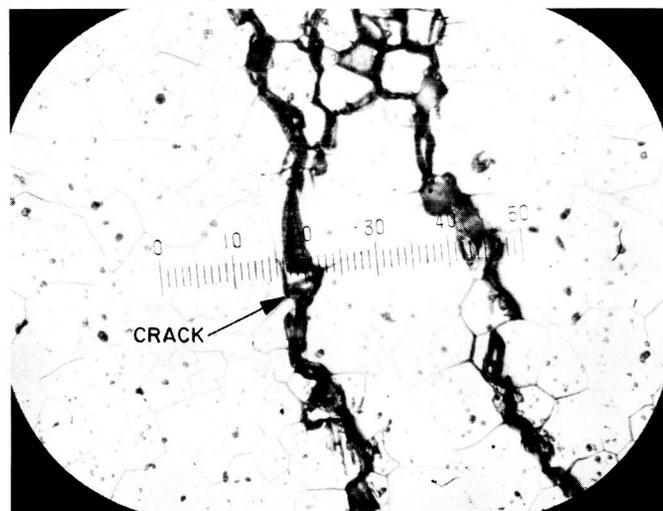
( a ) BEFORE EXPOSURE (x400 MAGNIFICATION)

( b ) AFTER EXPOSURE (x100 MAGNIFICATION)

( c ) AFTER EXPOSURE (x400 MAGNIFICATION)

Fig. 28. Titanium carbide (TiC) before and after exposure to 2000°F high-velocity lithium for 100 hr

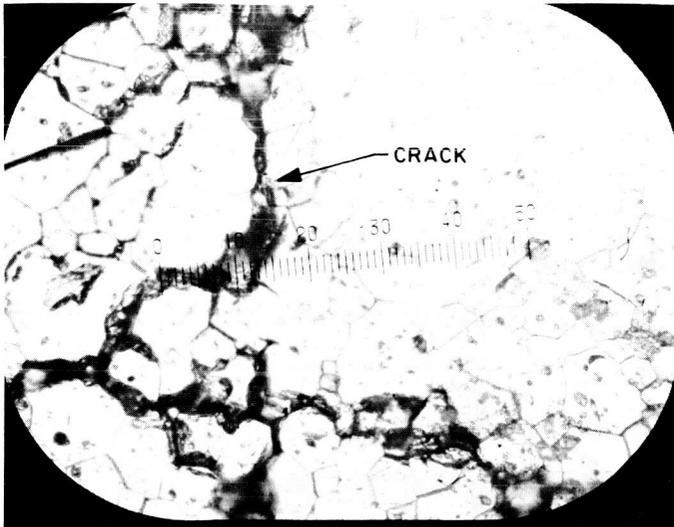
**Fig. 29. Titanium carbide (TiC) after exposure to 2000°F static lithium for 2000 hr (× 400 magnification)**

The results for the carbides are especially significant since 2000 hour exposure to static lithium at 2000°F produced less mechanical damage than the 100 hour exposure, to impinging lithium in this test. This result was for the same batch of hot-pressed material so purity differences were not an important factor. On the basis of these tests the use of the softer Cb-1%Zr for the separator appears more promising than use of these hard carbides or of thoriated tungsten.

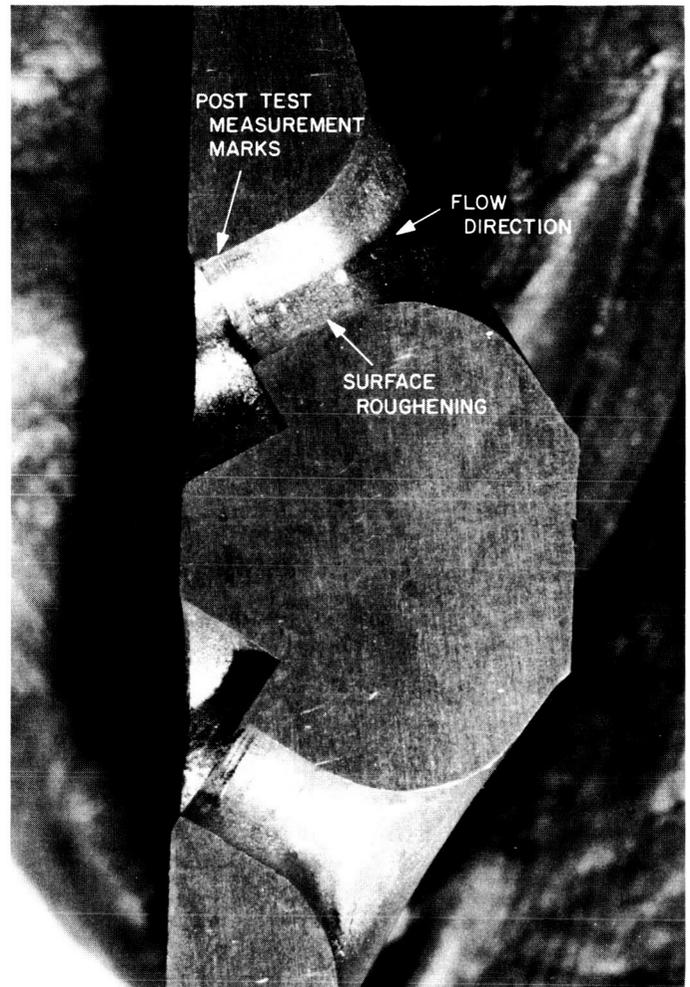
**Fig. 30. Cross-section of Cb-1%Zr flow nozzles after 100 hours operation with 2000°F lithium. Velocity range of 180–270 ft/s**

A cross section of the flow nozzles after the test is shown in Fig. 30. The velocity in the nozzles during the 2000°F portion of the test ranged from 180 to 270 ft/s. The diameter of the nozzles was measured and found to be equal to the pretest value (0.1095 in.). The original tool marks can also be seen in Fig. 31, which provides a closeup of each nozzle. Some pitting or grain removal is evident on both nozzles. However, it is not clear whether these defects existed prior to testing or resulted from it. Other machined surfaces of the Cb-1%Zr which were not exposed to lithium show similar defects.
