NATIONAL AERONAUTICS AND SPACE ADMINISTRATION

*Technical Report 32-1150*

*A 2000°F Lithium Erosion and Component  
Performance Experiment*

**JET PROPULSION LABORATORY  
CALIFORNIA INSTITUTE OF TECHNOLOGY  
PASADENA, CALIFORNIA**

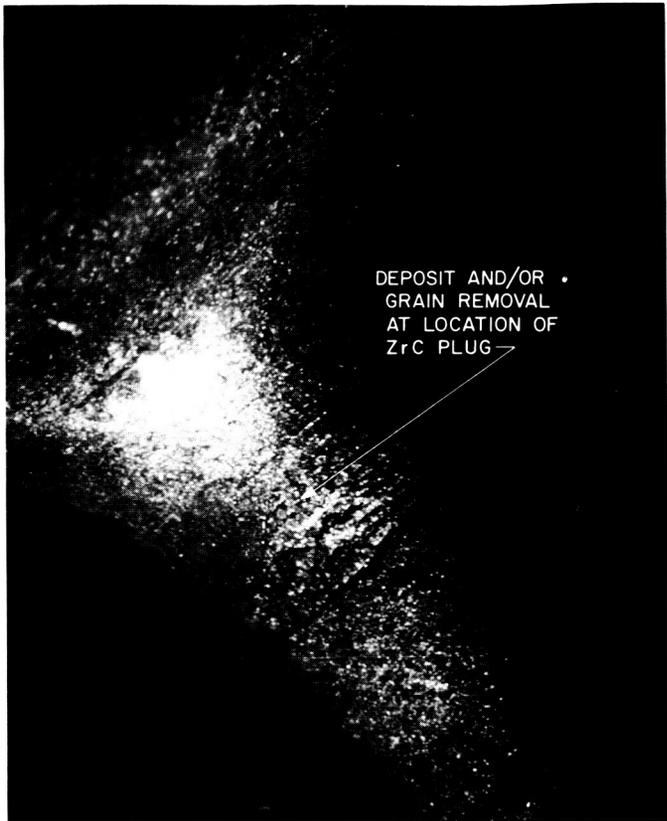
Fig. 31. Cross-section of flow nozzles after testing (0.1095-in. diameter)
