**SUMMARY OF  
GEMINI EXTRAVEHICULAR  
ACTIVITY**

Reginald M. Machell  
Manned Spacecraft Center, NASA  
Houston, Texas

*Scientific and Technical Information Division*  
OFFICE OF TECHNOLOGY UTILIZATION  
NATIONAL AERONAUTICS AND SPACE ADMINISTRATION  
1967  
*Washington, D.C.*

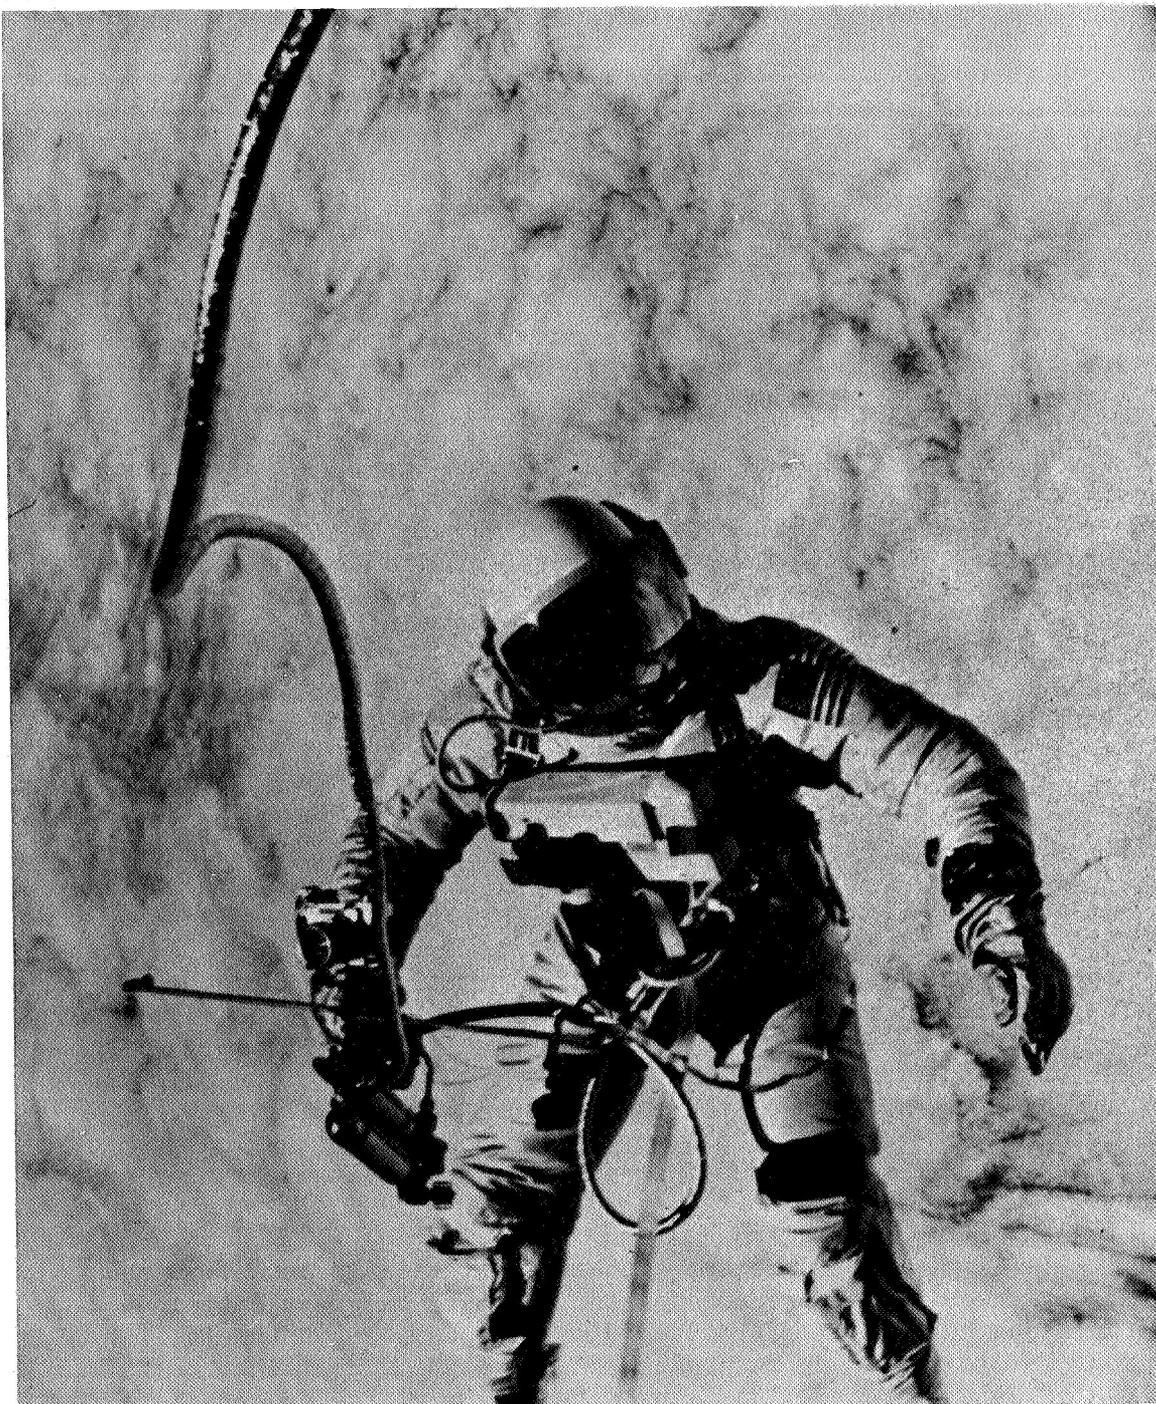
Figure 3.1-1. - Gemini IV EVA equipment.

Two of the objectives of the Gemini IV mission were to establish the initial feasibility of EVA and to evaluate a simple maneuvering device. The life support system was a small chestpack called the Ventilation Control Module (VCM), with oxygen supplied through a 25-foot umbilical hose assembly (fig. 3.1-1). The Hand Held Maneuvering Unit (HHMU) was a self-contained, cold-gas propulsion unit which utilized two 1-pound tractor jets and one 2-pound pusher jet. The G4C space suit was worn with an extravehicular coverlayer for micrometeorite and thermal protection. While outside the spacecraft, the pilot also wore a special sun visor designed for visual protection.

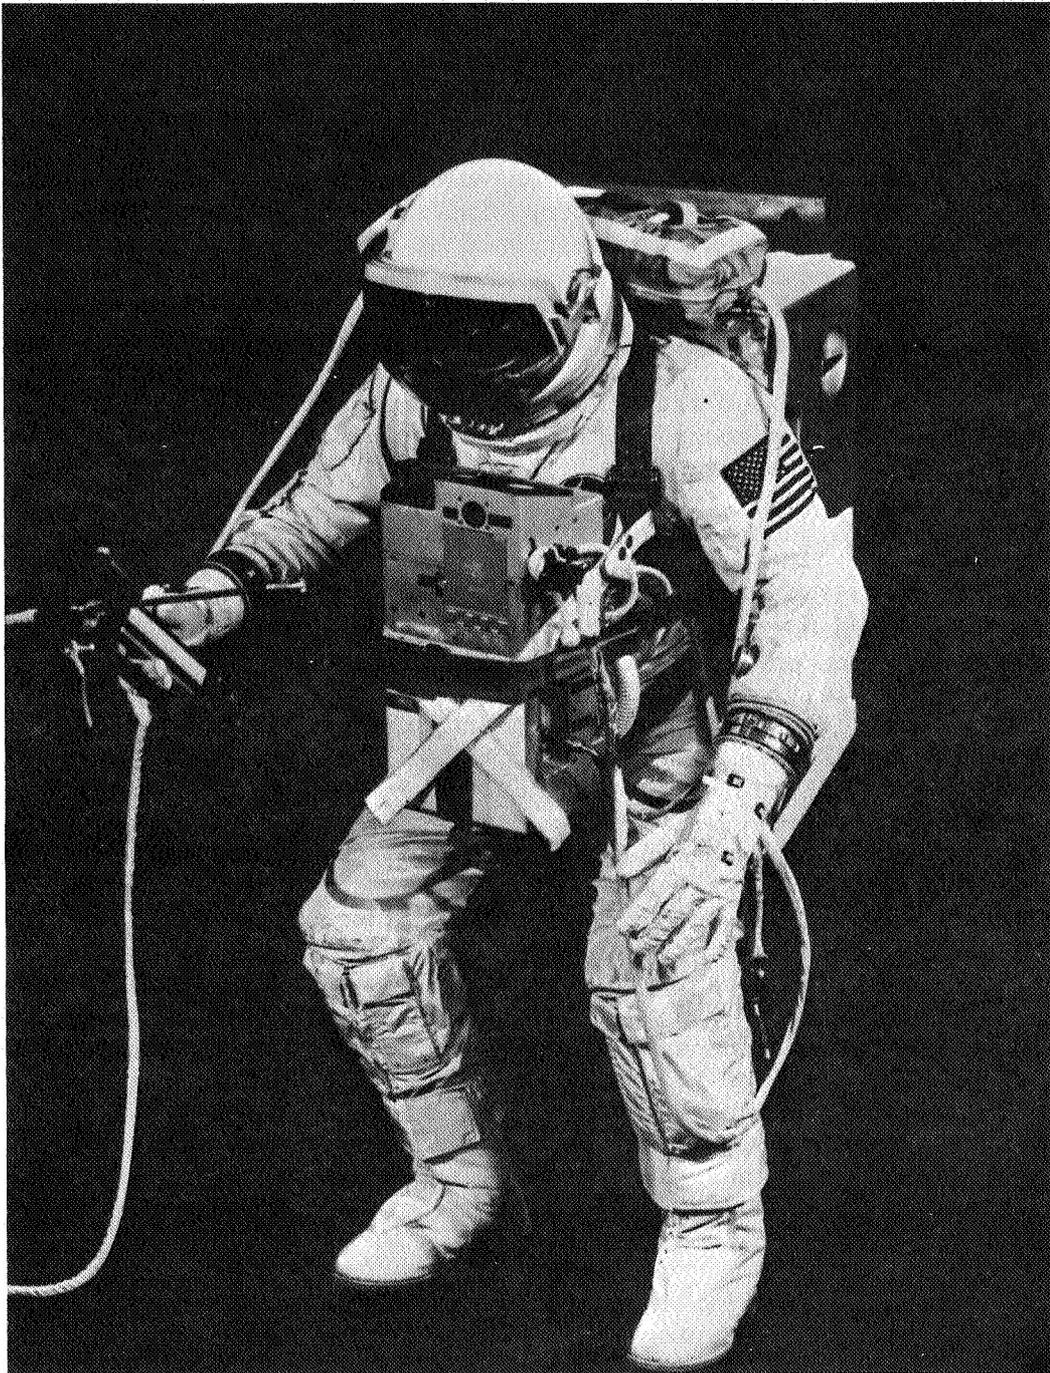
Figure 3.2-1. - Gemini VIII EVA equipment.

The primary objectives for EVA during the Gemini VIII mission were evaluation of the Extravehicular Life Support System (ELSS), the HHMU and the Extravehicular Support Package (ESP). The ELSS was a chestpack unit with an increased reserve oxygen supply and a substantially greater thermal capacity than the VCM used during Gemini IV. The ESP consisted of a backpack unit containing an independent oxygen supply for life support, a larger propellant supply for the HHMU, and an ultrahigh frequency radio package for independent voice communications. A detailed evaluation was planned of the HHMU with the pilot on a 75-foot lightweight tether. The equipment for the EVA is shown in figure 3.2-1. The Gemini VIII mission was terminated before the end of the first day because of a spacecraft control system malfunction; therefore, no EVA was accomplished.

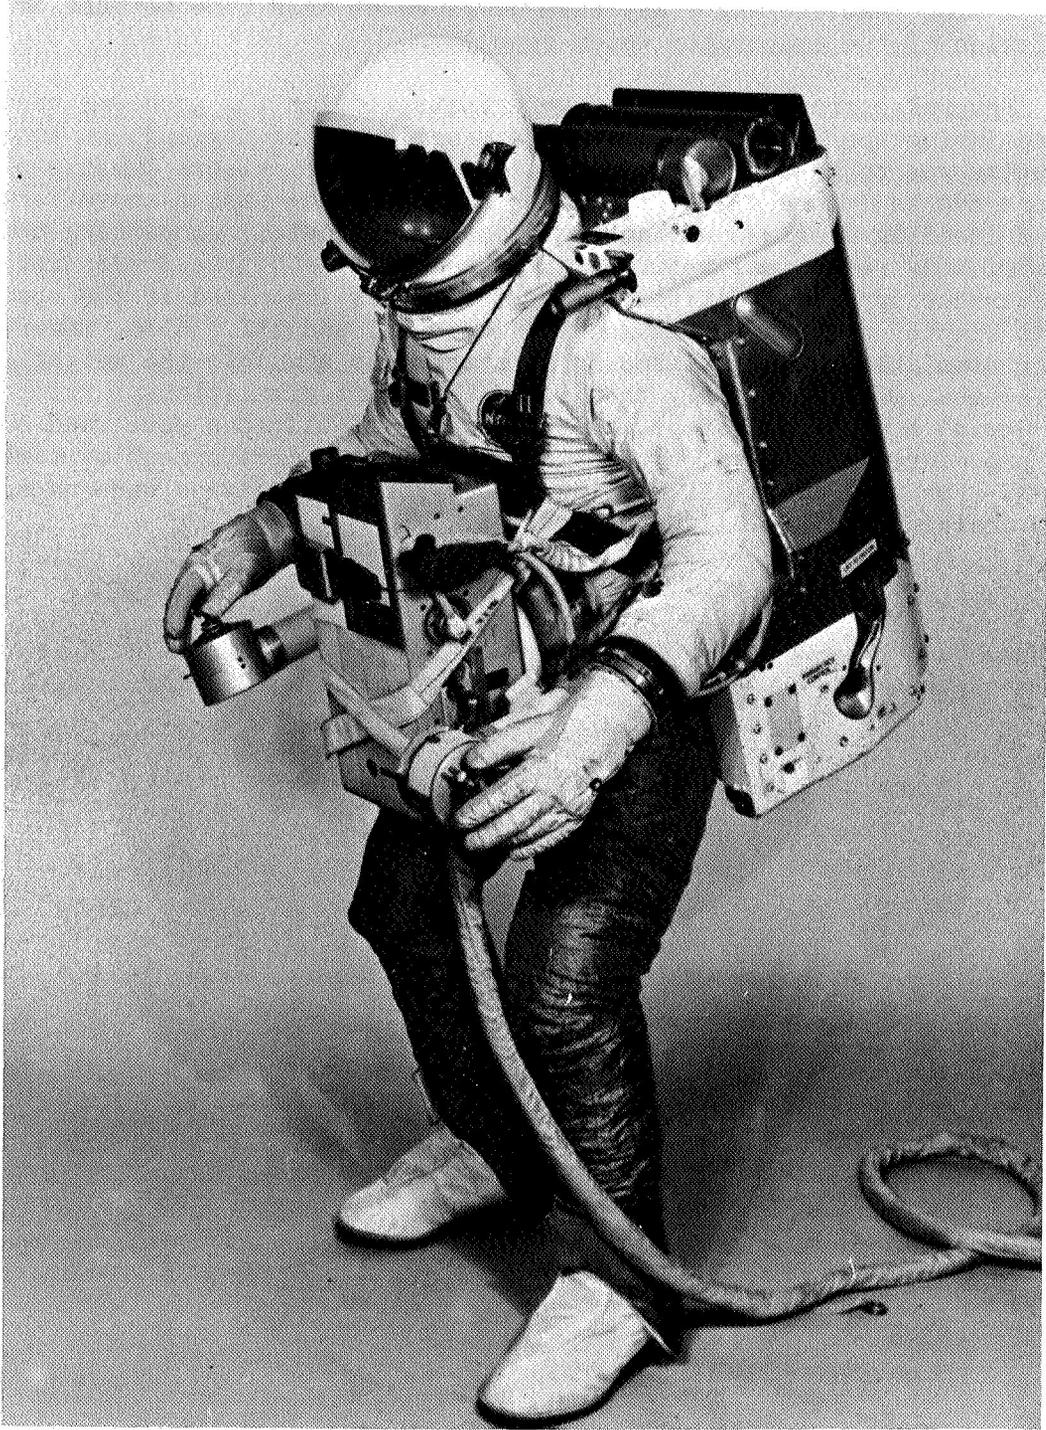
Figure 3.3-1. - Gemini IVA EVA equipment.

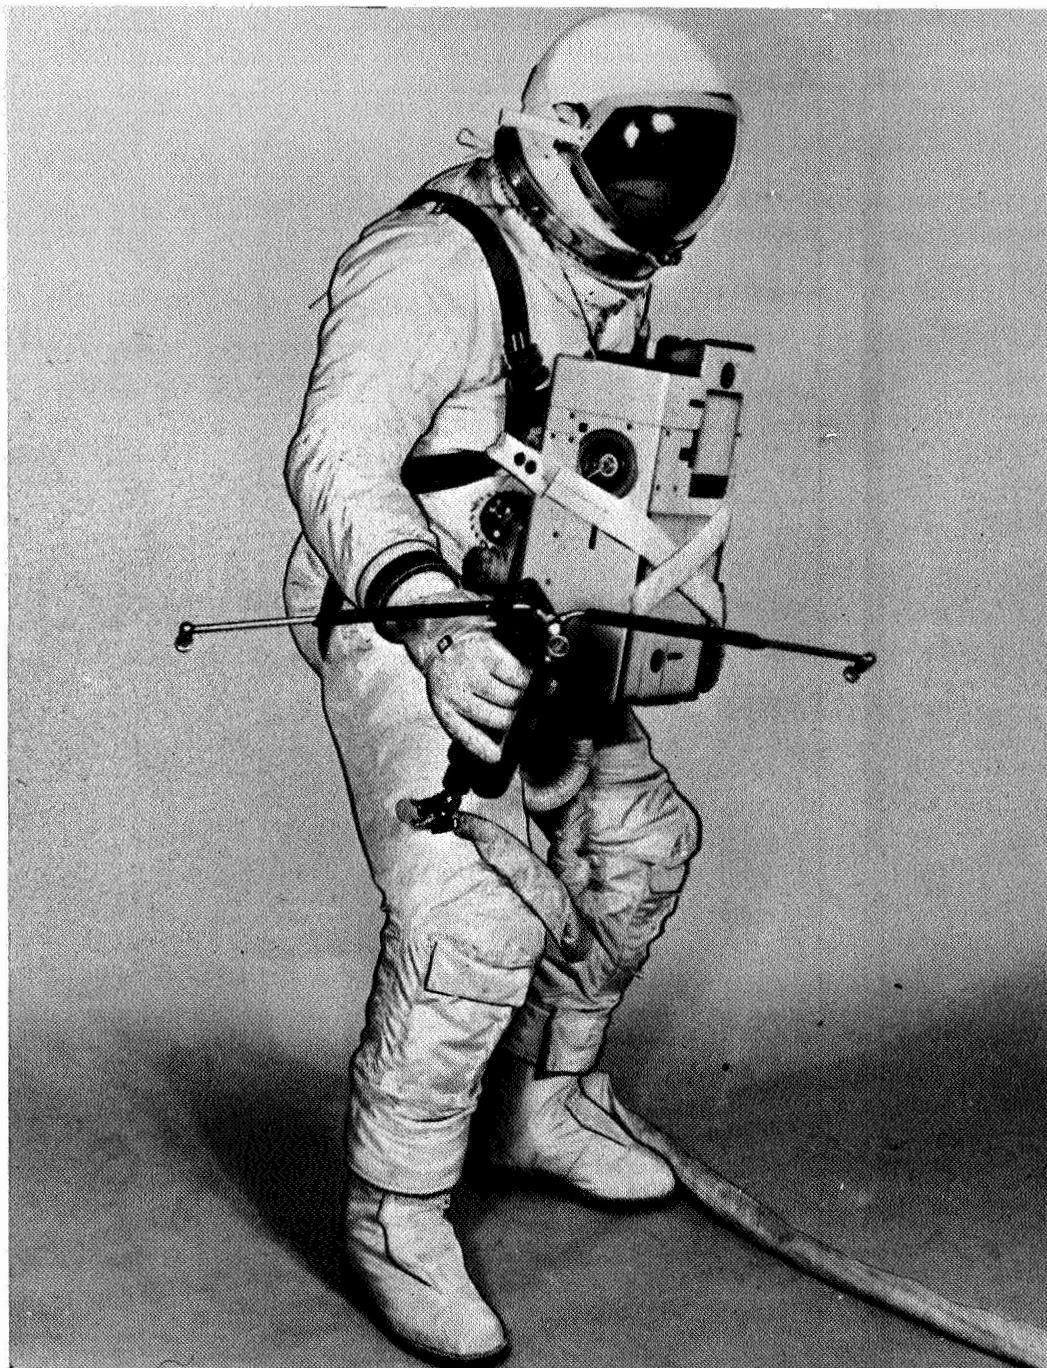
Figure 3.4-1. - Gemini X umbilical EVA equipment.

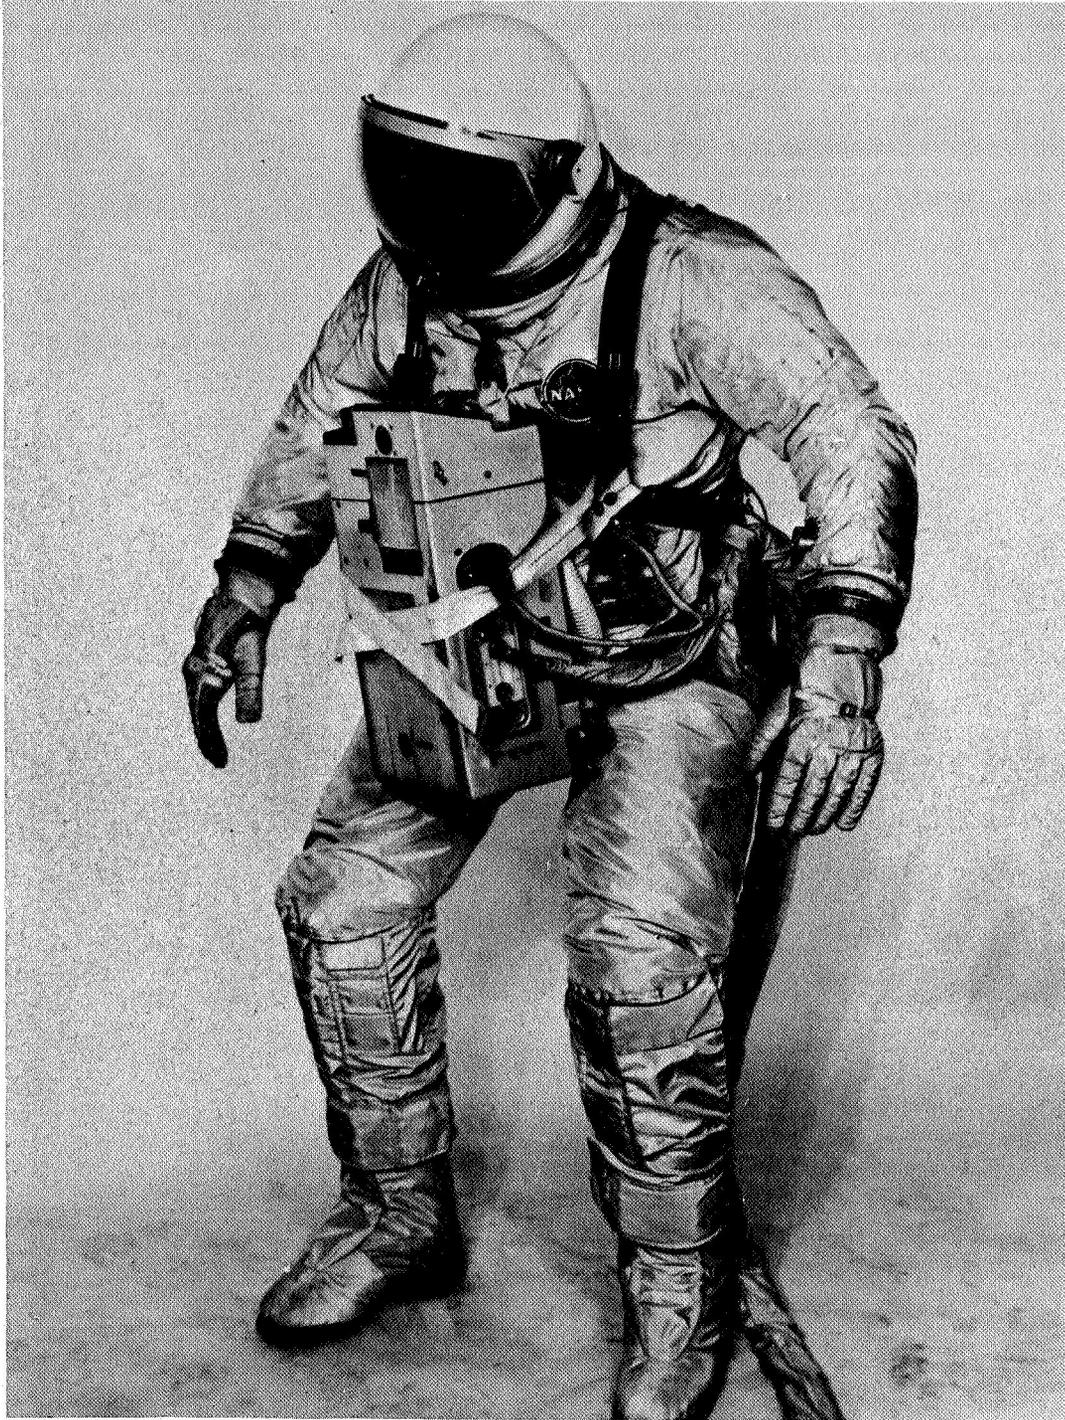
Figure 3.5-1. - Gemini XI umbilical EVA equipment.

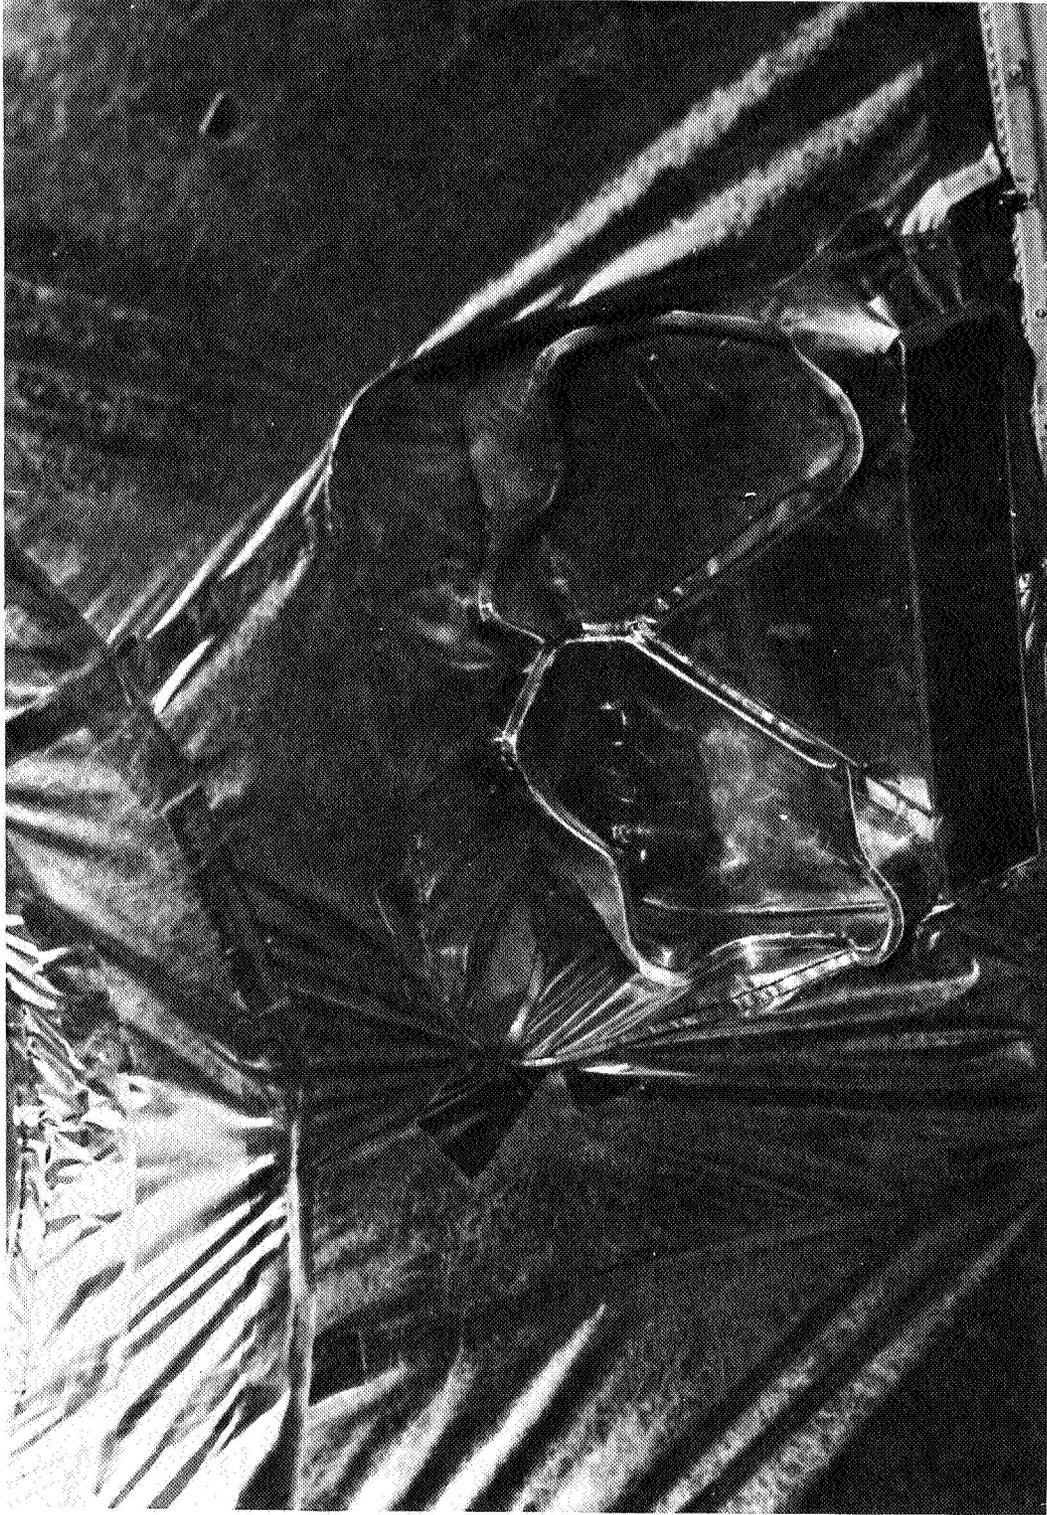
Figure 3.5-2. - EVA foot restraints used on Gemini XI and XII.

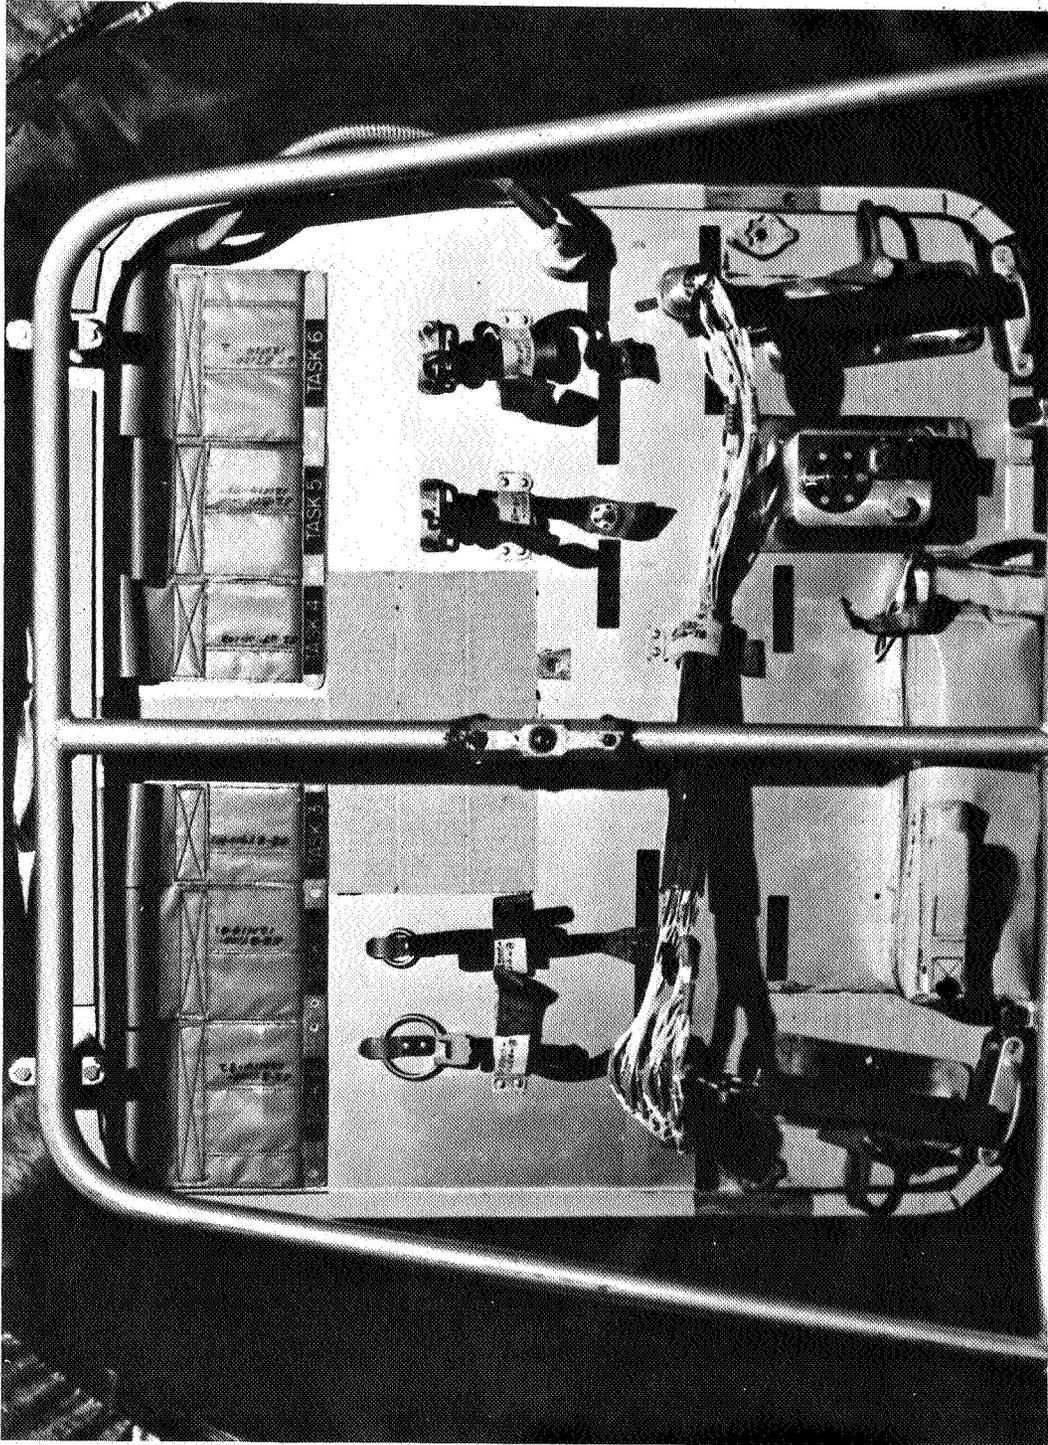
Figure 3.6-1. - Gemini XII EVA work station in adapter equipment section.

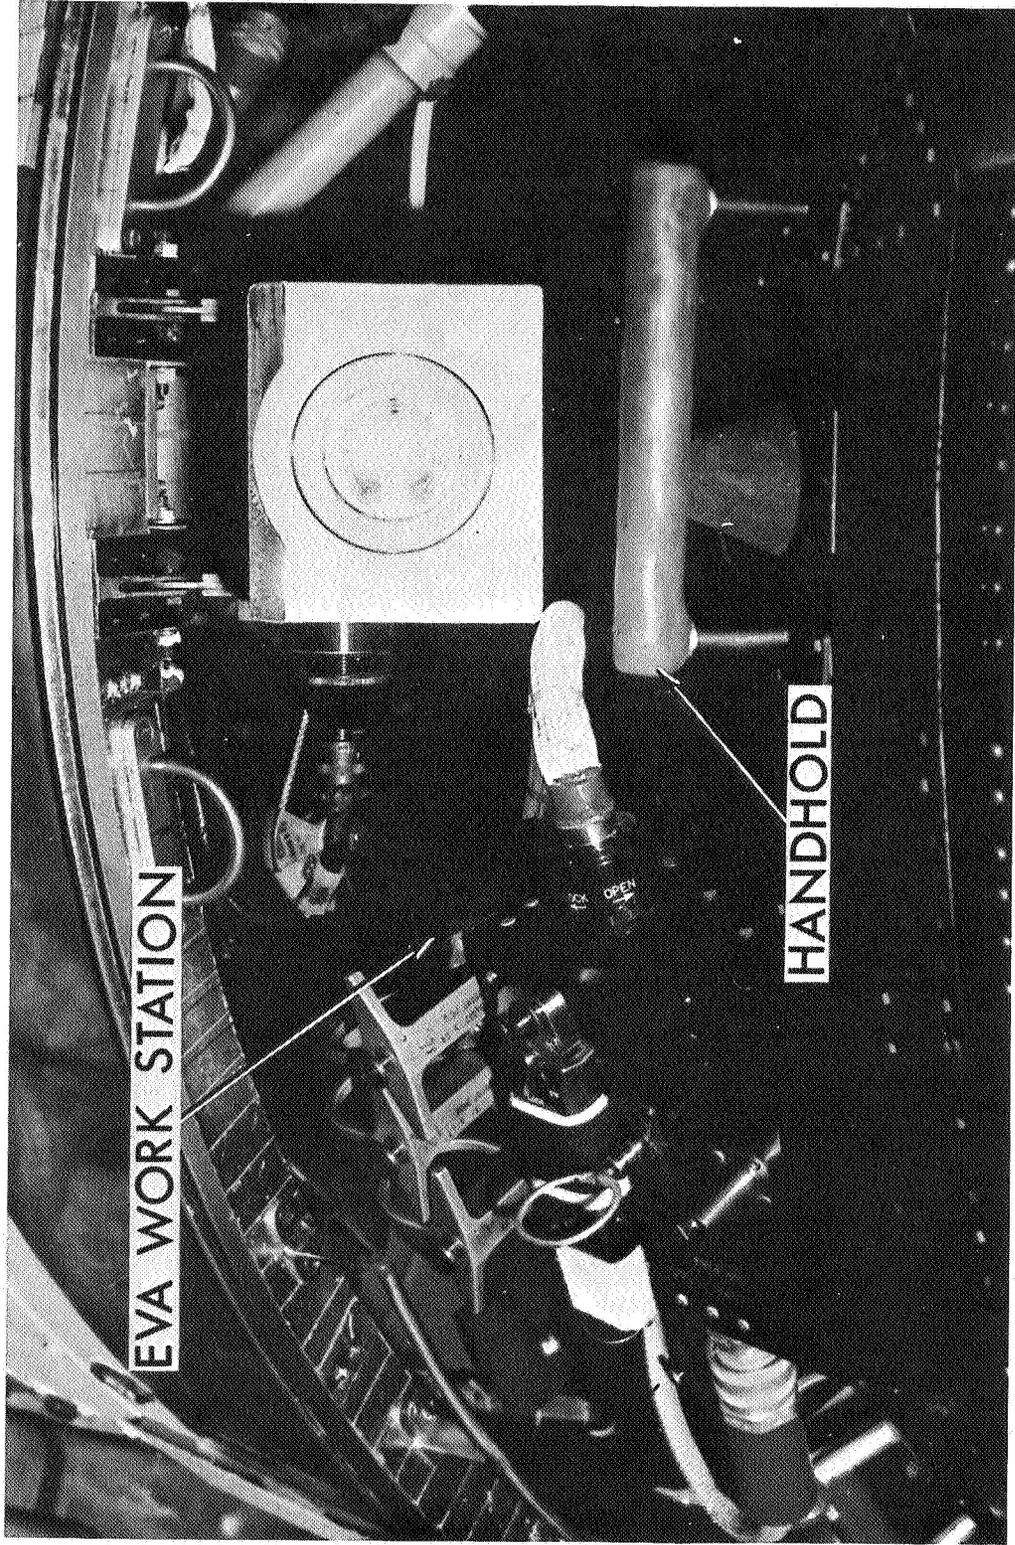
Figure 3.6-2. - Gemini XII TDA work station.

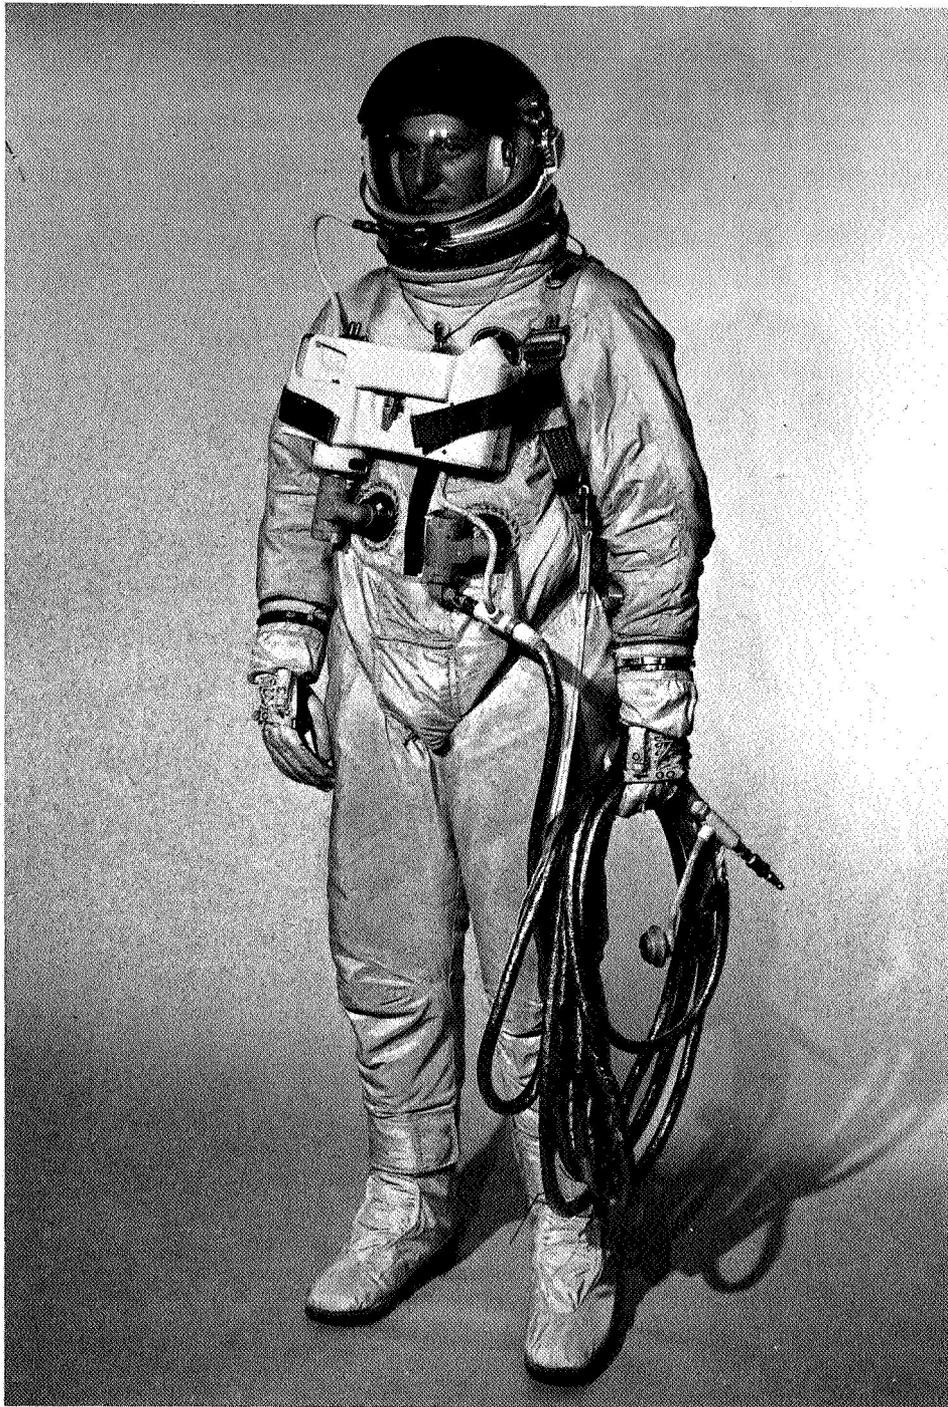
Figure 4.1-1. - Gemini IV extravehicular space suit and life support system.

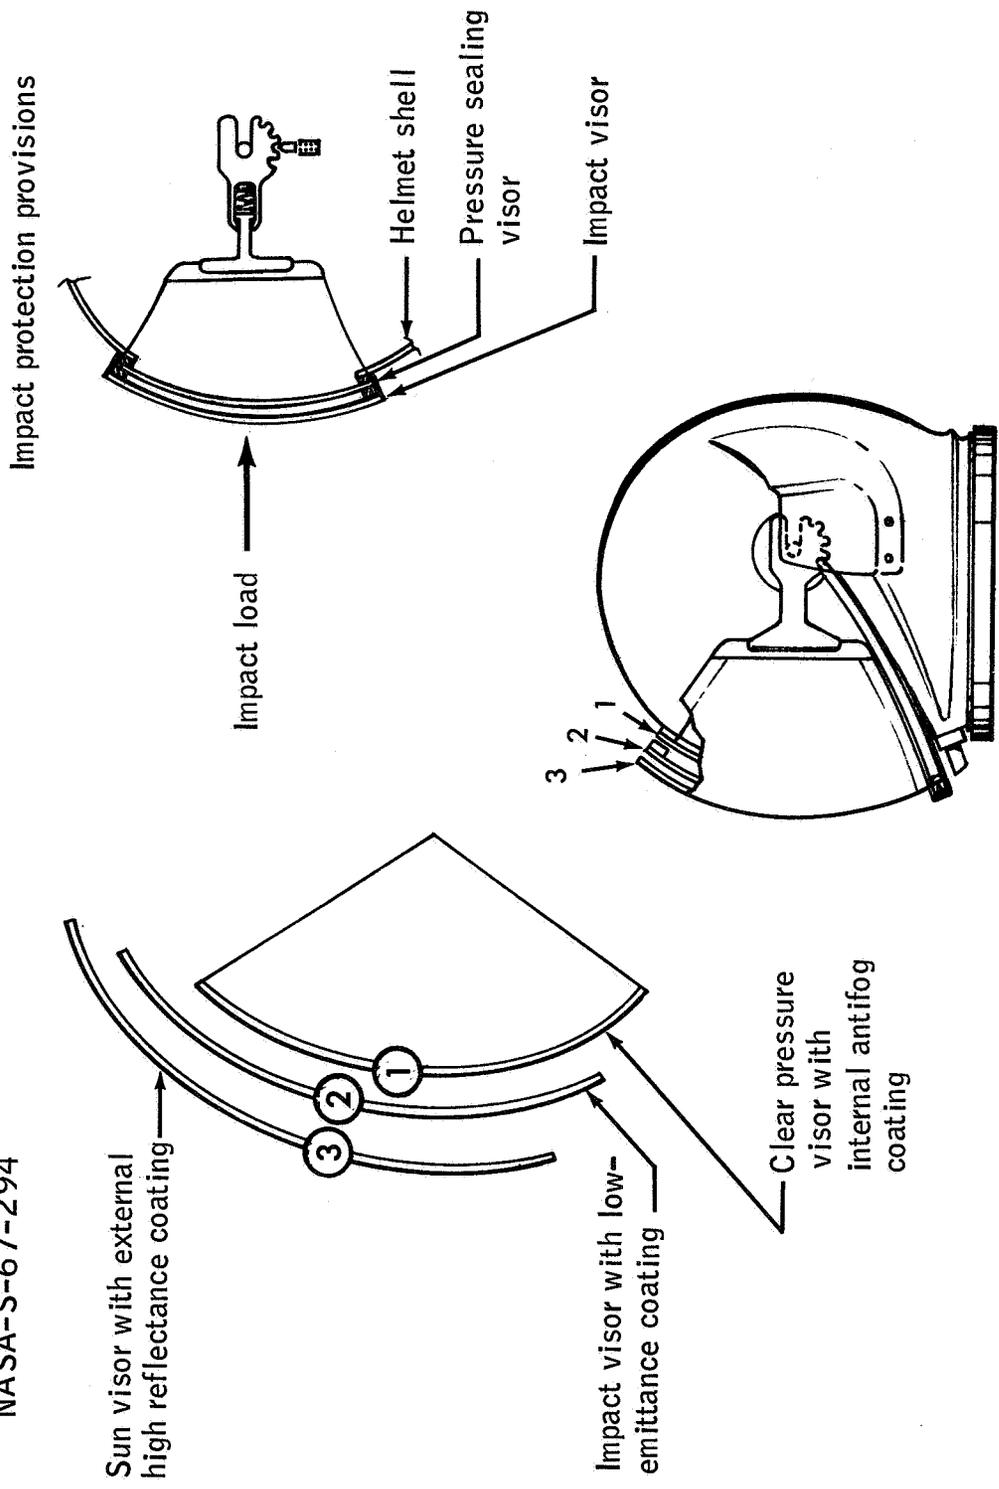
Figure 4.1-3. - Gemini IV extravehicular helmet.

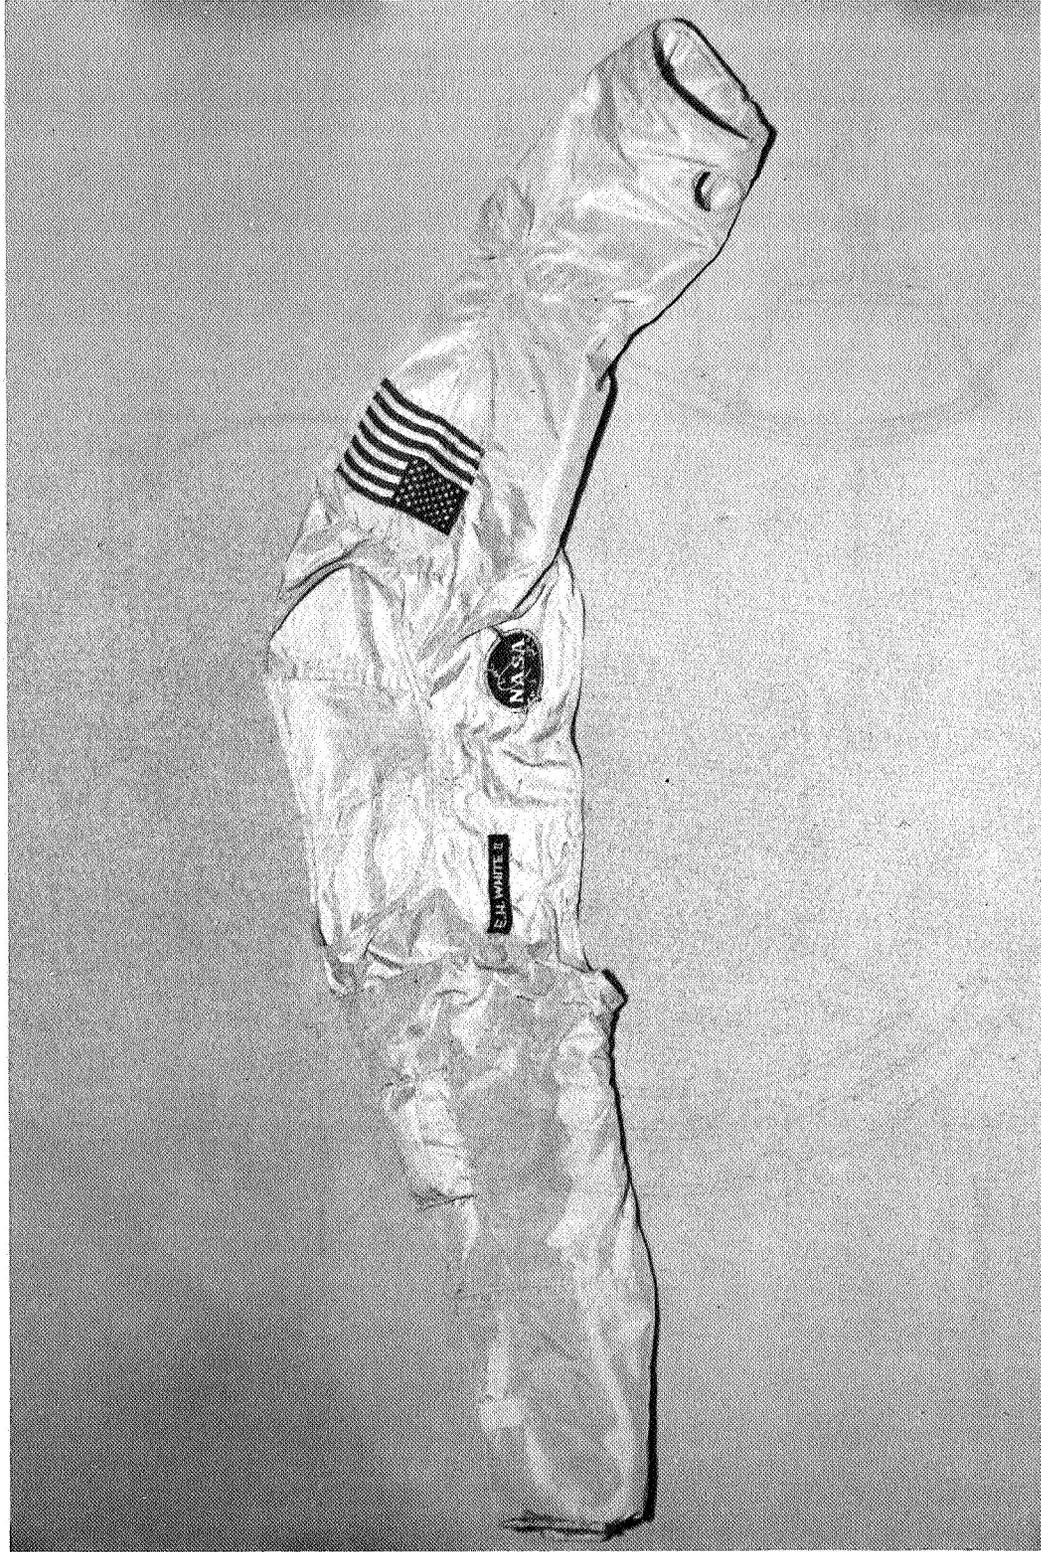
Figure 4.1-4. - EVA protective jacket for pilot.

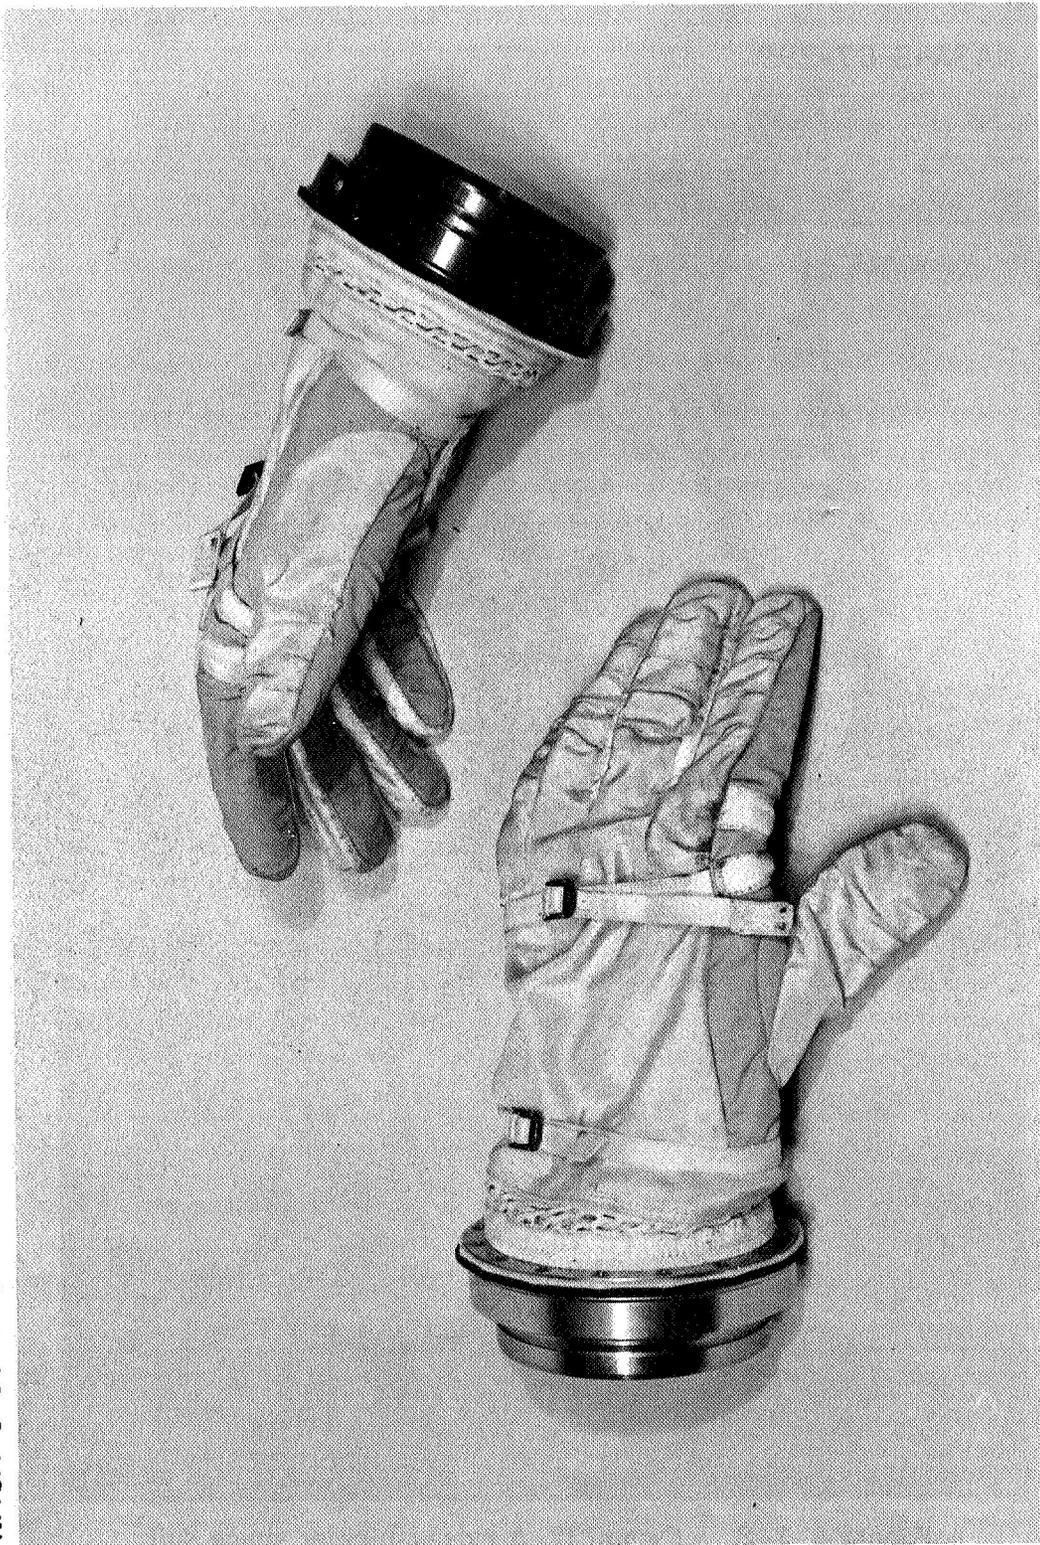
Figure 4.1-7. - Integrated pressure-thermal gloves for EVA.

4.1.2.2 Development and qualification testing.— The new coverlayer material (fig. 4.1-6) and the integrated pressure thermal gloves (fig. 4.1-7) were tested to the original specifications (see section 4.1.1.2), except a maximum time of 90 seconds was used for thermal exposure testing. These modifications exceeded qualification specifications. The micrometeoroid testing of the new coverlayer material demonstrated a  $P_0$  of 0.999 for worst-case conditions.

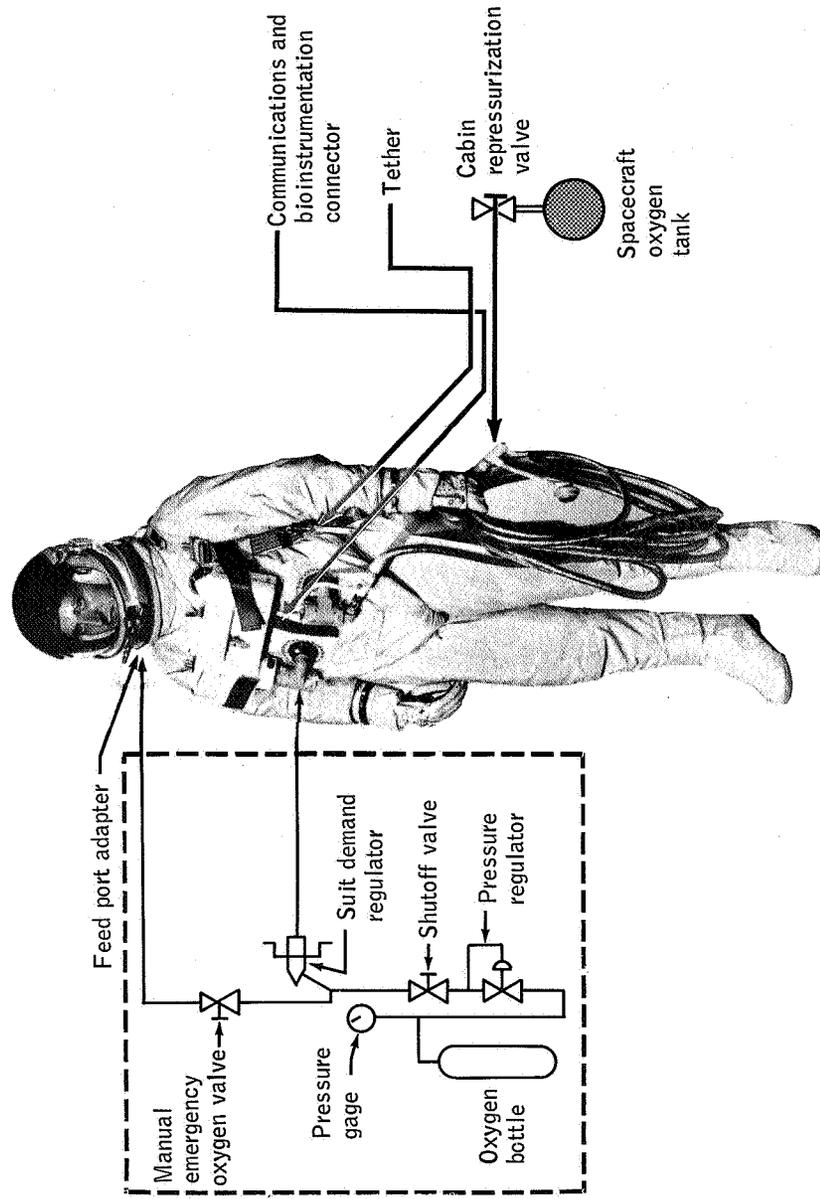
Figure 4.2-1.1 - Ventilation Control Module system.

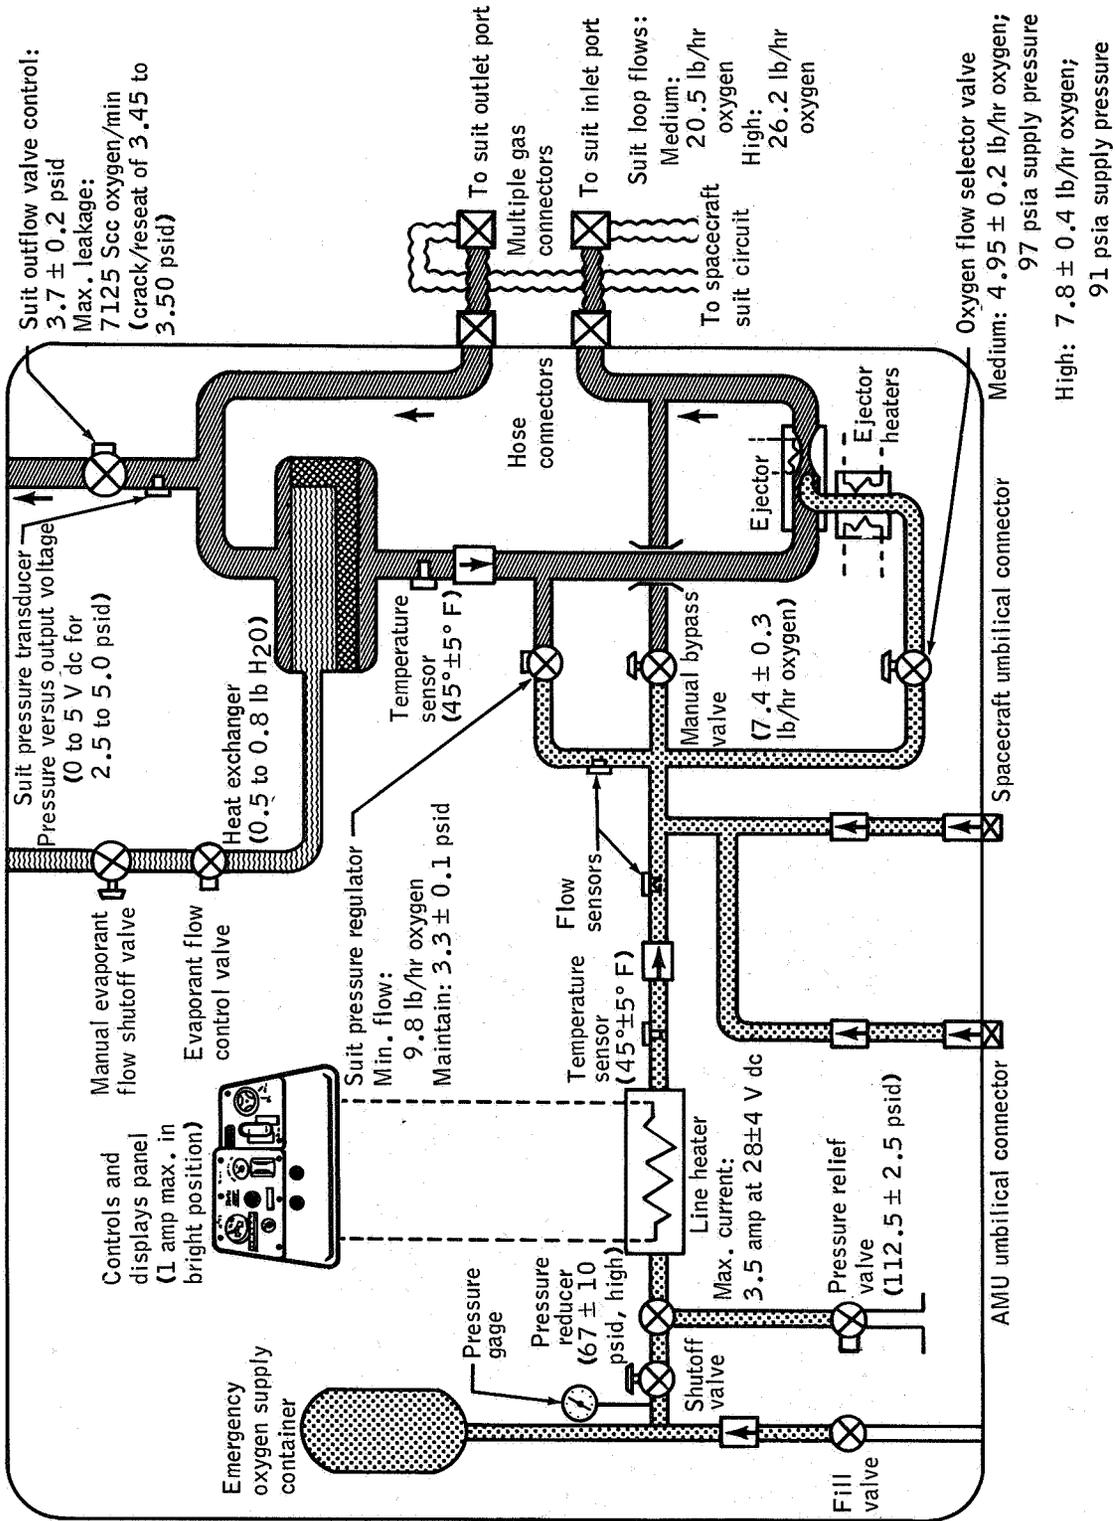
Figure 4.2-4. -- ELSS chestpack pneumatic subsystem with nominal component performance values.

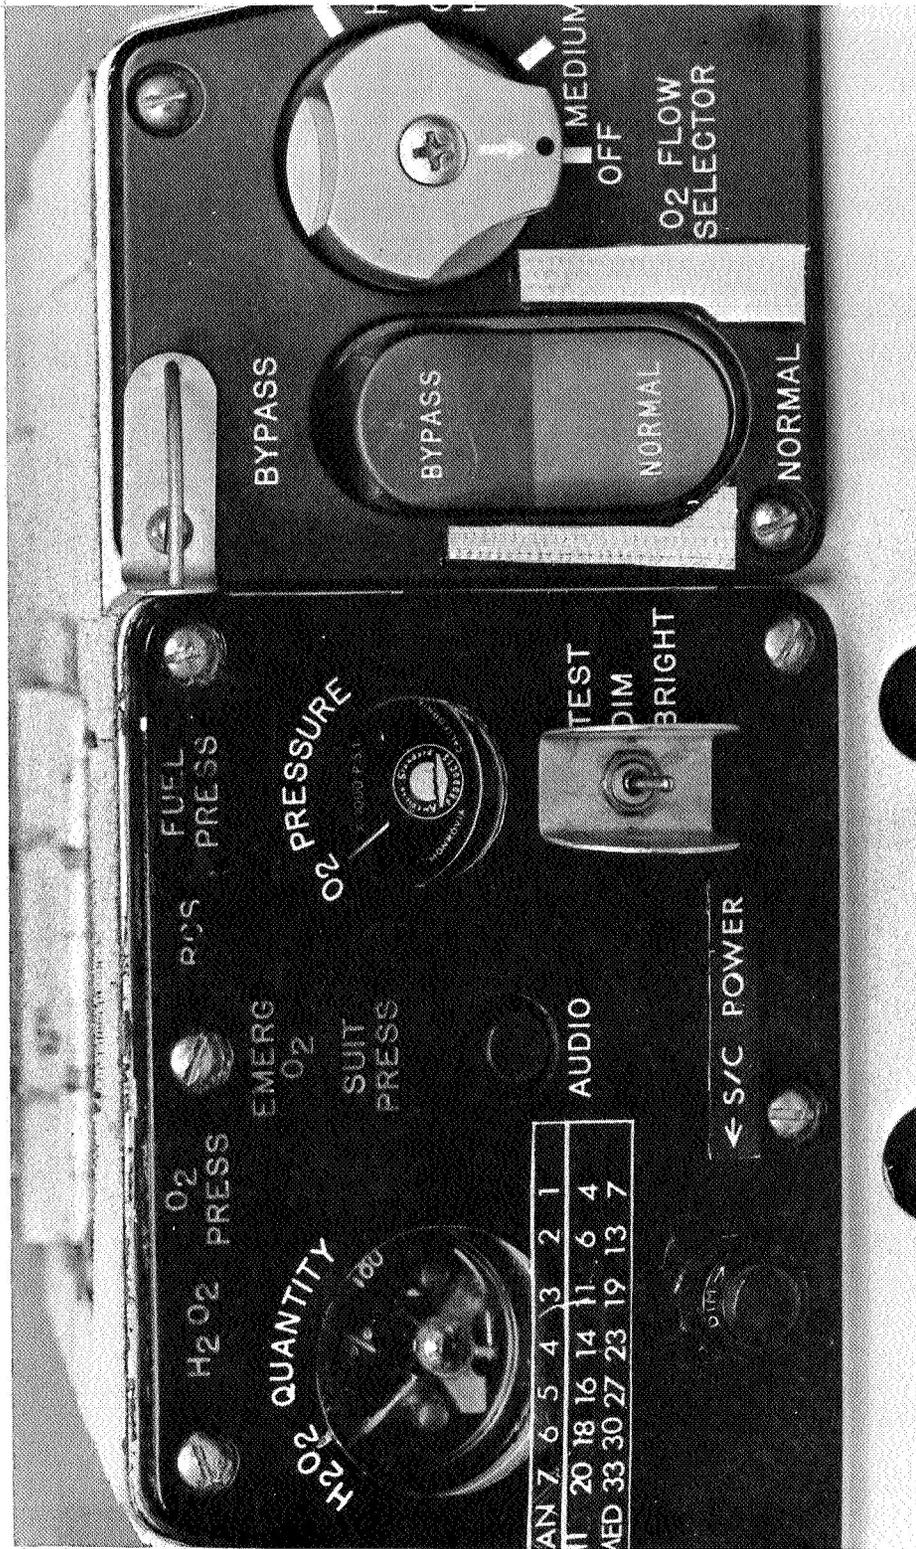
Figure 4.2-5. - ELSS chestpack controls and displays panel with AMU emergency displays.
