**SUMMARY OF  
GEMINI EXTRAVEHICULAR  
ACTIVITY**

Reginald M. Machell  
Manned Spacecraft Center, NASA  
Houston, Texas

*Scientific and Technical Information Division*  
OFFICE OF TECHNOLOGY UTILIZATION  
NATIONAL AERONAUTICS AND SPACE ADMINISTRATION  
1967  
*Washington, D.C.*

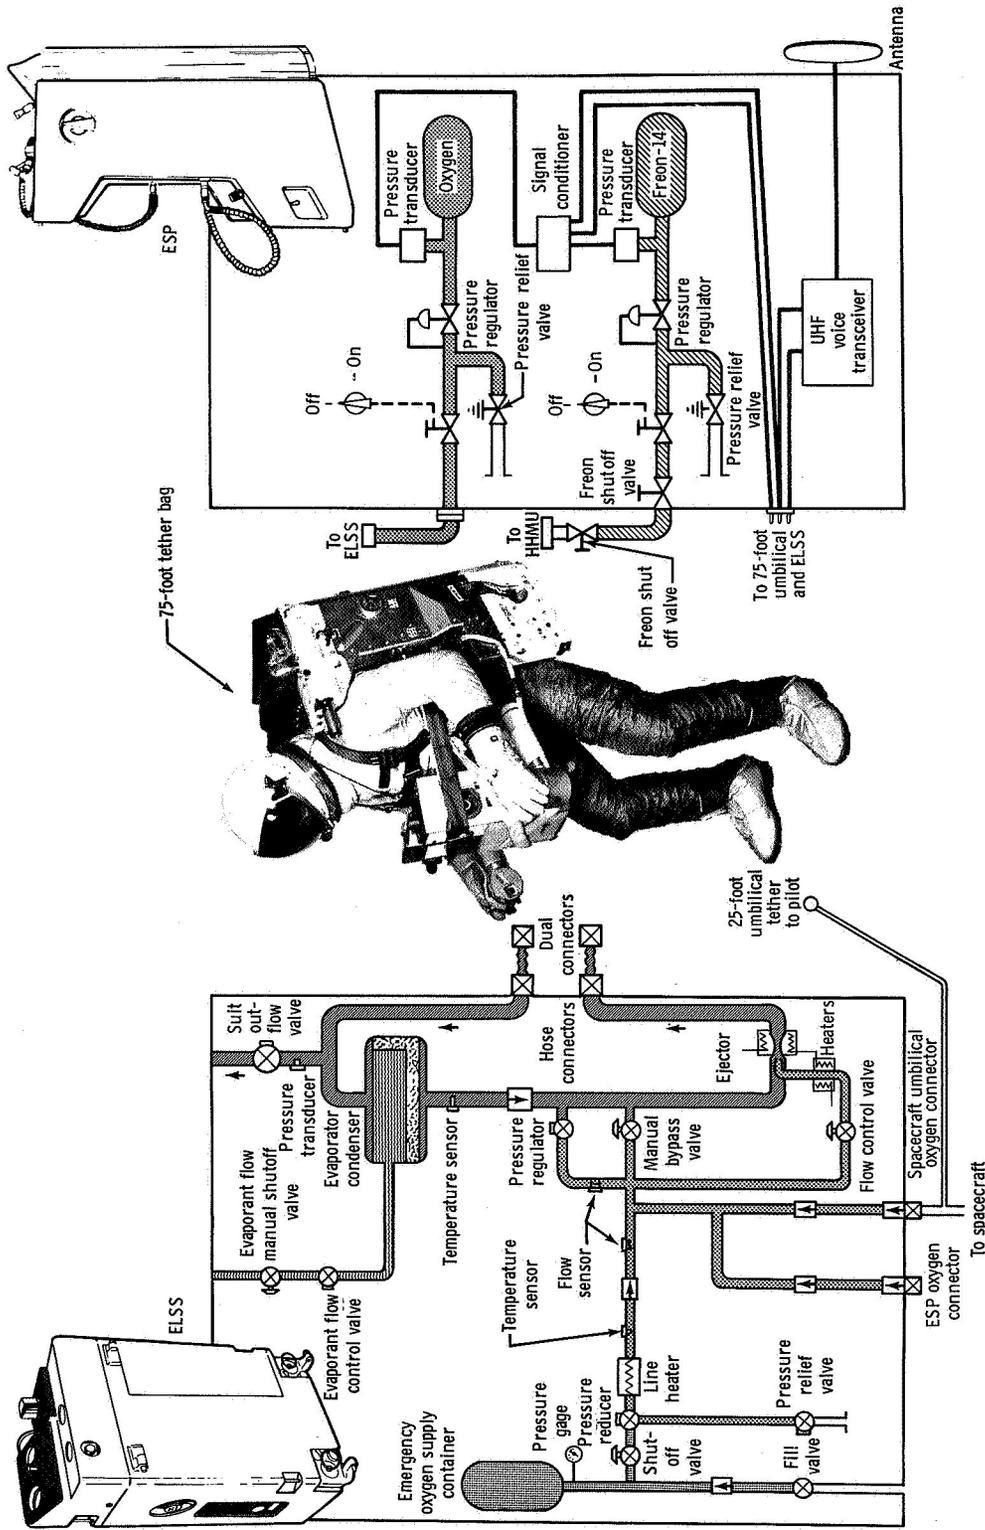
Figure 4.2-16 - Gemini VIII extravehicular system - ELSS / ESP.

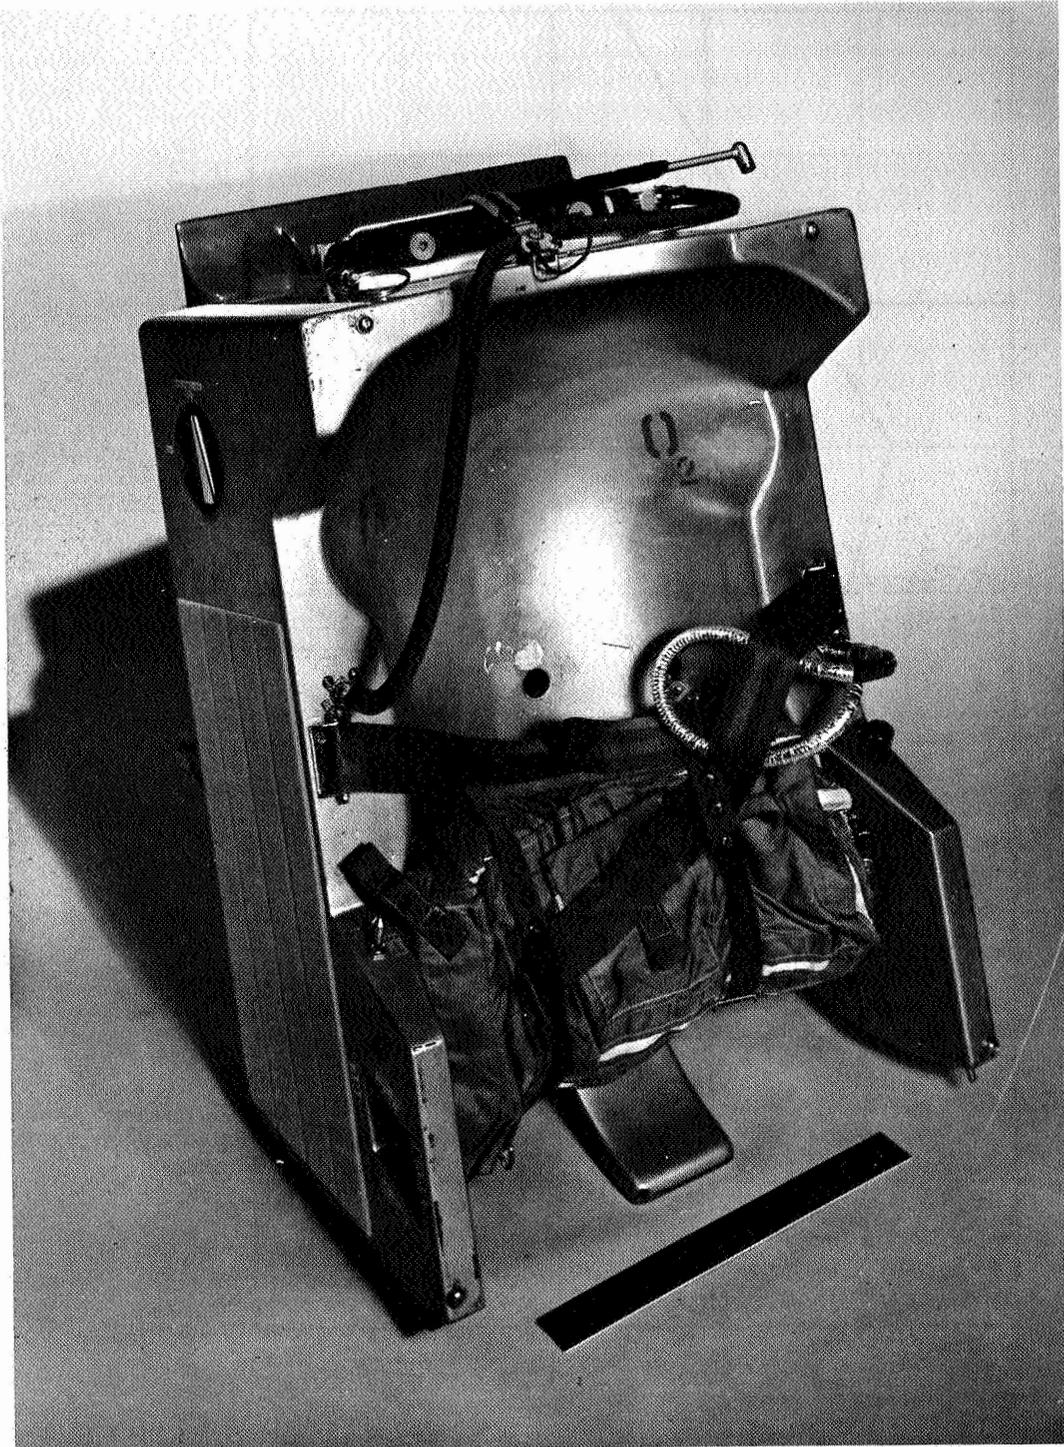
Figure 4.2-19. - Front view of ESP with 75-foot tether stored.

4.2.3.6 Mission results.- The ESP was flown on the Gemini VIII mission; however, because of a malfunction of the spacecraft Orbital Attitude and Maneuver System, the flight was terminated early, and the ESP was not utilized. Figures 4.2-19 and 4.2-20 show some parts of the ESP.

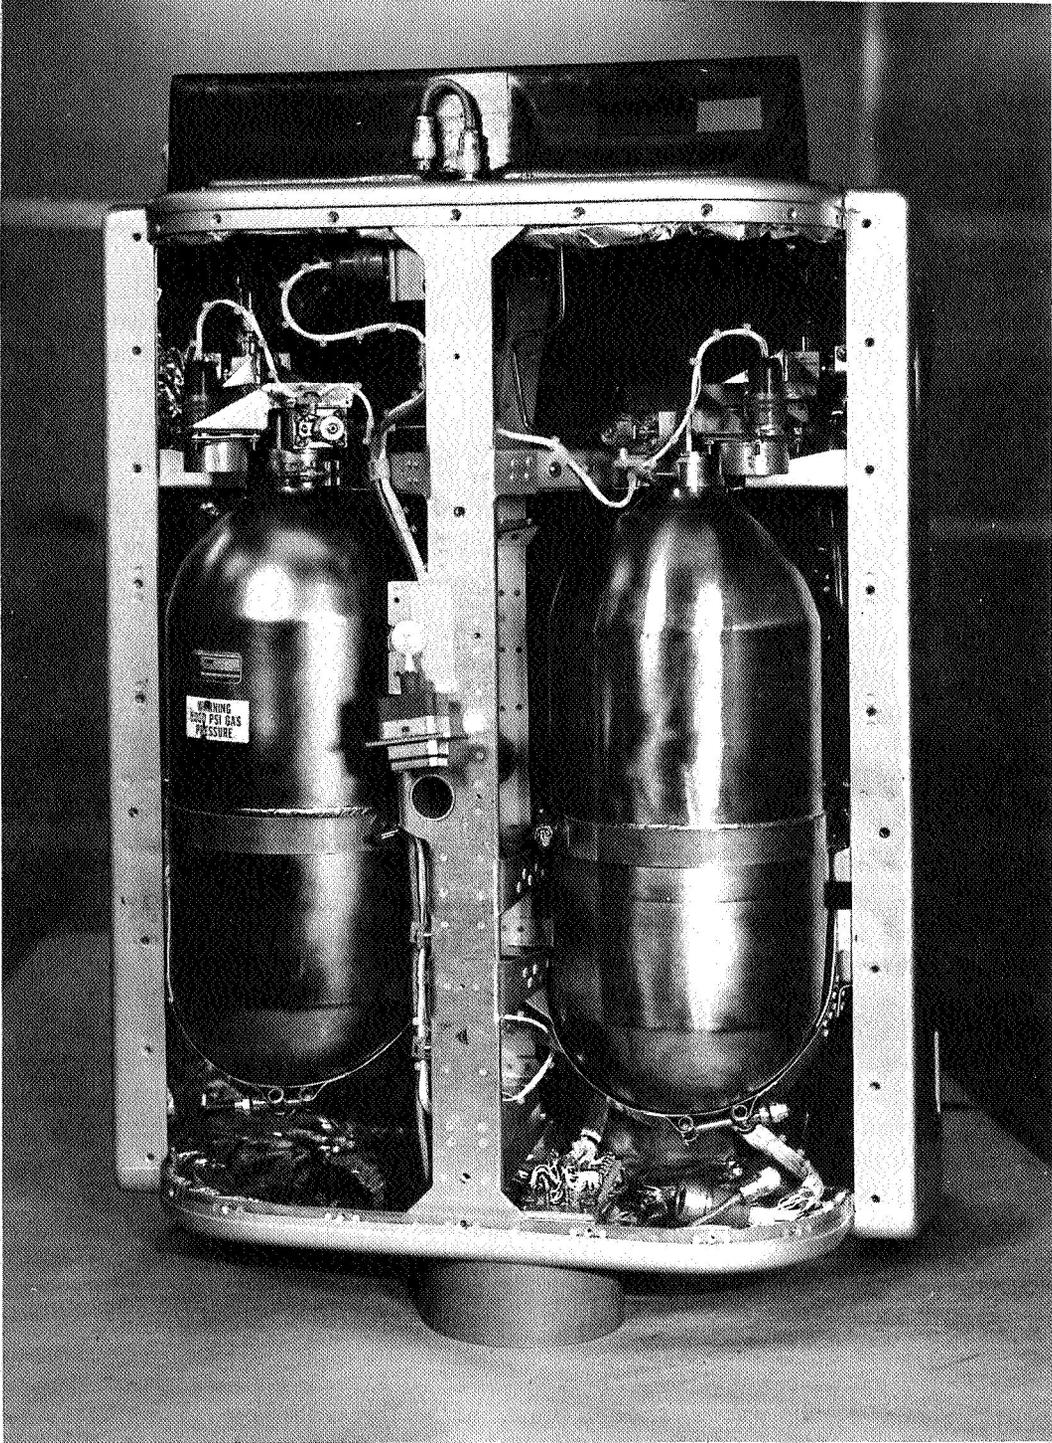
Figure 4.2-20. - ESP internal components.

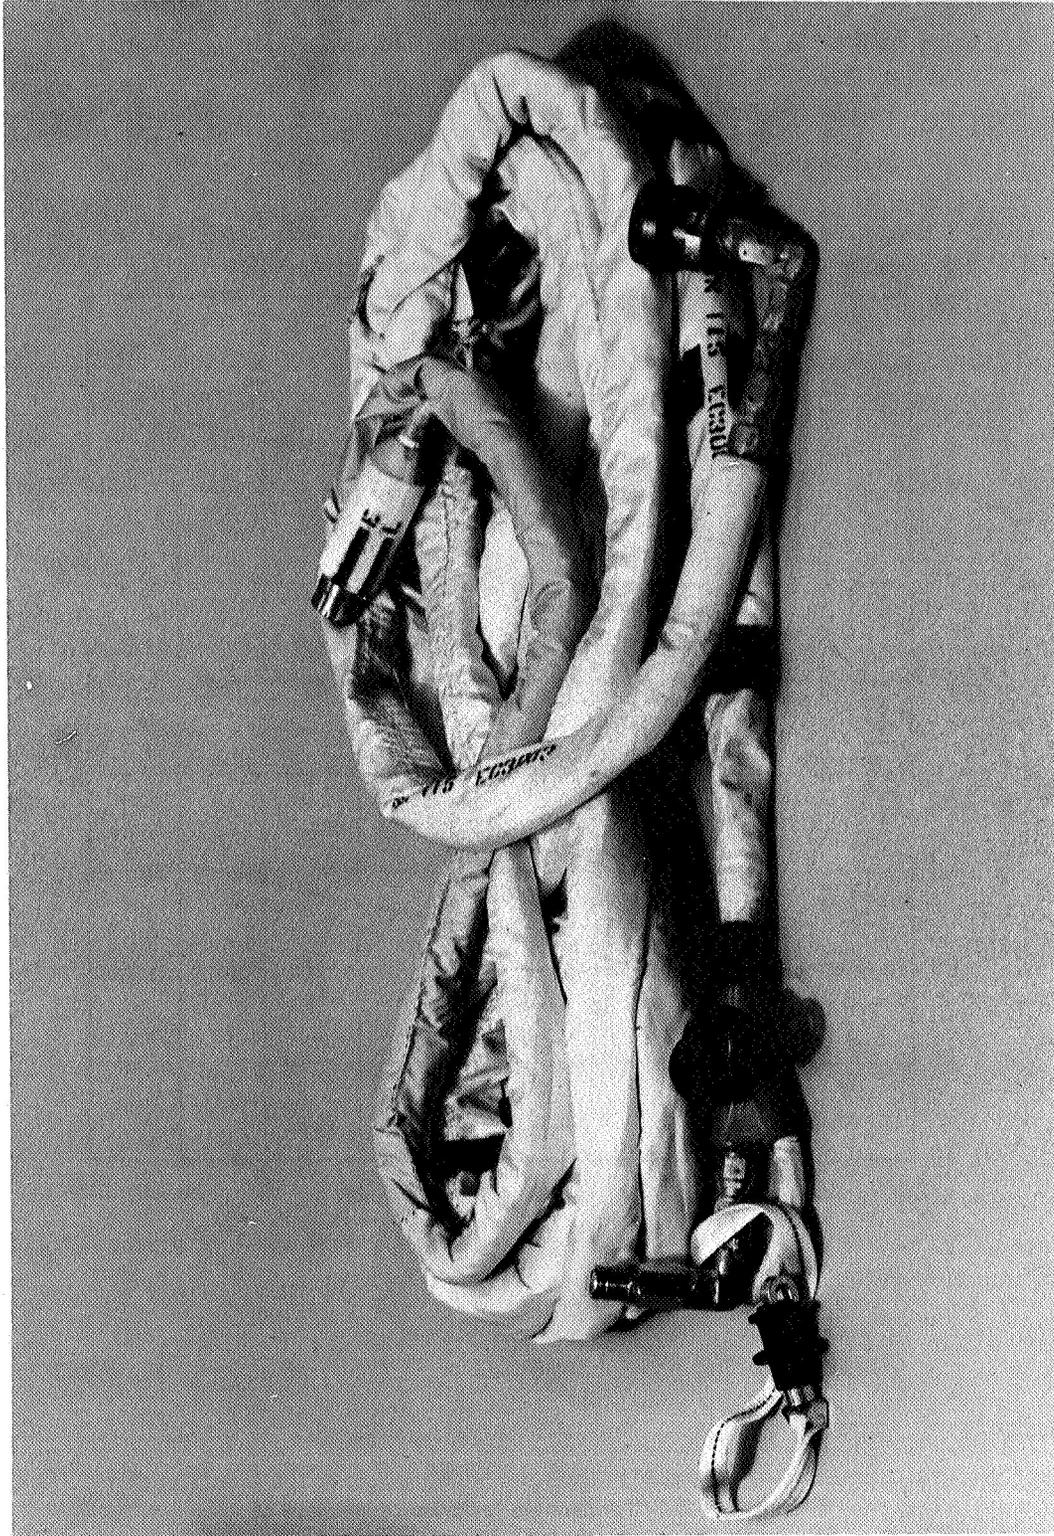
Figure 4.3-3. - Coiled configuration of 25-foot umbilical.

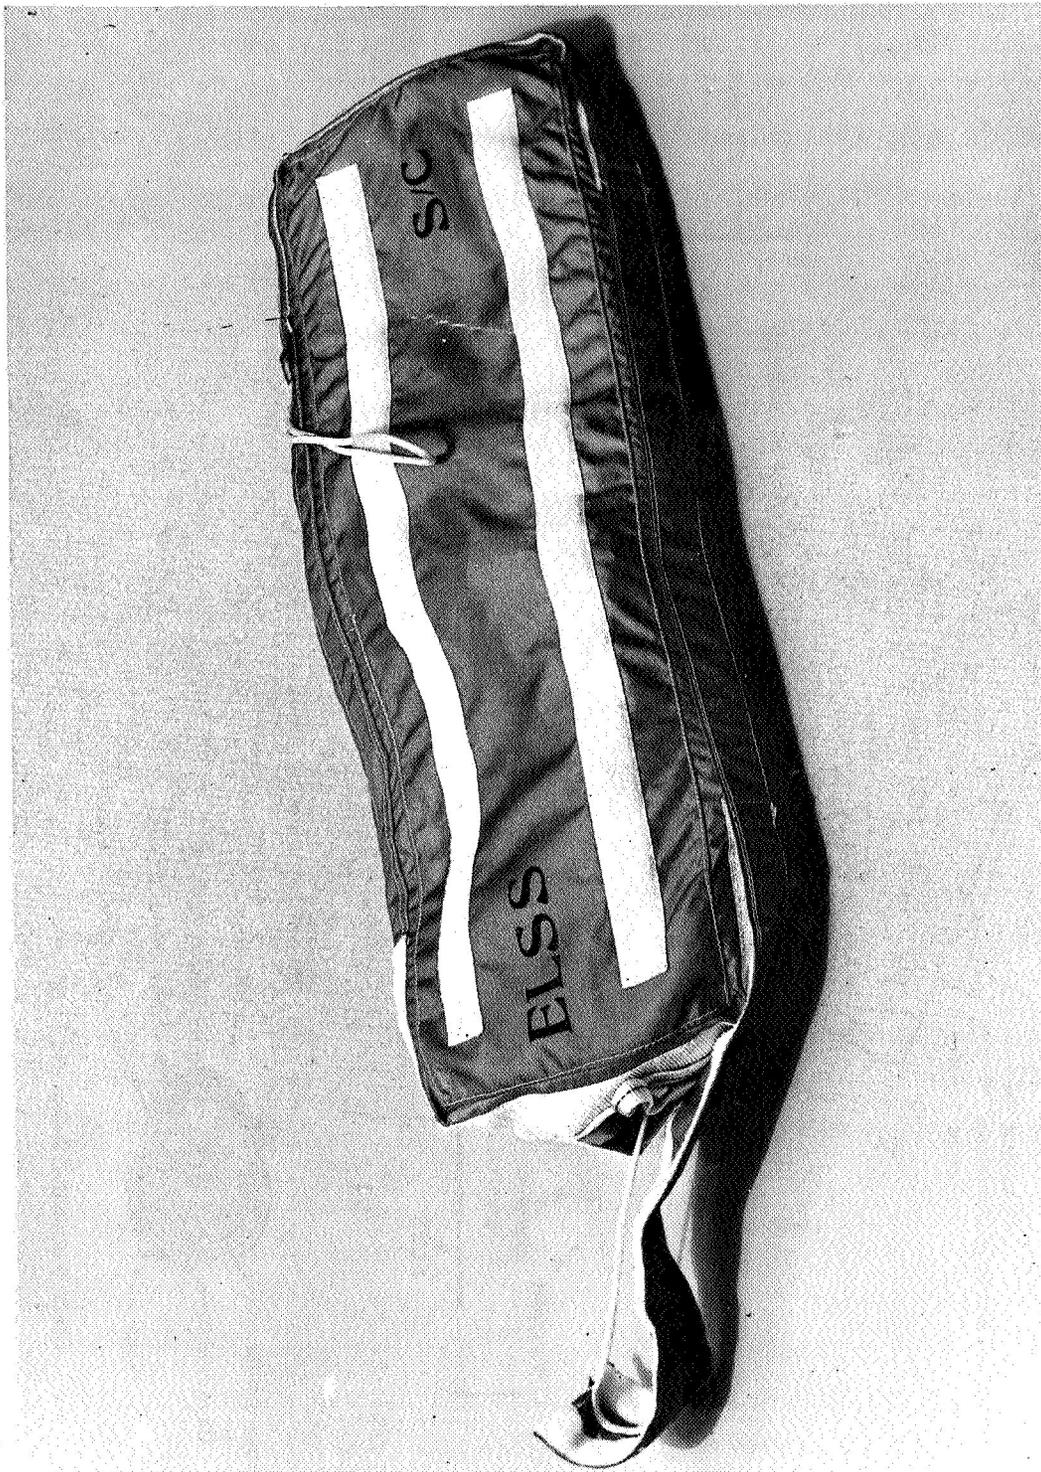
Figure 4.3-4. - Twenty-five-foot umbilical stowed in bag.

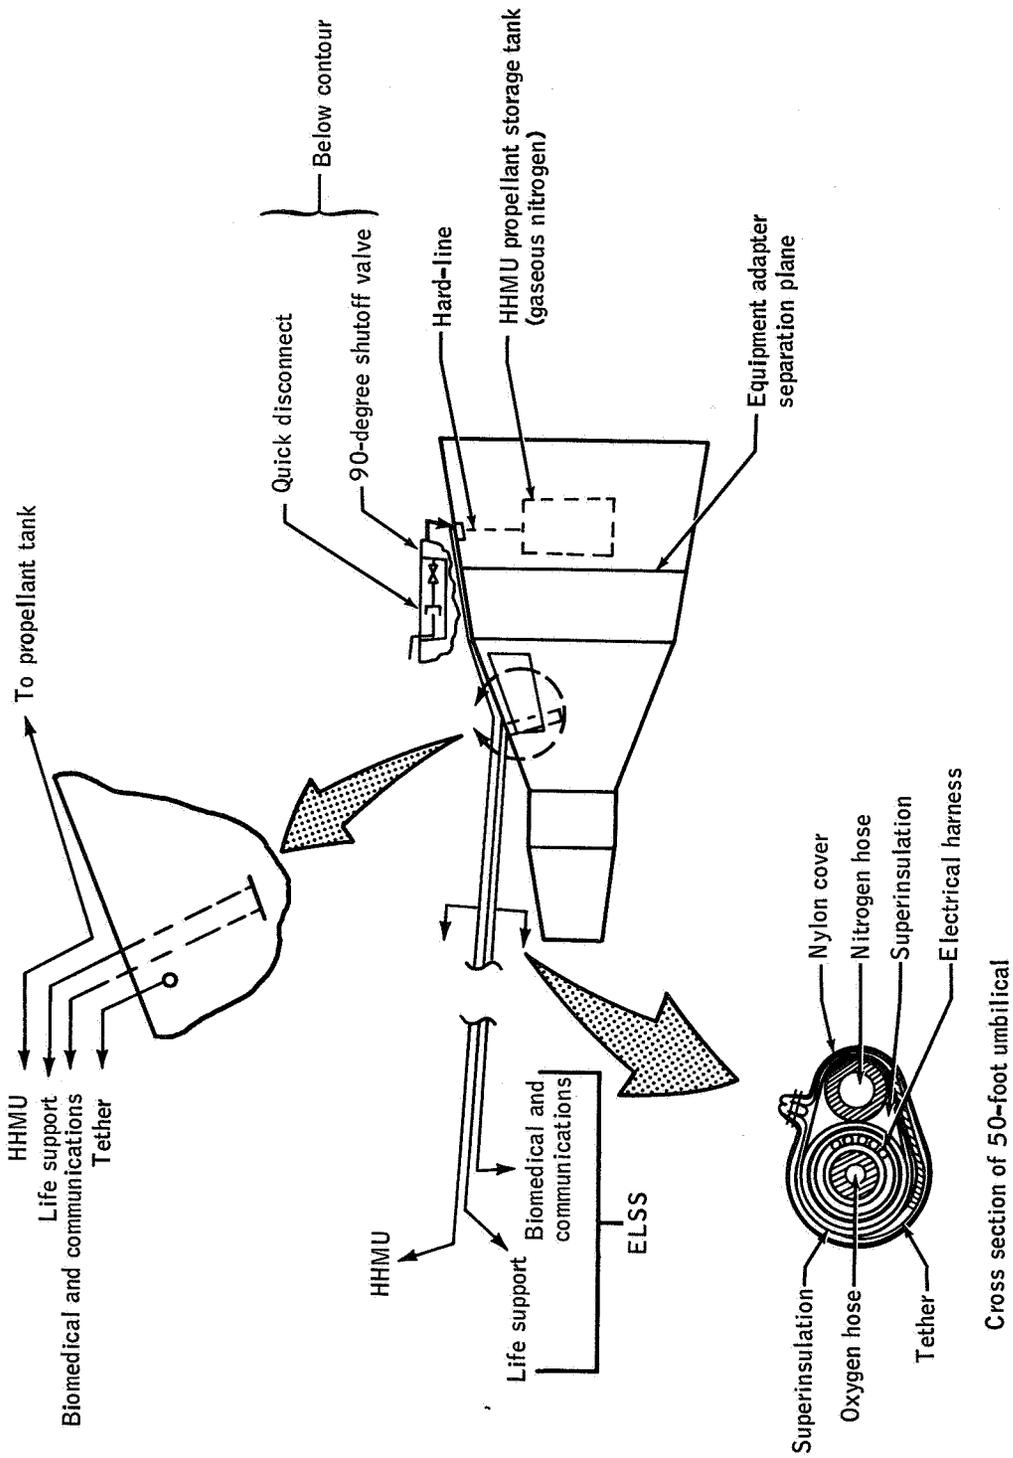
Figure 4.3-5. - Design and interface requirements of the 50-foot umbilical.

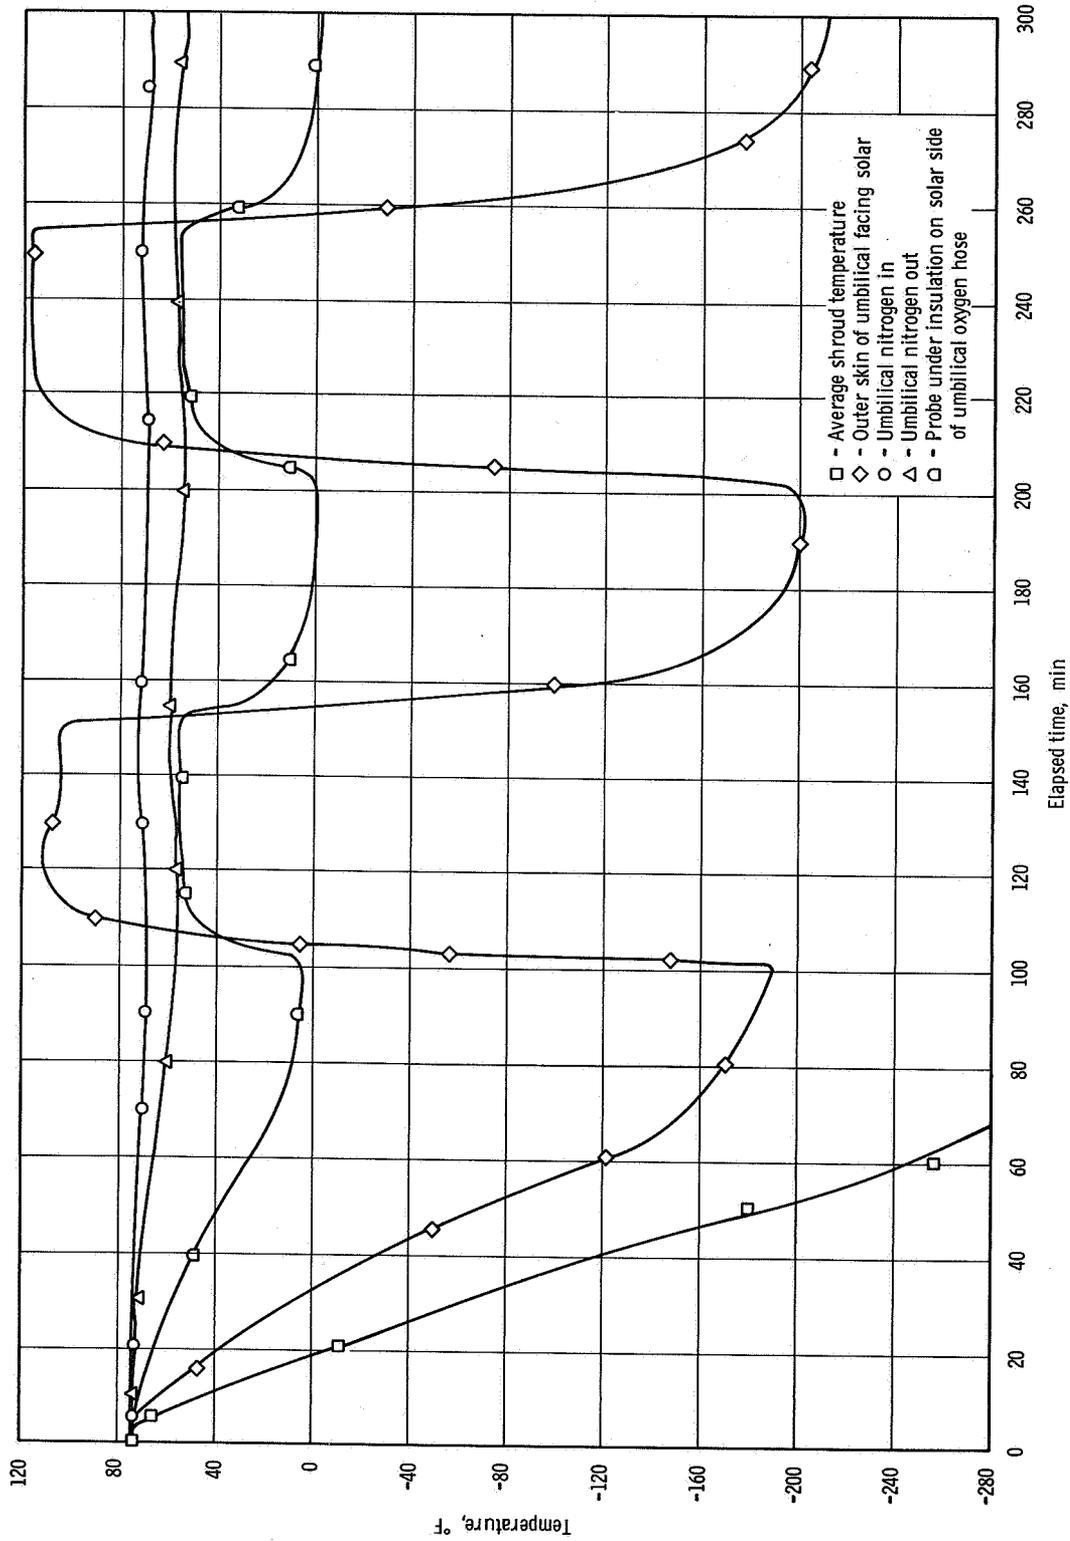
Figure 4.3-7. - Umbilical thermal test, June 14, 1965.

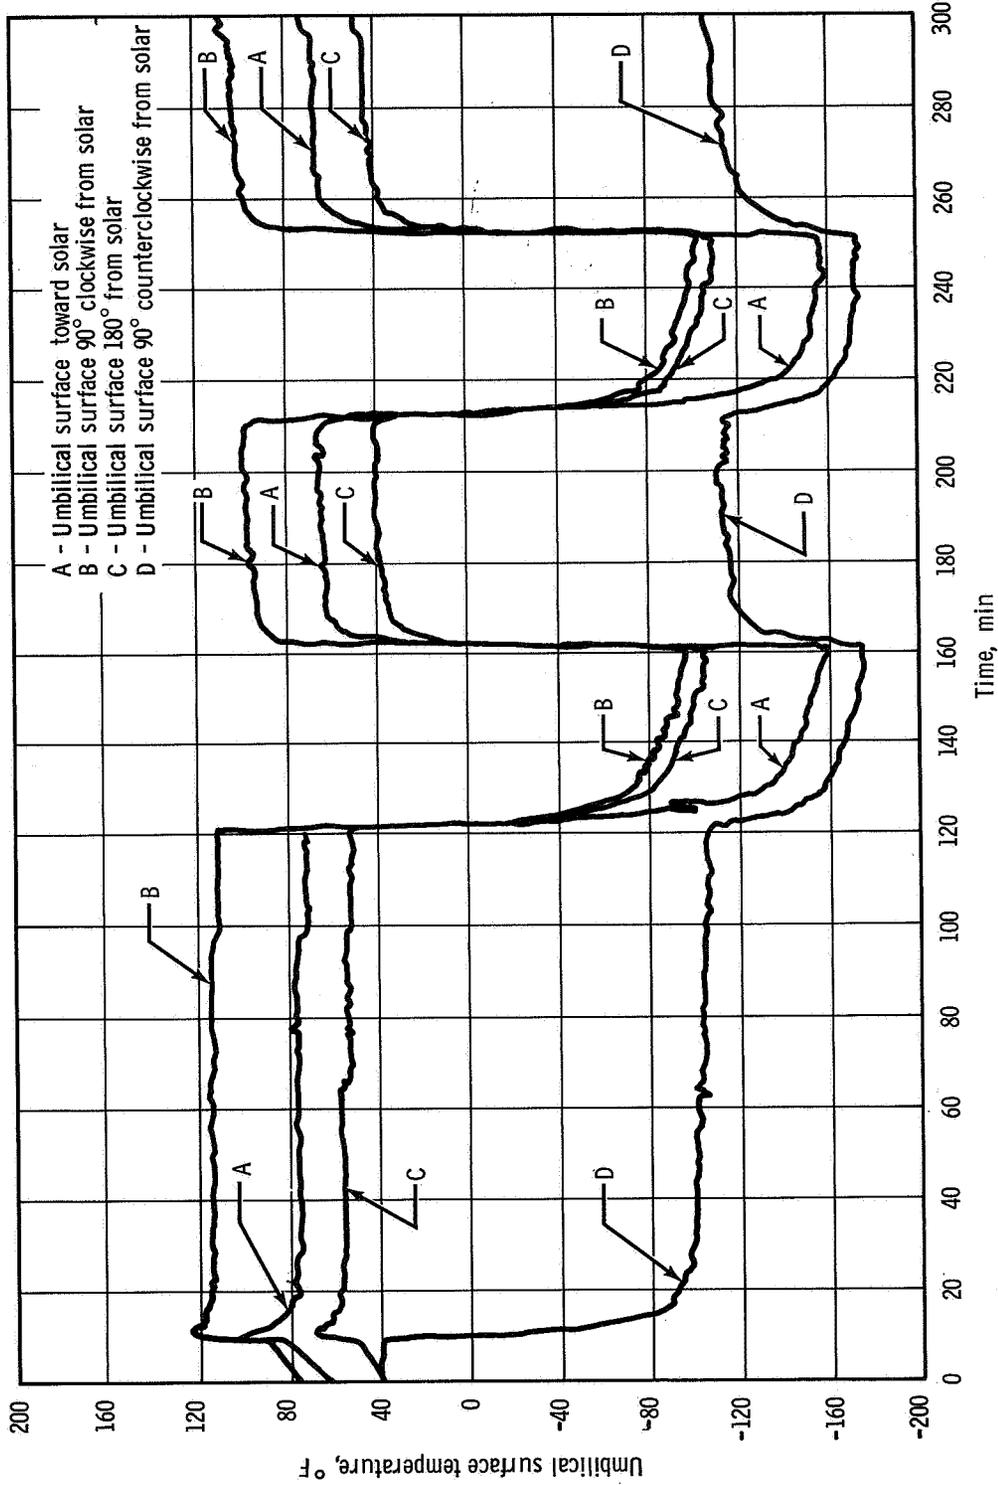
Figure 4.3-8. - Gemini ELSS environmental operation qualification test, umbilical surface temperature, test day 4.

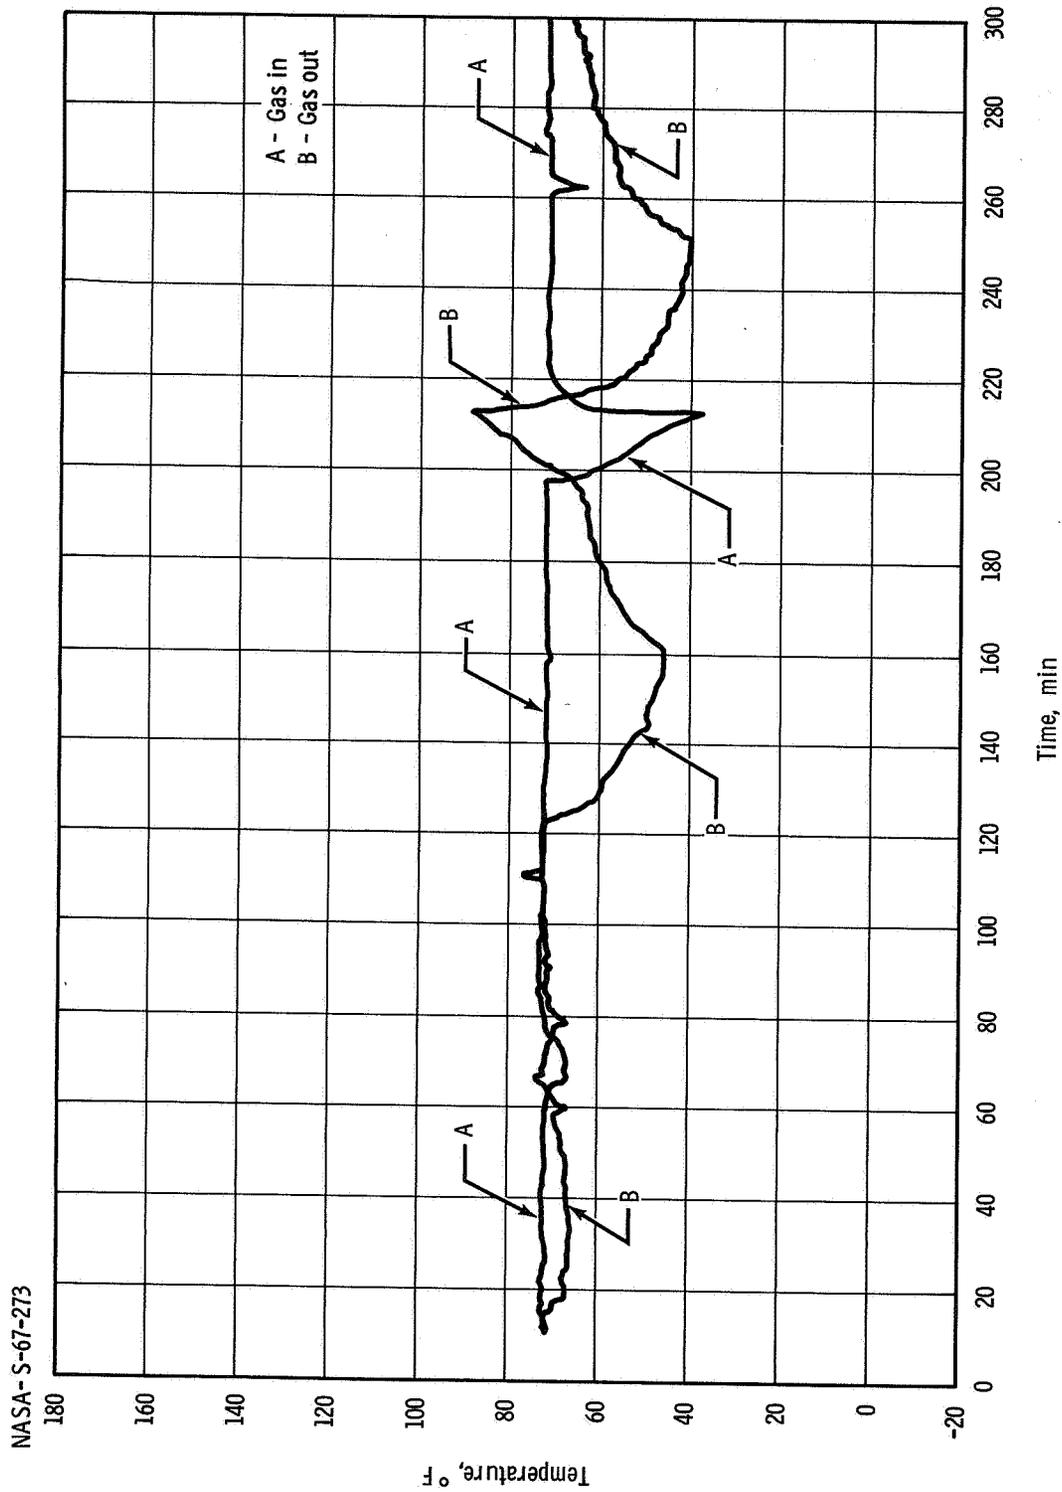
Figure 4.3-9. - Gemini ELSS environmental operation qualification test, umbilical gas temperature, test day 4.

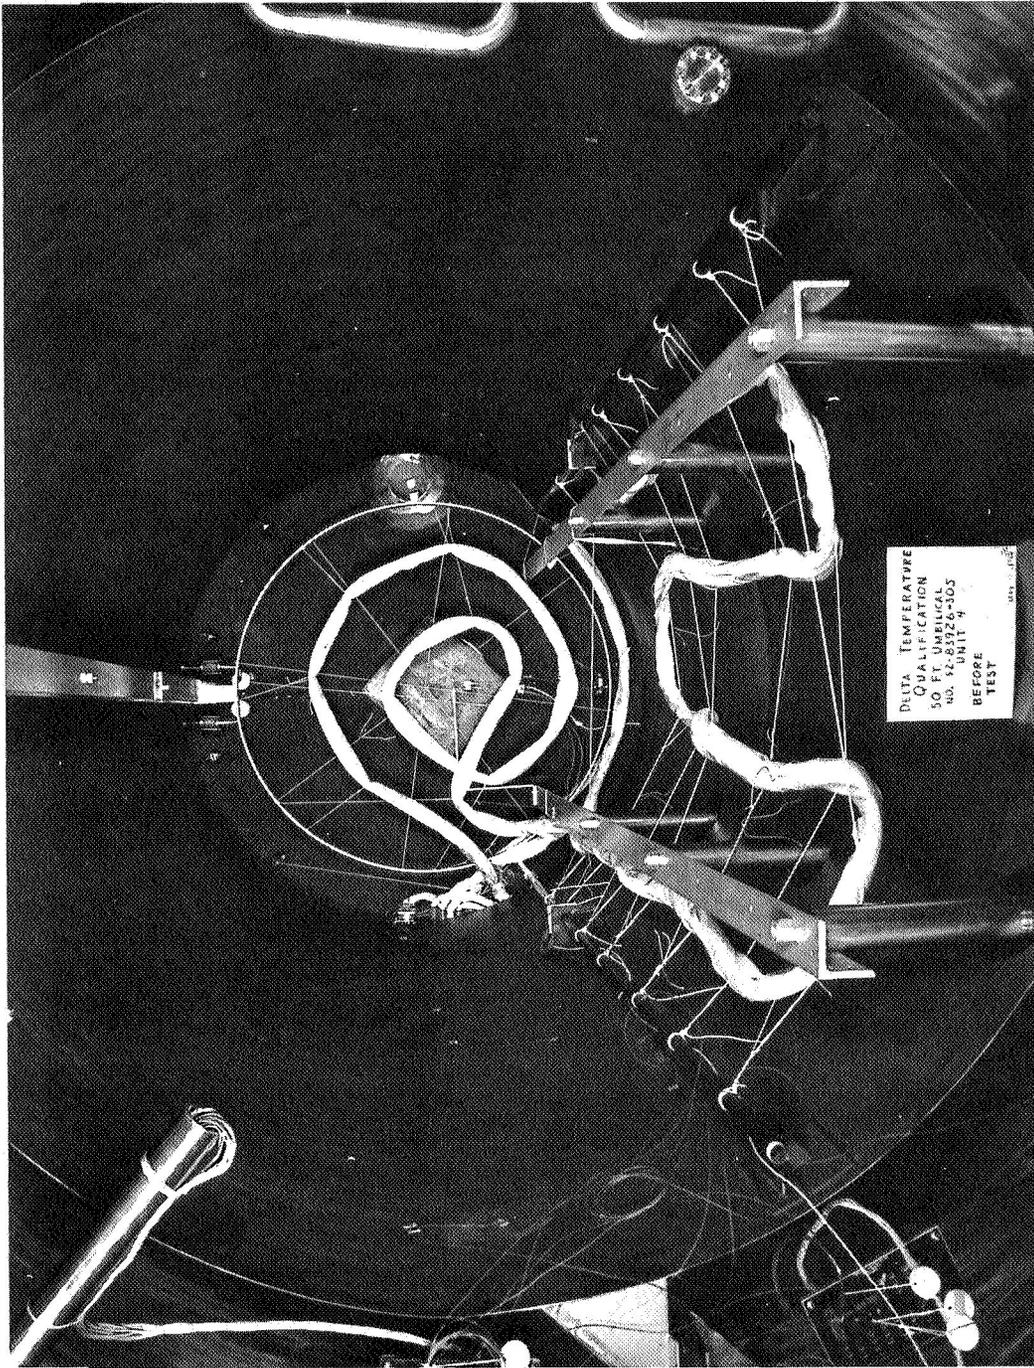
Figure 4.3-10. - Fifty-foot umbilical qualification test setup in Chamber E facility.

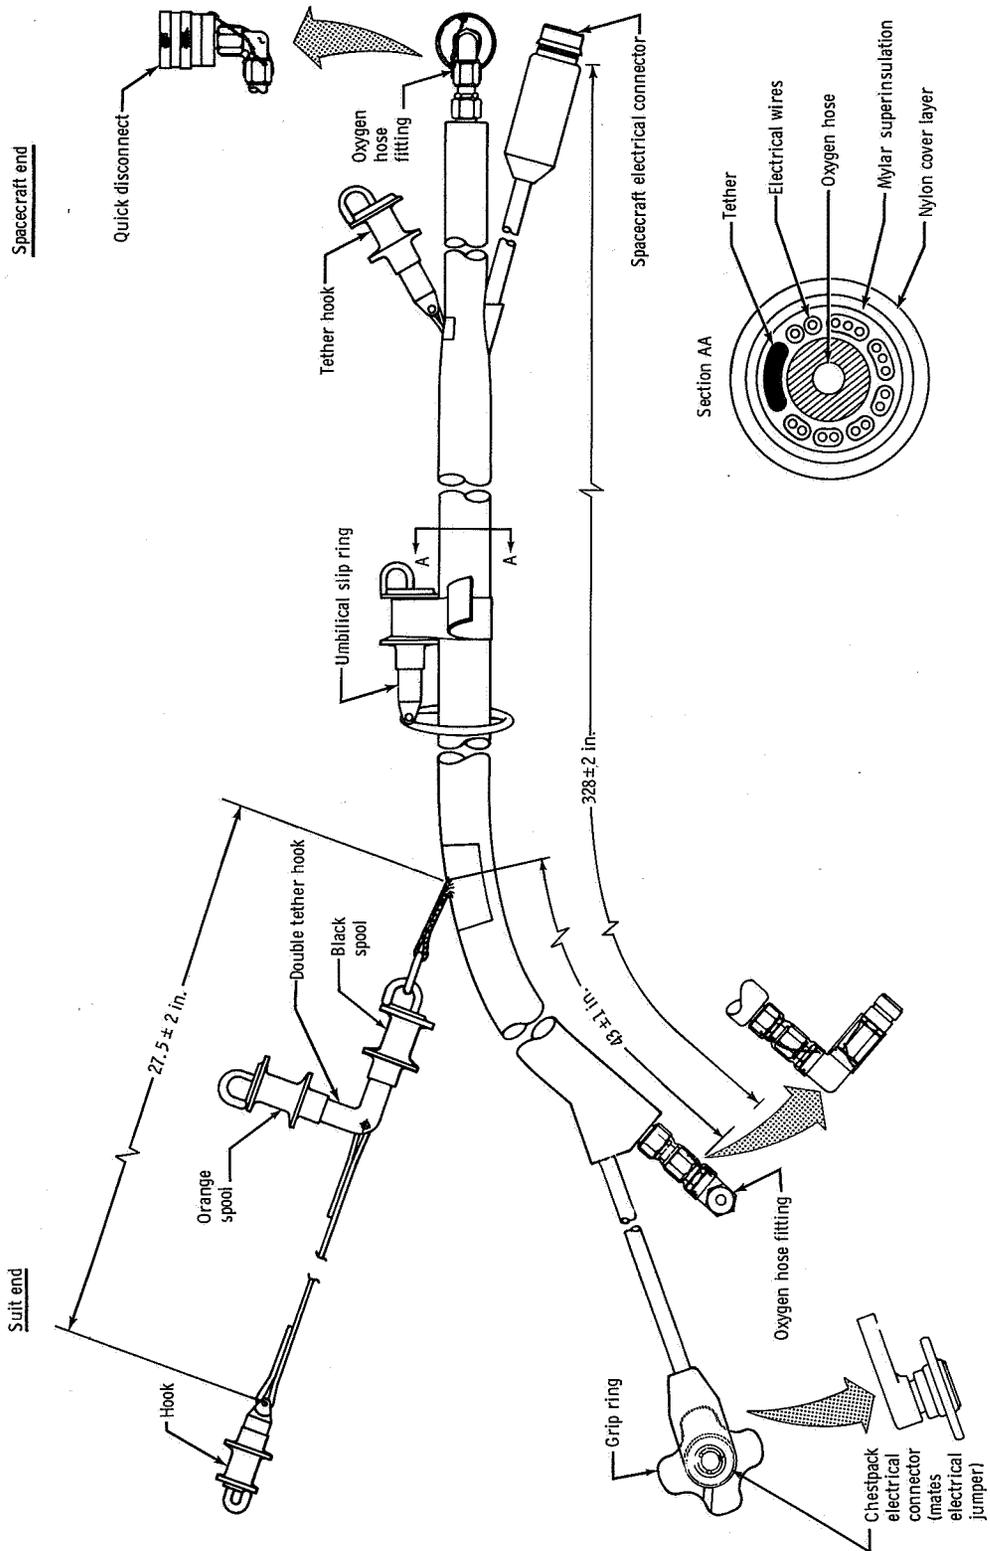
Figure 4.3-15. - ELSS 25-foot umbilical used for Gemini VIII.

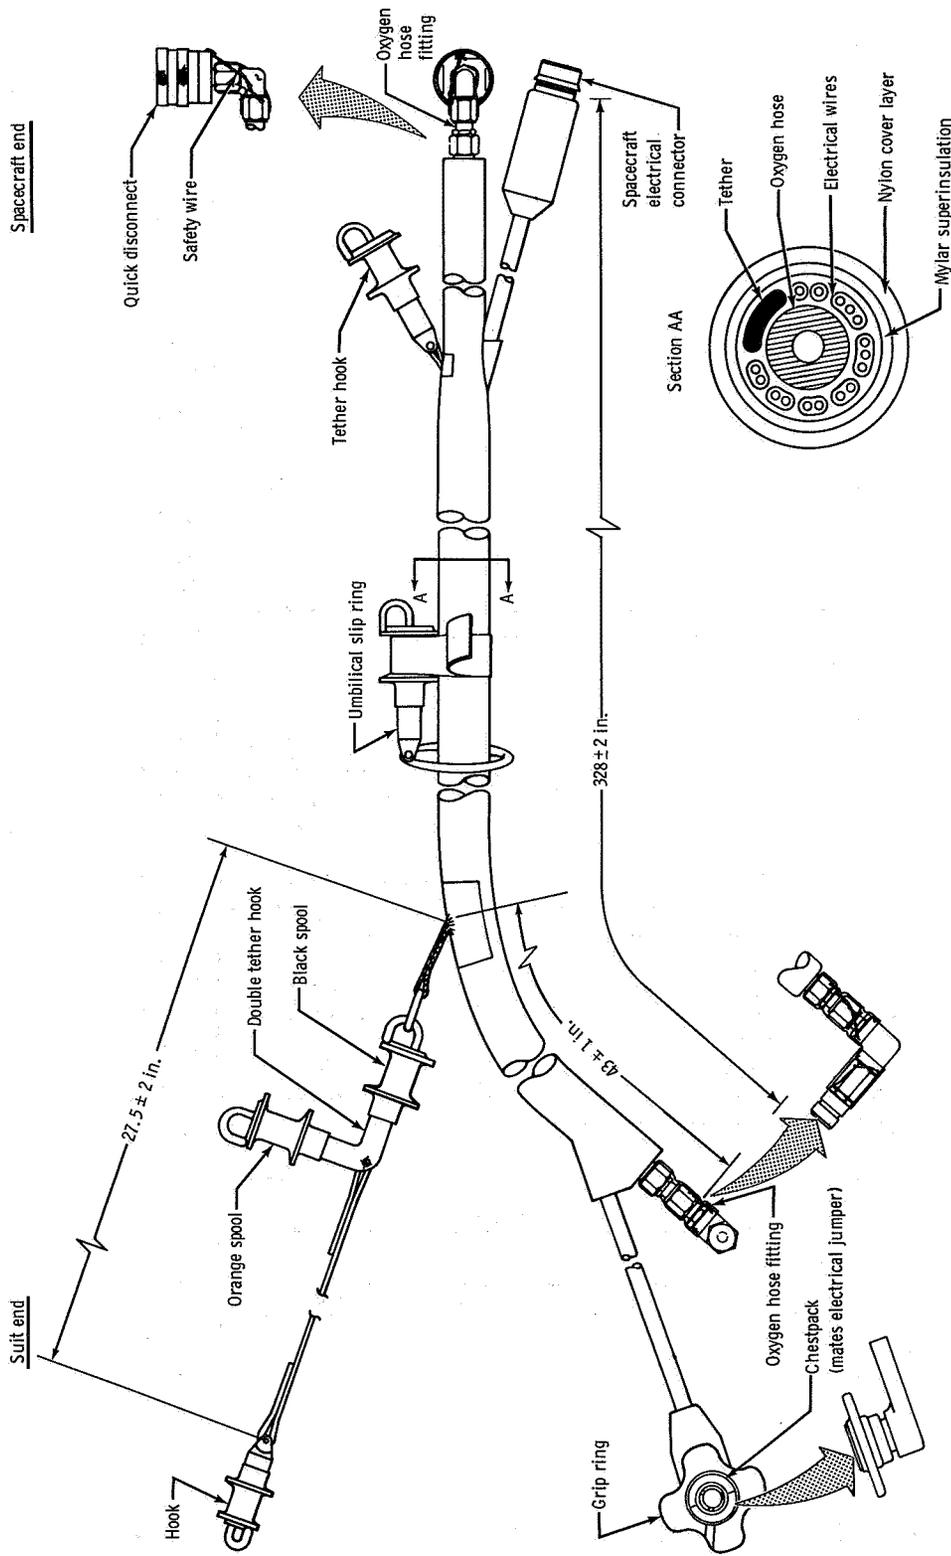
Figure 4.3-17. - ELSS-25 foot umbilical used for Gemini IX-A.

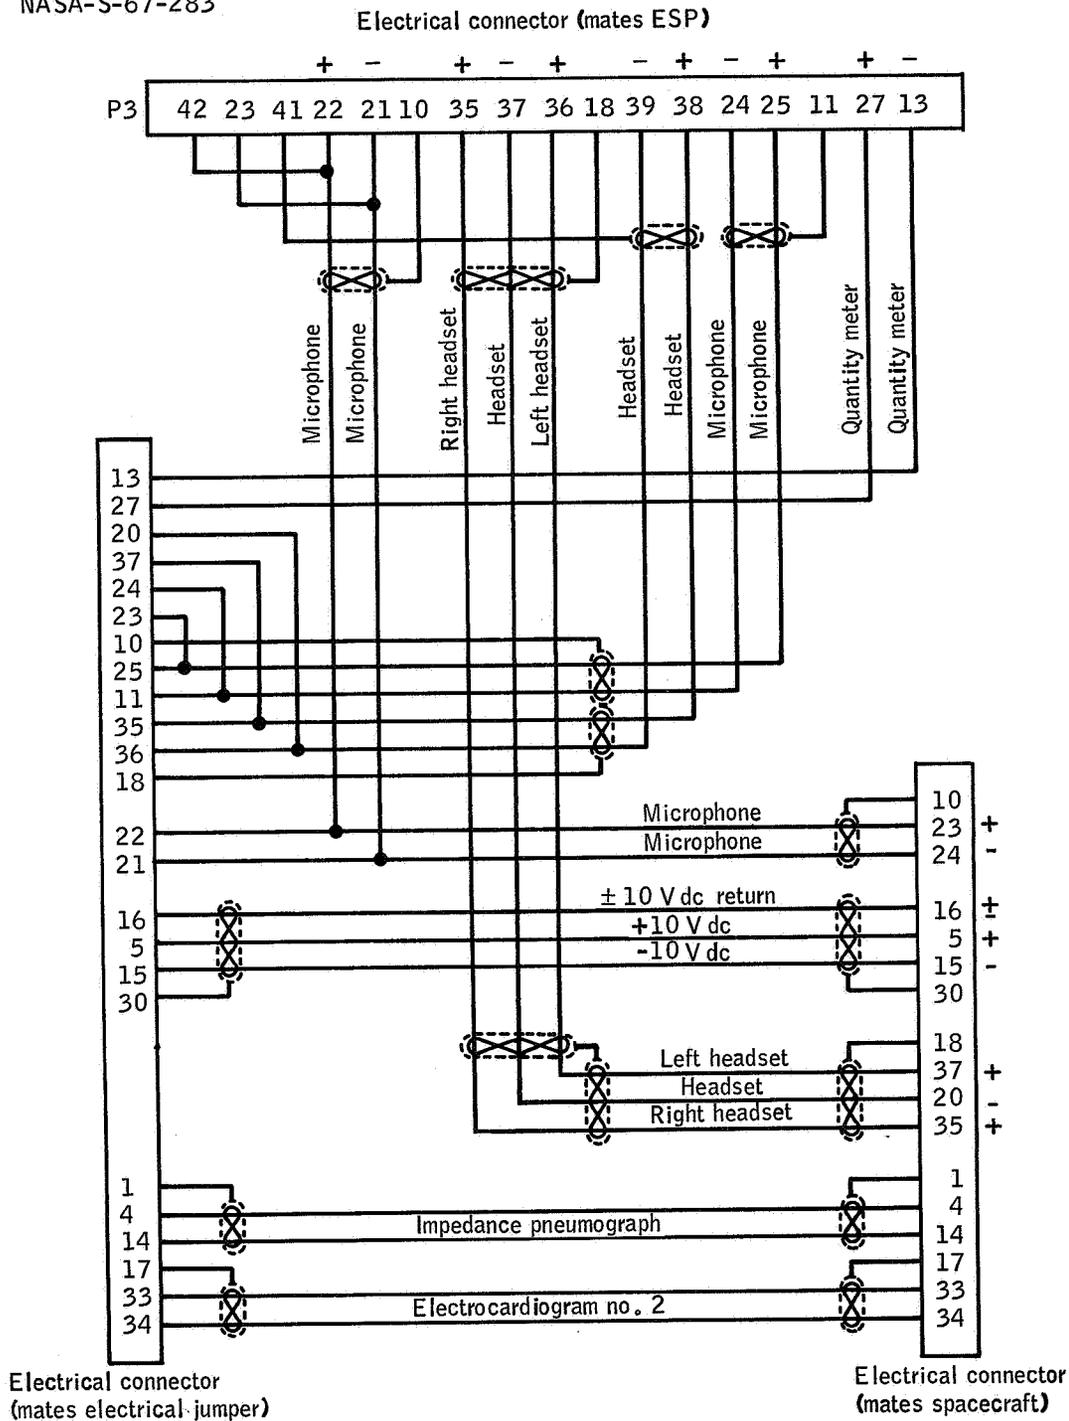
Figure 4.3-20. - Electrical schematic of 75-foot electrical tether.

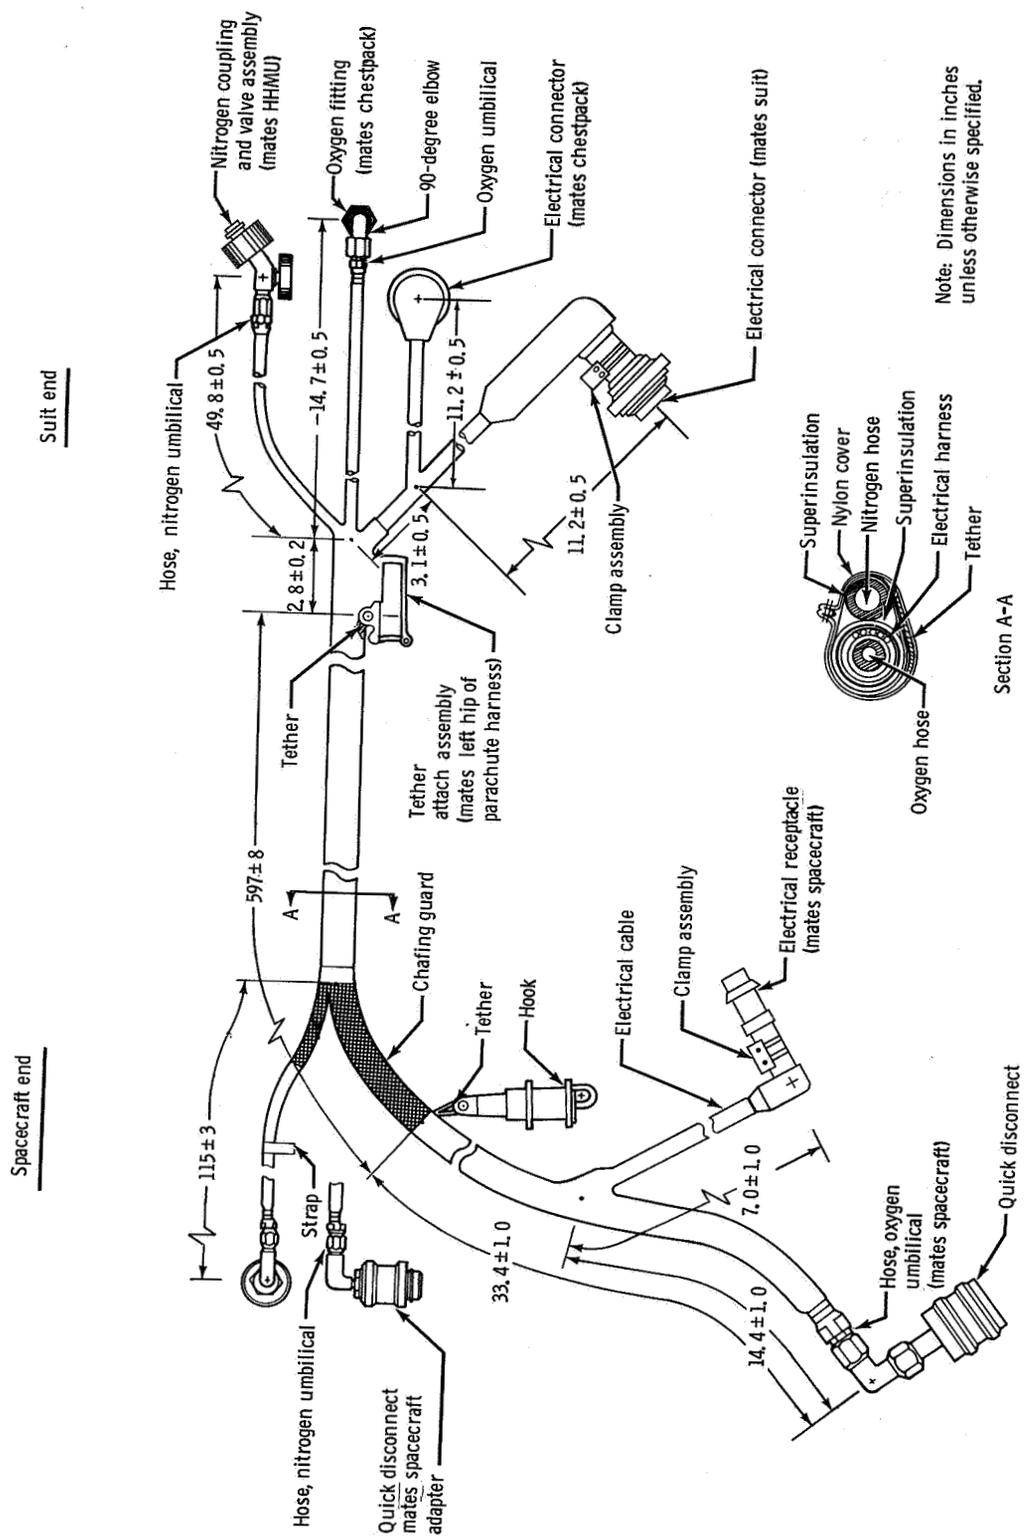
Note: Dimensions in inches unless otherwise specified.

Figure 4.3-21. - ELSS 50-foot umbilical.

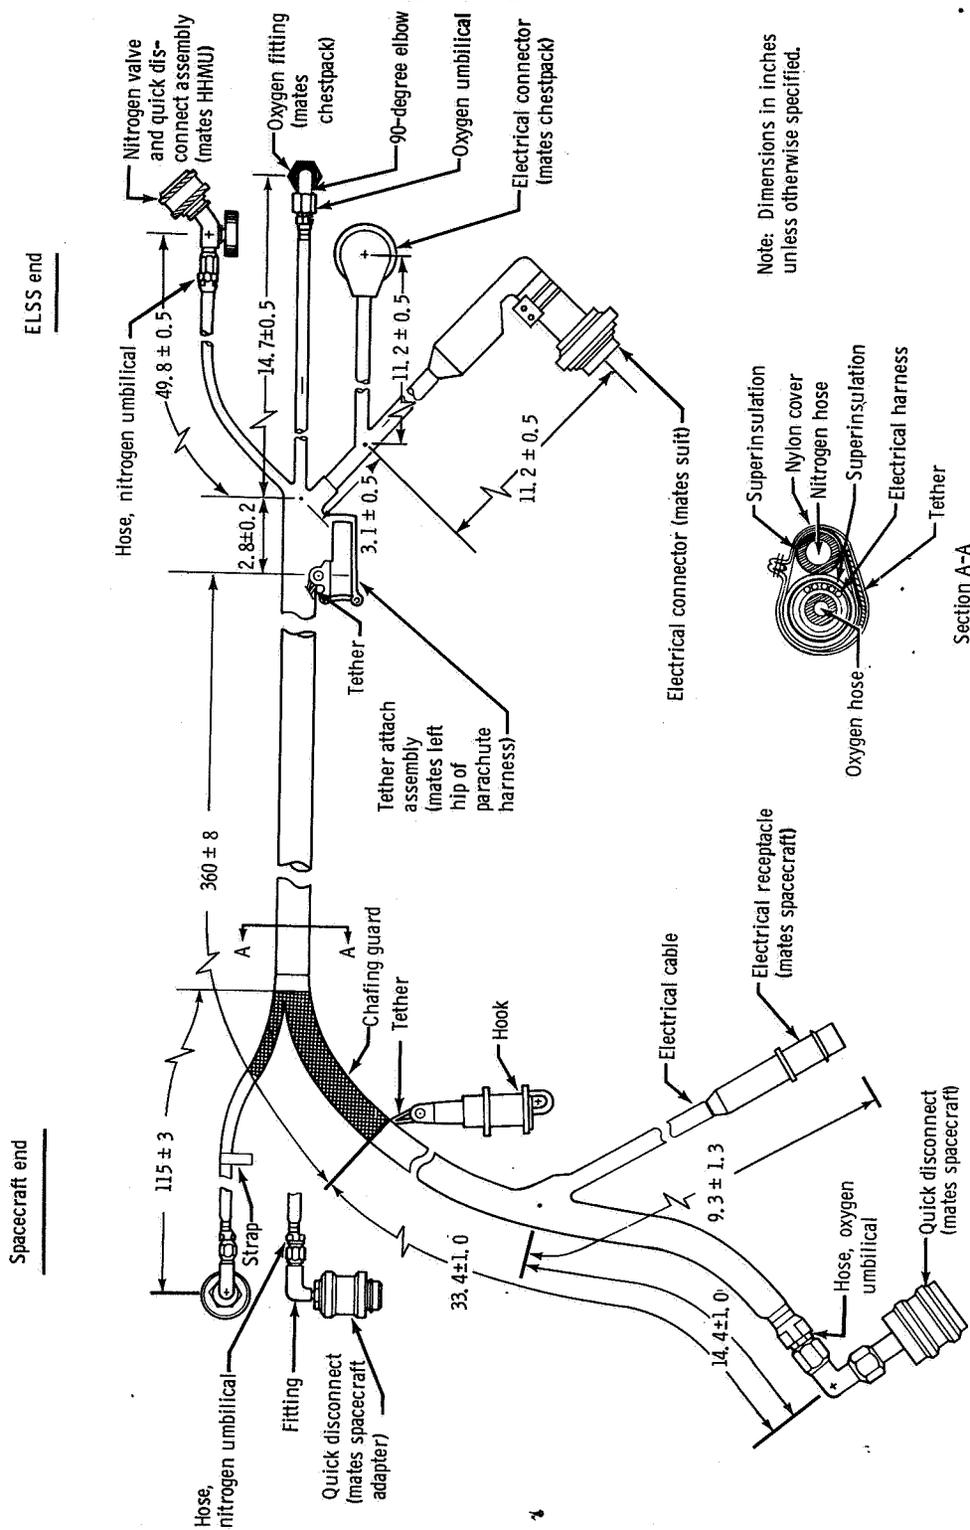
Figure 4.3-23. - ELSS 30-foot umbilical.
