**SUMMARY OF  
GEMINI EXTRAVEHICULAR  
ACTIVITY**

Reginald M. Machell  
Manned Spacecraft Center, NASA  
Houston, Texas

*Scientific and Technical Information Division*  
OFFICE OF TECHNOLOGY UTILIZATION  
NATIONAL AERONAUTICS AND SPACE ADMINISTRATION  
1967  
*Washington, D.C.*

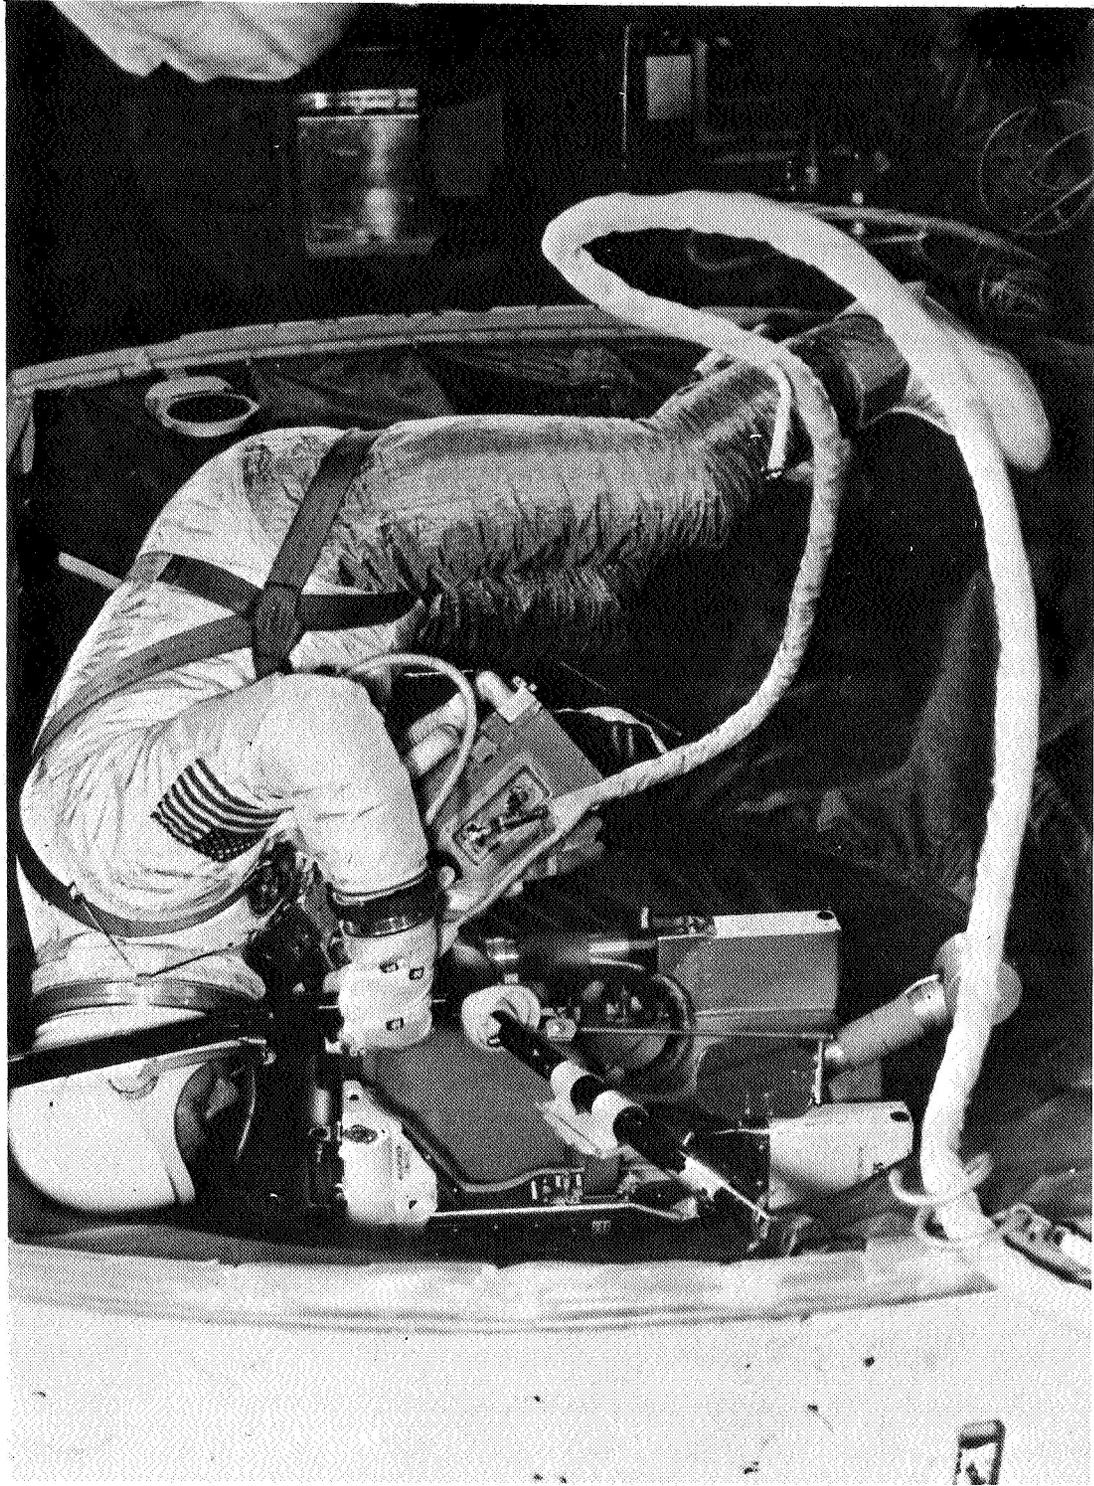
Figure 5.1.1-1. - AMU donning without foot restraints in zero-g aircraft.

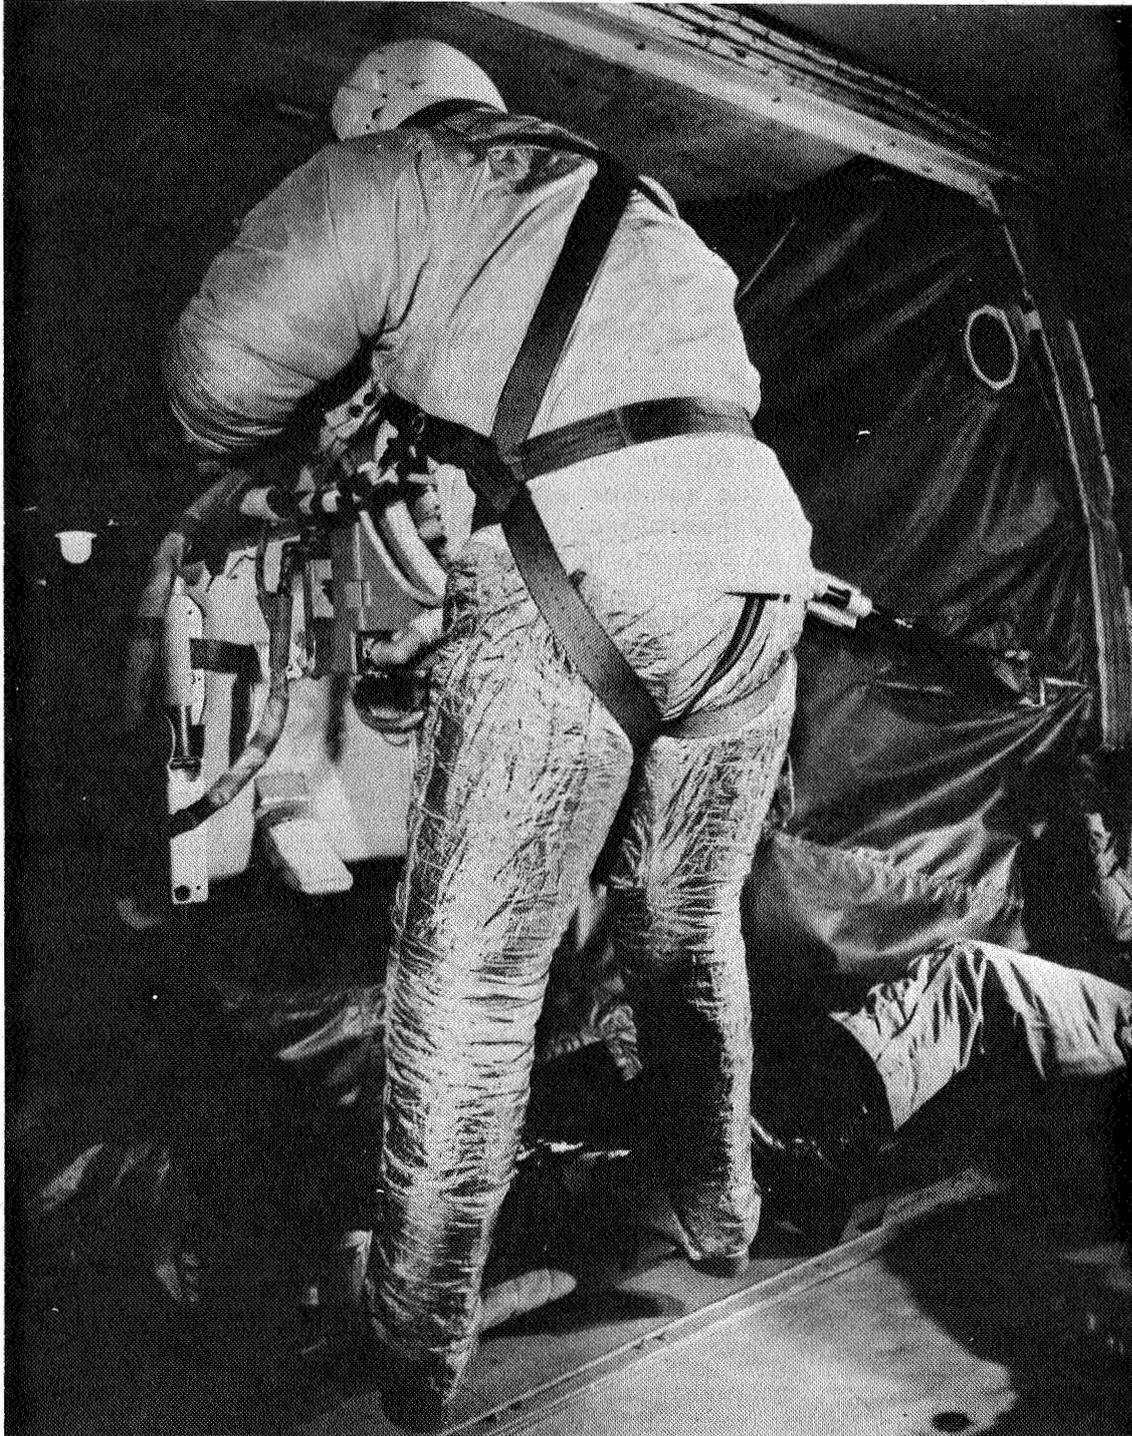
Figure 5.1-2. - AMU donning with foot stirrups in zero-g aircraft.

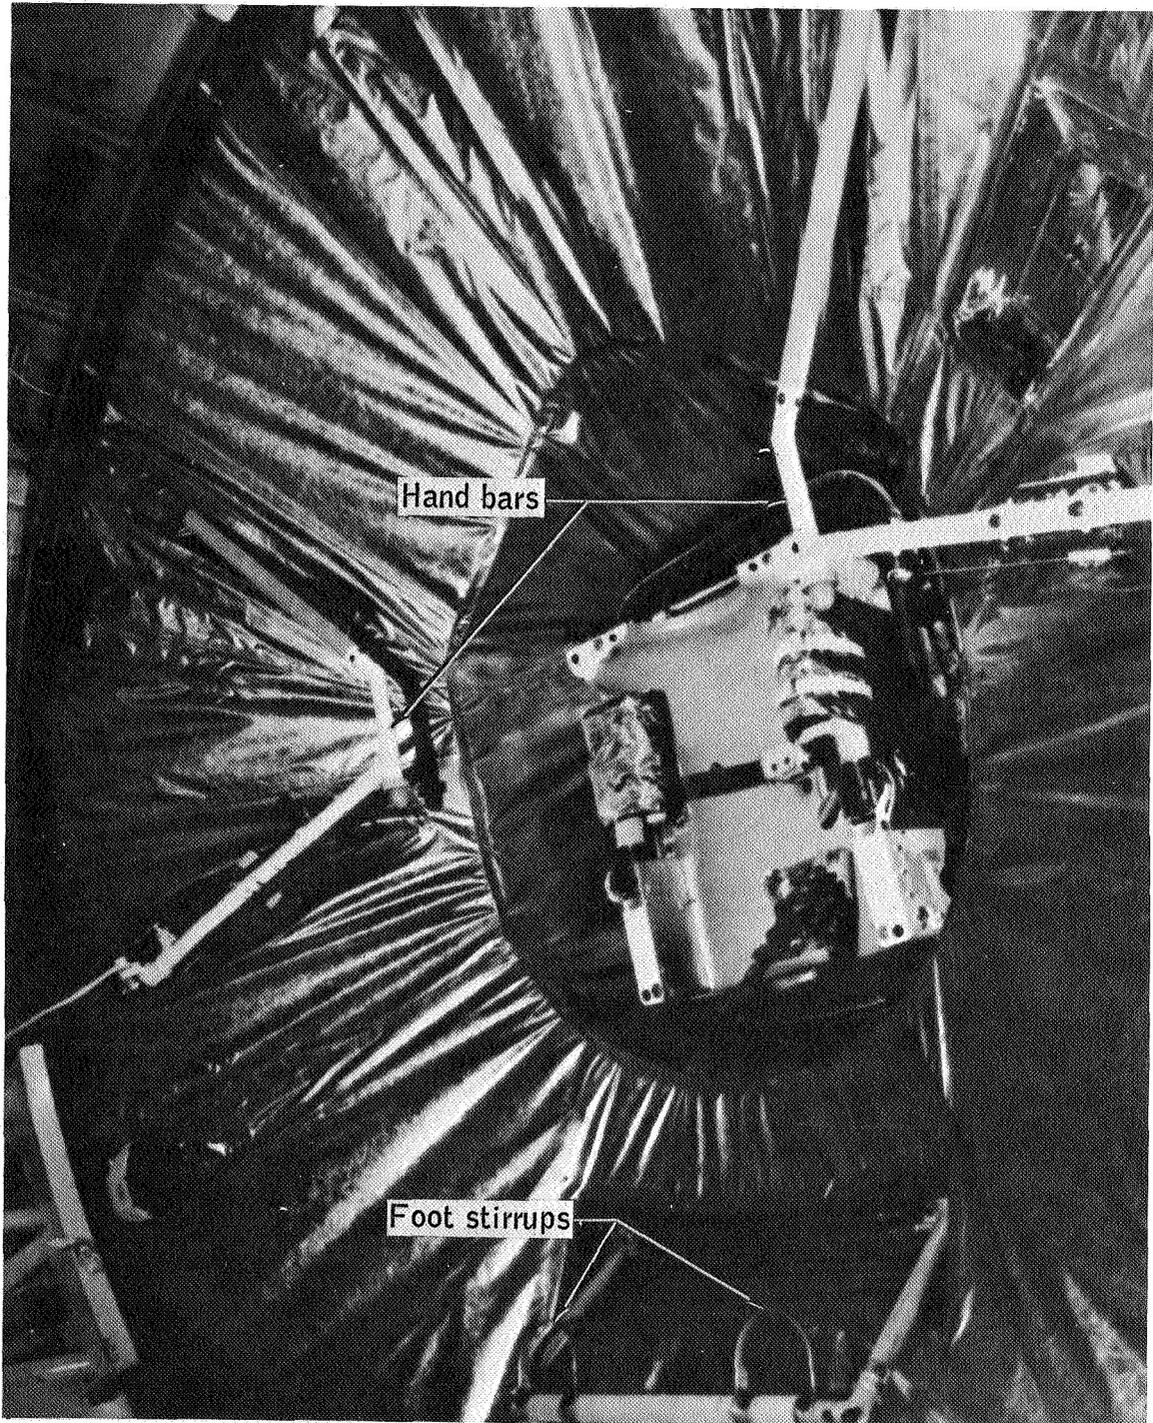
Figure 5.2-2. - Gemini IX-A adapter provisions for EVA.

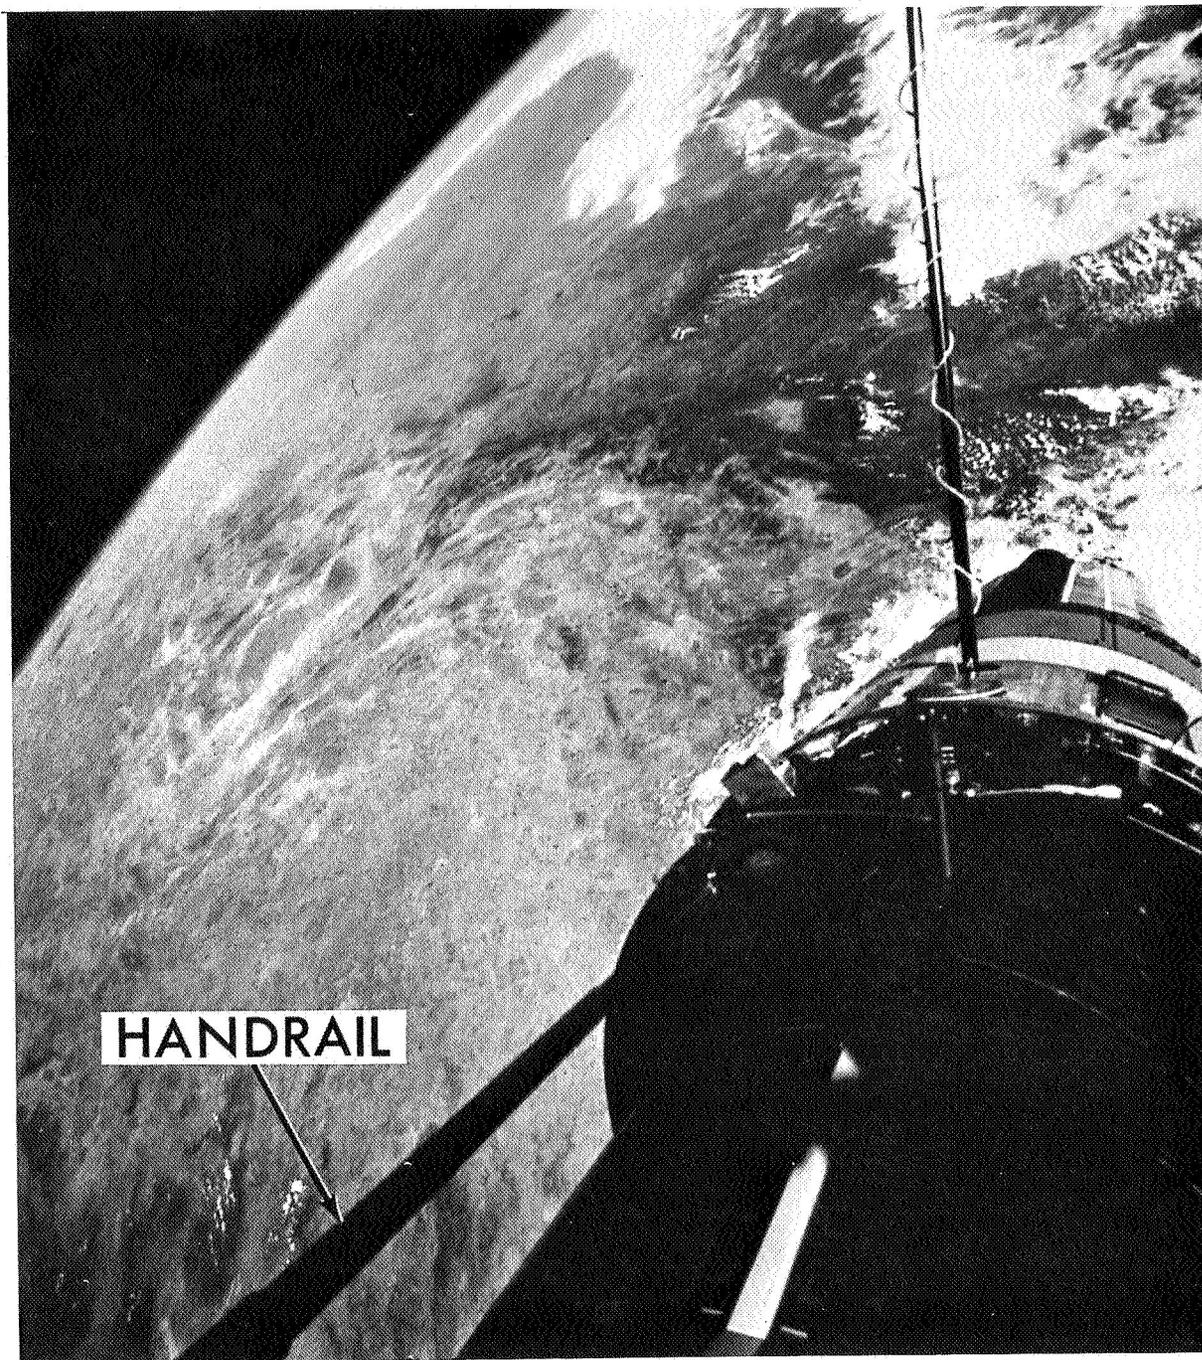
Figure 5.2-5. - Telescoping handrail used on Gemini XII.

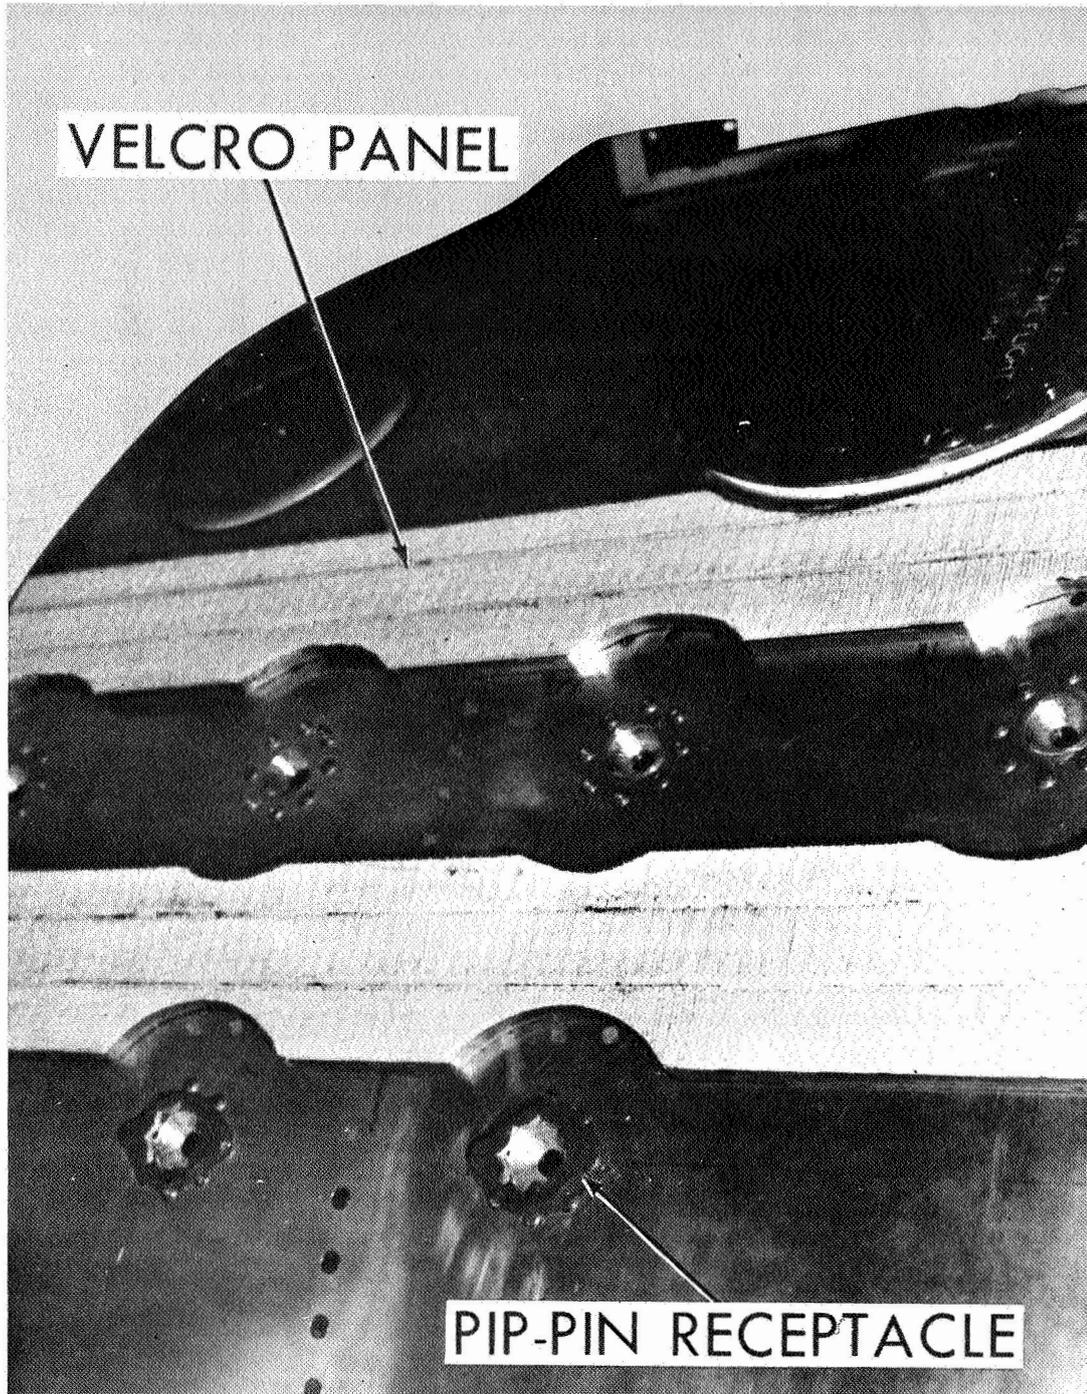
Figure 5.2-12. - EVA restraint provisions on Gemini XII GATV.

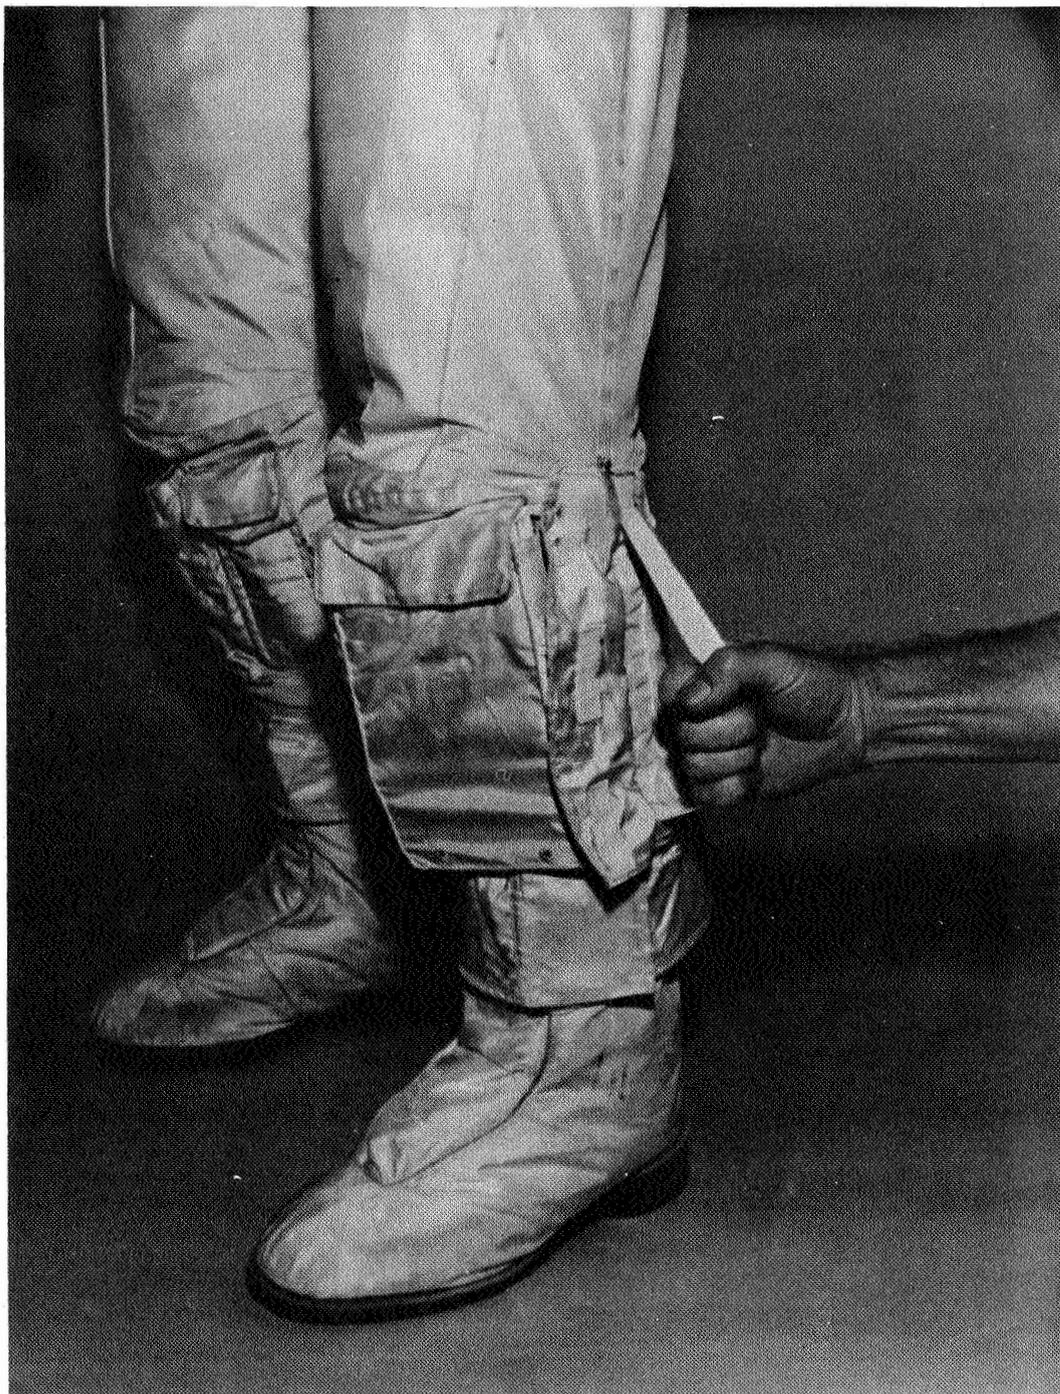
Figure 5.2-14. - Strap on space suit leg.

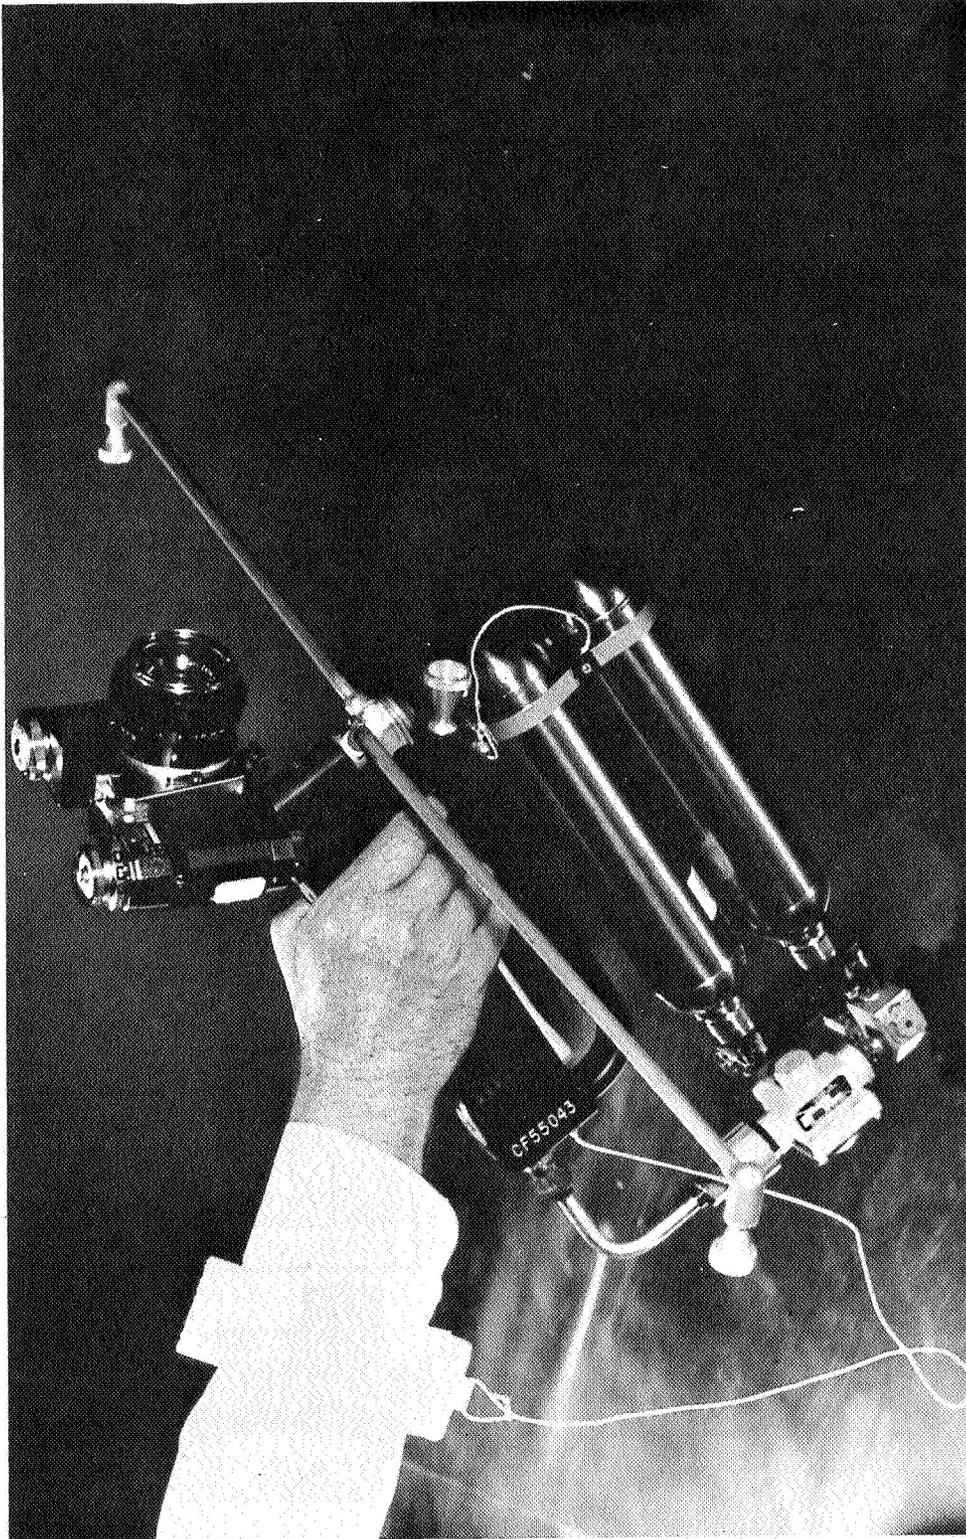
Figure 6.1.1-1. - Gemini IV Hand Held Maneuvering Unit.

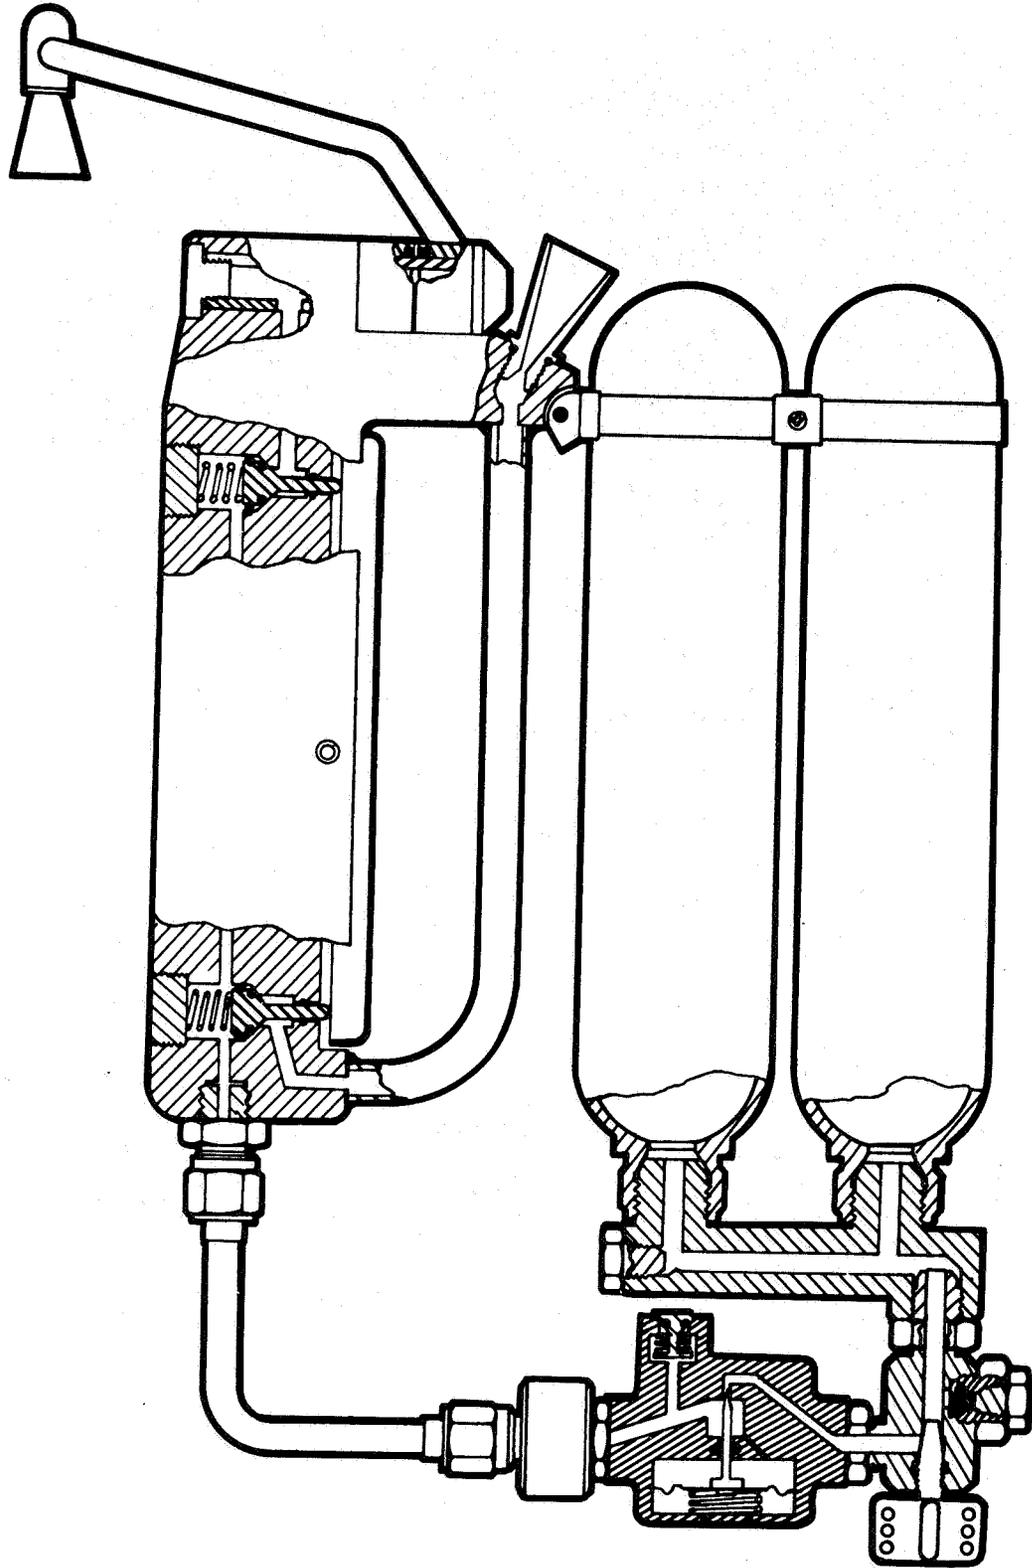
Figure 6.1-2. - Cutaway of Gemini IV Hand Held Maneuvering Unit.

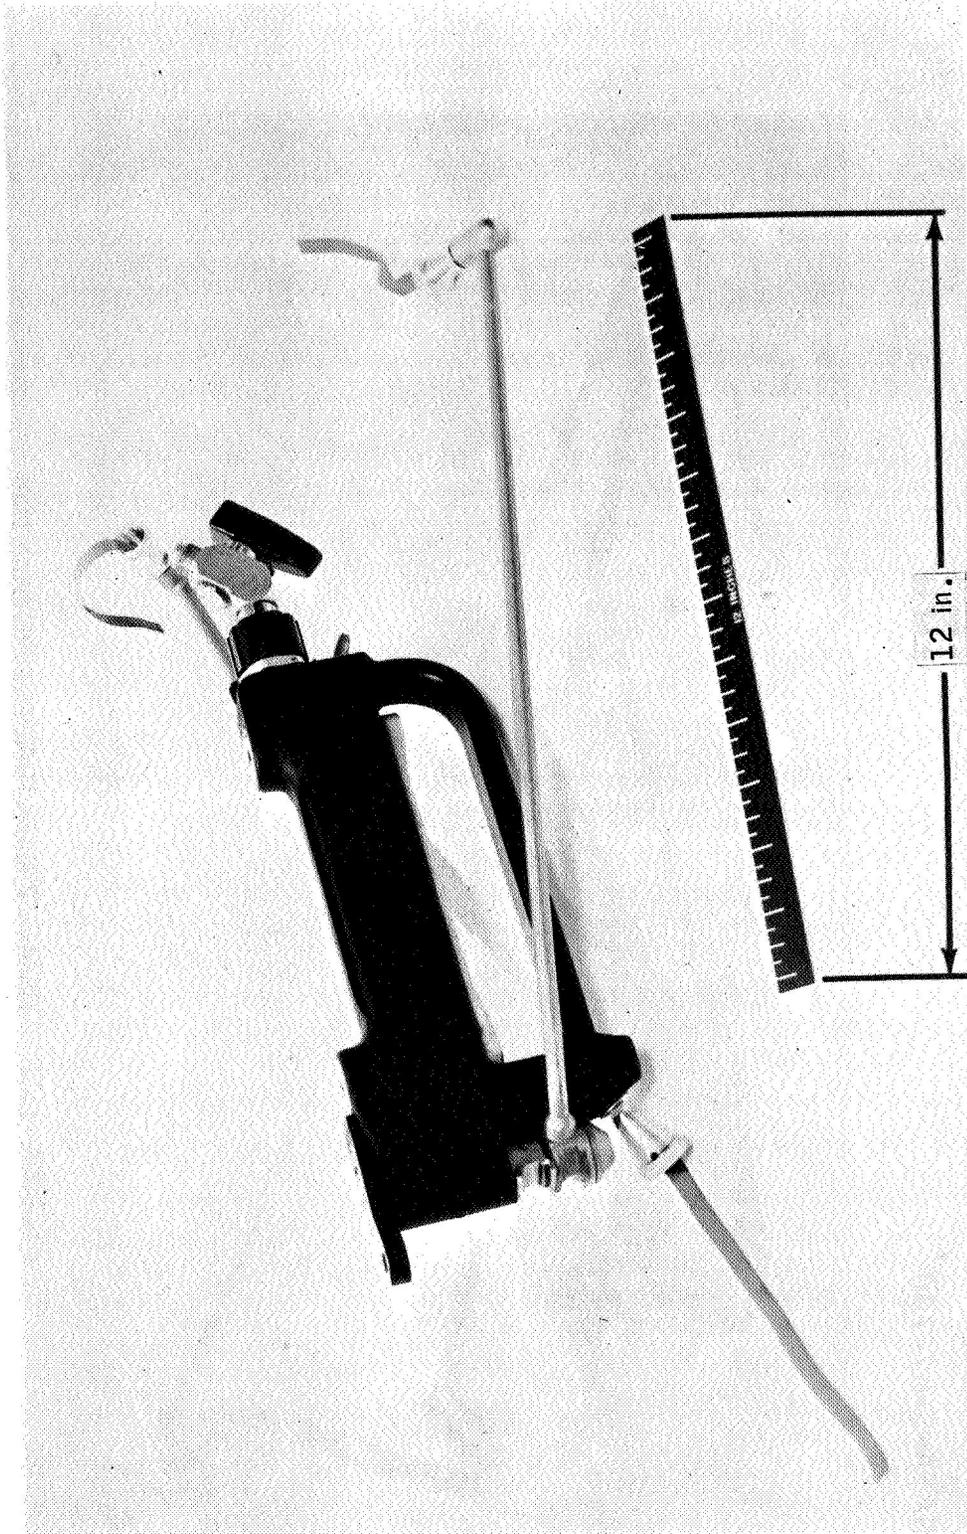
Figure 6.1-3. - Gemini VIII Hand Held Maneuvering Unit.

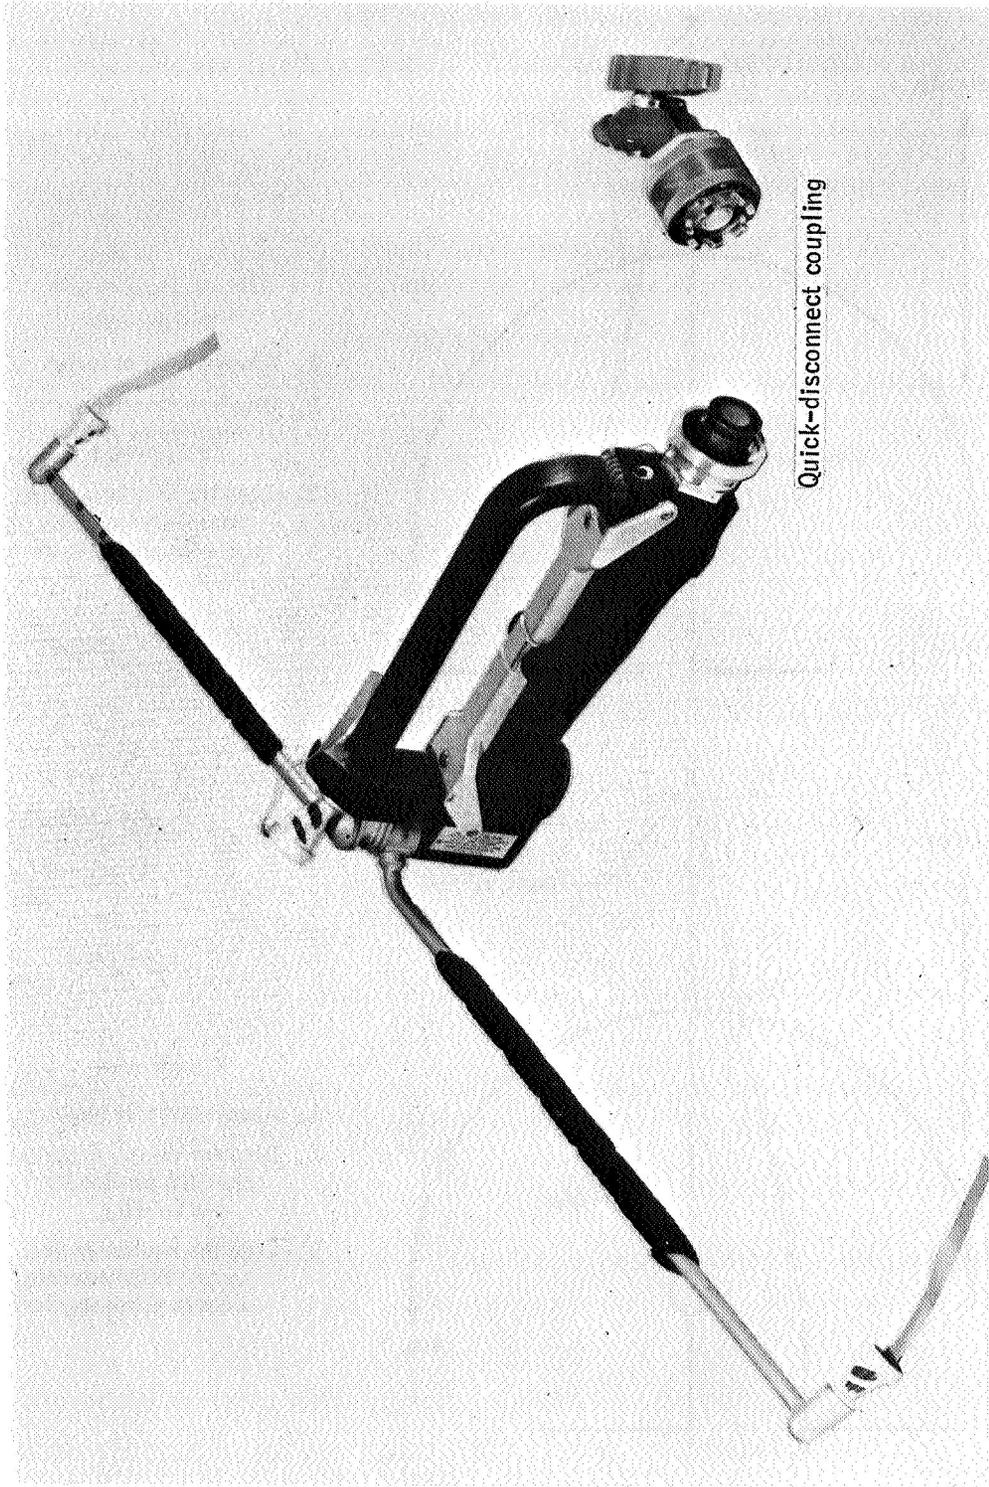
Figure 6.1-5. - Gemini  $\Xi$  Hand Held Maneuvering Unit.

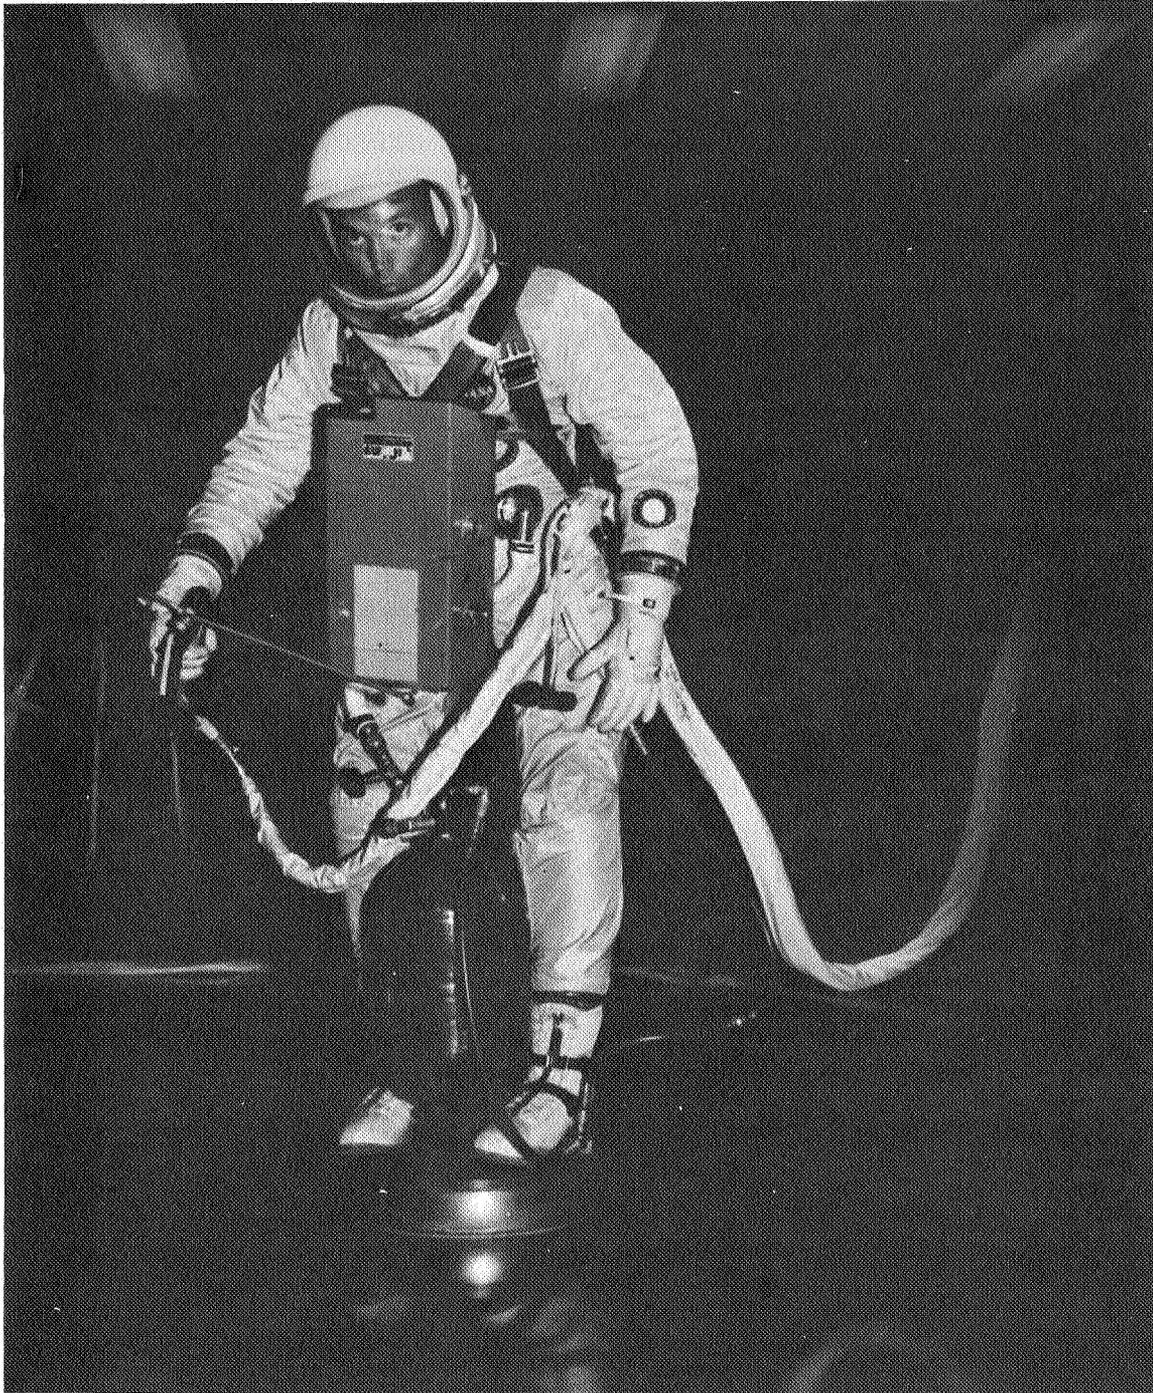
Figure 6.1-7. - HHMU air-bearing simulation (yaw-axis training).

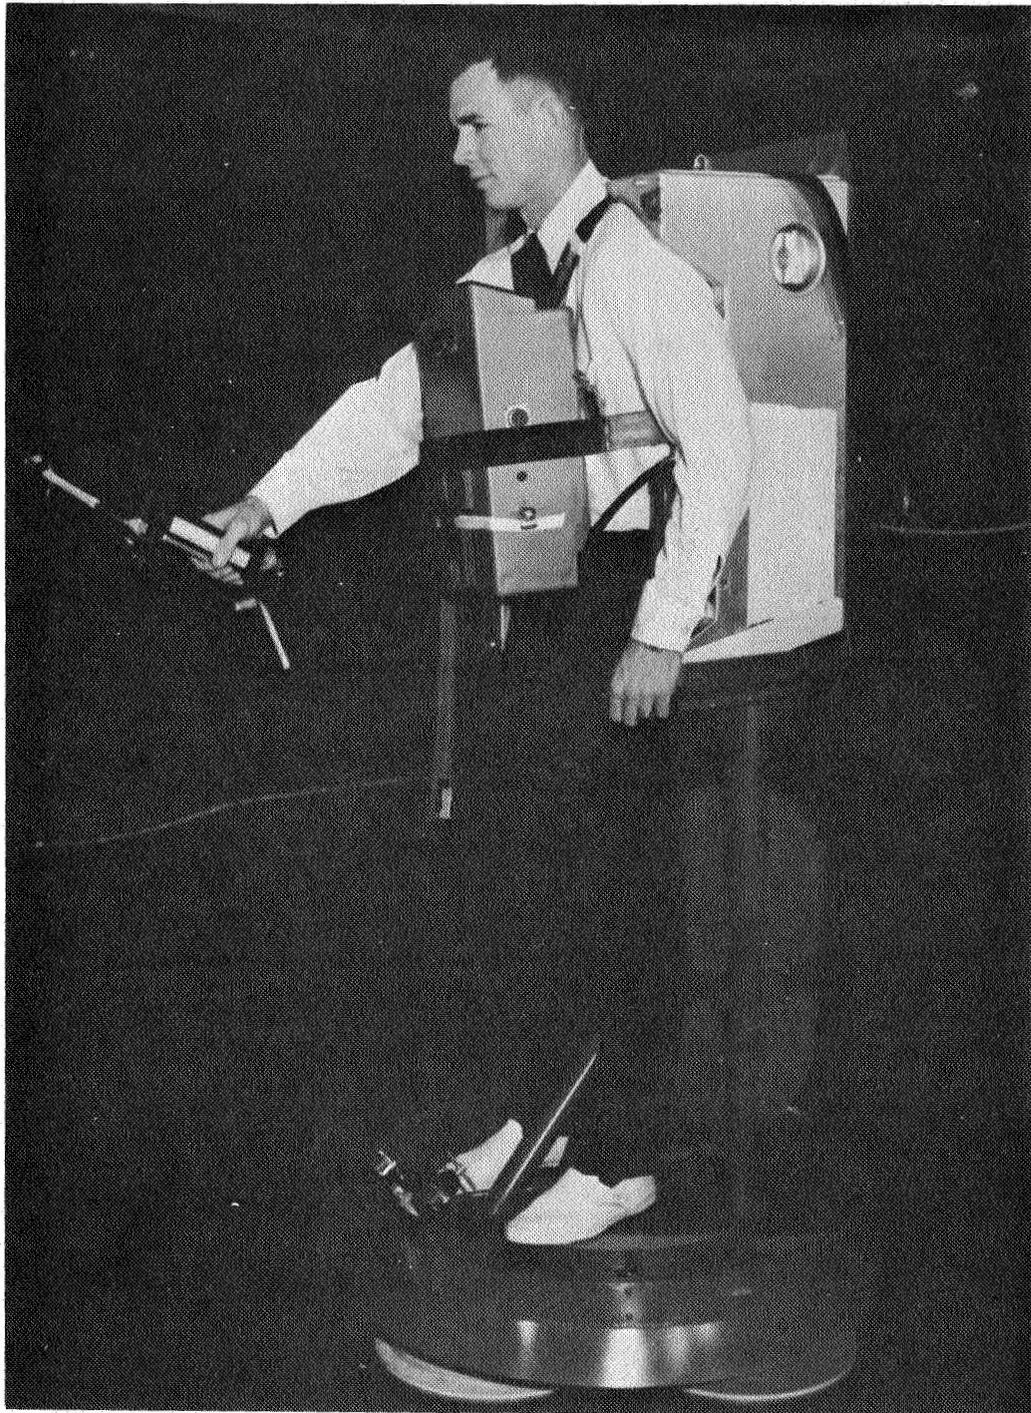
Figure 6.1-8. - HHMU/ESP air-bearing simulation (yaw-axis training).

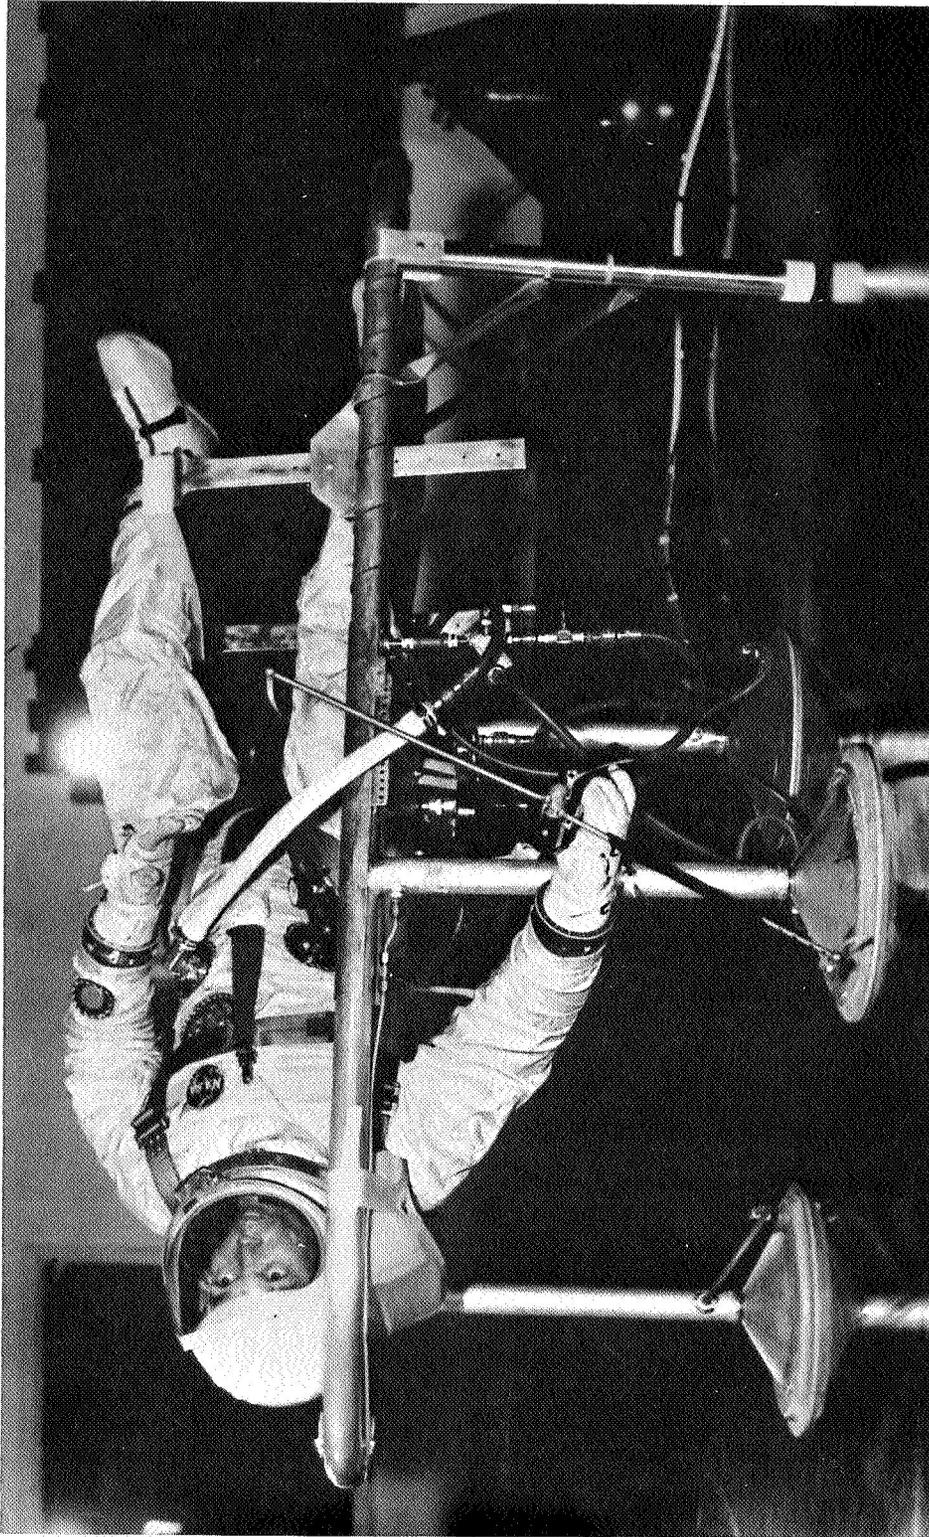
Figure 6.1-9. - HHMU air-bearing simulation (pitch-axis training).

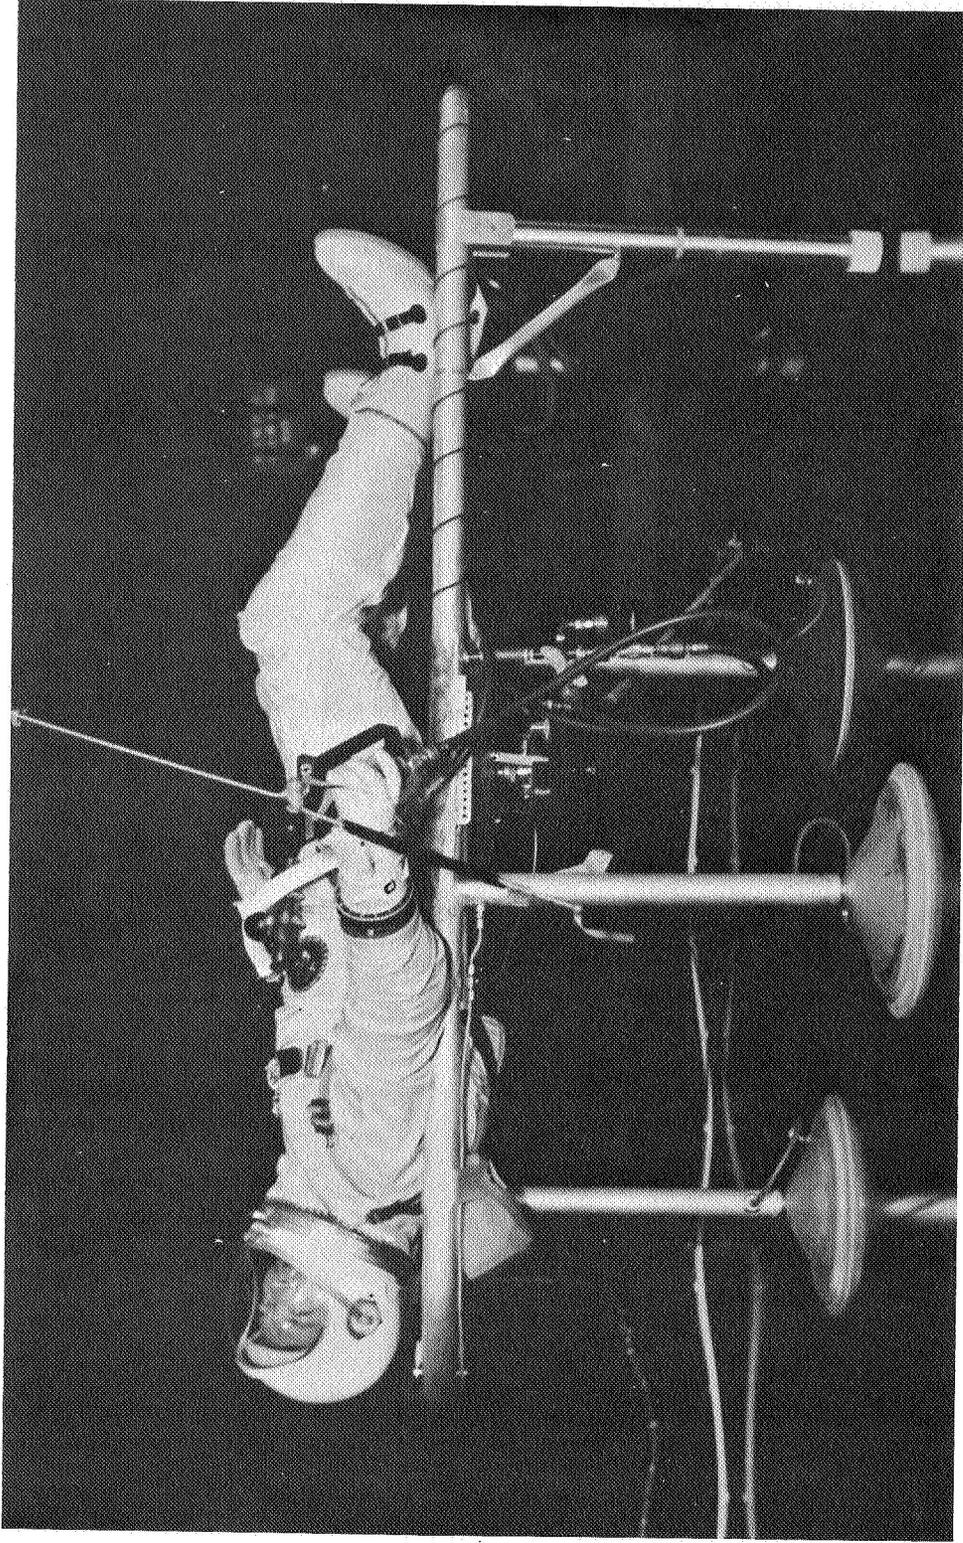
Figure 6.1-10. - HHMU air-bearing simulation (roll-axis training).

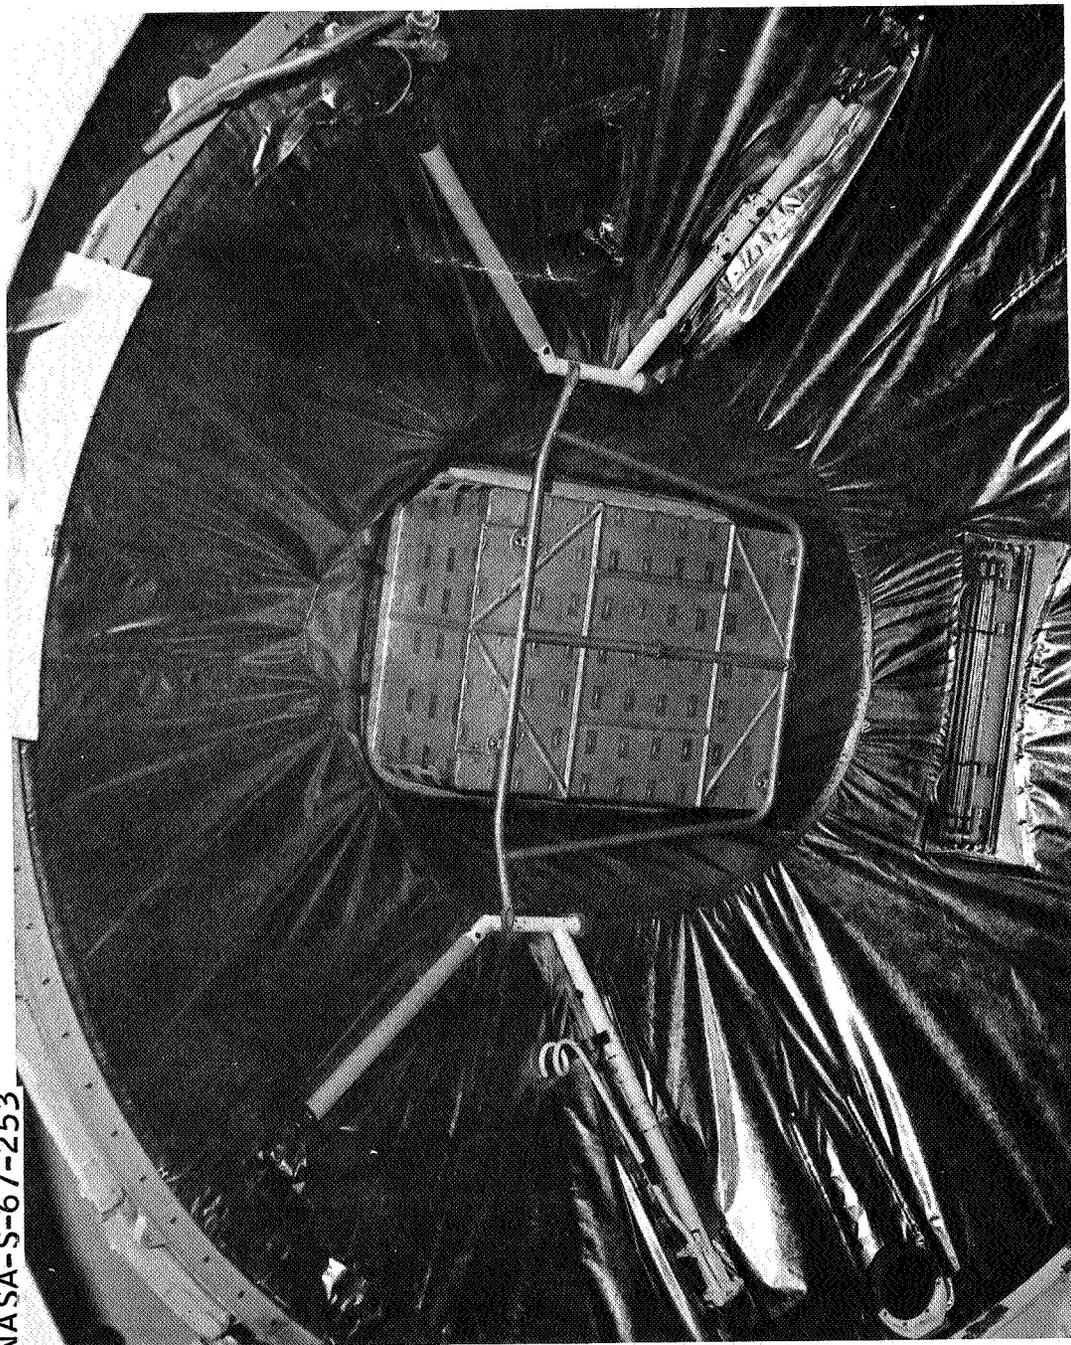
Figure 6.2-2. - AMU installation in spacecraft adapter.
