**SUMMARY OF  
GEMINI EXTRAVEHICULAR  
ACTIVITY**

Reginald M. Machell  
Manned Spacecraft Center, NASA  
Houston, Texas

*Scientific and Technical Information Division*  
OFFICE OF TECHNOLOGY UTILIZATION  
NATIONAL AERONAUTICS AND SPACE ADMINISTRATION  
1967  
*Washington, D.C.*

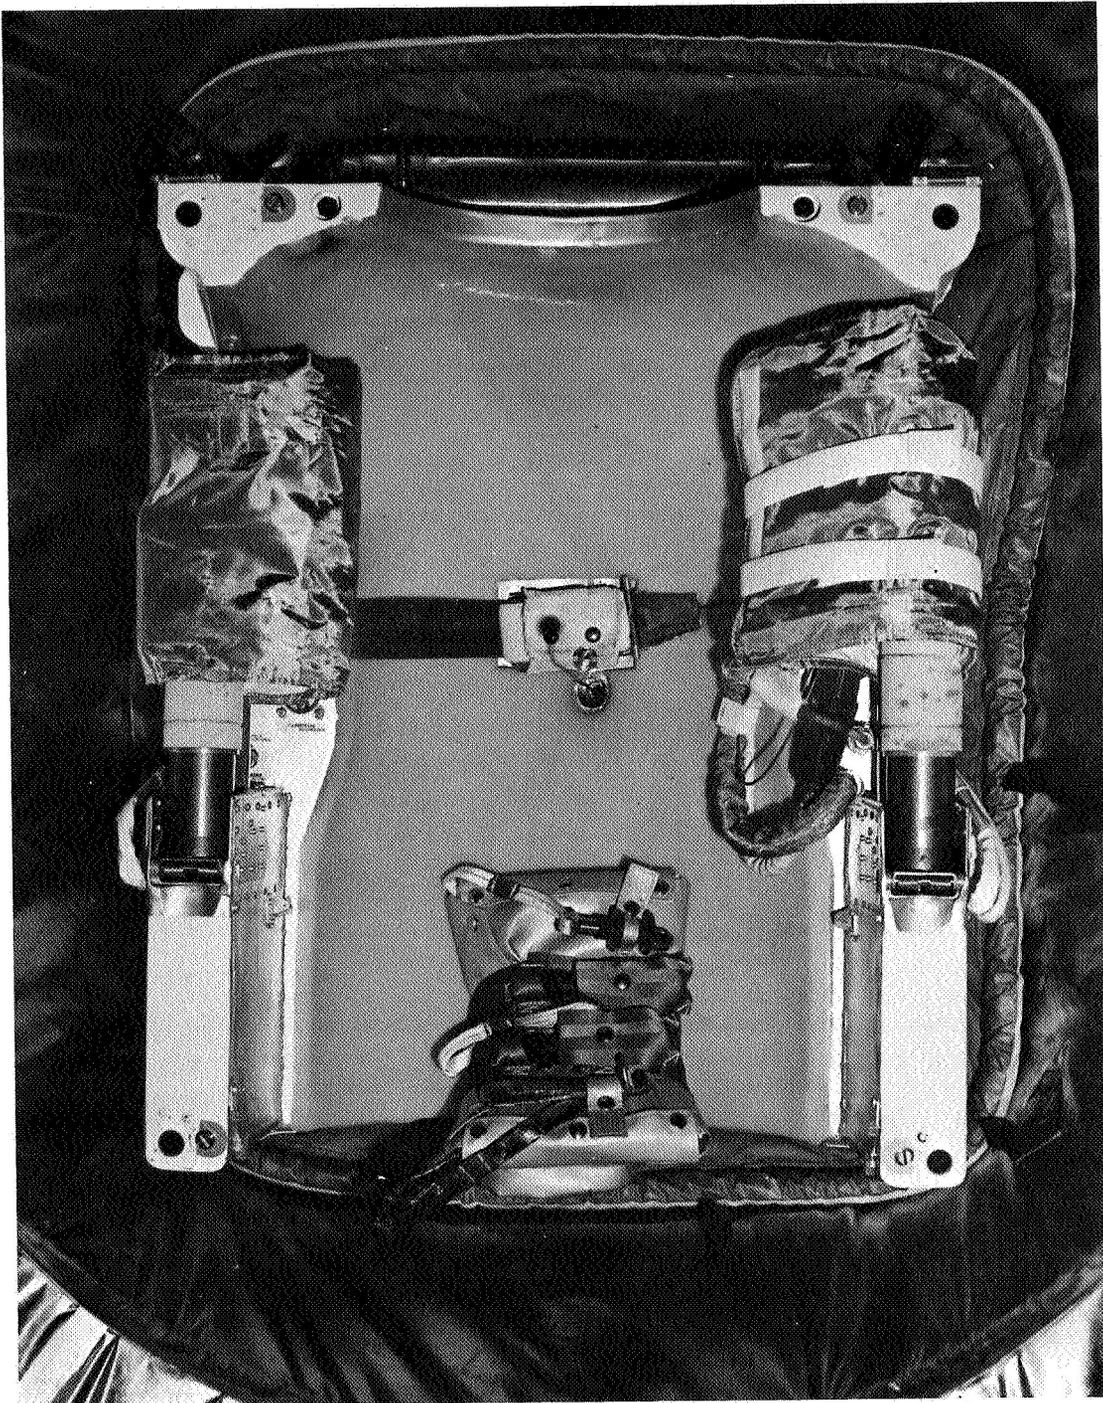
Figure 6.2-4. - AMU with thermal protective cover removed.

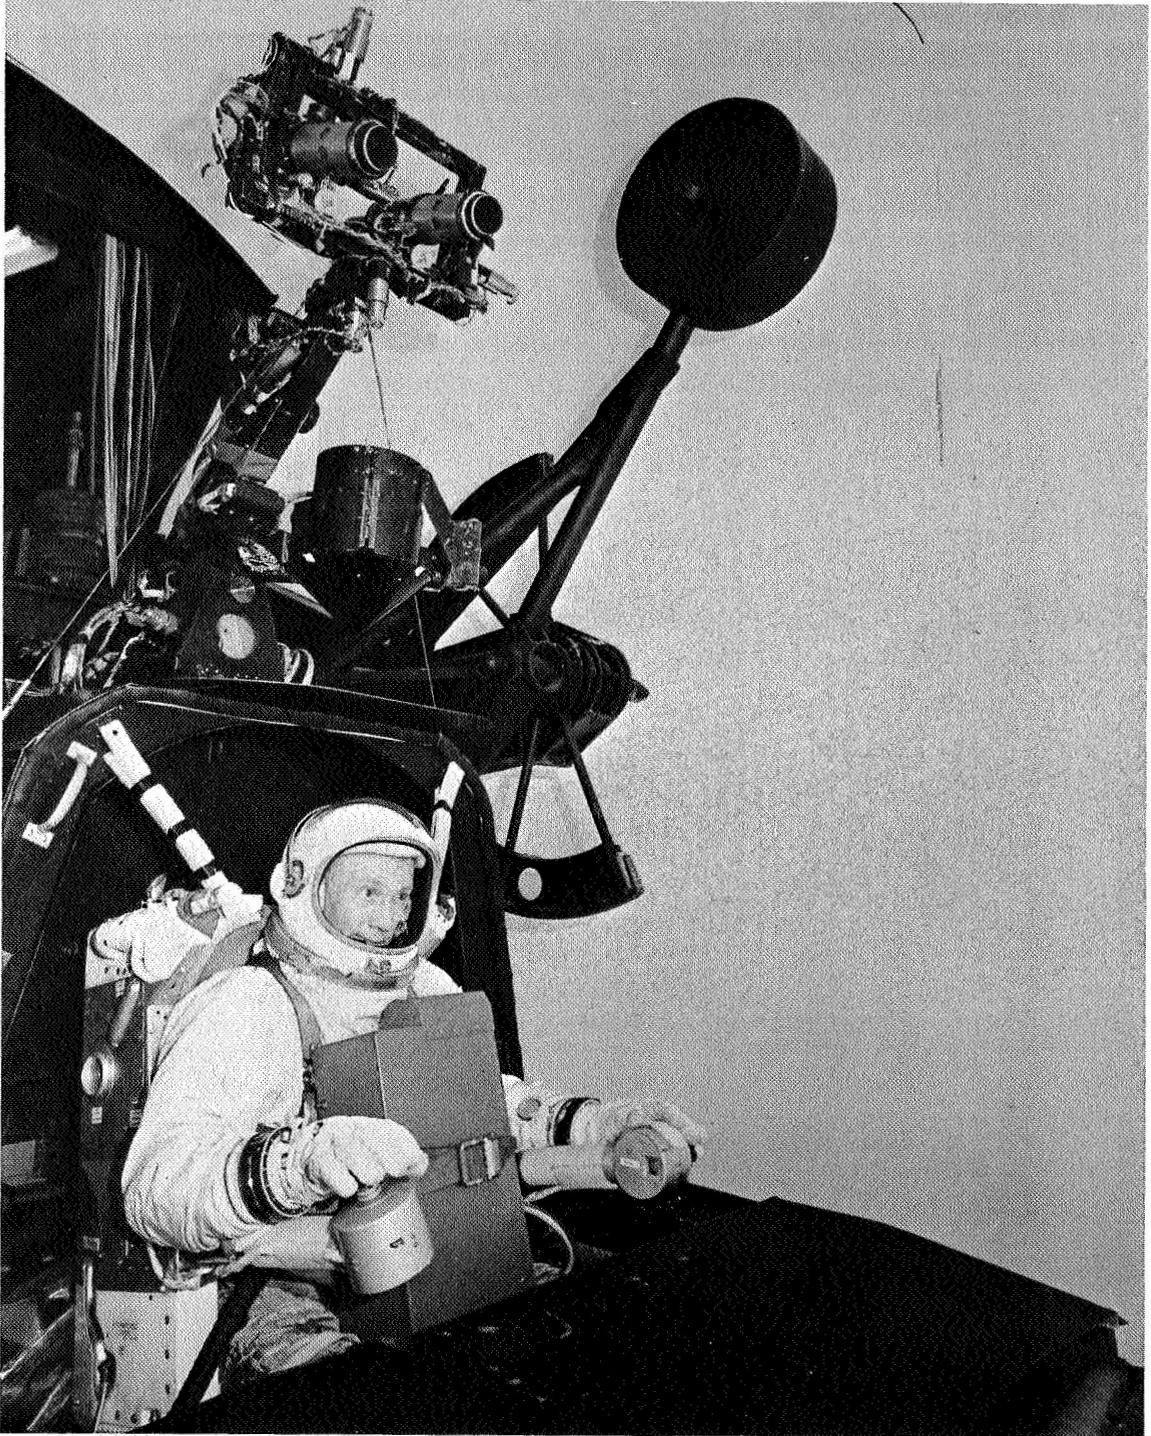
Figure 6.2-5.- AMU moving-base simulator.

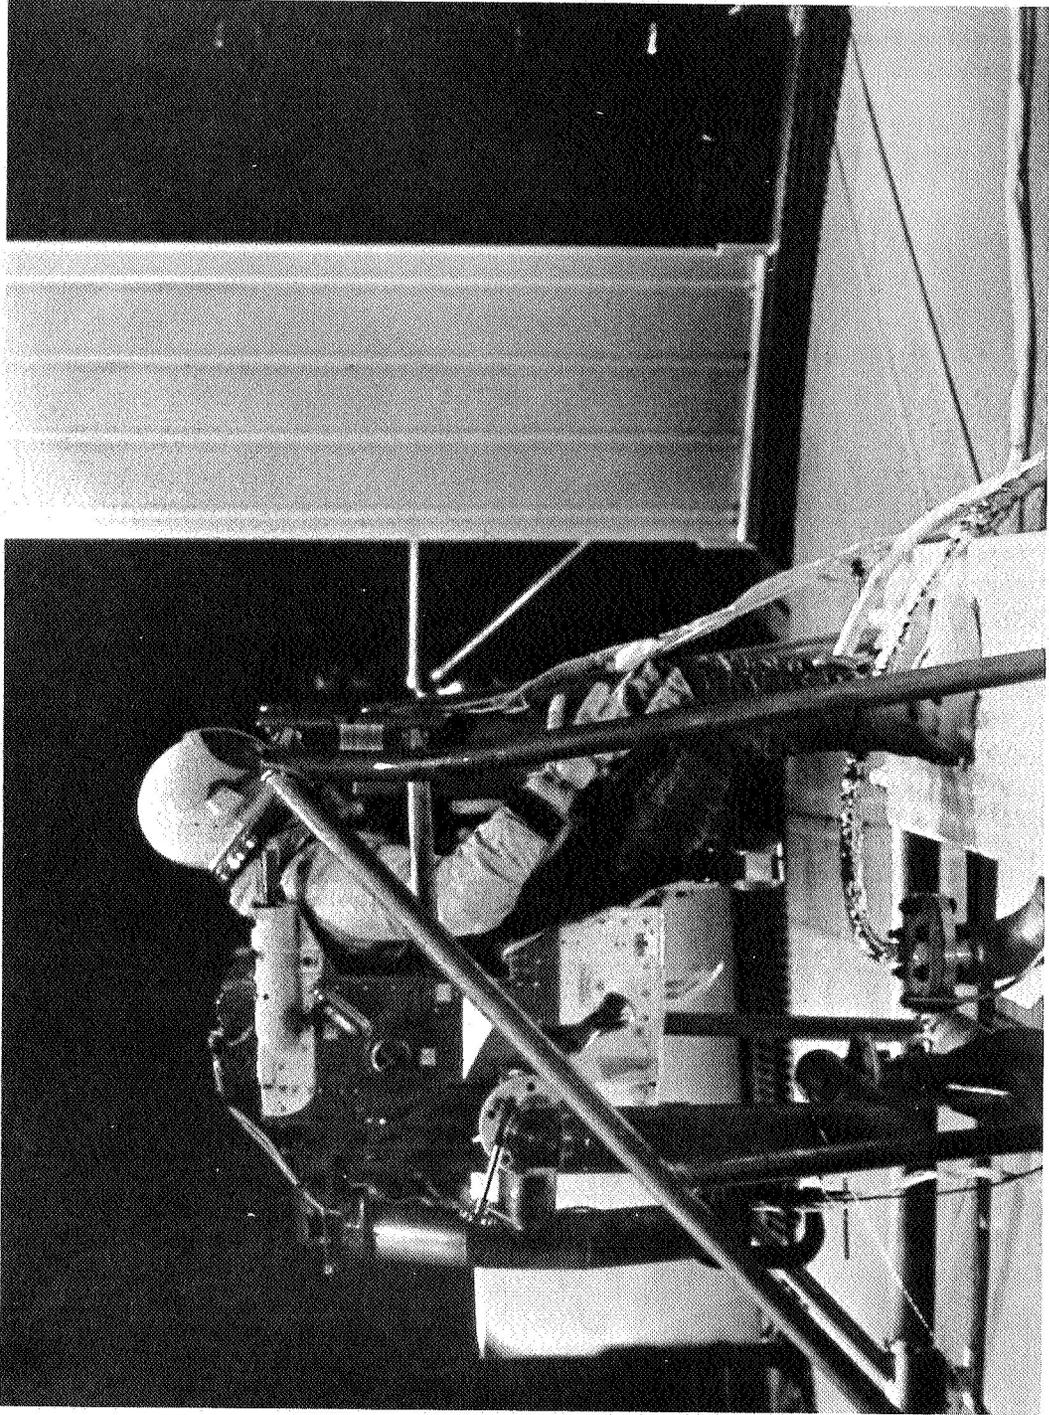
Figure 7.1-3. - Altitude chamber training for AMU.

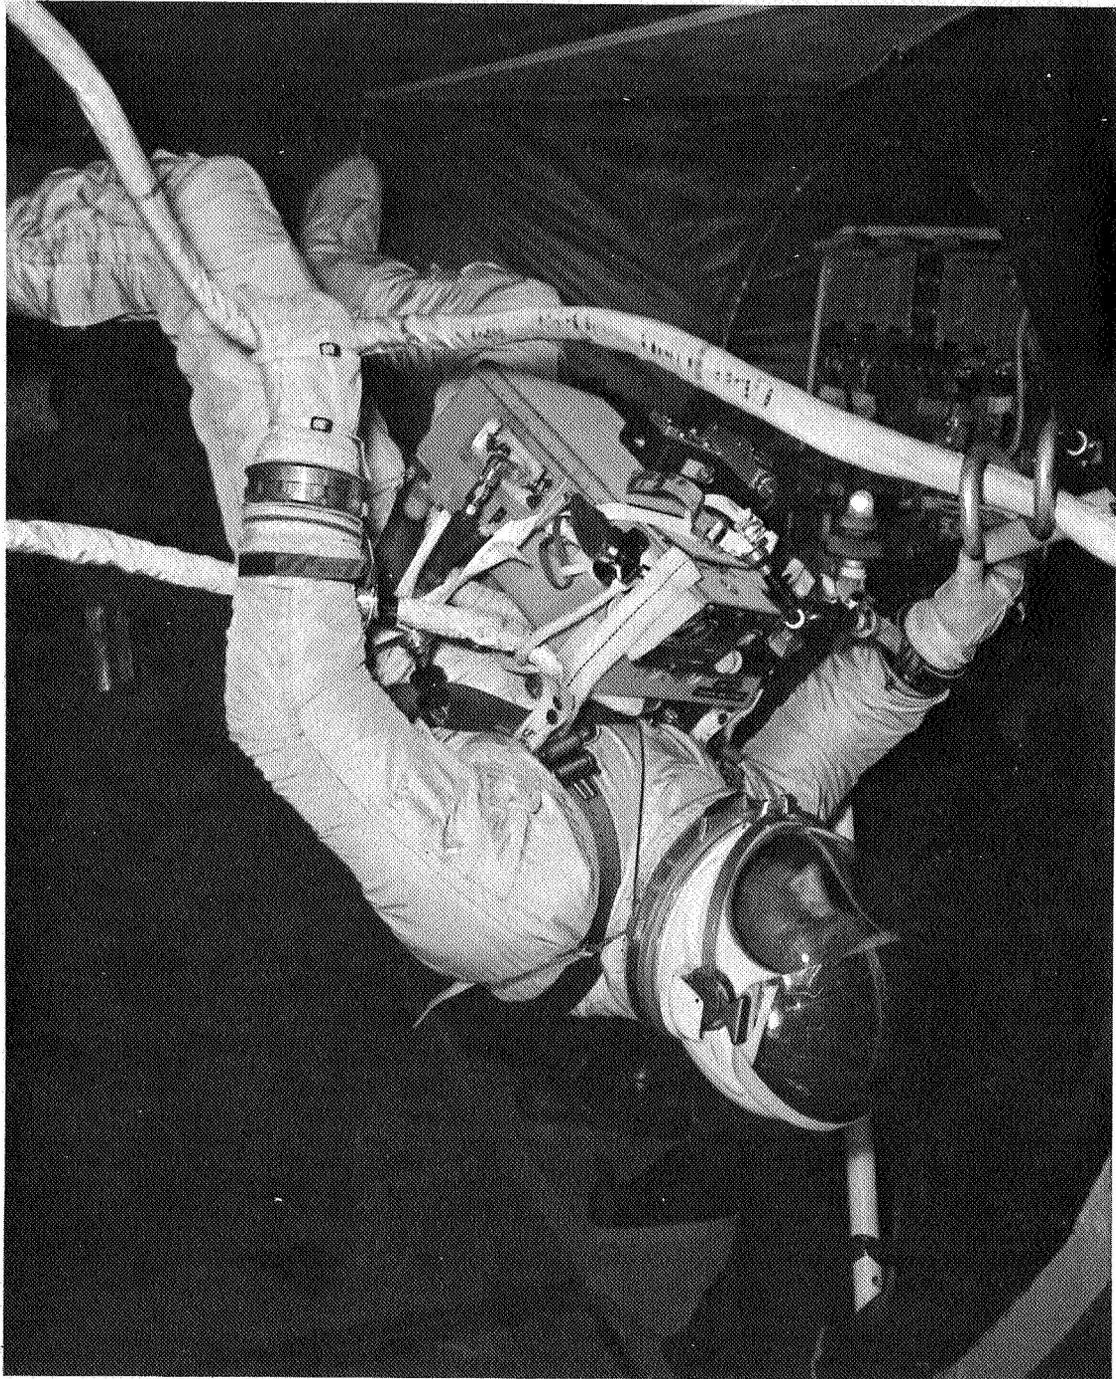
Figure 7.2-9. - Installation of umbilical in adapter umbilical guide.

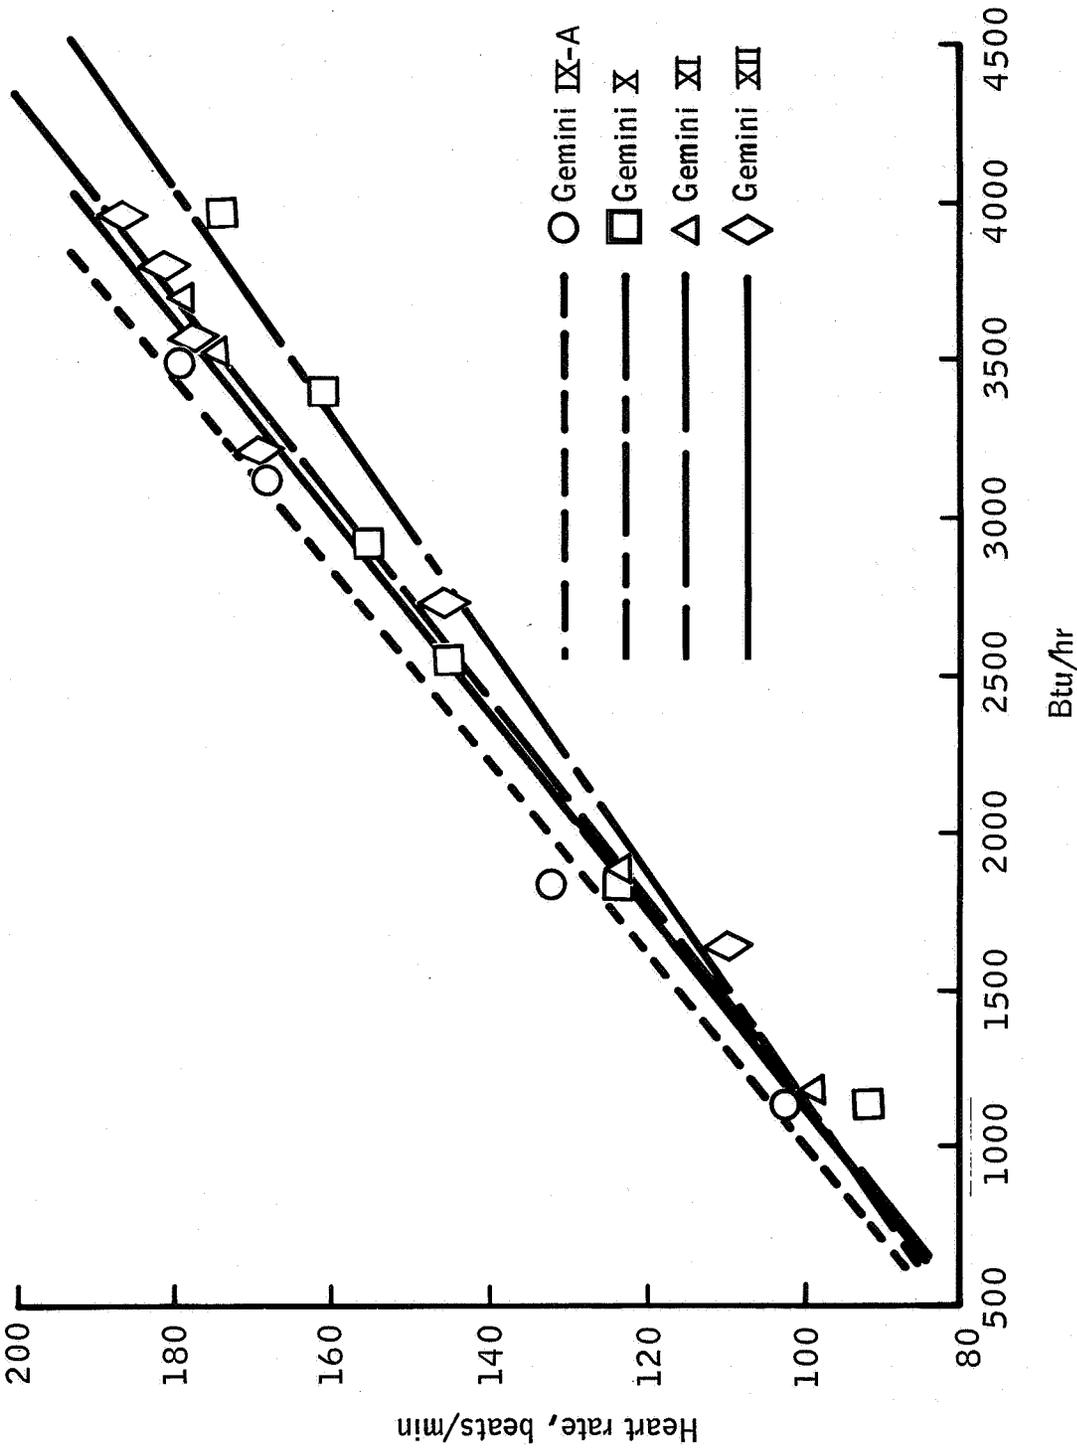
Figure 9.1-1.1. - Preflight ergometry.

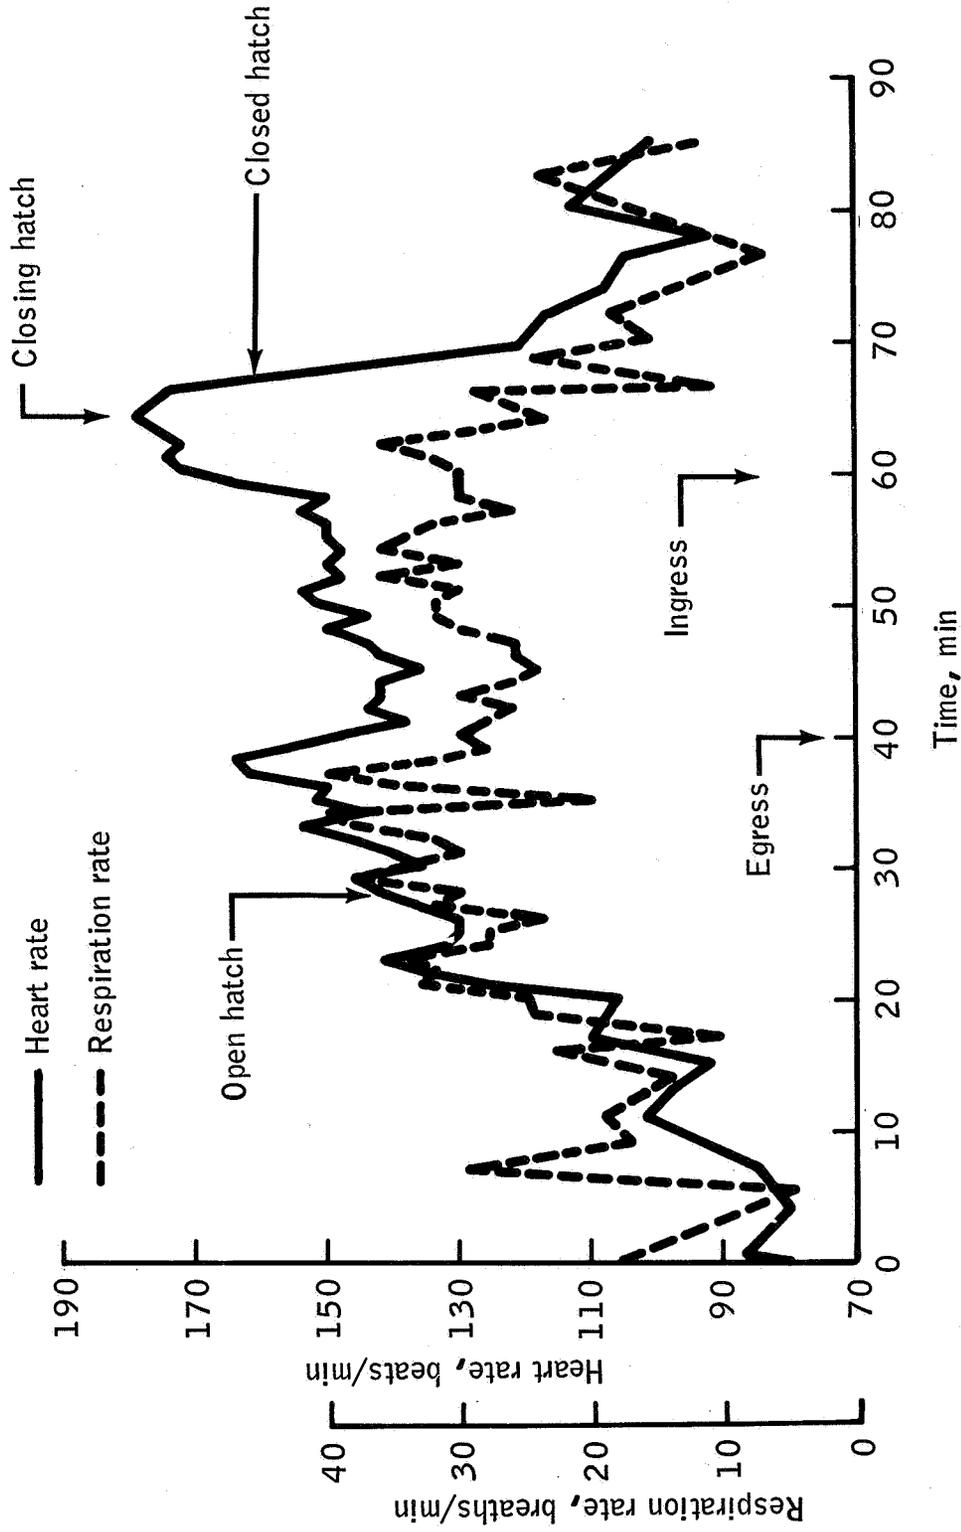
(a) Gemini IV.  
Figure 9.1-3. - Umbilical EVA.

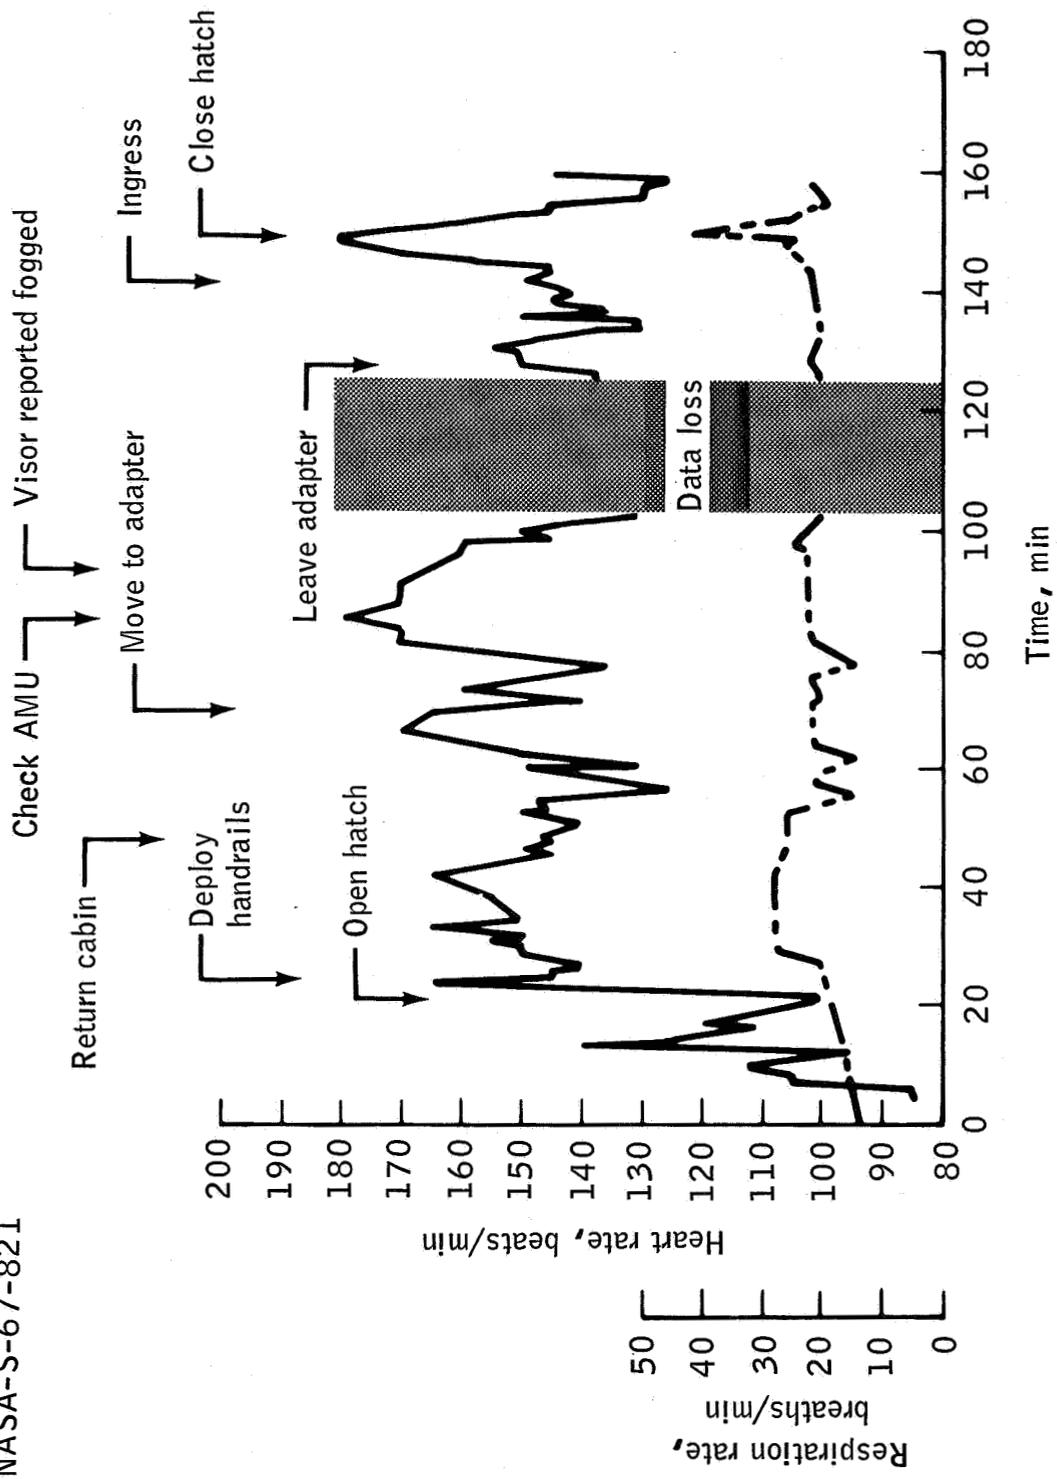
(b) Gemini IX-A.  
Figure 9.1-3. - Continued.

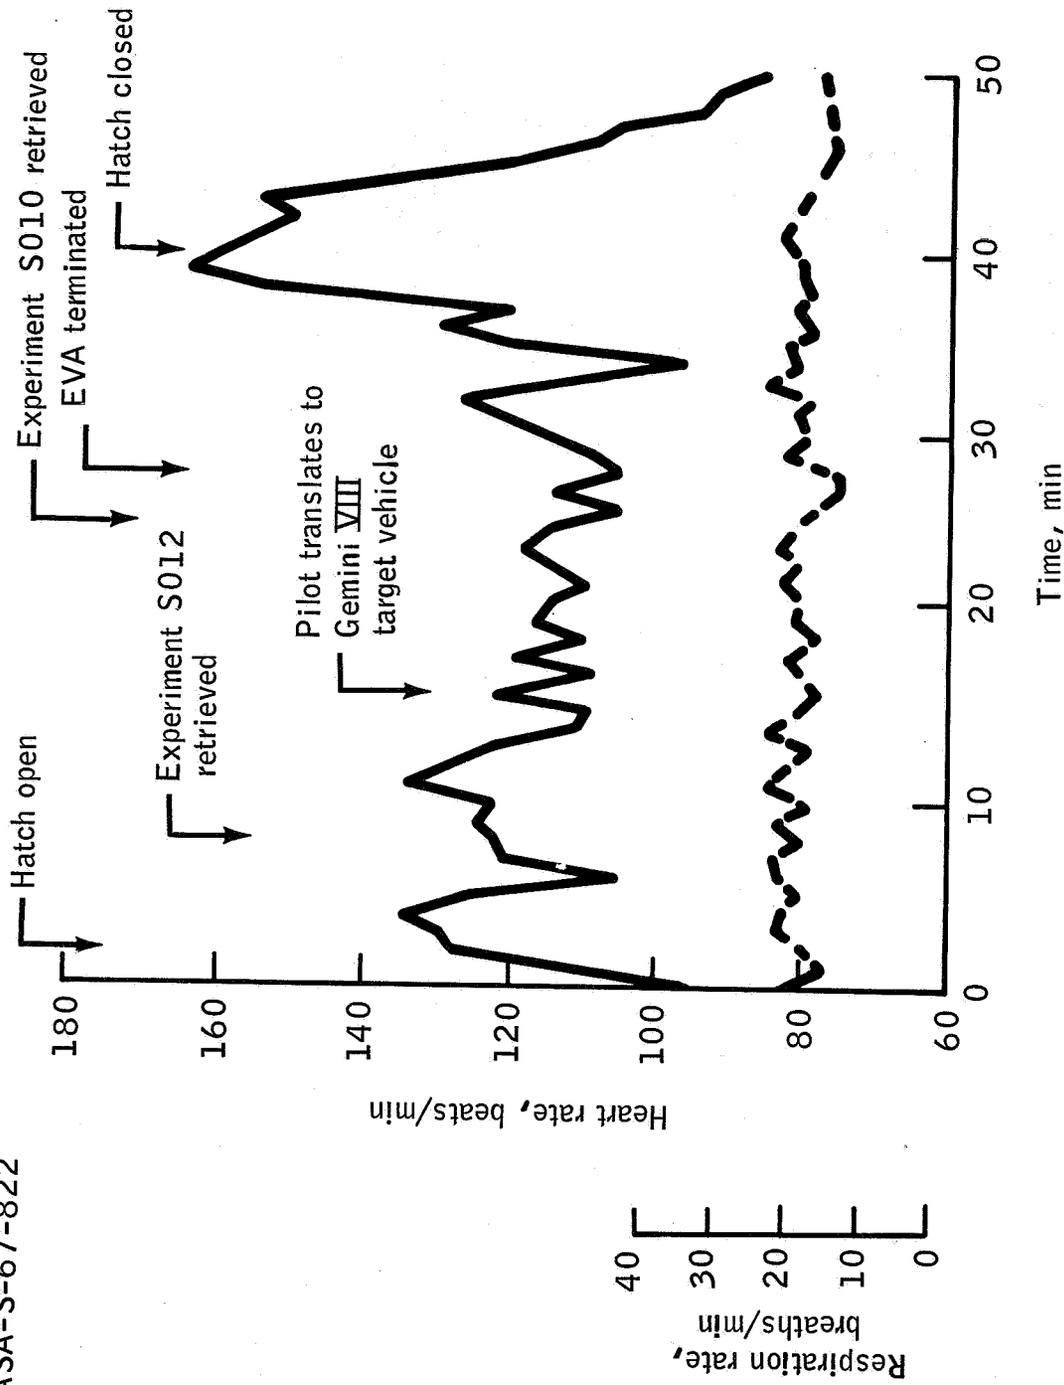
(c) Gemini X.  
Figure 9.1-3. - Continued.

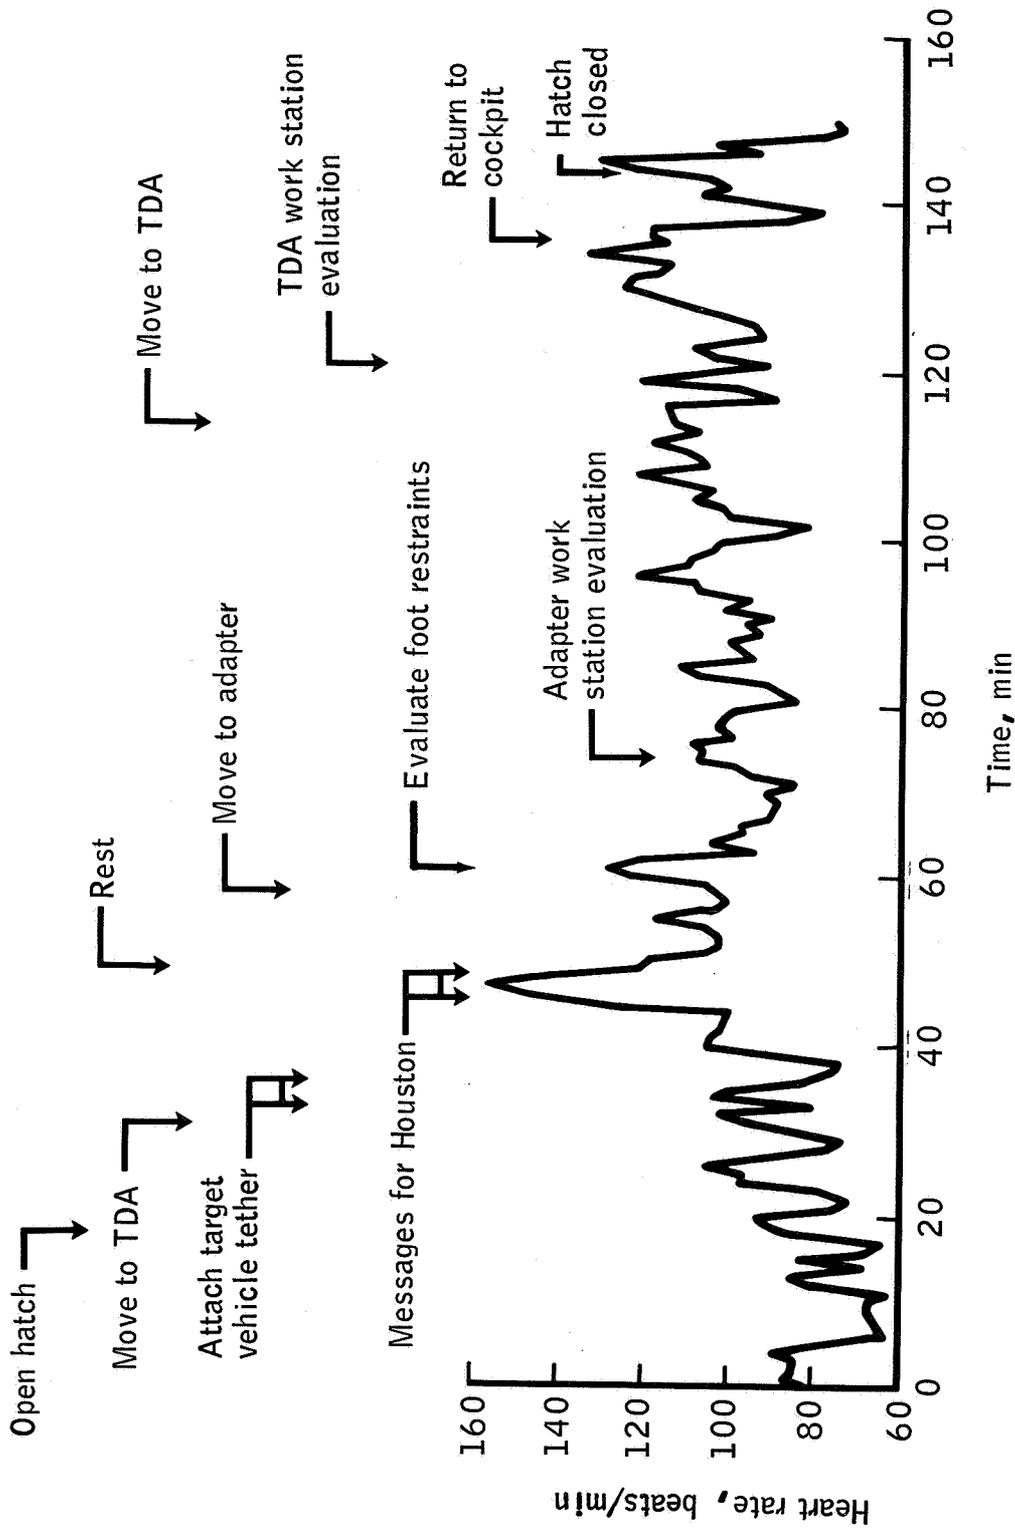
(e) Gemini XII.  
Figure 9.1-3. - Concluded.
