NASA CR-72115
BEECH ER 15091

DEVELOPMENT OF CRYOGENIC POSITIVE EXPULSION BLADDERS

D. H. POPE AND J. E. PENNER

CONTRACT NAS 3-6288

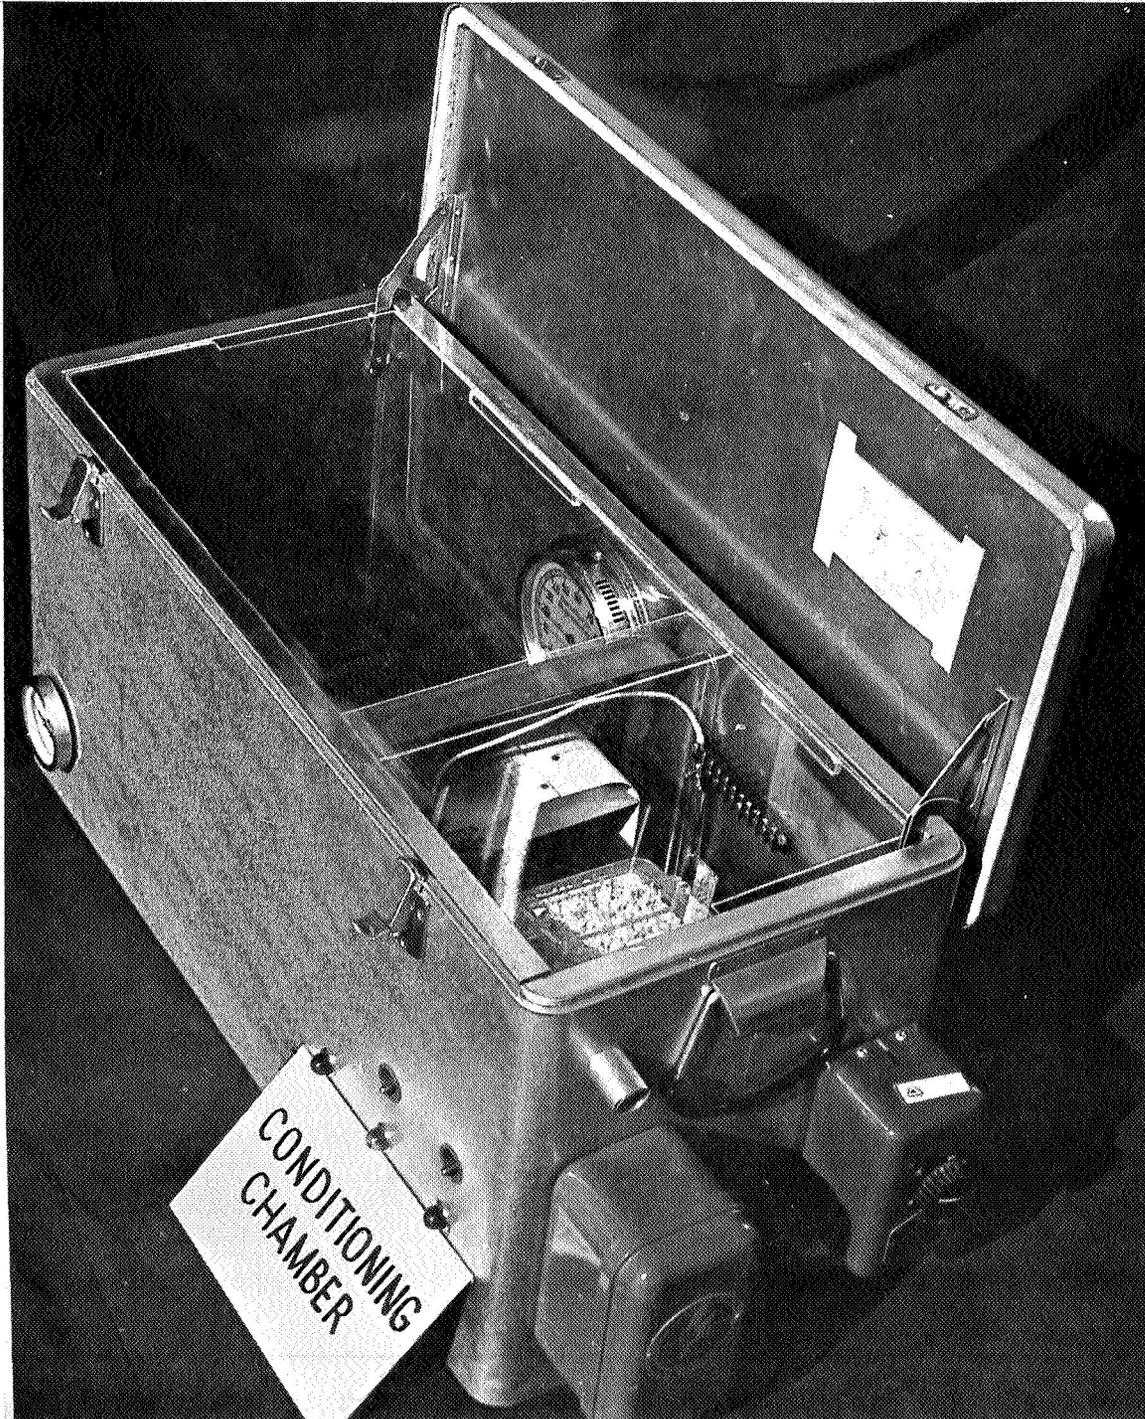
FIGURE 3.13
CONDITIONING CHAMBER

The samples which passed the receiving analysis and permeability check were then placed in an environmental conditioning chamber, shown in Figure 3.13, prior to actually being subjected to the Twist-flex test in liquid nitrogen or hydrogen. The purpose of this chamber was to provide assurance that the samples were all tested under the same conditions of moisture content. The chamber provided both a temperature and humidity control. After removal from the chamber, the samples were installed in the Twist-flex apparatus for flexibility test in liquid nitrogen or liquid hydrogen.

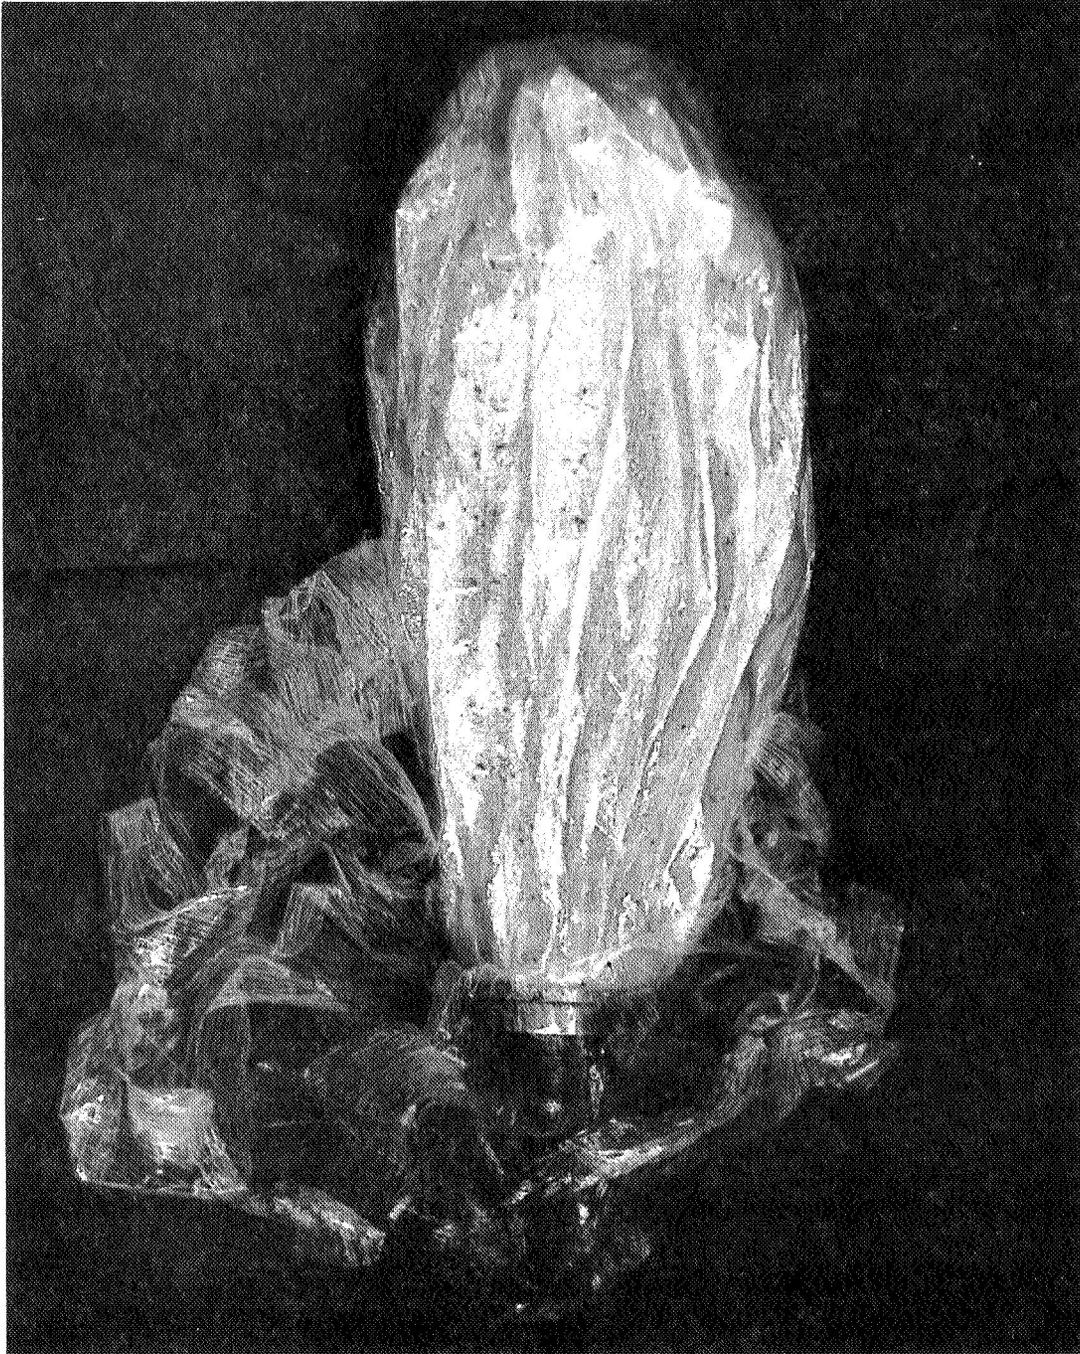
FIGURE 4.18.2

CONDITION OF PLYS: BLADDER B101
